OPTIMIZATION OF CONCRETE PAVEMENT MIX DESIGN IN COLORADO

PHASE I REPORT NO. 2002-8

*An Executive Summary Report
Developed by The Transtec Group, Inc.
26 June 2002*

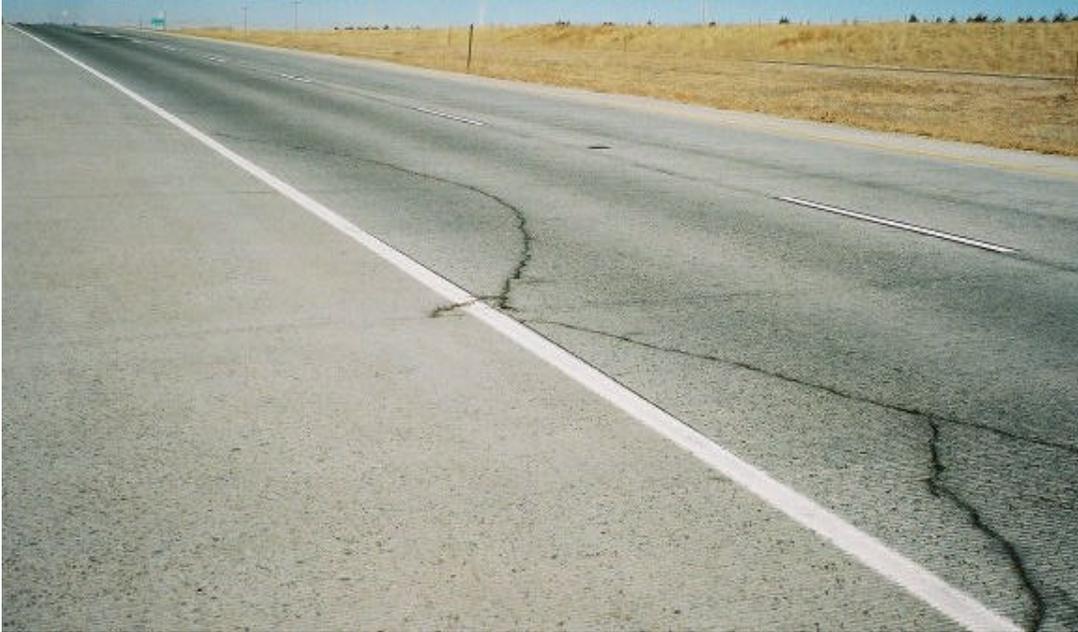
- Some longitudinal cracking observed.
- Cracks have been routed and sealed.
- Cracking could be due to loss of support or from late sawing.

Figure B-1. Longitudinal Cracking of I-70.

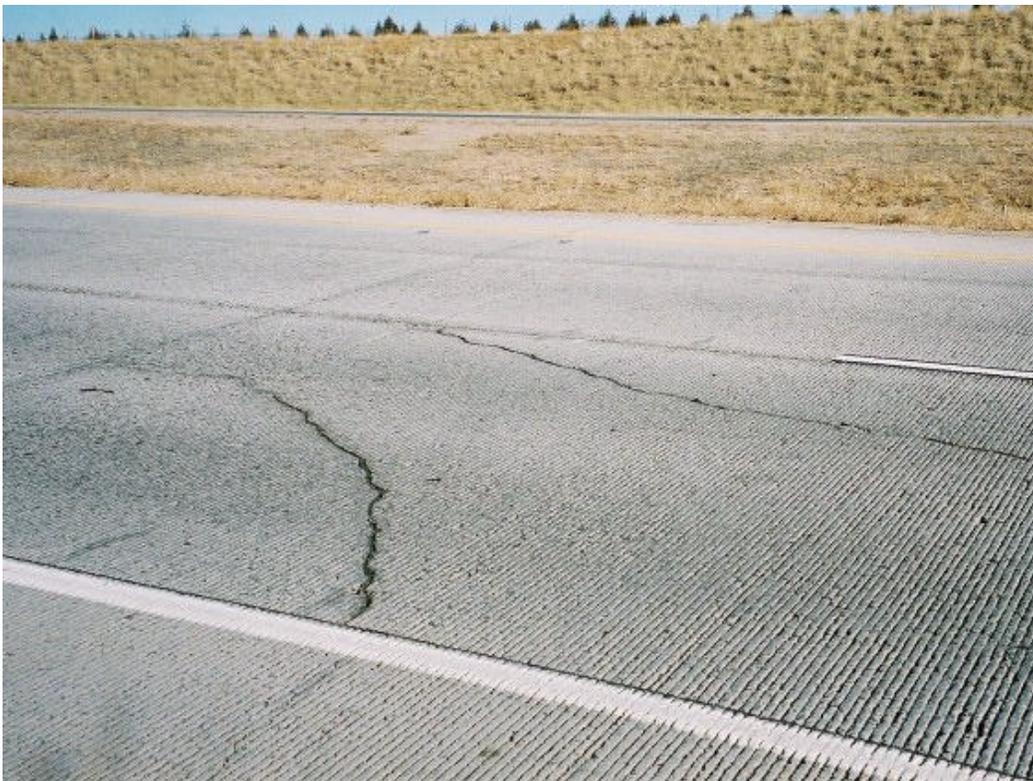
Figure B-2. Longitudinal Cracking of I-70.

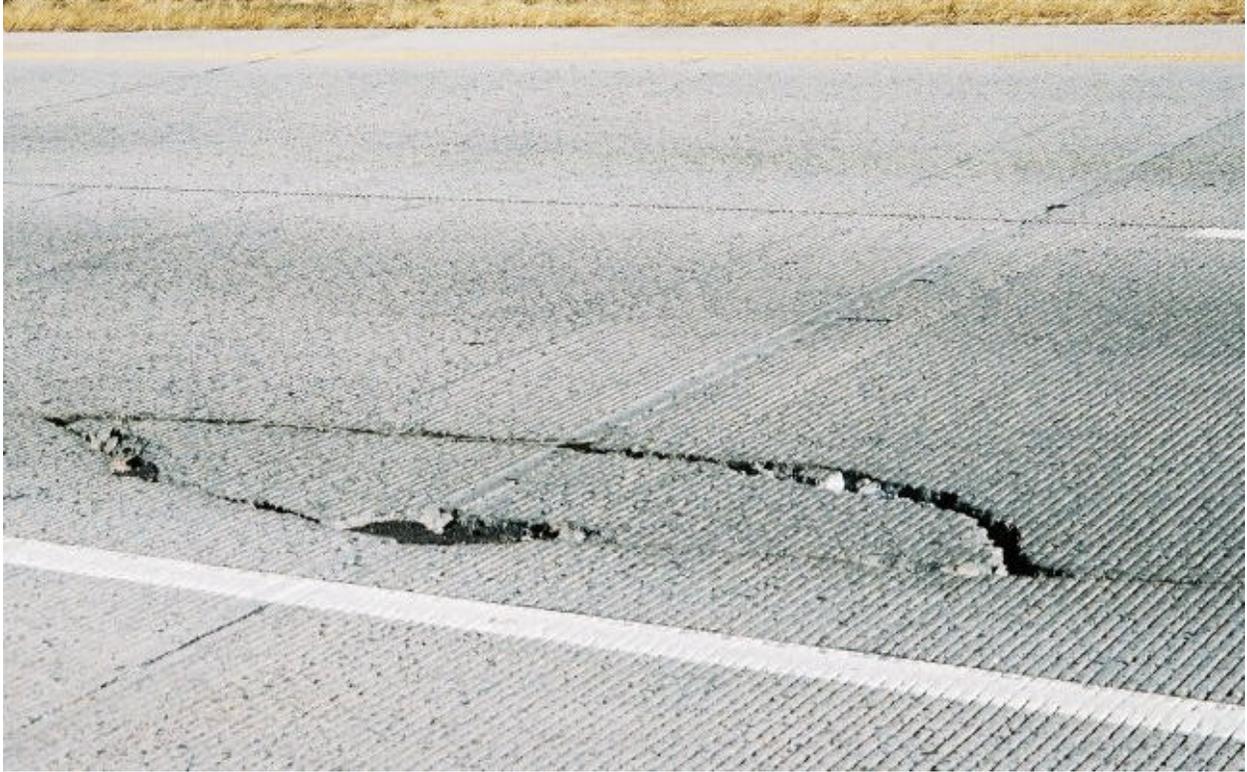
- Evidence of spalling at the cracks.
- Some patching of the spalls noted with an asphalt mix, however additional spalling has progressed after patching.

Figure B-3. High Severity Spalling of Cracks on I-70.

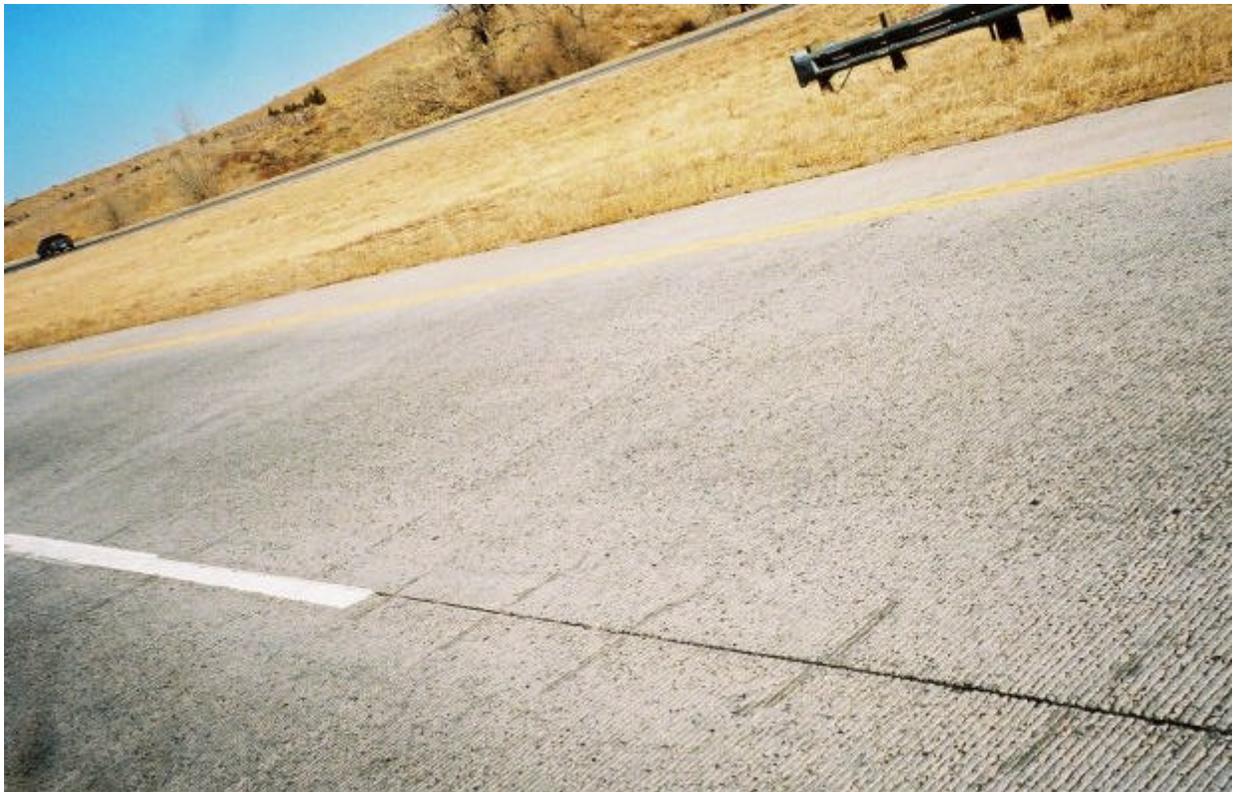
- Significant spalling observed at a longitudinal crack parallel and adjacent to the shoulder.
- Tie-bar “scars” observed. Possibly due to lack of compaction (vibration) from the tie-bar insertion both between the lanes, and at the shoulder.

Other observations included “scarring” of the surface at the tie bar locations observed on both the I-70 and US-34 projects. Improper consolidation of the concrete immediately above the tie bars is suspected. Discoloration of the surface was noted, but no significant disintegration of the concrete was found. On the western I-76 location, some cracks were found to have a white-colored residue. This residue may simply be deicing salt crystals, or it may instead be indicative of a chemical reaction, possibly alkali-silica. However, crack patterns that are typically observed in conjunction with a severe chemical reaction were not noted. A petrographic evaluation of these pavements should reveal additional information.

Figure B-4. Tie-Bar "Scarring" on I-70.

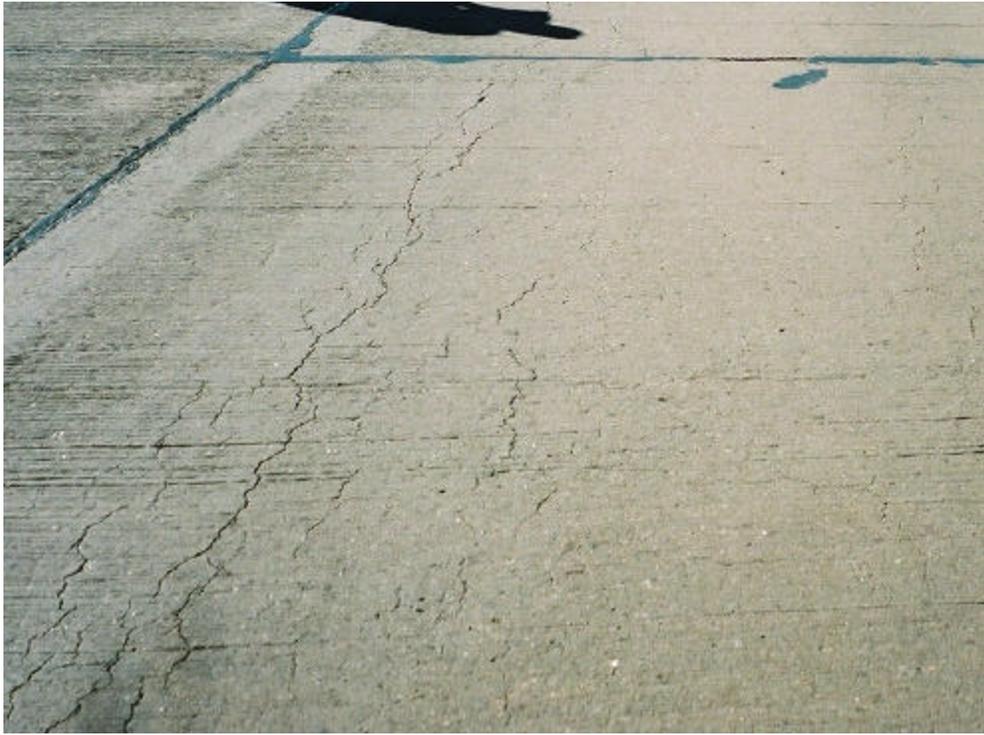
Figure B-5. Possible Fatigue Cracking on I-76 (Western Site).

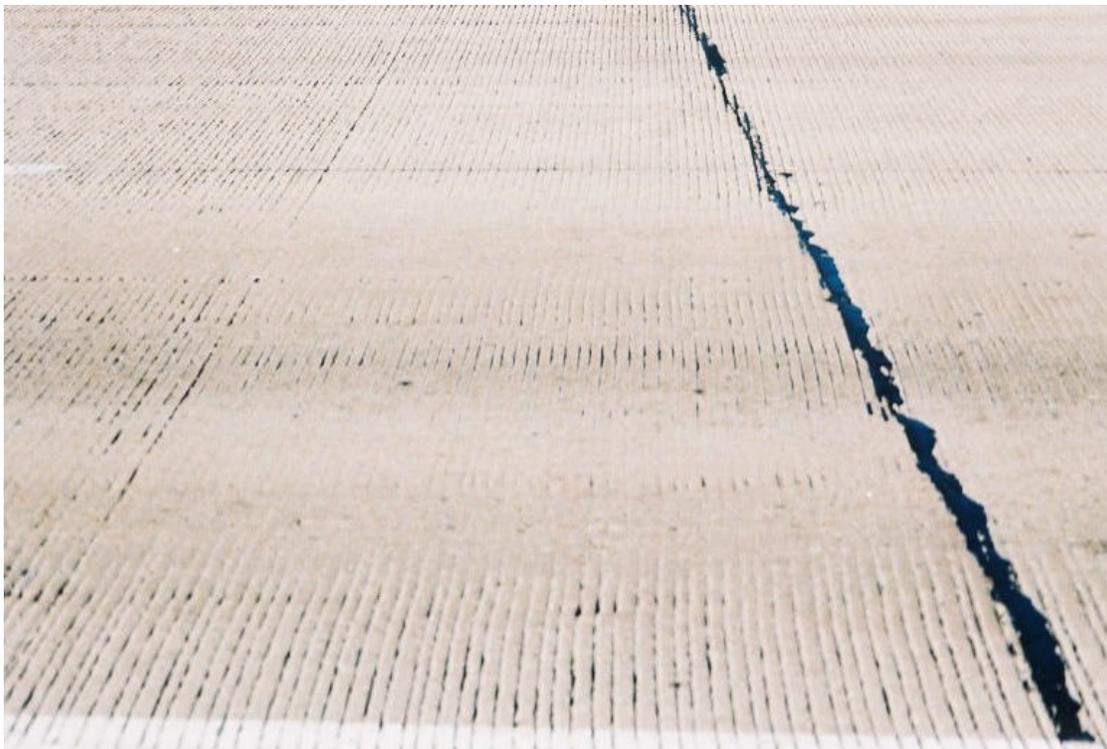
Figure B-6. Surface Polishing on I-76 (Western Site).

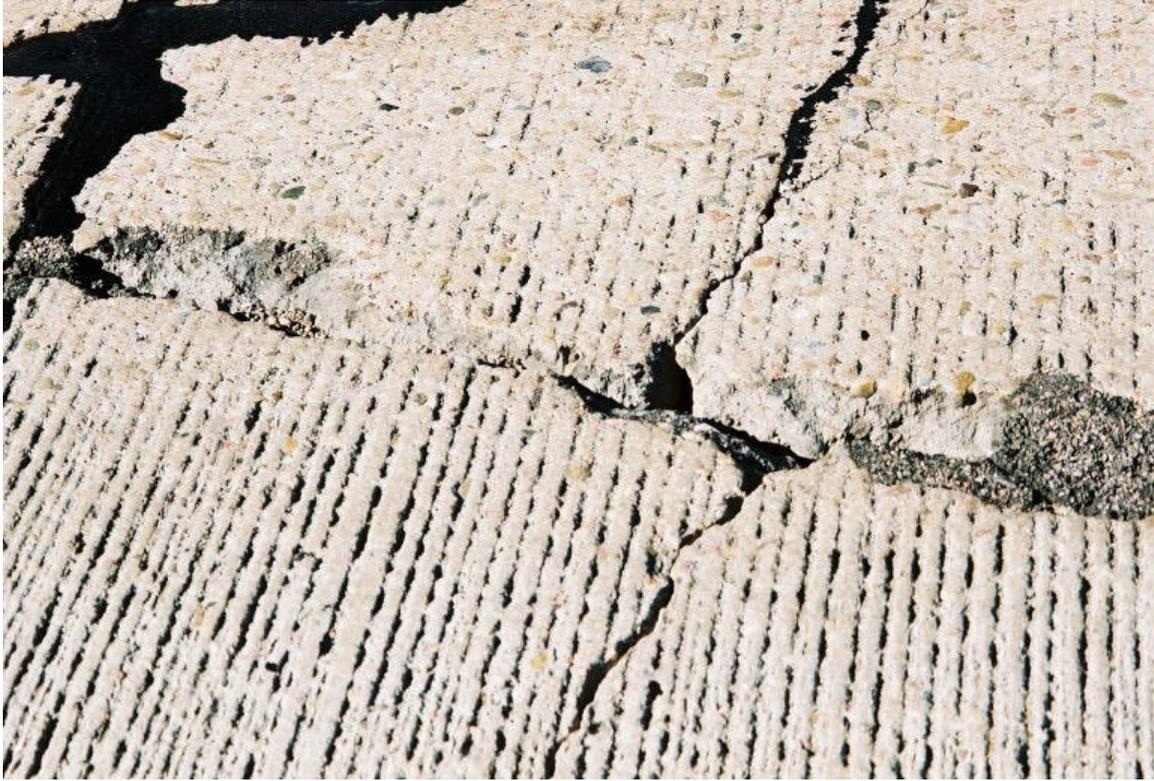
Figure B-7. Severe Spalling on I-76 (Western Site).

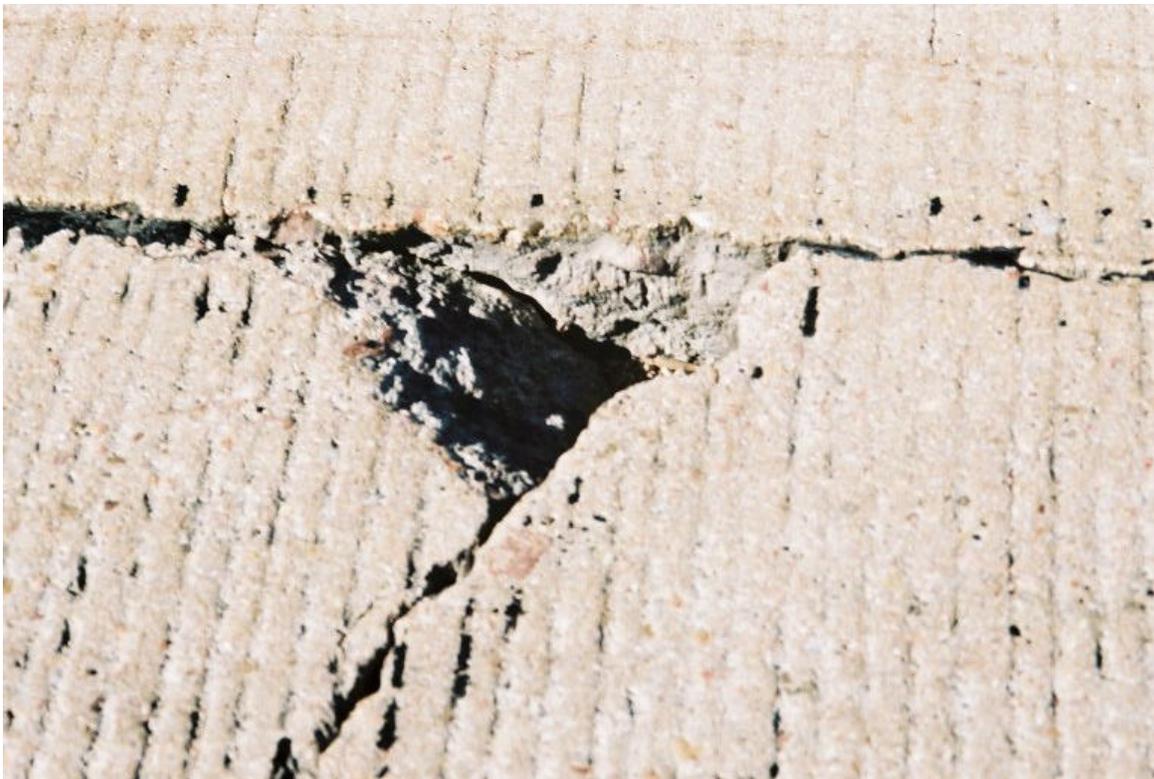
Figure B-8. Severe Spalling on I-76 (Western Site).

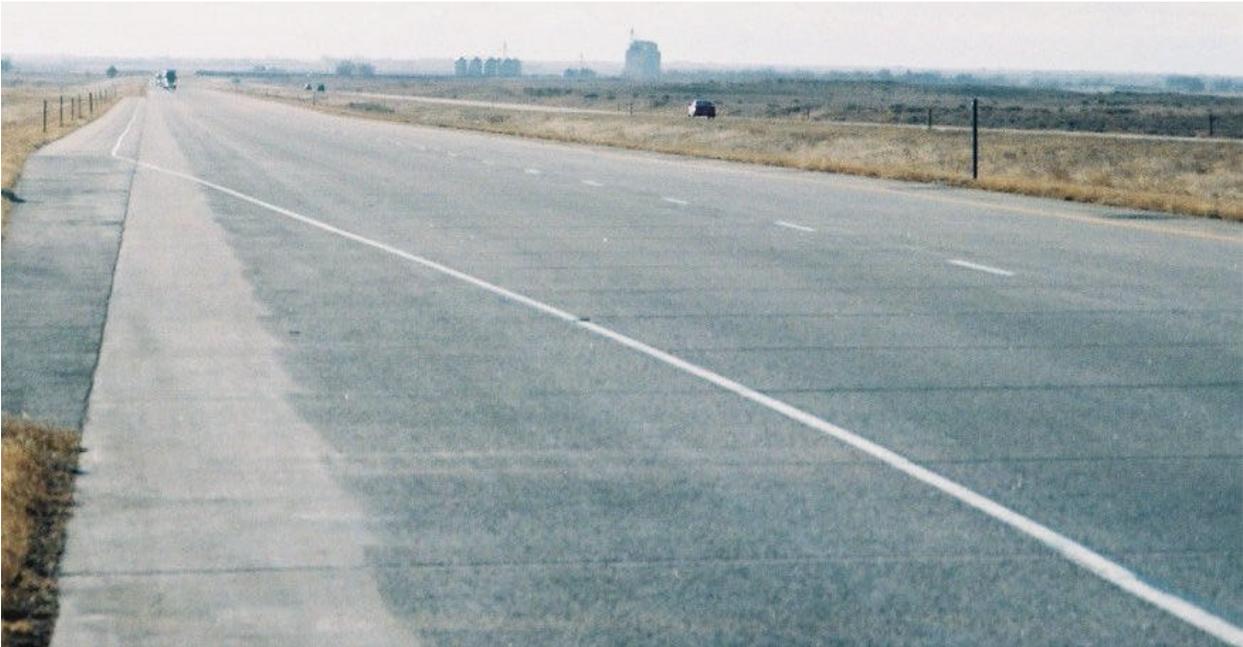
Figure B-9. Good Pavement Condition on I-76 (Eastern Site).

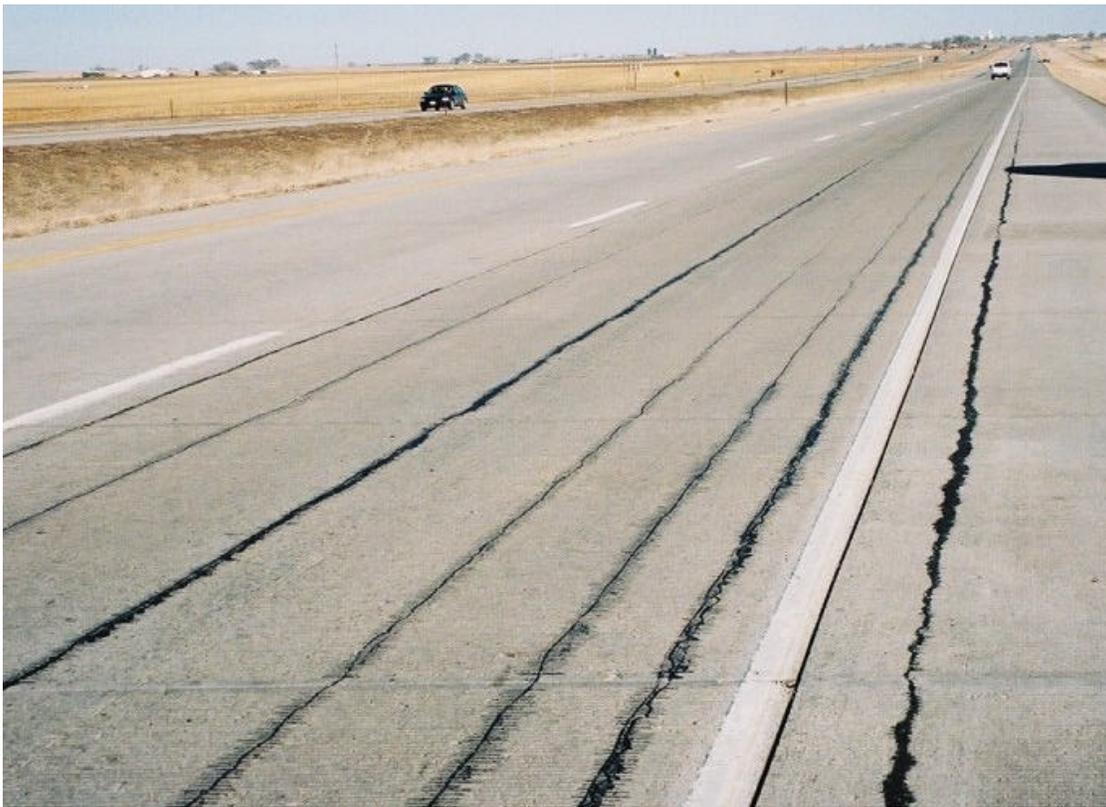
- Longitudinal cracking noted in PMS data is due to grooves in the pavement, not cracks.
- No polishing in wheelpath apparent.
- Ride quality is good.

Figure B-10. Traffic Scarring of Pavement Falsely Identified as Longitudinal Cracking by PMS on I-76 (Eastern Site).

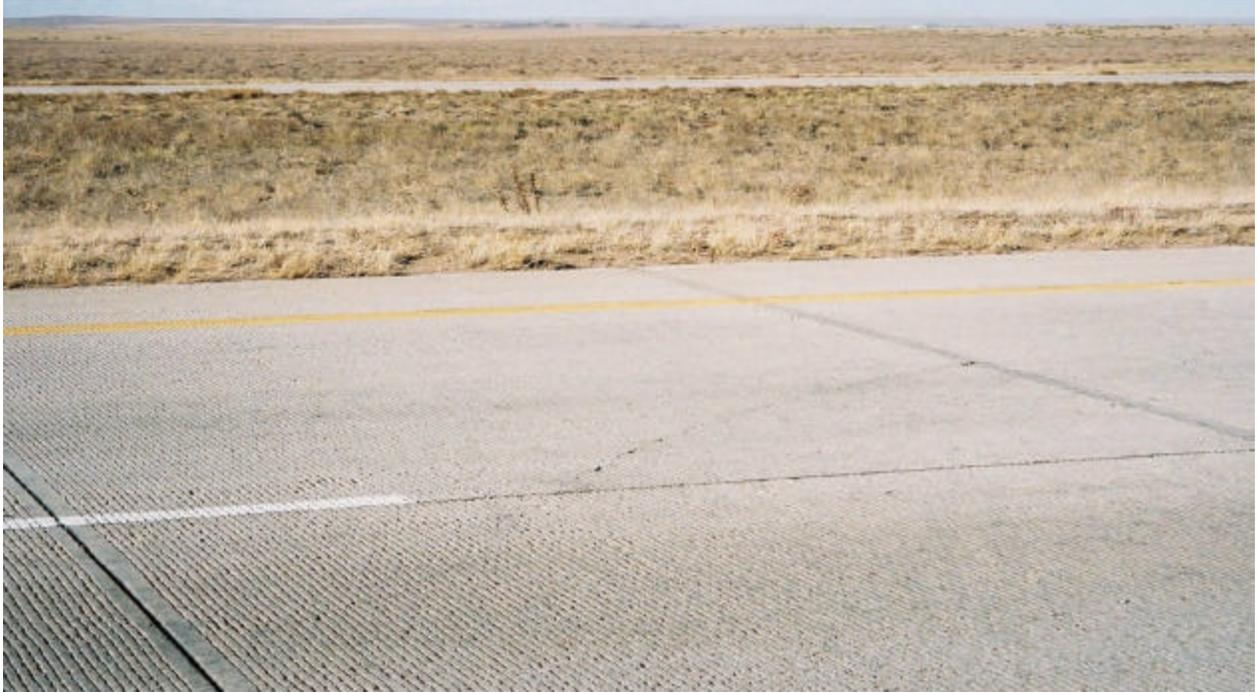
Figure B-11. Occasional Slab Crack on I-76 (Eastern Site).

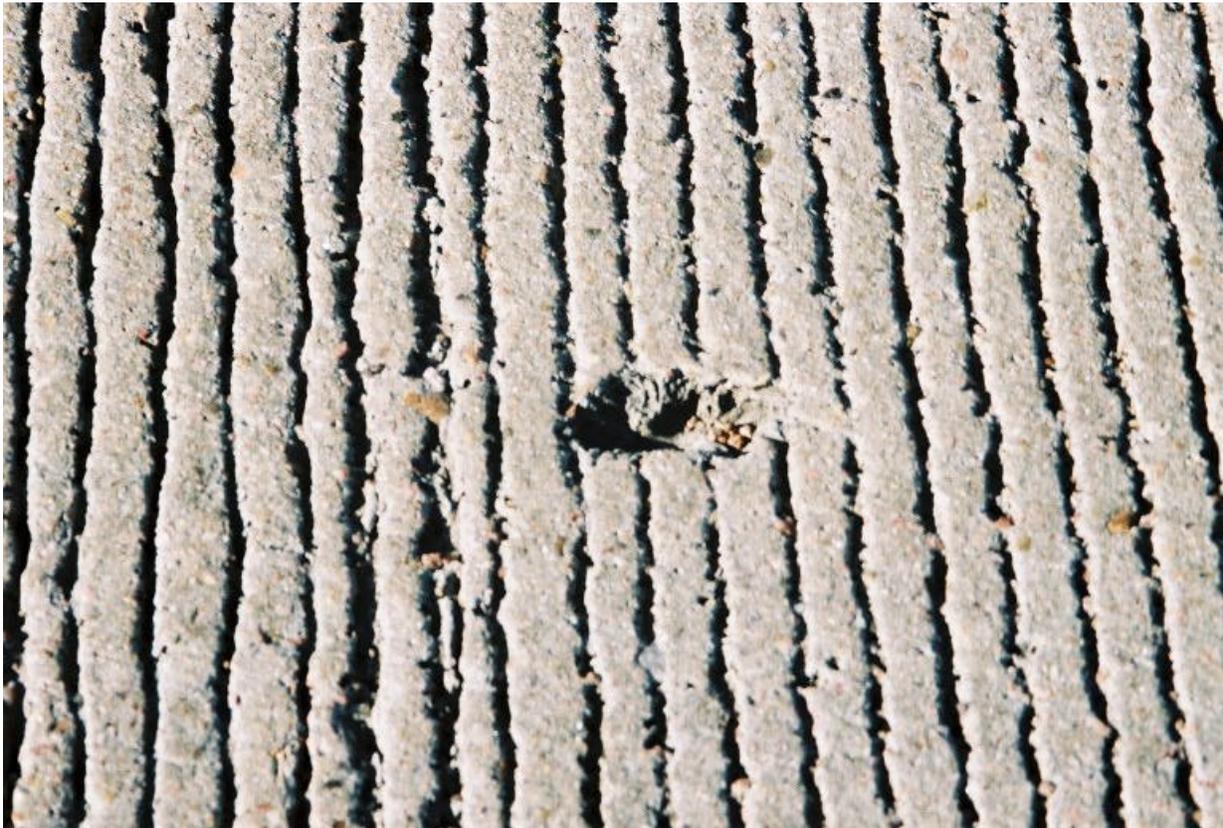
Figure B-12. Occasional Minor Popout on I-76 (Eastern Site).

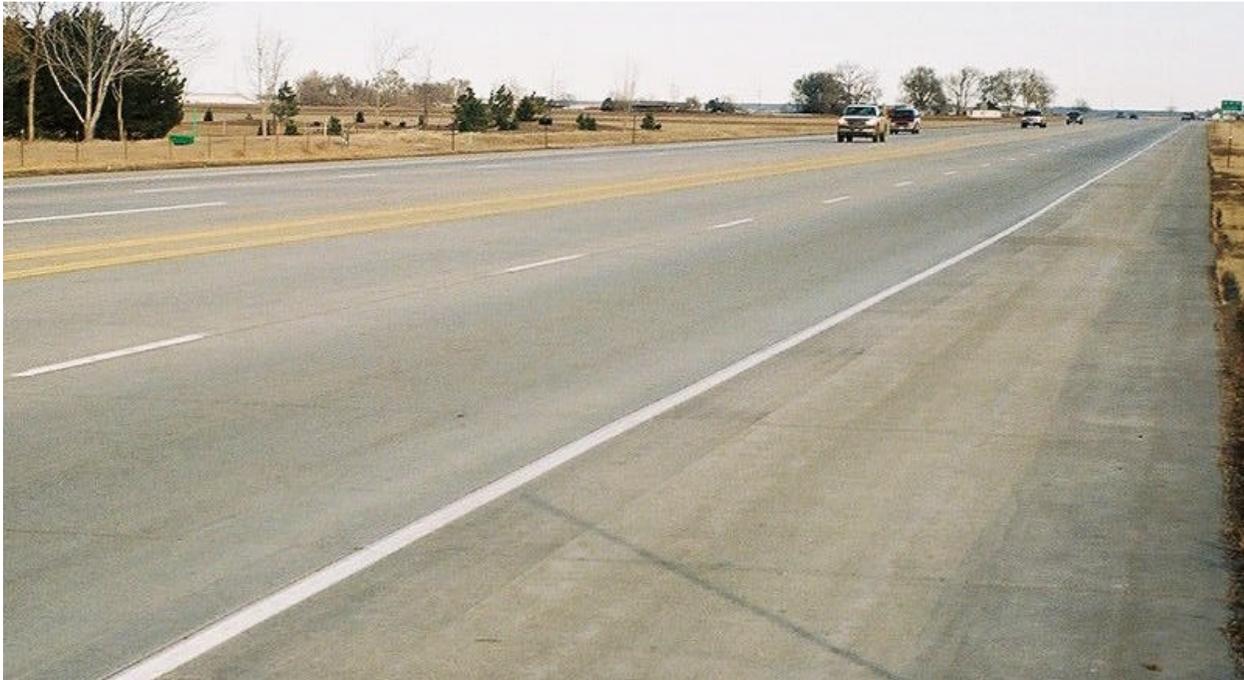
Figure B-13. Good Pavement Condition on US-34.

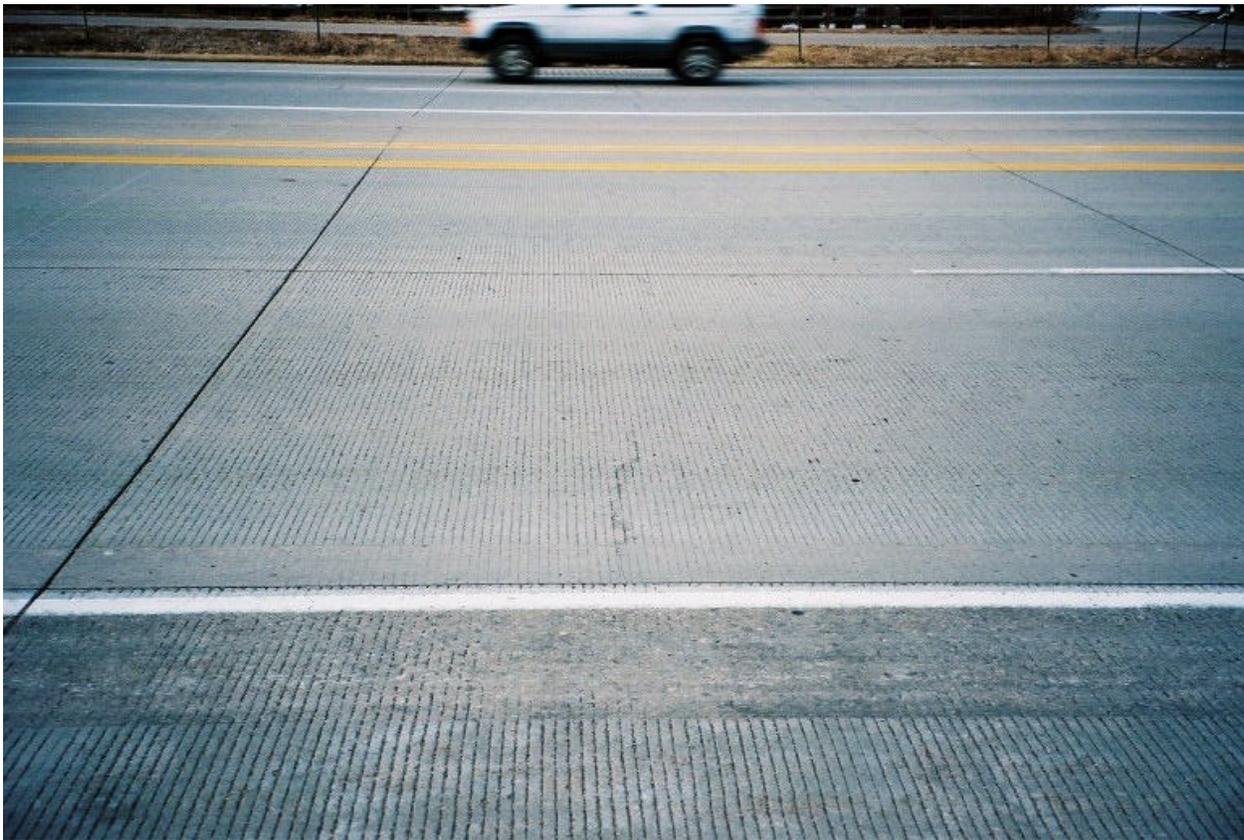
Figure B-14. Localized Mid-Panel Transverse Cracking on US-34.

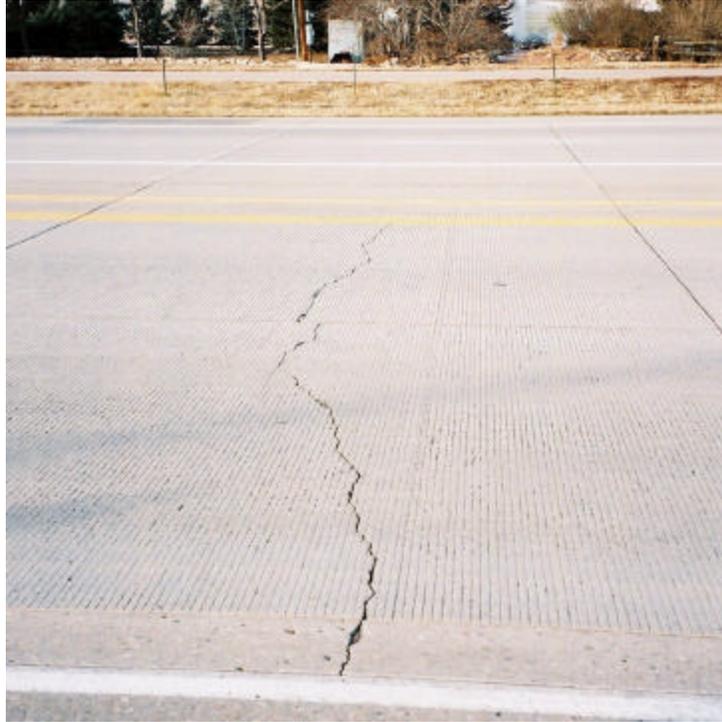
Figure B-15. Localized Mid-Panel Transverse Cracking on US-34.

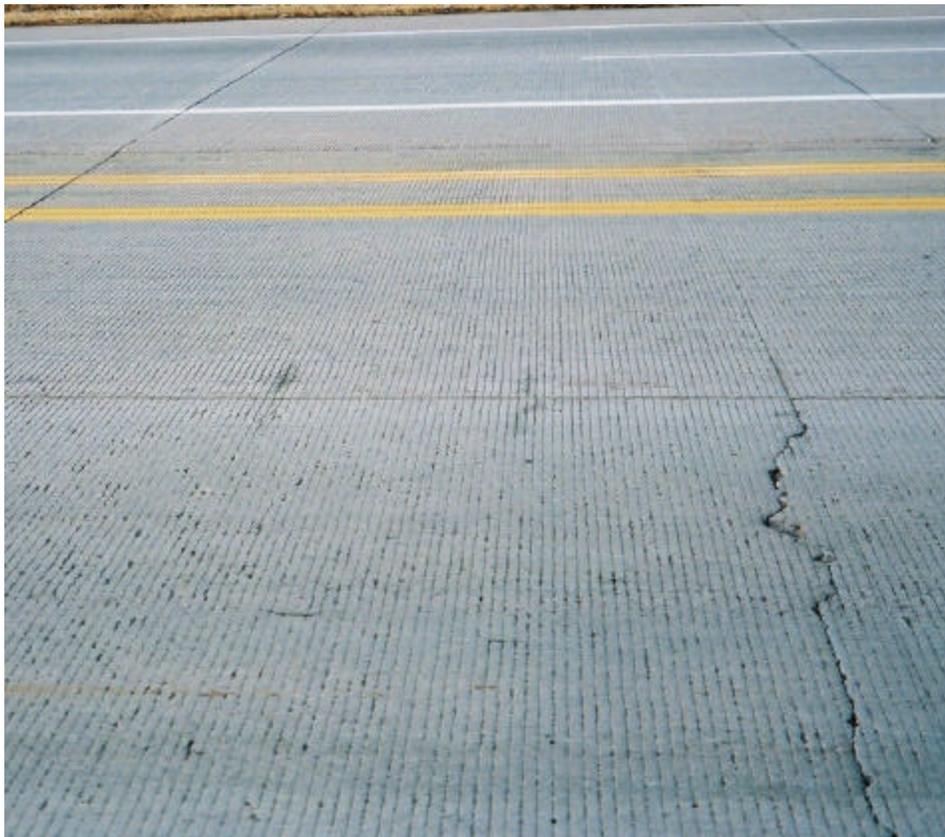
Figure B-16. Mid-Panel Crack and Tie-Bar "Scarring" on US-34.

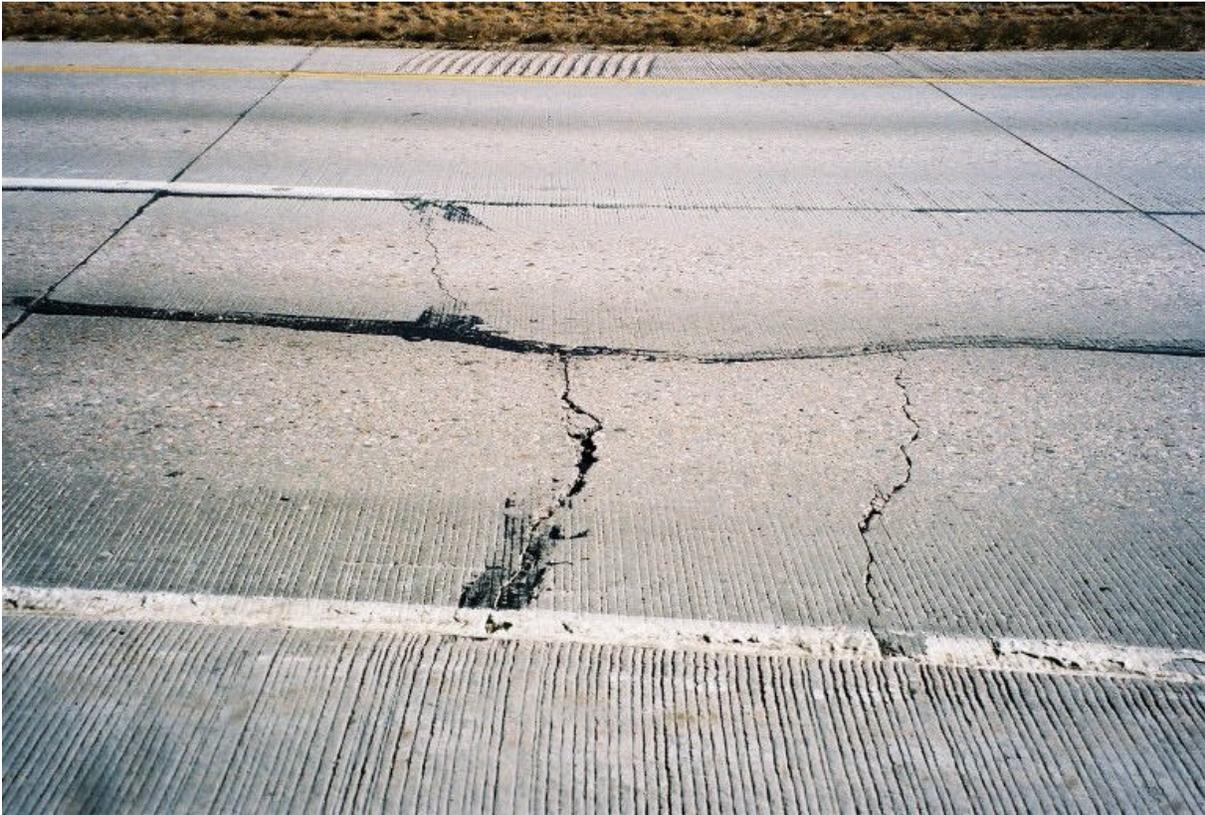
Figure B-17. Shattered Slab on I-25.

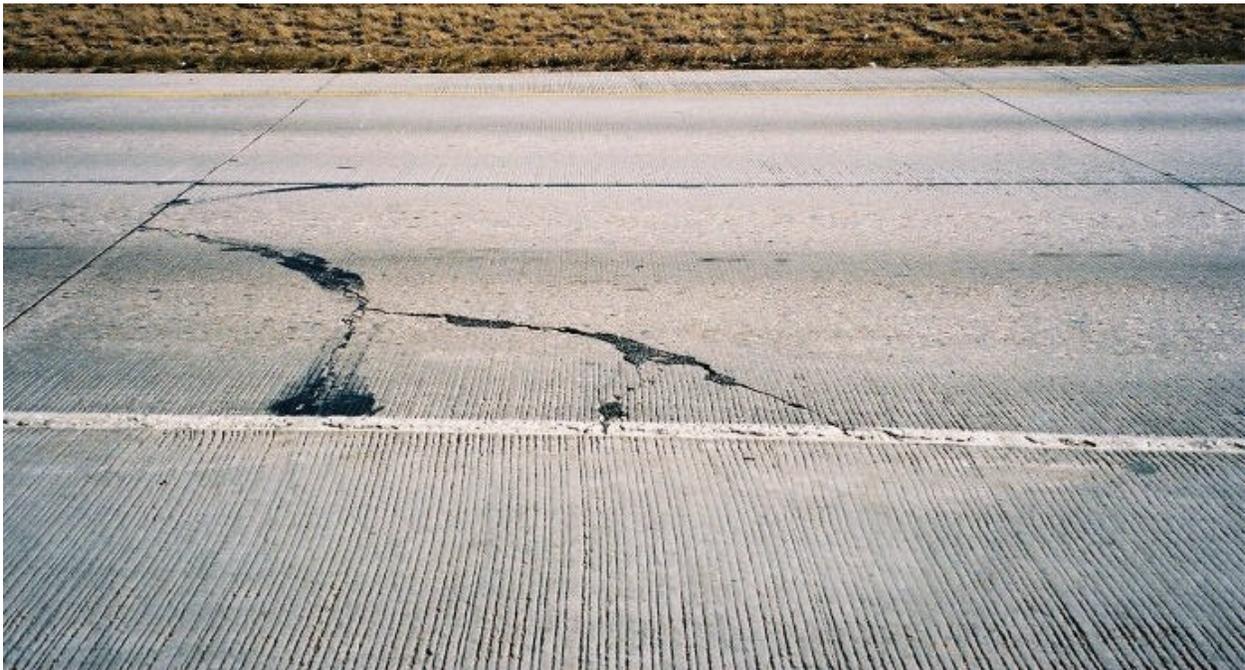
Figure B-18. Shattered Slab on I-25.

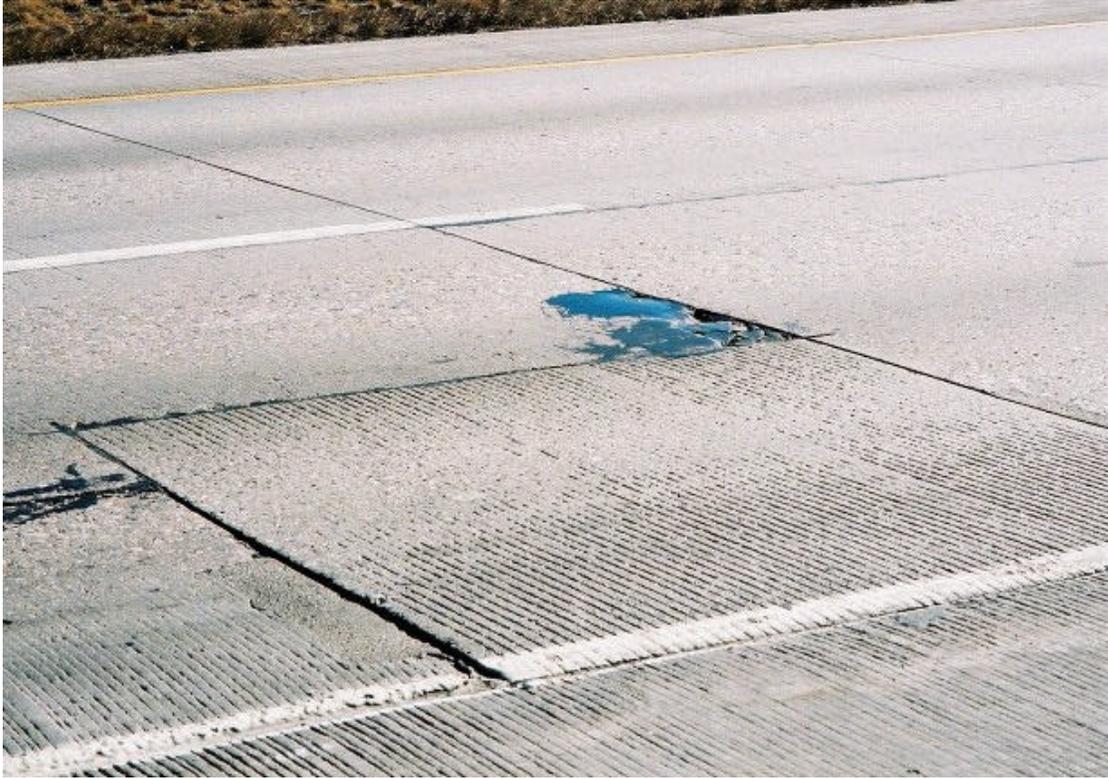
Figure B-19. Failing PCC Patch on I-25.

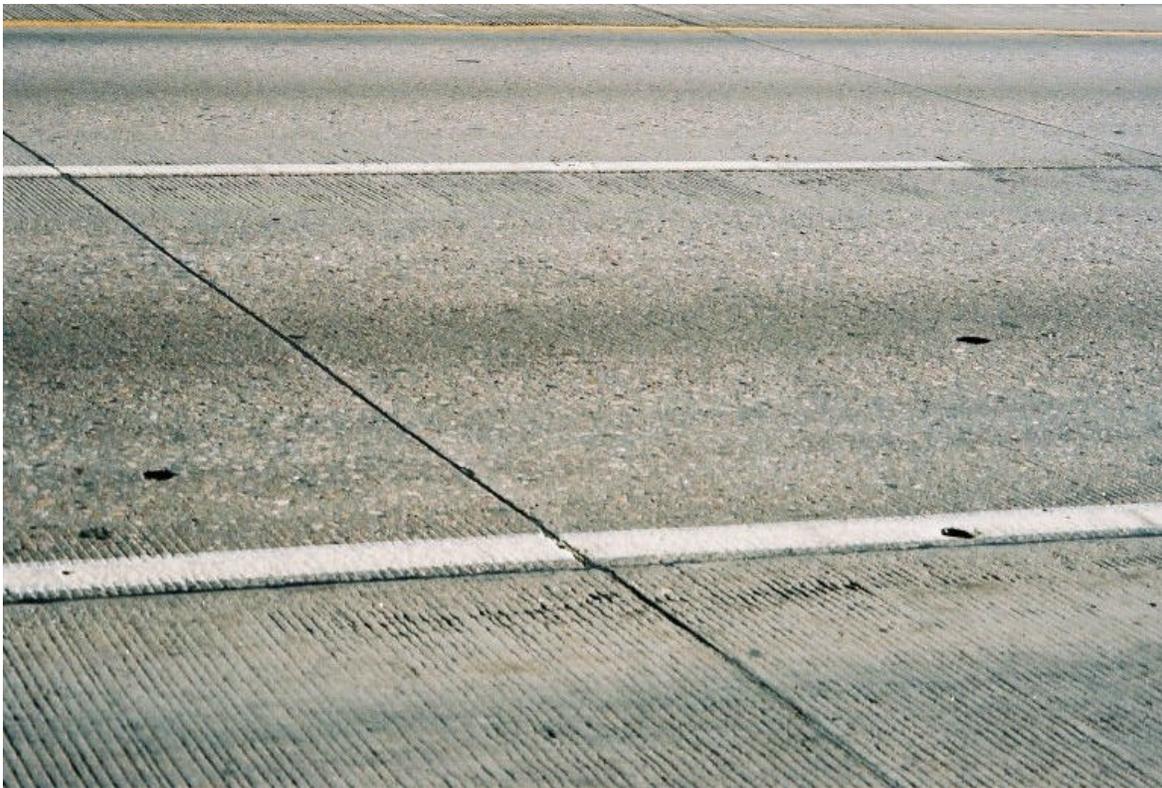
Figure B-20. Surface Polishing on I-25.
