**I-70 OVER FOREST SERVICE ROAD STRUCTURE  
F-13-S\_MINOR REPLACEMENT FEASIBILITY STUDY  
PROJECT NO: FBR 0702-385 (22712)  
CDOT REGION 3  
SUMMIT COUNTY, CO**

Date: April 11, 2019

REV 1 - Final Report Submittal

# Structure F-13-S\_MINOR Replacement Feasibility Study

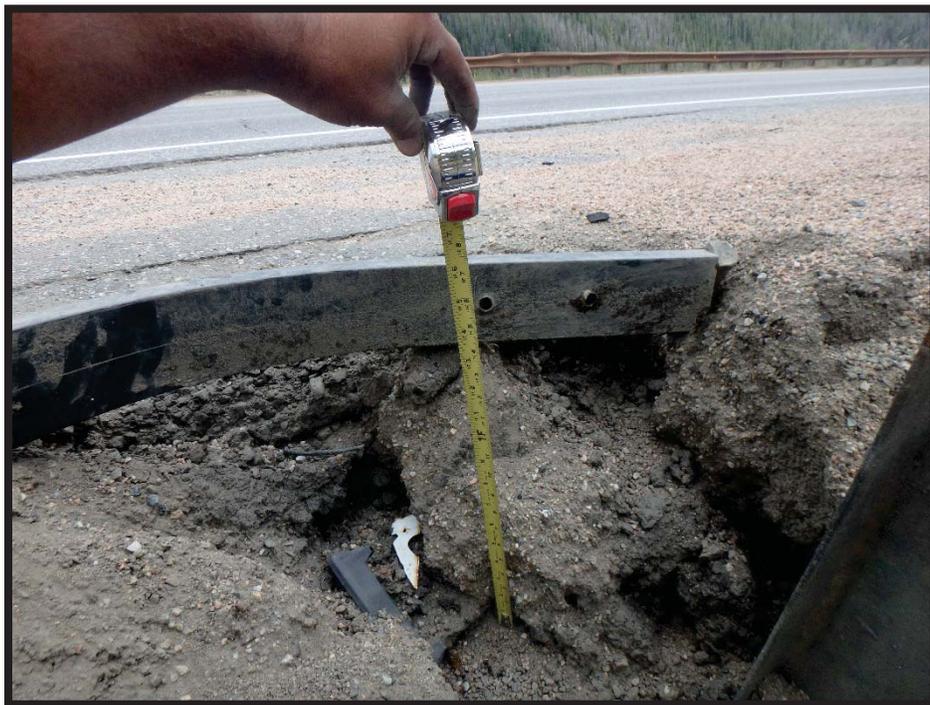
**Photo 1 WB shoulder at guardrail, erosion 15-inches deep**

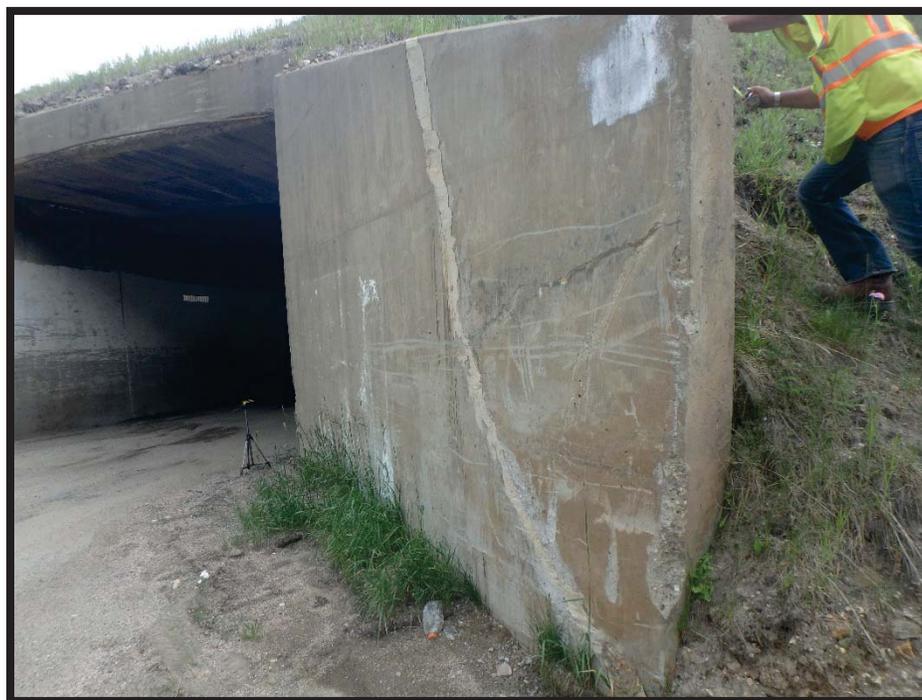
**Photo 2 NW Wingwall, showing 1 large diagonal sealed fracture extending from top to bottom of wing and 1 smaller sealed horizontal crack**

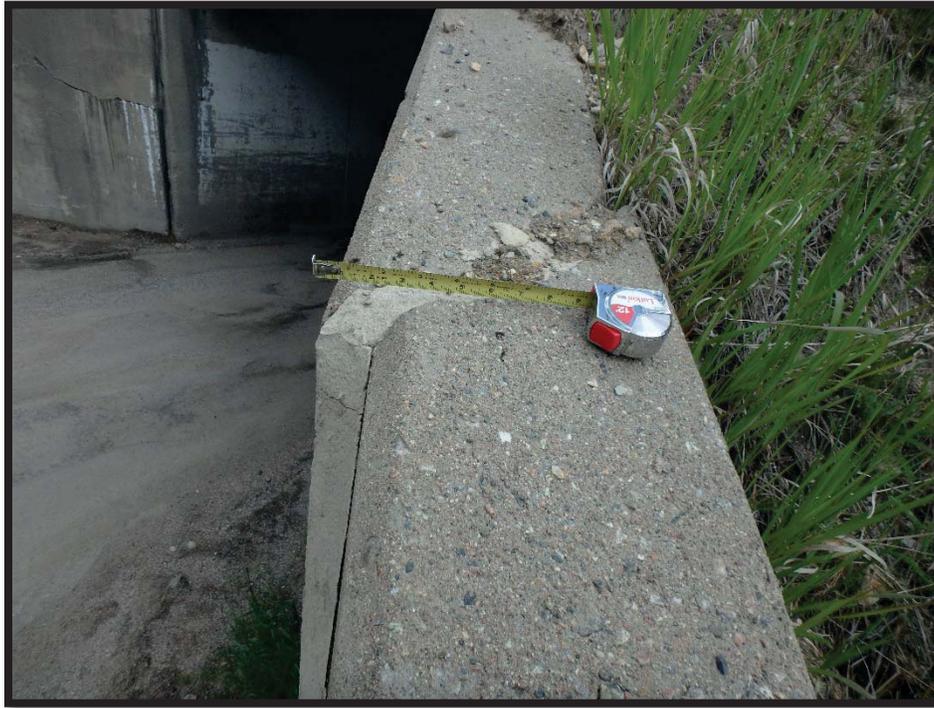
**Photo 3 NW Wingwall showing sealed fracture, 4-iches of displacement**

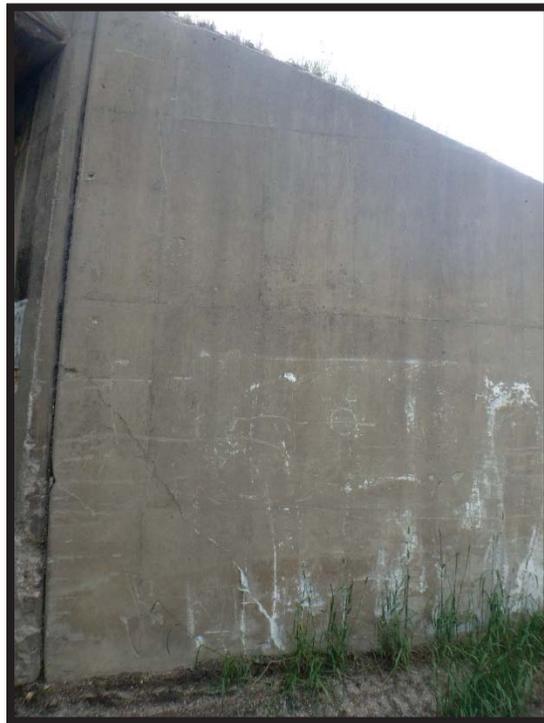
**Photo 4 NW Wingwall showing diagonal 1/8-inch crack extending from joint to bottom**

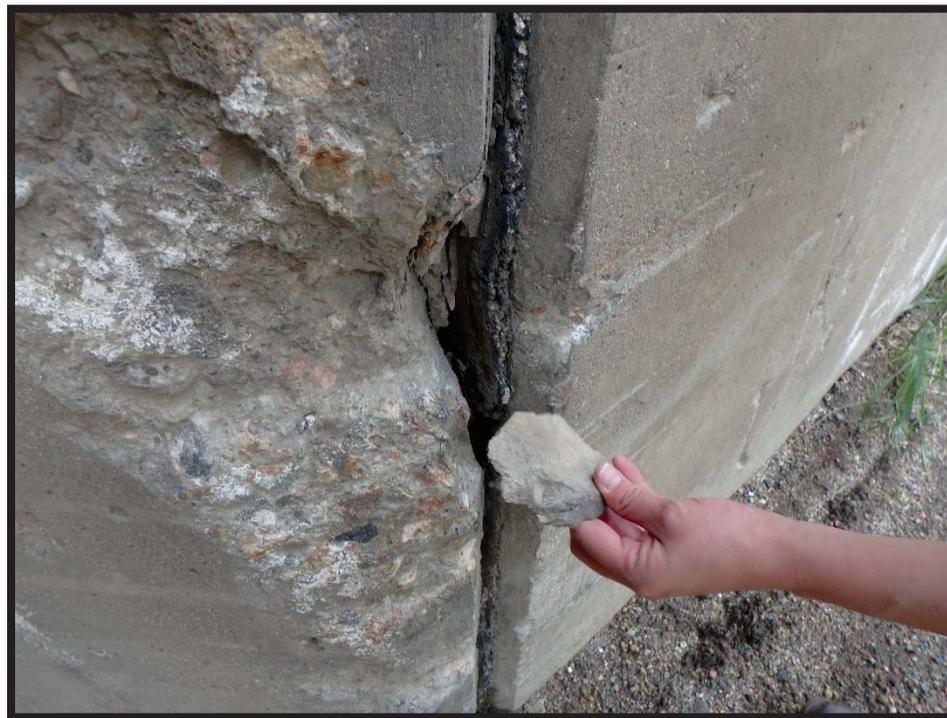
**Photo 5 NW Wingwall at culvert joint, significant spalling**

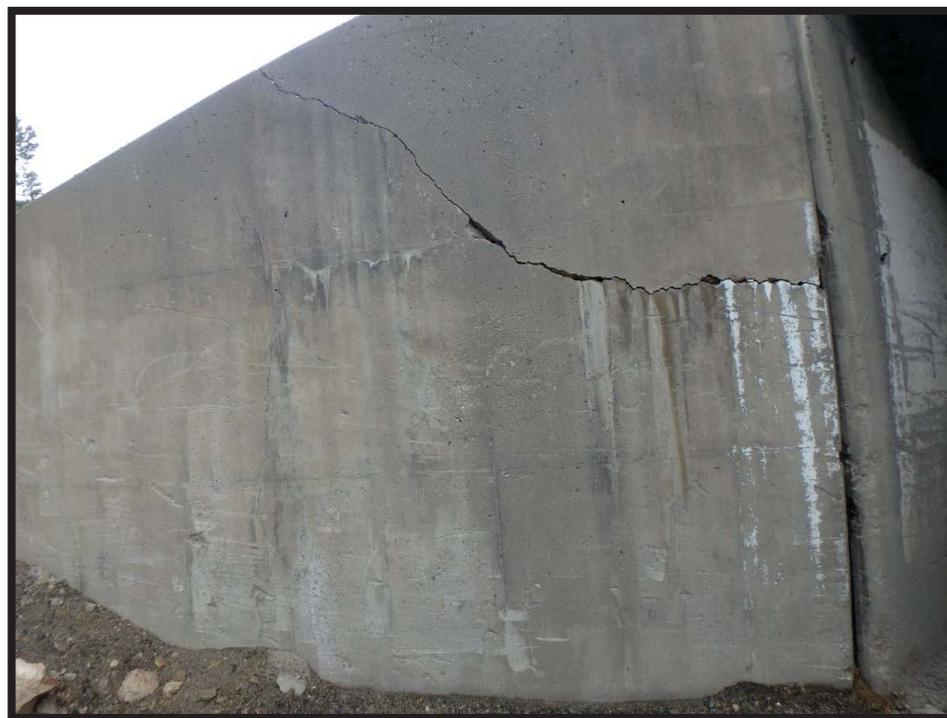
**Photo 6 NE Wingwall, 1 diagonal crack extending from top to culvert joint, other vertical and horizontal sealed cracks migration**

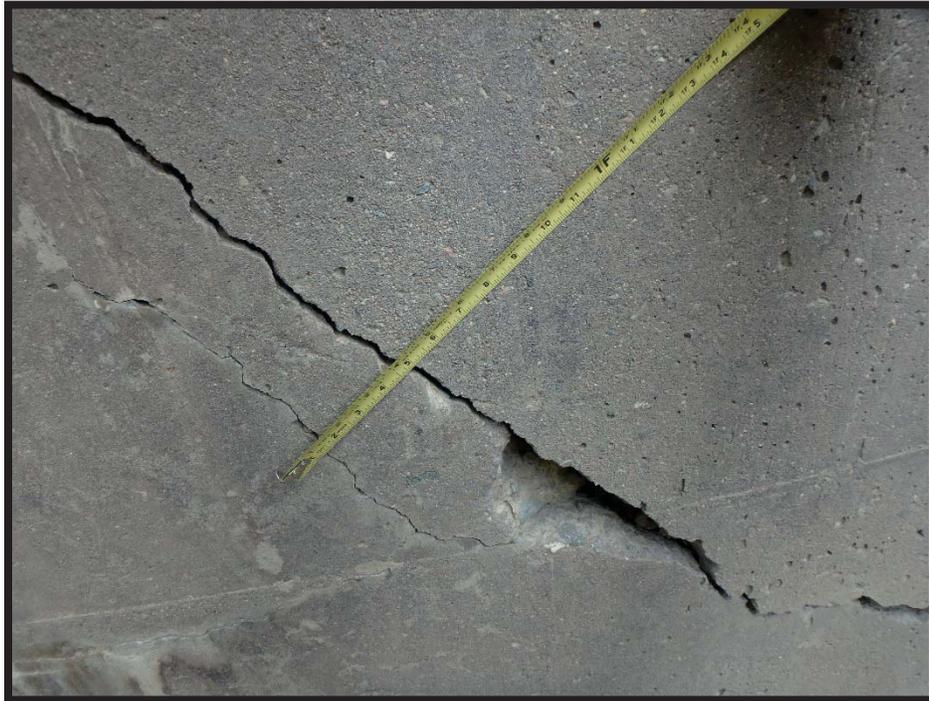
**Photo 7 NE Wingwall, showing 3/8 to 1/2-inch crack with spalling in between migrating smaller crack, refer to photo 6**

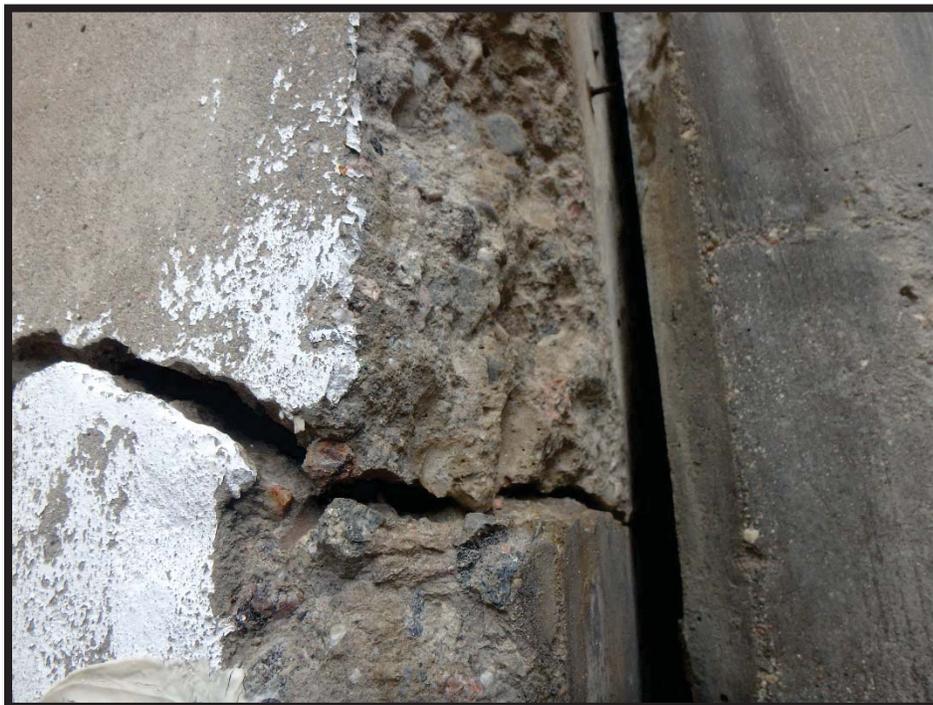
**Photo 8 NE Wingwall, showing 1/2-inch crack at culvert joint, crack appears to be deep. Also showing spalling/scaling, refer to photo 6**

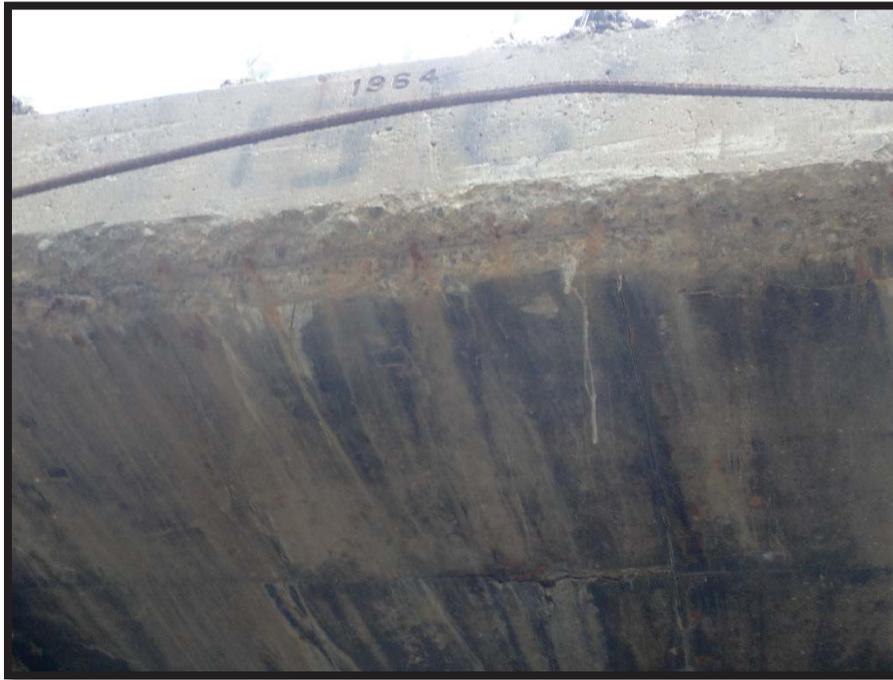
**Photo 9 North headwall/edge of top slab, exposed rebar, concrete at bottom spalled off at edge. Also showing scapes from live load.**

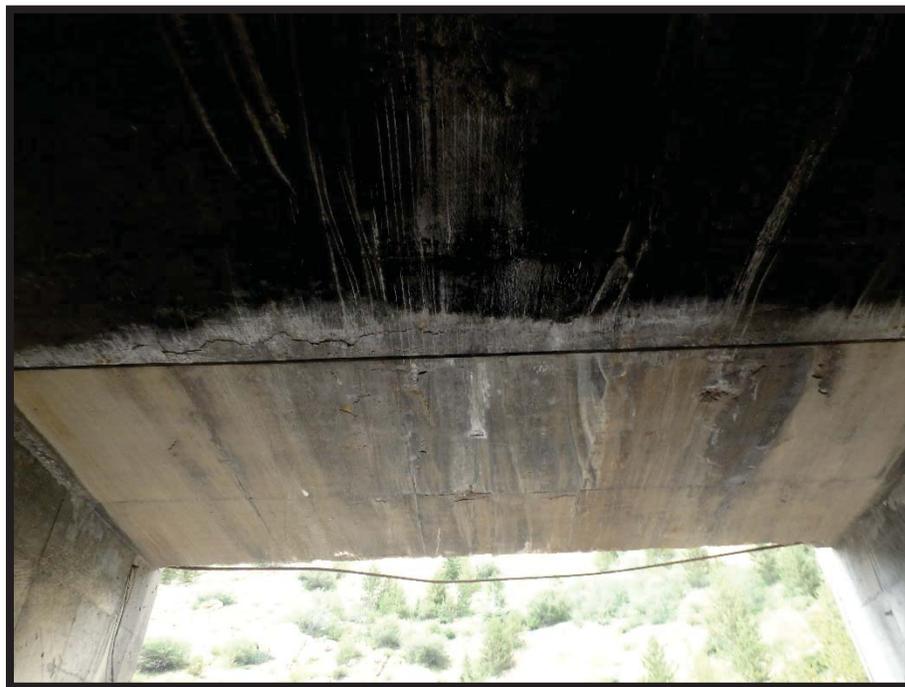
**Photo 10 North End showing delamination/efflorescence and scapes from live load**

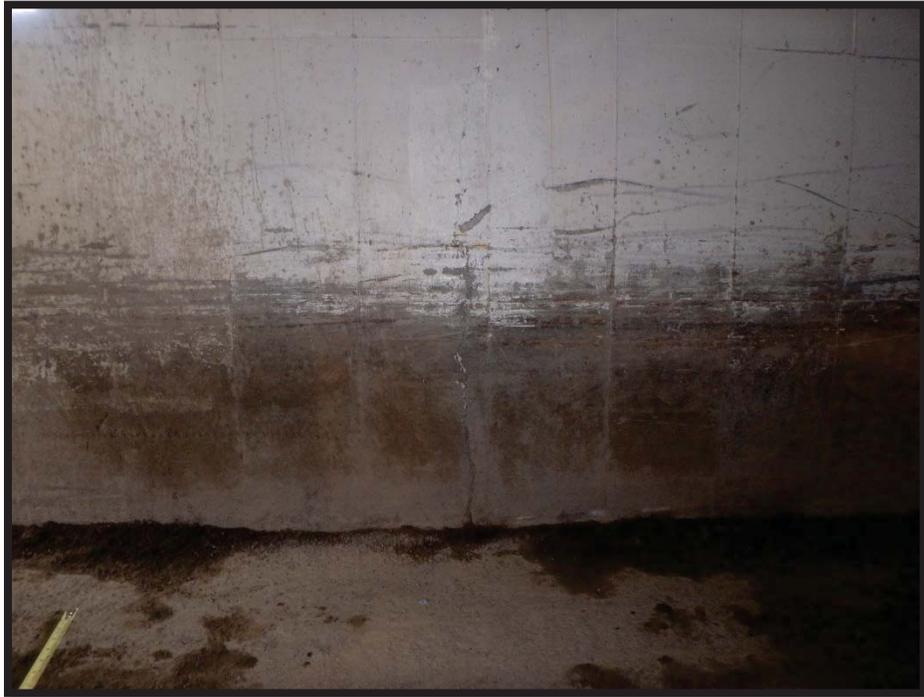
**Photo 11 West wall, vertical 1/4-inch shear crack migrating from top to bottom located at 26-ft from north end**

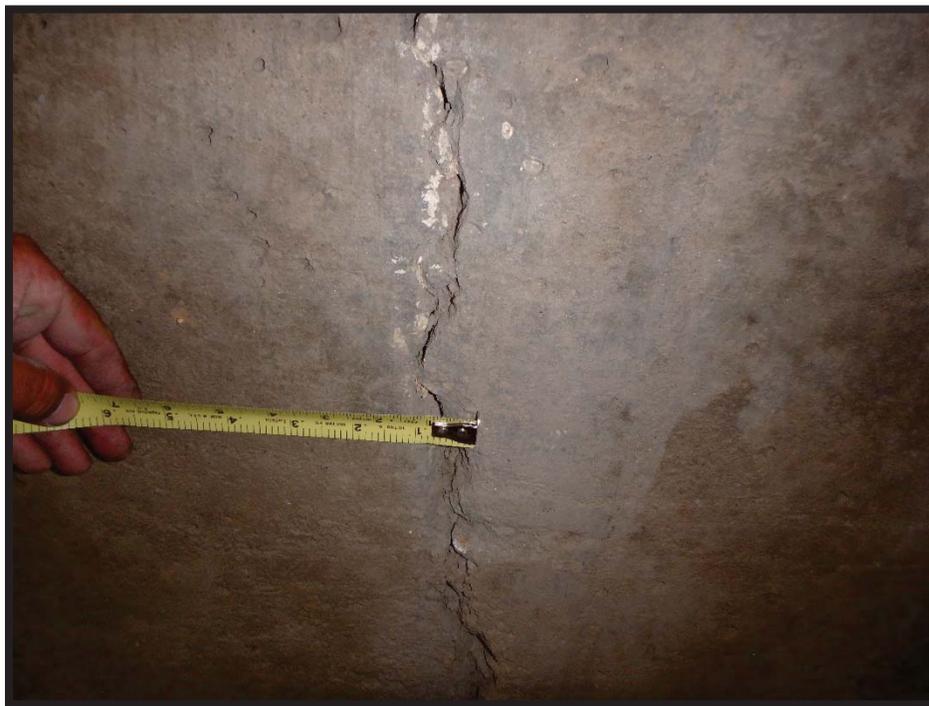
**Photo 12 Close up of 1/4-inch crack from Photo 11**

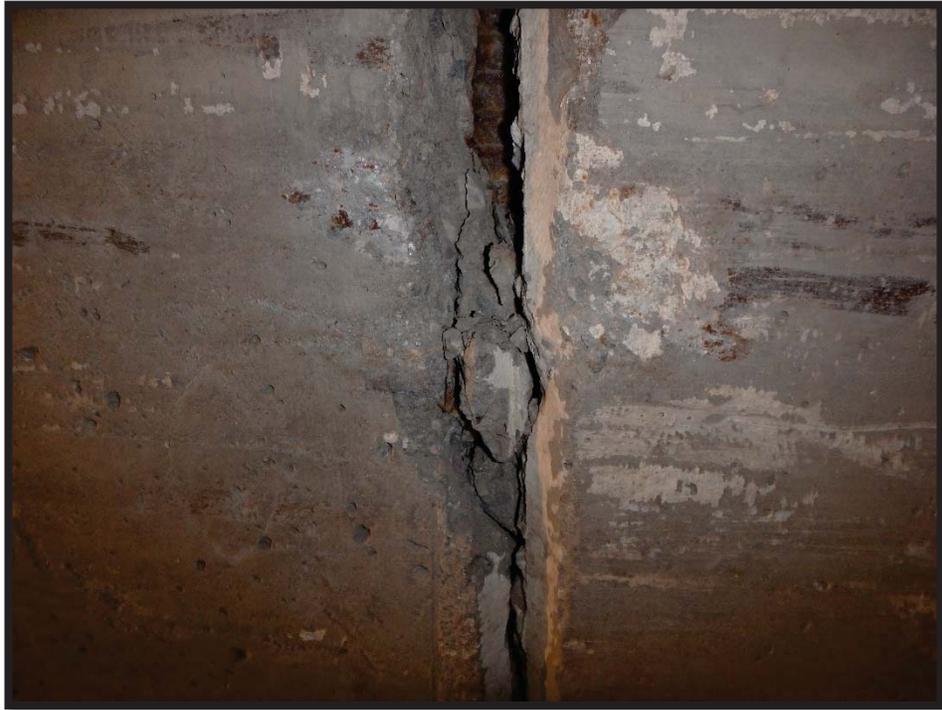
**Photo 13 West wall at 44-ft from north, spalled and exposed rebar**

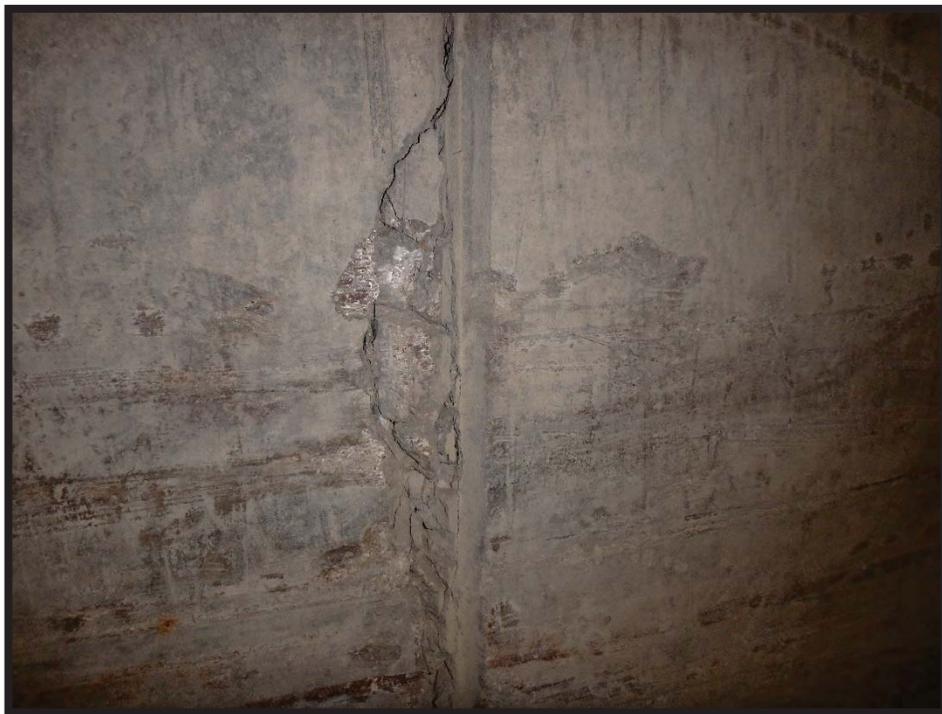
**Photo 14 East Wall at 44- from North, spalled concrete. Construction joint not shown at this location on plans**

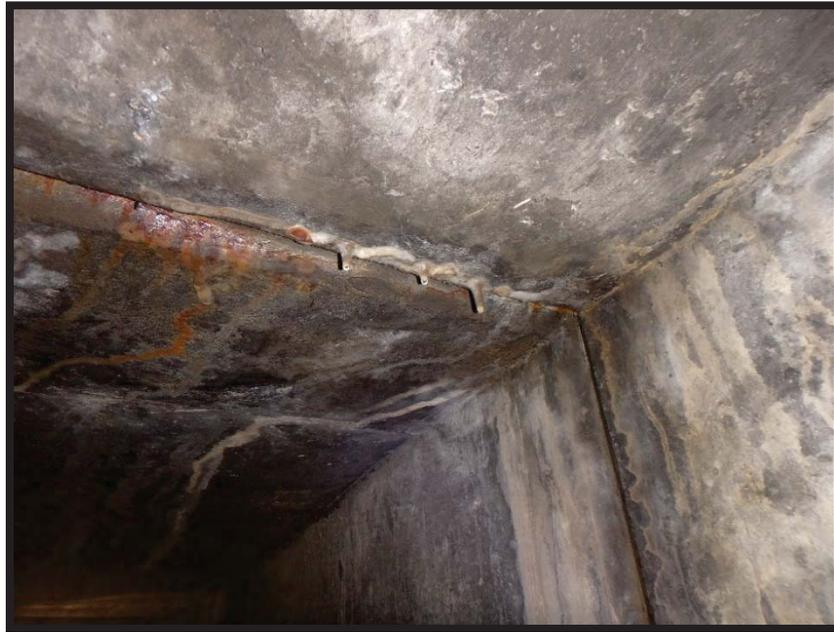
**Photo 15 East Wall/Top Slab at construction joint 53-ft from North. Actively leaking and showing stalactites, efflorescence, delamination**

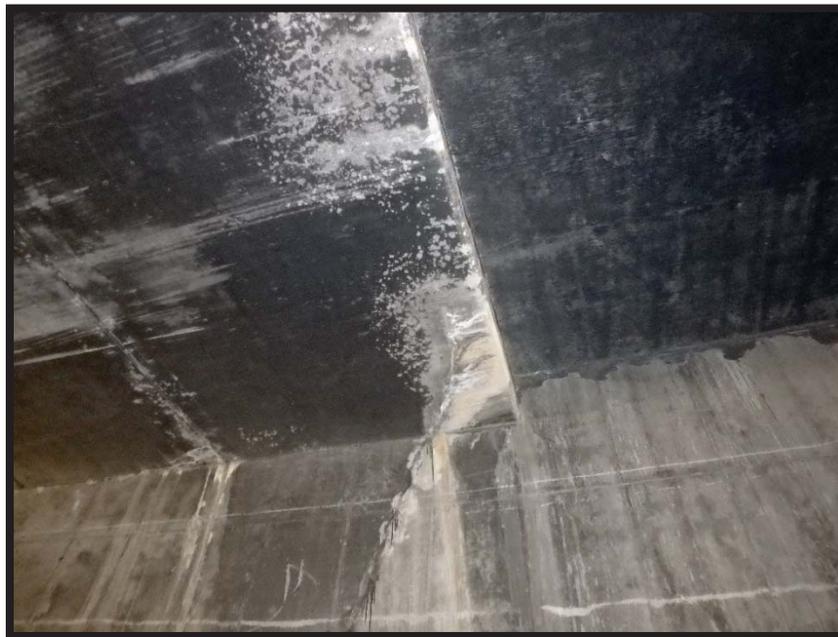
**Photo 16 Top Slab at 85-ft from North (WB median) showing 1/2-inch to 2-inch shear crack migration from top slab down through wall**

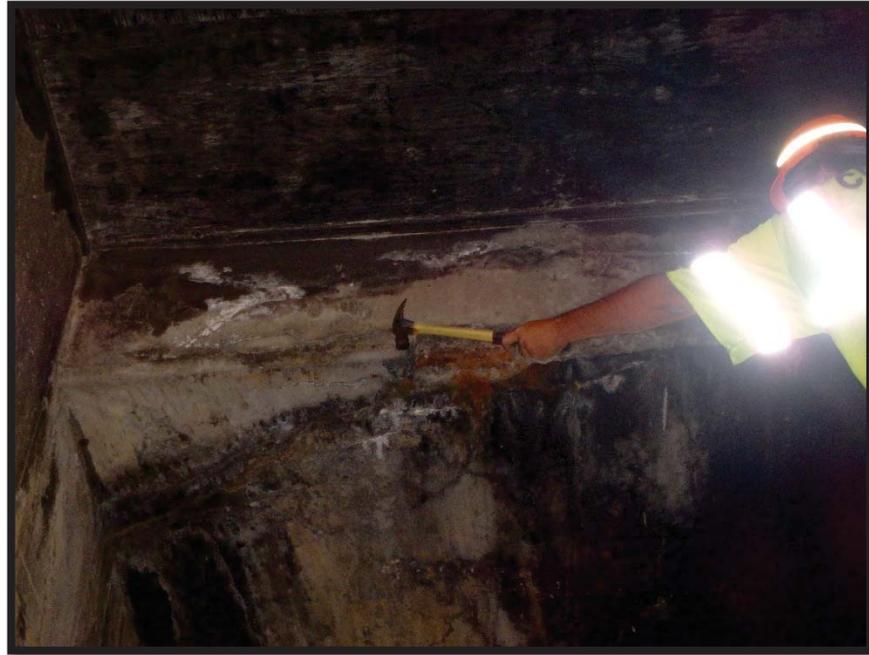
**Photo 17 Top Slab at 90-ft from North (EB median), showing efflorescence, delamination, unsound and spalling, and large crack migration throughout entire top slab down through wall**

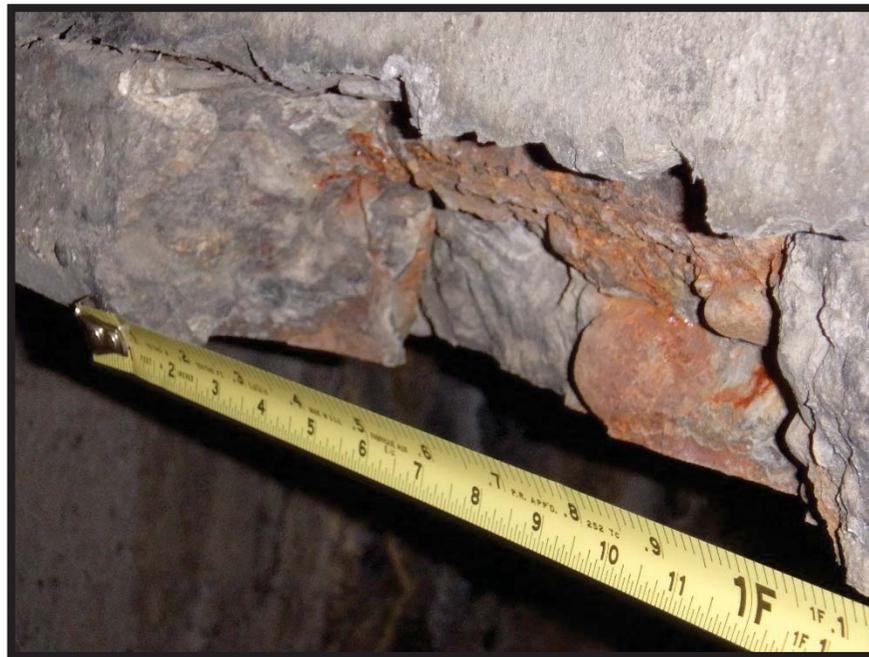
**Photo 18 Section loss, refer to photo 17**

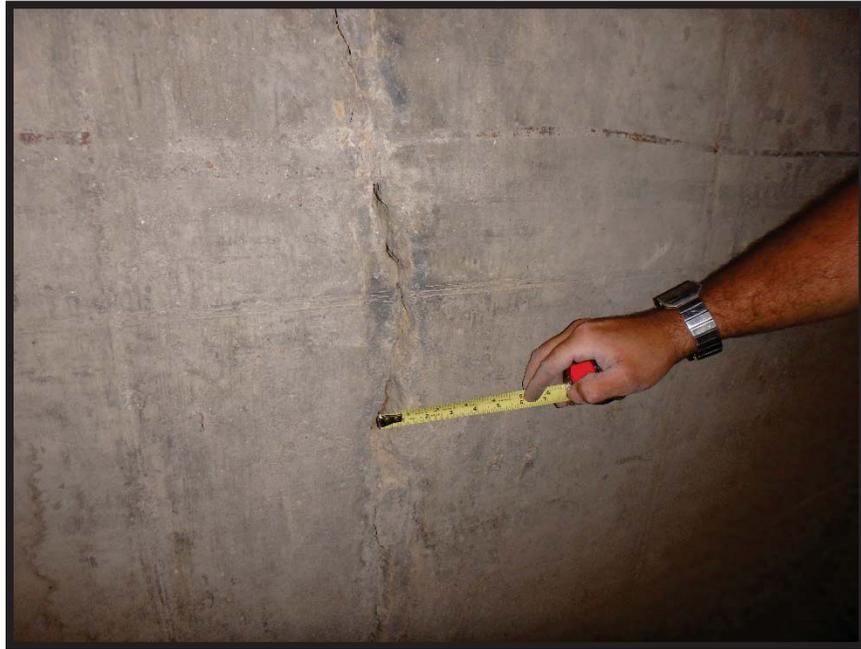
**Photo 19 West Wall at 50-ft from south, showing vertical 1/2 to 3/4-inch shear crack**

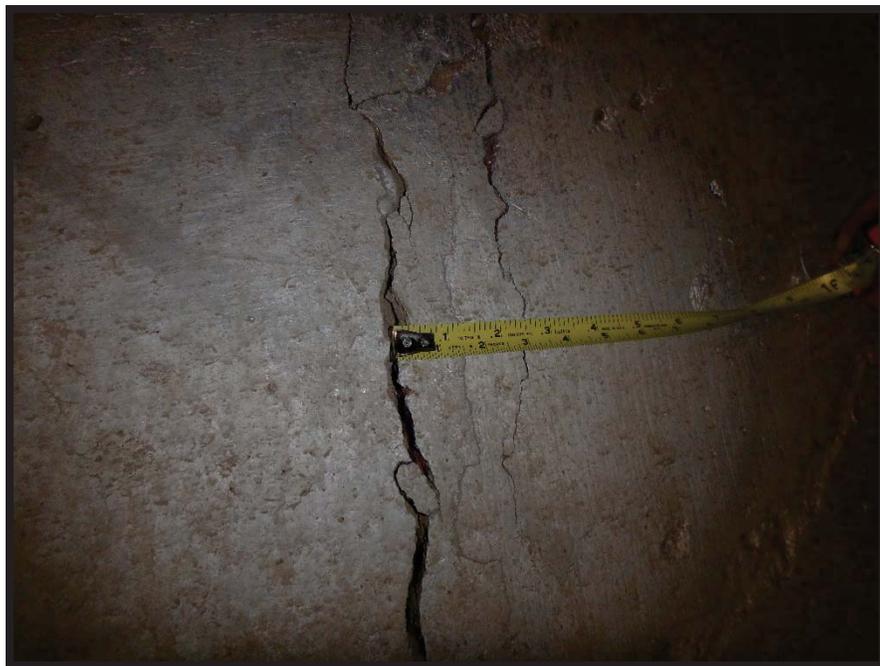
**Photo 20 East Wall at 55-ft from south, showing 2-migrating cracks varying 1/8 to 1/2-inch and spalling**

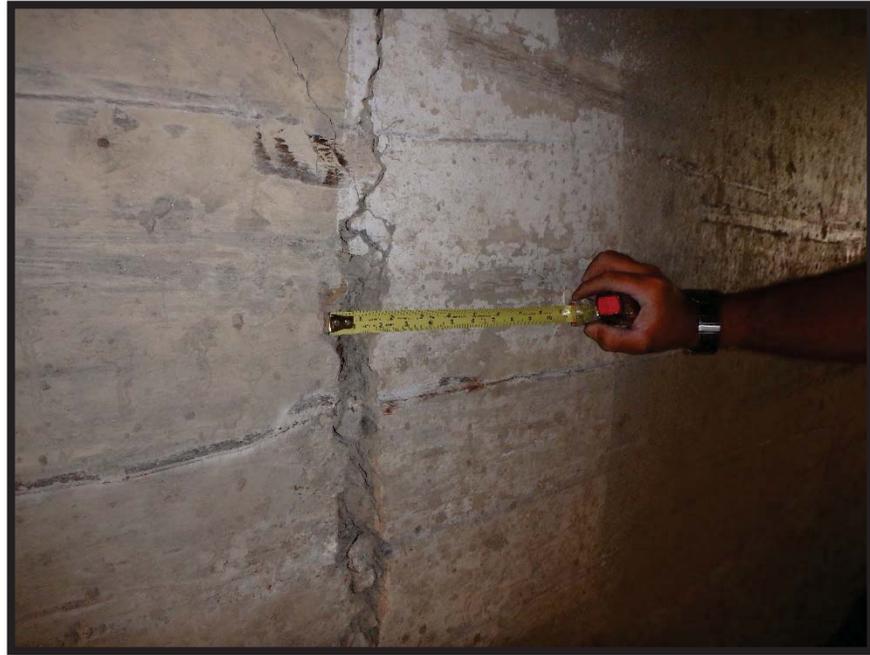
**Photo 21 West Wall at 48-ft from south, showing multiple migrating cracks varying between 1/8 to 2-inches**

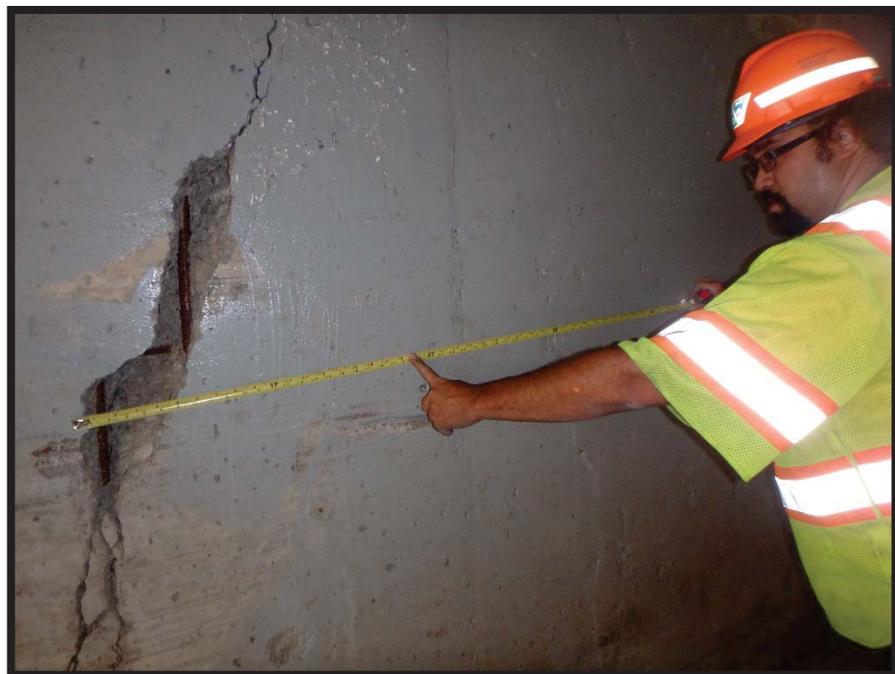
**Photo 22 West Wall at 22-ft from south, showing diagonal shear crack ranging from 1/8 to 4-inches, migrating from top to bottom, spalling**

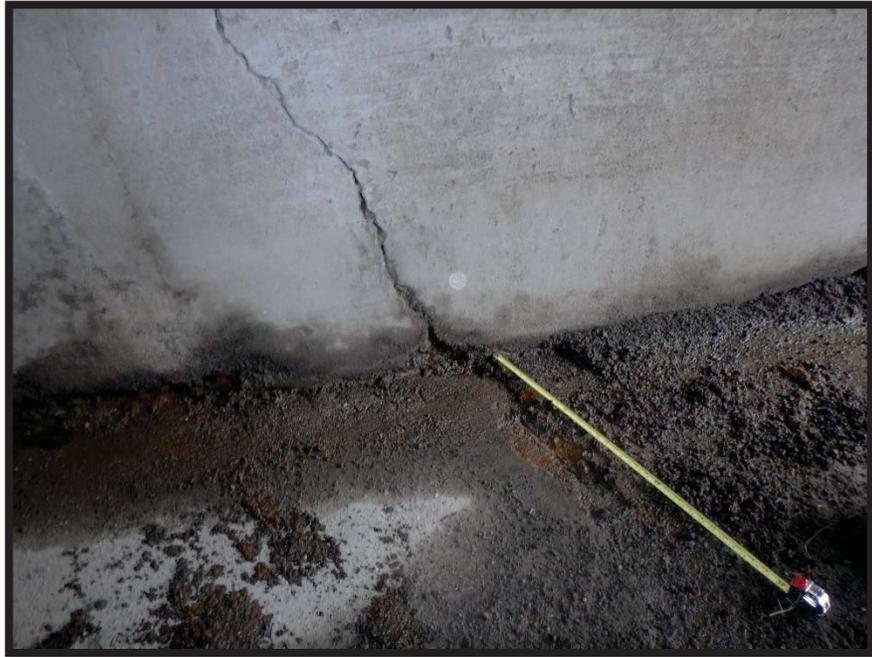
**Photo 23 East Wall at 22-ft from south, showing diagonal shear crack ranging from 1/8 to 4-inches, migrating from wall into bottom slab**

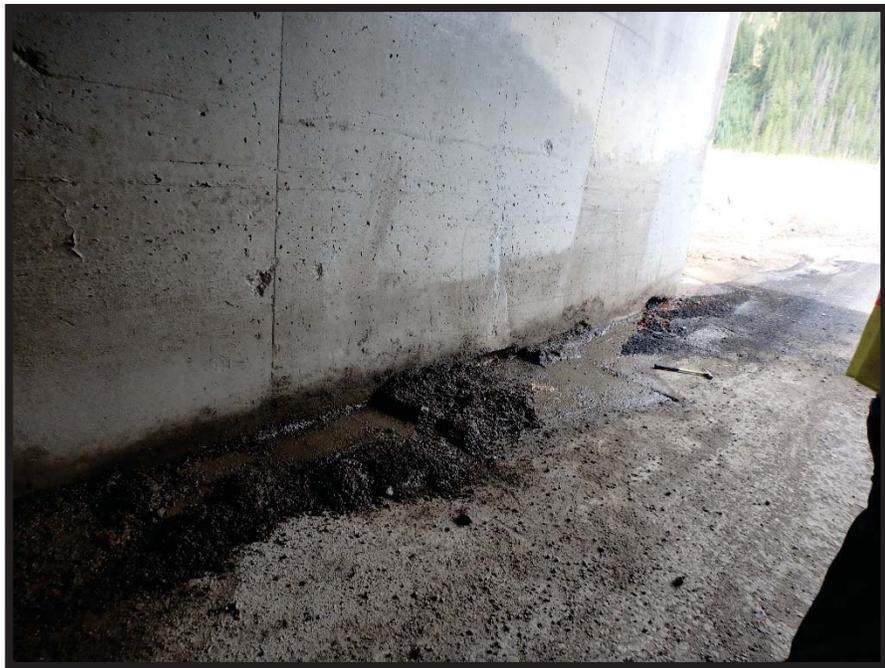
**Photo 24 East Wall at south end showing concrete deterioration and section loss at bottom for several feet, heaving leakage**

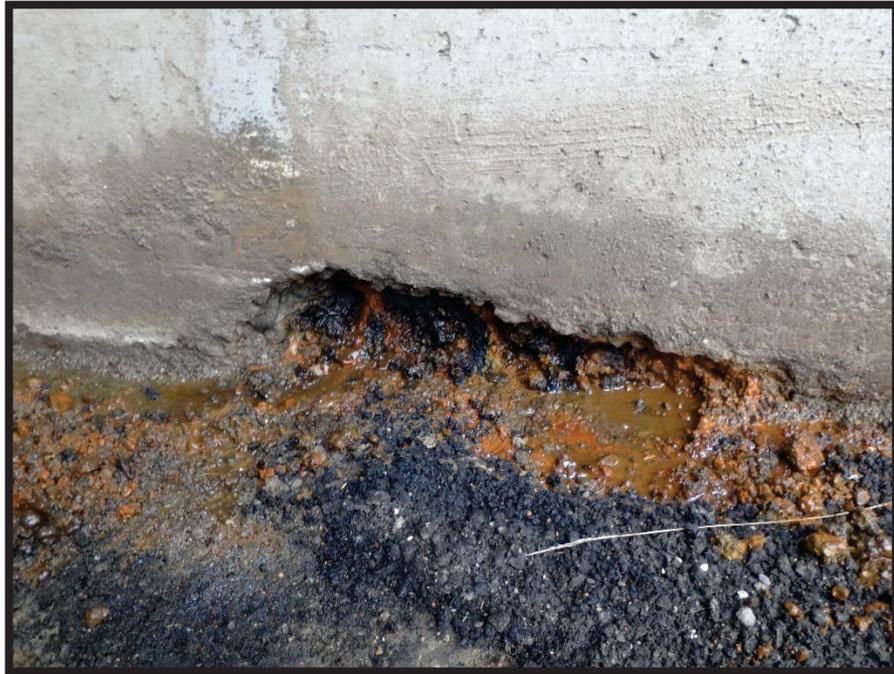
**Photo 25 close up of photo 24, see video**

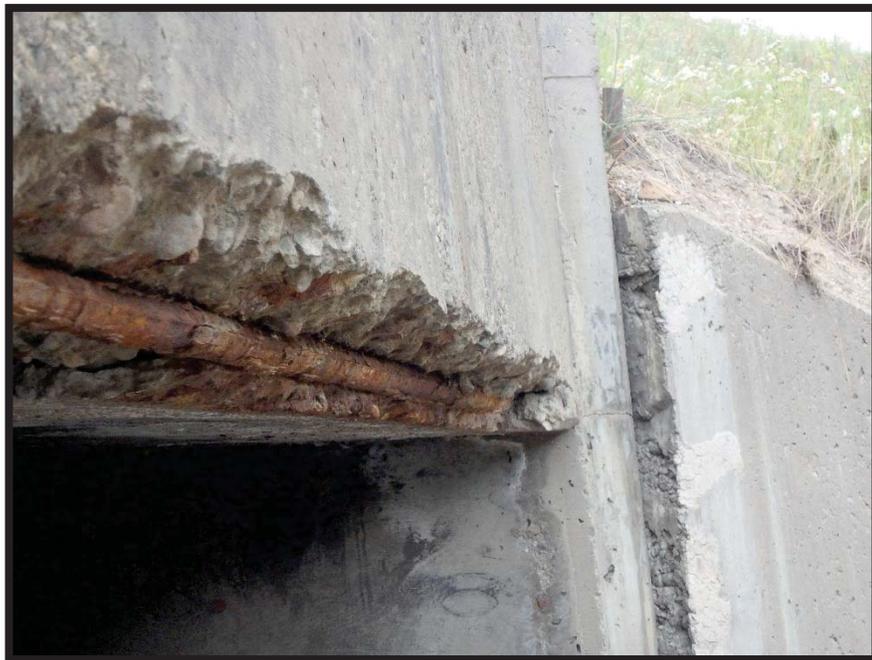
**Photo 26 Bottom edge of top slab at south end, major spalling with exposed rebar along entire edge**
