STATE DEPARTMENT OF HIGHWAYS
DIVISION OF HIGHWAYS
STATE OF COLORADO

REPORT OF GEOLOGICAL
INVESTIGATIONS AND RECOMMENDATIONS
ON THE

STRAIGHT CREEK

LANDSLIDES

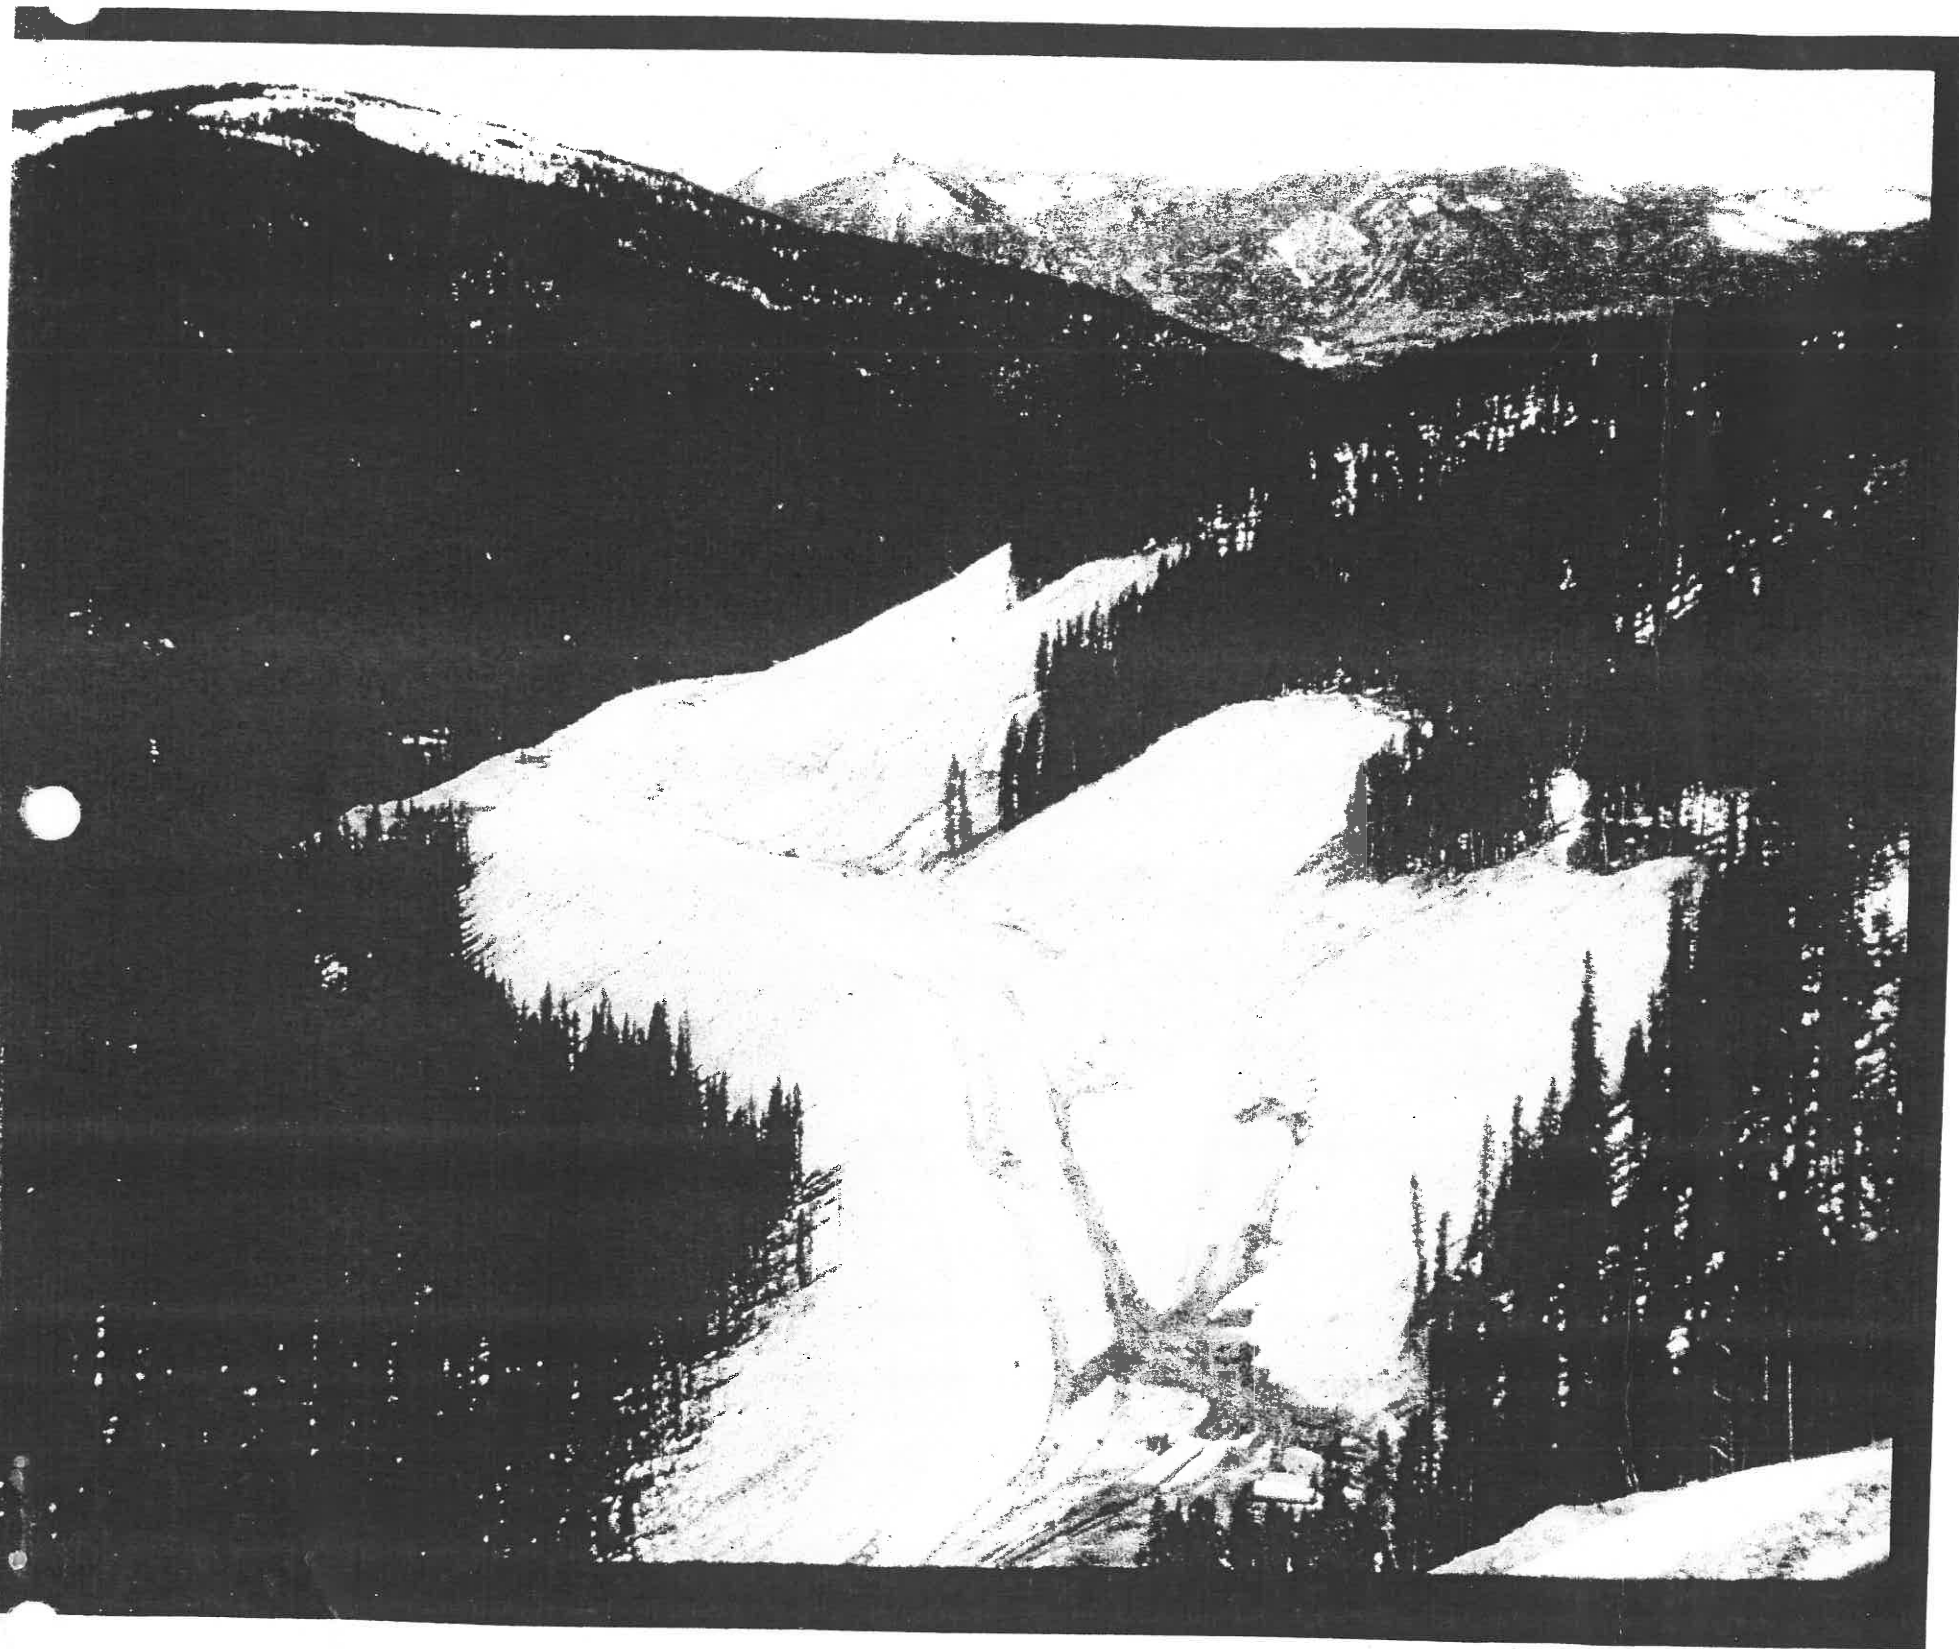
PHOTO II

Taken from the top of Slide A facing west. Slide B is located in the area where the aggregate is stockpiled on the westbound lane. Slide 1 is located beyond the tree-lined draw past Slide B. The near edge of Slide 2 is the last visible cut slope.

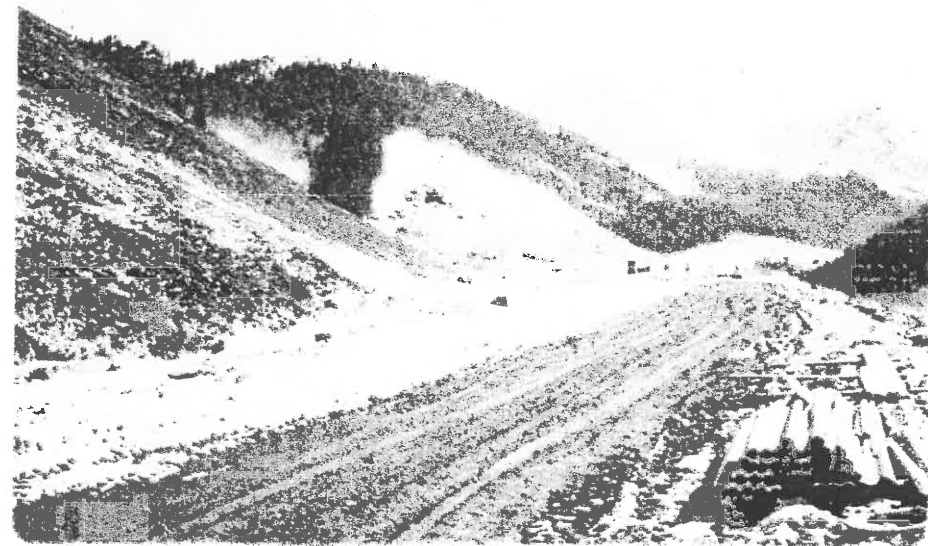
PHOTO III

Slide A and surrounding terrain taken from Slide 2.

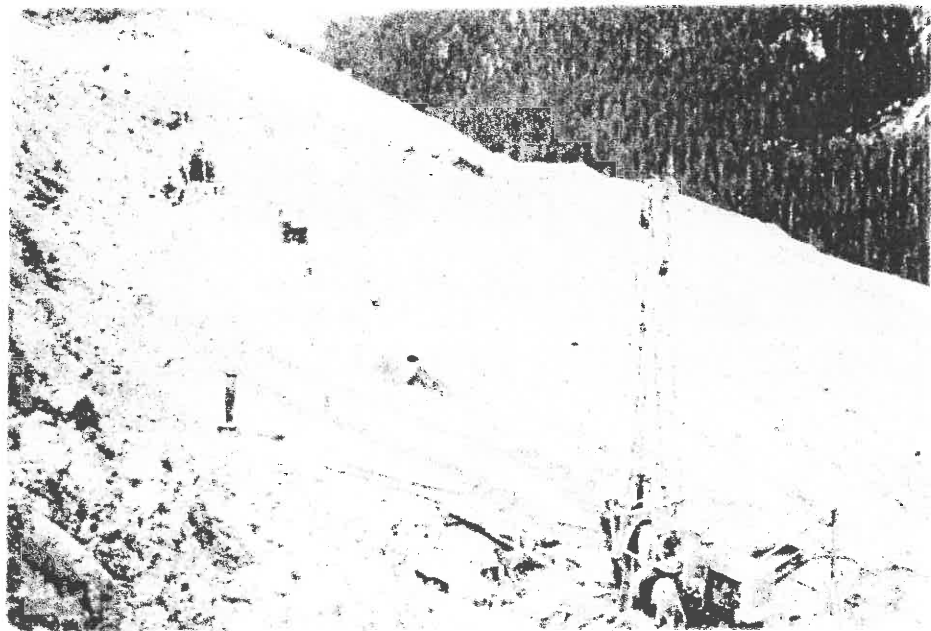
PHOTO IV

Drill rigs on location, Slide 2

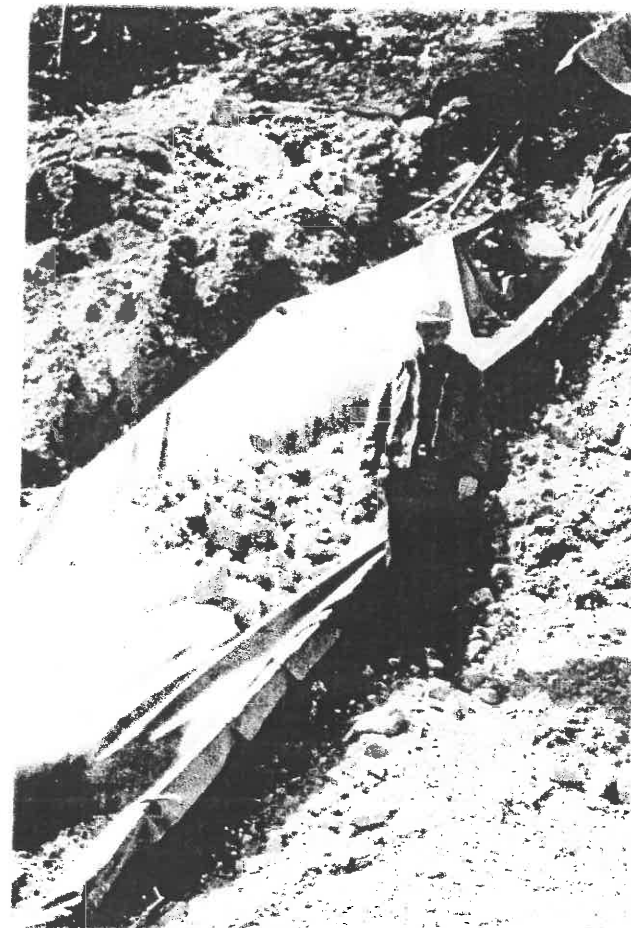
PHOTO VII

Rubber-lined ditch disrupted
by slide movement, Slide 2

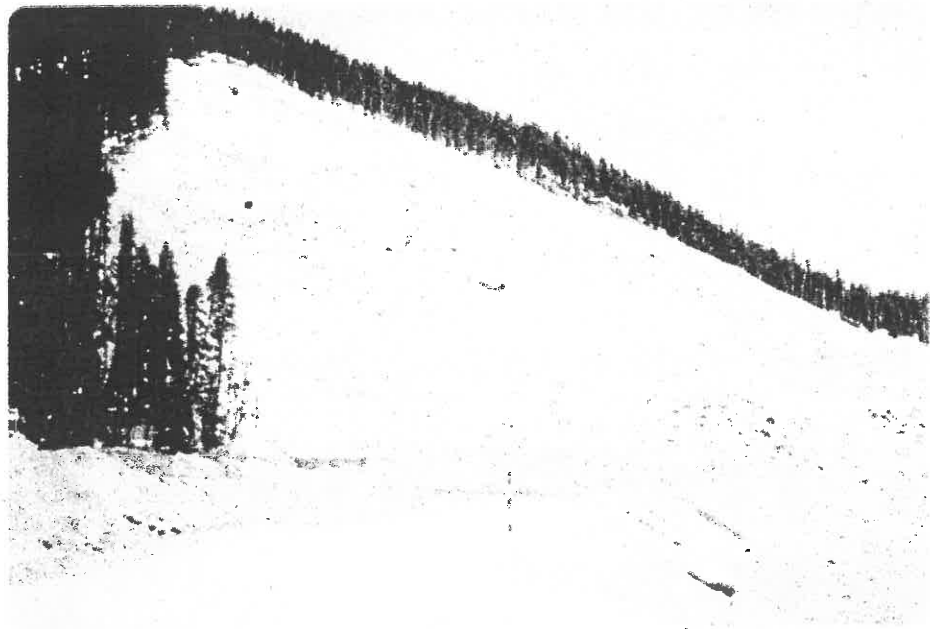
PHOTO VIII

In Slide A, unlike the other slides, the metasedimentary foliation dips toward the roadway. Unloading the face and toe of the slope by construction has resulted in failure by stress relief along the foliation planes. During the summer of 1971, a series of cracks cutting across foliation developed. New surface cracks developed in the cut and on the slopes 500 feet above the roadway.

Slide A is a growing area of slope failure. The area of greatest movement is in the central portion of the slide. As the material fails, zones of cracks develop and enlarge on both sides and above. A continuing maintenance program will be required to remove the buildup of debris along the ditch line.

Slide A

It is recommended that Slide A be disturbed as little as possible by construction. The stress relief problem will probably abate as the slope becomes covered with rubble. A slope of 1½:1 should be fairly stable with time.

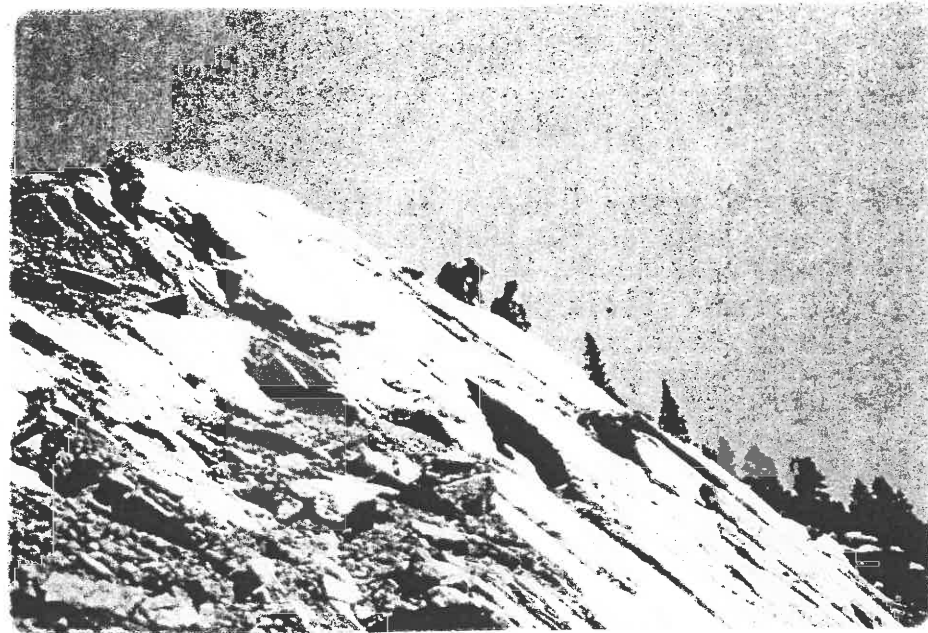
PHOTO IX

Biotite gneiss in the central section of the slide has a strong foliation that causes the rock to break into thin slabs. (See Photo IX below.) The foliation strikes east-west, parallel to the face of the slide, and dips 40° to 50° southward toward the road. This orientation of the foliation is one of the main contributing factors to the instability of the slope. The dip of the foliation steepens at intersections with pegmatite sheets that cut through several layers of gneiss. The larger bands of pegmatite, 2 to 8 feet in thickness, that cut across the gneiss are nearly horizontal or dip 15° north. A strong set of joints parallel to the strike of the foliation dips 62° north. At the base of the largest gneiss face, large blocks of rock have separated along one of these joints and moved several feet downslope forming an overhang of 4 to 7 feet.

Foliation surfaces, Slide A

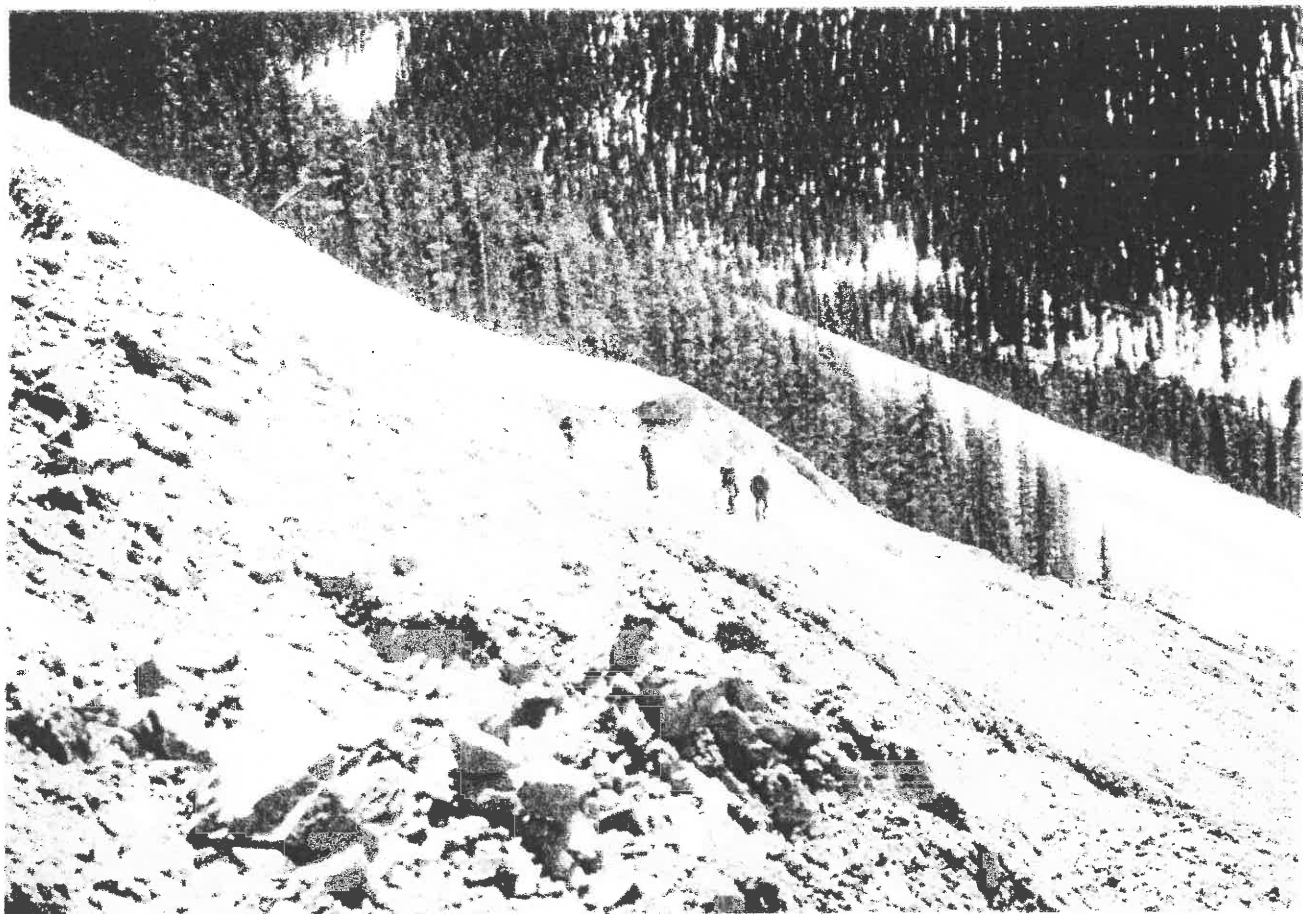
PHOTO X

Taken from central area of Slide A facing east and south. The rubble in the foreground was derived from the outcrops in the center of the slide. Also visible is the head scarp of the slide in the eastern portion of the slide. Both lanes are visible on the extreme right.

A zone of surface tension cracks branch westward from the scarp. The zone extends 300 feet west in an arc through the forest. Displacements range from visible cracks in the surface to vertical displacements of 1 foot. At the west end of the zone, the surface cracks trend down the slope and pinch out. Upslope 150 feet above this zone, isolated surface cracks were noted. A search was made in late August, 1971, on the steep slopes above the surface cracks upward to timberline and no further cracks were located.

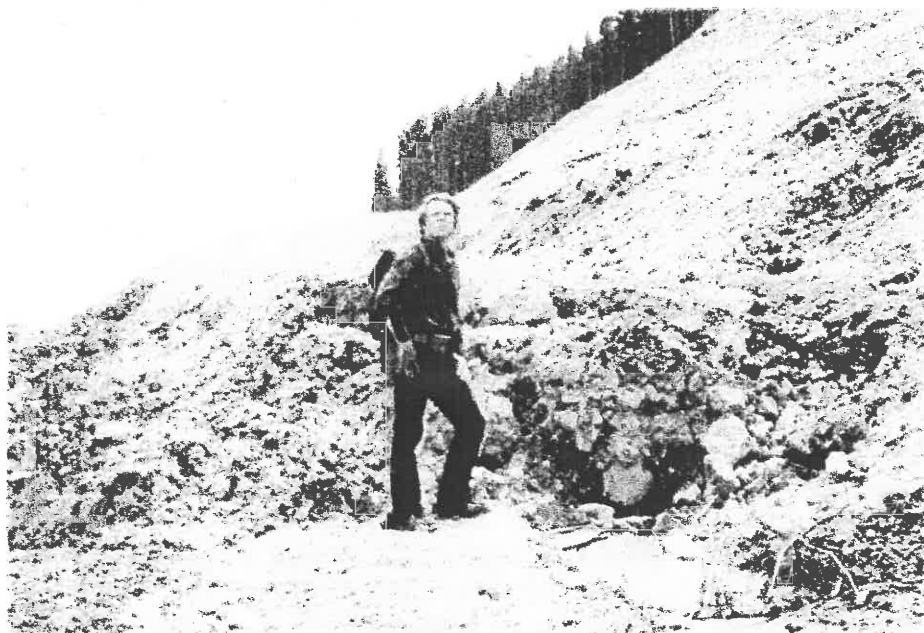
PHOTO XI

Disrupted access trail, Slide 1

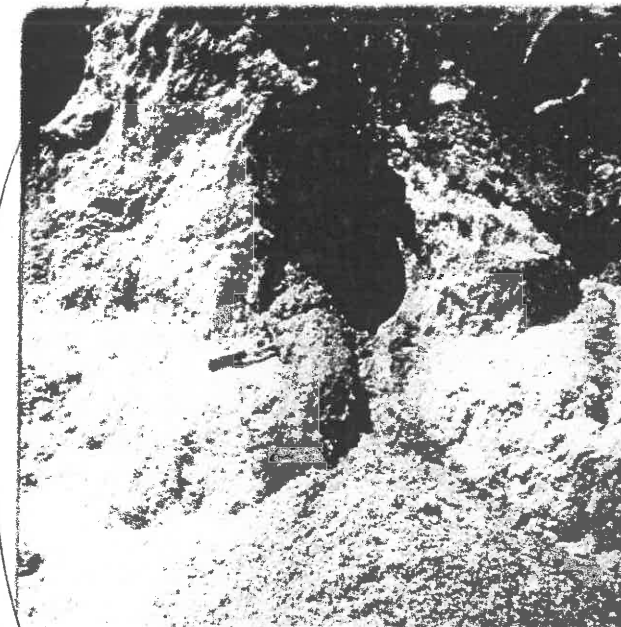
PHOTOS XII and XIII

Decomposed pegmatite, Slide 2

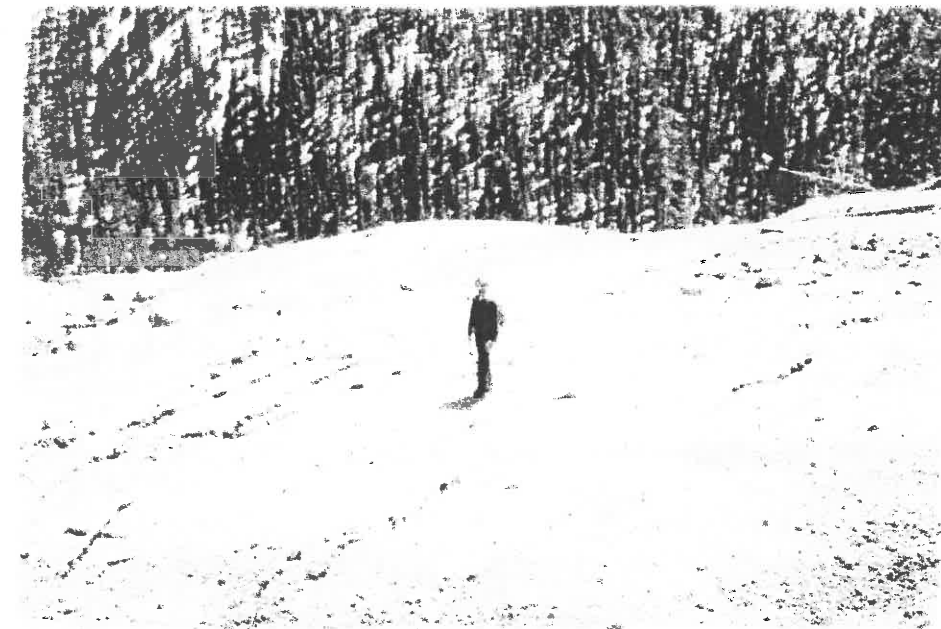
PHOTO XIV

The surface cracks and scarps above the rim of the cleared slope extend westward for 500 feet. Maximum vertical displacement along the scarps is 6 feet. Near the western end of the cracks the zone branches with a zone of smaller cracks trending south for 300 feet down the slope. The main branch of the surface cracks die out on the nose of a ridge.

Tension cracks at the upper limits
of clearing on Slide 2

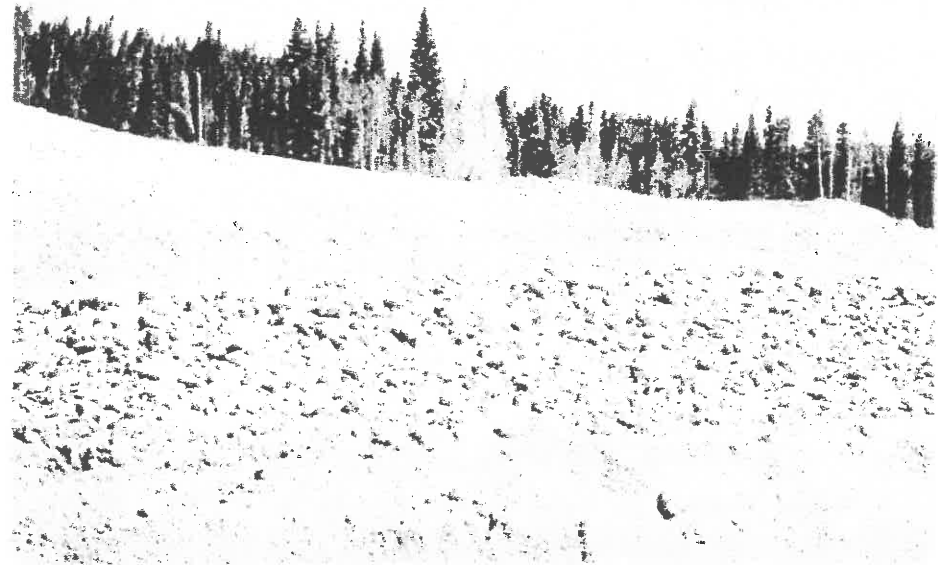
PHOTO XV

Slide 3 is a potential sleeping giant that should be watched. A rock buttress along the roadway presently provides stability of the landslide mass adjacent to the road and will provide protection if the upper slopes continue to move. The combined effect of the buttress and the diversion of surface water across the slide are contributing to minimize the instability of the slope. Maintenance of drainage is of great importance. The upper limits of the cracks and scarps should be marked to assist in future determination of the slope stability.

Slide 3, with buttress

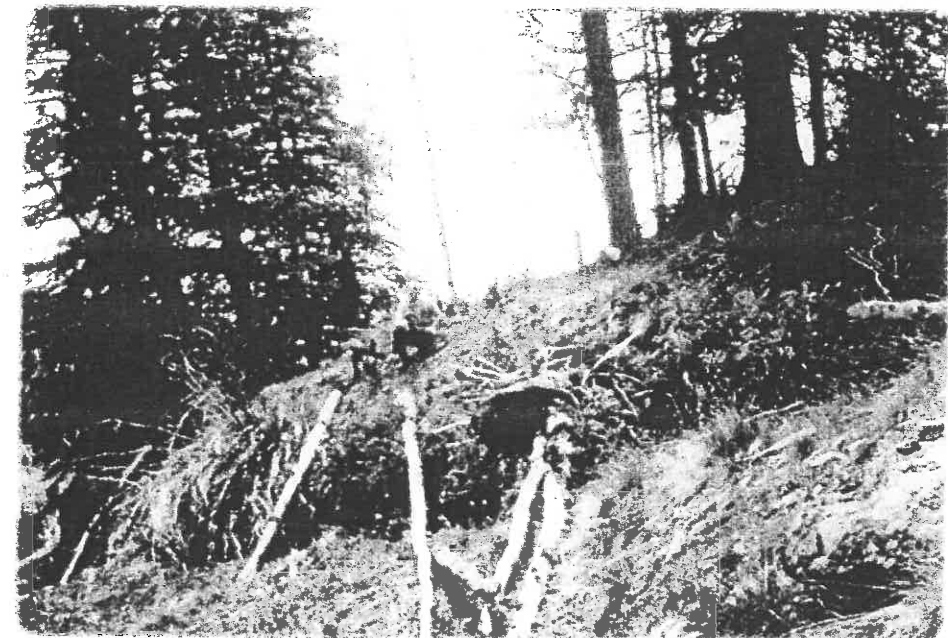
PHOTO XVII

The toes of the fills at Slides 2 and 3 are currently in failure. Both problems apparently result from placing embankment on peat and organic soils. There does not appear to be interconnection between the cut slope failures and the fill failures at this time.

Below the roadway at Station 275, movement has occurred in an elongated lobe and in the valley floor on each side of the lobe. The lobe is 100 feet wide and extends from the fill 140 feet out onto the valley floor. Willow swamps underlain by peat 2 to 4 feet thick border the lobe. Drilling in the lobe indicated silt, sand, and gravel to a depth of 10 feet overlying 7 feet of micaceous silt. Below the silt, boulders, gravel and silt were encountered to a depth of 30 feet. The slope of the valley floor dips 5° to 10° toward the creek.

Overriding lobe, Fill Toe, Slide 2

The fill failure at Slide 2 can be corrected in conjunction with the proposed line shift. Excavation of the peat and organic soils prior to placing the proposed embankment and constructing the lower portion of the embankment with an obviously free draining material should produce a buttress-like correction.
