**SH 7A (Lower)
Raymond to Lyons
Site Repairs between Mileposts 19 and 33**

**Boulder County
COLORADO**

Damage Assessment Report

**100% DRAFT
Revised: July 28, 2014**

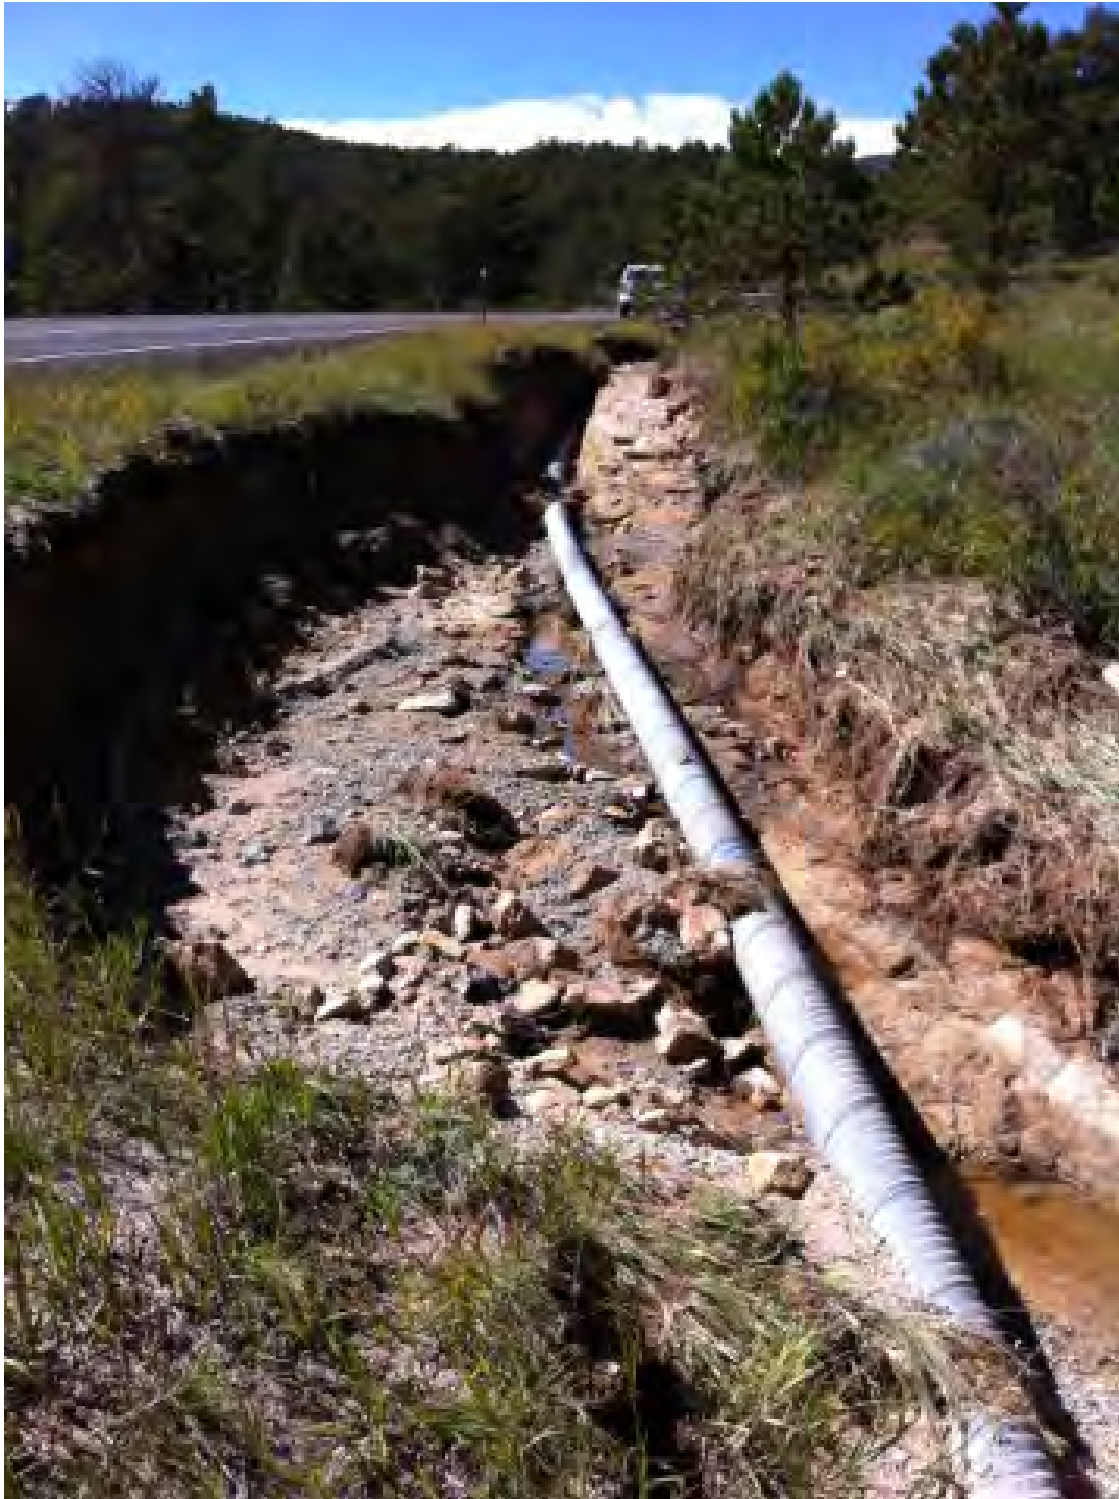
Milepost		Description of Damage
Start	End	
19.06	19.35	The roadside ditches on both sides of highway experienced erosion scour damage, washing out approximately 5-6 ft wide and 2-4 ft deep the full length of this section. Underground utilities were exposed in areas as a result.

Figure 9 - MP 19.15, Eastbound ditch damage.

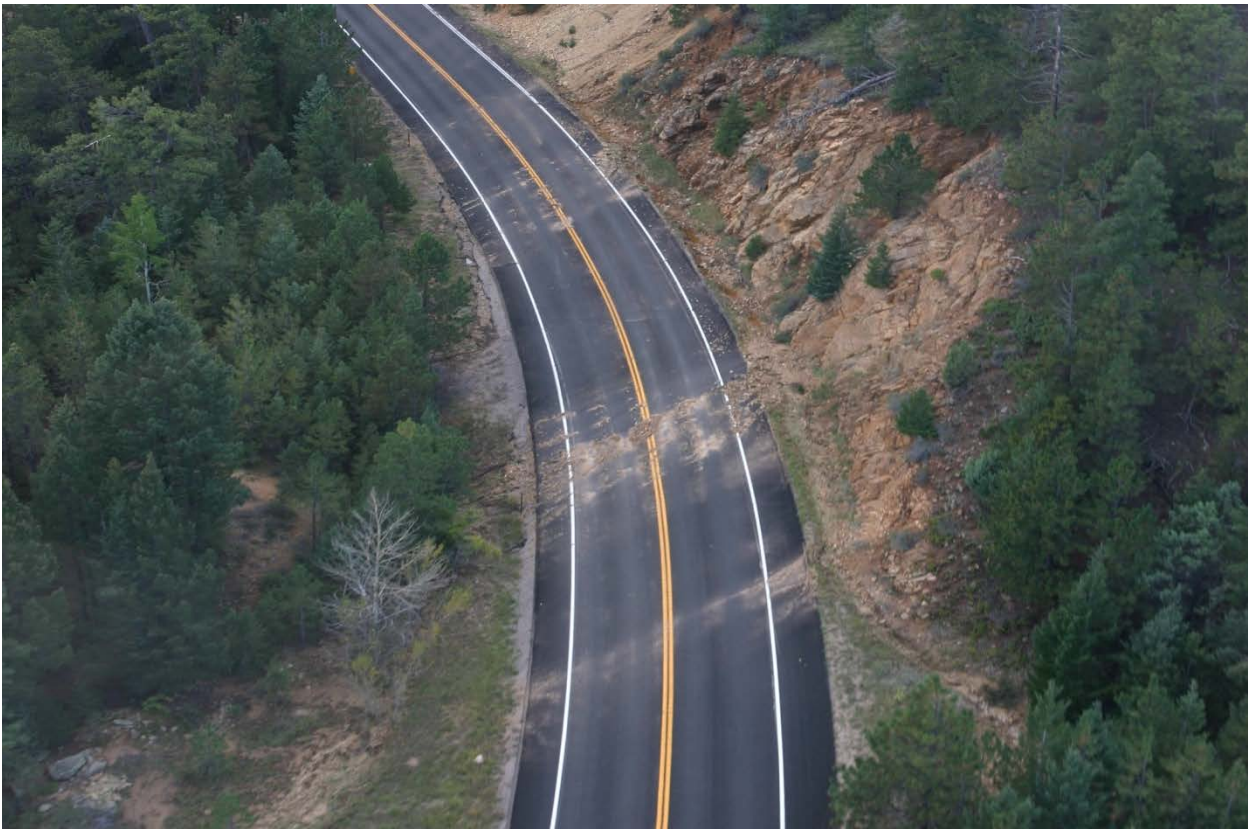
20.58	20.66	The eastbound roadside ditch experienced minor erosion scour damage, washing out approximately 0.5-1 ft deep and 1-2 ft wide in areas along this section.

Figure 11 - MP 20.66, Westbound ditch damage and material slide.

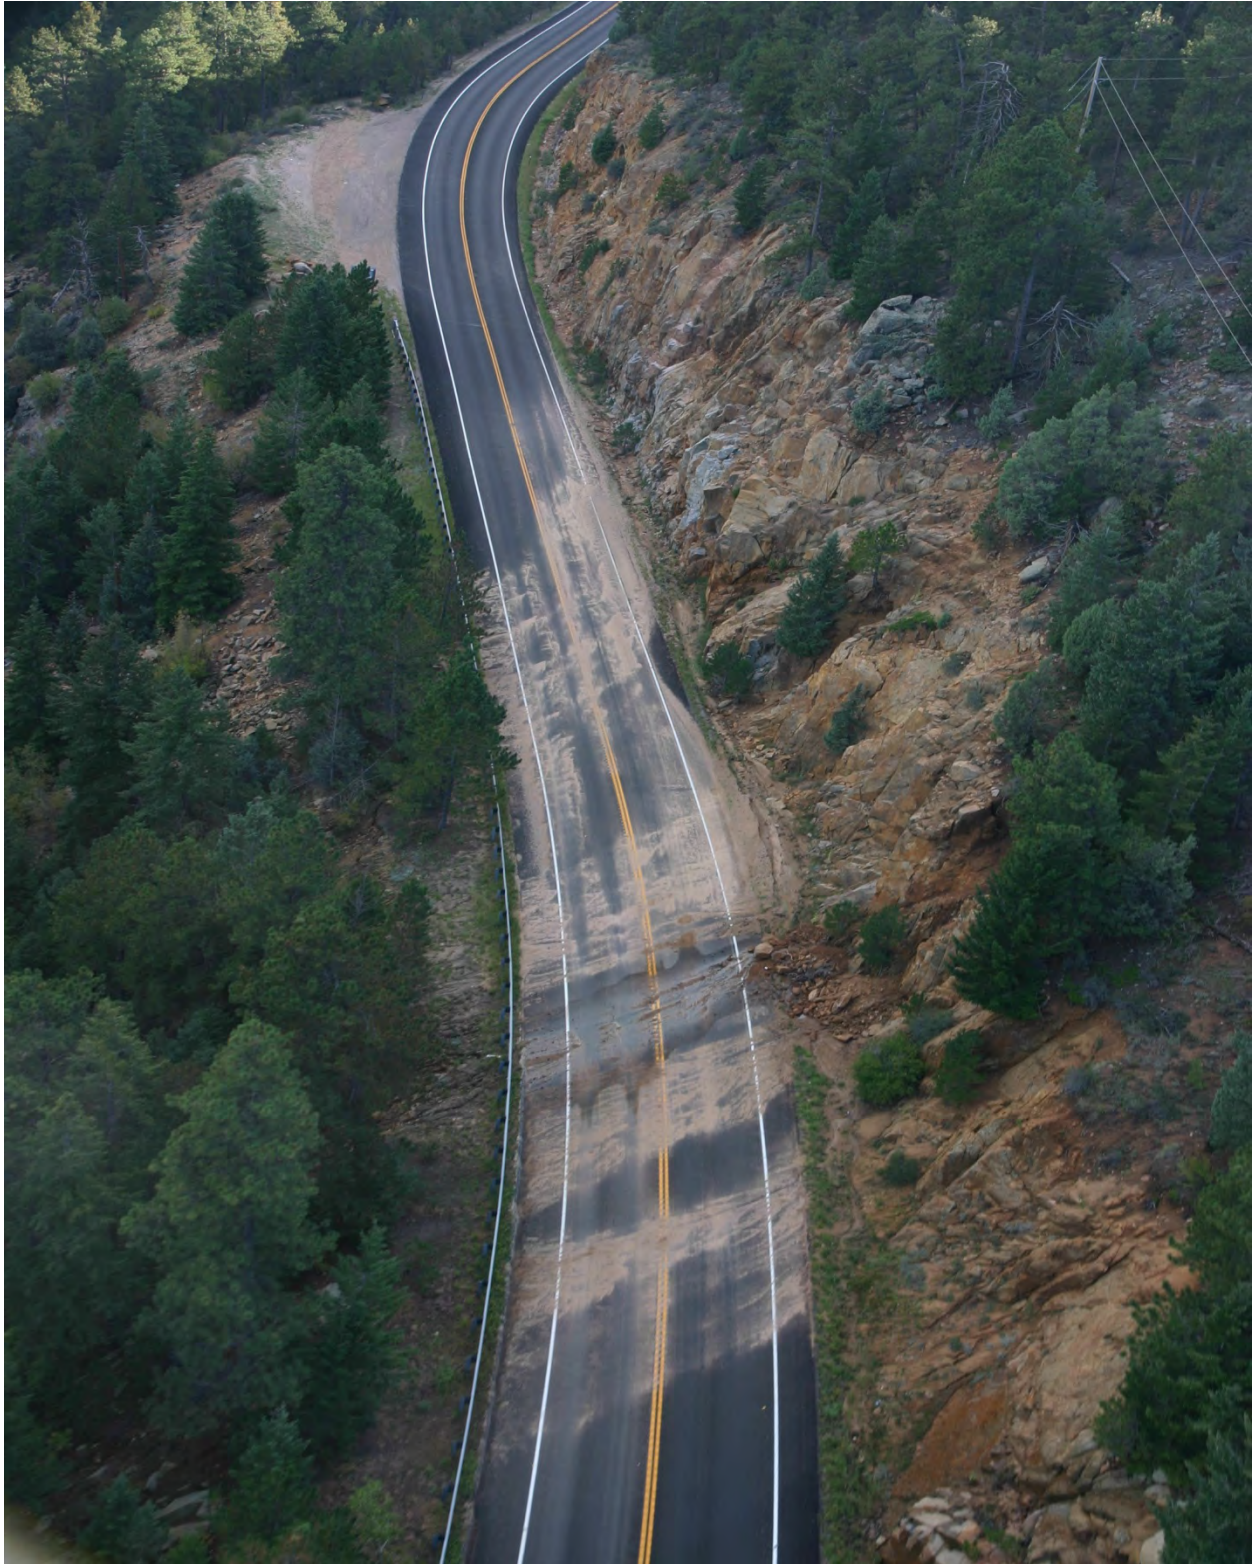
Figure 12 - MP 20.86, Material slide onto road.

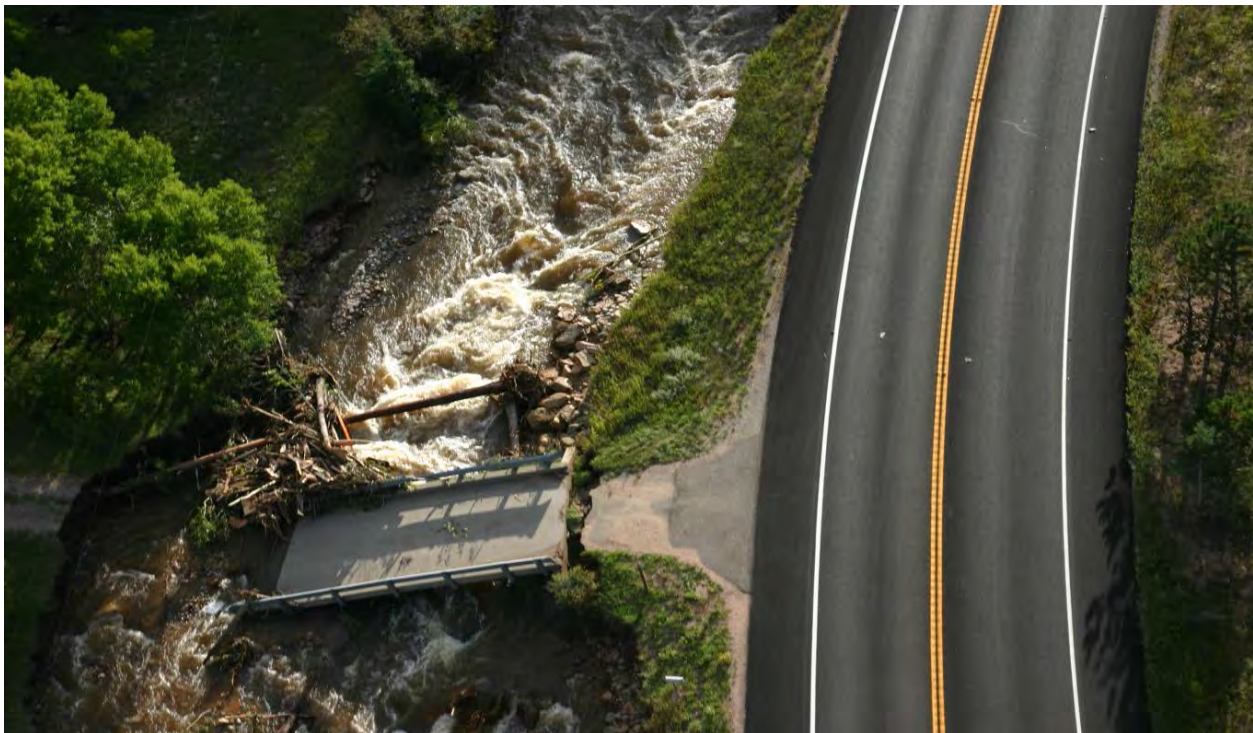
21.92	21.93	High flows in Middle Saint Vrain Creek caused severe scour damage to a local access bridge over the creek resulting in wash out of the bridge and scour damage to the eastbound roadway embankment slope upstream and downstream of bridge.

Figure 14 - MP 21.68, Local access bridge washed out and embankment damaged upstream and downstream of structure.

21.68	21.72	The material deposited in the ditch and on the road was removed and the ditch was regraded.
21.92	21.93	The damaged roadway embankment slope was repaired.

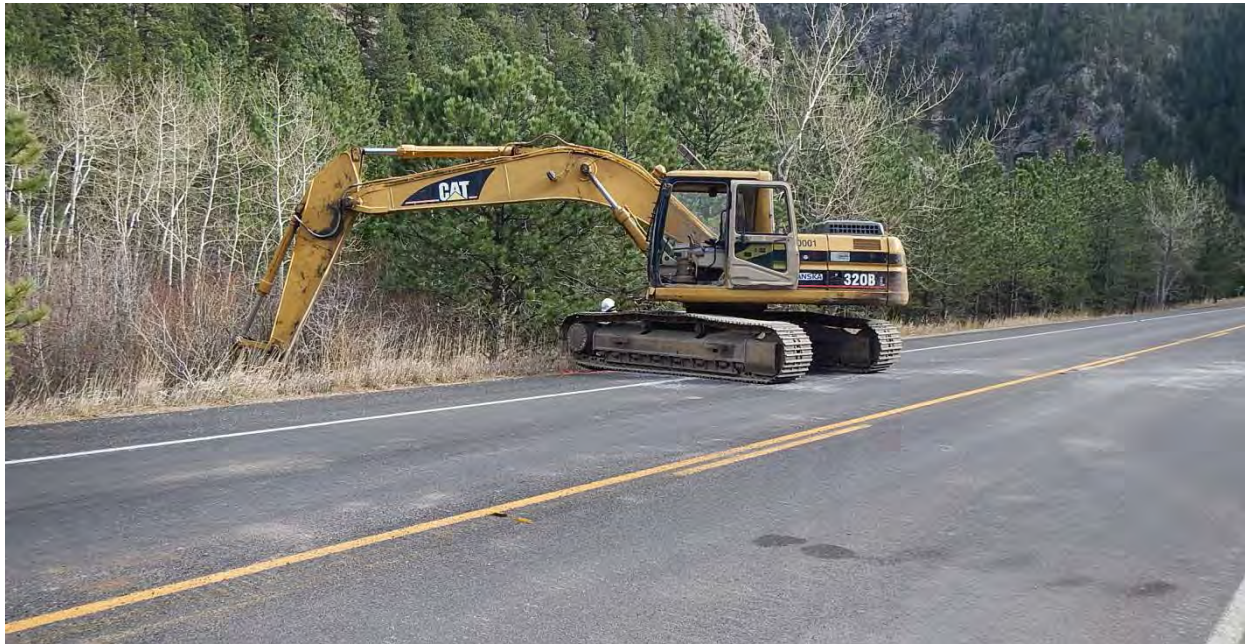
Figure 15 - MP 22, Emergency repair.

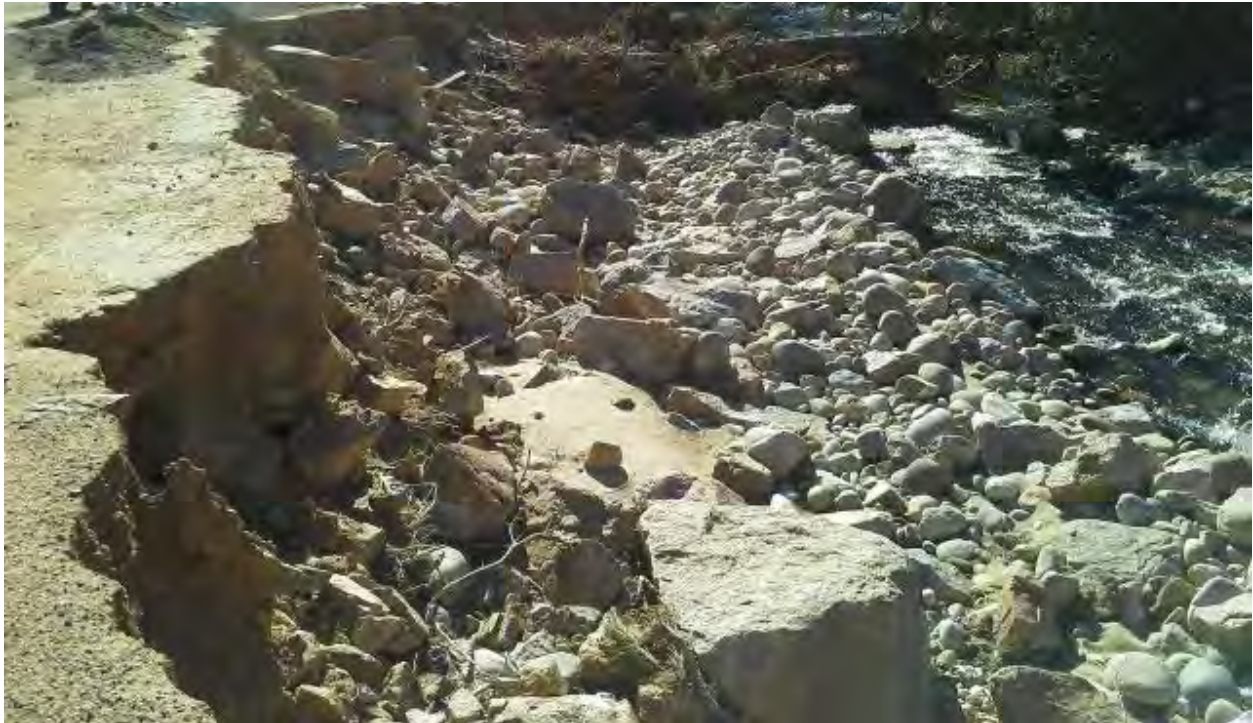
Figure 17 - MP 22.13, Eastbound roadway embankment scour damage.

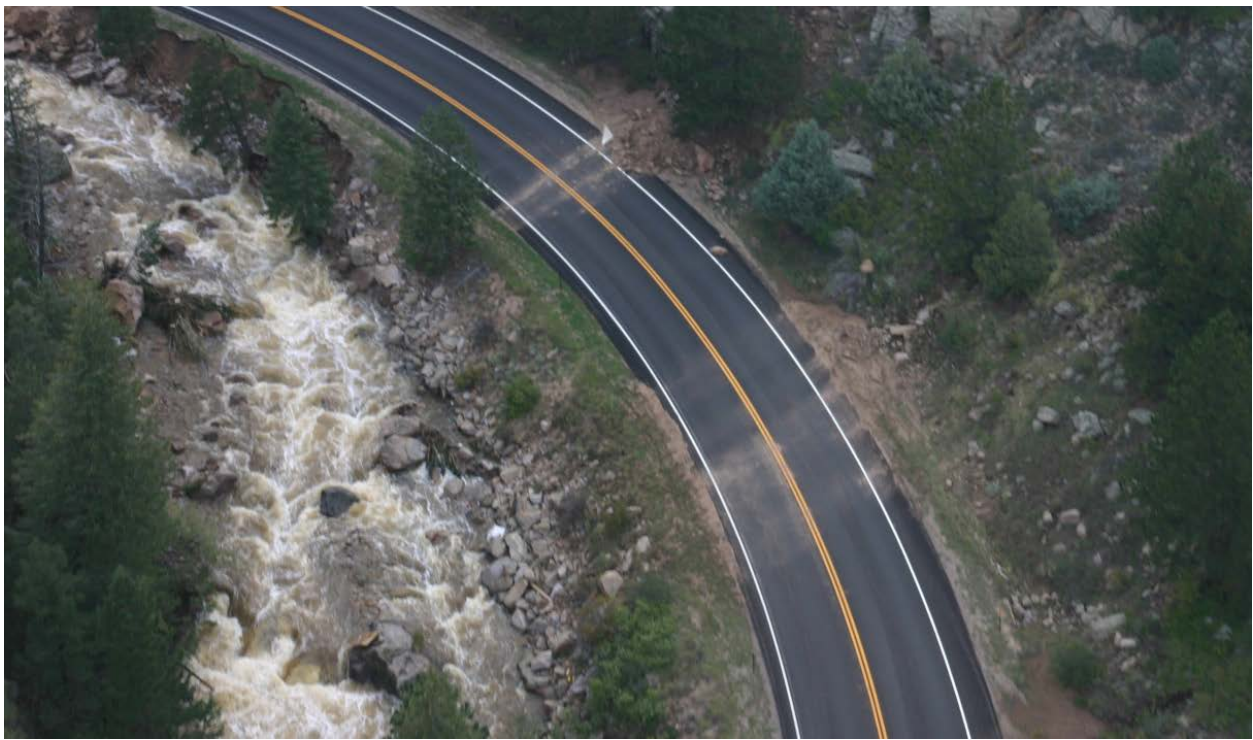
Figure 18 - MP 22.5, Riverside embankment loss and material slide onto the roadway.

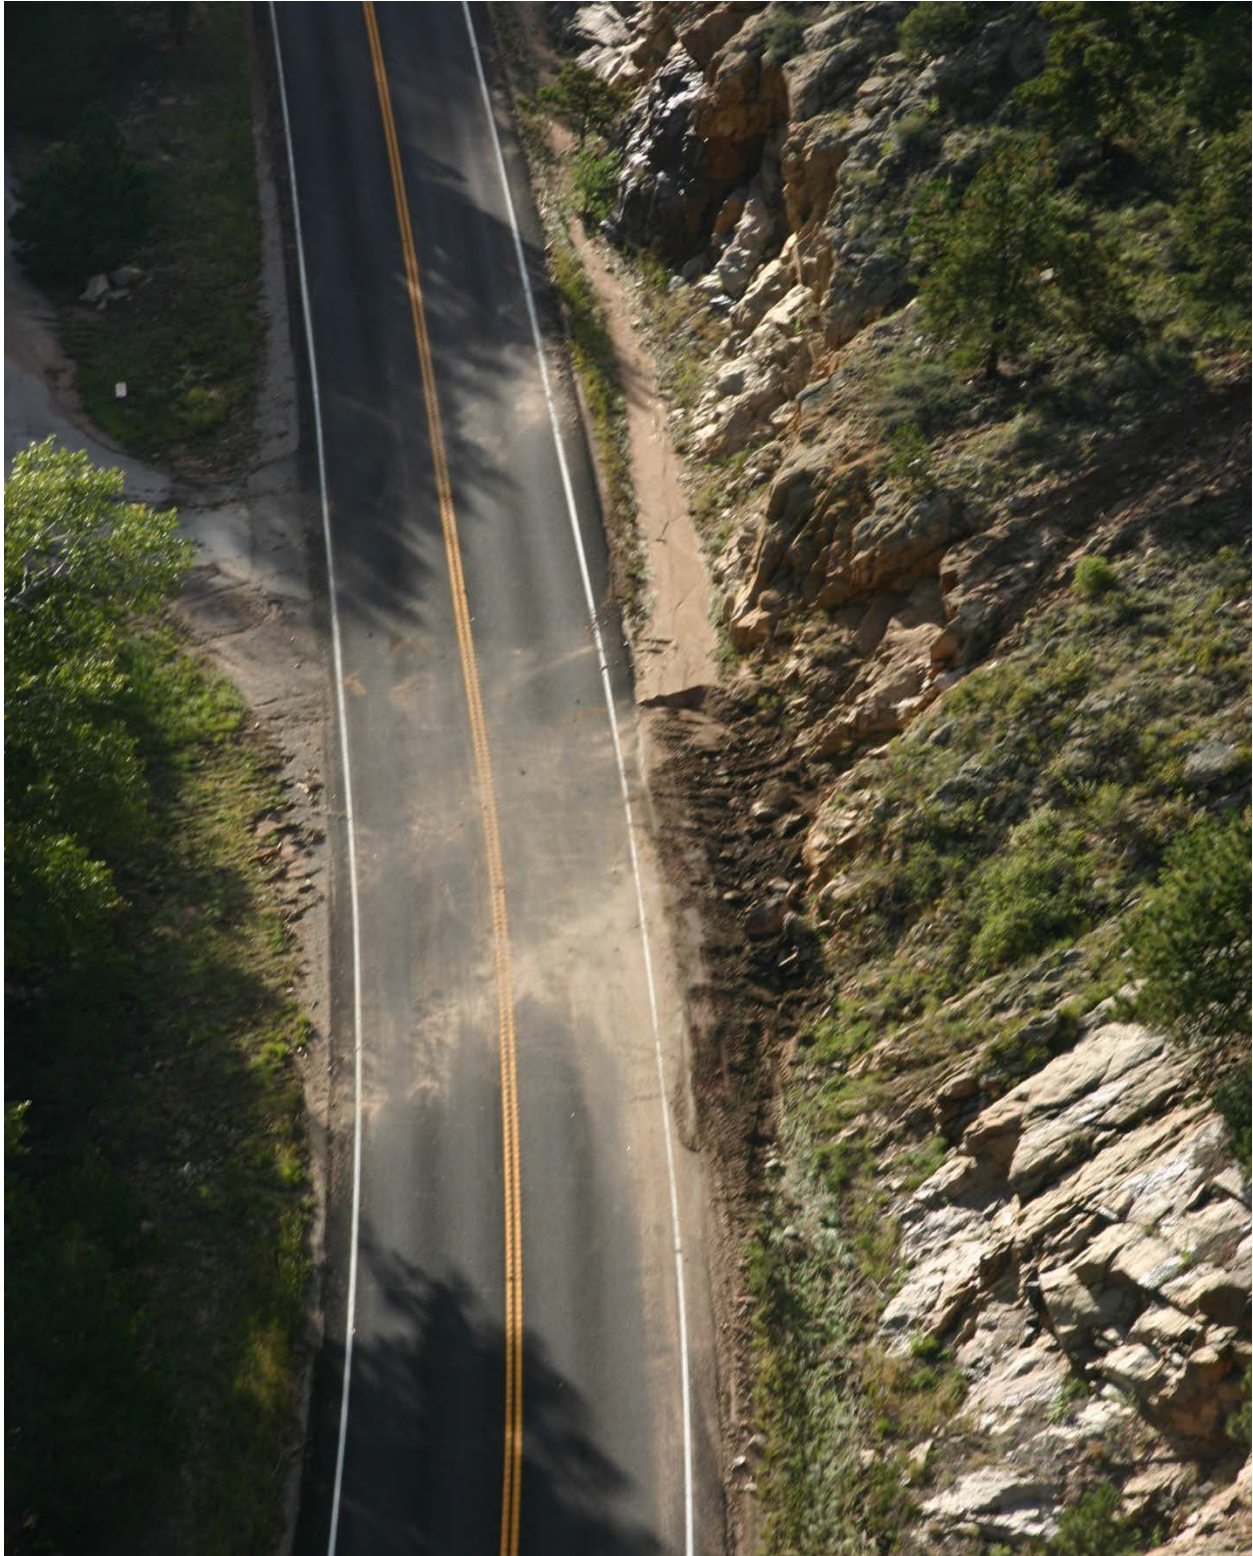
Figure 19 - MP 22.83, Material slide onto roadway.

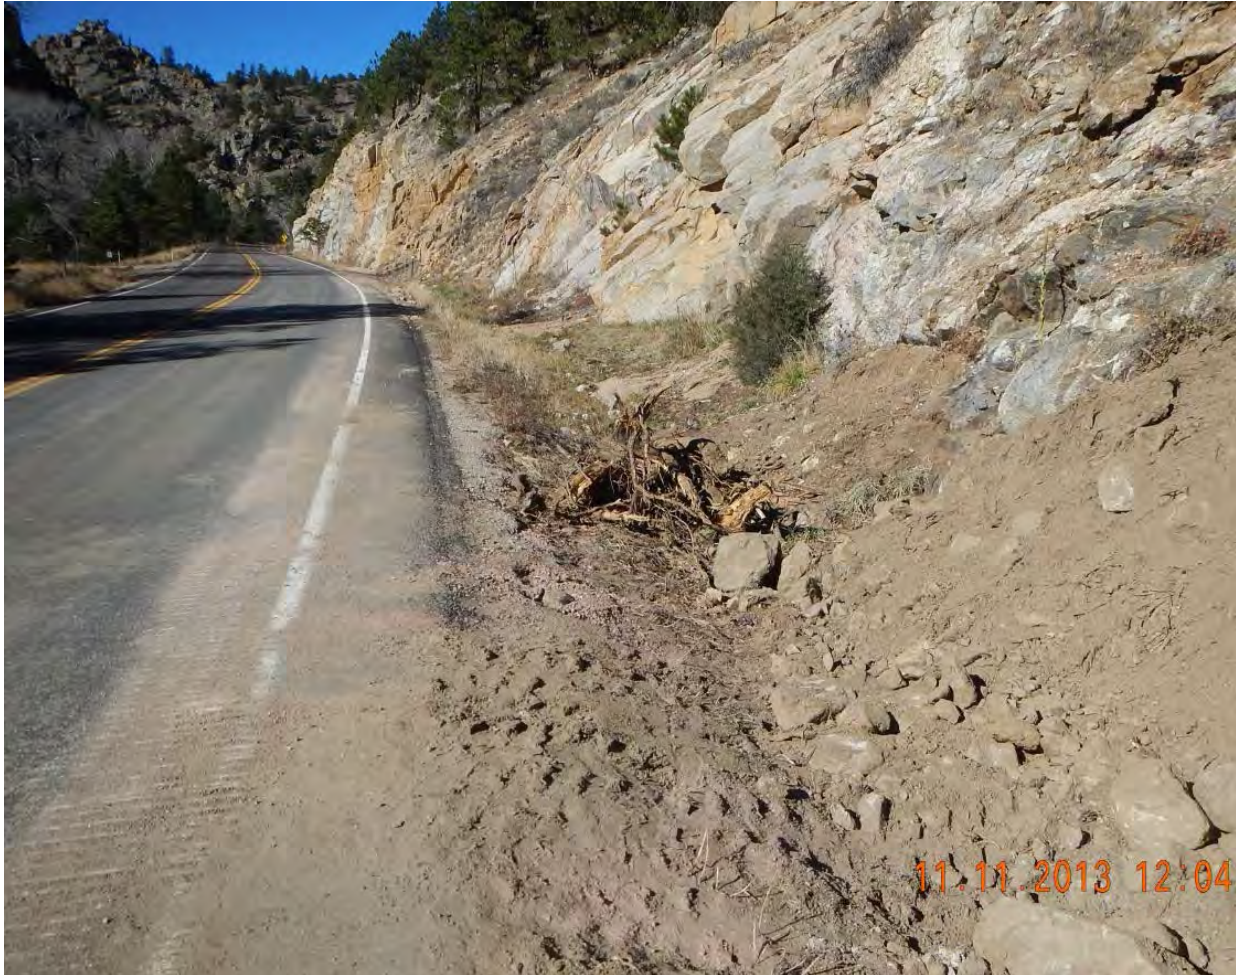
22.95	22.97	There was a material slide onto the westbound lane causing minor overtopping of the roadway with runoff and sediment. The outlet of the existing cross culvert was undermined.

Figure 21 - MP 22.95, Removal of material from slide and regarding of westbound roadside ditch.

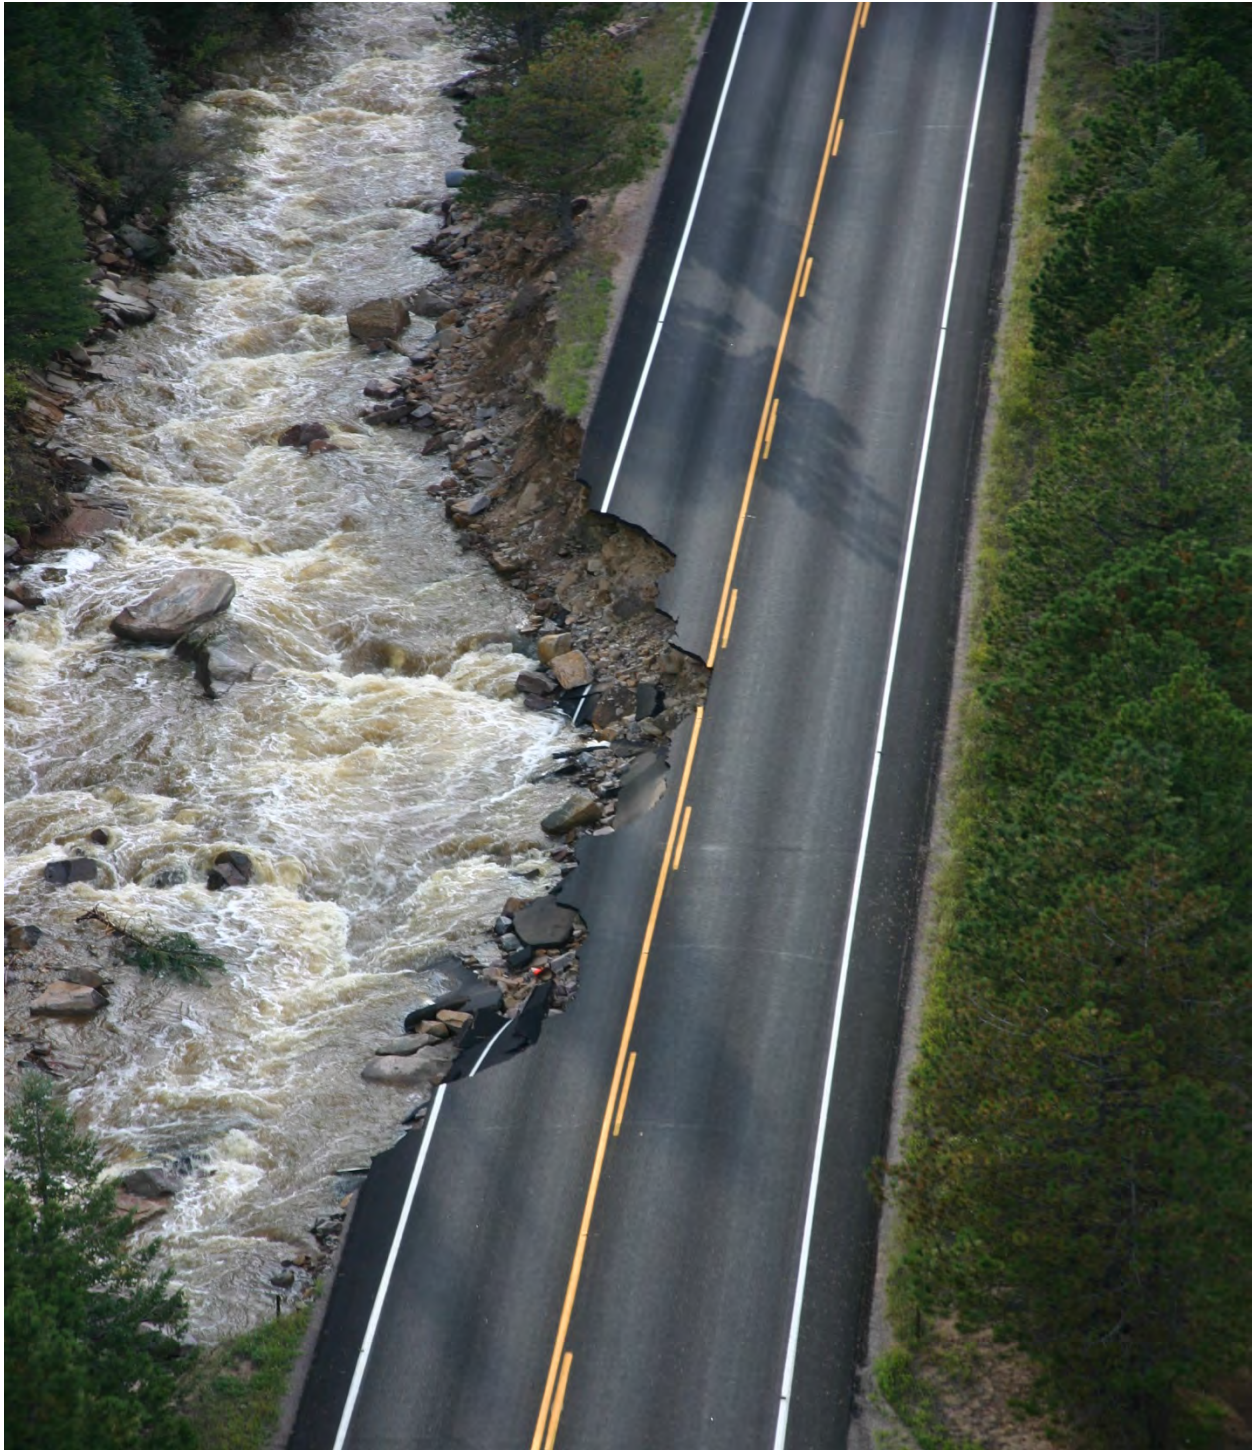
Figure 24 - MP 23.54, Roadway embankment damage, partial wash out of EB lane.

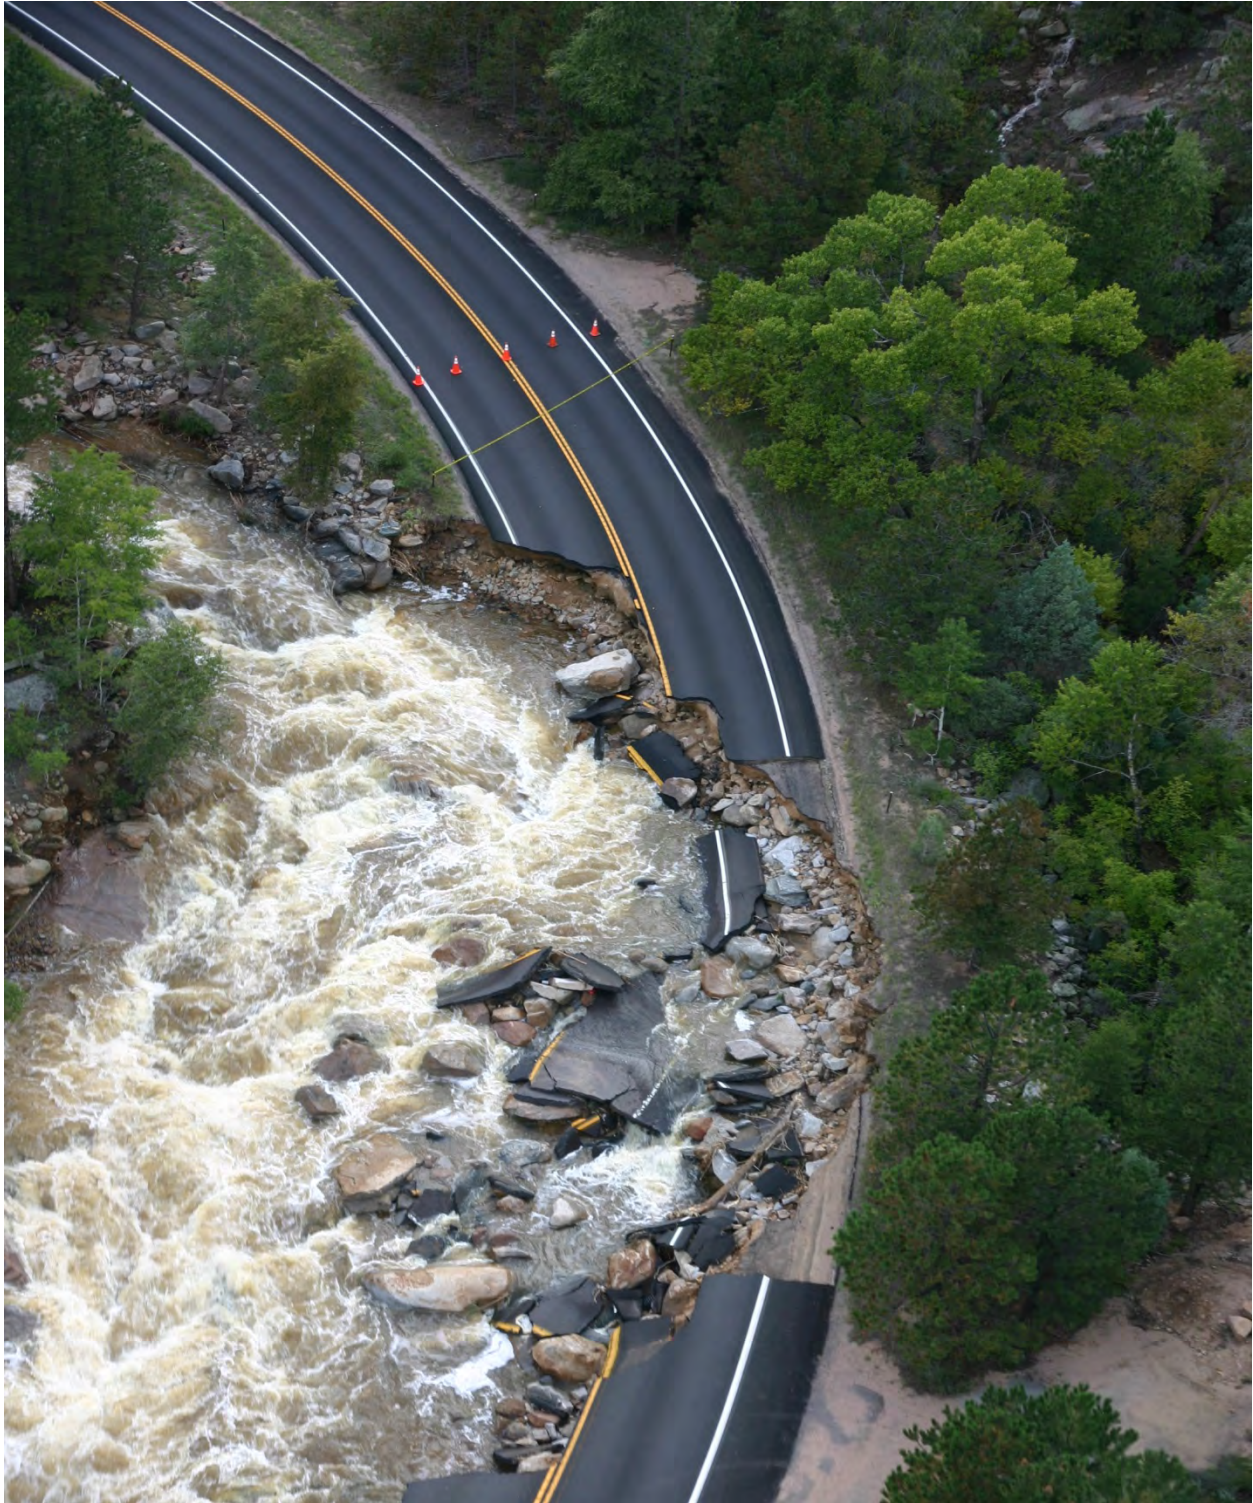
Figure 25 - MP 23.8, Complete 2 lane roadway wash out.

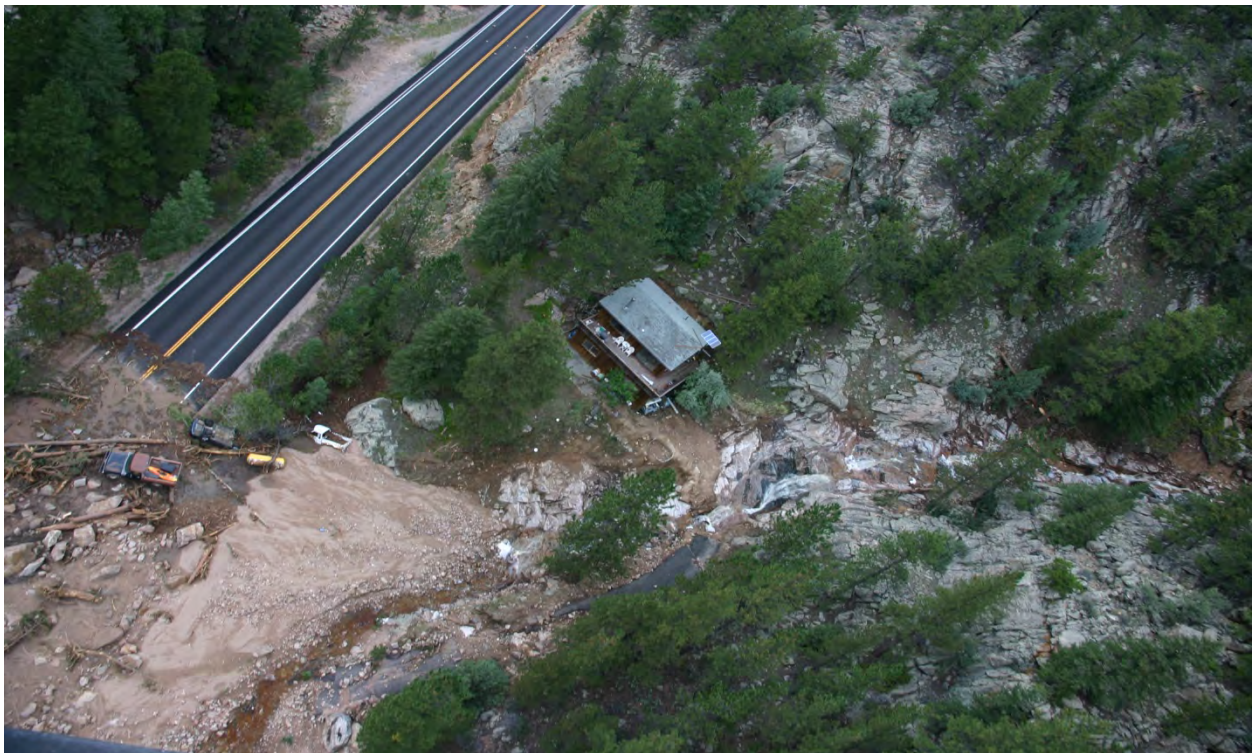
Figure 27 - MP 24.6, Rock slide, debris and sediment covering both roadway lanes.

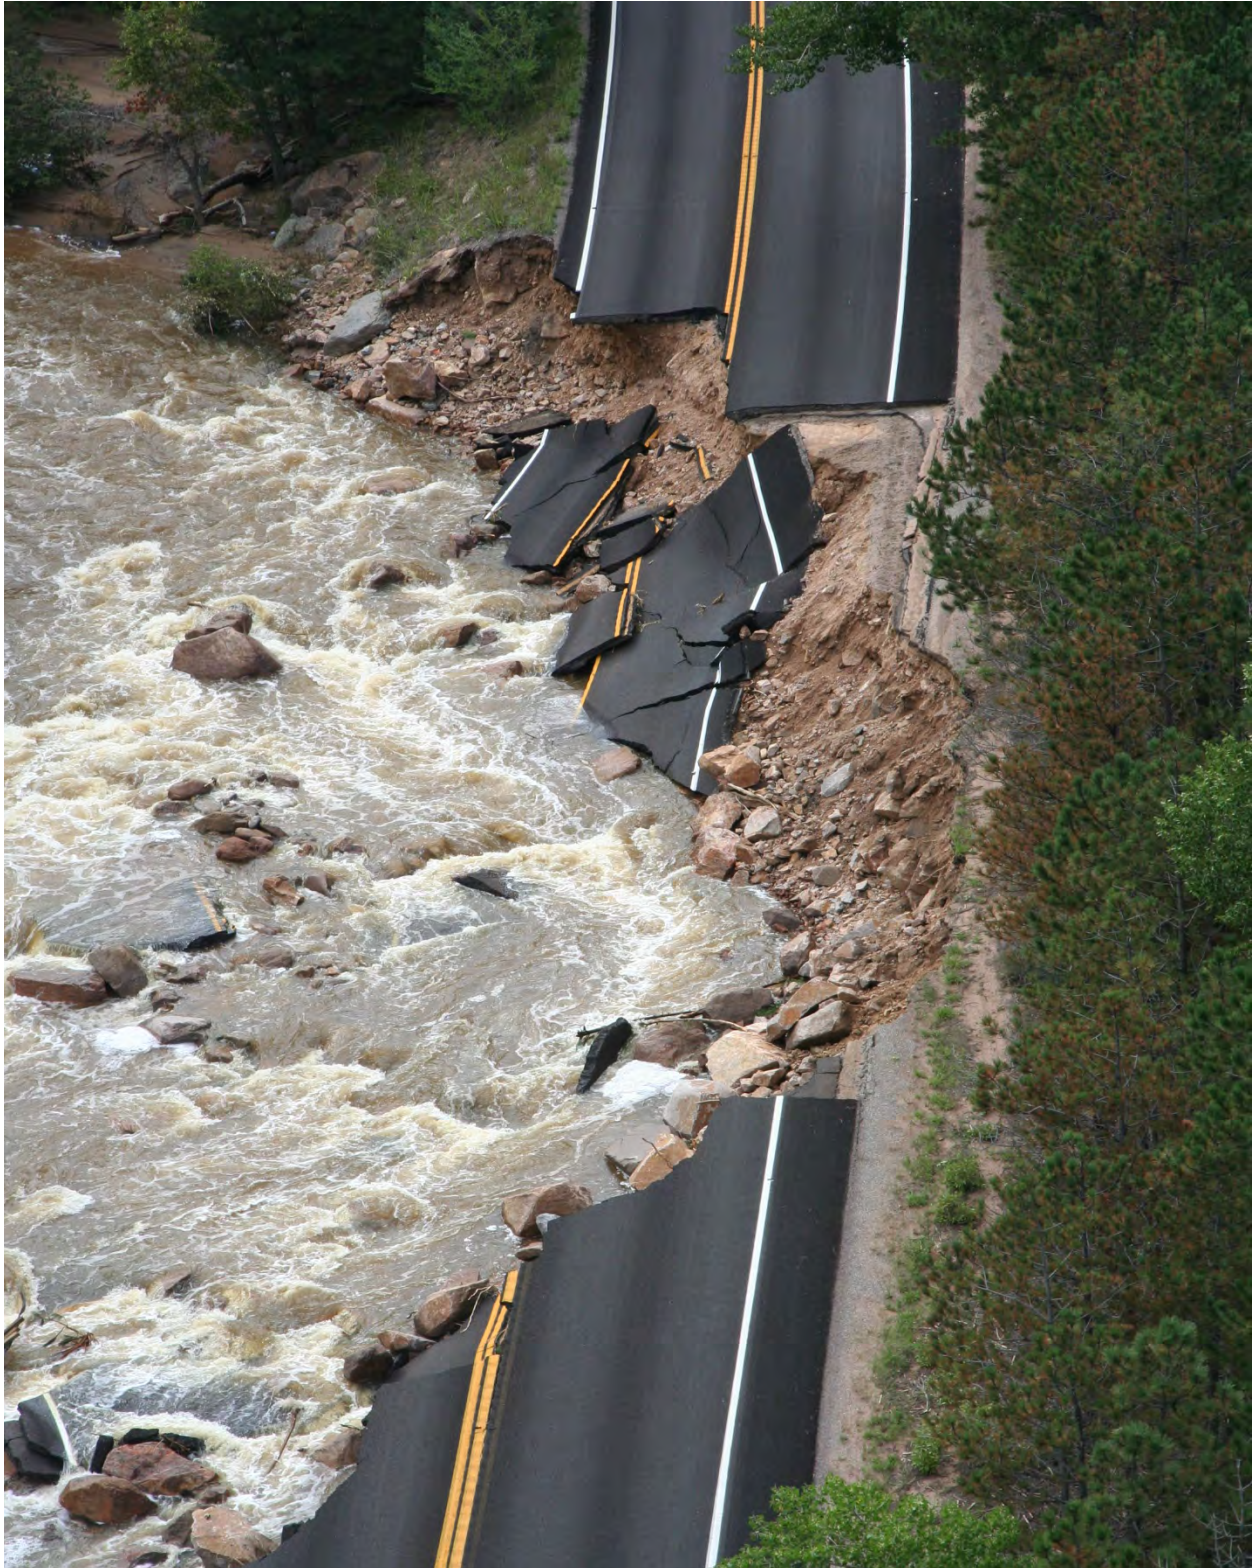
Figure 30 - MP 25.5, Embankment and roadway washout.

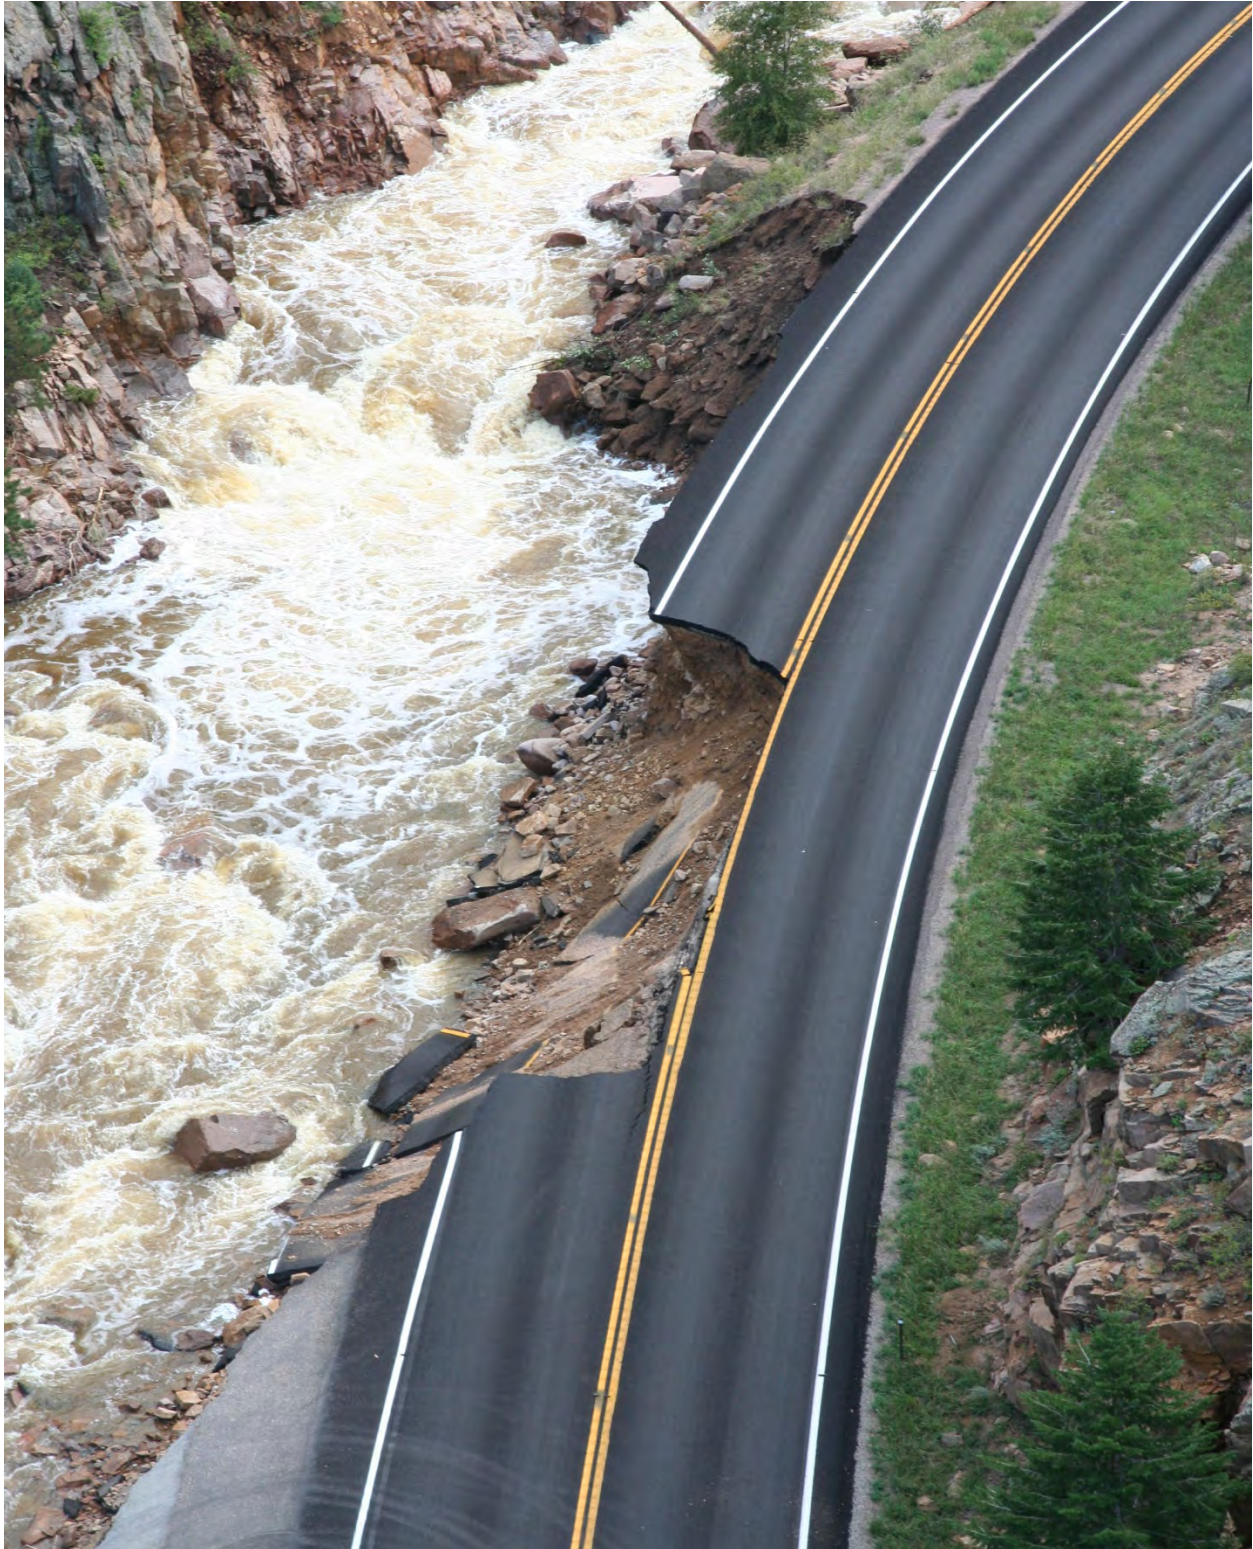
Figure 31 - MP 25.75, Embankment and partial roadway washout.

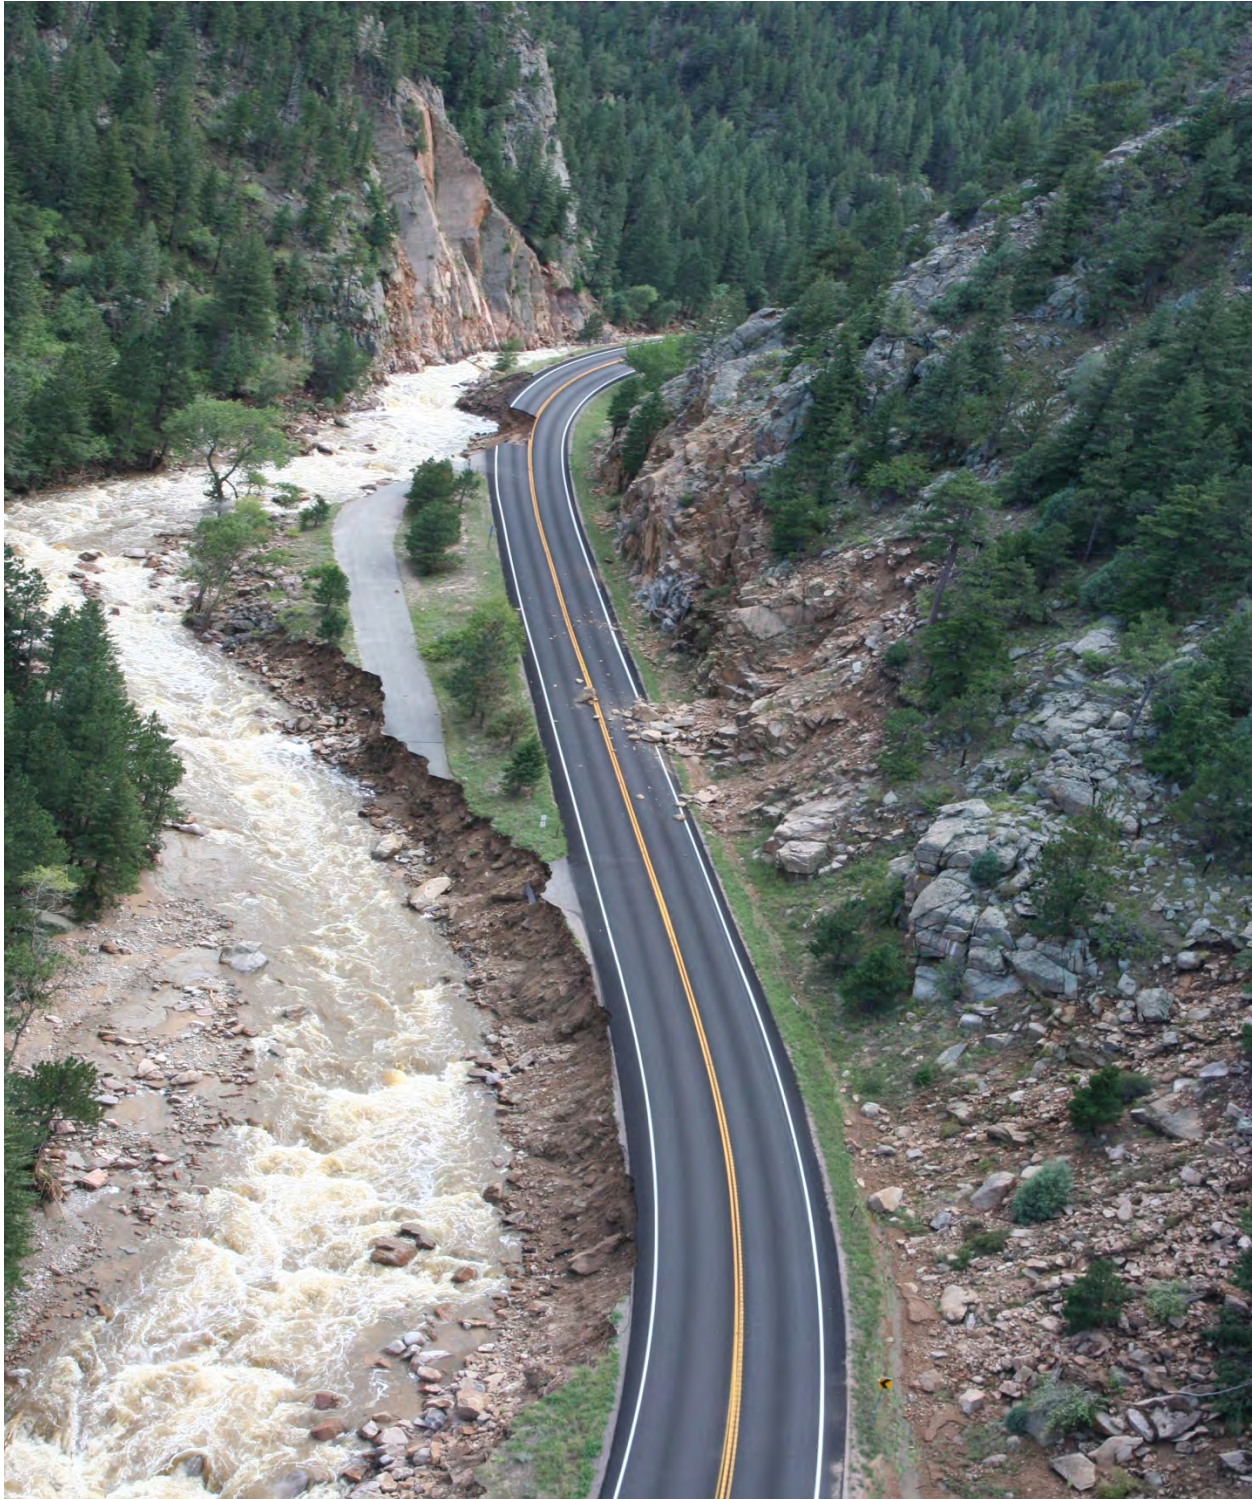
Figure 32 - MP 25.8, Embankment/pavement washout and rockslide.
