**SH 7A (Lower)
Raymond to Lyons
Site Repairs between Mileposts 19 and 33**

**Boulder County
COLORADO**

Damage Assessment Report

**100% DRAFT
Revised: July 28, 2014**

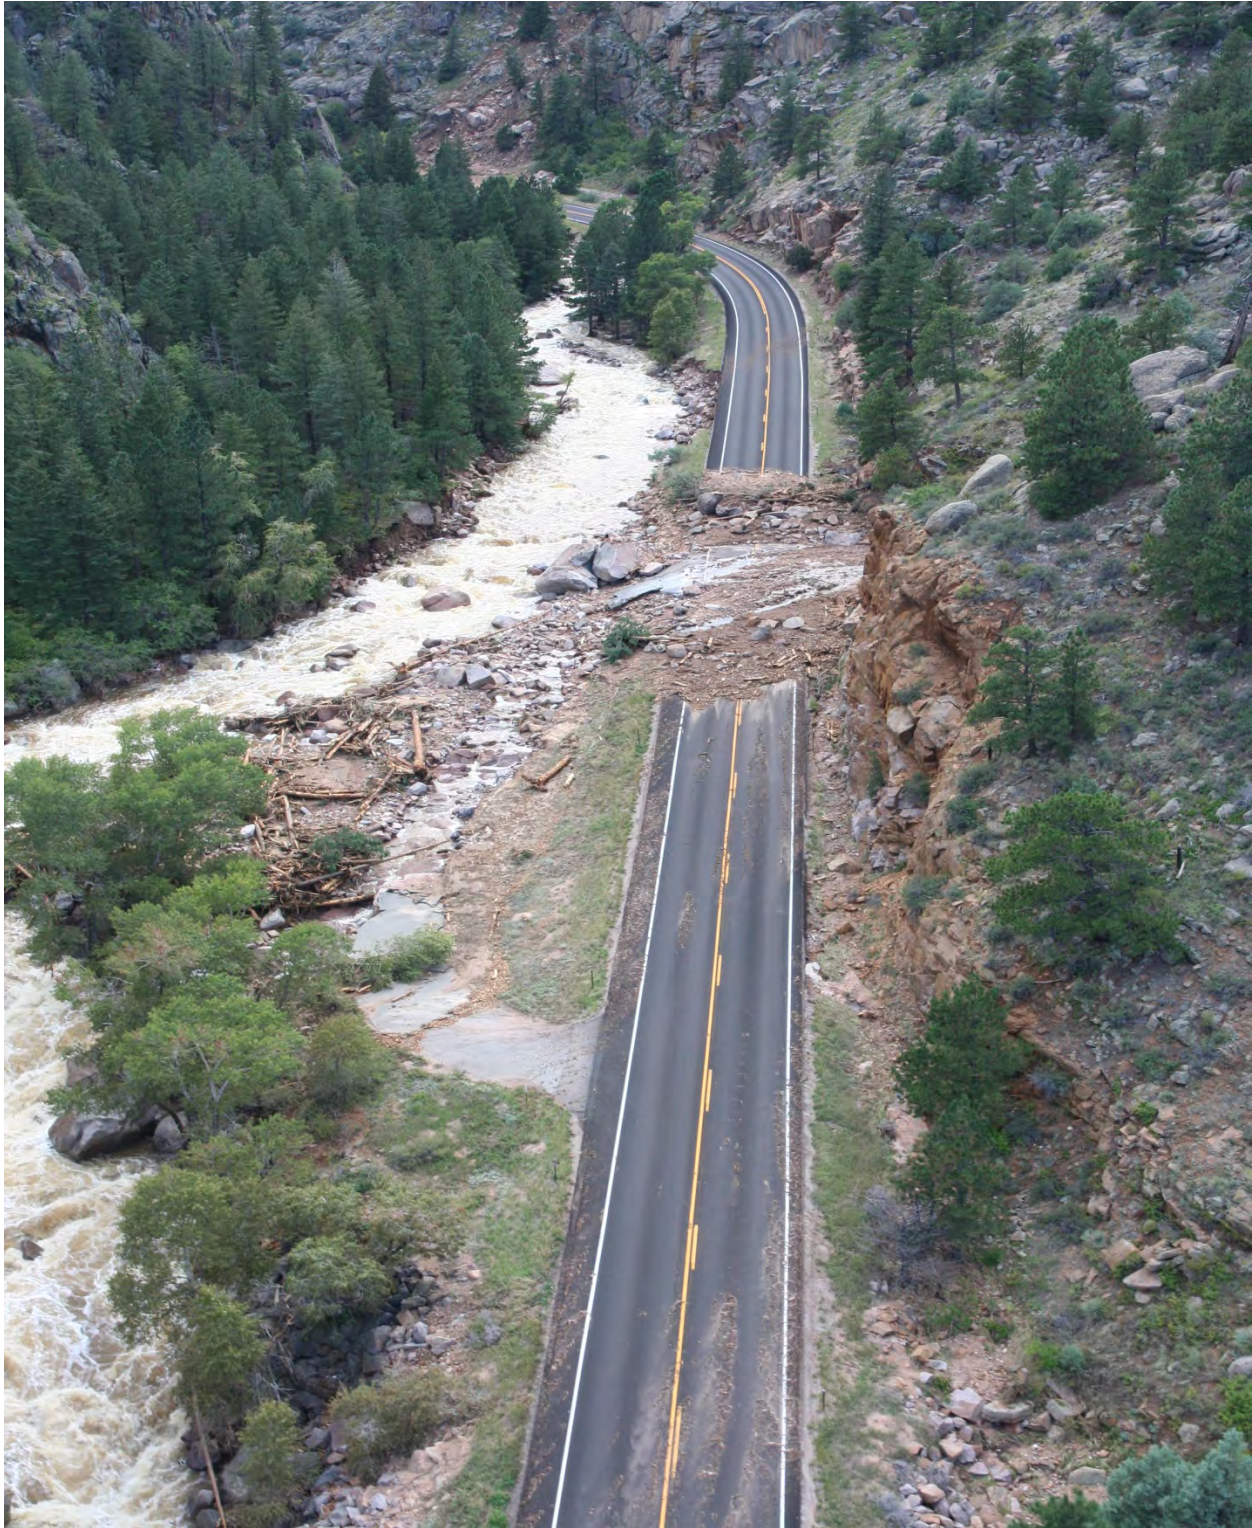
Figure 33 - MP 26.25, Rock slide and debris covering both roadway lanes.

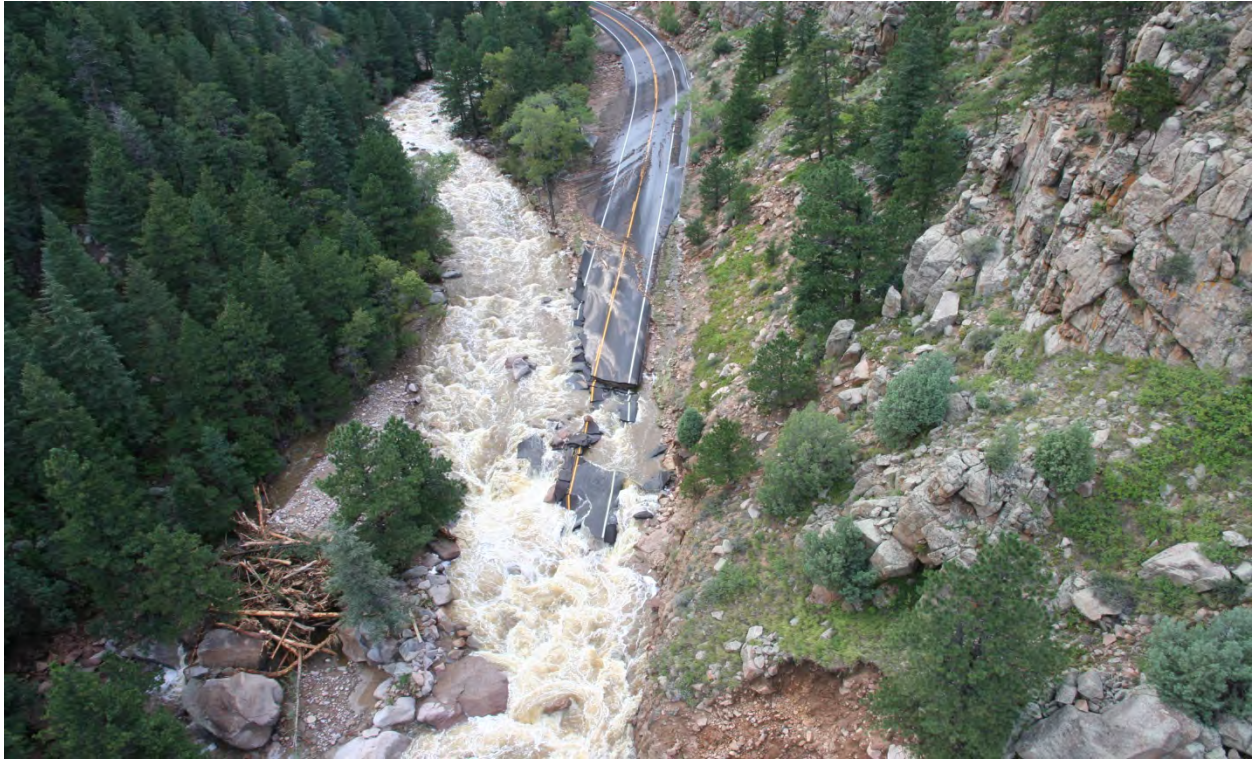
Figure 34 - MP 26.61, Complete roadway loss due to overtopping.

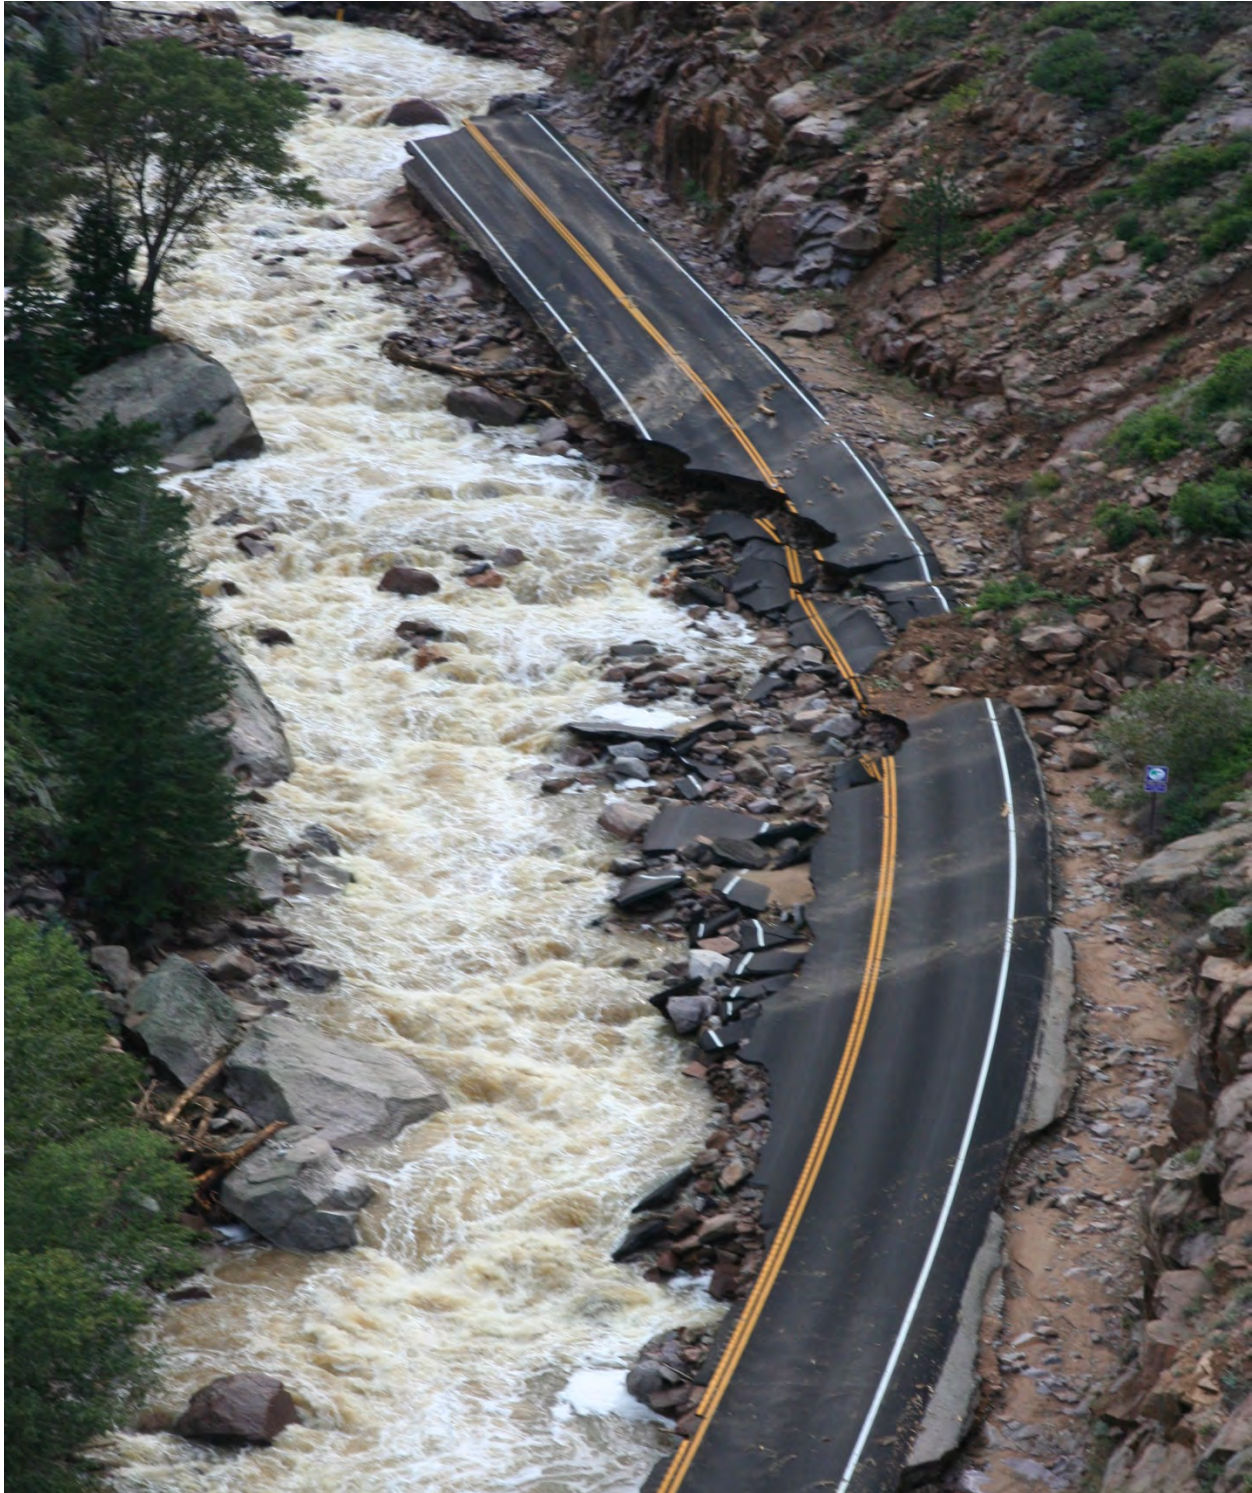
Figure 36 - MP 26.9, Roadway undermined and washed out embankment.

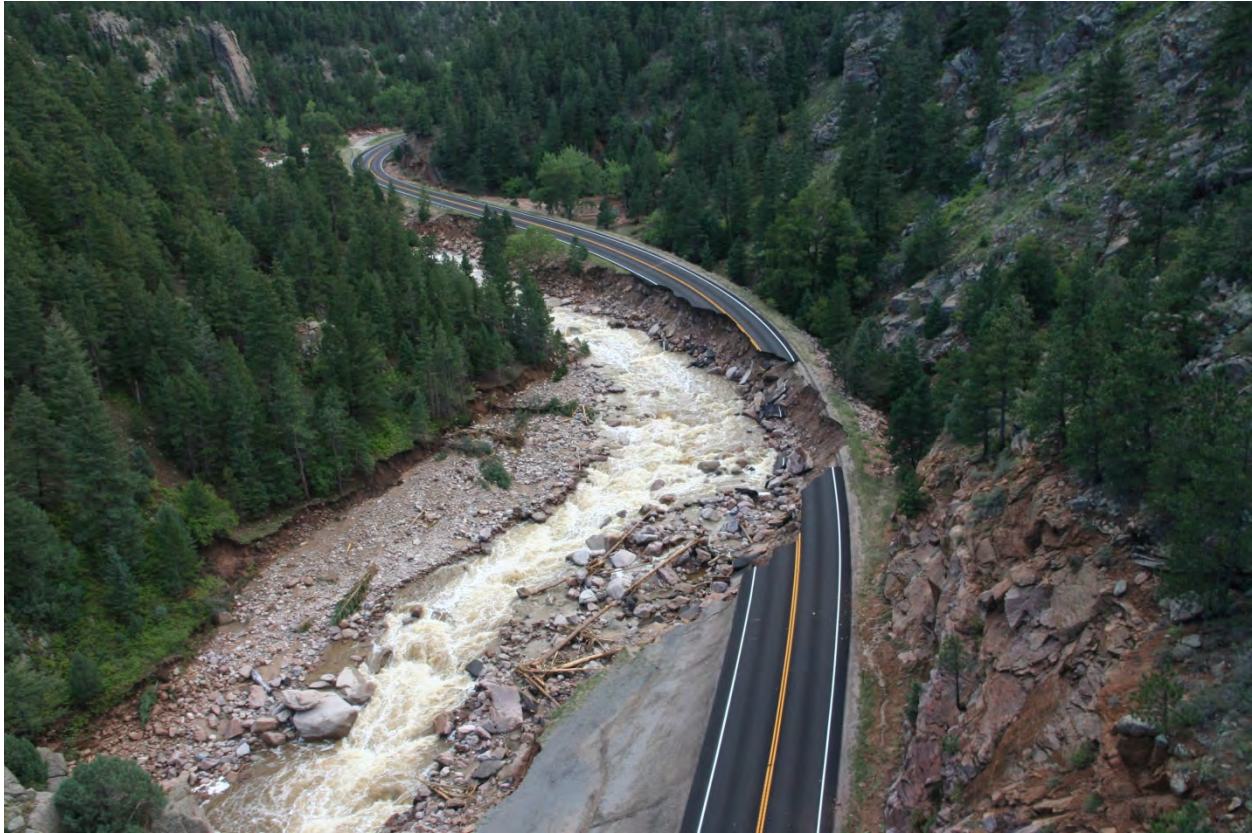
Figure 37 - MP 27.28, Complete roadway loss due to embankment scour damage at the river bend.

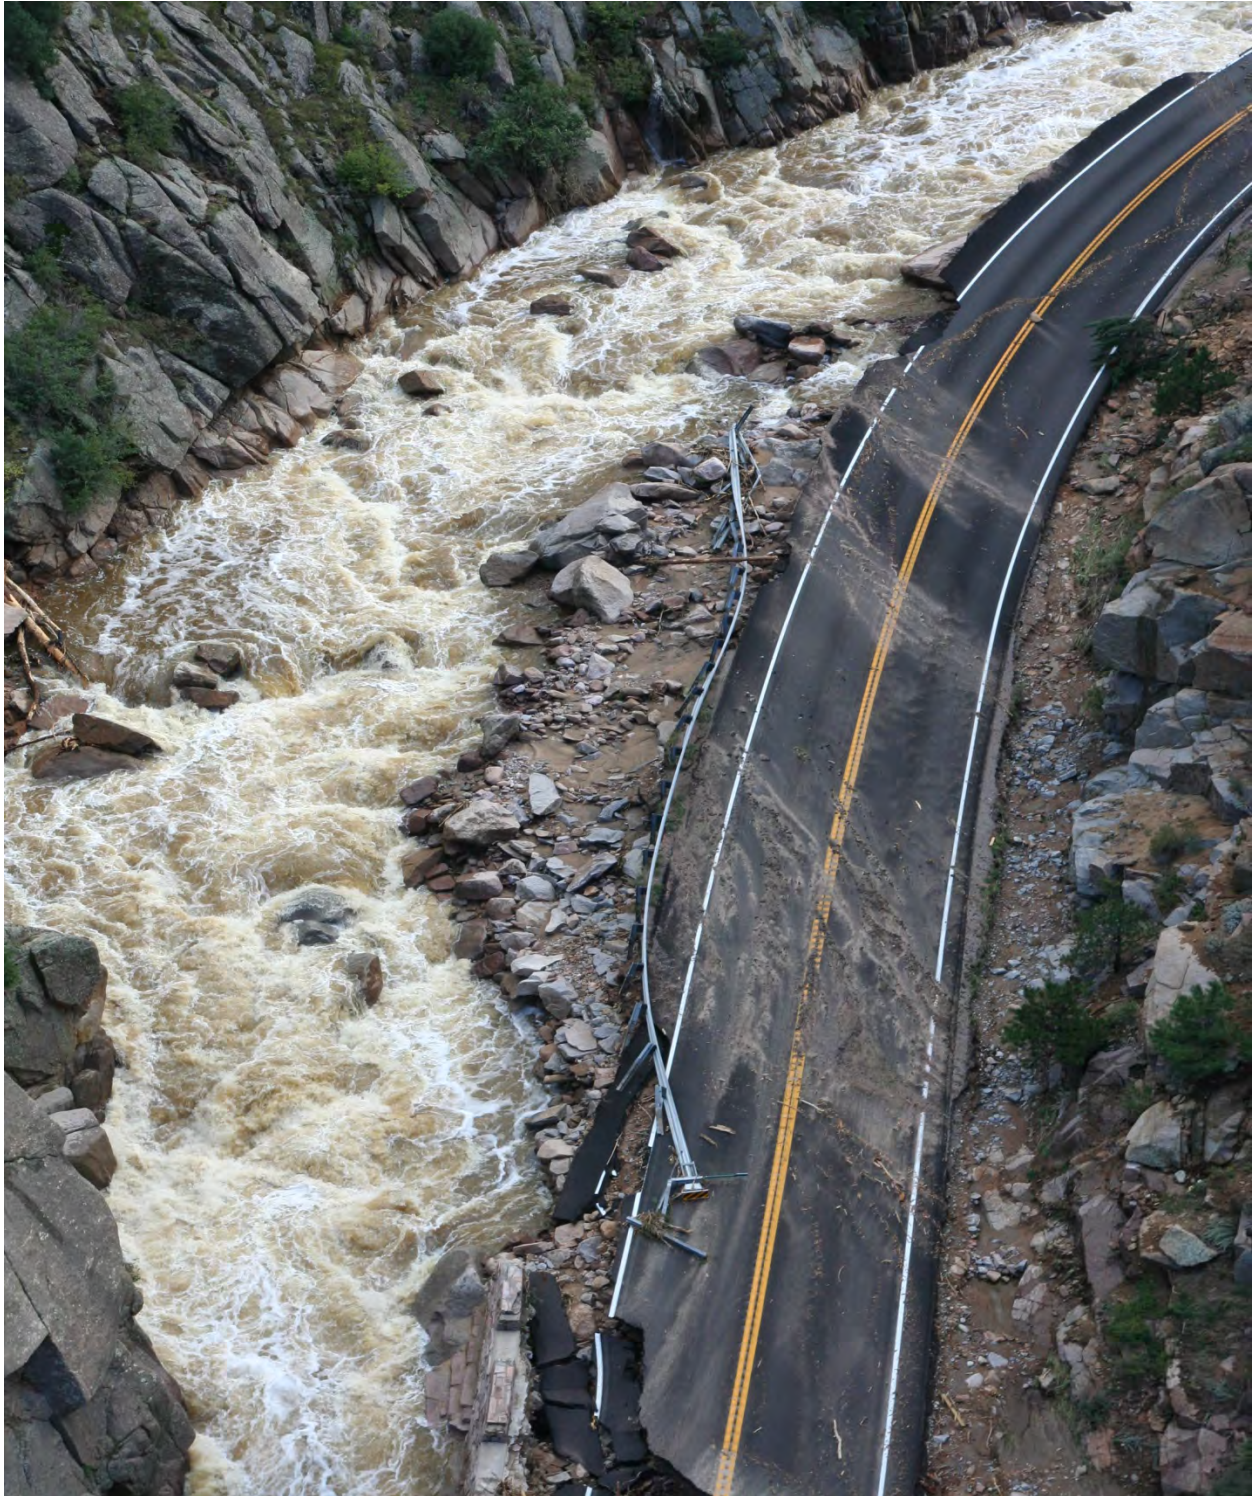
Figure 38 - MP 27.61, Riverside embankment and eastbound lane damage due to lateral scour and overtopping of the roadway.

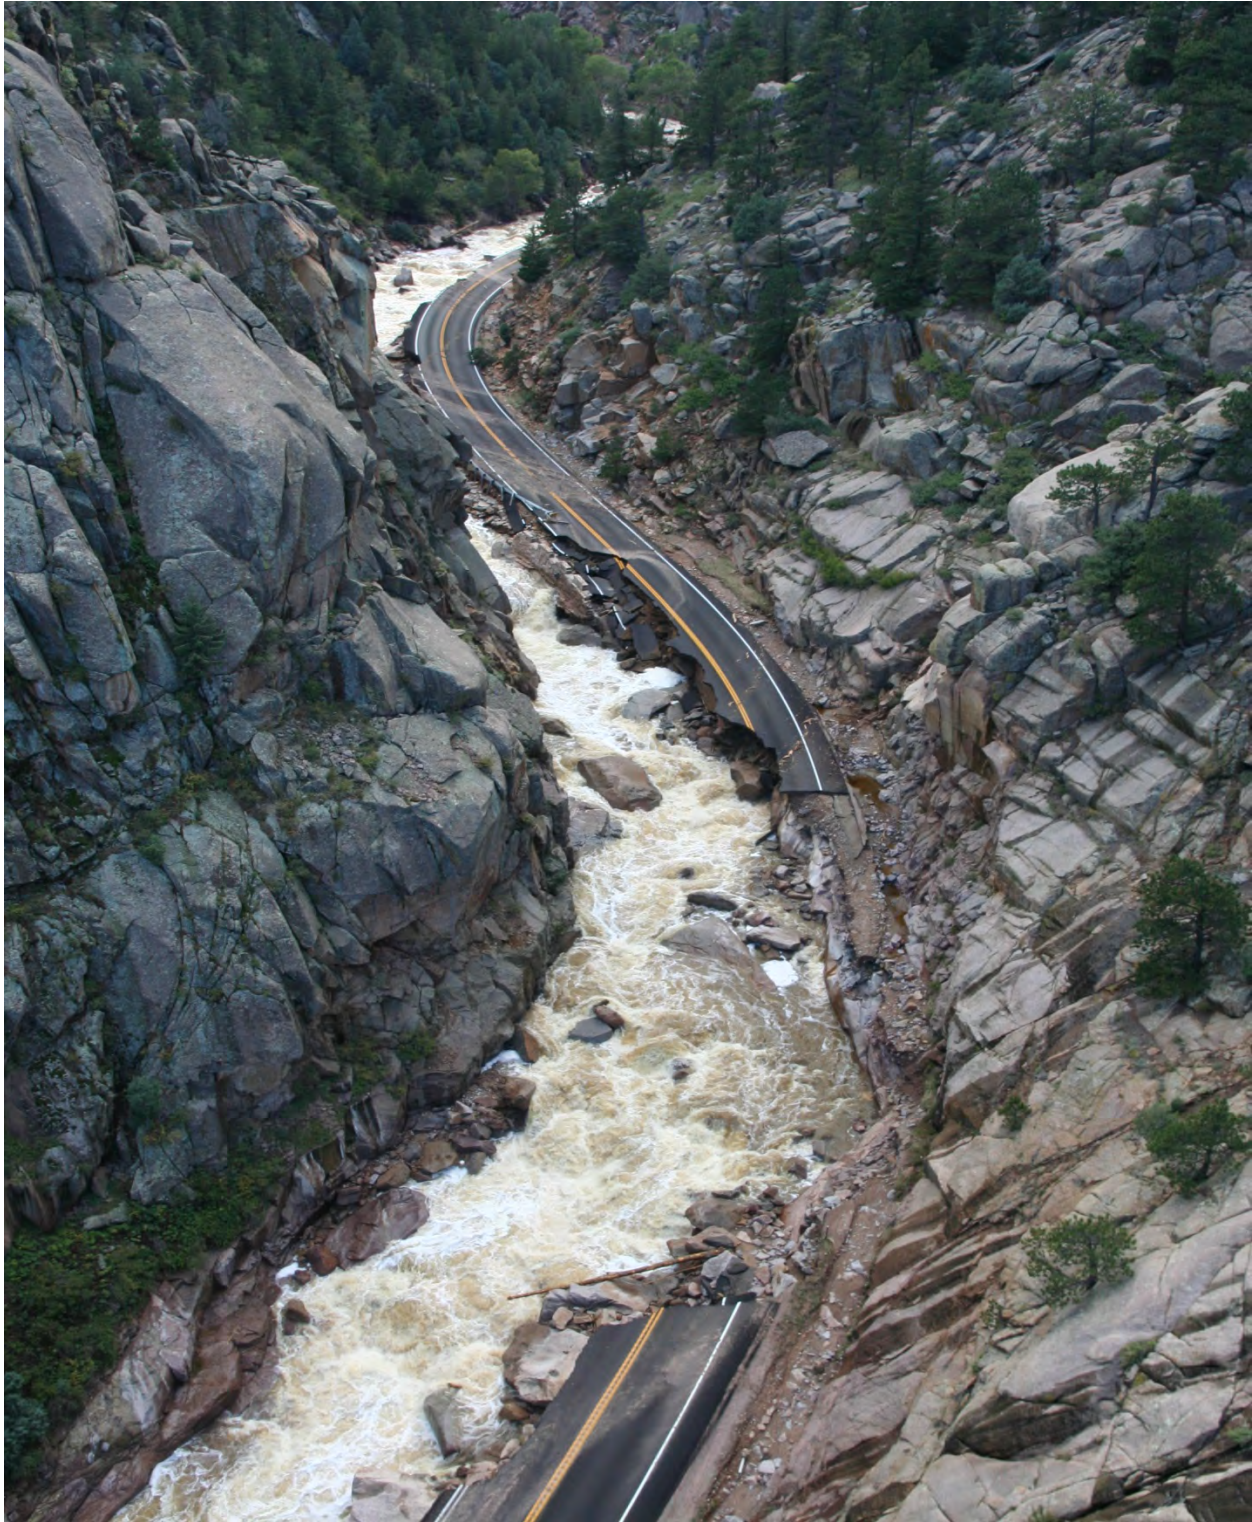
Figure 39 - MP 27.68, Wash out of riverside embankment and roadway due to lateral scour and overtopping of the roadway.

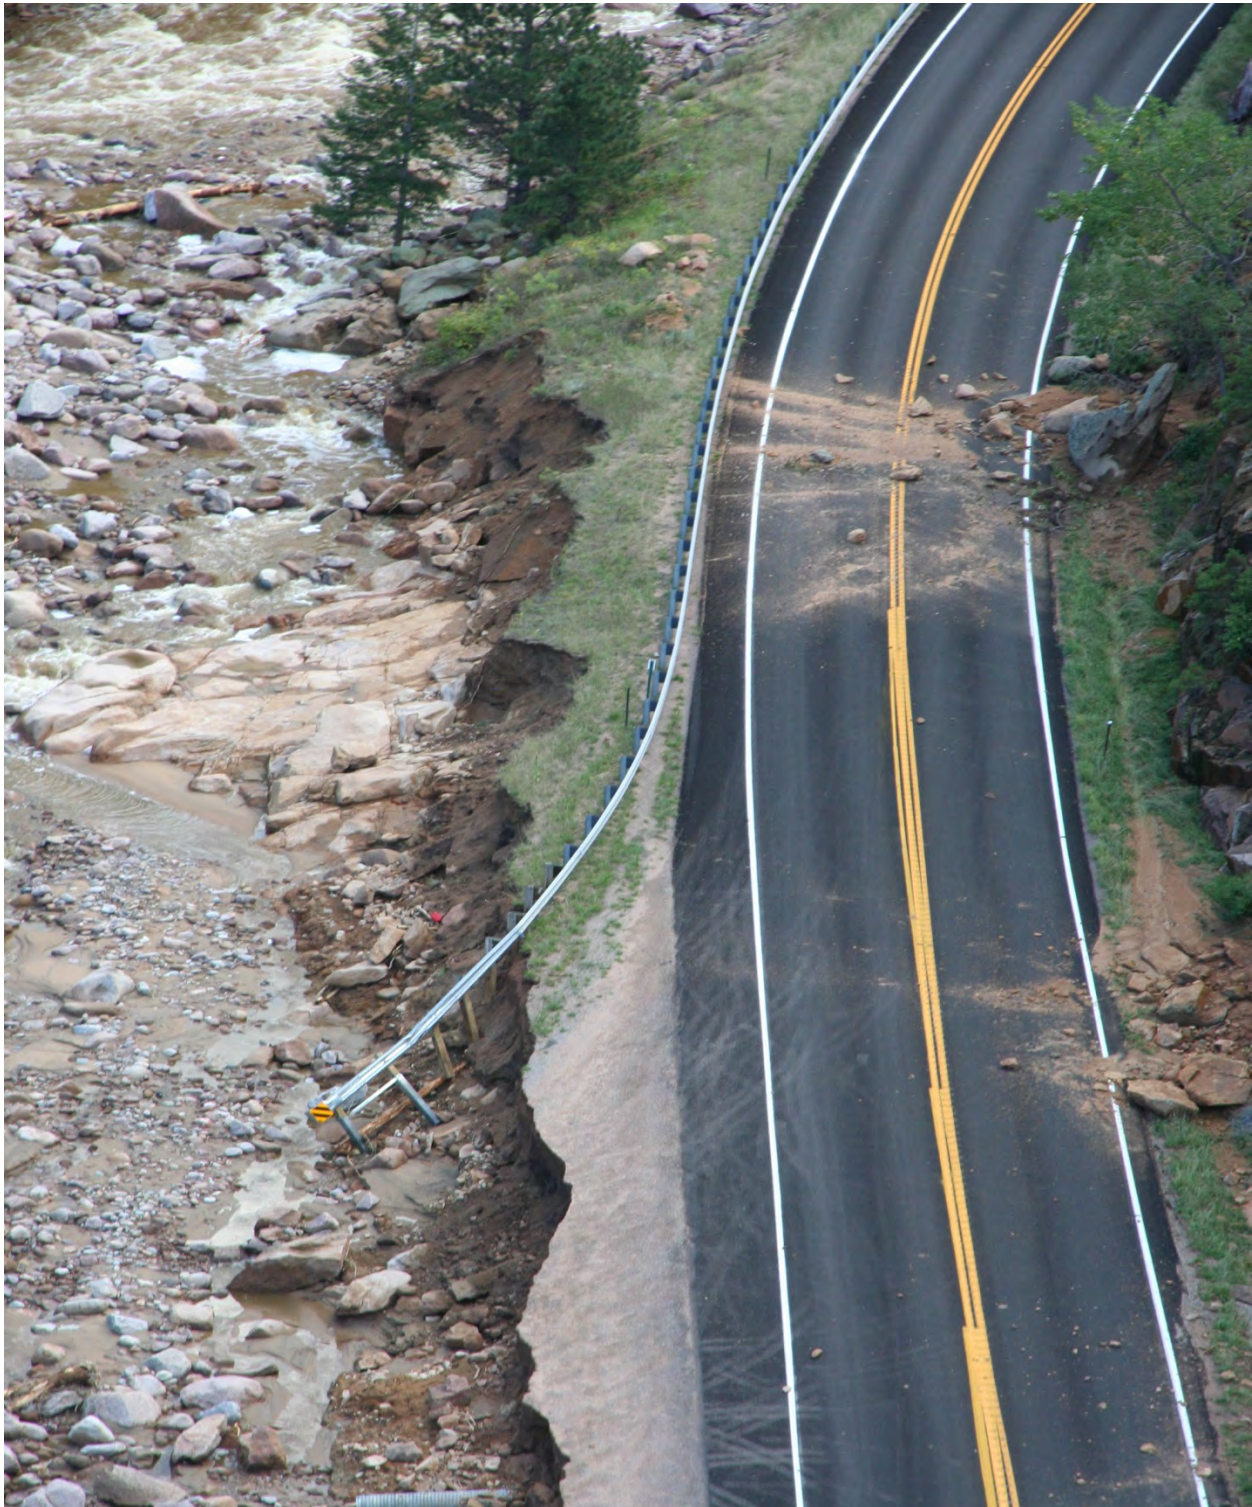
Figure 40 - MP 28.3, Scour damage to gravel pullout, EB embankment and guardrail; and material slides.

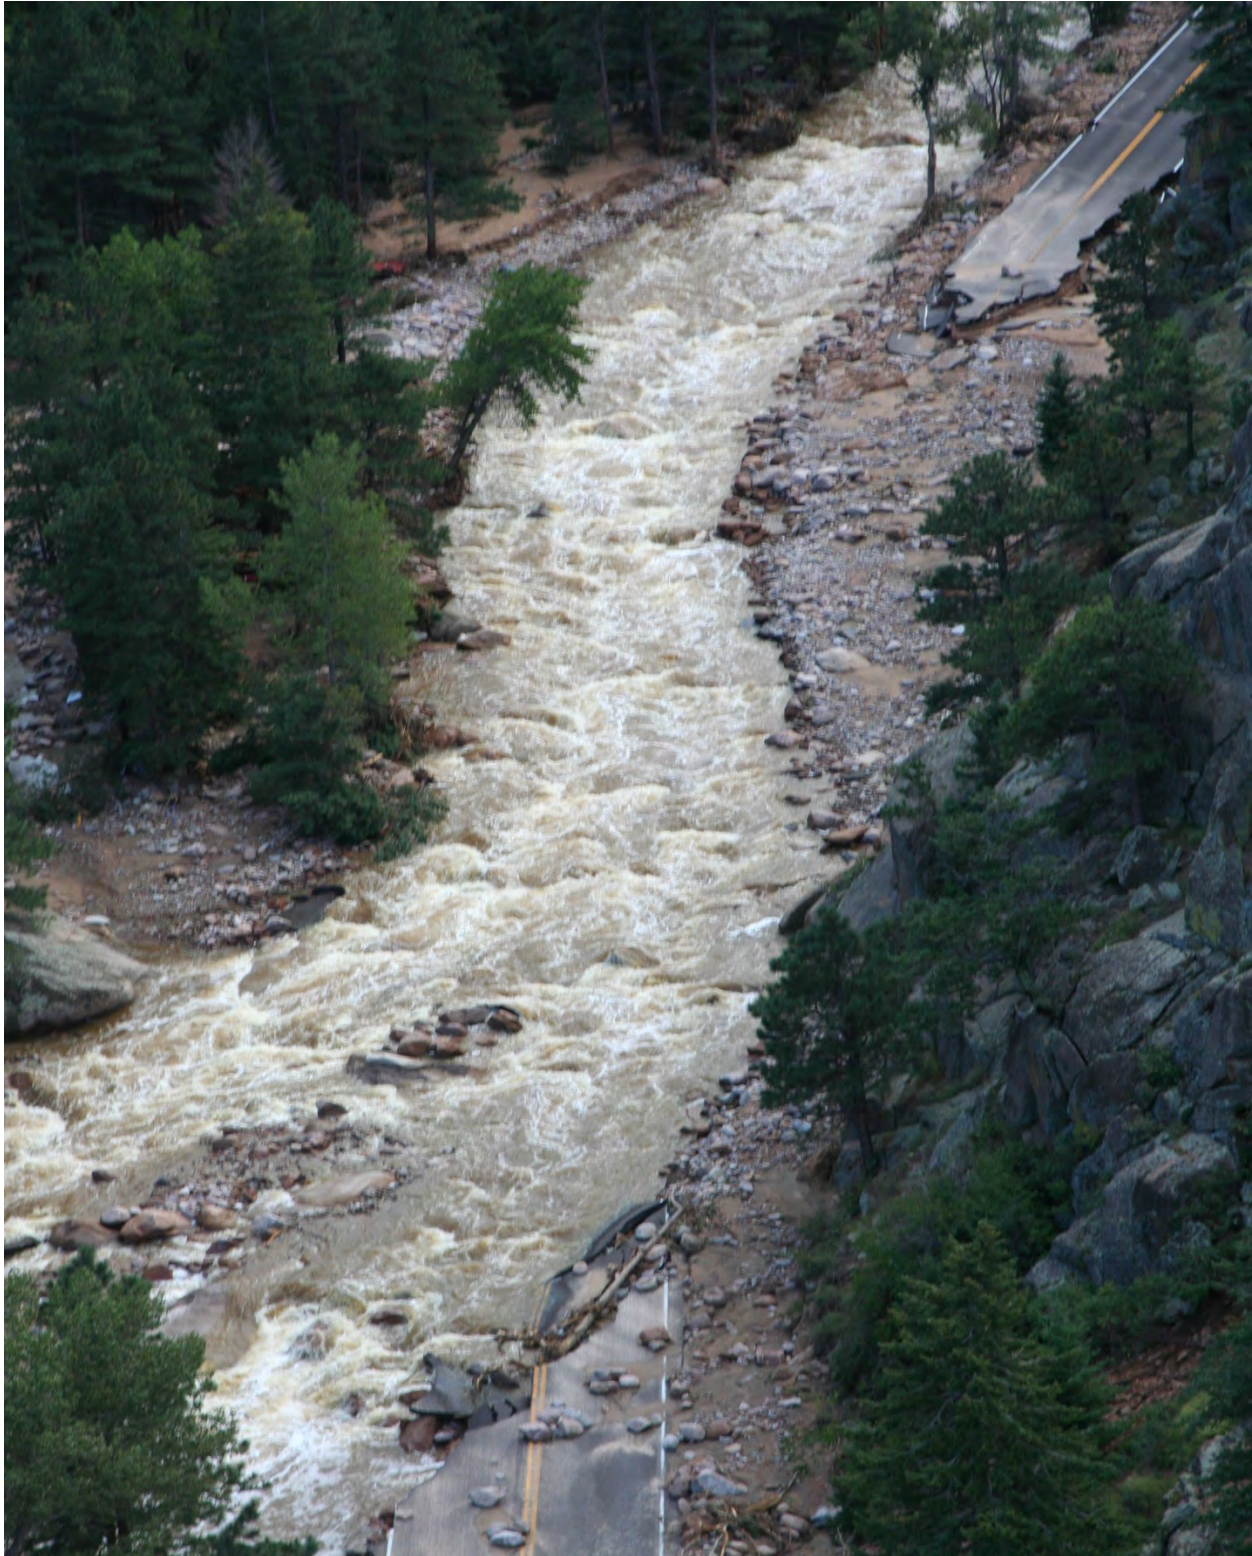
Figure 41 - MP 28.5, Complete wash out of the roadway due to lateral scour and overtopping of the roadway.

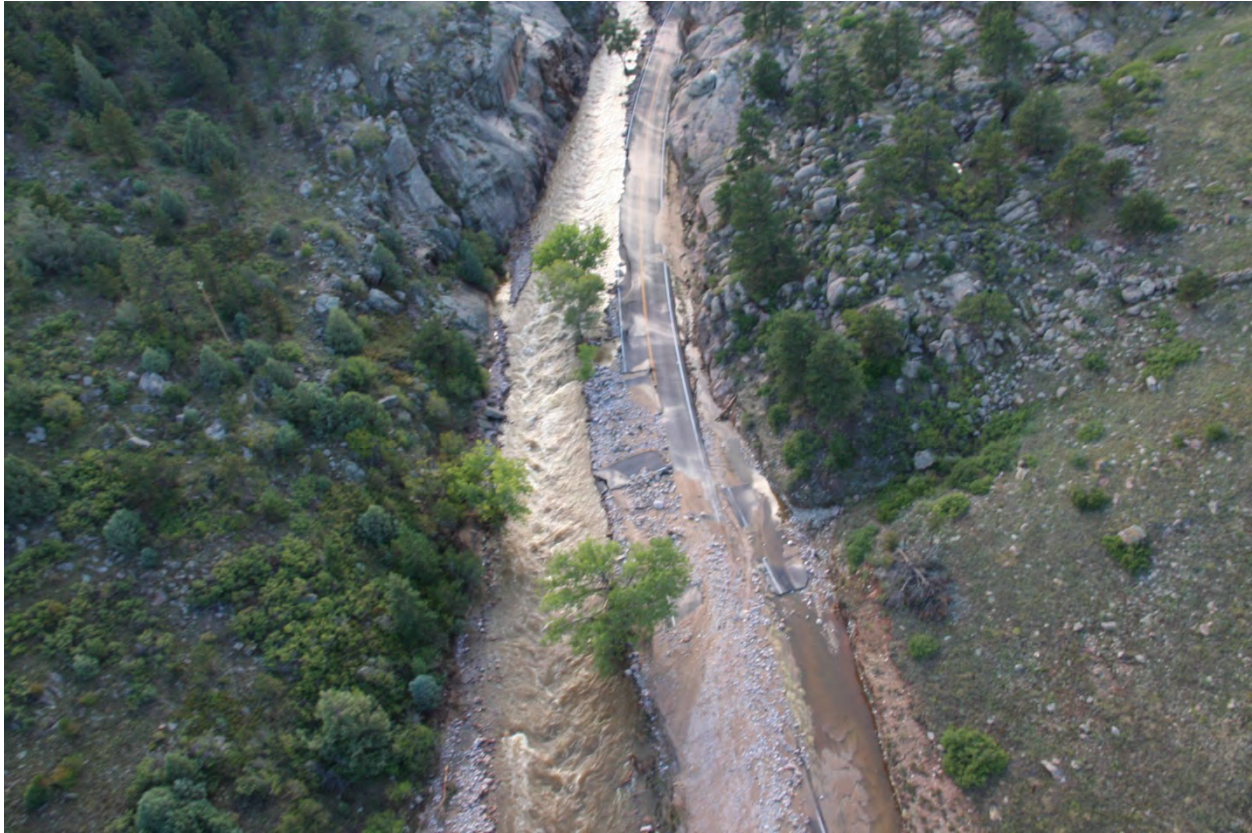
Figure 42 - MP 30.08, Wash out of the roadway embankment and pavement due to lateral scour and overtopping of the roadway. Sediment and debris deposition throughout.

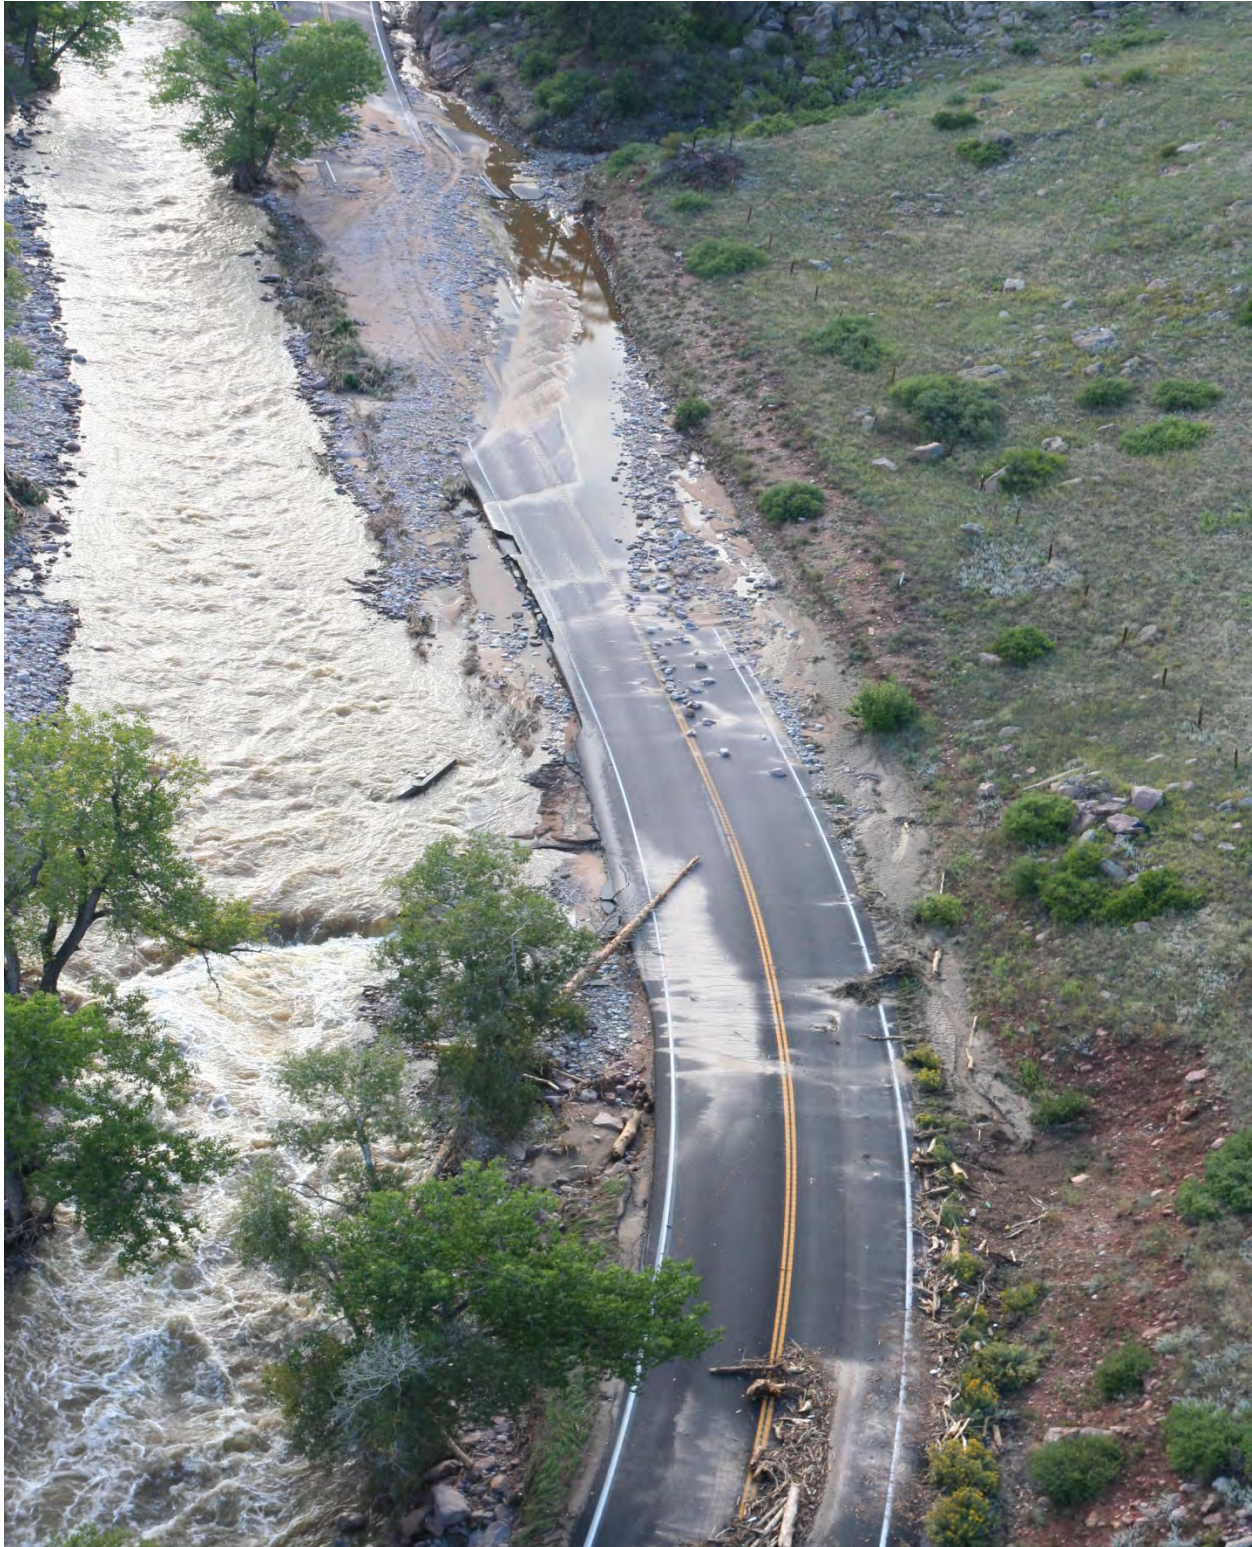
Figure 43 - MP 30.1, Wash out of the roadway embankment and pavement due to lateral scour and overtopping of the roadway. Sediment and debris deposition throughout.

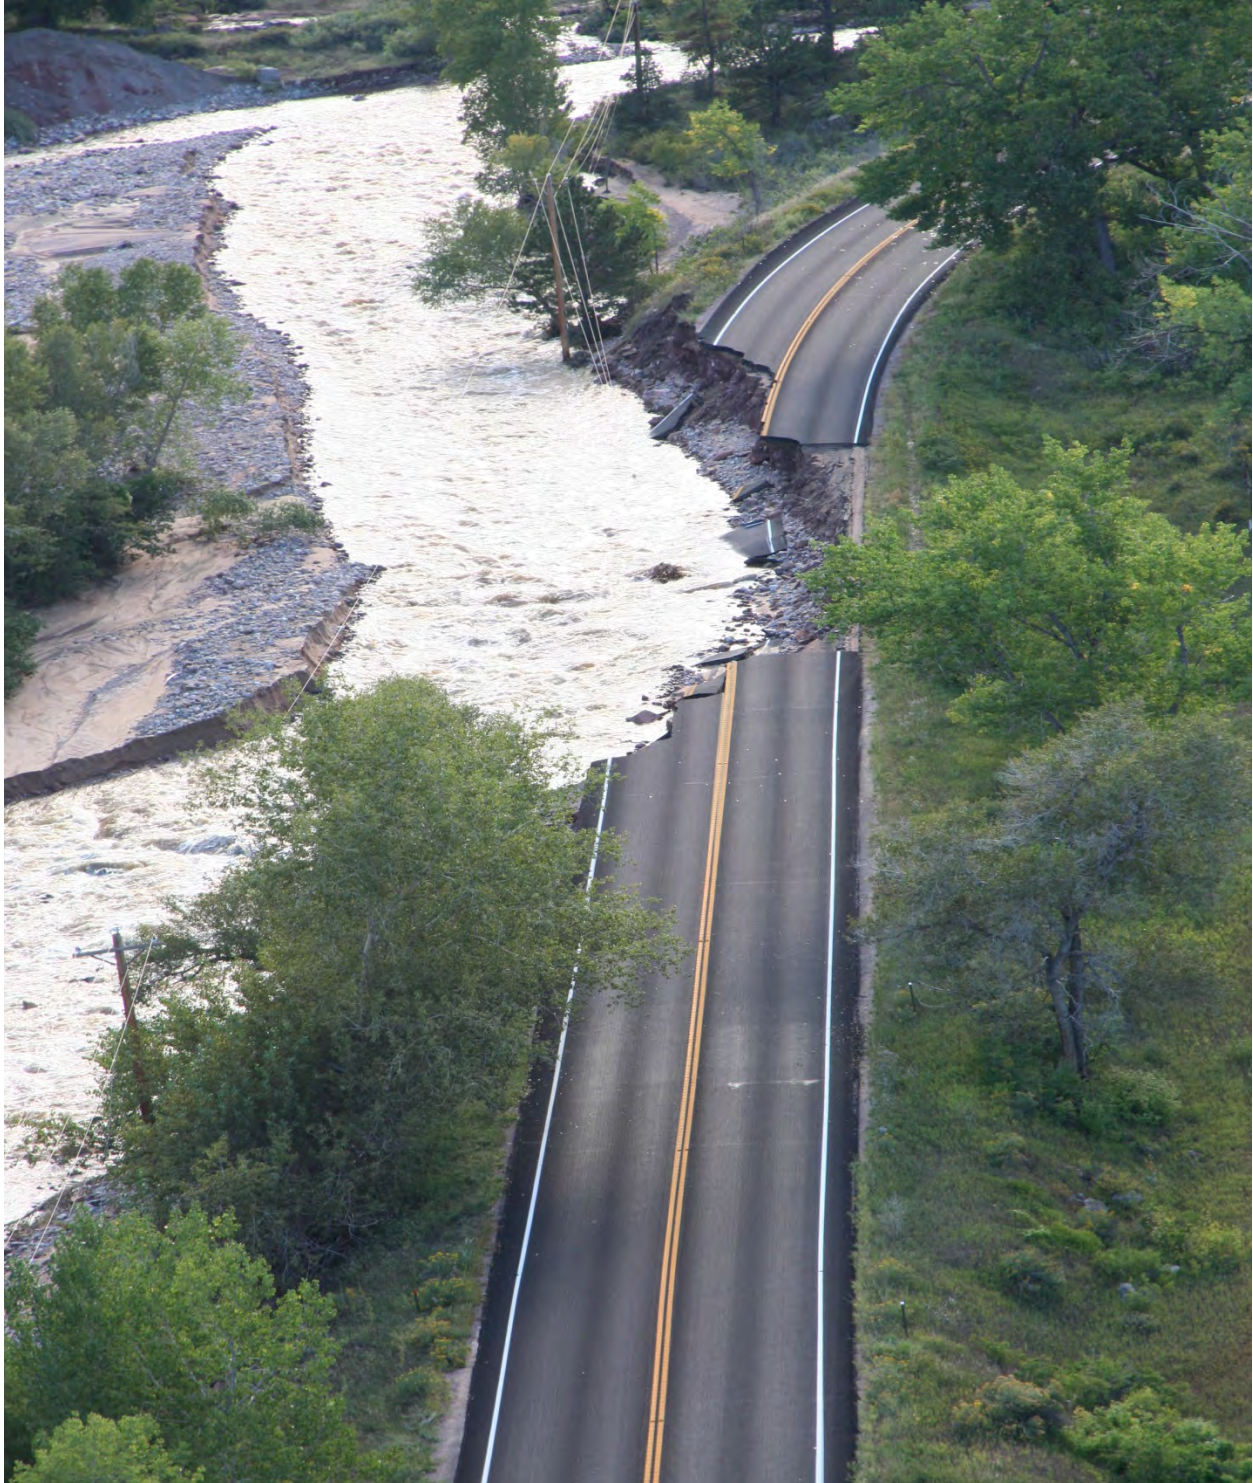
30.48	30.54	The 2 lane roadway was a complete loss for approximately 300 LF.

Figure 44 - MP 30.49, Complete roadway loss

Milepost		ER Work
Start	End	
28.75	28.84	The damaged embankment and pullout were repaired.
28.84	28.86	Rocks were removed from the roadway.
28.88	28.96	The undermined pavement was repaired.
29.00	29.06	The pavement loss was repaired.
29.24	29.30	The damaged embankment and pavement were repaired.
29.45	29.46	The embankment, undermined road and CBC were repaired.
29.55	29.65	The full width roadway loss was repaired.
29.65	29.94	Topsoil and riprap were replaced.
29.94	30.08	The ditch and overtopped pavement were repaired.
30.08	30.20	The damaged embankment, pavement and undermined paved shoulder were repaired.
30.30	30.40	Material in the roadway was removed.
30.48	30.54	The full width roadway loss was repaired.

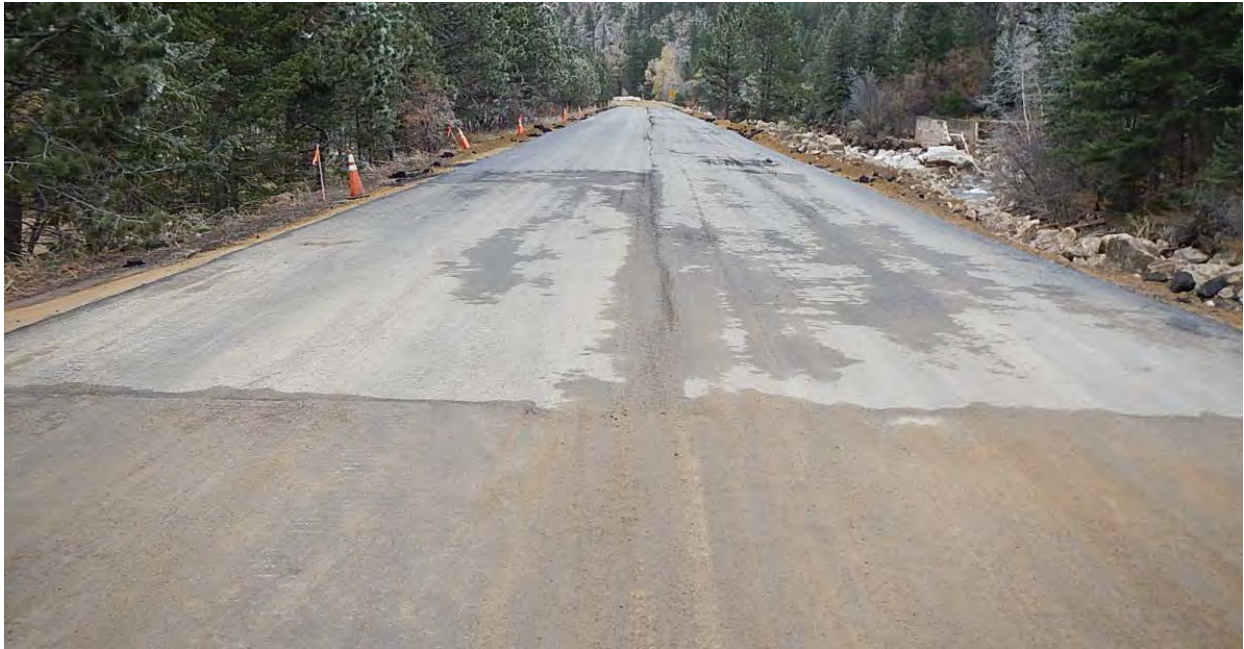
Figure 45 - MP 23.4 Facing east, Completed ER roadway section.

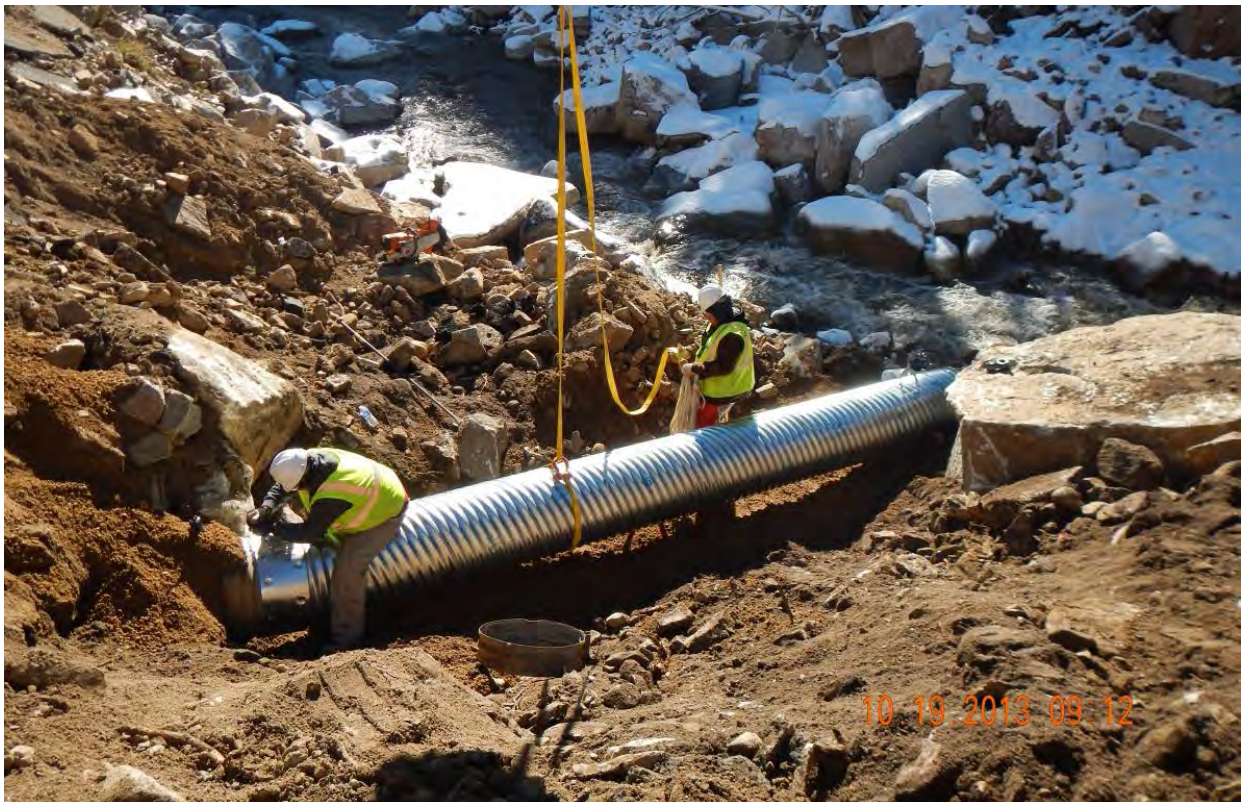
Figure 46 - MP 23.4, CMP repair.

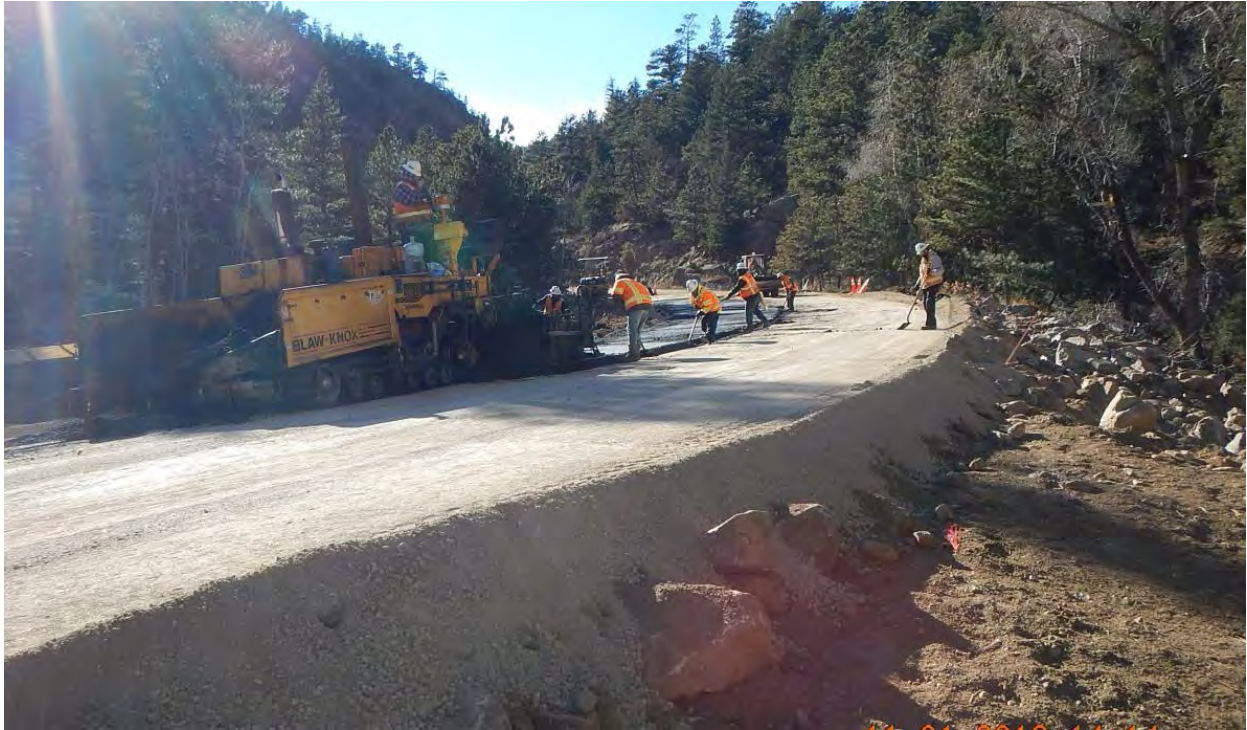
Figure 47 - MP 23.8 Facing west, Roadway repair.

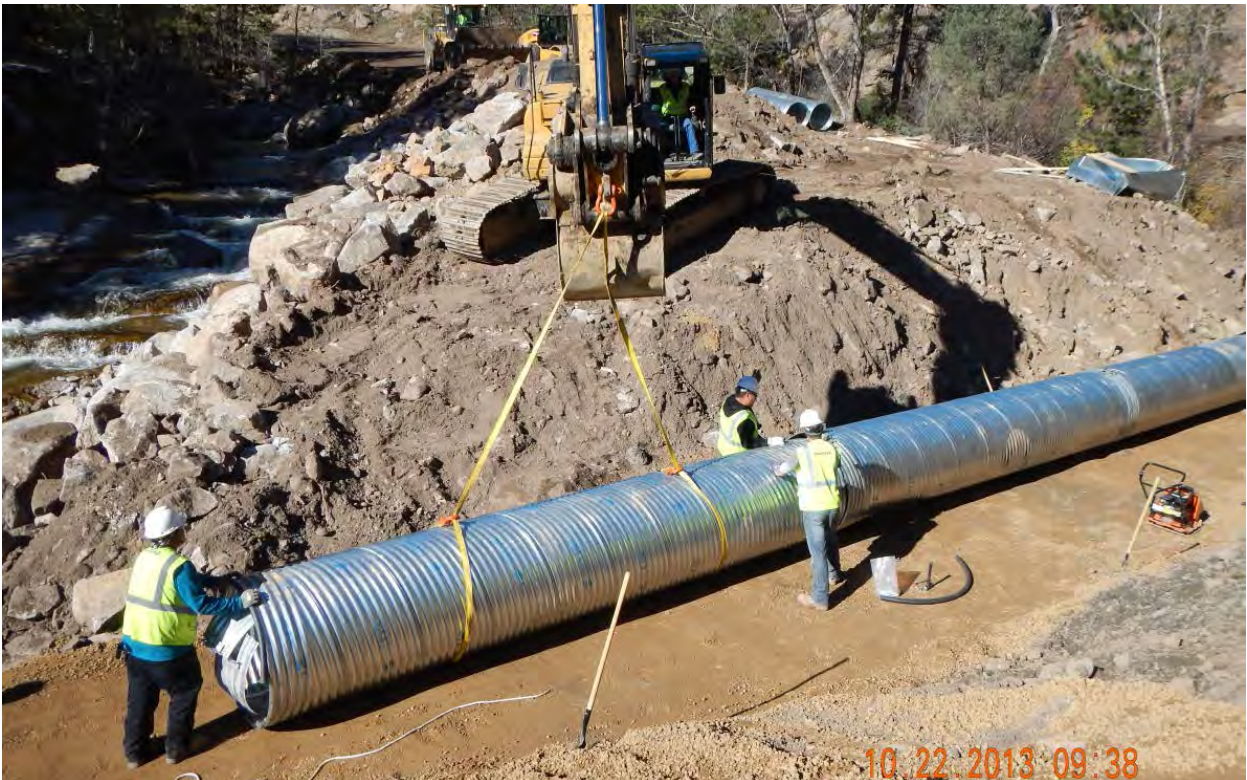
Figure 48 - MP 23.8 Facing northwest, CMP repair.
