**SH 7A (Lower)
Raymond to Lyons
Site Repairs between Mileposts 19 and 33**

**Boulder County
COLORADO**

Damage Assessment Report

**100% DRAFT
Revised: July 28, 2014**

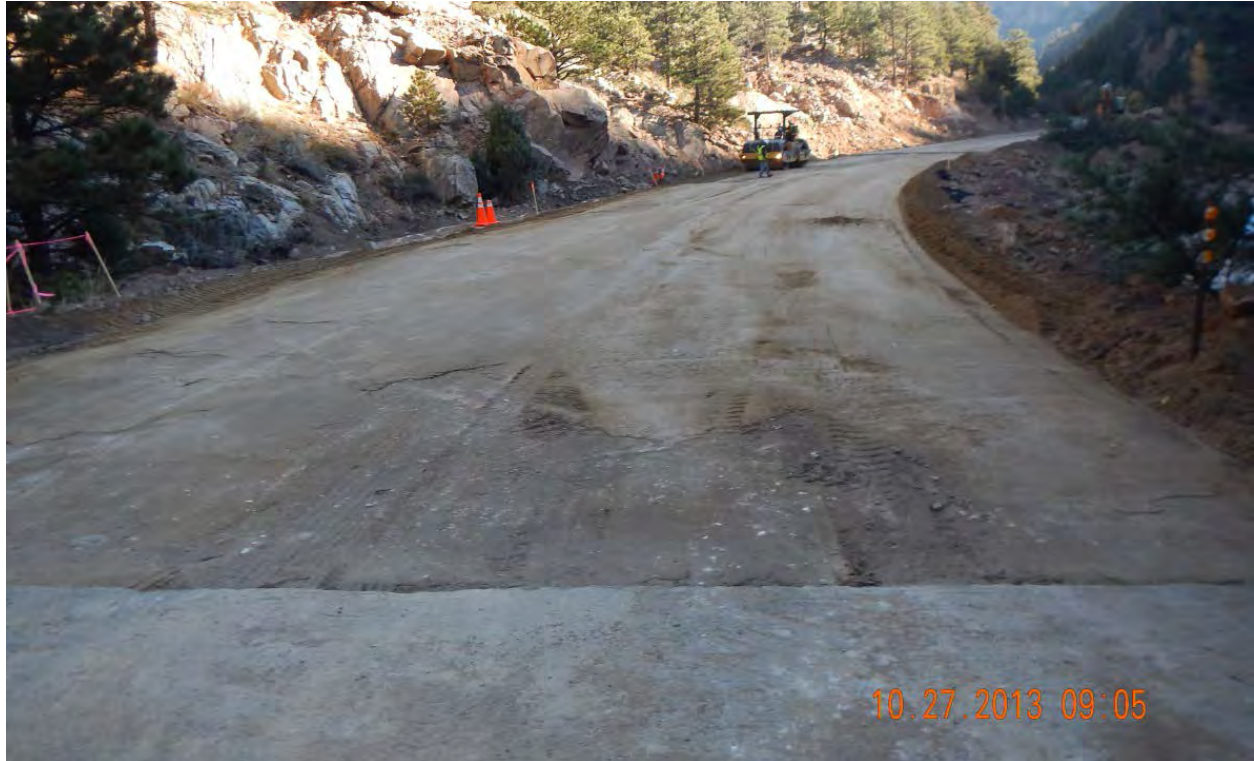
Figure 49 - MP 24.7 Facing northeast, Roadway repair.

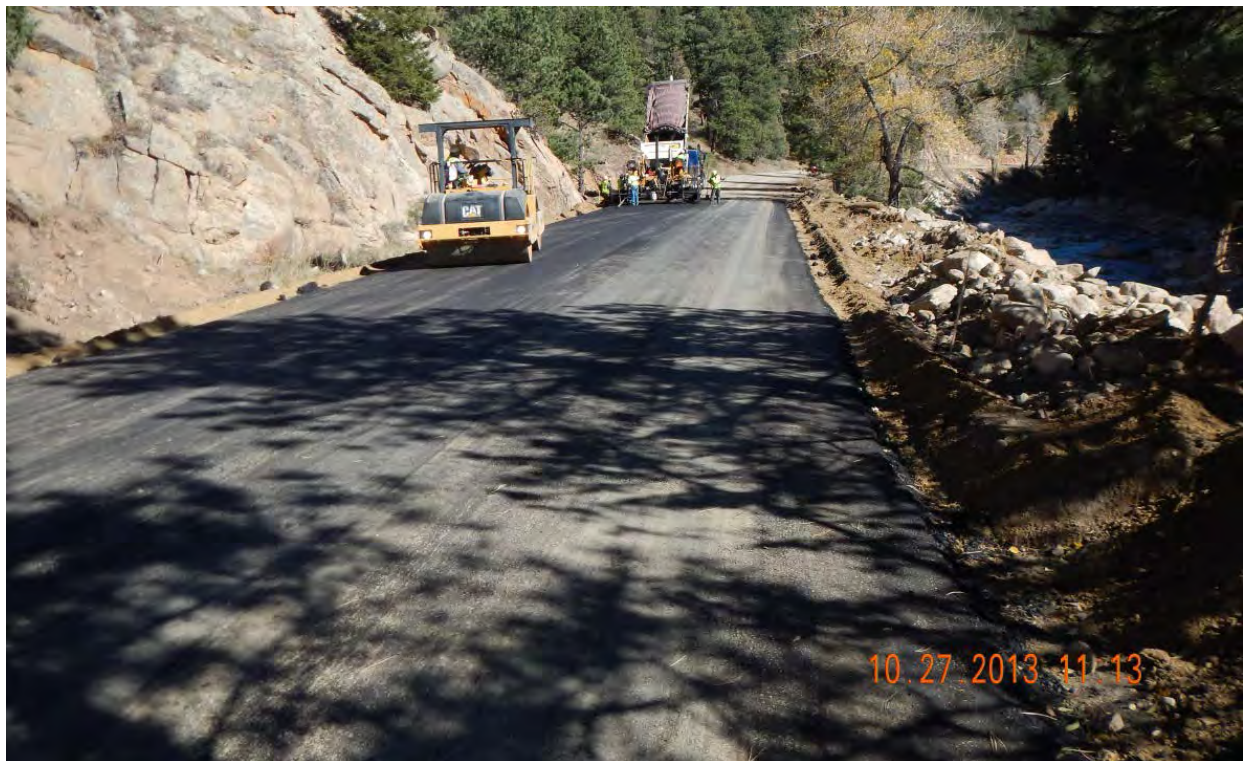
Figure 50 - MP 25.3 Facing east, Roadway repair.

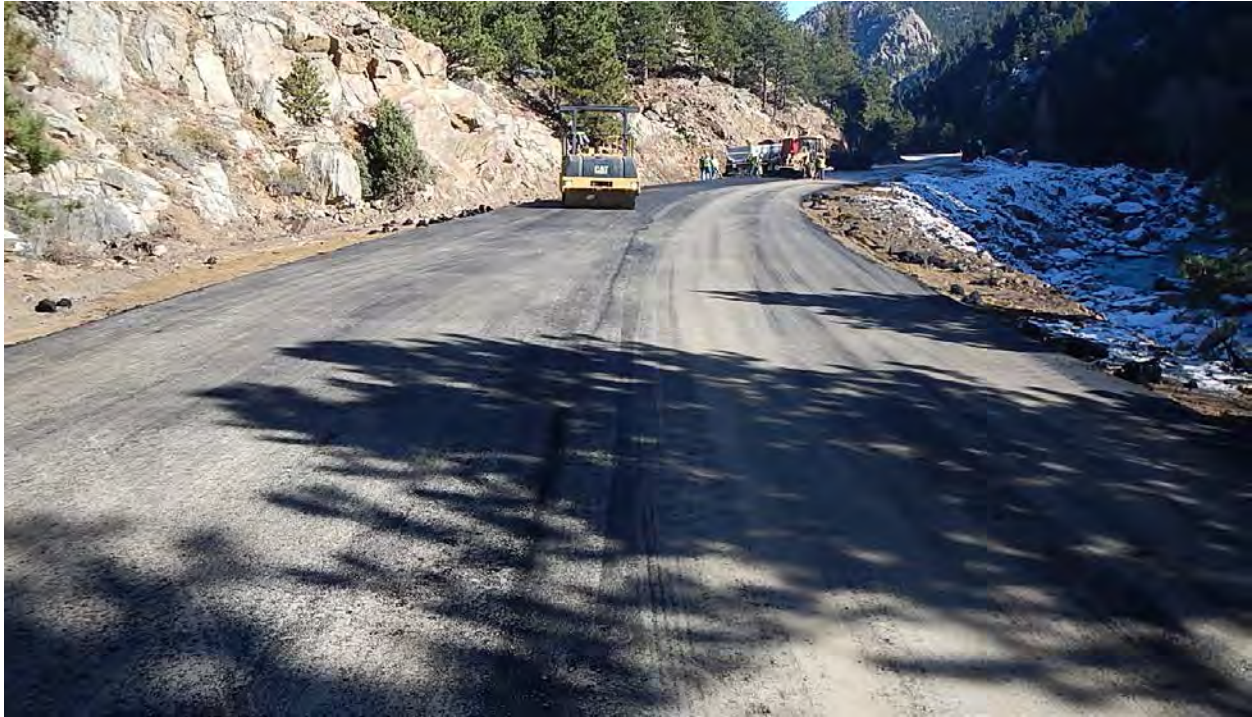
Figure 51 - MP 25.5 Facing east, Roadway repair.

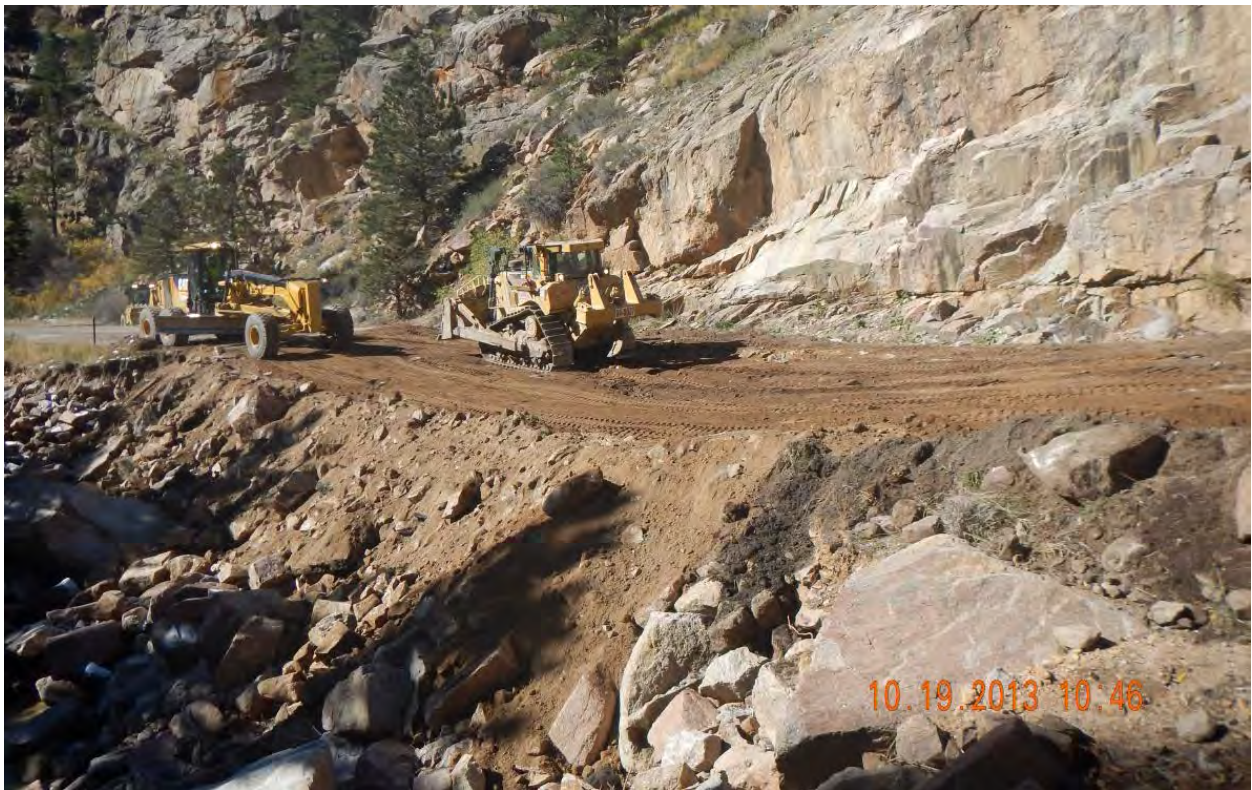
Figure 52 - MP 25.9 Facing west, Roadway repair.

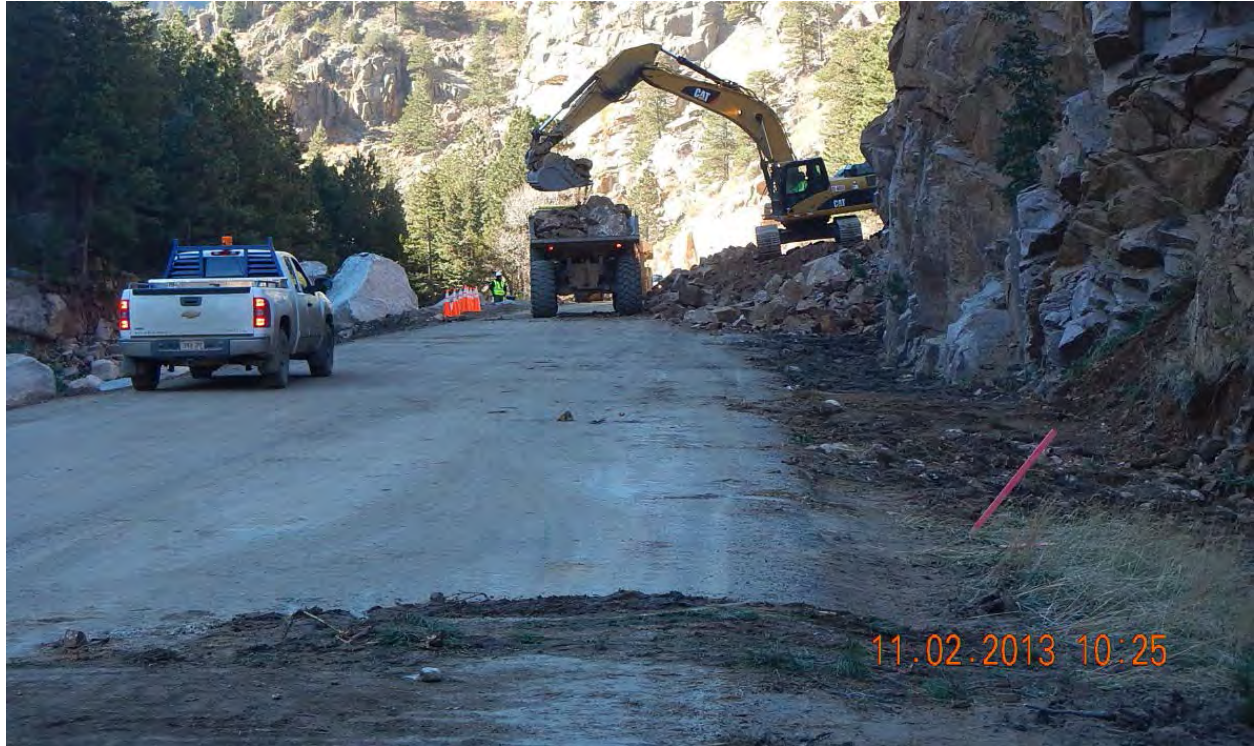
Figure 53 - MP 26.2 Facing west, Clearing rockfall.

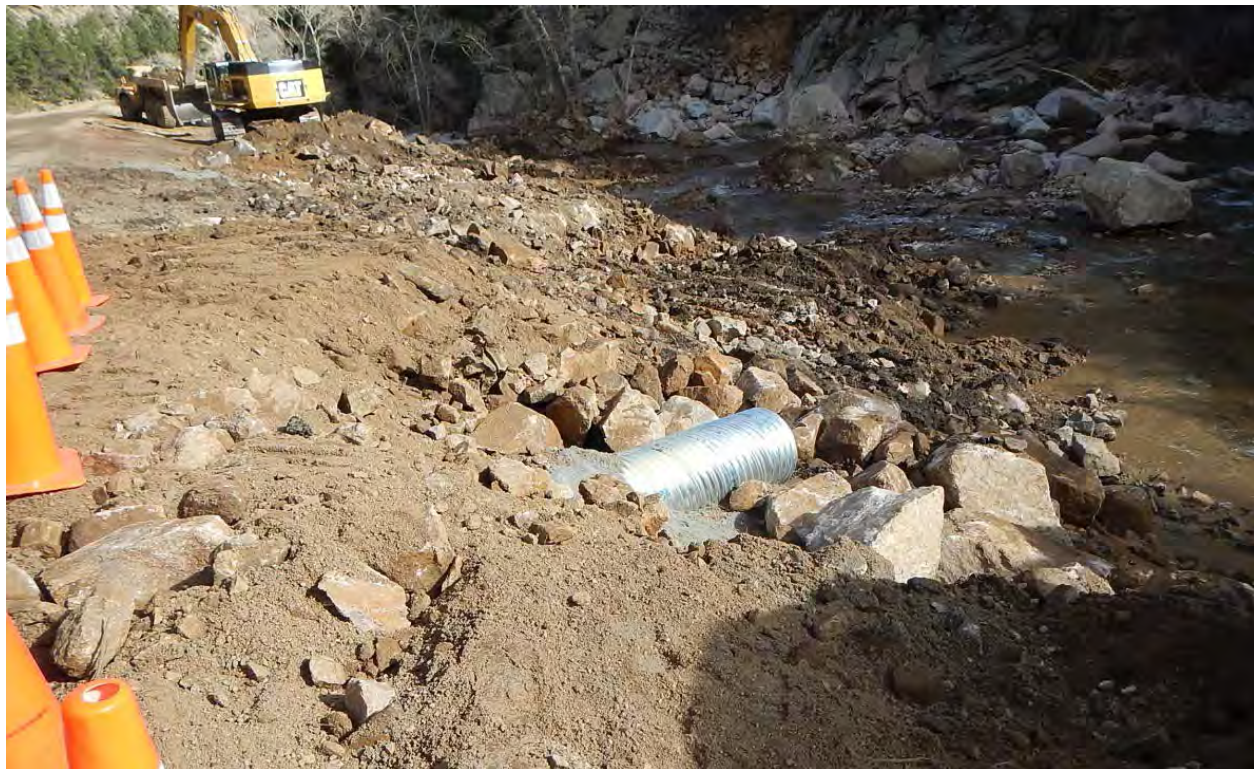
Figure 54 - MP 26.2, CMP Repair.

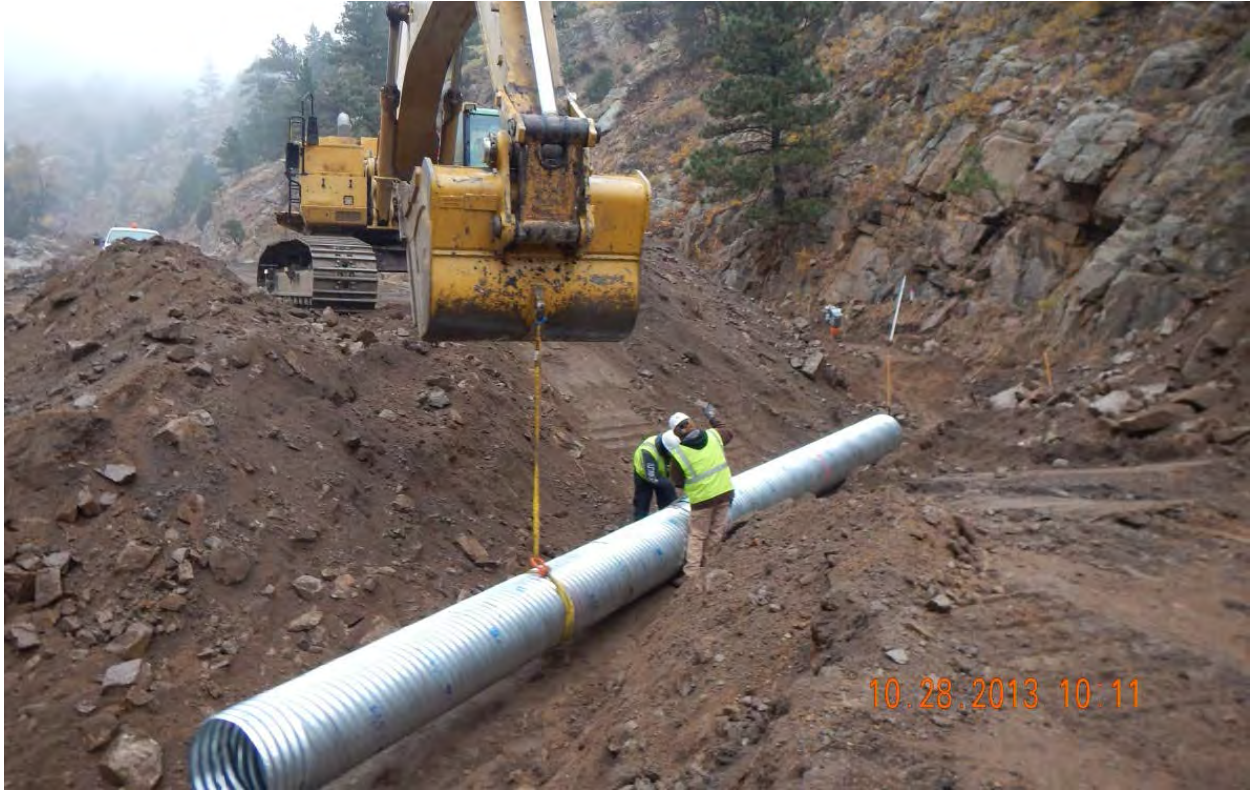
Figure 55 - MP 26.5, CMP repair.

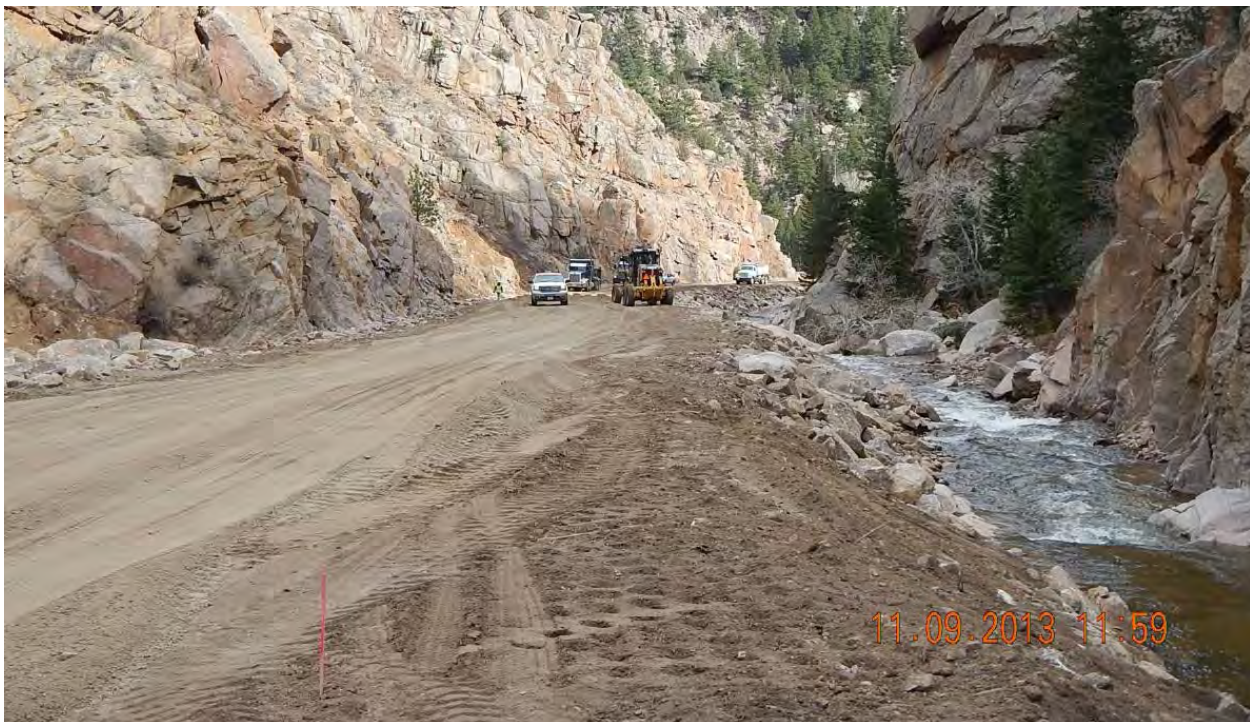
Figure 56 - MP 26.9, Facing northeast, Roadway repair.

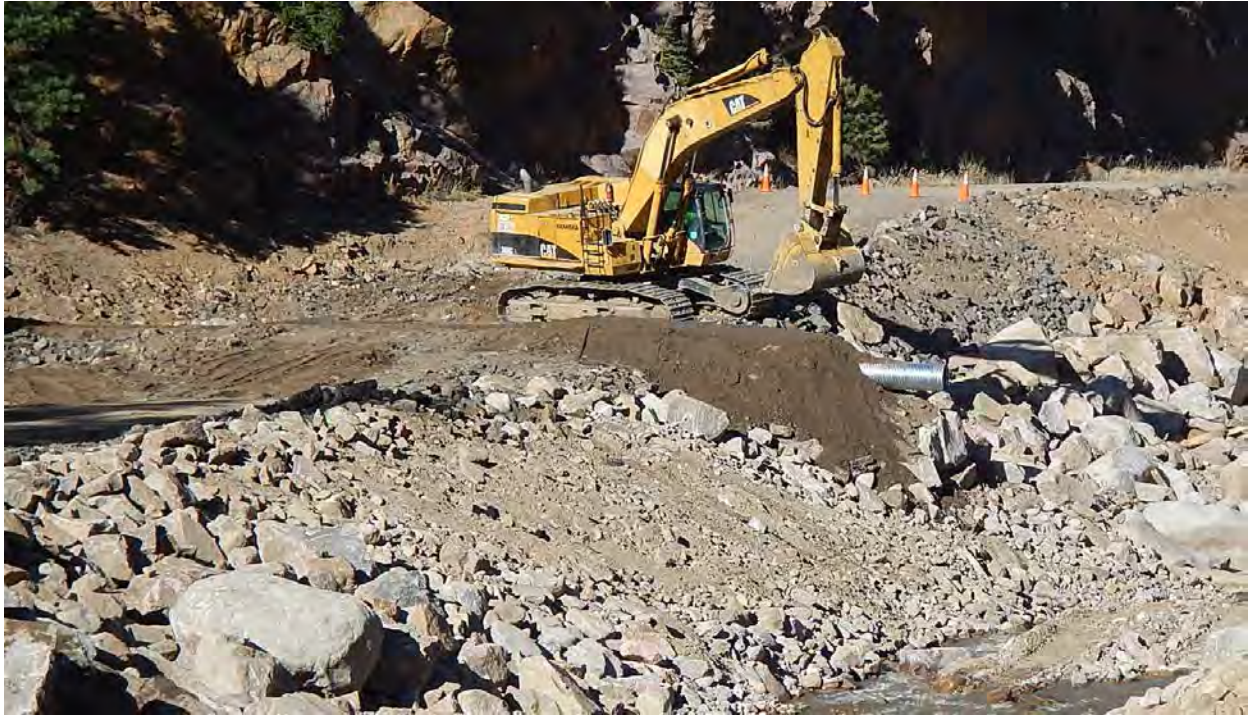
Figure 57 - MP 27.2, Facing north, Roadway and CMP repair.

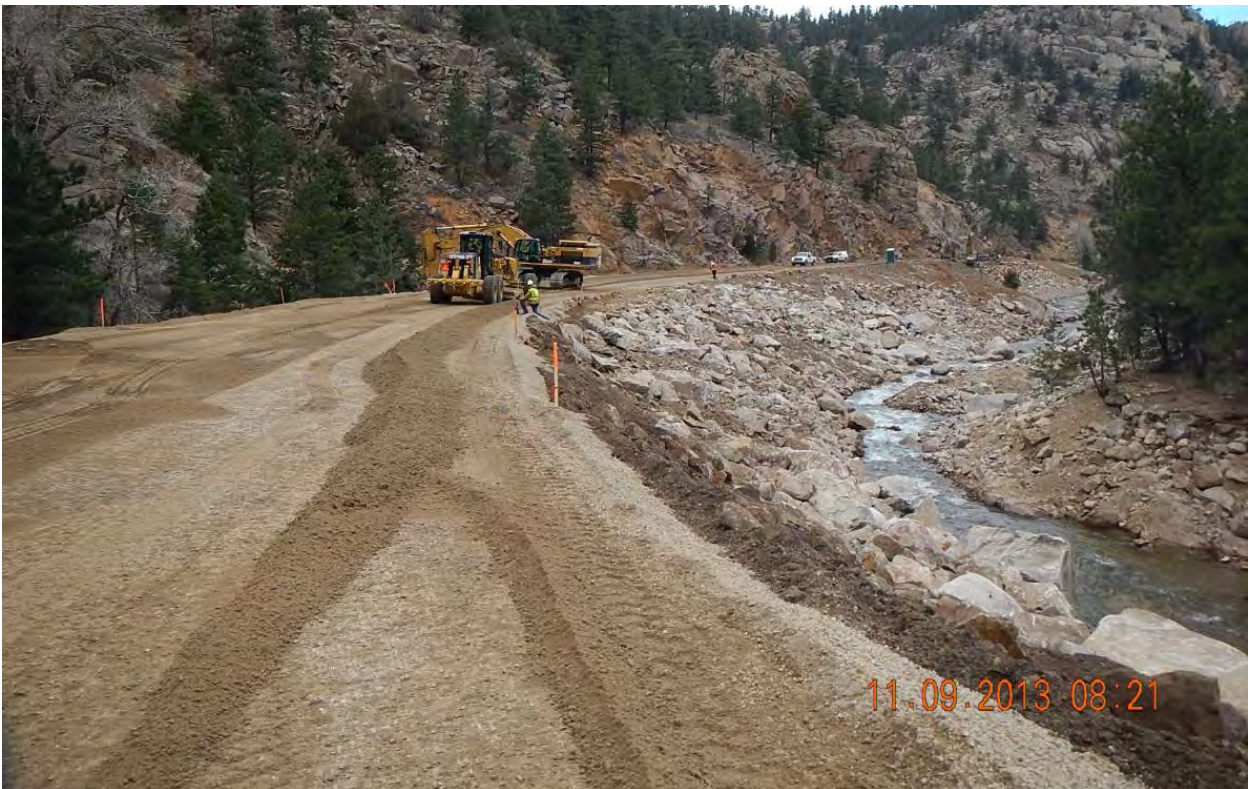
Figure 58 - MP 27.2, Facing north, Roadway repair.

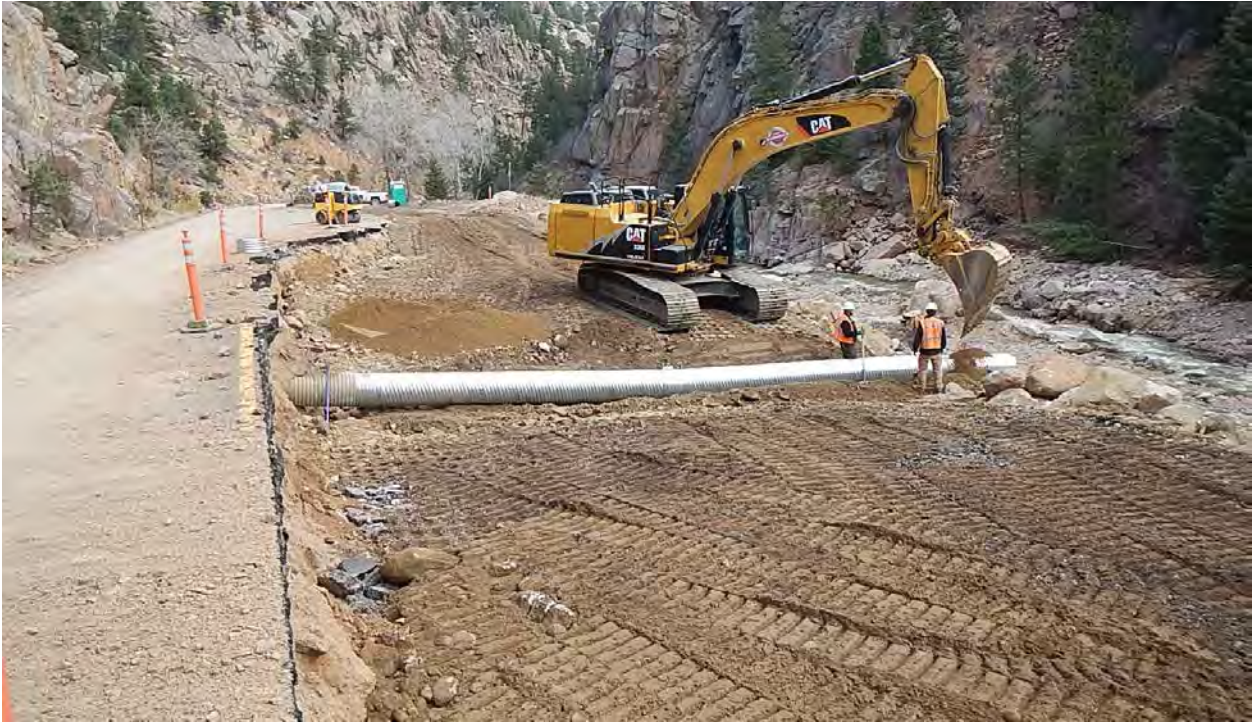
Figure 59 - MP 27.35, Facing North, Roadway and CMP repair.

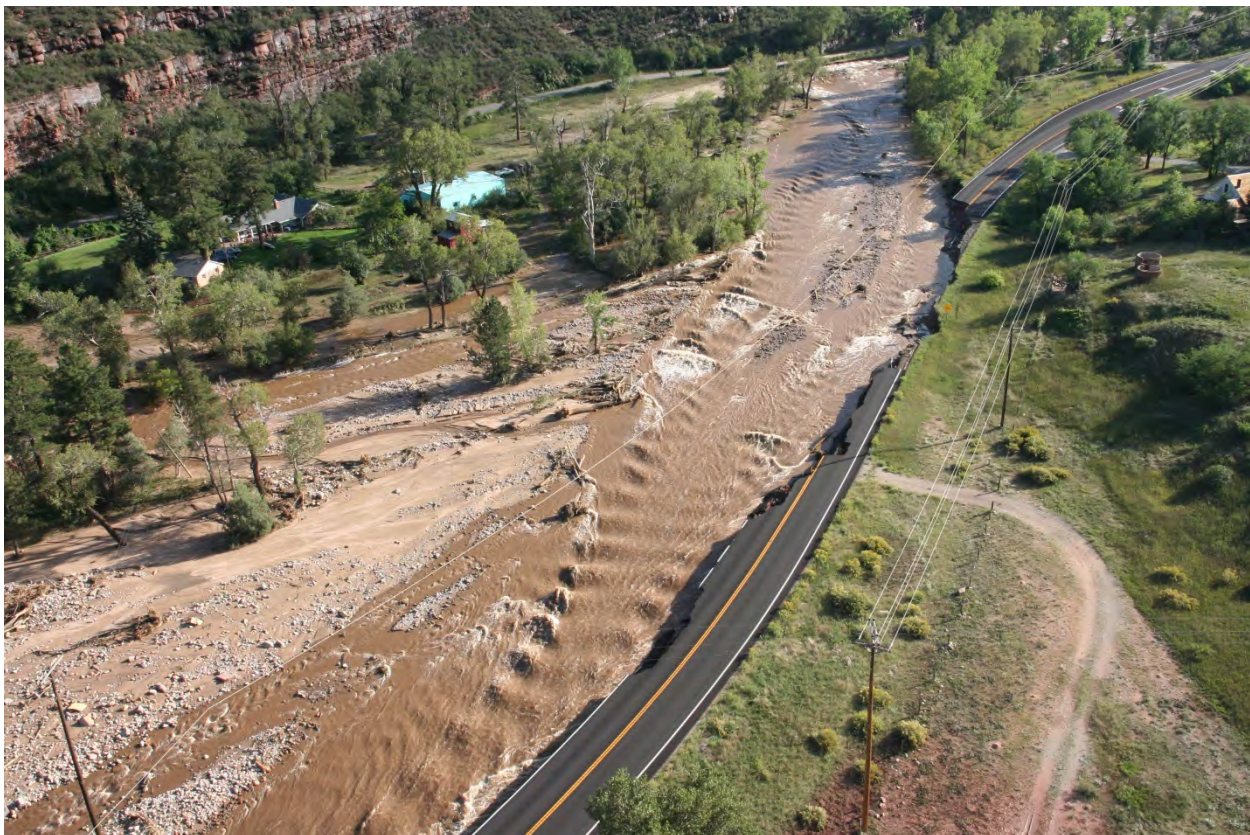
Milepost		Description of Damage - All Dimensions are "Approximate"
Start	End	
31.29	31.36	Complete wash out of the roadway for approximately 400 ft.
31.36	31.45	The riverside embankment washed out, the eastbound lane was undermined for 450 ft and washed out for 500 ft.
31.59	31.66	Complete wash out of the roadway for approximately 400 ft.
31.8	31.94	The roadway was overtopped and covered with sediment and debris and the CBC at MP 31.9 was completely buried in sand and sediment. 200 ft of the roadway washed out just east of the CBC.
32	32.25	The roadway was overtopped through the entire section; there were shoulder and ditch washouts on both sides of road. Both paved shoulders were undermined throughout section.
32.66	32.7	The riverside embankment washed out and the paved shoulder was undermined.

Figure 63 - MP 31.3 – 31.42, Riverside embankment washout and EB and WB undermined pavement loss.

Milepost		ER Work
Start	End	
31.29	31.36	Repair full width roadway loss.
31.36	31.45	Repair embankment and pavement loss.
31.59	31.66	Repair full width roadway loss.
31.80	31.94	Remove sediment, replace overtopped road section and washed out roadway. Reset CBC.
32.00	32.25	Repair overtopped and undermined pavement sections. Repair shoulders and re-grade ditch.
32.66	32.70	Repair embankment and undermined shoulder.

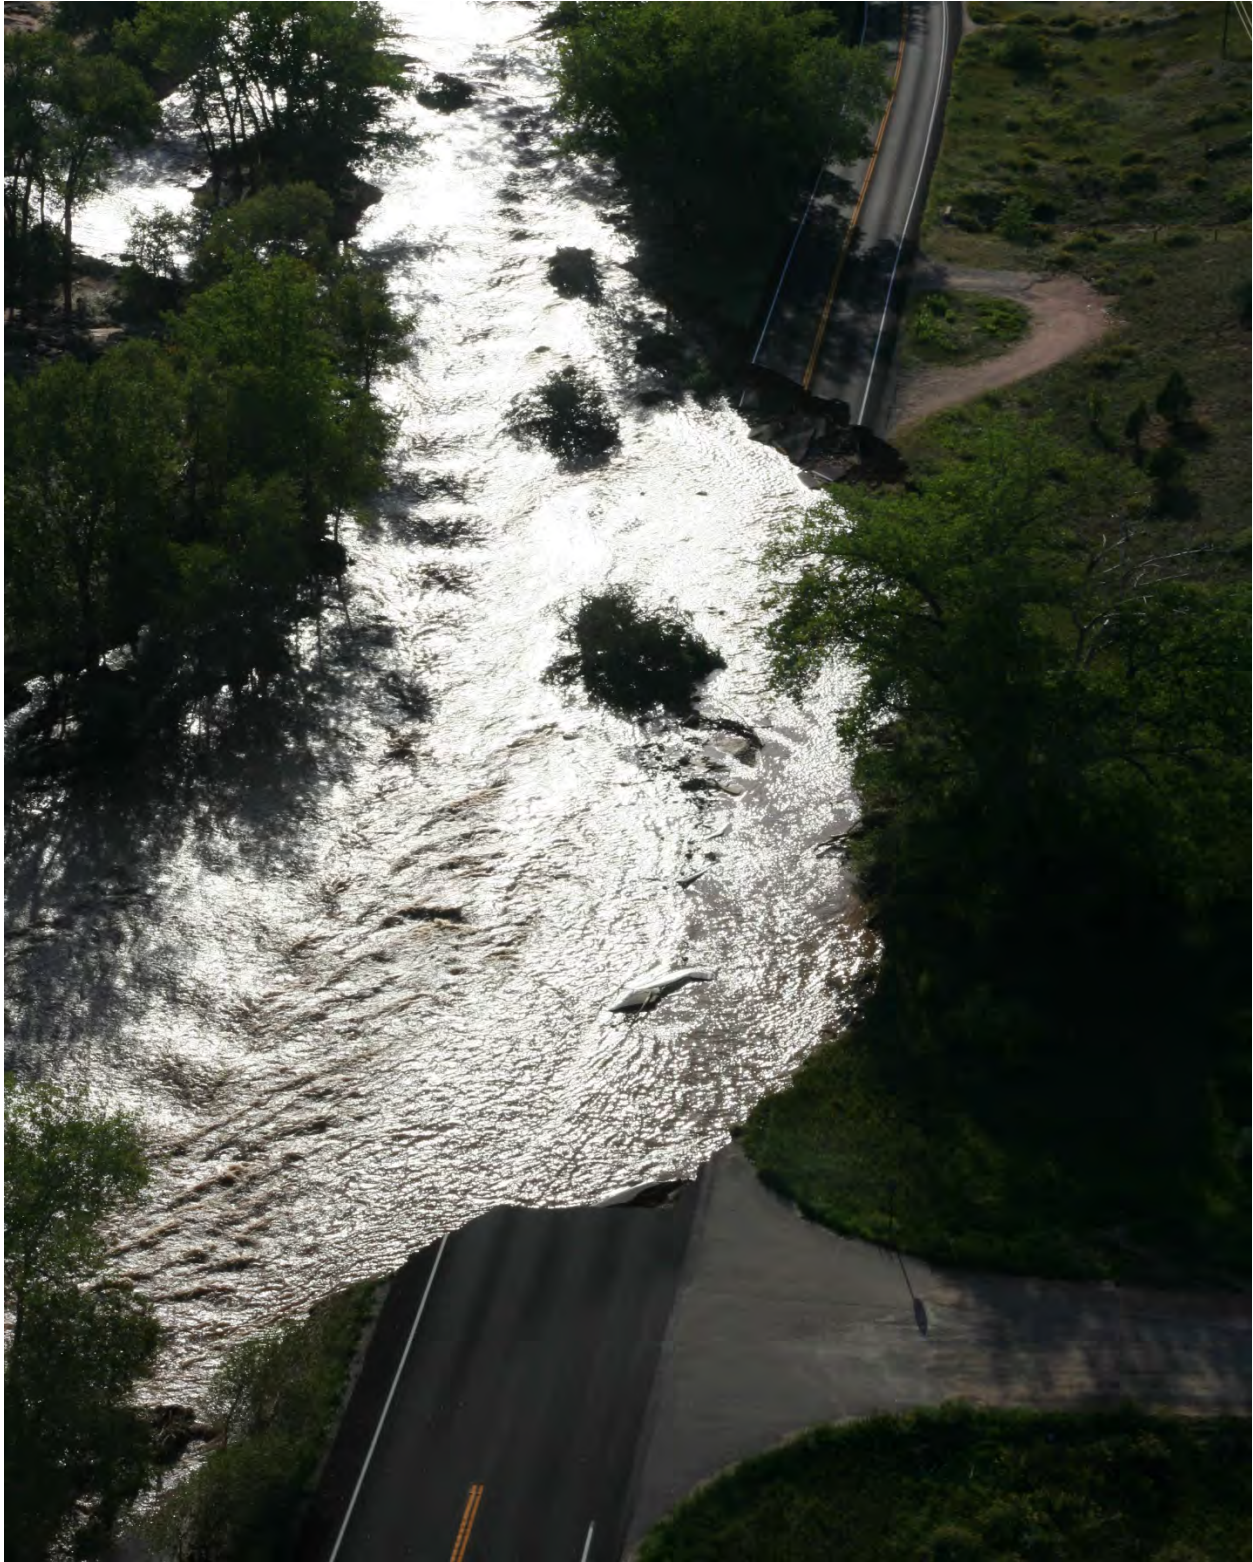
Figure 64 - MP 31.64, Complete loss of roadway.

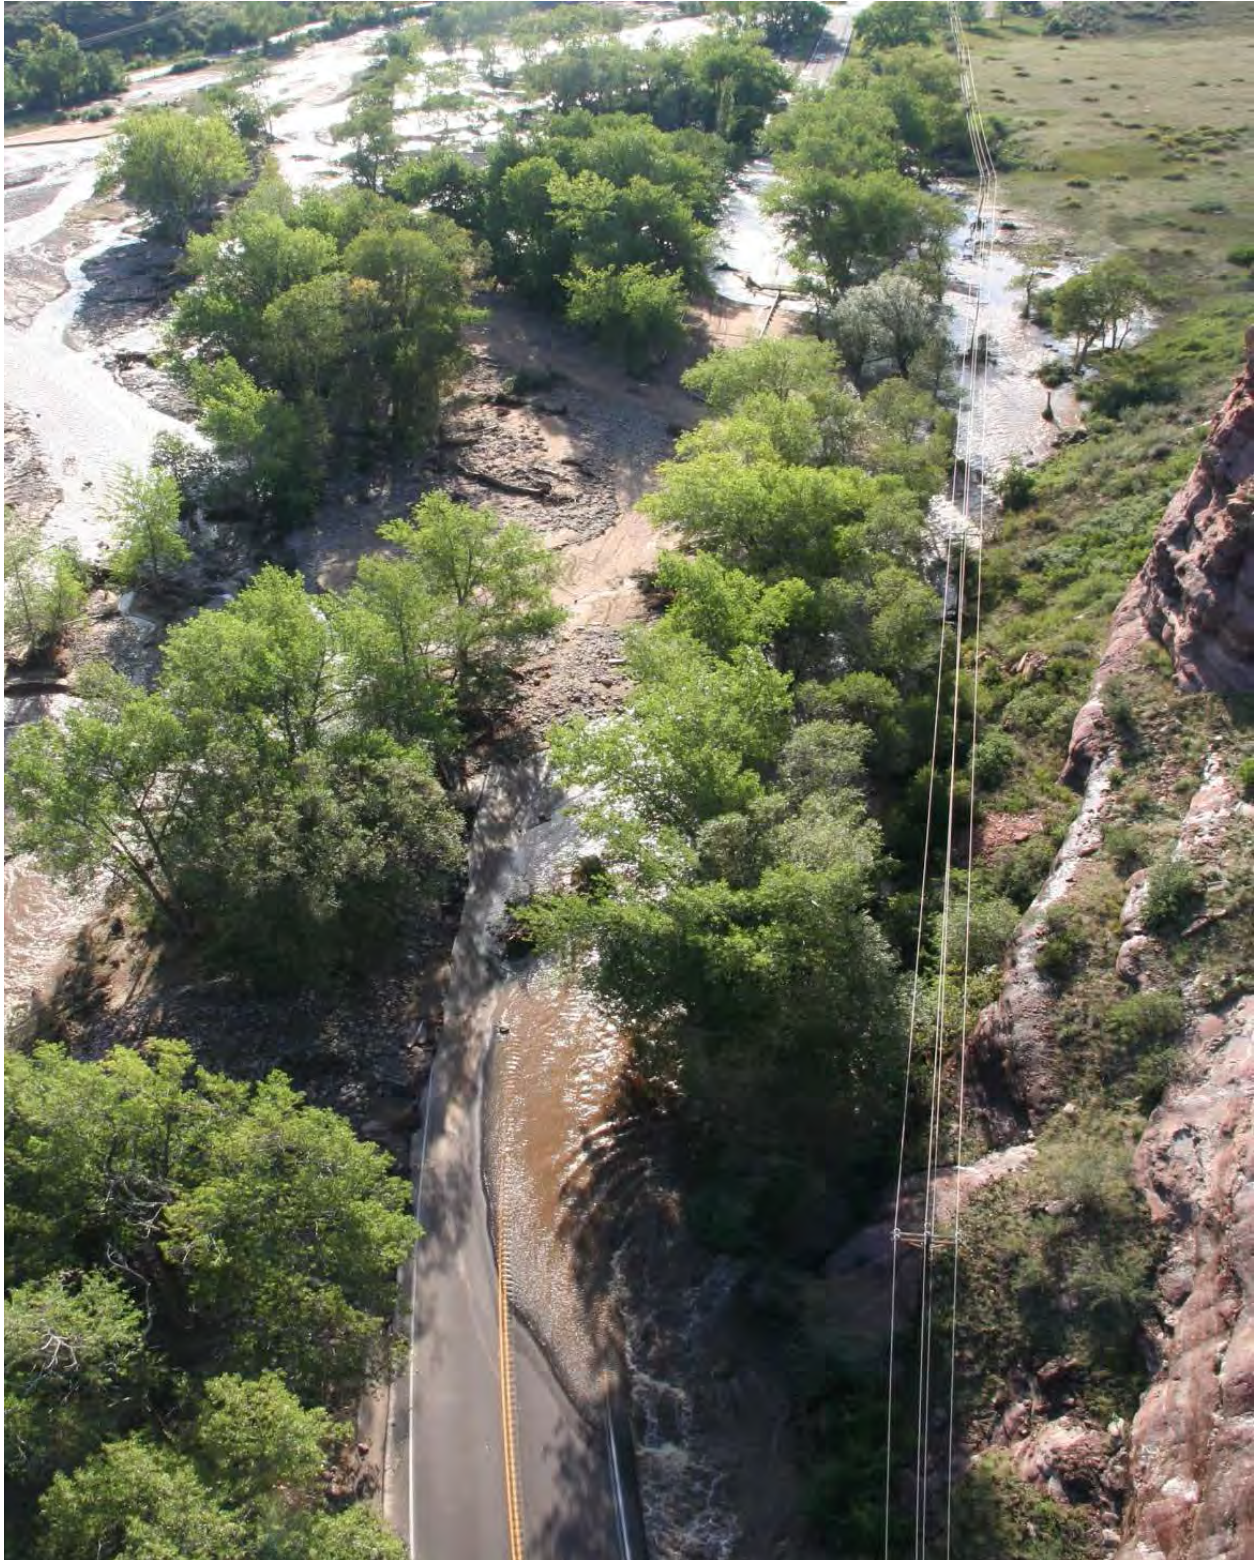
Figure 65 - MP 31.64, Roadway overtopped throughout section, shoulder and ditch washouts on both sides.

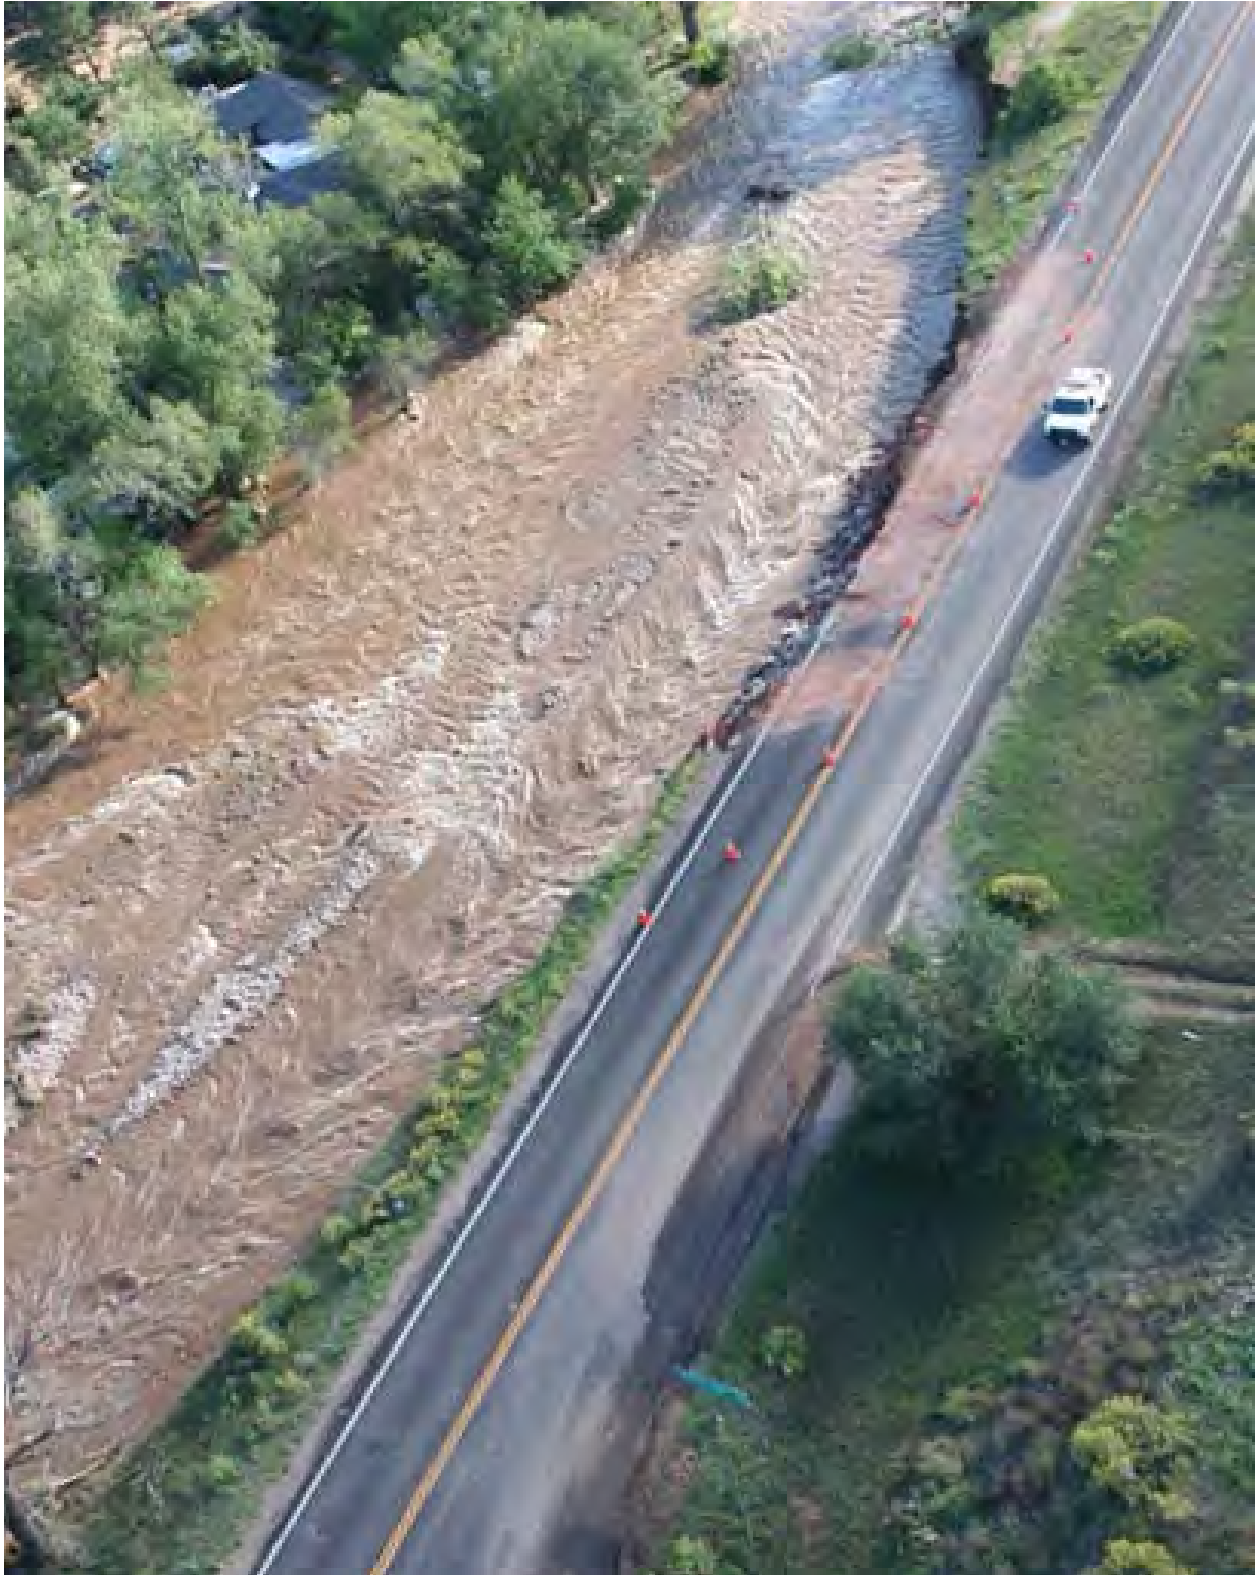
Figure 66 - MP 32.7, Riverside embankment washout and undermined paved shoulder.

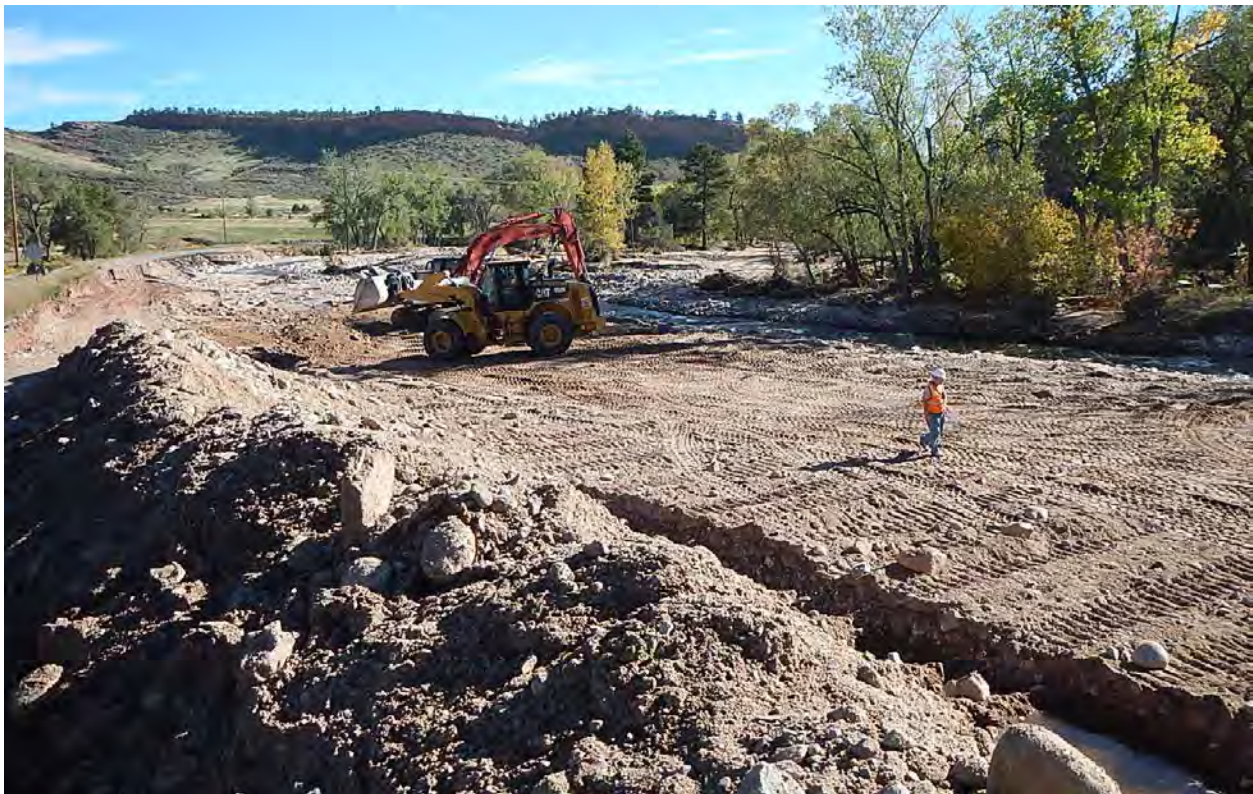
Figure 67 - MP 31.2, Facing southwest, ER Roadway repairs.

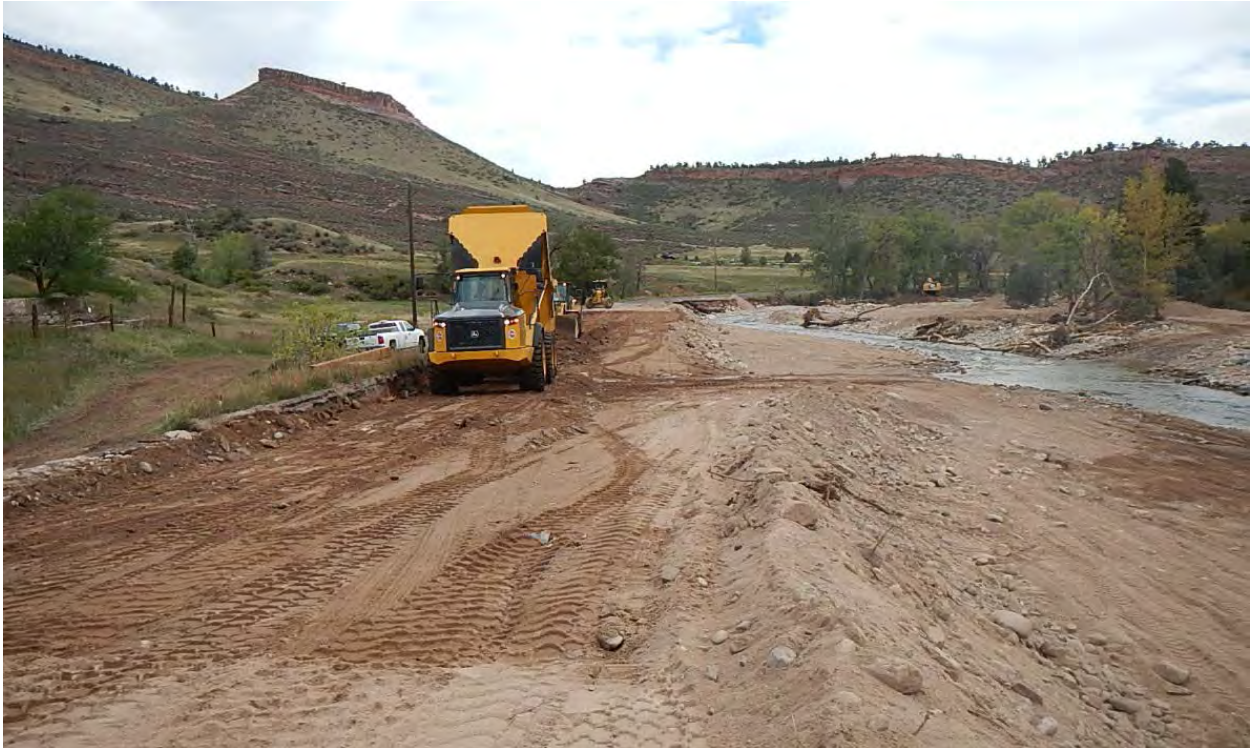
Figure 68 - MP 31.2, Facing northeast, ER Roadway repairs.

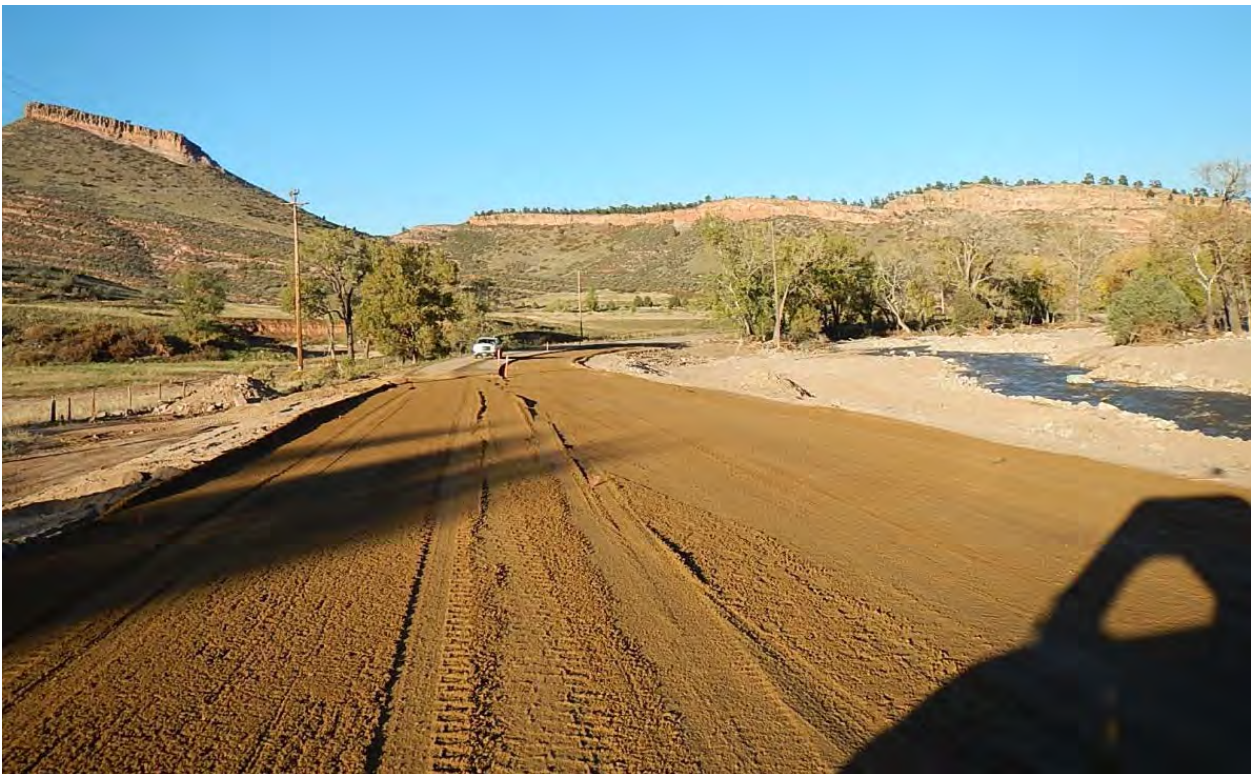
Figure 69 - MP 31.2, Facing northeast, ER Roadway repairs.

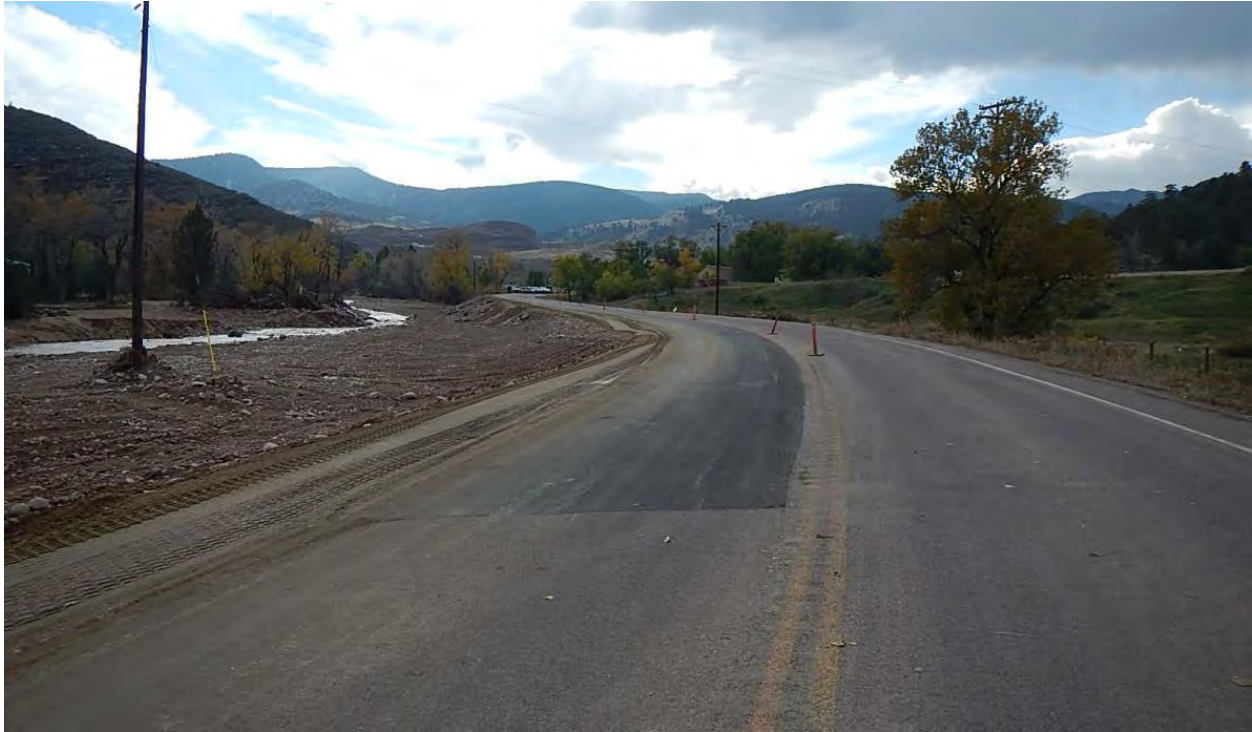
Figure 70 - MP 31.2, Facing southwest, ER Roadway repairs.

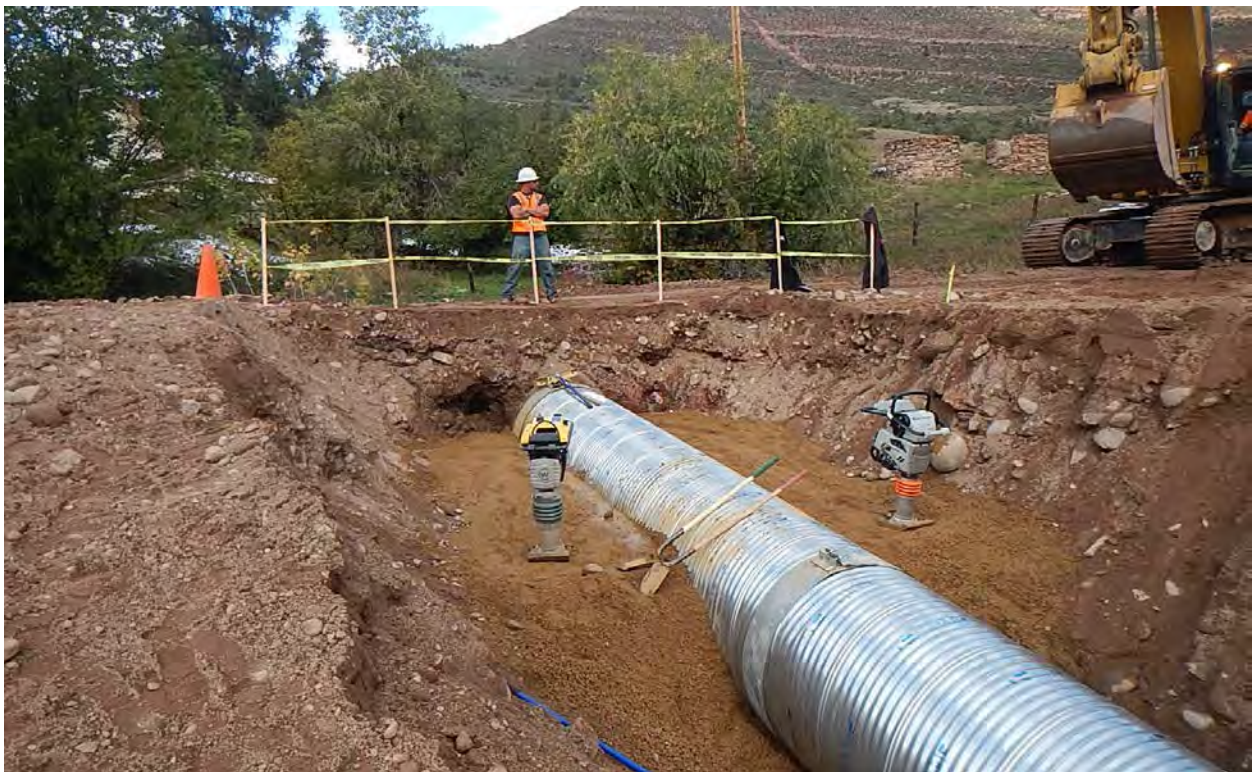
Figure 71 - MP 31.2, ER CMP Installation.
