**SH 7A (Lower)
Raymond to Lyons
Site Repairs between Mileposts 19 and 33**

**Boulder County
COLORADO**

Damage Assessment Report

**100% DRAFT
Revised: July 28, 2014**

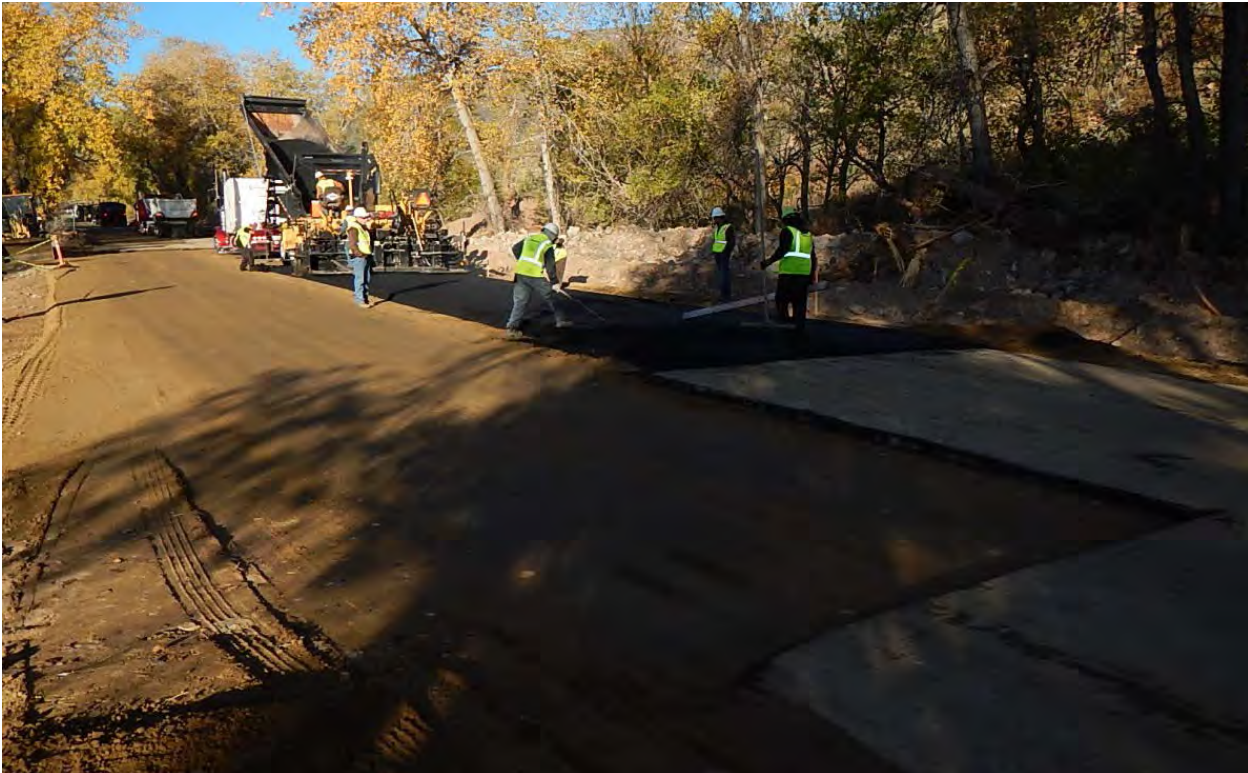
Figure 73 - MP 31.7, ER Paving operations.

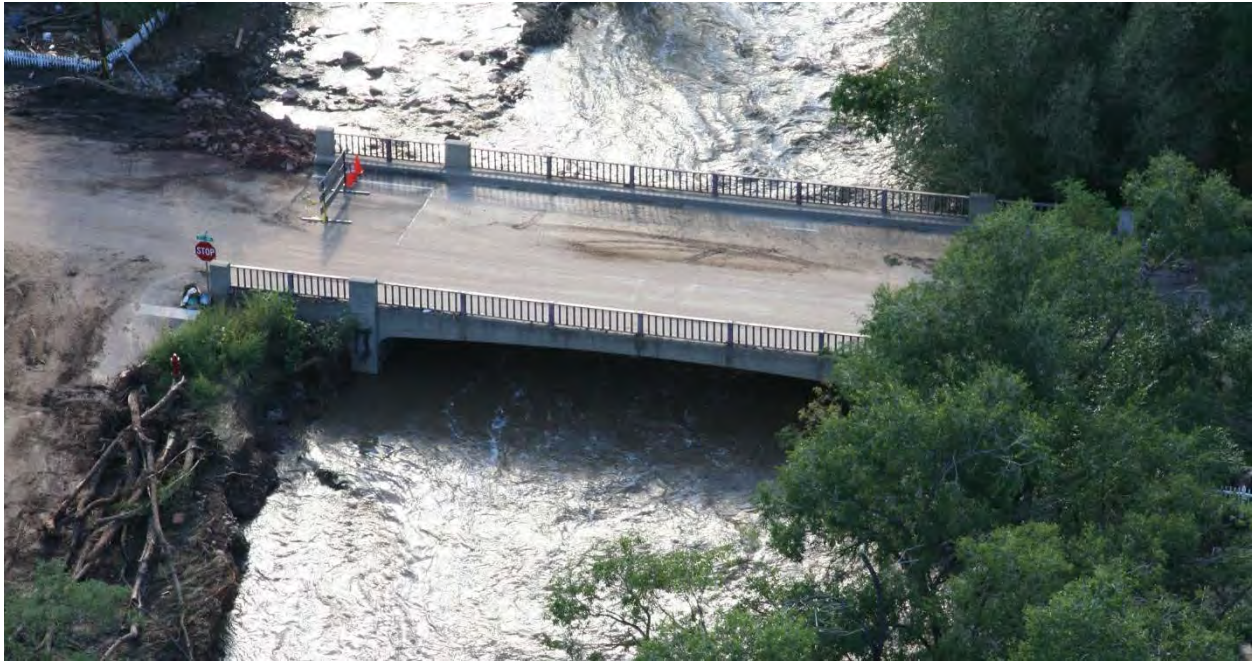
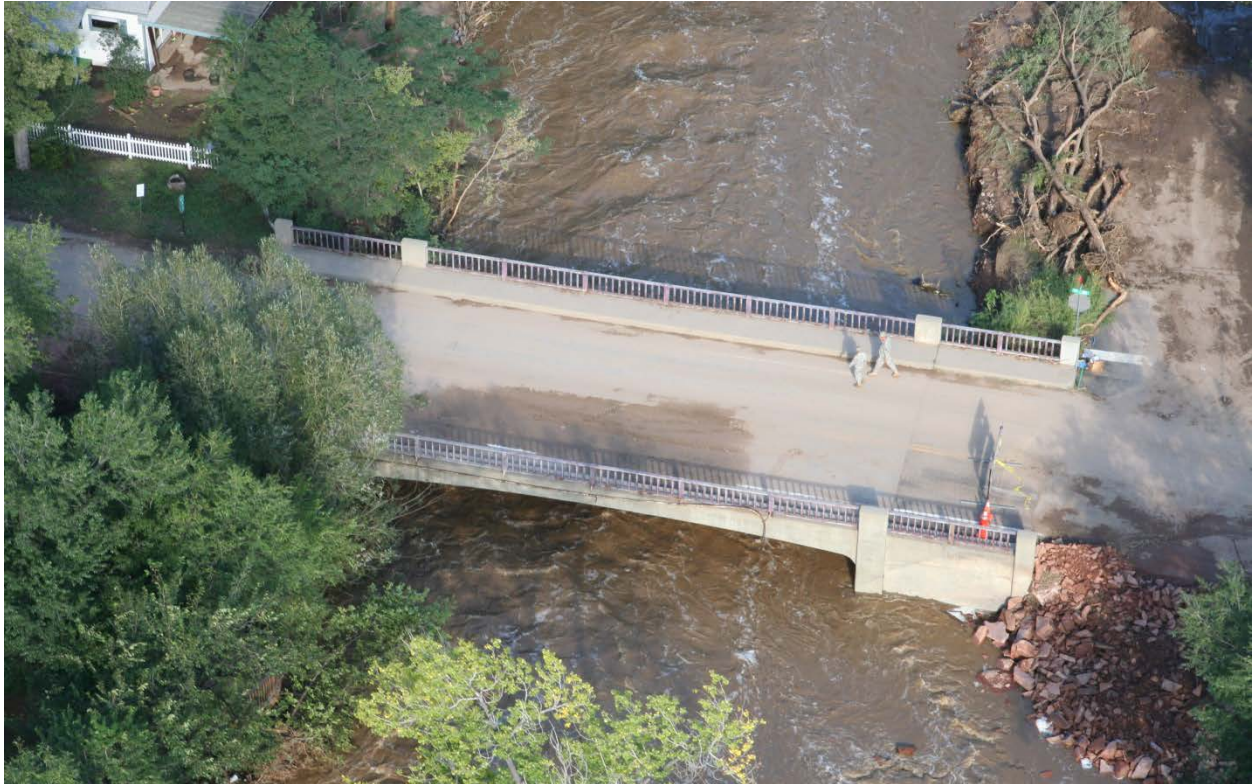
Milepost		Description of Damage
Start	End	
32.98	32.98	Structure D-15-A had scour damage at the south abutment, both on the upstream and downstream sides. The pavement was undermined behind the abutment at the southwest corner.

Figure 76 - MP 32.98, Structure D-15-A with abutment scour and undermined pavement behind abutment.

Figure 77 - MP 32.98, Structure D-15-A with abutment scour and undermined pavement behind abutment.

Milepost		ER Work
Start	End	
32.98	32.98	Repaired abutment scour and undermined pavement.

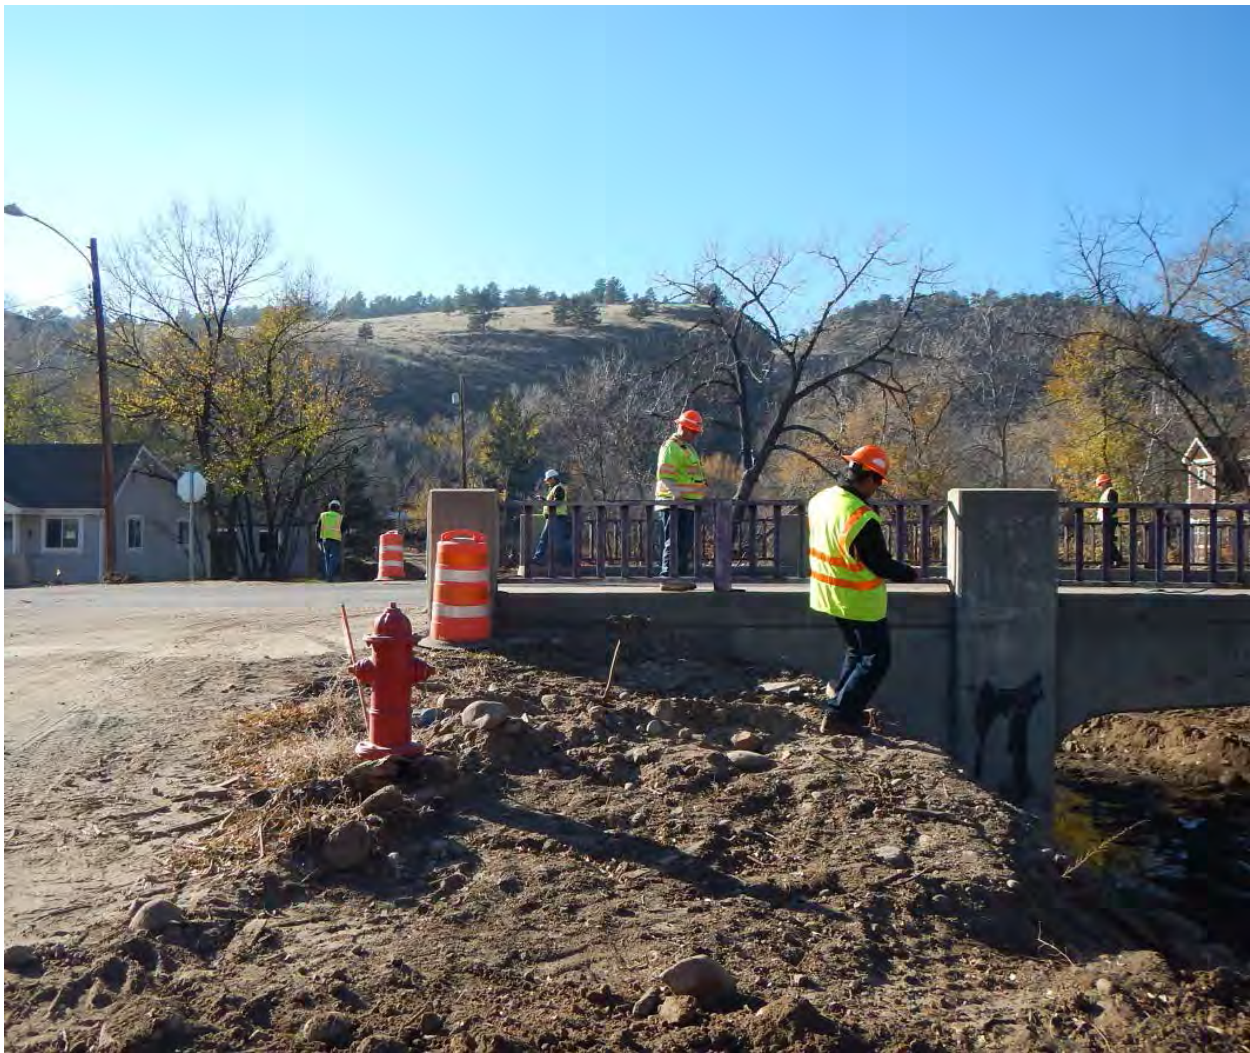
Figure 78 - MP 32.98, Facing west, Structure D-15-A embankment repair.

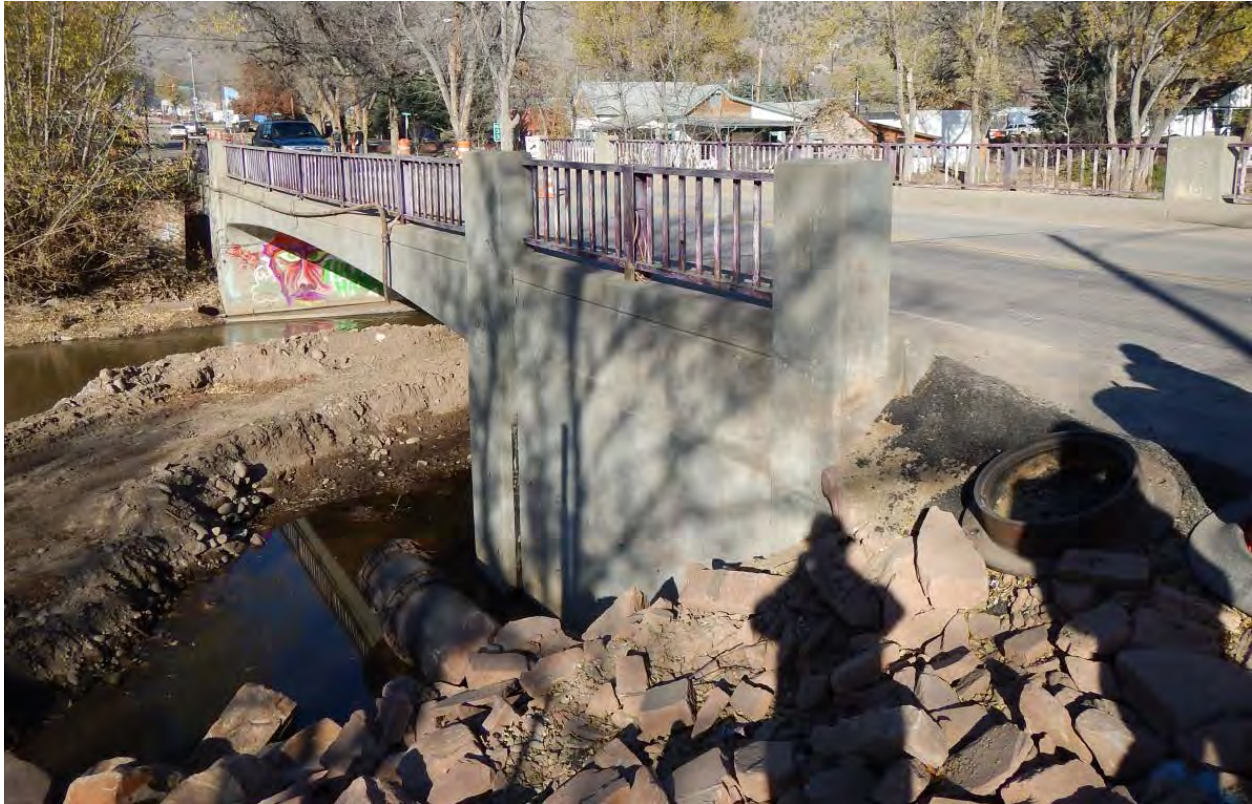
Figure 79 - MP 32.98, Facing northeast, Structure D-15-A temporary access.
