COLORADO
Department of Transportation

RE: Asbestos and Lead-Based Paint Inspection Report for Bridge I-13-H located at US 24 over Draw MM 229.431 West of Hartsel, Colorado

Bridge I-13-H Photographic Log

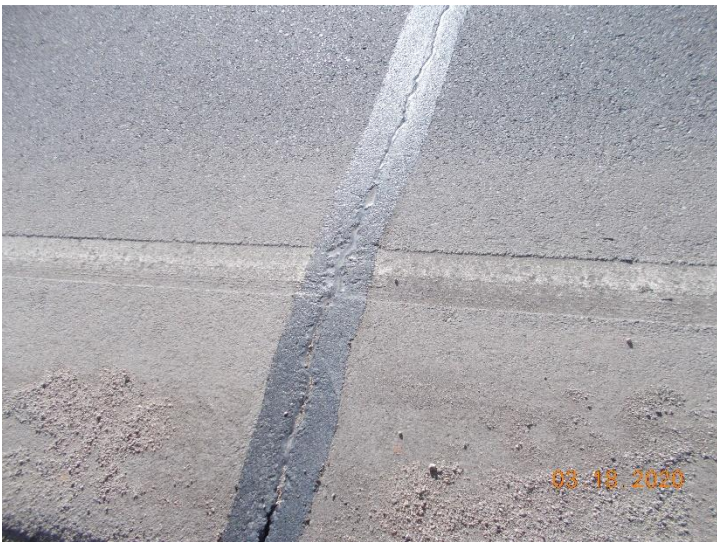
Two suspect asbestos-containing materials (ACMs) were identified during the inspection. Two bulk samples of a black, semi-pliable tar material were collected from the northeast and southeast off the bridge deck. Two bulk samples were collected from a second black, tar-impregnated coating material from the northeast wing wall and northeast edge of the bridge deck. The four bulk samples were non-detect for asbestos.

Suspect asbestos-containing material I-13-H-TR01. The tar material is non-detect for asbestos.

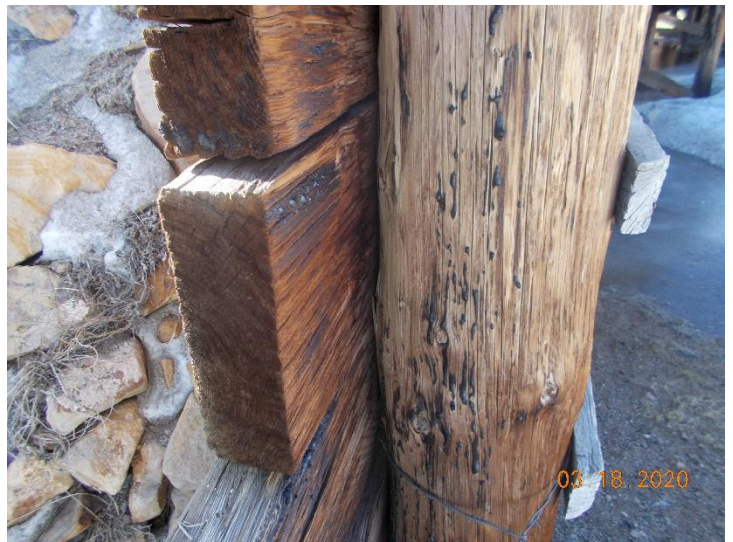
Suspect asbestos-containing material I-13-H-TR02. The tar material is non-detect for asbestos.
