**PRE-DEMOLITION/RENOVATION
ASBESTOS AND LEAD-BASED PAINT
INSPECTION REPORT FOR
COLORADO DEPARTMENT OF
TRANSPORTATION BRIDGE STRUCTURE
J-14-C**

STRUCTURE ID: J-14-C
WALSH Project Number: WA-000944-0160-X

February 22, 2012

**PRE-DEMOLITION/RENOVATION SPECIFIC
ASBESTOS AND LEAD-BASED PAINT
INSPECTION REPORT
FOR
COLORADO DEPARTMENT OF
TRANSPORTATION
BRIDGE STRUCTURE J-14-C
STATE HIGHWAY 9 AT MP 20.111**

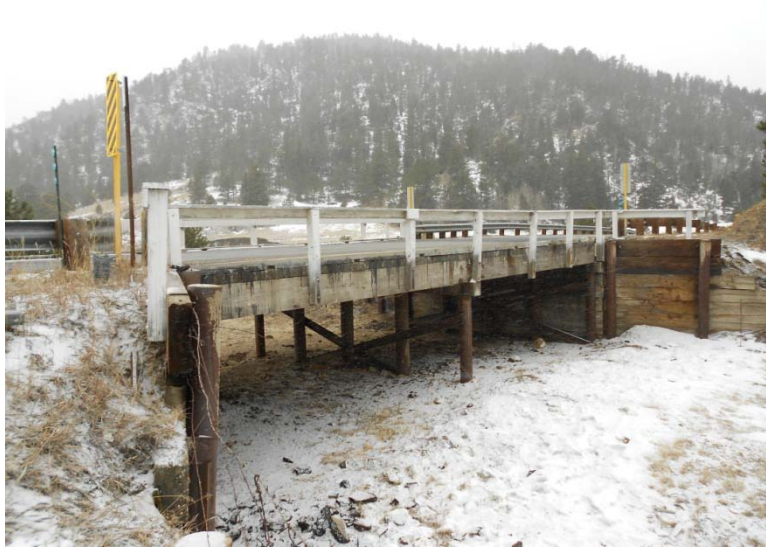
View of Bridge Structure ID: J-14-C
on
State Highway 9.

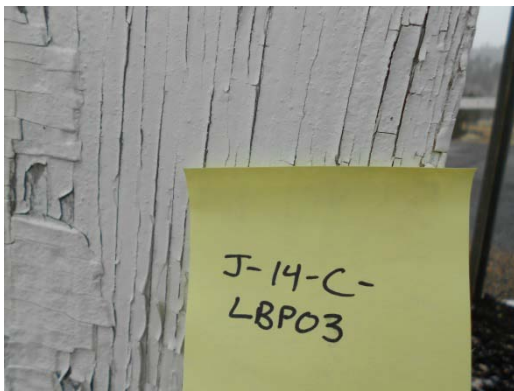
LBP03

- Wood – White – Located on Wooden Railing, Sides of Bridge.
