TO: Don Connors, P.E.
Vice President
Wood, PLC
600 17th Street, Ste 500 – South Tower
Denver, CO 80202

DATE: October 8, 2018

SUBJECT: CDOT Project Code 22420 – US 550 S Connection to US 160 D-B
Gulch A Landslide Mitigation

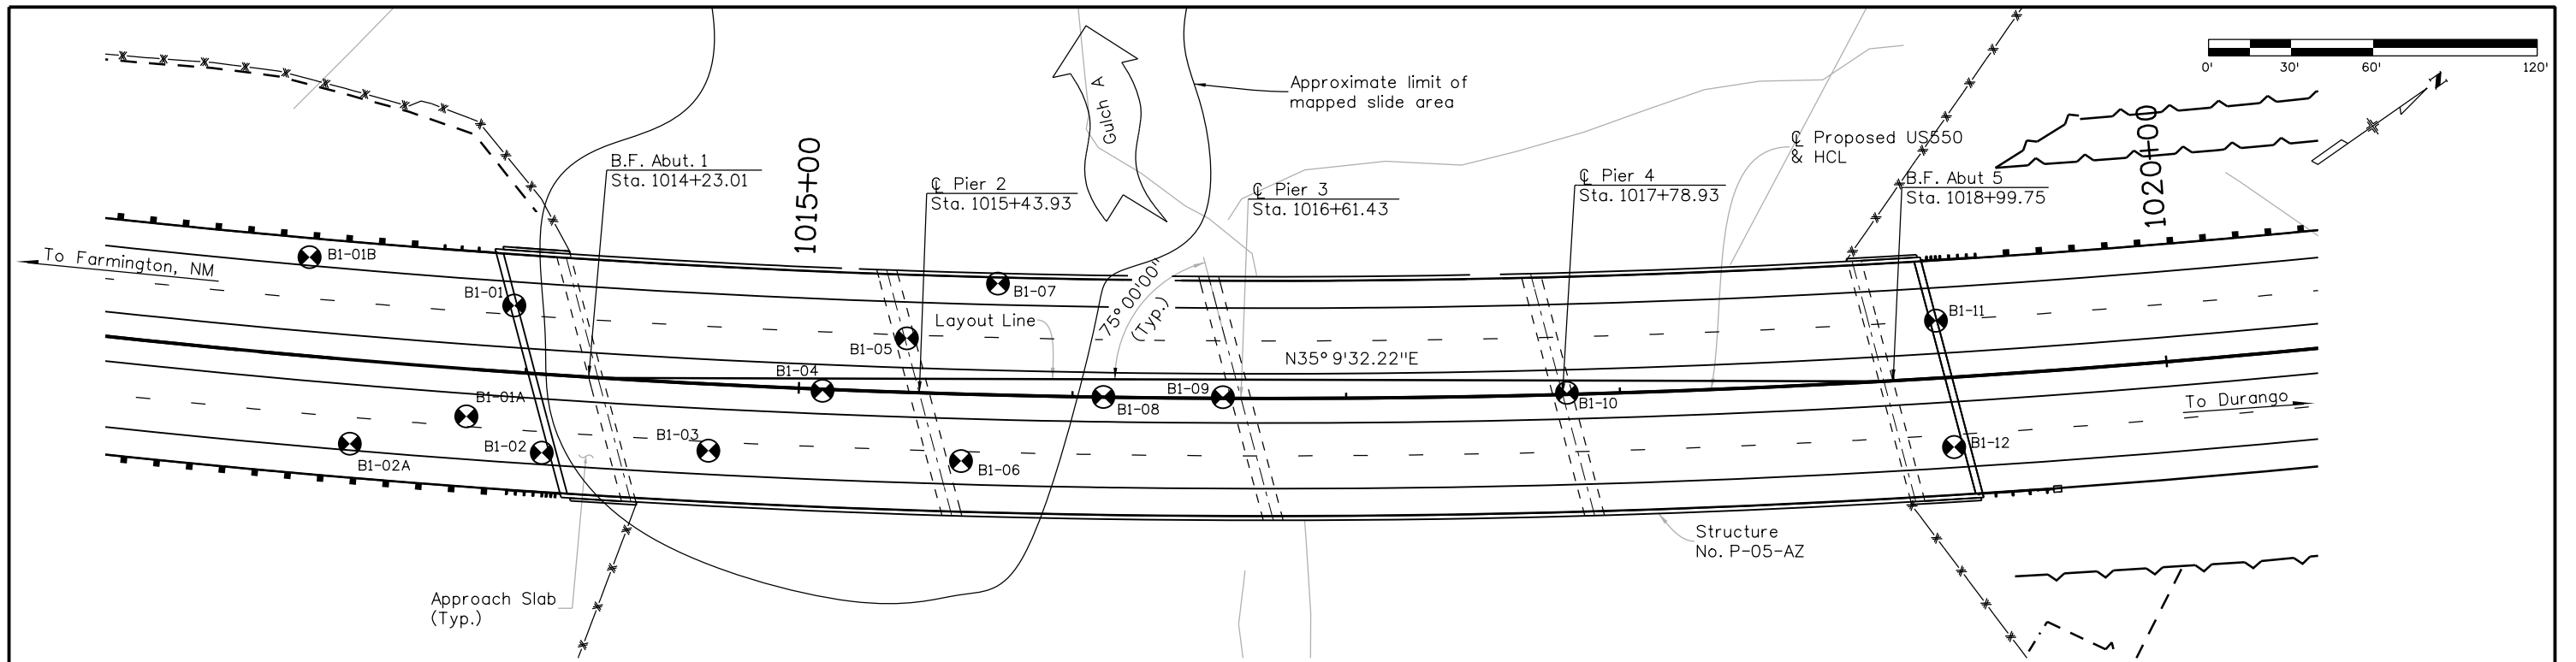
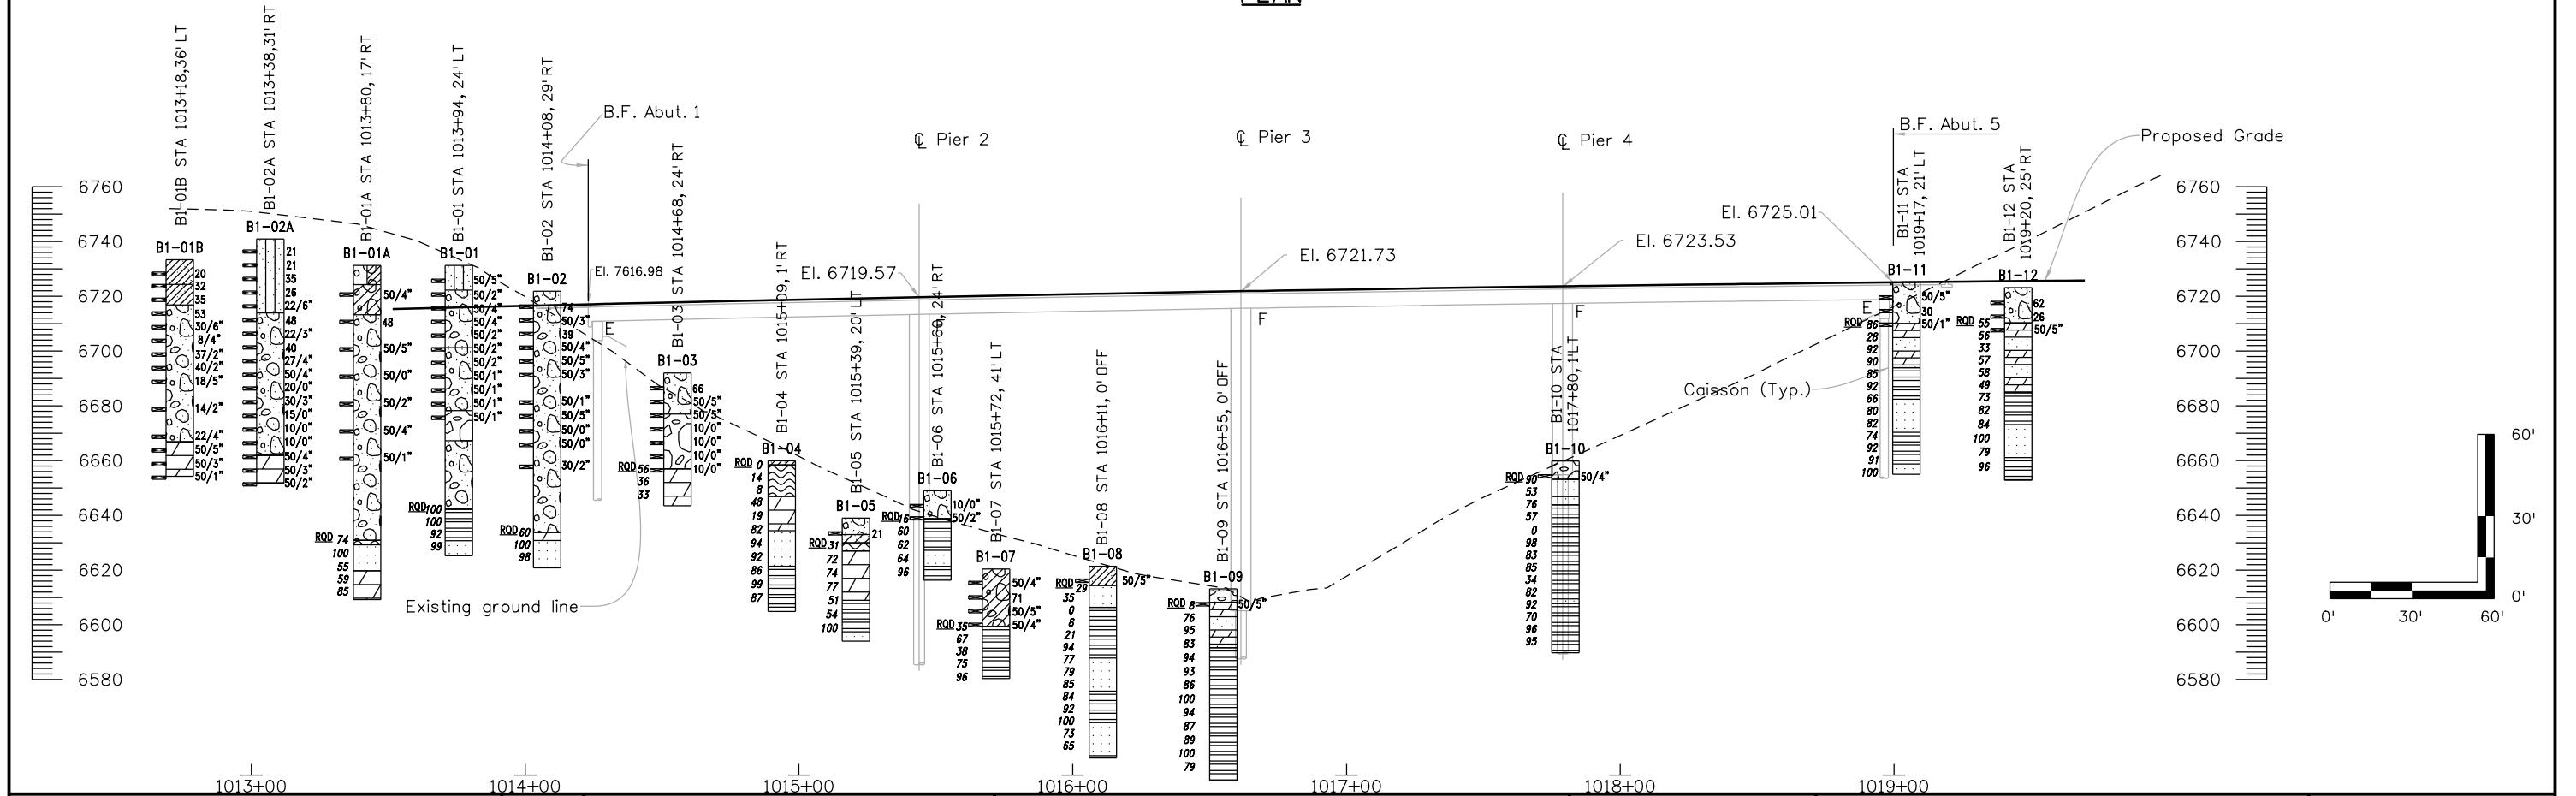
Fifteen (15) borings were drilled to investigate subsurface conditions at Bridge 1. The boring locations and logs are shown on the attached Structure Engineering Geology plan sheet. The conditions encountered in the borings generally consist of 5 to 20 feet of clayey sand soil or clayey sand and gravel over dense alluvial terrace gravel or claystone/shale bedrock. A summary of the conditions encountered in each boring at Bridge 1 is provided in Table 1.

Borings B1-01 and B1-02 were drilled at the proposed location of Abutment 1 as shown on the plans. These borings encountered silty sand soil over sandy gravel with cobbles and boulders. Bedrock was encountered at depths of 89 feet and 88 feet respectively. The bedrock surface elevation is, in general, lower in these borings than in other nearby borings.

We believe irregular erosion of the bedrock near the proposed location of Abutment 1 has resulted in a bedrock surface depression that was subsequently infilled with colluvium that consists of a mixture of clayey soils and terrace deposits, and contains cobbles and boulders (referred to as slope wash deposits in the GDR). The materials were transported by erosion and gravity from their original alluvial deposit and are believed to be unstable and the source of the landslide. Boring B1-01A was drilled south of the abutment location to identify the extent of the bedrock depression and colluvial materials. This boring encountered conditions similar to those in Borings B1-01 and B1-02, with bedrock at a depth of approximately 100 feet. Borings B1-01B and B1-02A were drilled approximately 80 feet south of the planned location of Abutment 1. These borings encountered clayey surficial soils overlying terrace alluvium that appears to be unaltered by recent erosion. These in-place alluvial materials are expected to have good foundation support characteristics.

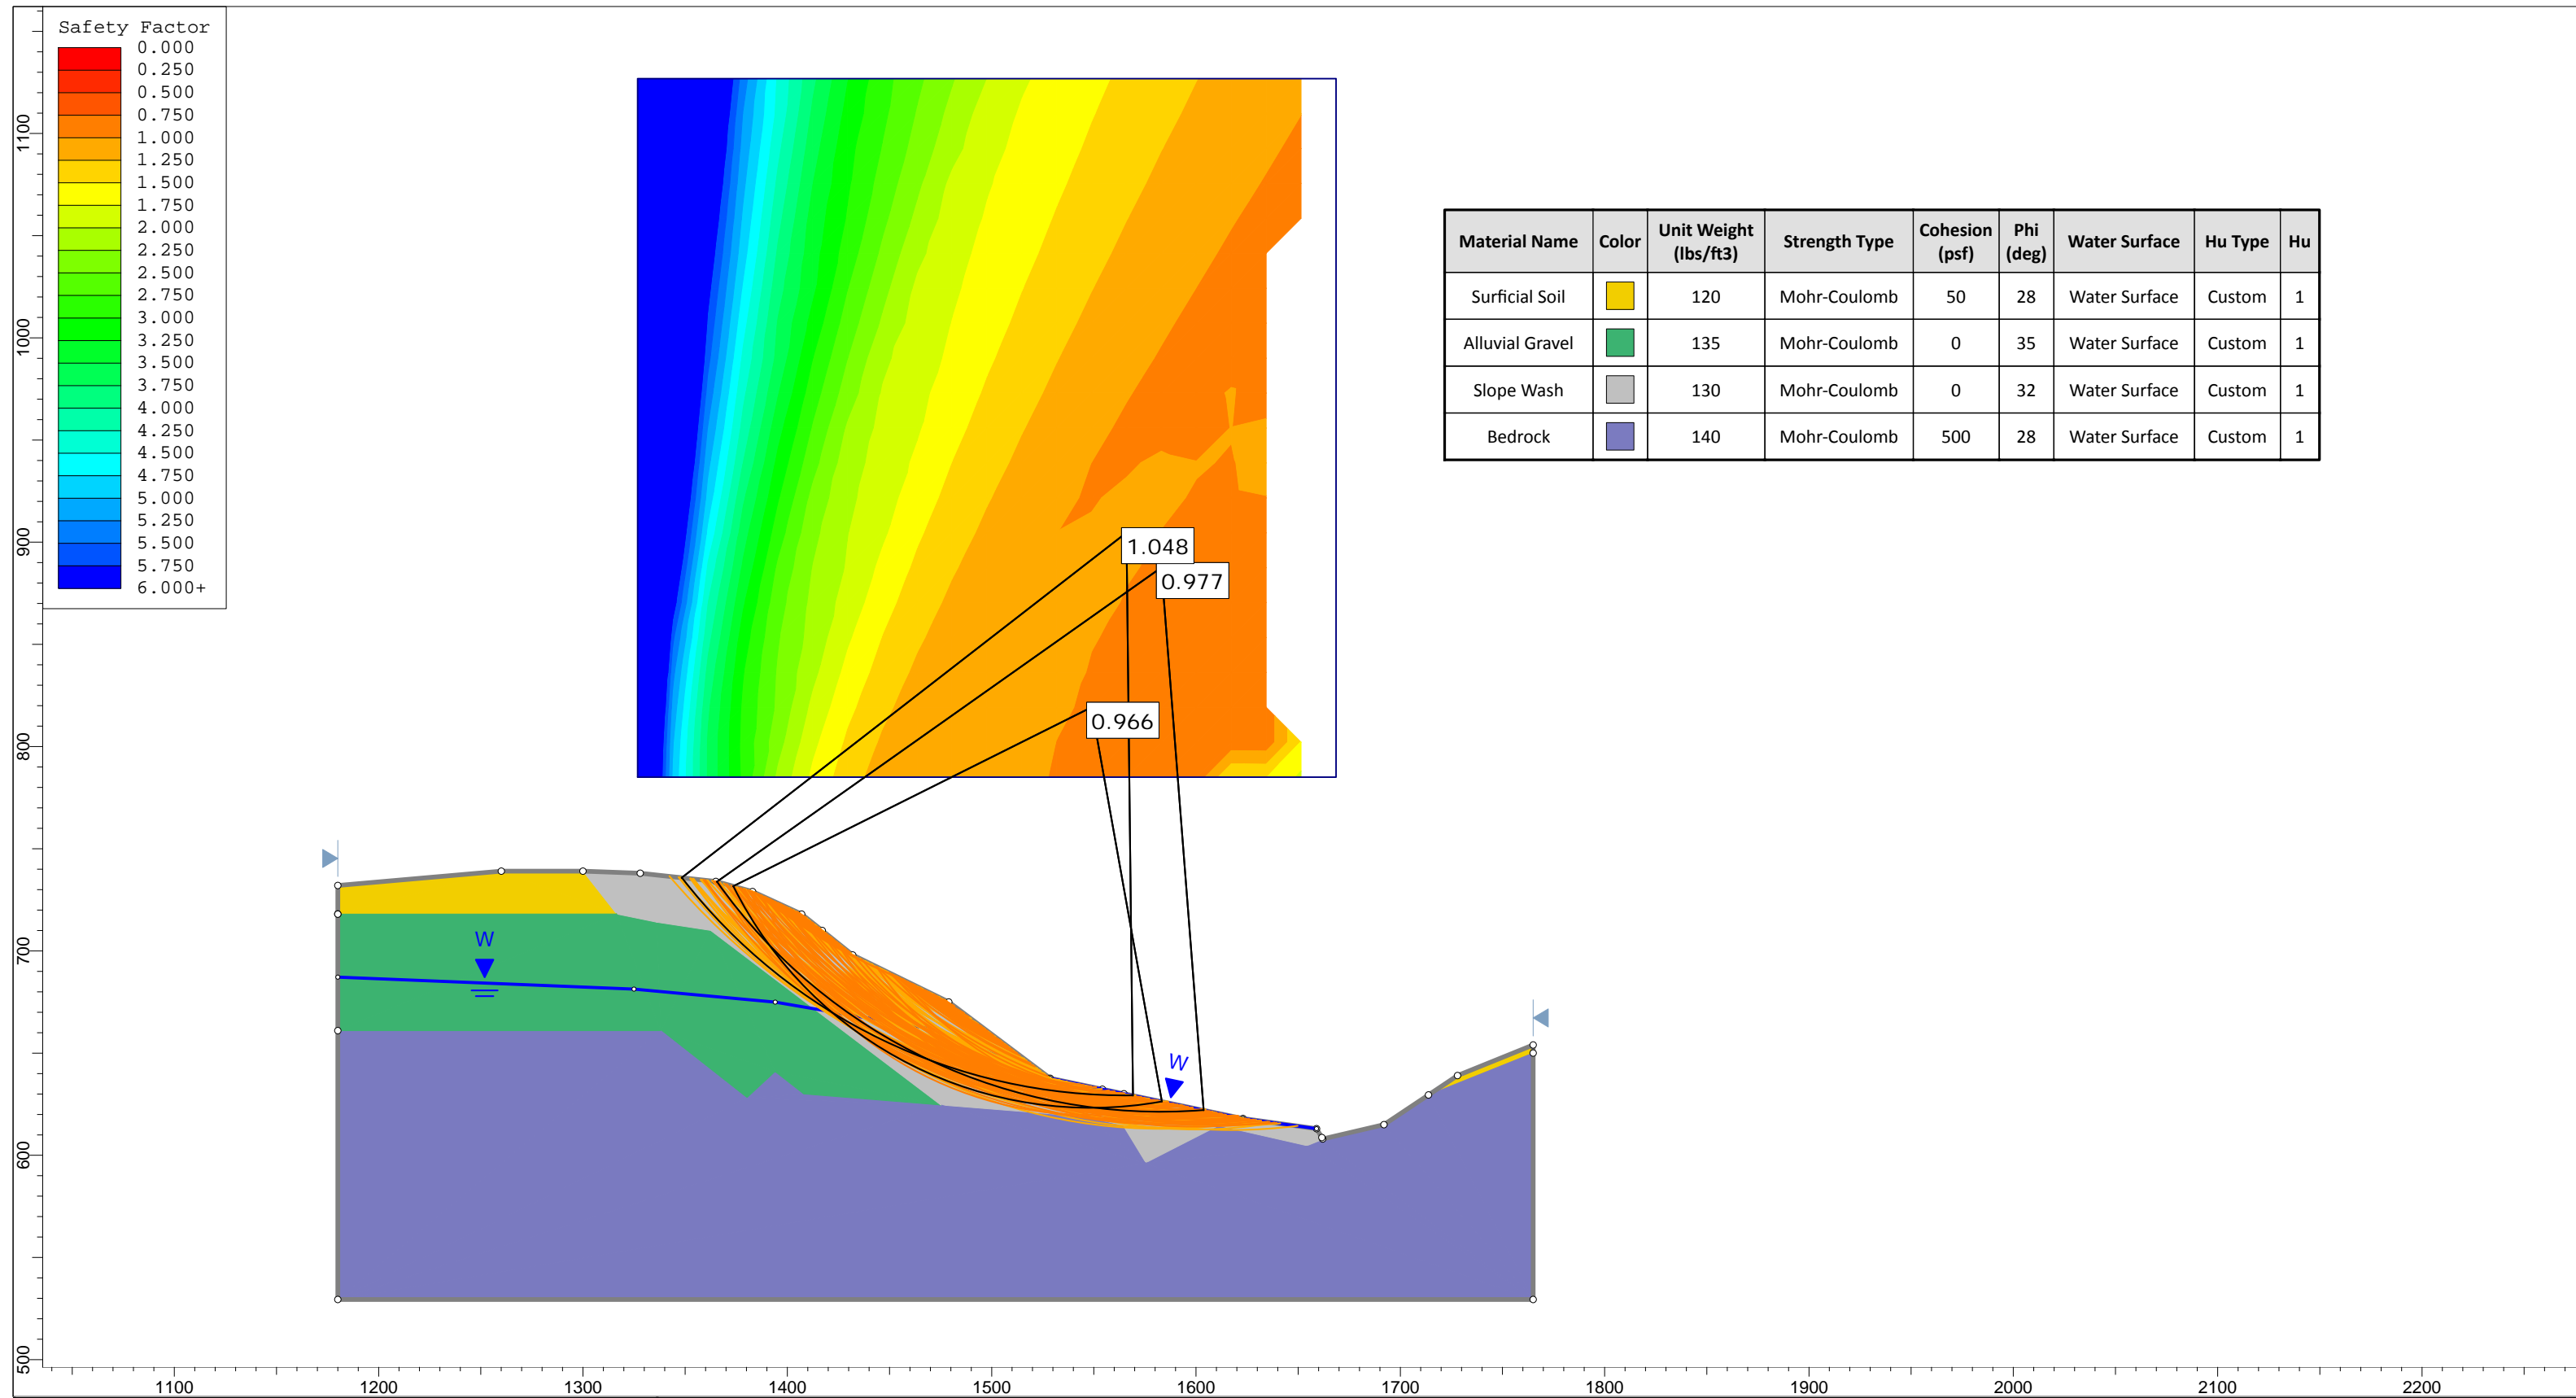
As the first step of our analysis, YA modeled the global stability of the existing condition to match approximately the existing location of the headscarp at approximate Station 1013+80. A FS near 1.0 was back calculated to represent the marginal stability of the existing slope. The SLIDE output for the existing conditions is included as an attachment.

It appears that the slope failure shear zone is located within the colluvial materials and above the approximate bedrock surface as measured in the borings. Water infiltration through the alluvial terrace gravel from precipitation during wet years and from irrigation likely contributes to the slope failure.
