Drainage Assessment Report

US 50 Corridor
Pueblo to Kansas

Colorado Department of Transportation

PRELIMINARY DRAINAGE ASSESSMENT REPORT
US Highway 50 Corridor
Pueblo to Kansas Border

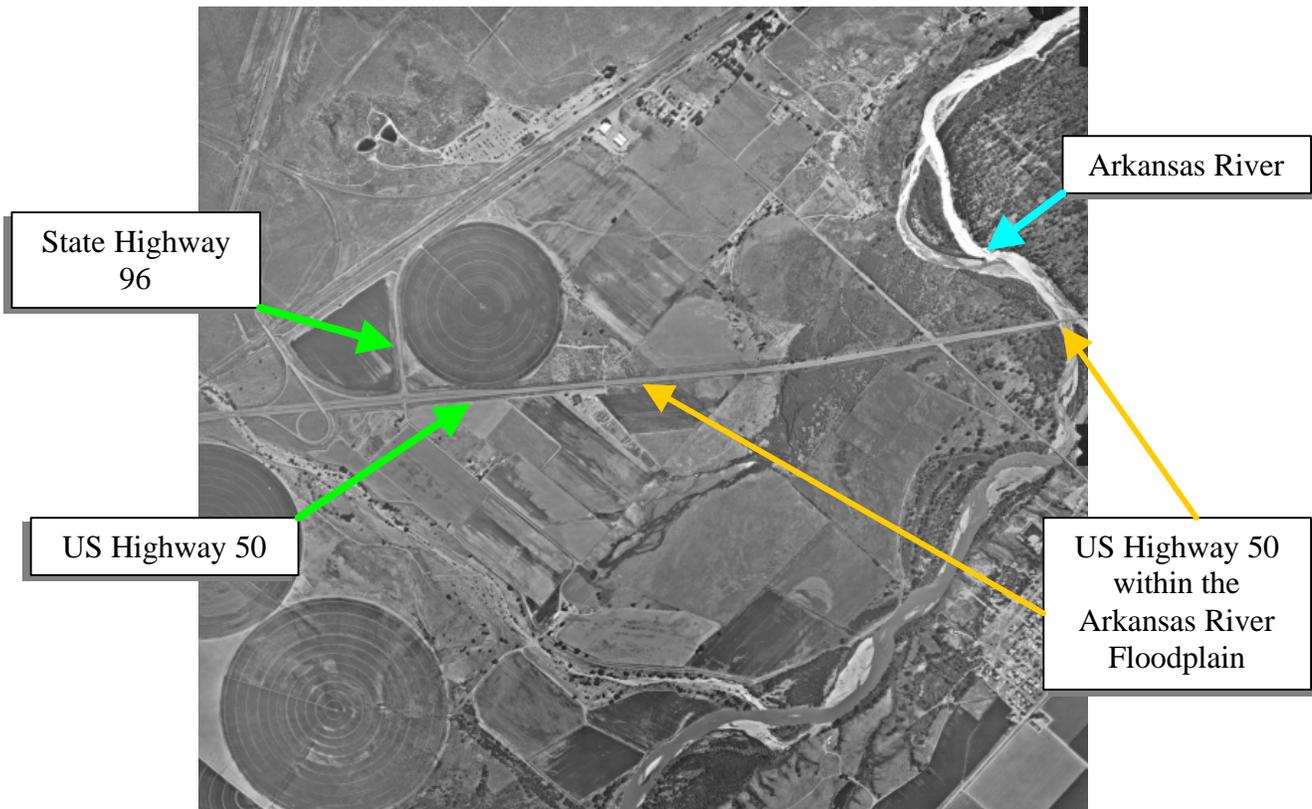
The area is located well within the Flood Hazard Area of the Arkansas River, US 50 is often overtopped even during minor flood events. Flood flows originate from the Arkansas River to the south, flow northeast towards US 50 paralleling the Arkansas River, then return to the river just north of the US 50 bridge. The road was last overtopped in 1999 by as much as 1-ft of water and was closed to traffic for over 14 hours. Improvements will likely require raising the US 50 roadway surface and installing several additional cross culverts.

Aerial photo of US Highway 50 Corridor, vicinity Intersection with SH 96 and the Arkansas River Crossing, miles 329.3 to 332.0

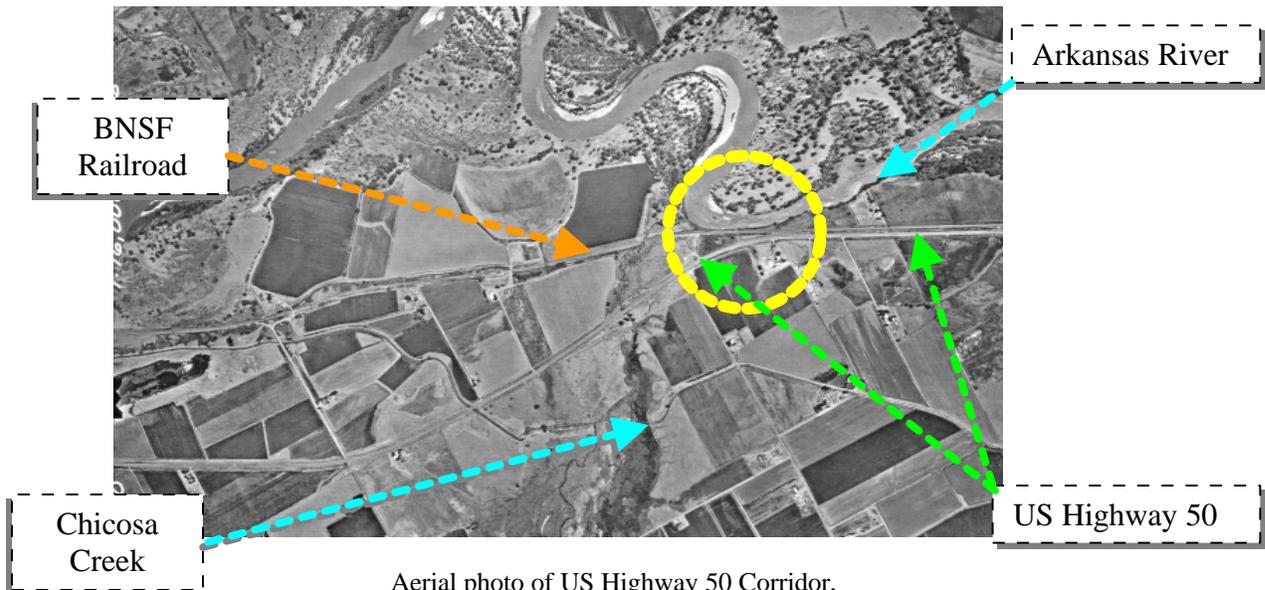
At this location, the US 50 ROW and the Arkansas River are almost adjoining. The south bank of the river and US 50 are within approximately 200-ft. The elevation difference between the river and the highway is approximately 25-ft. The BNSF railroad grade is just north of the highway and separates the river and US 50. Floodplain encroachment onto US 50 should be a concern here.

Aerial photo of US Highway 50 Corridor,
Vicinity Chicosa Creek crossing, west of Fowler, CO, mile 348

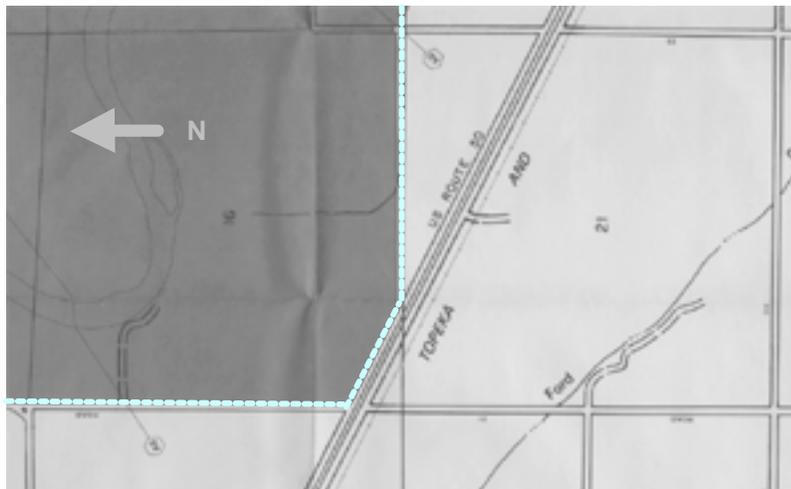
The 1985 Flood Boundary map indicates that the 100-yr Flood Boundary is immediately adjacent to the US 50 ROW at this location. The Flood Boundary parallels US 50 from the intersection of CR 21, east for approximately 1200-ft.

FEMA map showing flood boundary adjacent to US 50 ROW

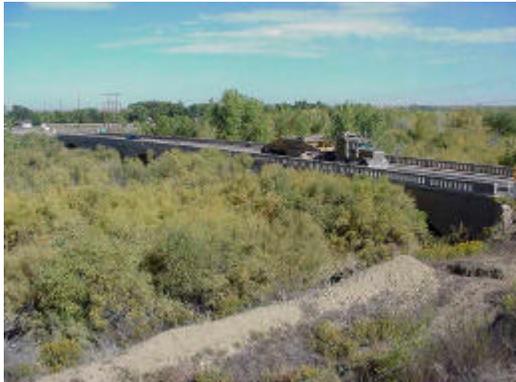
The Huerfano River crosses under US 50 at mile 335.86 (structure: L-19-B). The bridge is a five span concrete arch bridge originally constructed in 1921 and widened in 1948. The confluence of the Huerfano and Arkansas Rivers is approximately 1-mile north-northeast of the US 50 crossing. In the vicinity of the US 50 crossing the Huerfano River Flood Hazard Area is relatively narrow and well defined. Dense vegetation within the floodplain may reduce conveyance and possibly cause debris accumulations at the multi-span arches of the US 50 structure.

Huerfano River Crossing and floodplain, structure L-19-B

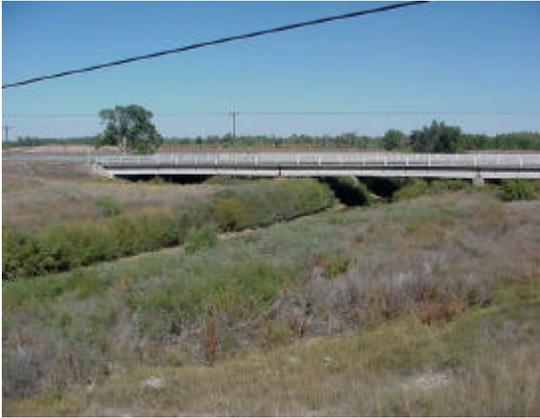
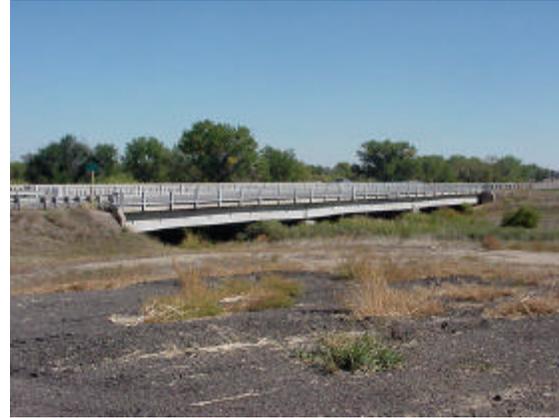
Nepesta Road to La Junta). According to the 1985 FEMA Flood Insurance Study, the 50-yr, 100-yr and 500-yr events all overtop the US 50 bridges at Timpas Creek.

US 50 bridge over Timpas Creek, structure L-22-AL, mile: 373.64

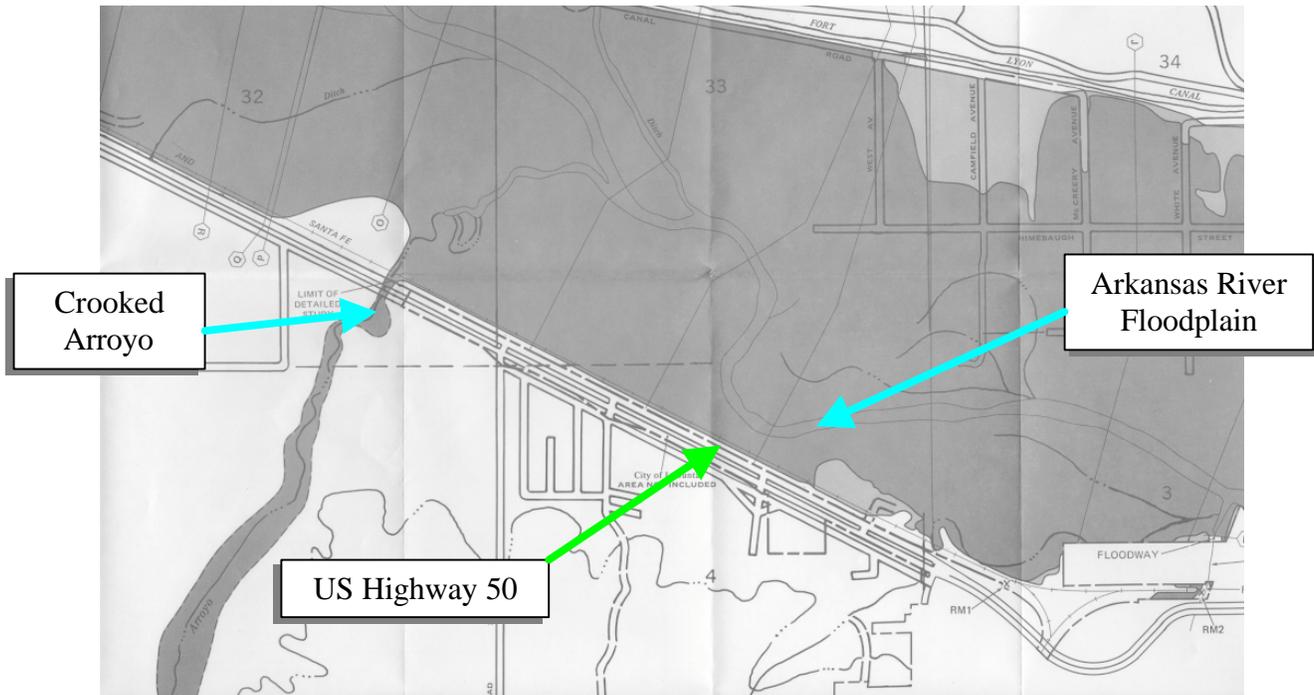
FEMA map showing flood boundaries for Crooked Arroyo and the Arkansas River adjacent to US 50

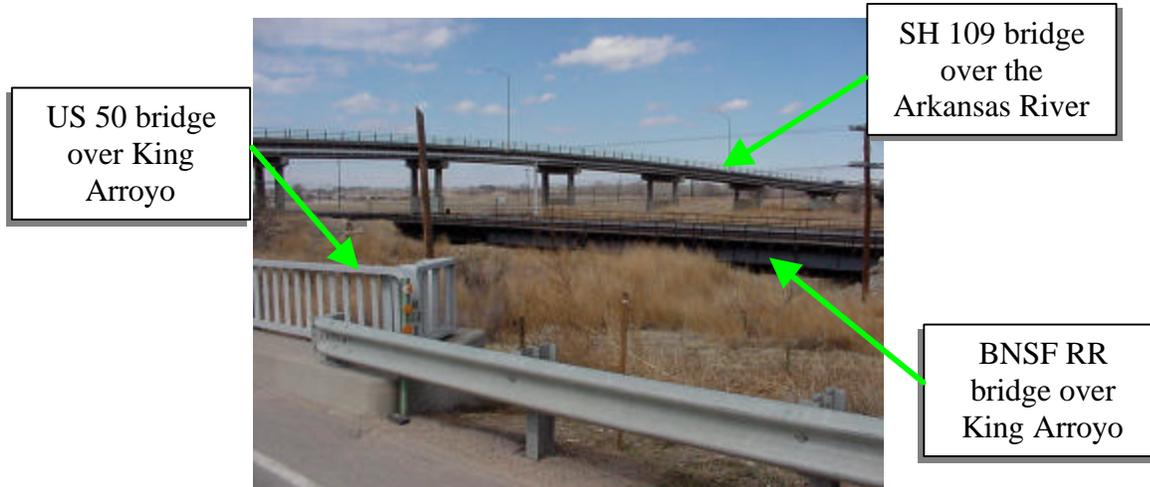
within the 100-year Flood Boundary; the FEMA 100-year peak discharge is 7,500 cfs, which does not overtop the US 50 structure.

US 50 bridge
 over King
 Arroyo

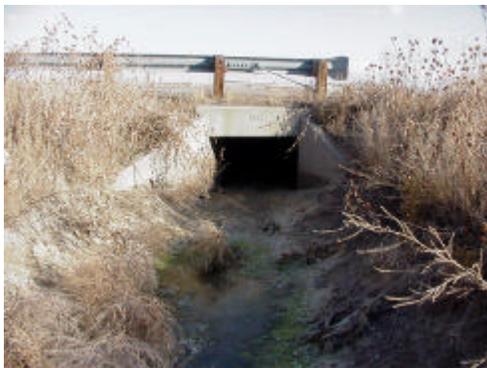
After crossing under US 50, the Excelsior Ditch runs immediately parallel to US 50 for approximately 2000-ft. The close proximity of the ditch to the highway has resulted in vehicle accidents as reported by Mr. Evans. Mr. Evans recommends relocating the ditch further to the north to improve safety and maintainability. Also, as originally constructed, a lateral exists just east of the existing crossing site and crosses back under US 50. Mr. Evans feels re-routing the lateral along the southside of US 50 could eliminate the need for an additional crossing under US 50.

Excelsior Ditch CBC entrance under US 50

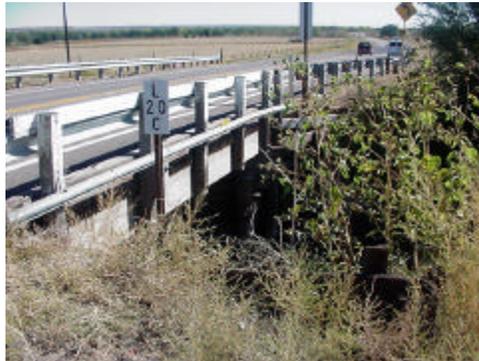
The existing structure is a 25-ft single span timber bridge constructed in 1938. The ditch has a Decreed Flow of 130 cfs and a normal flow of approximately 130-cfs. Storm water runoff to the canal can be as much as 70 cfs increasing total flow at this site to 200 cfs. There is a head gate located approximately 50-ft just upstream and north of US 50. The existing structure is showing signs of severe deterioration below water level. The timber abutment piles are rotting and have decreased in their overall diameter. The ditch was last overtopped in the Spring of 1999 when an estimated flow of 220 cfs topped the ditch approximately 2 miles upstream of the US 50 crossing. Replacement of this structure will be required in the near future. Capacity of the existing structure is barely adequate for flows approaching 200 cfs. The Ditch Company would prefer a concrete, single span bridge. Access to the Ditch Rider road and structure is adequate but could be improved.

Oxford Farmers Ditch, CDOT Structure L-20- C

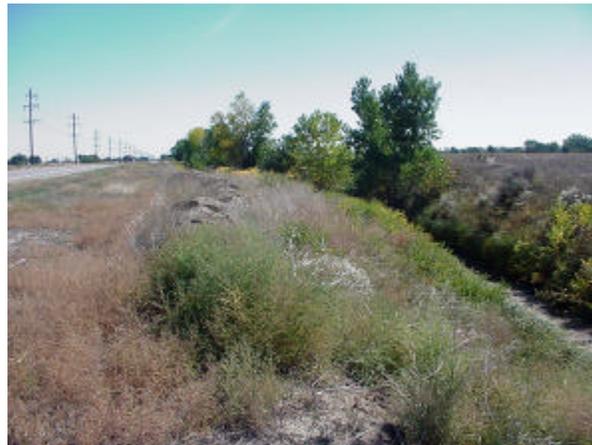
An additional unique feature to this location is that the existing ditch, after crossing under US 50, parallels the highway for approximately one third of a mile. Any improvements to US 50 would most certainly affect the Otero Ditch since the ROW's are so close together. Dredge spoils from the ditch already appear to encroach upon the US 50 ROW.

Otero Ditch looking east from CDOT structure L-21-b, ditch closely parallels US 50

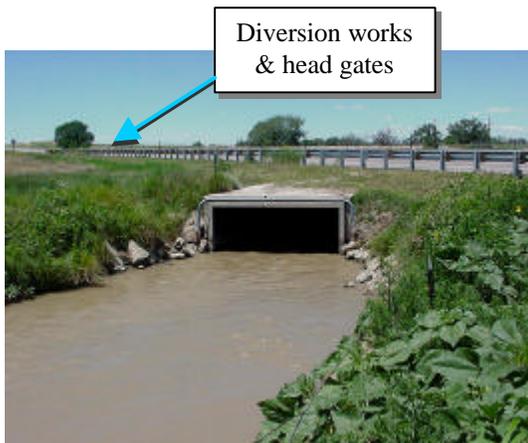
The existing canal crossing structure is a single cell concrete box culvert constructed in 1958. The canal, formally known as the Jones Ditch, has a decreed flow of 135-cfs and a normal flow of approximately 75-cfs. Excel Energy, Denver, Colorado now owns 98% of the canal shares. There is a diversion works with head gates located approximately 500-ft upstream of the US 50 crossing site. The canal also flows through a flood control levee equipped with gates just downstream of the diversion works. The gates at the levee are employed in the event of a flood and are only used to shutoff flow through the levee. Between the levee and the US 50 crossing is a Parshall flume used by the Canal Company to measure canal flows. The flume and canal closely parallel the US 50 Right of Way (ROW). A smaller ditch called the Riverside Ditch diverges from the Las Animas Consolidated Canal just upstream (approximately 50-ft) of the US 50 crossing. A concrete structure and gate exist at the juncture of the Los Animas Consolidated Canal and Riverside Ditch and is located immediately adjacent to the US 50 ROW. There are no major issues with this canal or crossing site. Access from US 50 to the diversion works, head gates and levee will need to be maintained.

Las Animas Canal CBC outfall

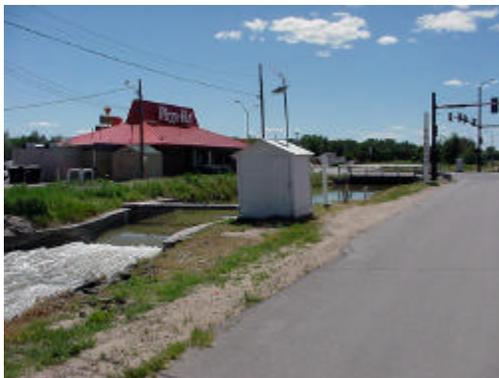
The Lamar Canal crosses US 50 in two locations in or near the city of Lamar, Colorado. The decreed flow for the Lamar canal is 285.7-cfs, the design capacity of the canal at the crossing sites is 285-cfs and the normal flow is approximately 150-cfs. The first crossing is on the north end of town at mile 434.78 utilizing a 25-ft concrete slab bridge. A Parshall flume is located just downstream of this crossing which reduces the flow velocities and causes an accumulation of sediment beneath the US 50 bridge. The second crossing is just east of town through a concrete box culvert at mile 436.76. Immediately downstream of this crossing is an entrance to an inverted siphon where the Lamar Canal passes under the Willow Creek Drainage channel. Sediment routinely collects between the siphon entrance and CBC and within the CBC under US 50.

Lamar Canal, Structure L-26-E
 Parshall flume directly downstream

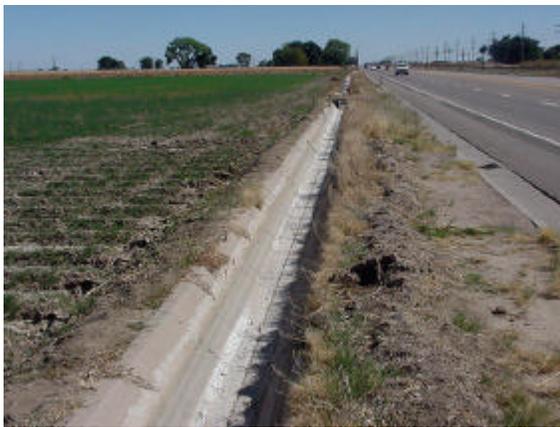
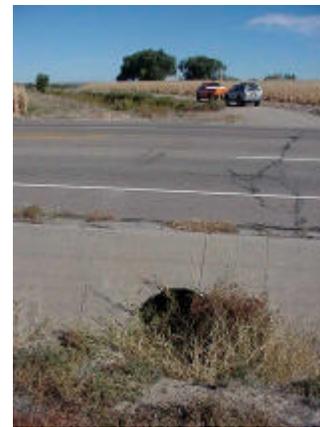
East of Manzanola and continuing to Rocky Ford, CO, from approximate mile: 361.5 to mile: 368, there are several locations where irrigation ditches are immediately adjacent to the US 50 roadway. In some locations the irrigation ditch inverts are higher than the adjoining roadway curb/profile. The close proximity of the ditches to the road causes issues with roadside drainage, occasional overflow of irrigation water onto the roadway, deposits of drifting snow onto the roadway, and safety issues due to the lack of a shoulder. In other locations irrigation ditches are immediately adjacent to US 50 but with inverts below the roadway curb/profile. In these particular locations, roadway shoulders are minimal and make for unsafe conditions, as vehicles are able to enter the ditch directly after leaving the roadway surface. The area also includes cross drains that can contribute to various drainage problems.

Irrigation ditches immediately adjacent to the US 50 roadway

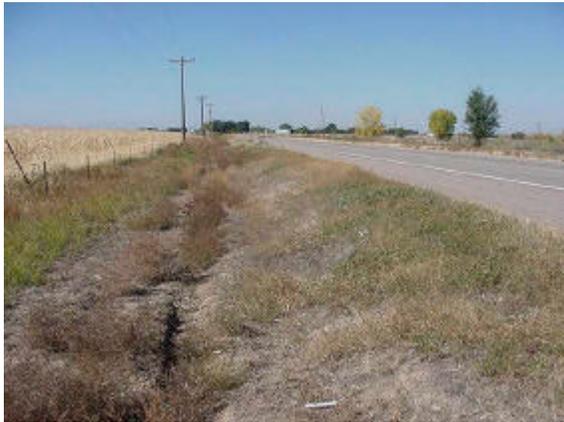
Throughout the corridor there exist locations where roadside ditches and irrigation ditches combine flows. With few exceptions the roadside ditches were sized for the additional irrigation drainage flows and during storm events are quickly overtopped. The additional flows from irrigation drainage also carry sediment that can quickly reduce the capacity of the roadside ditch exacerbating a lack of capacity. Siltation of roadside ditches combined with increased flows has caused additional vegetation to prosper and require significantly more maintenance. Future designs should require segregation of irrigation drainage flows from roadside drainage ditches. Separate systems should be considered to reduce combined flows and increased maintenance requirements for CDOT crews.

Combined roadside and irrigation drainage ditch

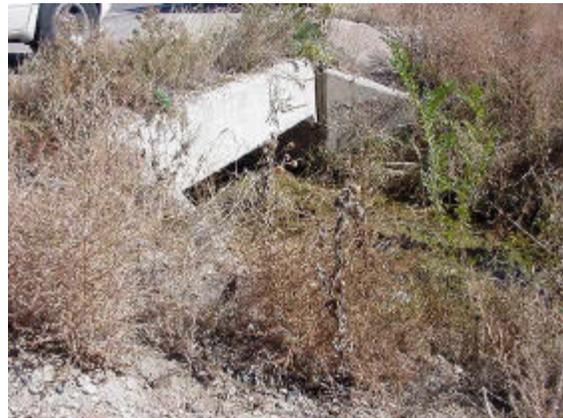
Silt accumulation at highway cross culvert due to combined roadside and irrigation drainage

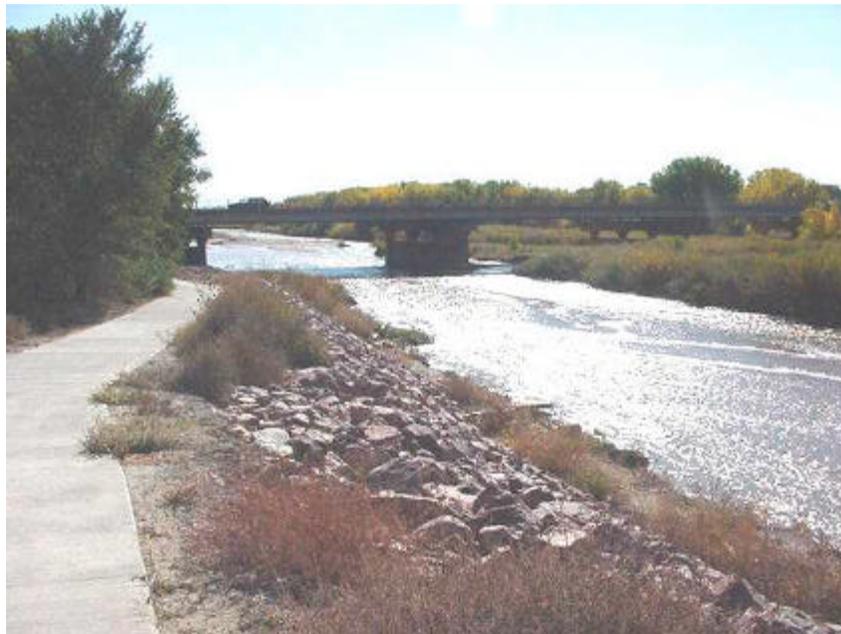
4.3.1.1. Mile 314, Fountain Creek Bridge. Alignment of Fountain Creek through structure K-18-L continues to be an issue. During the Spring 1999 floods, Fountain Creek migrated to the west and was impinging upon the northwest abutment/approach of the US 50 bridge. Late in 1999 URS completed an analysis and design for counter measures to protect the abutment and help ensure proper alignment of Fountain Creek through the structure. The current alignment of Fountain Creek is adequate but channel migration is a continuous possibility during future flood events. Improvements should include construction of the URS designed guide banks and other counter measures as soon as possible.

Bridge over Fountain Creek, Structure K-18-L looking downstream

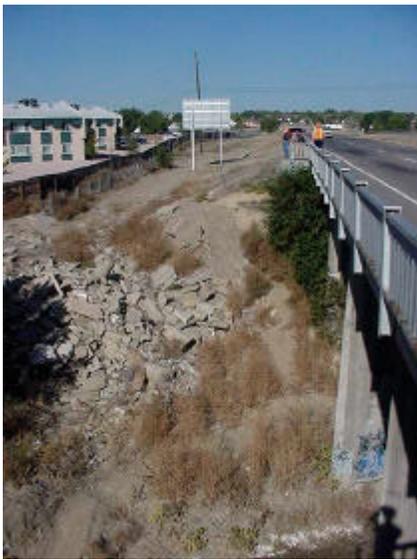
4.3.1.2. Mile 318, Dry Creek Bridge Scour and Erosion. Structures K-18-BZ, BY, and FG all show signs of significant pier and abutment scour. Numerous emergency repairs have been made to curtail erosion of the abutments and piers. The last major event causing damage was in 1999. Support piles beneath the US 50 bridge piers have already been exposed!

Concrete riprap repairs for abutment scour

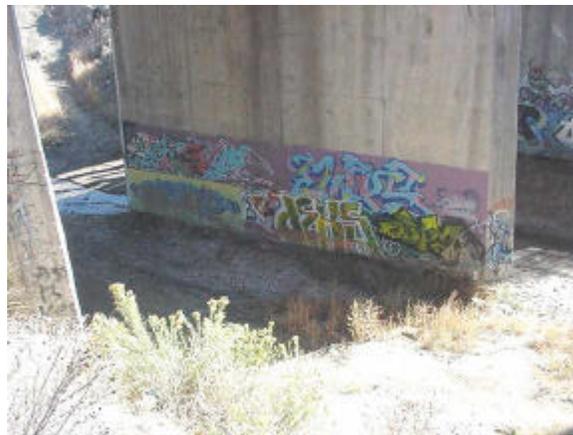
Scour has exposed the support piles under the pier

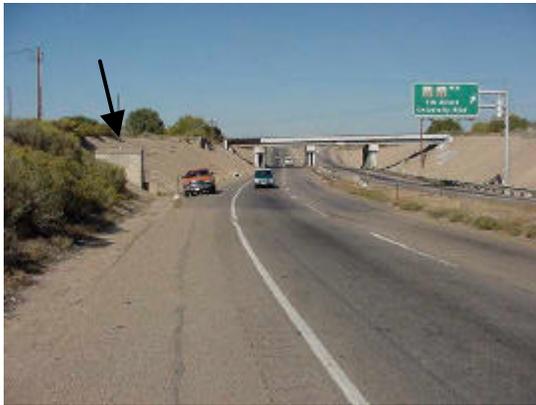
4.3.1.3. Mile 319, Inadequate Underpass Drainage beneath BNSF Railroad Bridge. The US 50 roadway beneath the BNSF railroad tracks (structure K-18-W), east side of Pueblo, is flooded routinely. Two existing sump pumps transfer water from a sump on the south side of the road to a concrete lined ditch that drains generally south and parallel to the railroad ROW toward the Arkansas River. The two pumps were replaced approximately five years ago but are inadequate to handle any but the smallest events. Contributing surface flows converge on the underpass from the east and west along the US 50 roadway and from the northeast along the BNSF roadbed. High ground water can also influence the amount of water entering the pump sump.

K-18-W looking west, pump house on left near truck

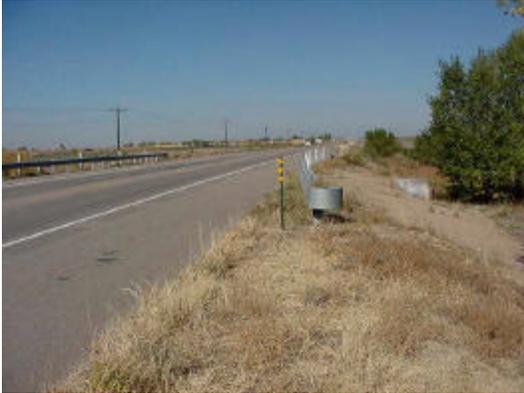
4.3.1.4. Mile 329 – 330, Inadequate Cross Drainage, vicinity Arkansas River Floodplain. This area begins in the vicinity of the junction of US 50 and CO 96 and extends east approximately two miles along US 50 to the bridge over the Arkansas River (structure L-19-H). There are presently only two locations where cross drainage can occur, a single 72-inch CMP and at a collection of seven 36-inch CMPs located just west of the intersection of US 50 and the roads to Avondale and North Avondale.

72-inch Cross Culvert; looking west along US 50

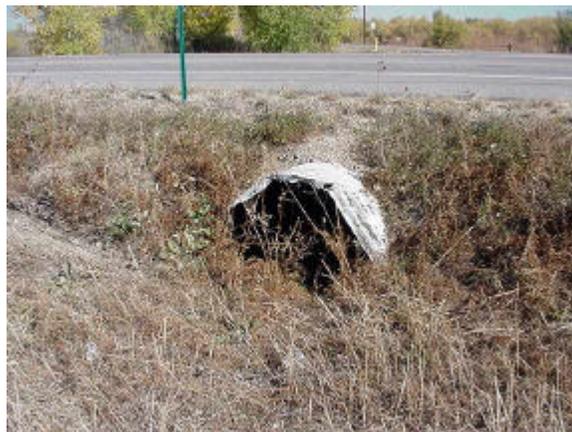
The area is located within the floodplain of the Arkansas River; US 50 is often overtopped during flood events. Flood flows originate from the Arkansas River to the south, flow northeast towards US 50 paralleling the Arkansas River, then return to the river just north of the US 50 bridge. The road was last overtopped in 1999 by as much as 1-ft of water and was closed to traffic for over 14 hours. Improvements will likely require raising the US 50 roadway surface and installing additional cross culverts.

One of the seven 36-inch cross culverts inlets

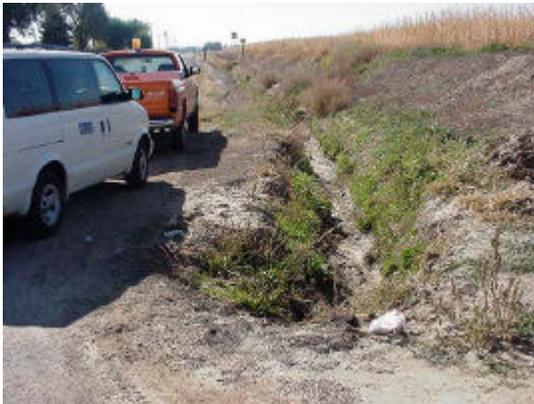
Just west of the intersection of US 50 and Business 50 there is an existing 30-inch CMP beneath US 50. Flow through this culvert is a combination of overland storm runoff and irrigation drainage. During the summer irrigation season, the irrigation drainage ditches often flow at or near capacity and directly into the 30-inch CMP. During summer storms, the combination of stormwater and irrigation drainage flows quickly exceeds the capacity of the 30-inch culvert. Possible improvements include replacement of the CMP with a CBC capable of conveying the combined storm and irrigation drainage flows.

Irrigation ditch upstream of US 50 30-inch CMP

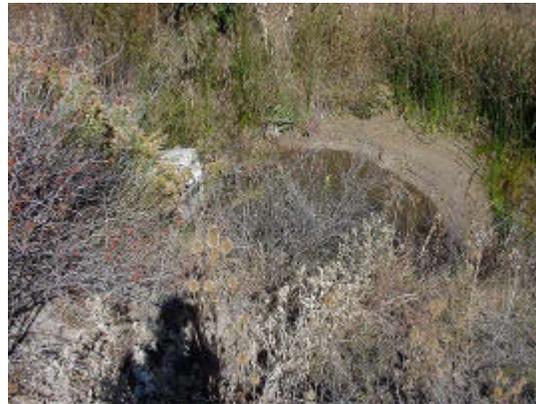
30-inch CMP outfall, northside of US 50

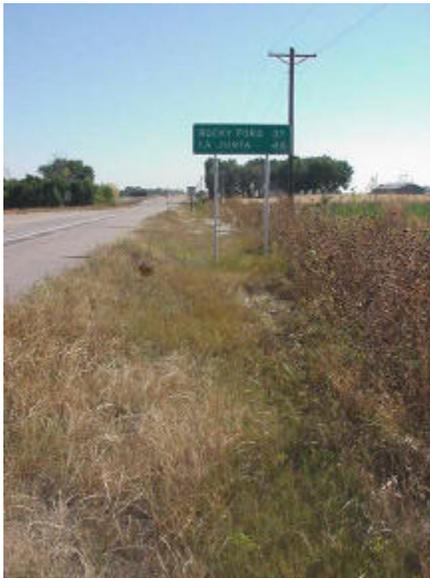
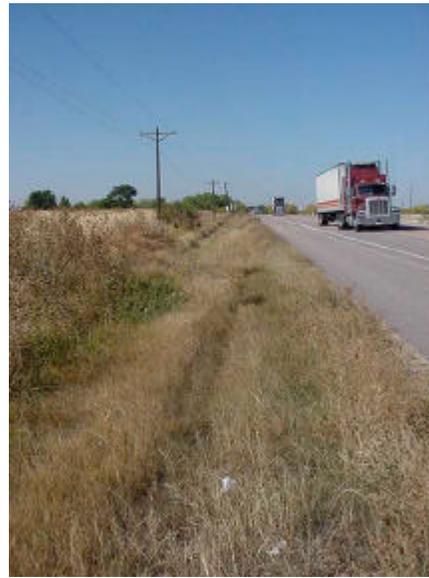
4.3.1.6. Mile 332 – 334, Inadequate Roadside and Cross Drainage.

Roadside Drainage Ditches south side US50 vicinity mi. 333

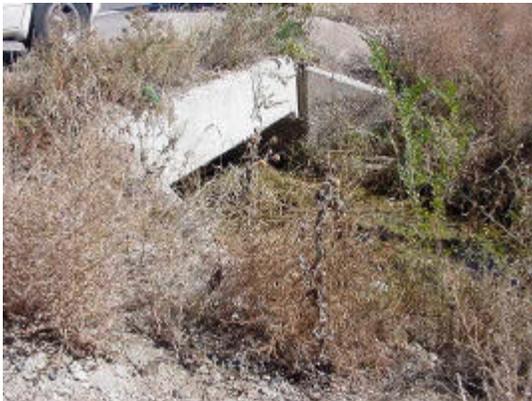
Near mile 335 there are two cross culverts beneath US 50 that lack established outfalls to the Arkansas River. One of the culverts is a CBC that drains water from a perennial spring. The existing CBC adequately conveys the spring flows, but north of the US 50 ROW there is not an established drainage to the Arkansas River. The drainage flows migrate across private land through a series of marshy areas. The lack of established drainage ditches connecting US 50 cross culverts and the Arkansas River is typical along this area east to the Huerfano River bridge (structure L-19-B).

CBC inlet, flow is from a perennial spring

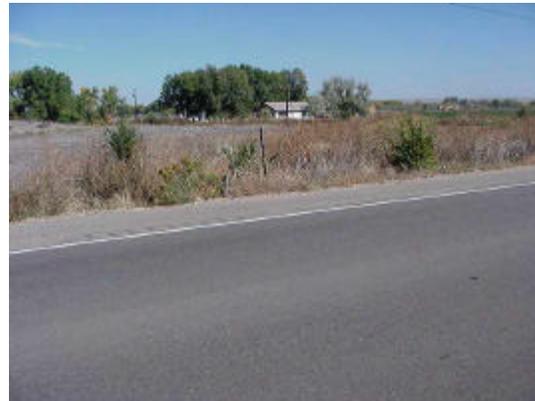
CBC outfall looking toward Arkansas River

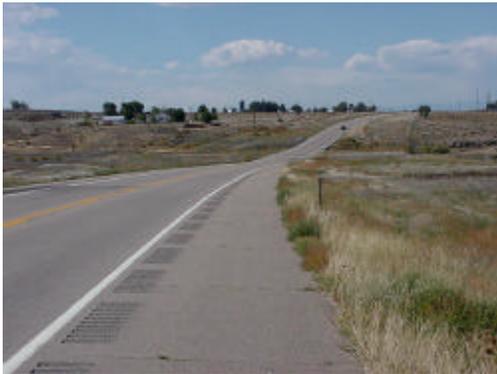
US50 descends into a low area as it crosses Thompson Arroyo. Currently there is a single 72-inch CMP conveying flows beneath US50. The existing 72-inch CMP performs adequately for most flow events. During wet periods water can be retained upstream of the culvert and ponding can occur. There is a good outfall and established drainage north to the Arkansas River. Improvements would include possible replacement of the 72-inch CMP if required by updated hydrology.

Mi. 341 Low Area looking west

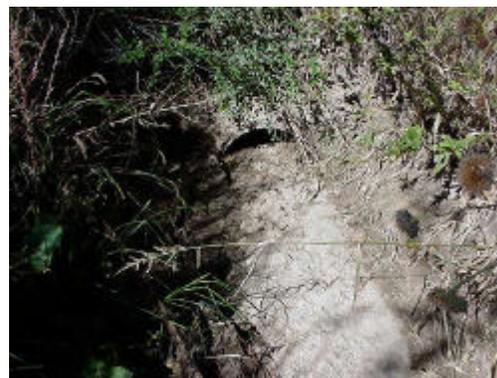
Silted Storm Drain Outfall

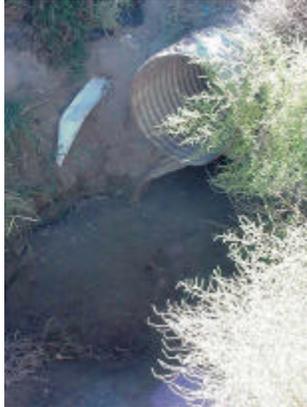
An irrigation ditch on the northside of US 50 drops into a culvert and discharges into a drainage ditch. The irrigation culvert is placed directly on top of a larger cross culvert that directs flow from the concrete roadside drainage ditch on the southside of US 50. The two culverts discharge into a common drainage ditch that then flows north and east to SH 71.

Piggyback Culverts

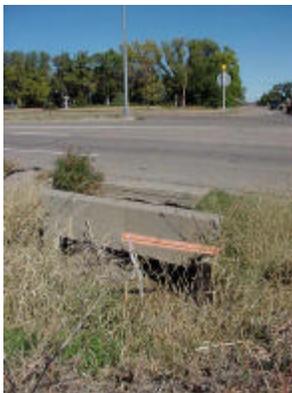
The existing structure beneath US 50 is inadequate, as is the ditch that receives the water and flows north along SH 71 to the Arkansas River. This intersection floods routinely. The existing structure needs to be increased in size and the slopes increased to prevent silt accumulation. Road 18 intersects US 50 from the south and acts as a divide with all flows to the east of the Road 18 intersection flowing east to a different cross culvert. Flows from the west flow to the intersection and underneath US 50 through the existing structure.

Cross Culvert under US 50 Looking North

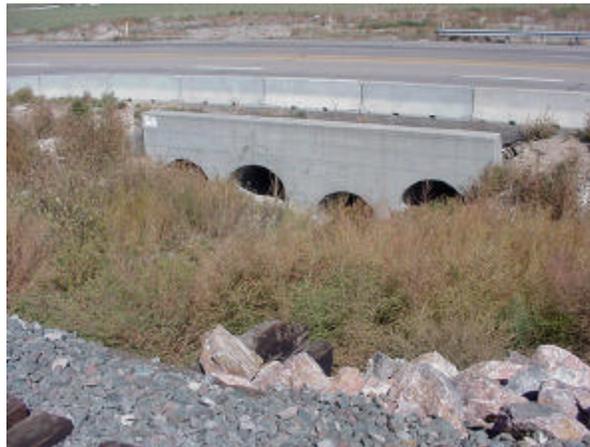
The existing structure has 4 each 72-inch CMP's. The structure was replaced during the summer of 2001.

Structure L-21-Q, Patterson Hollow, Replaced in 2001

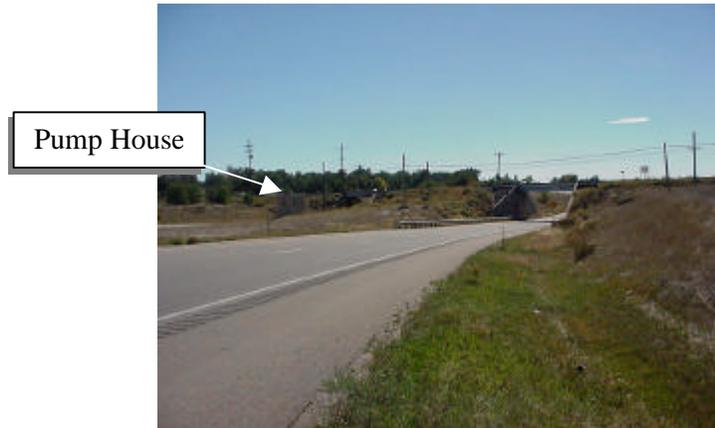
Current sump pump configuration is adequate for most storms unless electrical power is lost. New pumps were installed approximately 4 years ago and work well. The pumps discharge can exceed the capacity of the discharge channel, but this has not been a problem. However, pump stations are still subject to failure and undesirable in rural locations. Improvements in this area should address reducing surface runoff that drains to the pump station and riddance of the need for a pump station (e.g. re-alignment of US 50 and elimination of the underpass).

Underpass for BNSF RR, Sump Pump House near WB Bridge

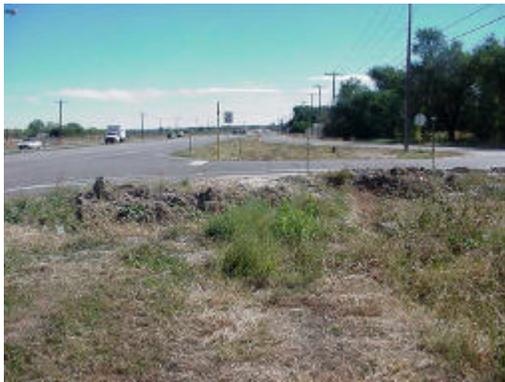
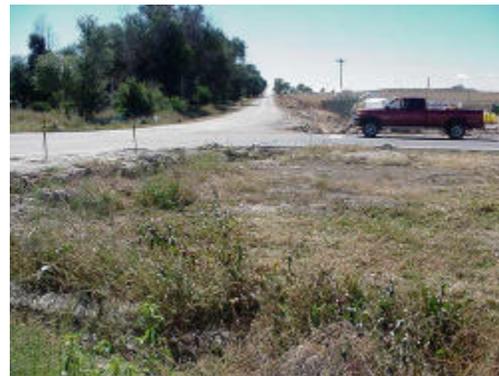
The drainage from this point east to the low spot near Bent Ave and the McDonalds Restaurant is inadequate and floods often. Improvements will be required all along US 50 with new/improved cross culverts. Specifically at the Road 27 intersection a new cross culvert system is probably required. Flows currently converge on the west side of Road 27 from the south, west and from a median drain between the east and westbound lanes of US 50. The culvert connecting the median drain to the main ditch is currently closed to prevent water from discharging onto the westbound lanes during moderate to heavy flow events. The main cross culvert beneath US 50 is just east of the Road 27 intersection.

Road 27 Intersection Looking East

Road 27 Intersection Looking South

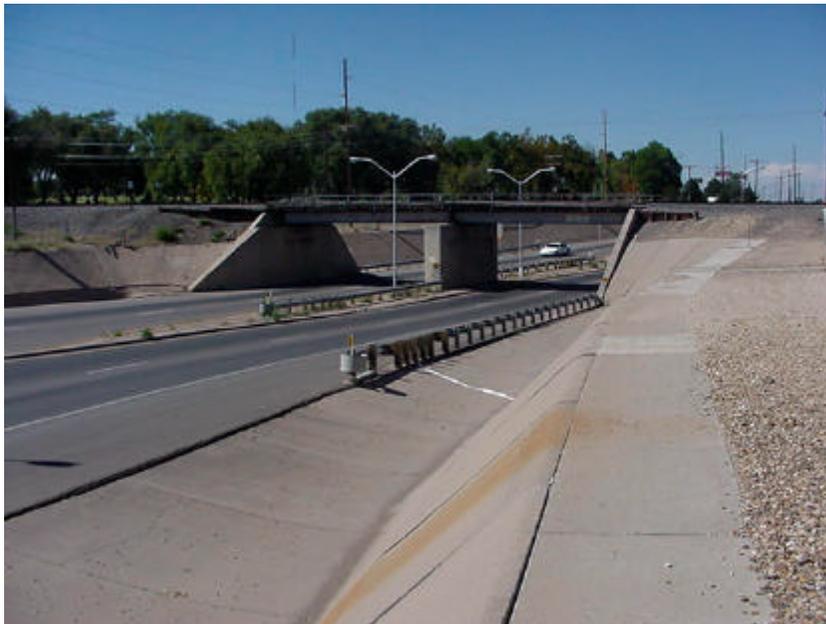
As US 50 enters the western edge of La Junta, the highway passes beneath the BNSF railroad (CDOT Structure M-22-R). This underpass has been subject to frequent and deep flooding. Considerable improvements would be required to reduce or eliminate flooding and consequent road closures at this location.

BNSF Underpass, M-22-R looking west , westside of La Junta,

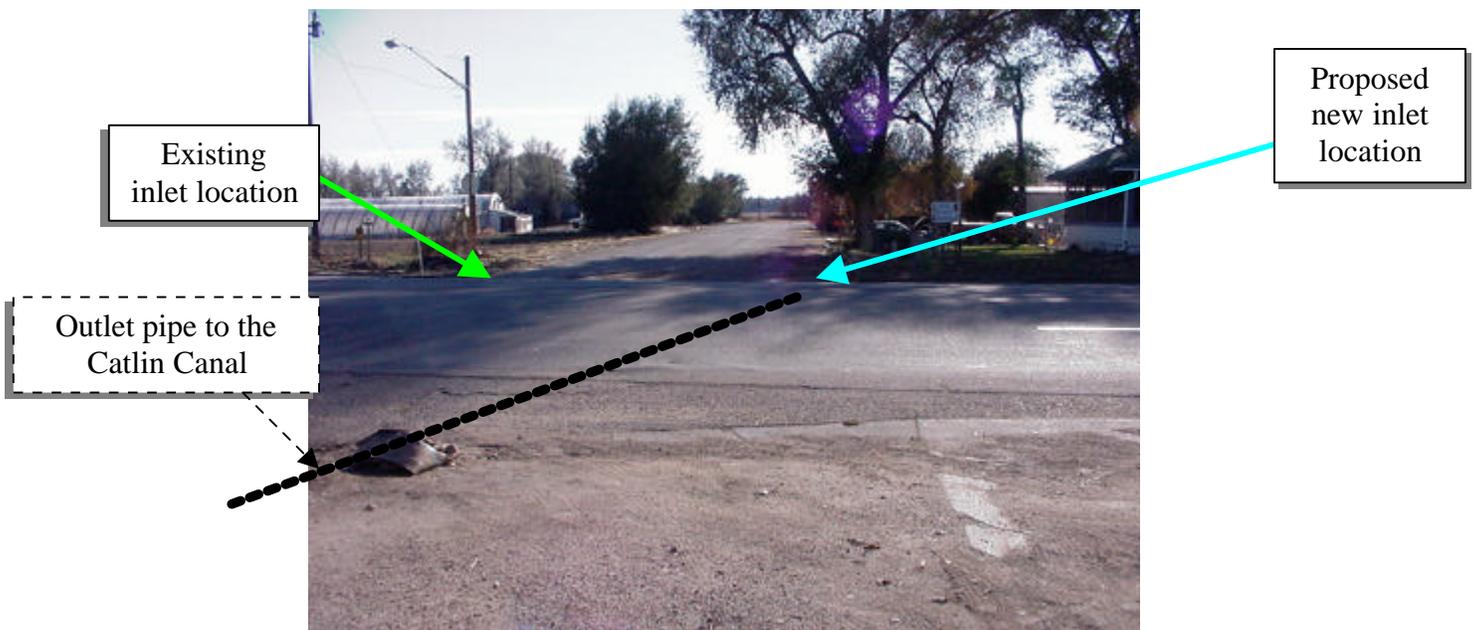
On 16 Nov 00, a meeting with Mr. Elmer Bauman, Superintendent of the Catlin Canal Company and Mayor of Manzanola was held on site to discuss issues with the Catlin Canal (see separate report for US 50 Irrigation Canal Crossing Issues, 16 Nov 00). Mr. Bauman also discussed the problems with the curb and gutter at mile 360. Mr. Bauman suggests the addition of a new grated storm inlet on the southwest corner of the Washington Street and US 50 intersection. A pipe connecting the storm inlet could be connected directly to the Catlin Canal approximately 200-ft to the north. This corrective action would provide two separate locations for stormwater runoff to enter rather than relying on the single existing inlet on the southeast corner of the Washington Street/US 50 intersection. The city of Manzanola has completed initial concept design of this alternative and has received preliminary bids of approximately \$10k to install the new inlet and connect to the Catlin Canal.

Intersection of Washington Street and US 50, Manzanola, CO, looking south. Existing inlet location shown on the left – proposed new inlet location on the right.

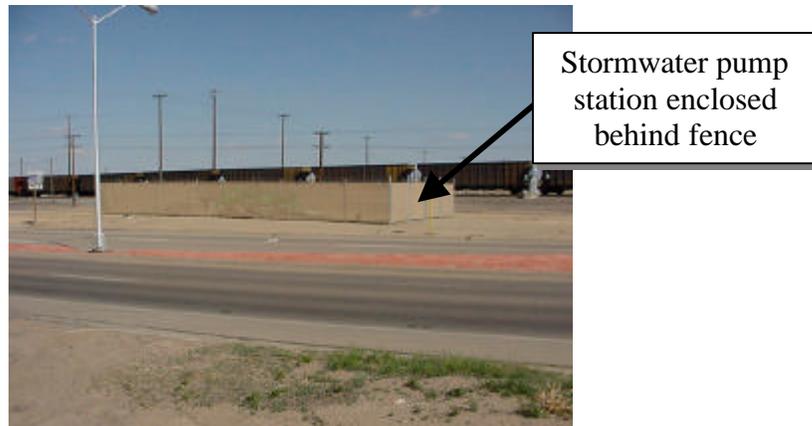
4.3.3.1. Mile 380.5, La Junta Stormwater system. A portion of the La Junta local stormwater system crosses US 50 near the intersection of US 50 (also known as First Street through La Junta) and Bradish Street. This particular area has experienced localized flooding and overtopping of US 50. A stormwater pump with an outfall to the Arkansas River was recently installed in 2000 to help reduce localized flooding.

La Junta Stormwater Pump Station located between US 50 and BNSF RR Yard

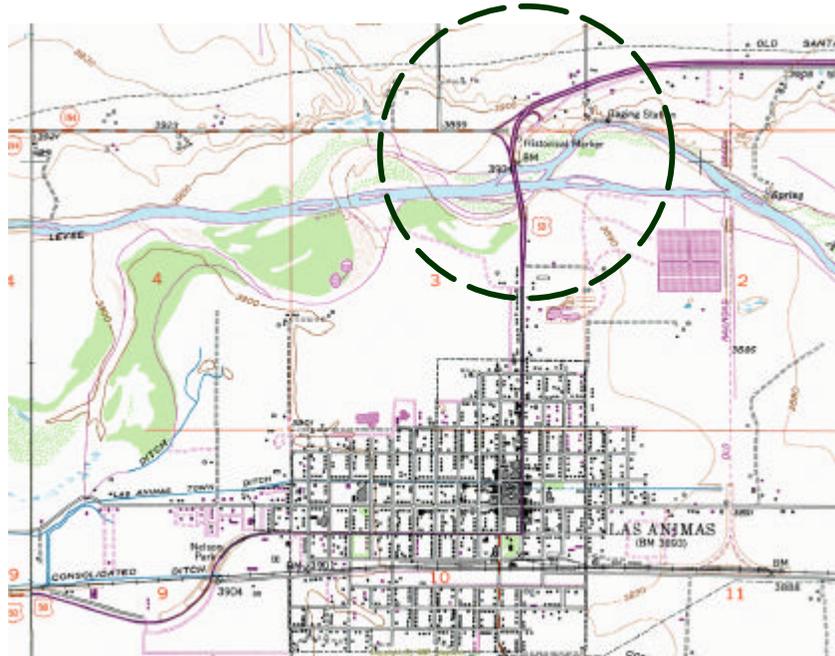
The Arkansas River flows between confining levees in the vicinity of the Town of Las Animas and the US 50 crossing. Immediately north of the US 50 crossing of the Arkansas River is the interchange between US 50 and SH 194 (CDOT structure L-24-B). Local drainage ditches flowing from the north must travel through gated culverts in order to pass through the levees and drain toward the Arkansas River. Gated culverts exist both west (upstream) and east (downstream) of the US 50 crossing site. As currently constructed, drainage through the gated culverts is inadequate and causes substantial ponding along the shoulders of SH 194 near the underpass for SH 194 below US 50. During periods of rain, SH 194 can be overtopped and was in fact closed during the most recent major storm event in April 1999. The gated culverts are normally operated in the “open” position and manually closed during periods of high flow in the Arkansas River. Aggradation of the bed of the Arkansas River is most likely exacerbating the condition with additional backwater affects through the culverts. Corrective action will possibly require modification/lowering of the inverts of the gated culverts, reestablishing drainage channels from the gated culverts to the Arkansas River low flow channel and raising of the SH 194 roadbed.

Map of the US 50 and SH 194 Interchange Area

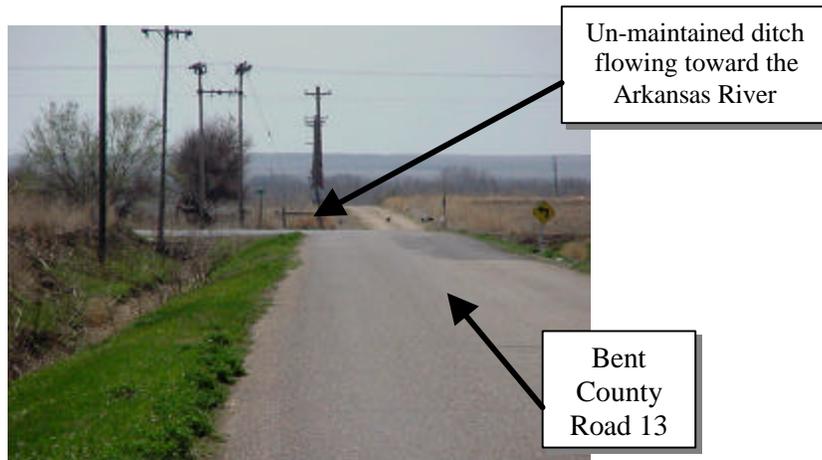
Localized drainage at this intersection flows south away from US 50. However, all drainage flows combine and must flow in a currently un-maintained ditch to the Arkansas River. Maintenance responsibility for the ditch is currently un-assigned resulting in an inefficient, overgrown ditch with reduced capacity that can cause flows to back up and flood the US 50 ROW and intersection.

County Road 13 looking south, away from the US 50 & CR 13 intersection

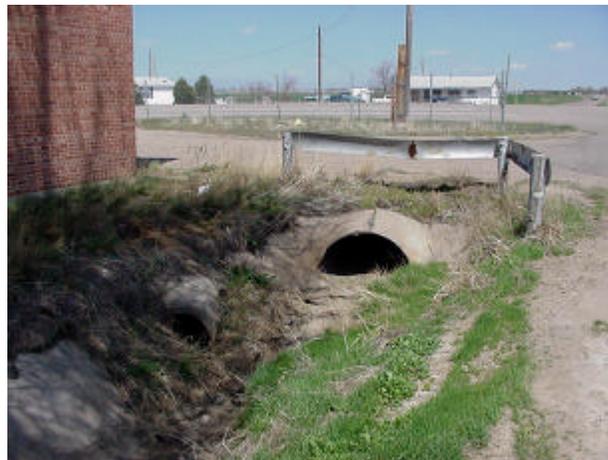
Two undersized culverts beneath US 50 contribute to flooding along the northside of US 50. Analysis of the local hydrology and culvert hydraulics will be required to determine possible corrective actions. Current conditions contribute to flooding of the residence on the NW corner of the intersection.

Culvert outfalls at US 50 and CR 14, looking north

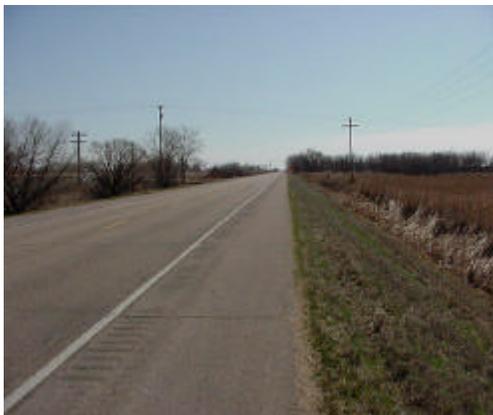
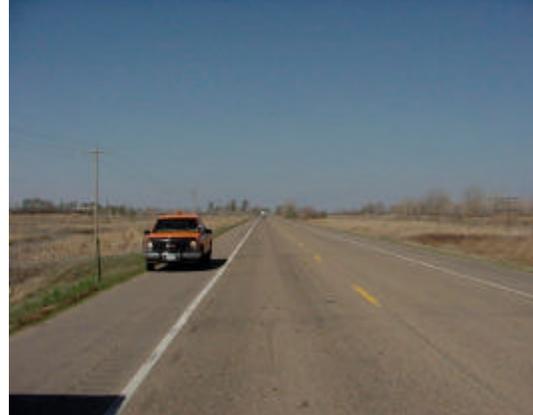
4.3.4.6. Vicinity mile 440.2 to 442, Morrios Bottoms, Low Area. The ground water level in this area is directly influenced by the stage of the Arkansas River. Ditch maintenance is problematic in this area as the ground water level is often near the inverts of the ditches. The Morrios Bottoms is a designated wetland area therefore limiting maintenance operations. Several cross culverts in the area are aged and in need of replacement. Culvert capacity and hydraulics should be re-evaluated prior to replacement.

Morrios Bottoms area and wetlands along US 50

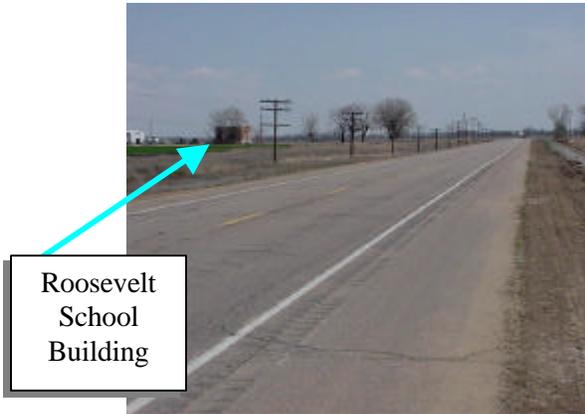
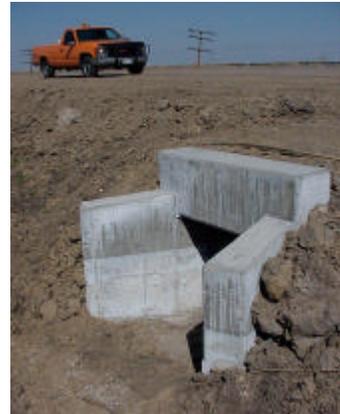
4.3.4.7. Vicinity mile 443, Roosevelt School, Drainage Overtops US 50. At this location, water has overtopped US 50 twice within ten years. The drainage ditch along the south shoulder of US 50 has combined flows of stormwater and irrigation tailwater. During larger storm events, capacity of the ditch is exceeded and overtopping of US 50 results. A single small CBC is the only cross structure which causes backwater

Roosevelt School area and new entrance to CBC under US 50
