Eisenhower / Johnson Memorial Tunnel Electrical Inspection Report

Volume I

November, 2005

Parsons Brinckerhoff Quade & Douglas, Inc.

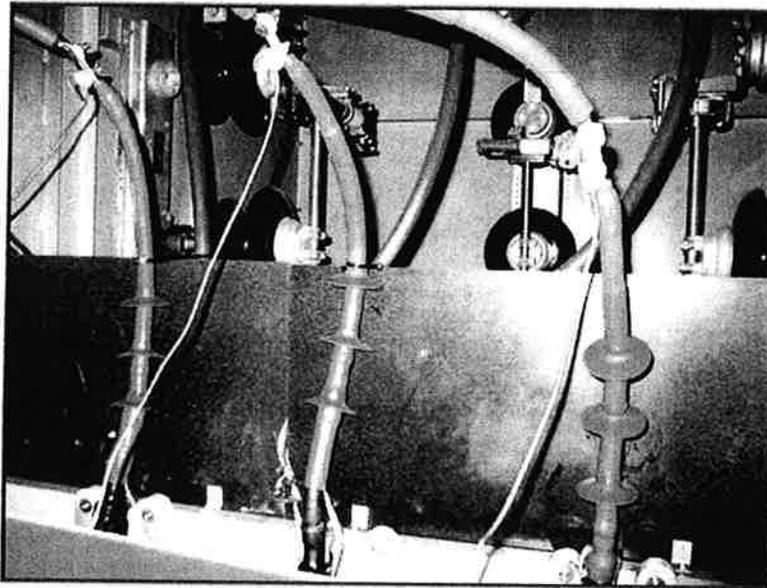
Relative to the incoming 24.9kV cubicle, panels were removed by CDOT personnel to allow a somewhat restricted view of the interior (line was still energized). This was shortly after a lightning storm had damaged an insulator at the switchgear cubicle, and emergency repairs had been made. What little could be seen (see photographs below), indicated that a fair amount of work would be required to bring this cubicle back to standard construction

Photo 2—Incoming 24.9kV Line Showing Connection to Regulator
Line Side Feeder Conductors. Note That Connection to
Feeder Conductors Is Unsupported

The main incoming 24.9kV cubicle at the East Portal Building is being rehabilitated as part of the project replacing the underground cable with an overhead line, mentioned above. The existing switchgear is rated for a short circuit interrupting current of 16,735 A @34.5kV, or 23,187A @ 24.9kV, which is well above the available duty from Xcel Energy. Since the duty rating is fine, and there are no apparent problems with this equipment, our recommendation is to leave it as it is (assuming the main incoming cubicle at the East Portal Building is rehabilitated, as mentioned previously).

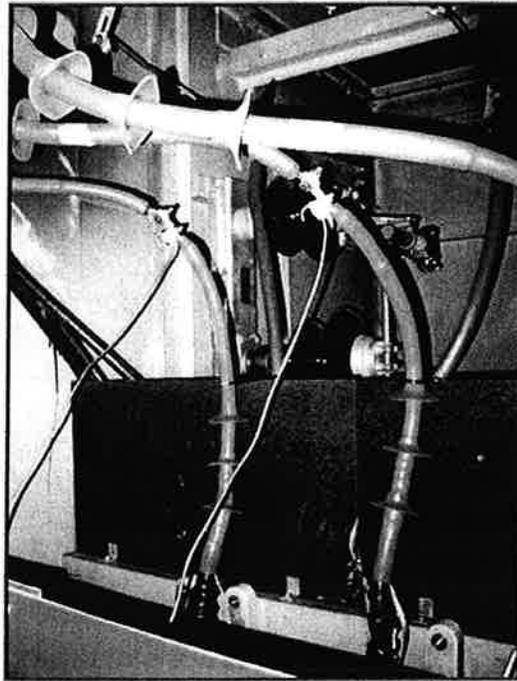
Photo 3—Another View of 24.9kV Incoming Conductors

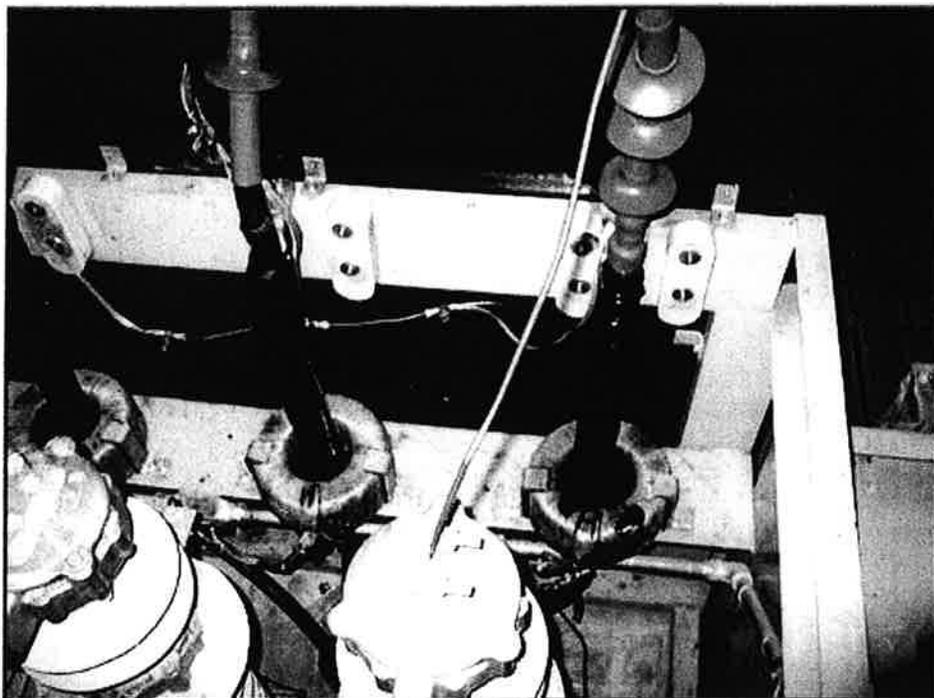
Photo 4—Incoming 24.9kV Conductors Showing Current
Transformers and Lightning Arresters in Foreground

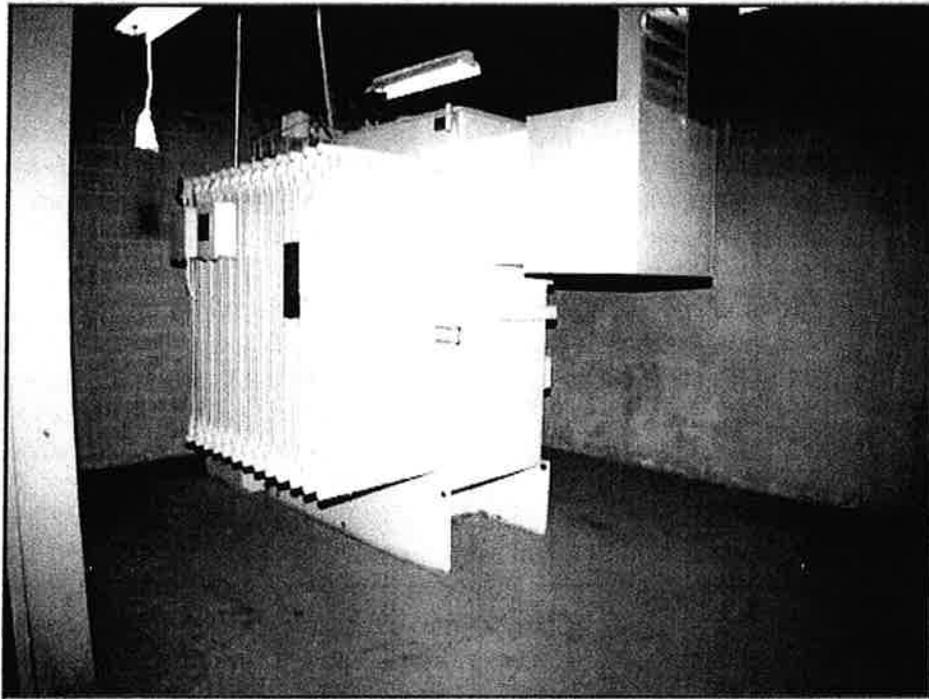
All eight power transformers, four rated at 2000kVA - 24.9kV/460V, and four rated at 2000kVA - 24.9/2.4kV, were tested for insulation resistance and turns ratio, and Doble tested for insulation power factor. Their insulating fluid was laboratory tested for dielectric strength, interfacial tension, acid content, moisture content, viscosity, specific gravity, color number, and visual condition. All transformer test values were within the acceptable range for transformers of this type.

Photo 5—Typical 24.9kV to 480/277V Transformer

All power transformers tested fine, both electrically and for condition of insulating fluid. No action is required at this time.

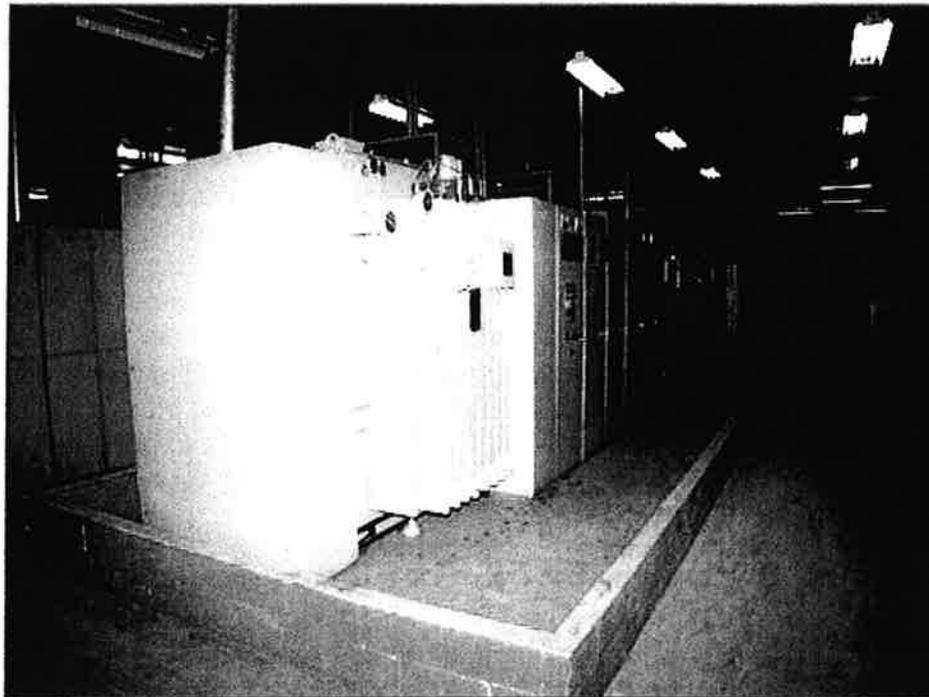
Photo 6—Typical 24.9kV to 2.4kV Transformer

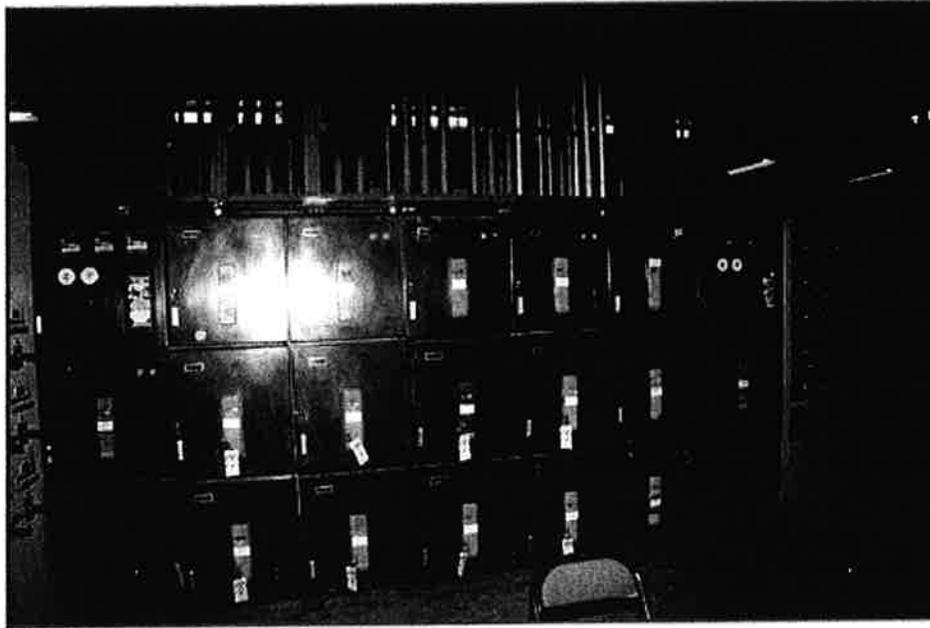
Multiple issues arose with this equipment. All feeder breakers have been retrofitted with current limiting fuses, allowing a higher short circuit current to be interrupted than if they were not installed. The two main breakers, however, did not have current limiting fuses installed. Further, no information could be found relative to the design short circuit capability of the gear itself, i.e., maximum level of short circuit current that the unit can safely handle on its buses with the original bus bracing.

It was very difficult to remove and reinstall the drawout breakers, both from and to their cells, due to the cell racking mechanisms being in poor to very poor condition. This condition might have been exacerbated due to the addition of the retrofitted current limiting fuses, which do add weight and change the center of gravity of the circuit breakers.

Mechanically, in addition to the racking problem, it was found that the spring charging gear case of all the AK breakers were leaking oil. In addition, all circuit breakers were found to be very dirty. The fixed and moveable contacts, intermediate contacts, and arcing contacts were cleaned as best as possible, but they are still in need of an extensive detailed cleaning. The lubrication of the circuit breakers was either non-existent, dry, contaminated or gummed-up. The best way to correct the above deficiencies is to have the circuit breakers sent to a shop facility for disassembly, cleaning and lubrication.

In addition to the preceding, the series over-current trip units for ten of the circuit breakers at the East Portal, and two at the West Portal, are no longer operating within the manufacturer's published time-current curves.

Photo 7—480V Switchgear

unknown is the actual short circuit duty that the switchgear can endure. No nameplate or other documentation could be located. All things considered, this gear has served for approximately 30 years, and is essentially at the end of its service life. It is recommended that the complete 460V switchgear be replaced.

Replace 460V switchgear and all protective relaying at both portal buildings, for an approximate cost of \$3,100,000. The cost is much higher than what normally might be expected. This is due to the fact that since this is an existing facility, it is not possible to simply take the switchgear out of service and replace it. Rather, a temporary work-around must be installed to allow the tunnel to remain functional, and then be removed, once the new switchgear has been installed. This has to occur at both Portal buildings in turn. The estimate does reflect the fact that the temporary equipment can be utilized at both buildings, in turn.

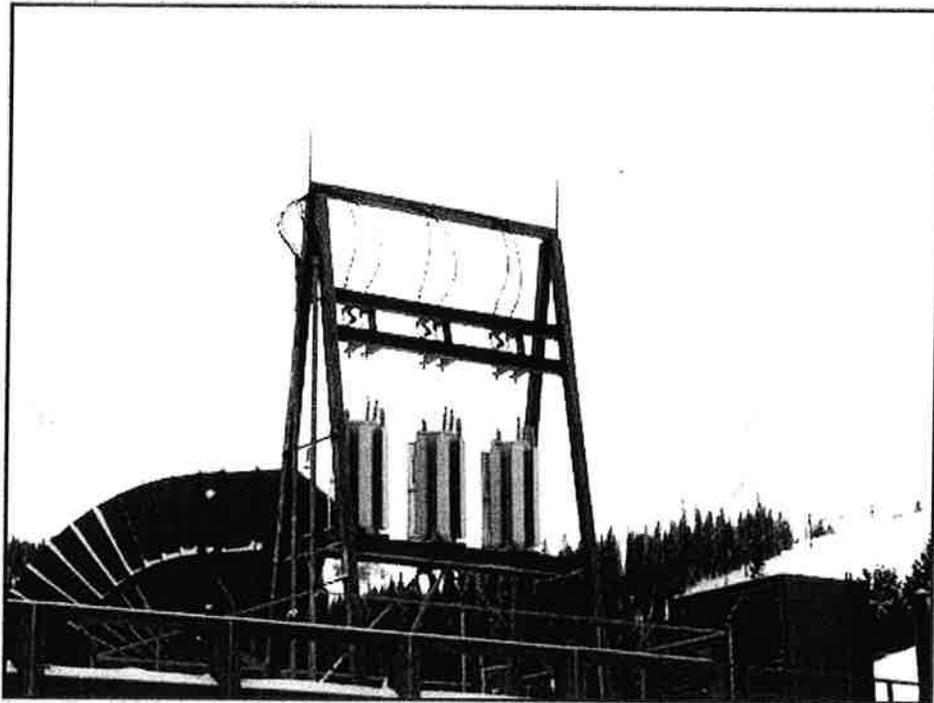
The visual inspection revealed rusting on the tops of the west side voltage regulators, at the base of the bushings. Also, the "C" phase SL bushing leaked at its base when tightening torque was applied, but stopped when the torque was removed.

The turns ratio of each tap setting was tested and found to be acceptable. Also, the Insulation Resistance was tested and Polarization Index calculated and all found to be acceptable. Similarly, the Insulation Power Factor was tested and found to be acceptable. In addition, the insulating fluid for all regulators was tested for impurities and dielectric strength, and found to be acceptable.

Photo 8—Step Voltage Regulators

The results of electrical and insulating fluid tests for all regulators showed them to be in good electrical condition. The only flaw was that some of the tanks are rusting on the tops, especially at the base of the bushings. The tanks should be cleaned and re-painted.
