# HPTE

**Engineer's Report 2021**

**C470 – Segment 1**

*Prepared for HPTE September 2021*

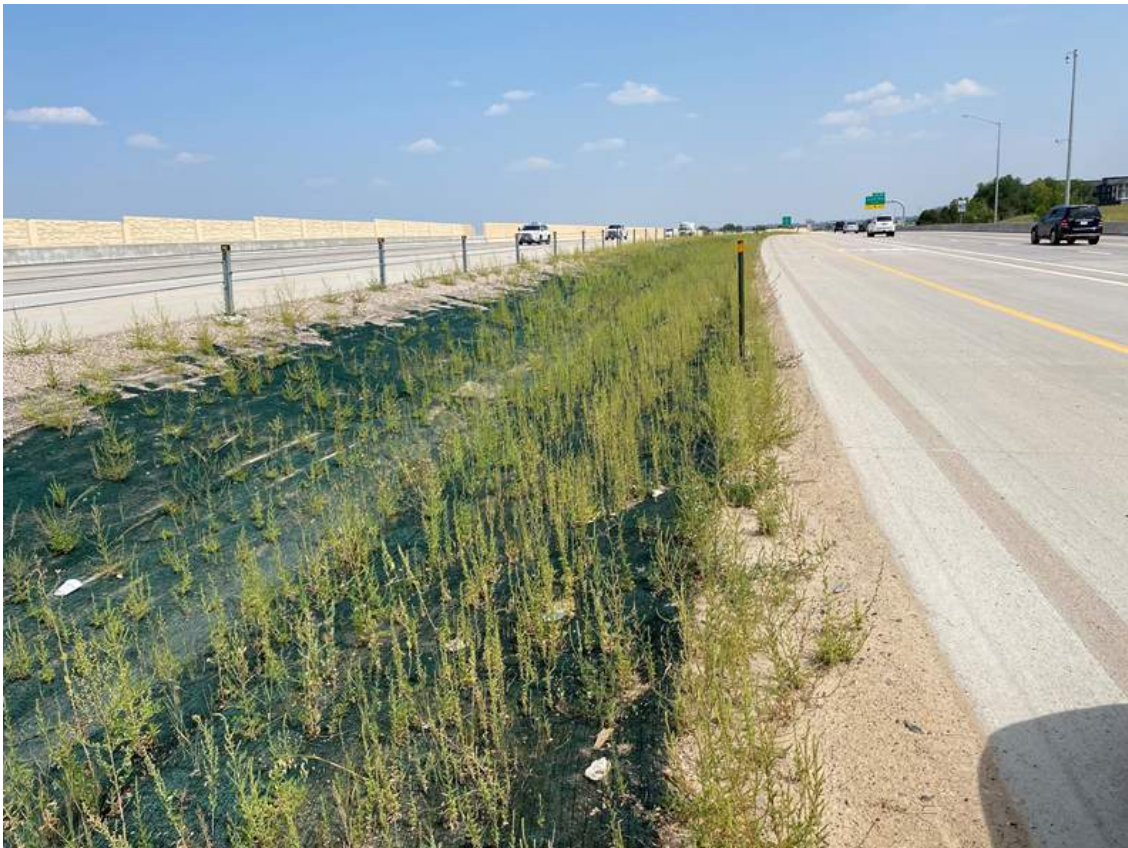
Median vegetation ranged from good to poor. Observations ranged from grass established with some weeds, weeds evident, erosion blanket exposed and some minor rills. As a project within the warranty period and landscaping maintenance establishment still being monitored this is not unusual.

*Typical Roadside Vegetation, Requires Re-seeding*

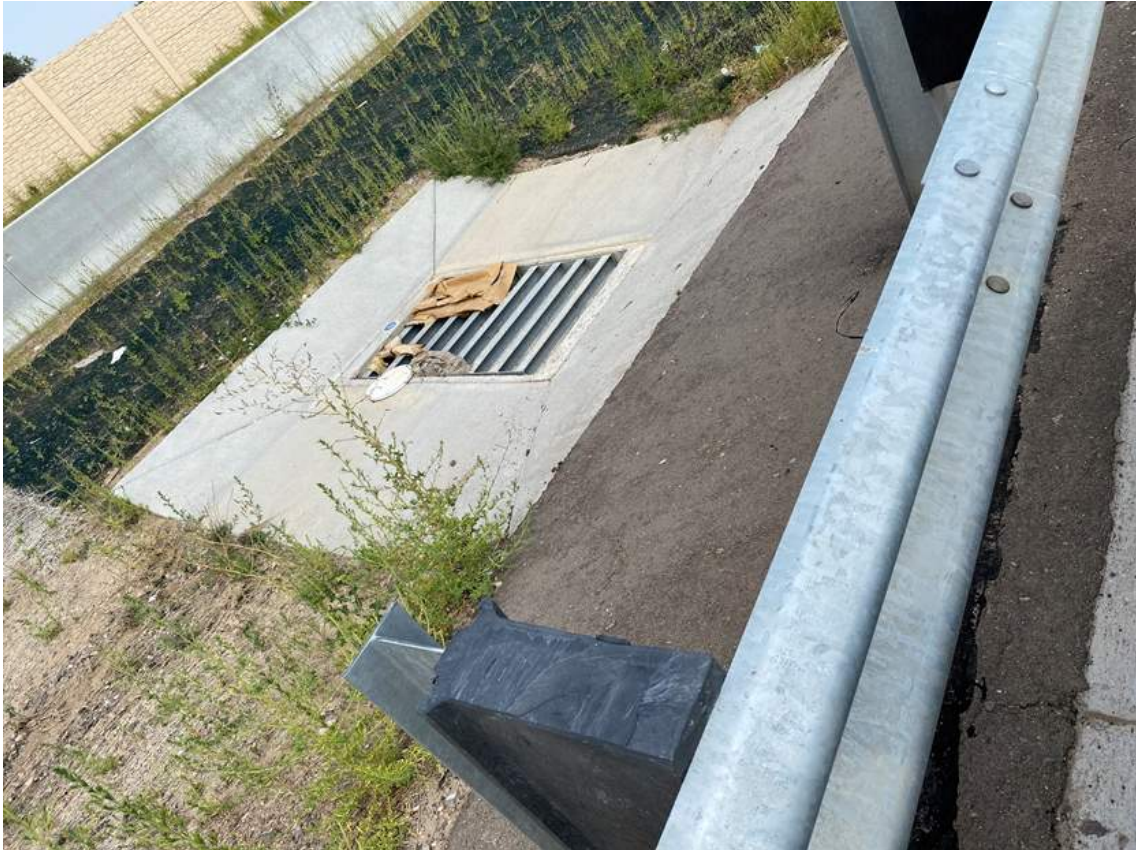
Median drainage in fair condition, inlets are in good condition. Some rills or erosion of the flow lines observed. Some debris settled on inlet aprons. (eb 26)

*Typical Median Inlet, Requires Minor Maintenance*

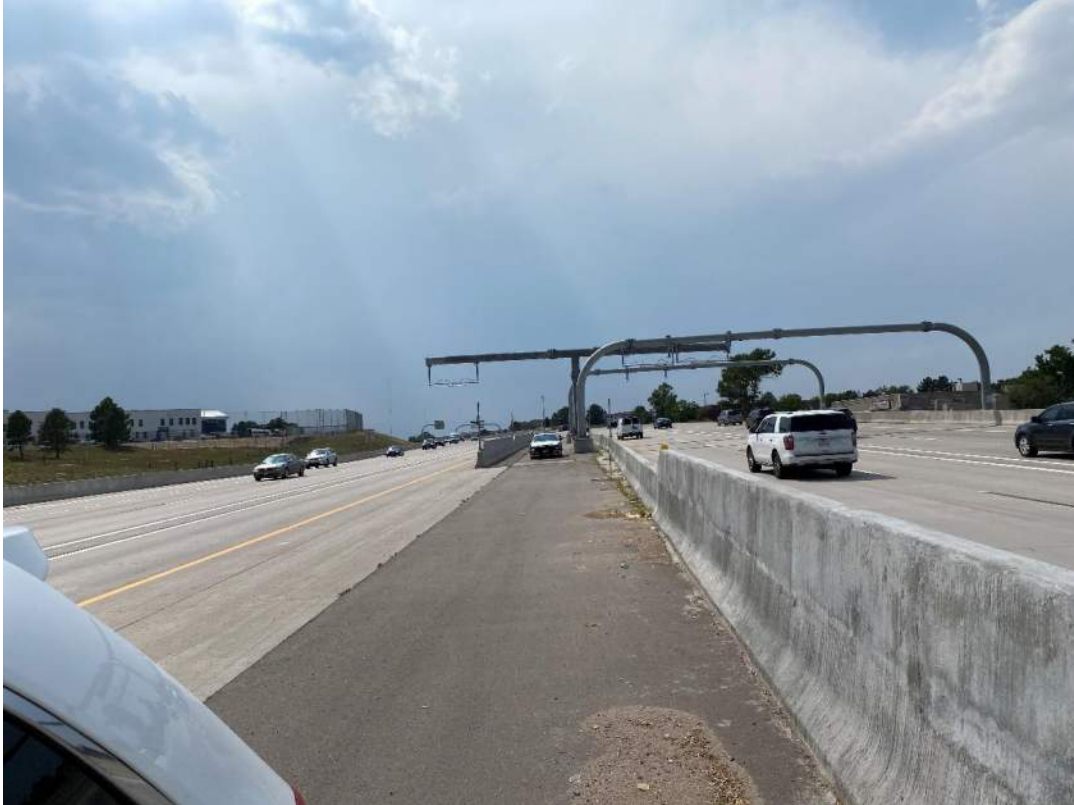
Type C inlet observed in good condition. Areas do show need of routine sweeping, and vacuum of inlet box. Note CSP monitoring toll lane for eastbound travel.

*Typical Median Inlet, Requires Sweeping Sediment Removal*

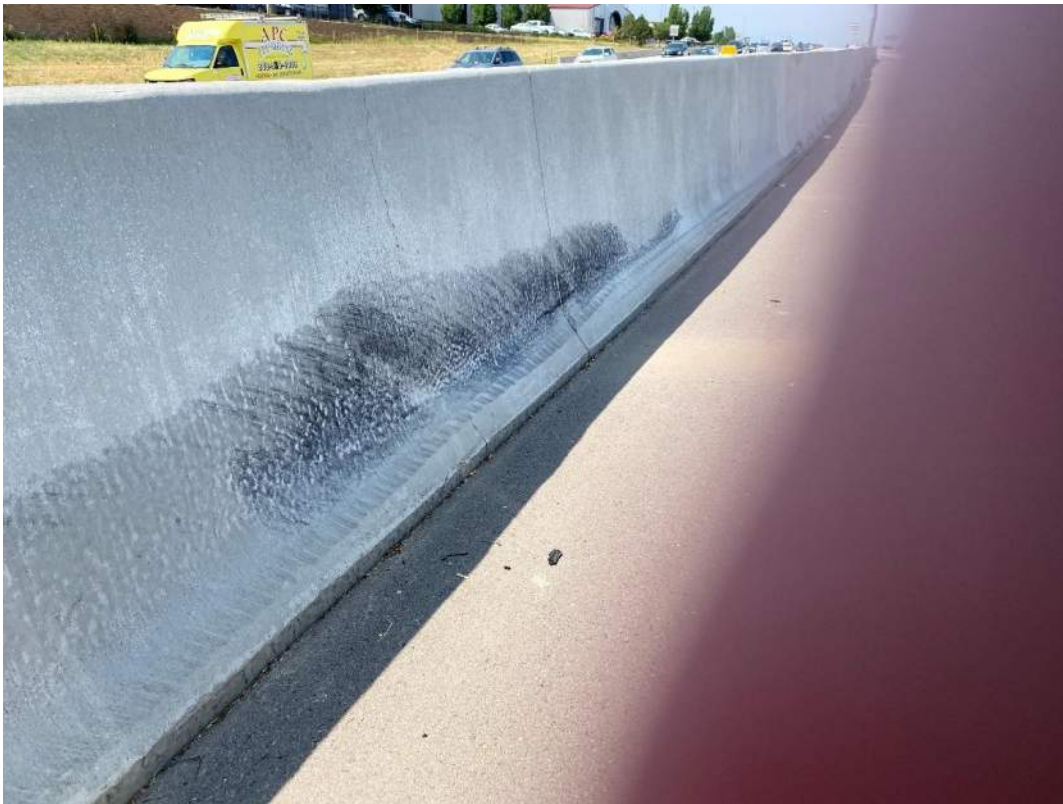
Two barrier types were observed, Type 7 concrete barrier and Type 3 Guardrail. All barriers appeared good condition. Type 7 barrier had tire marks, no structural damage. One section note with a horizontal crack, still functions. Crack sealing recommended at reasonable maintenance interval.

*Type 7 barrier in good condition. Note tire marks and crack for repair*

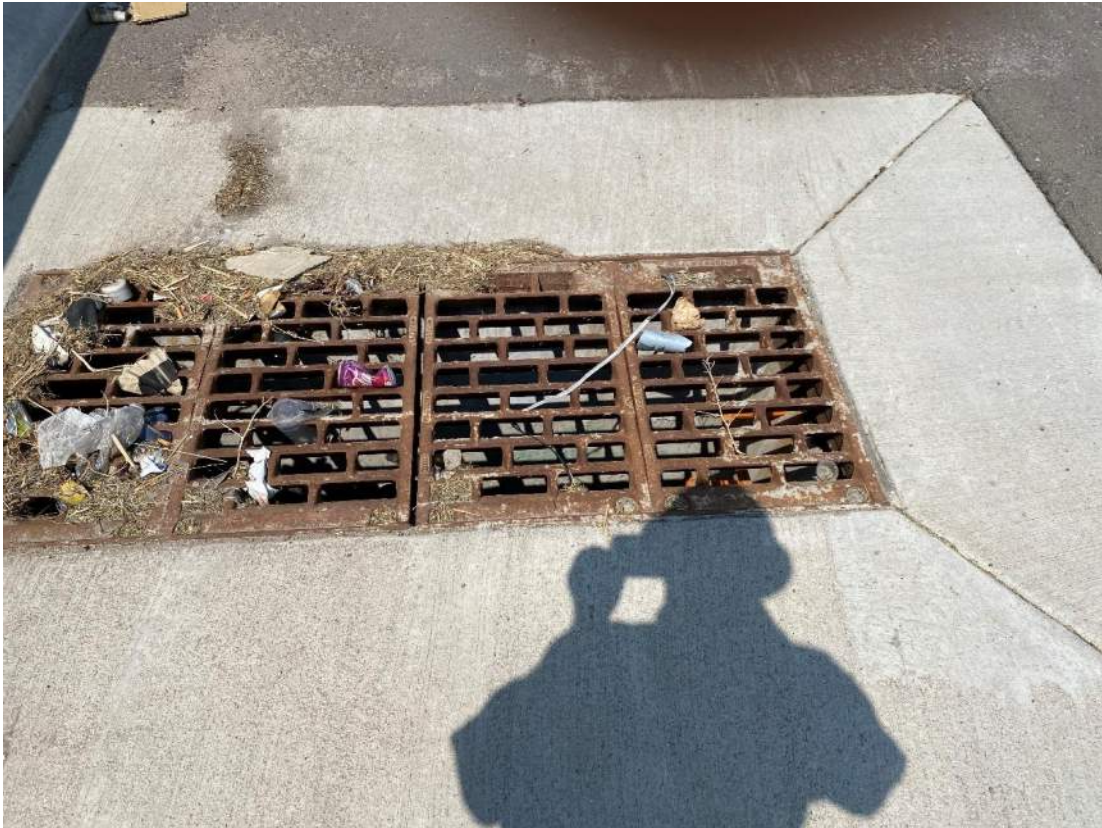
Shoulder inlets were observed in good condition. Some debris pictured to cleaned during routine maintenance.

*Typical Inlet and apron, Good condition, Required routine maintenance for trash and debris*

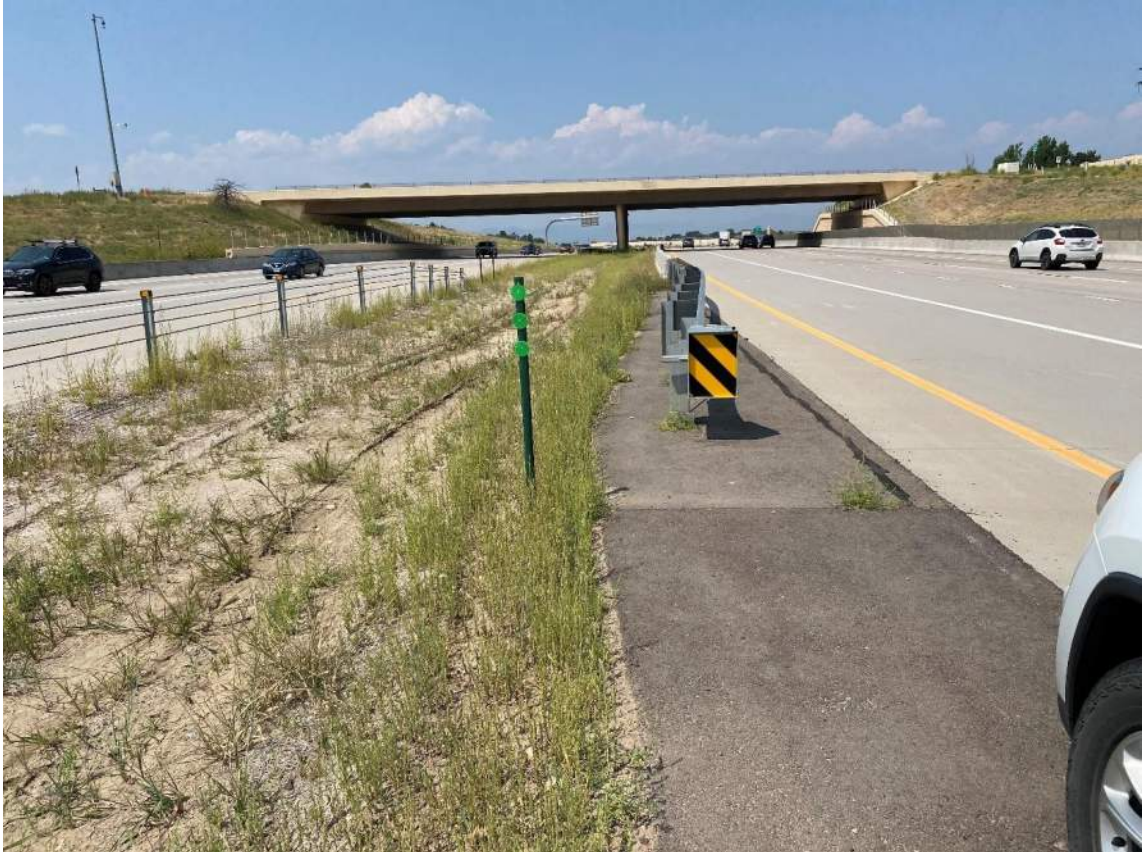
Median vegetation ranged from good to poor. Observations noted grass established with some weeds, weeds evident, erosion blanket exposed and some minor rills. As a project within the warranty period and landscaping maintenance establishment still being monitored, this is not unusual.

*Typical Median Seeding, Some Growth, Requires Reseeding*

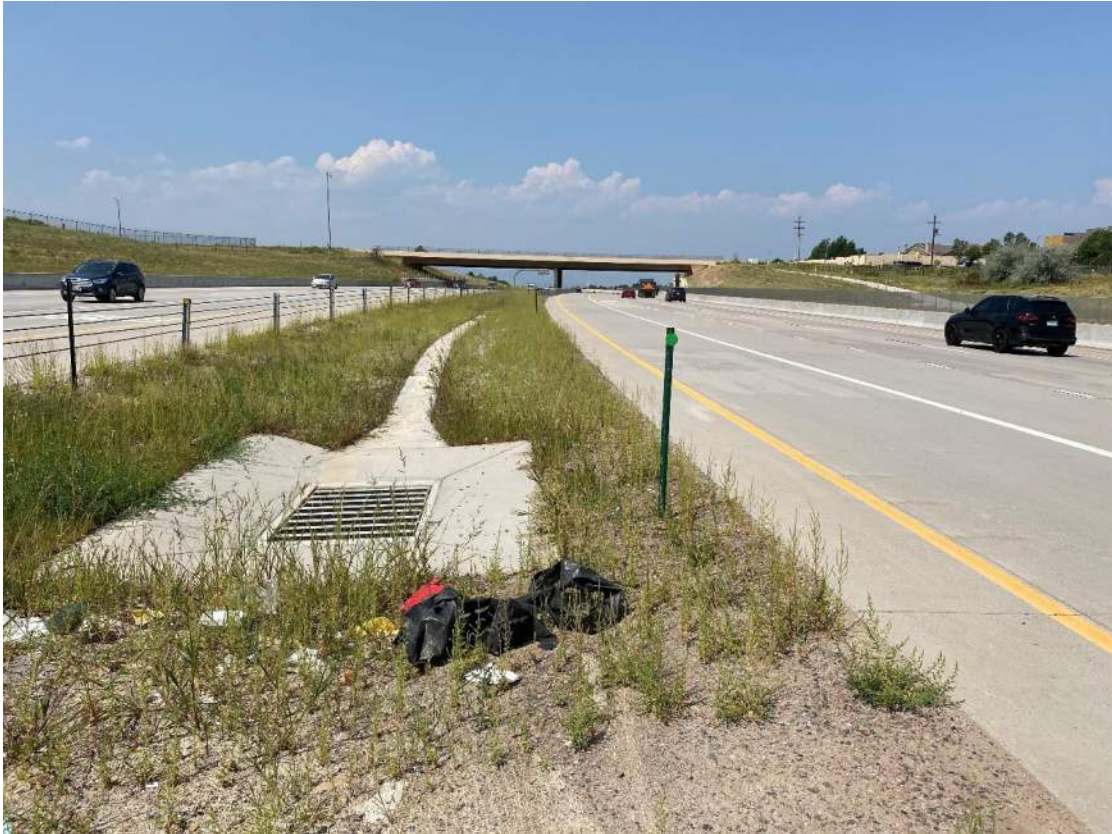
Median drainage in good condition, inlets are in good condition with need of trash and debris removal. Concrete low flow channel helps stabilize channel bottom.

*Typical Median Inlet, Requires Debris Cleanup, Inlet Good Condition*

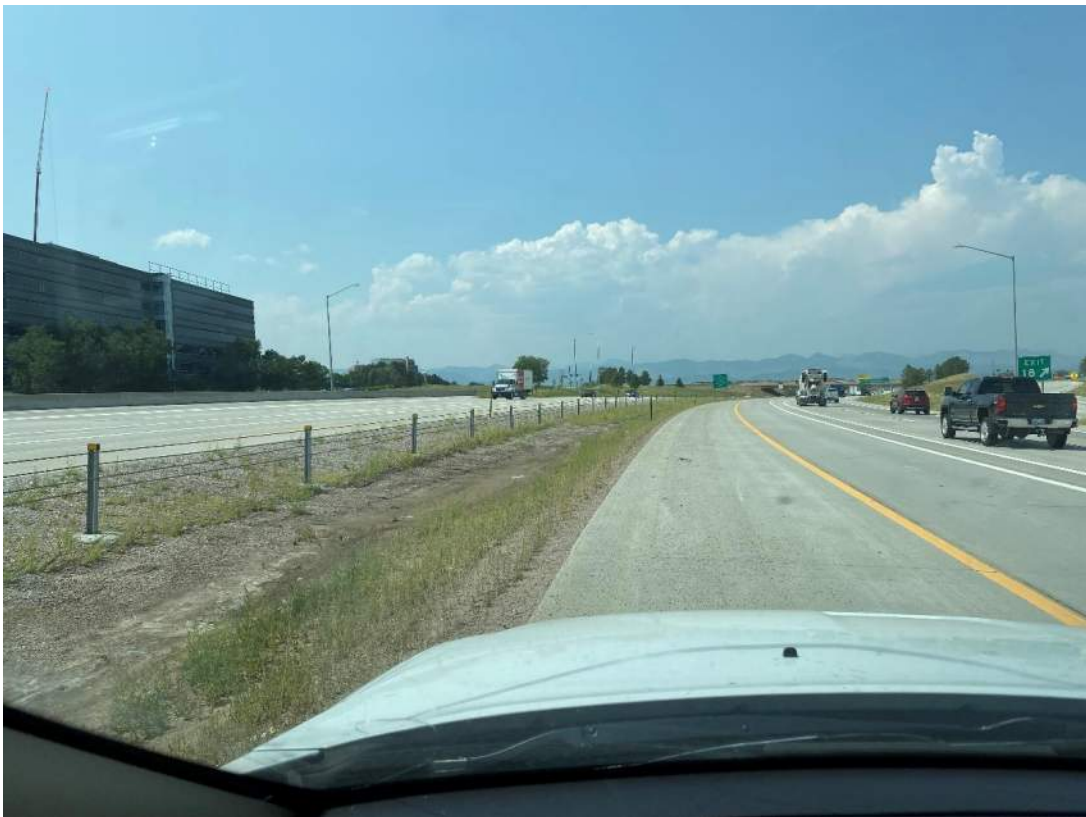
Median vegetation ranged from good to poor. Observations ranged from grass established with some weeds, weeds evident, erosion blanket exposed and some minor rills. As a project within the warranty period and landscaping maintenance establishment is still being monitored. The observations for this element identified areas that should be reseeded as warranty work with the construction contract.

*Typical Vegetation will need reseeding*

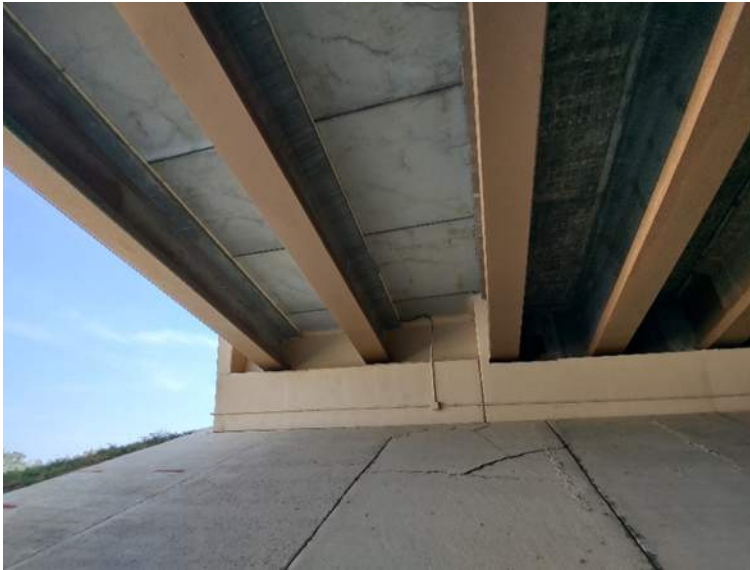
- The **concrete slope paving** at the Acres Green has cracked and warrants repair.

*Acres Green, Slope Paving Cracking, Requires Maintenance*

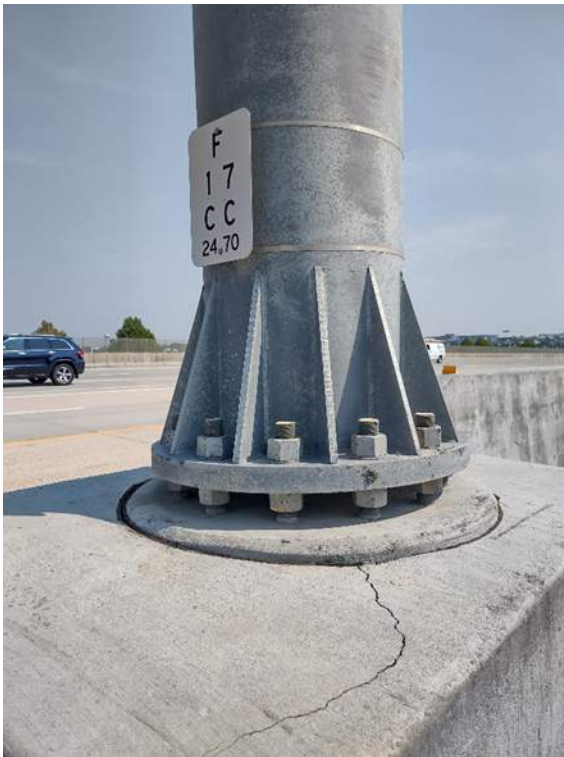
All sign structures were reviewed specifically for any identifiable structure deficiencies. Minor cracking of median concrete is primarily isolated to sign bridge locations at the east end of the facility, just west of I-25. The minor cracking can be repaired and maintenance to the cracking should be done to avoid further deterioration of the median concrete.

Weather and related moisture into the cracked concrete will expand when temperatures drop below freezing. Sign bridge structures where this cracking has occurred are noted below:

*Typical Median Barrier Cracking, Requires Maintenance*

- Minor Structure Repair
  - At five Sign Bases tied into the median barrier minor cracking was observed. It was noted this cracking should be repaired with an **Epoxy Resin** to avoid concrete spalling during freeze/thaw cycles.

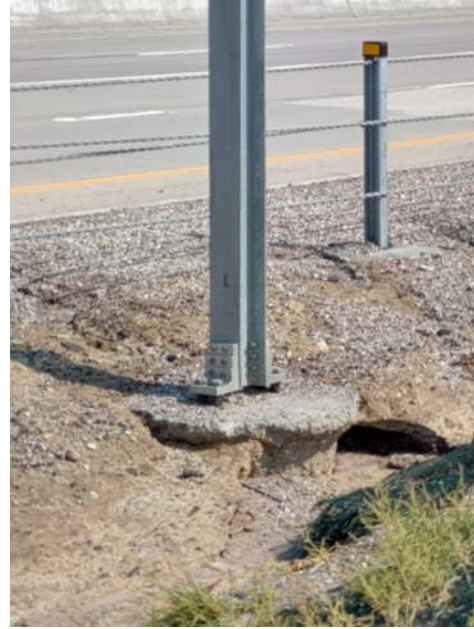
- It was noted that **embankment material** has eroded around several sign bases. This is a minor condition and is a condition of the overall erosion occurring within the median areas and should be corrected as part of the reseeding and mulching.

*Example, Sign Base Erosion/Repair*
