LOW VOLUME ROAD PROJECT REVIEW

Highway Name and Location	SH 103A, Milepost 18.0 - 22.5
Treatment Used	4" Thick Cold-in-Place overlaid with 2" HMA.

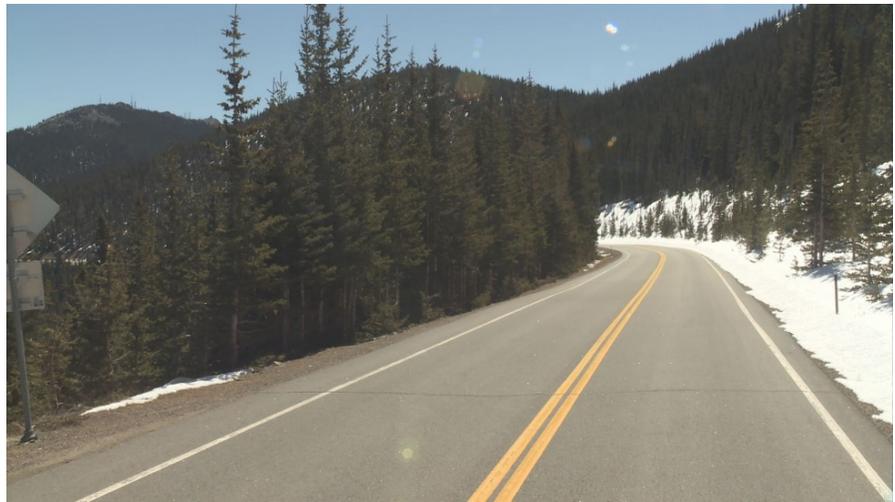
2018

Takeaways	<p>Seeing some cracking, which is disconcerting regarding the additional level of treatment (cold in place recycle); however, condition in recycled area is slightly improved over the mill and overlay section lower down the road. Maintenance has performed spot surface seals on this road. After 4 years of performance regularly-spaced transverse cracks have occurred throughout the project. These moderate severity transverse cracks are most likely caused by environmental freeze-thaw factors. These cracks appear to be less severe than the section of 103A from MP 13-18. This site is a prime candidate for a maintenance crack seal, which may add an additional 5 years of DL.</p>
-----------	--
