# LOW VOLUME ROAD PROJECT REVIEW

Highway Name and Location	SH 103A, Milepost 13.3 to 18.0
Treatment Used	2" Mill and Fill

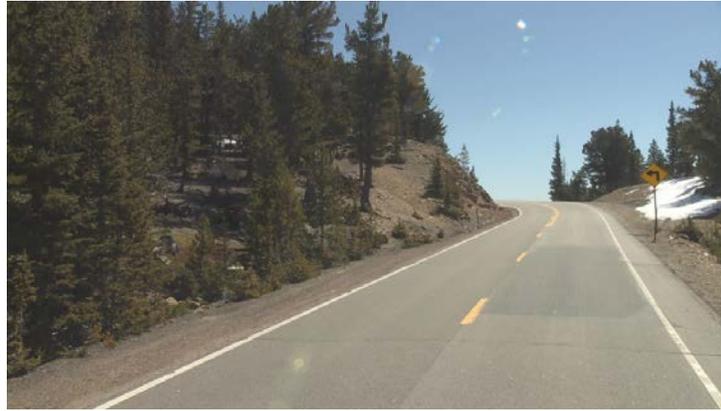
2018

Takeaways	Transverse cracking occurring in spots, very high altitude and harsh weather conditions. After 4 years of performance regularly-spaced transverse cracks have occurred throughout the project. These moderate
-----------	---

<p>severity transverse cracks are most likely caused by environmental freeze-thaw factors. This is the worst performing segment of 103A when compared to the segment before it and after. The high-elevation and extreme climate, compared to surrounding projects, may be contributing to the accelerated deterioration. This site is a prime candidate for a maintenance crack seal, which may add an additional 5 years of DL.</p>
--	---
