**PRE-DEMOLITION/RENOVATION
ASBESTOS AND LEAD-BASED PAINT
INSPECTION REPORT FOR
COLORADO DEPARTMENT OF
TRANSPORTATION BRIDGE STRUCTURE
L-18-AU**

**MESA AVENUE OVER INTERSTATE 25,
MILE MARKER 96.947**

WALSH Project Number: WA-000944-0229

May 21, 2013

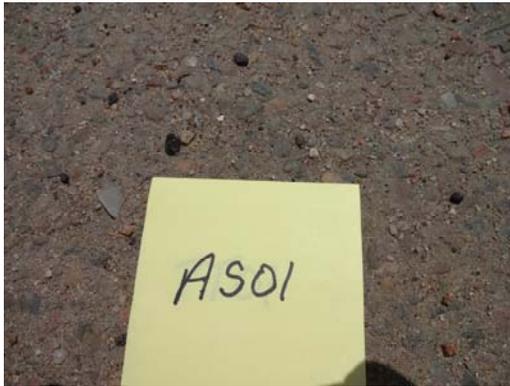
Homogeneous Area	Material Description	Asbestos Content	Location	Quantity
L-18-AU AS01	Asphalt	ND	Road Base	10,440 SF
L-18-AU PT01	Paint, Silver	ND	Guardrail	12,680 SF

- Asbestos-containing materials or trace-1% asbestos materials were not identified during the inspection; therefore, materials are not subject to the above-referenced provisions.

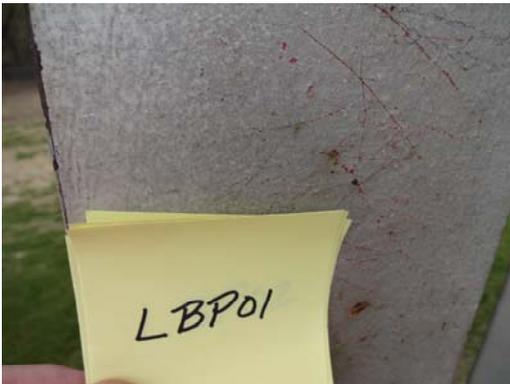
Sample ID	Location	Substrate	Color	Condition	Result % by Weight
L-18-AU LBP01	Guardrails, I-Beams	Metal	Silver	Poor	0.34%
L-18-AU LBP02	Guardrails, I-Beams	Metal	Red	Poor	3.4%
L-18-AU LBP03	Center Line	Asphalt	Yellow	Fair	0.50%

- Metal Substrate - Silver Paint on Guardrails and I-Beams (0.34% pb).
- Asphalt Substrate - Yellow Center Line Paint (0.50% pb).

- Materials that are recycled such as metal components are not subject to waste characterization provisions under EPA and CDPHE, but proper disclosure of lead-containing materials should be provided to the recycling facility for hazard communication purposes.

- The types and locations of lead-based paint and regulatory requirements should be disclosed to the demolition contractor and/or salvage contractor to avoid accidental disturbance, and for contractor compliance with applicable regulations (to ensure proper worker protection).

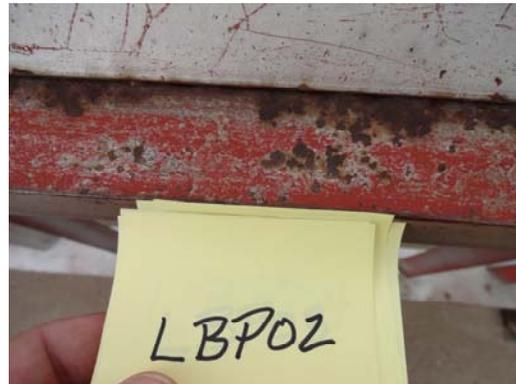
LBP02

- Metal Substrate – Red paint on guardrails and I-Beams (3.4% pb).
