**PRE-DEMOLITION/RENOVATION
ASBESTOS AND LEAD-BASED PAINT
INSPECTION REPORT FOR
COLORADO DEPARTMENT OF
TRANSPORTATION BRIDGE
STRUCTURE'S
L-18-M AND L-18-W
INTERSTATE 25 OVER INDIANA AVENUE,
MILE MARKER 95.901**

STRUCTURE ID's: L-18-M AND L-18-W

WALSH Project Number: WA-000944-0229

May 21, 2013

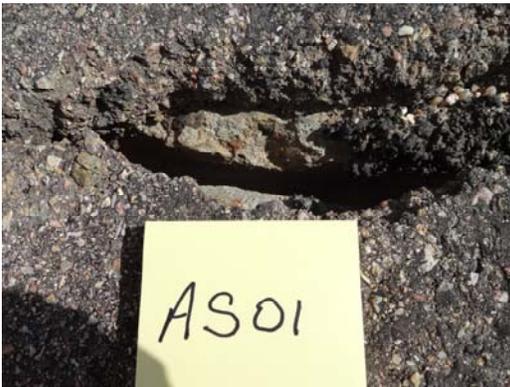
Homogeneous Area	Material Description	Asbestos Content	Location	Quantity
L-18-M AS01	Asphalt	ND	Road Base	7,560 SF
L-18-M EG01	Expansion Gasket	ND	Edges and Centers of Bridges	180 LF
L-18-M PT01	Paint, Silver	ND	I-Beams	10,080 SF
L-18-M RT01	Road Tar	ND	Over Expansion Gaskets	180 SF

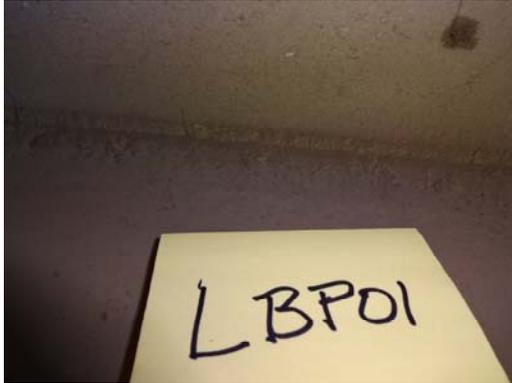
Sample ID	Location	Substrate	Color	Condition	Result % by Weight
L-18-M LBP01	I-Beams	Metal	Silver	Poor	0.0059%
L-18-M LBP02	Shoulder Stripes	Asphalt	White	Fair	BRL
L-18-M LBP03	Median Stripes	Asphalt	Yellow	Fair	BRL
L-18-M LBP04	I-Beams	Metal	Red	Poor	0.15%

- Metal Substrate - Silver Paint on I-Beams (0.0059% pb).
- Metal Substrate – Red Paint on I-Beams (0.15% pb).

- Lead-containing materials shown to have a total lead content below 0.01% by weight are not expected to reach or exceed the EPA RCRA limit for leachable lead, and need not be analyzed by TCLP. Samples exceeding 0.01% by weight may require TCLP analyses depending on whether the materials will be disposed of or recycled. If the materials will be disposed of then TCLP would be the industry standard.

- Materials that are recycled such as metal components are not subject to waste characterization provisions under EPA and CDPHE, but proper disclosure of lead-containing materials should be provided to the recycling facility for hazard communication purposes.
