In-depth Fracture Critical and Routine Inspection Report

Structure: K-18-R
Crossing: Arkansas River
Route: US 50 Business East-Bound
County: Pueblo
State: Colorado

Inspected by:
Stantec Consulting Services
2000 S. Colorado Blvd. Ste. 2-300
Denver, Colorado 80222
Frank J. Block, PE, NBI Team Leader

Inspection Date:
March 11, 2014

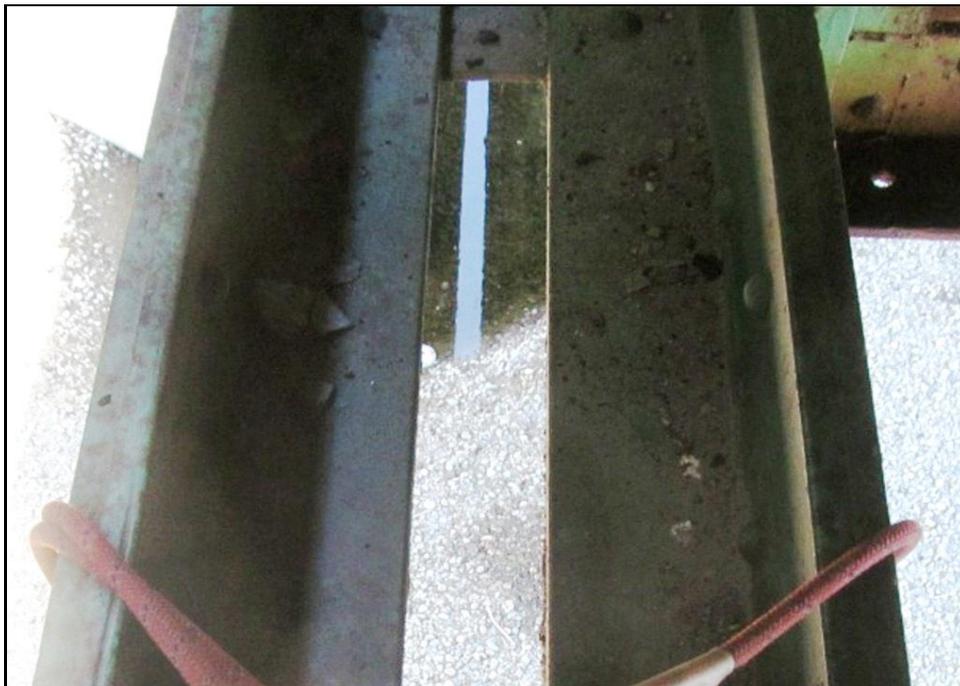
Lower chord condition typical in most bays with spotty Light R1 corrosion, paint system primarily intact

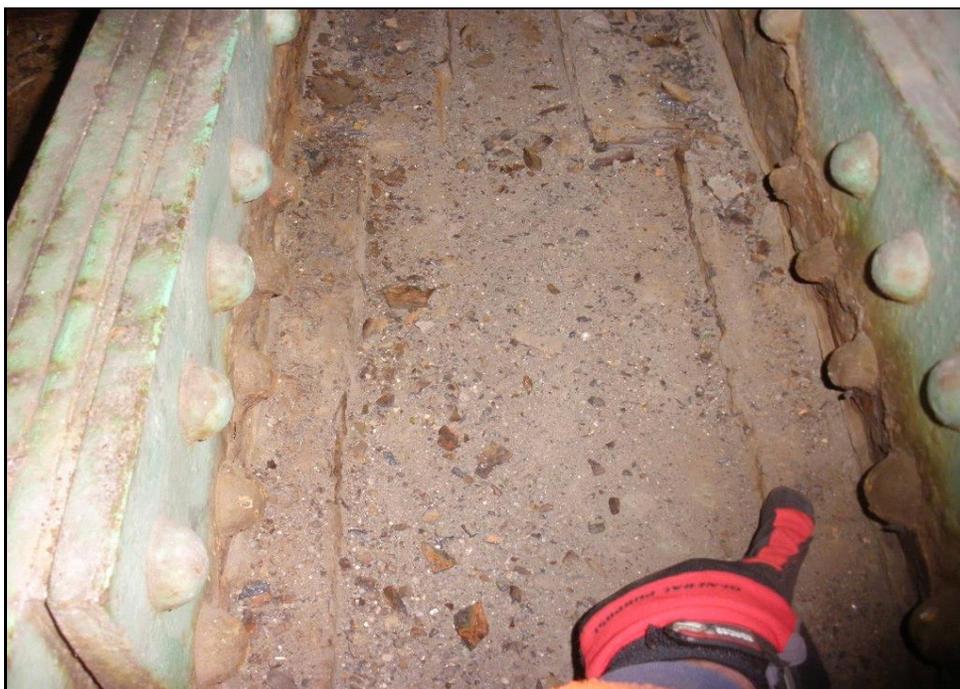
Lower chord splice at Panel Point 4 of the Right Truss (West) with heavy debris along top web splice plate and near 100% section loss to rivet heads

Lower chord rivets with section loss to the rivet head to the degree that the rivet is no longer adequately restrained within its connecting member should be replaced with high strength bolts. Refer to the list of rivets for replacement and respective locations within Appendix D. Several gusset plates to the lower lateral bracings and lower chord splice plates with significant section loss should be considered for replacement during rivet replacement.

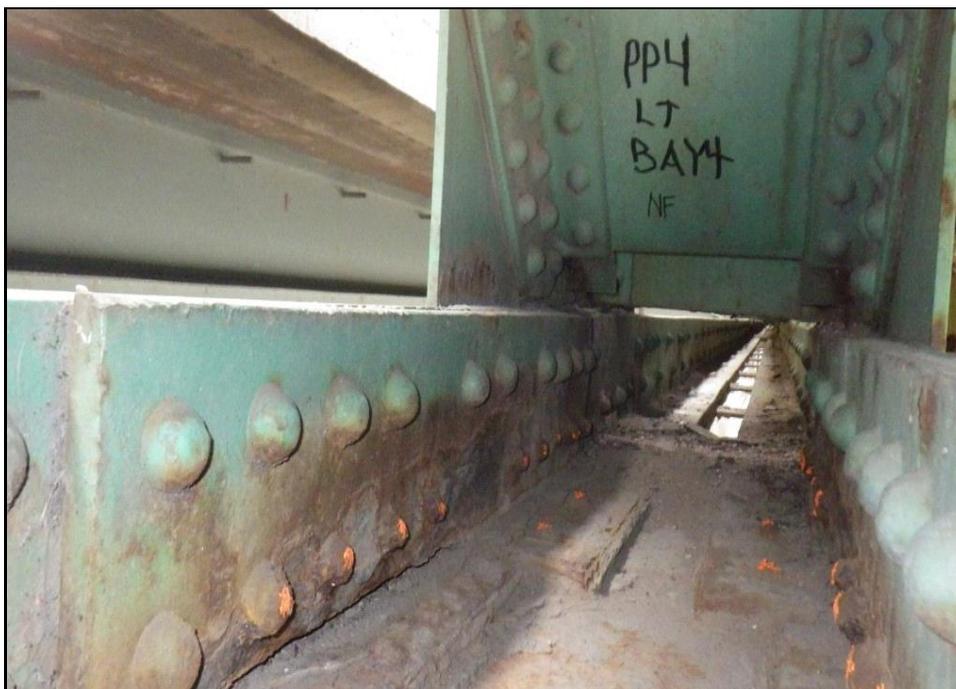
Lower chord splice at Panel Point 4 of the Left Truss (East) with heavy debris cleaned showing corrosion and section loss to top interior plates and rivets

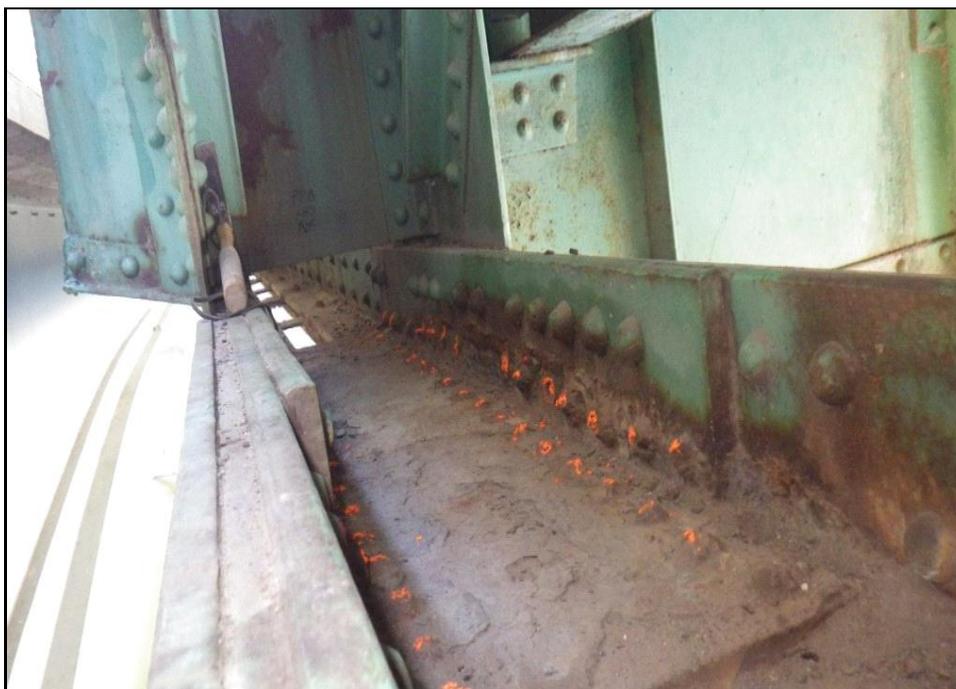
Lower chord splice at Panel Point 8 of the Left Truss (East) with heavy debris cleaned showing corrosion and section loss to top interior plates and rivets

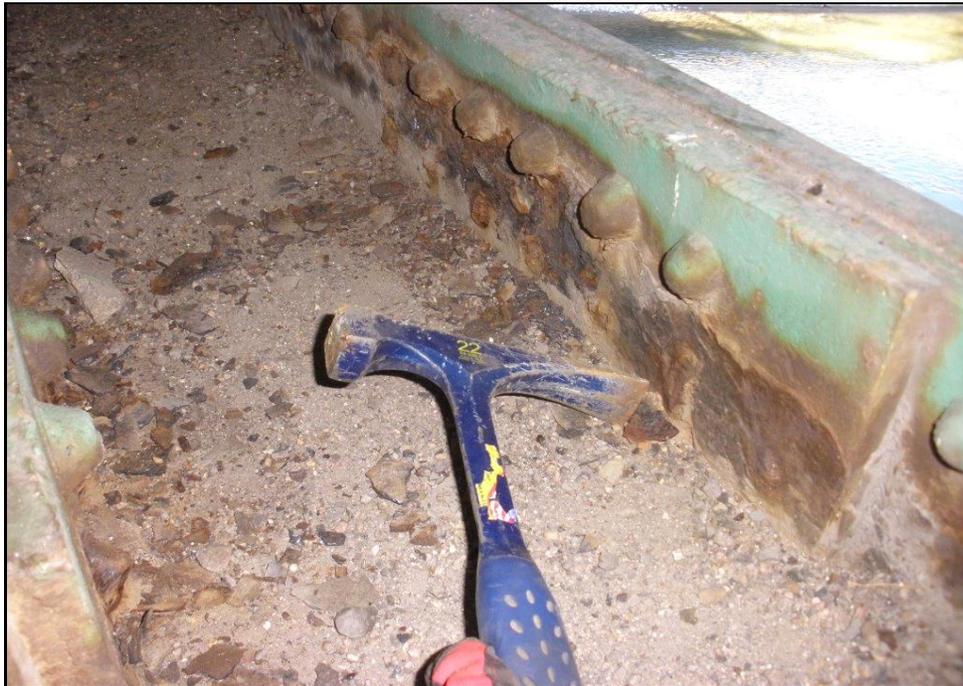
Lower chord splice at Panel Point 8 of the Right Truss (East) with heavy debris, corrosion and section loss to top interior plates and rivet heads

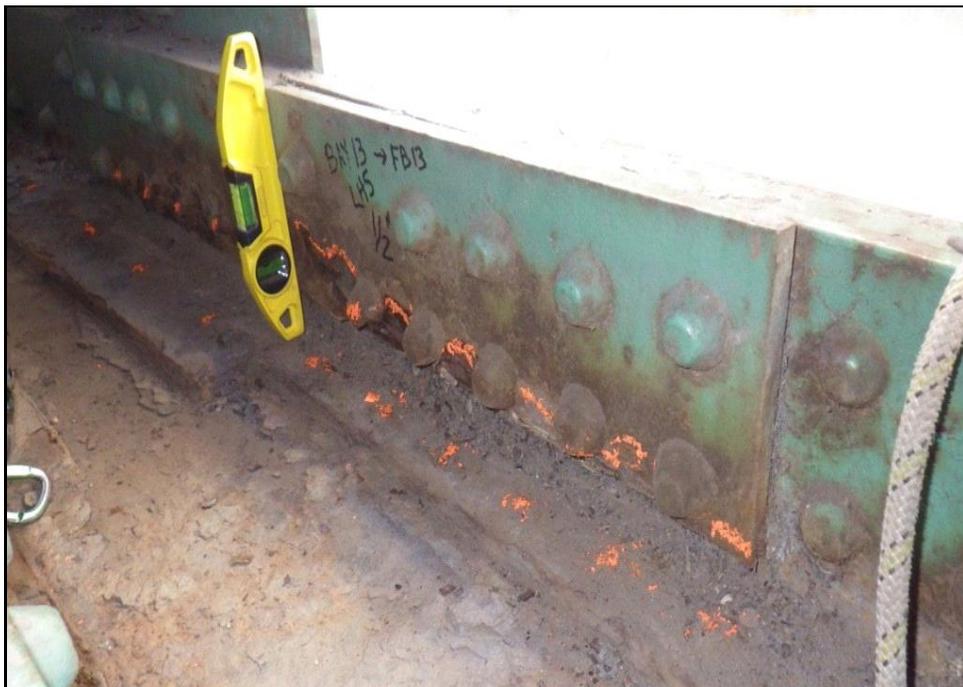
Left Truss lower chord splice near Panel Point 12 with up to 0.25 inch pitting and section loss to base of top angle interior splice plates

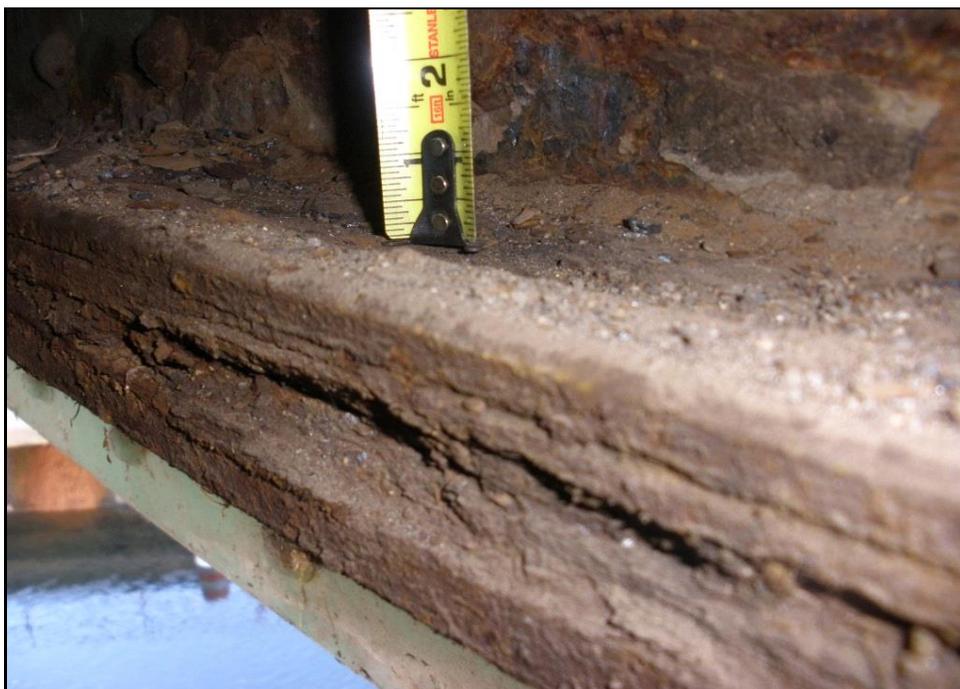
Isolated areas of R2 to R4 laminating corrosion of the lower chord top angles exist where debris has accumulated causing up to 5/8 inch section loss. The worst case lower chord top angle section loss was observed within Panel 10 of the right truss and Panel 12 of the left truss. Detailed measurements of section loss were recorded at these locations and are included in the cross-sectional sketches within Appendix D.

Close-up of pack rust formation between top and bottom angles through detailed section of Right Truss lower chord near Panel Point 10

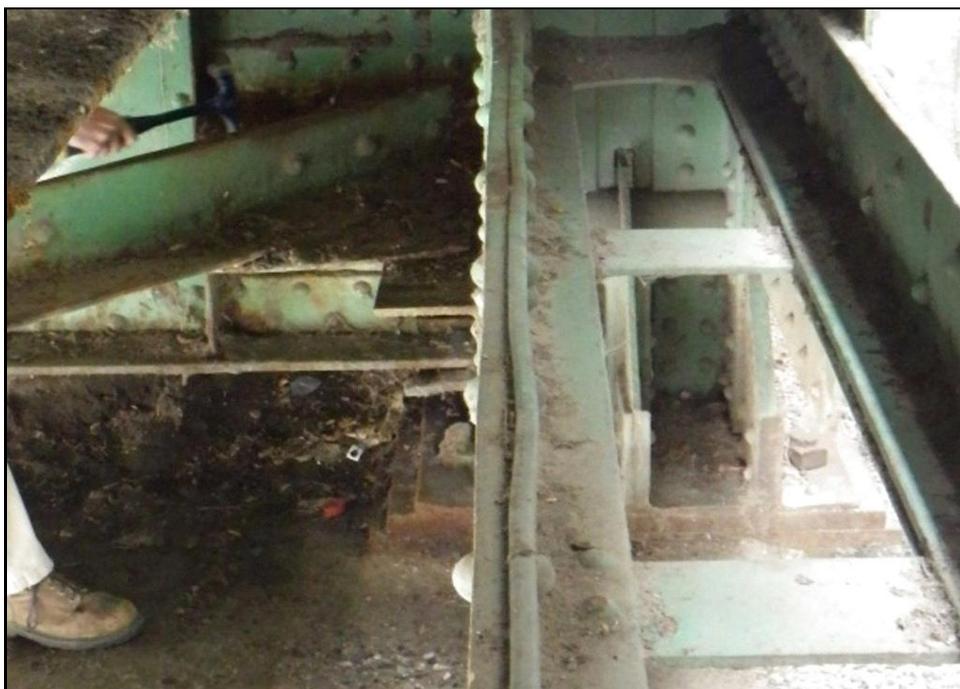
Typical pack rust formation between lower chord angles and plates at various locations

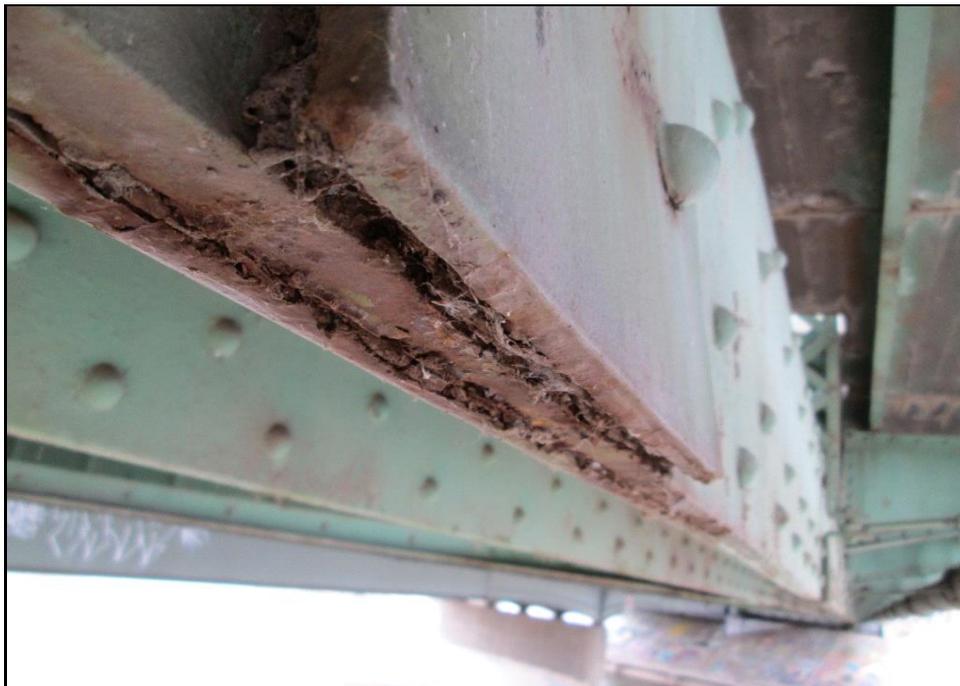
Typical pack rust formation between lower chord and gusset connections to vertical and diagonal truss members

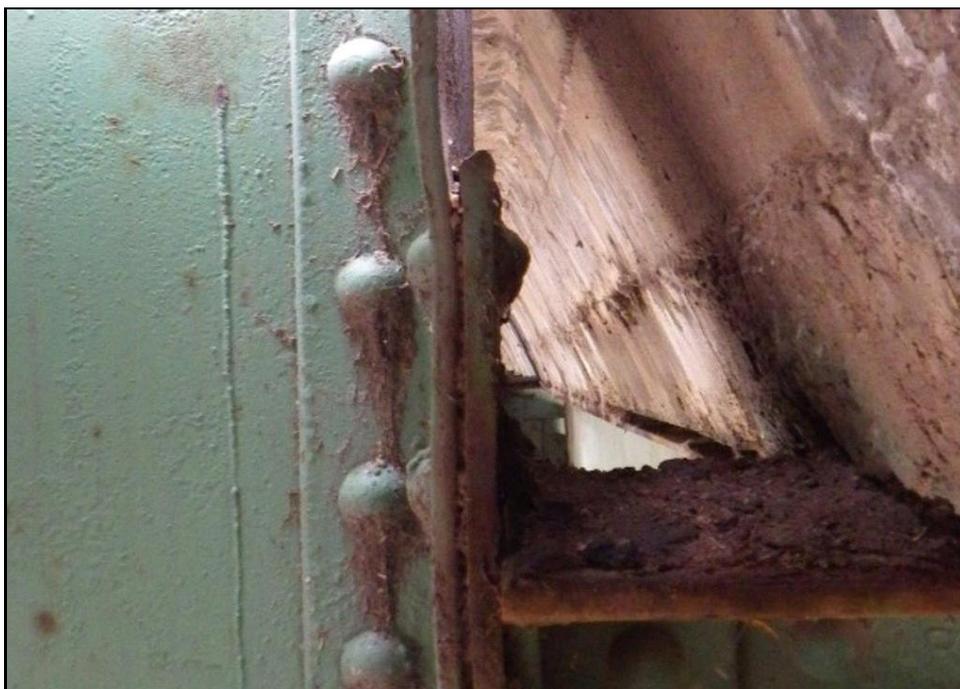
Pack rust formation and flange deformations at various plate connections between floorbeams and verticals or diagonals

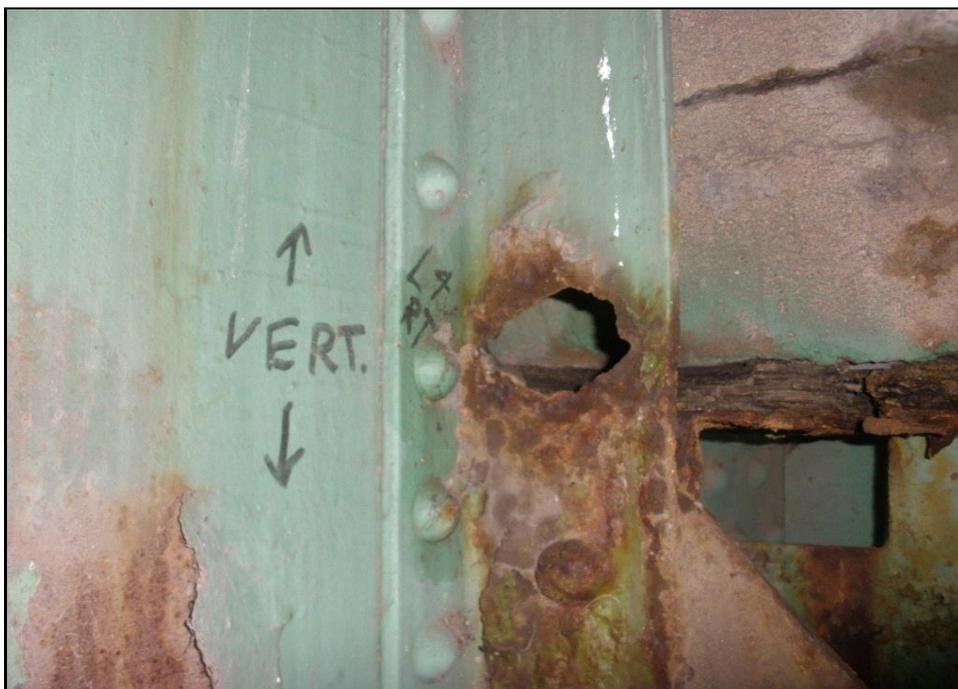
R4 corrosion with perforation to inboard flange of Vertical L4M4 at connection to Floorbeam 4

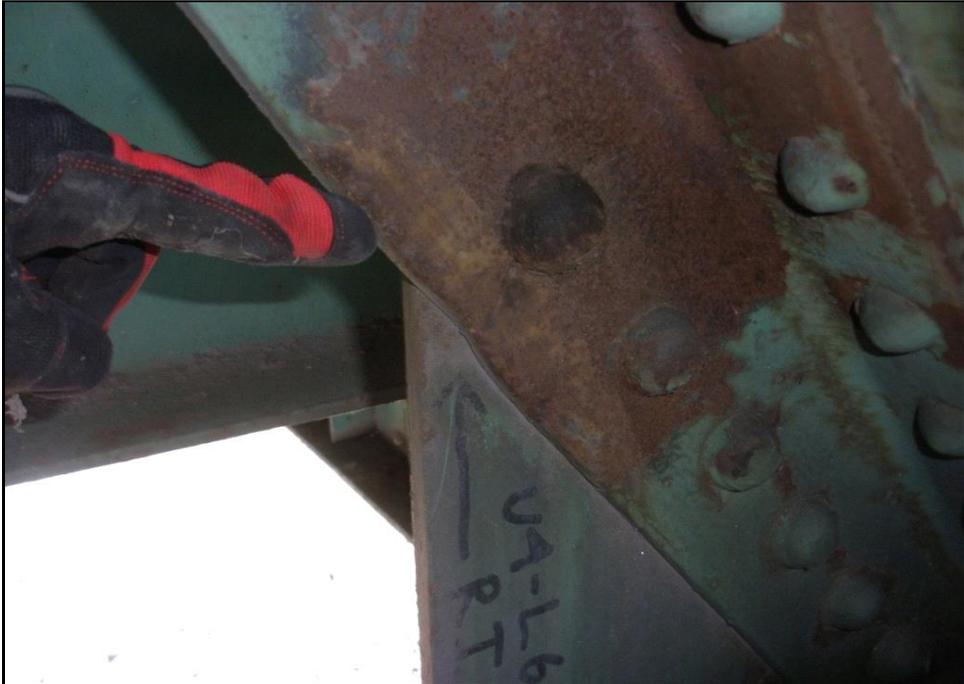
- Diagonal member U4L6 of the right truss has a crack through the rivet hole in the bottom inside flange due to vehicle impact to this member. There is no evidence of continued deterioration.

Crack in inboard bottom flange of Diagonal U4L6 at rivet connection to lower chord gusset plate

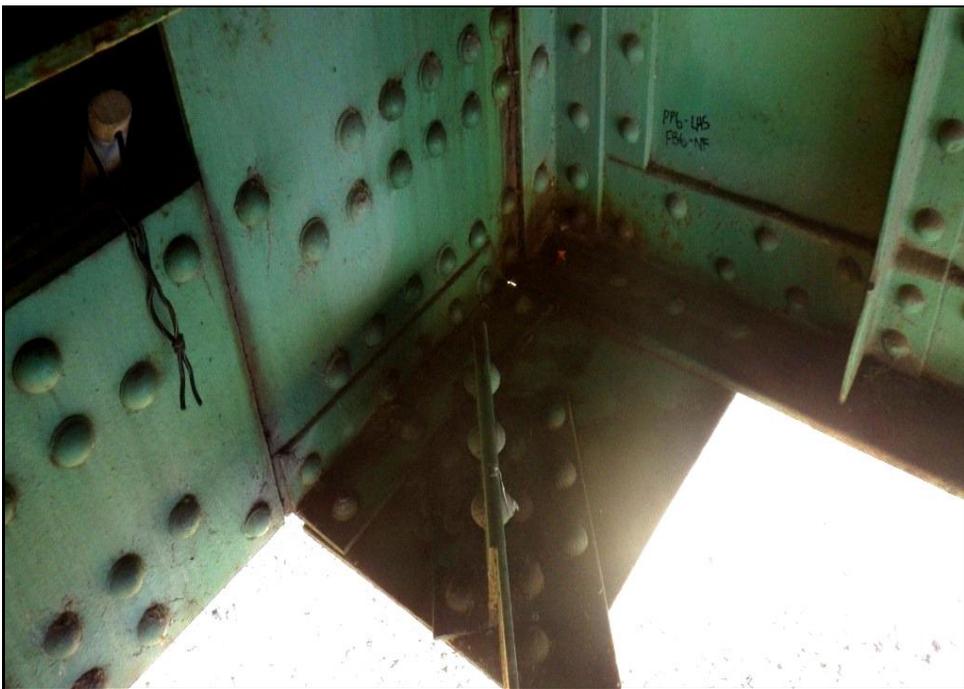
Panel Point 6 lower lateral bracing gusset to the Left Truss showing light to moderate corrosion of plate and laterals with R4 corrosion of (1) rivet head

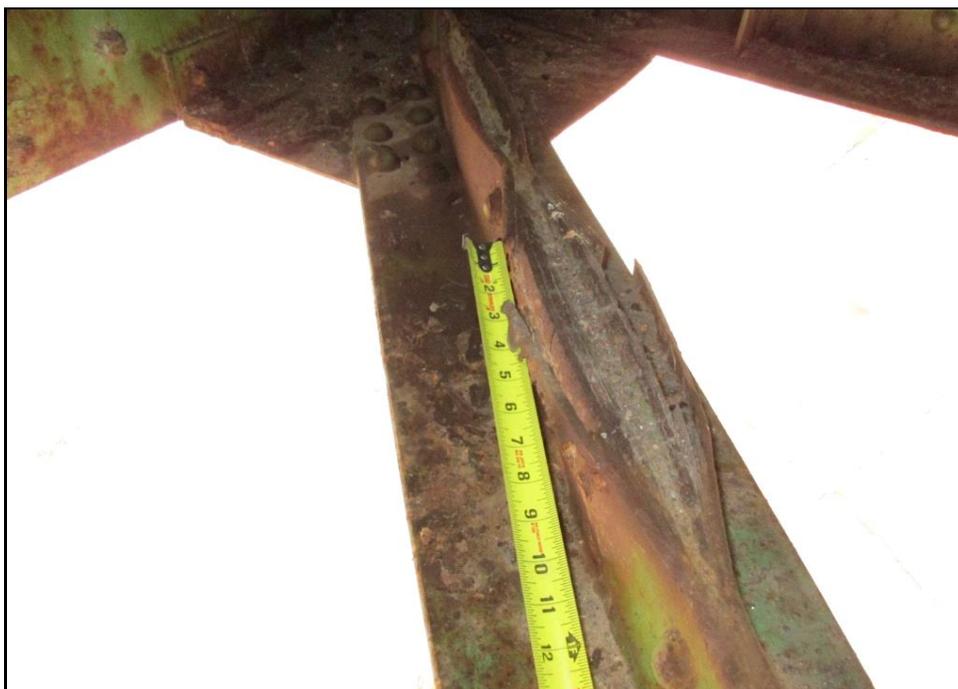
Pack rust with 100% section loss of lower lateral bracing angle top legs, Right Truss within Bay 3, Floorbeam 2

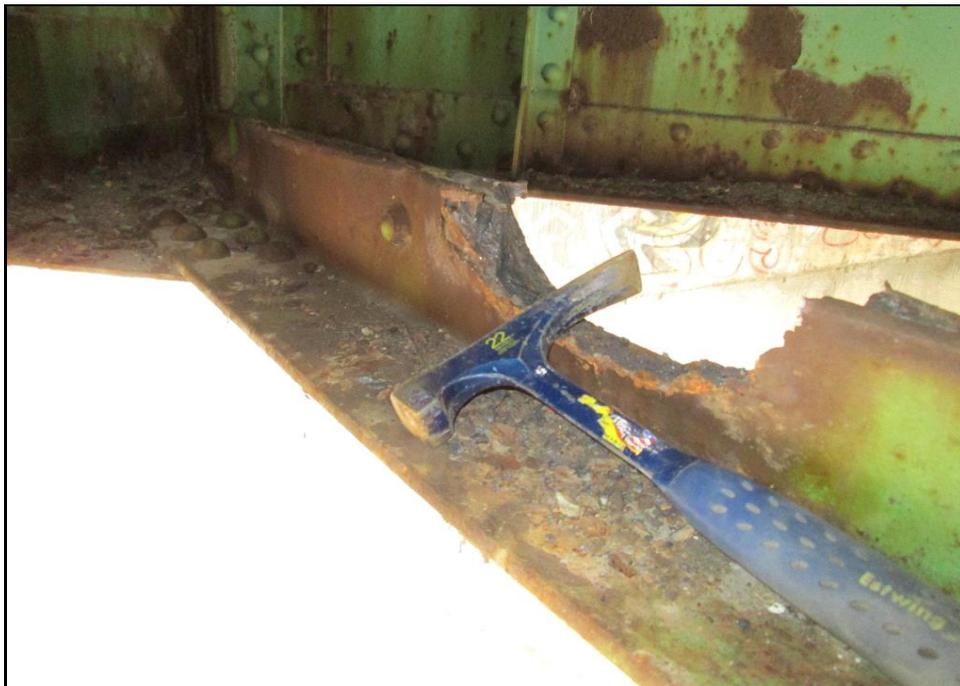
Lower lateral bracing angle top legs with pack rust and corroded steel removed, Right Truss within Bay 3, Floorbeam 2

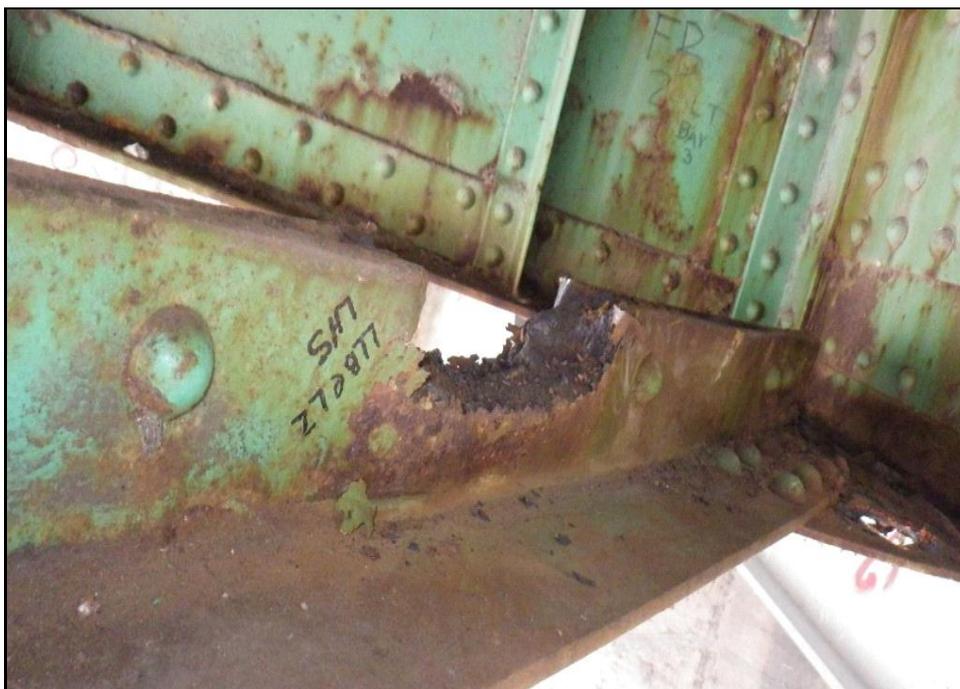
Lower lateral bracing, Bay 3, Left Truss with pack rust removed revealing 100% section loss to top legs of angles

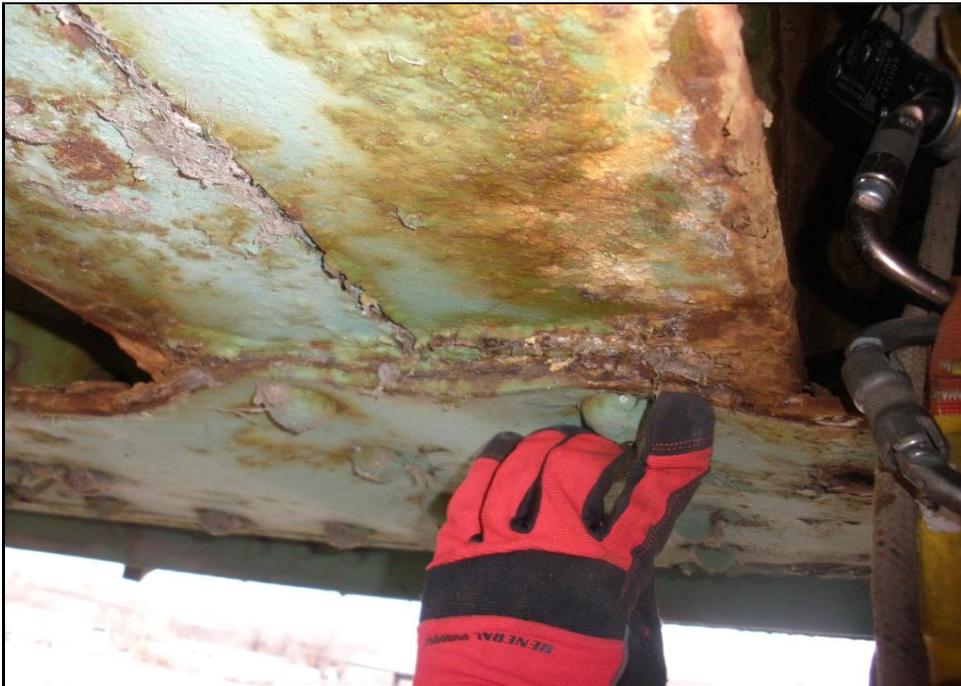
Lower lateral bracing gusset to Floorbeam 4, Right Truss with pack rust distorting plate up to 1 inch out of plane

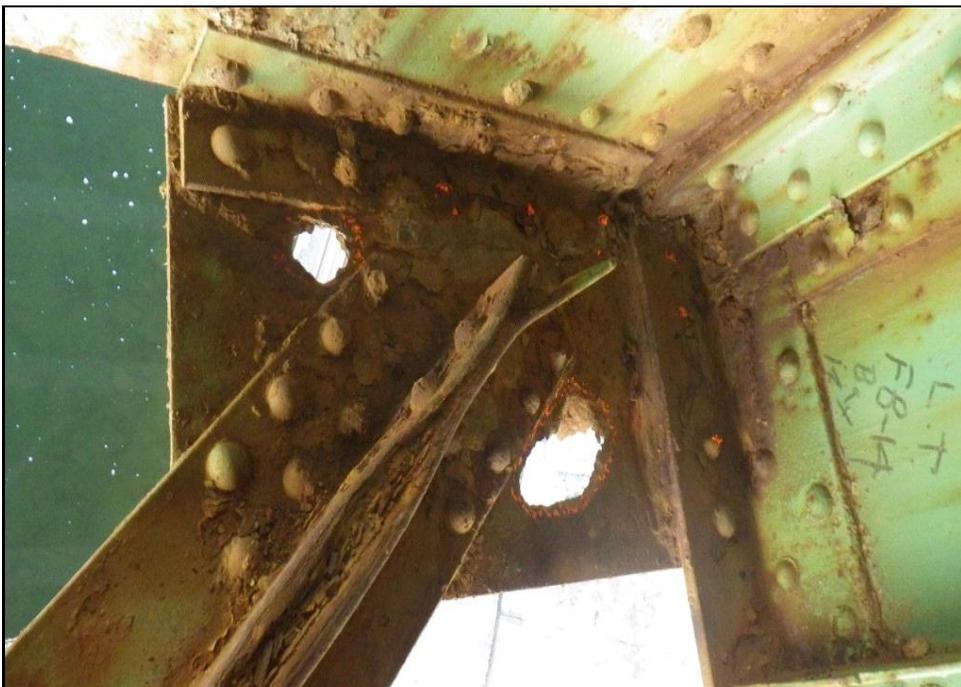
Corrosion perforations, section loss of rivet heads and pack rust separation of bracing angles at Left Truss, Bay 14, Floorbeam 14

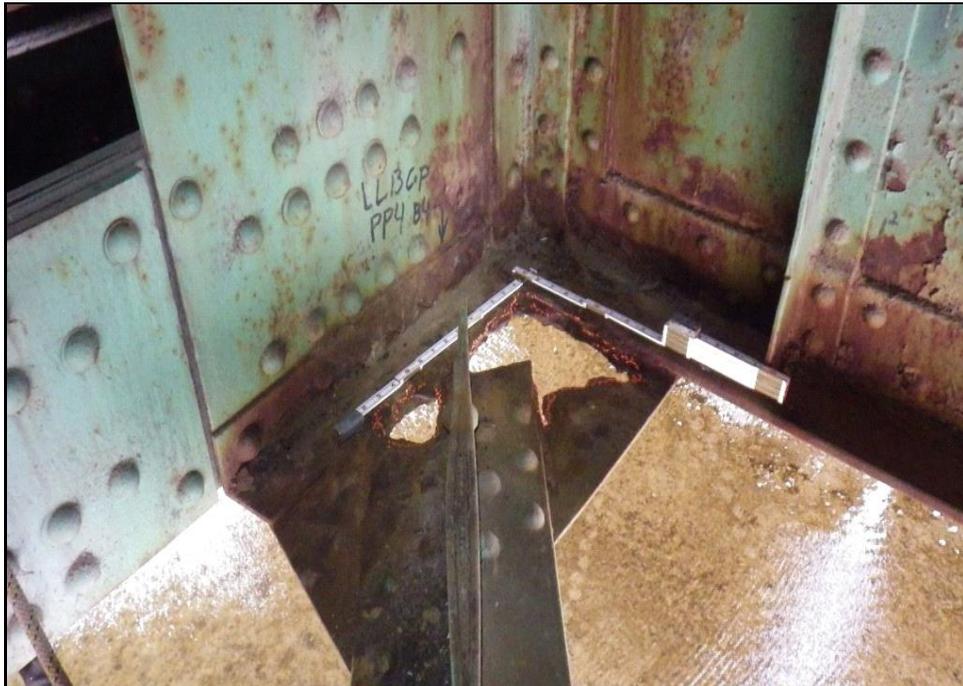
Corrosion and perforations through gusset plate at Left Truss lower chord and Floorbeam at Panel Point 4

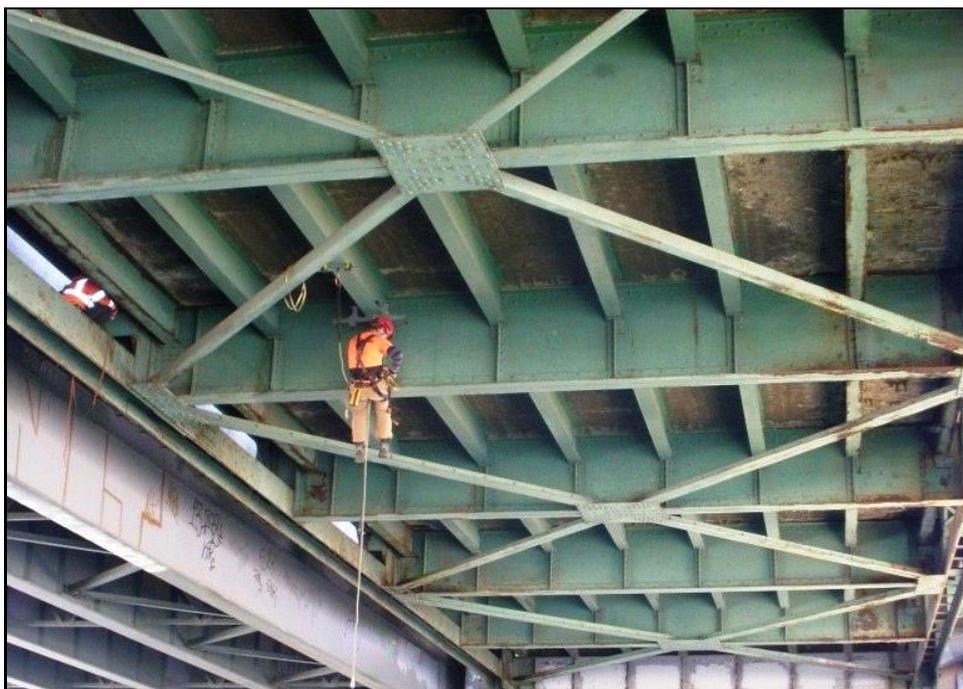
Overview of floor system and deck soffit showing typical floorbeam, stringer and deck soffit deterioration in exterior bays

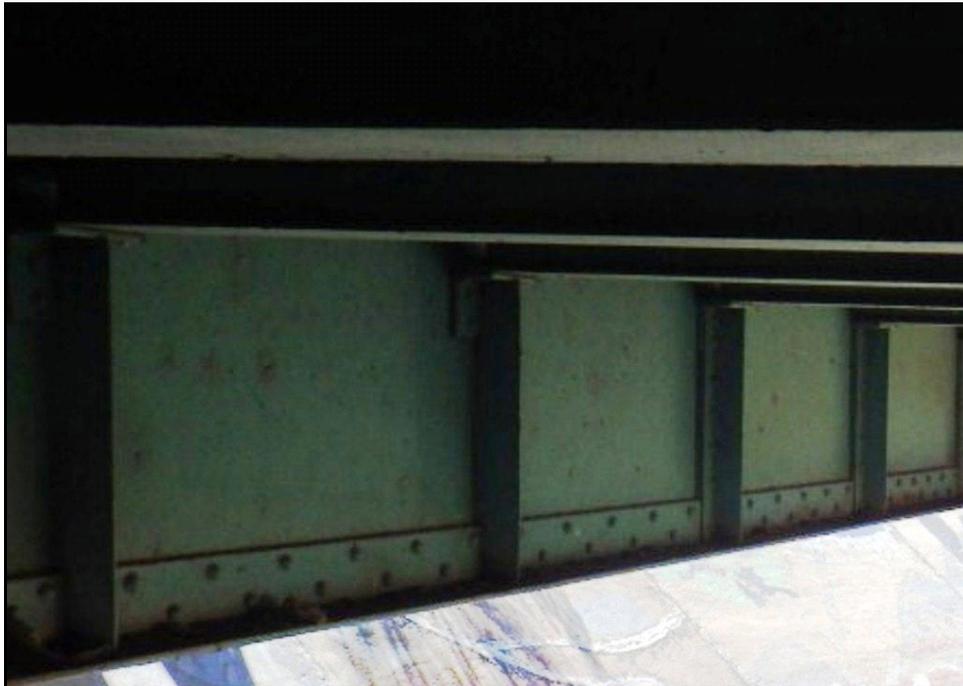
Typical floorbeam condition through interior Stringer Bays C-E

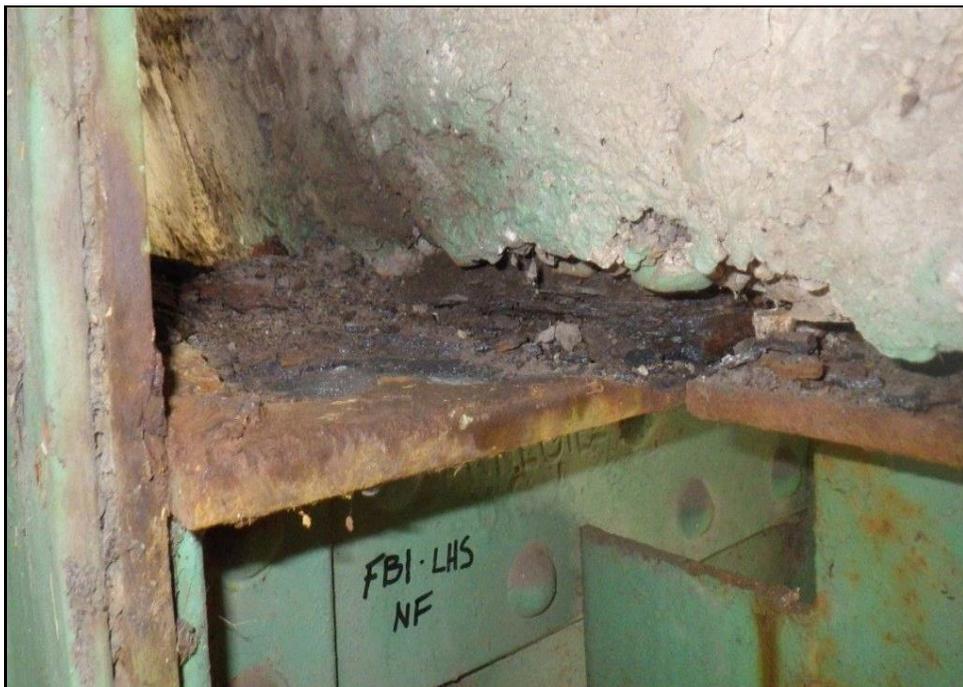
Pack rust and laminating corrosion with deck lift, top flange of Floorbeam 1 at Stringer A, Typical of many floorbeam top flanges

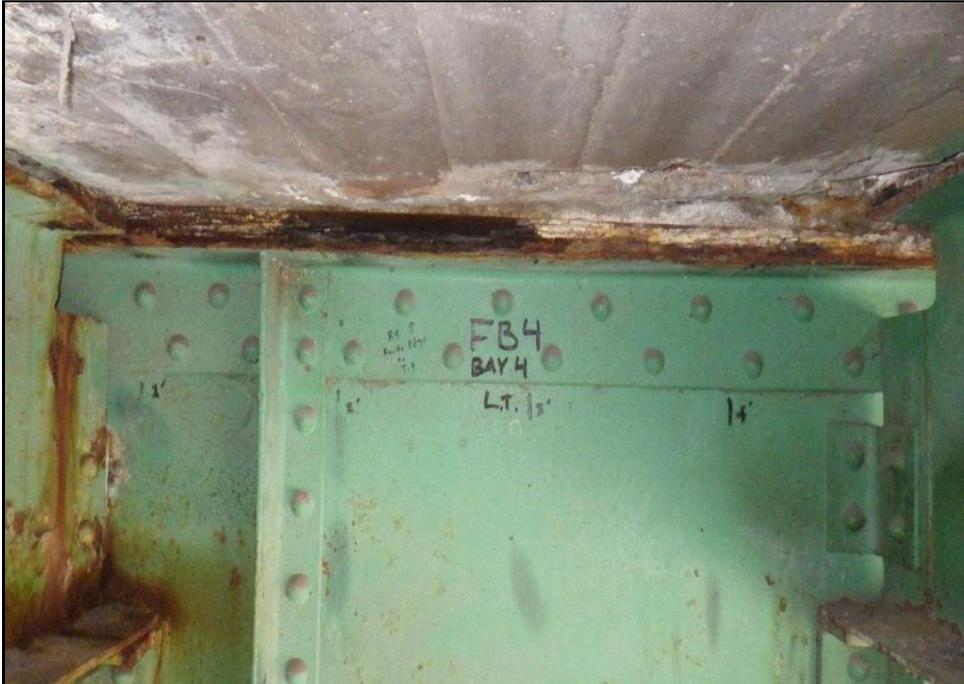
Floorbeam 4, Bay A, top flange with nearly 100% section loss (worst-case floorbeam corrosion)

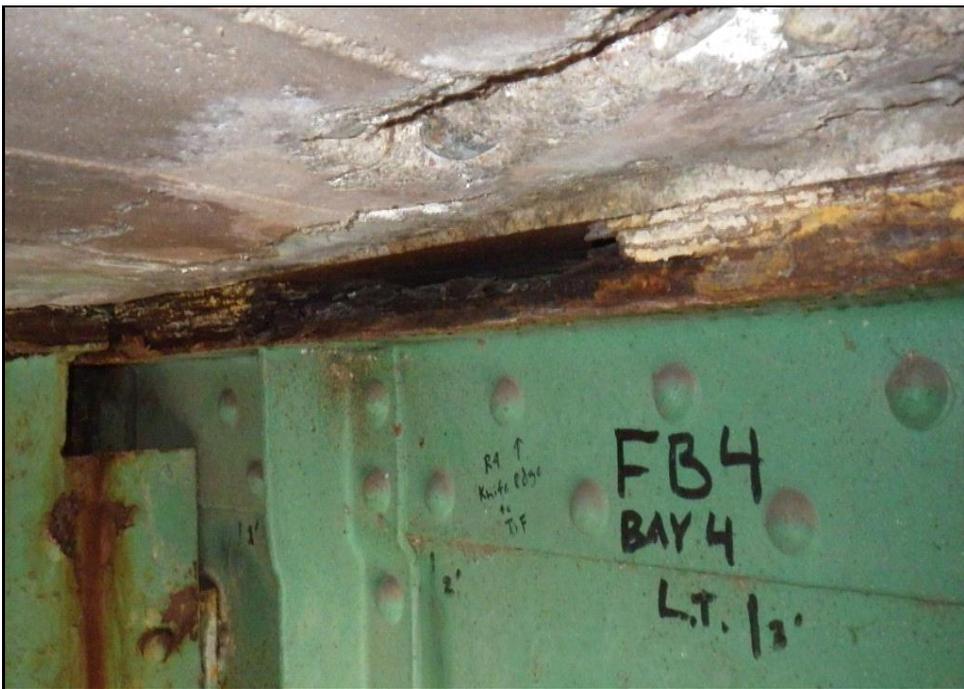
Close-up of section loss to Floorbeam 4, Bay A, top flange (worst-case floorbeam corrosion)

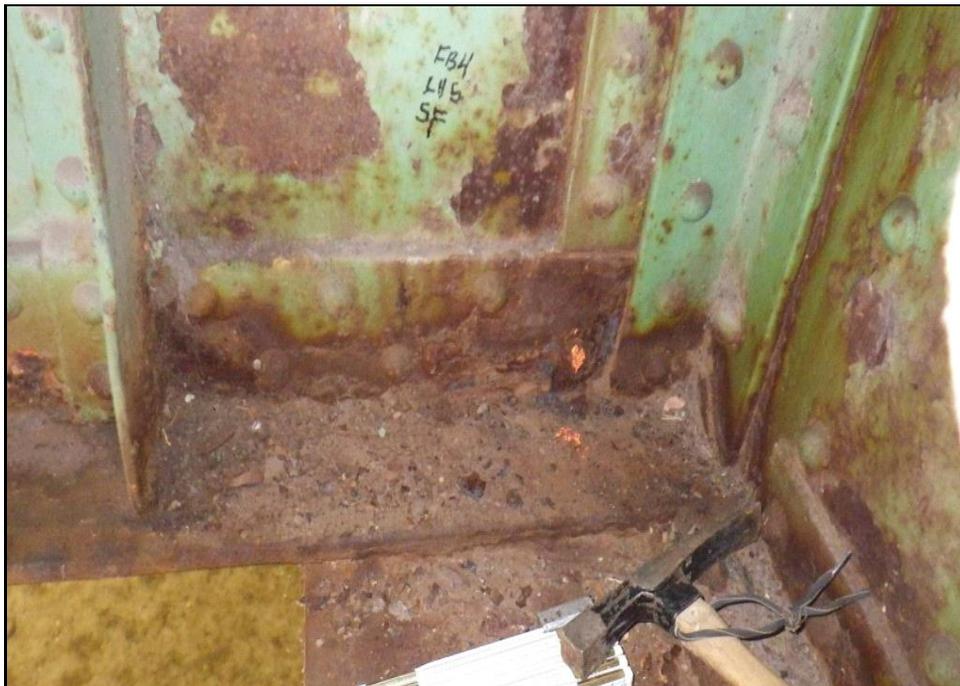
Floorbeam 4, Bay A, corrosion and section loss to bottom flange (worst-case floorbeam corrosion)

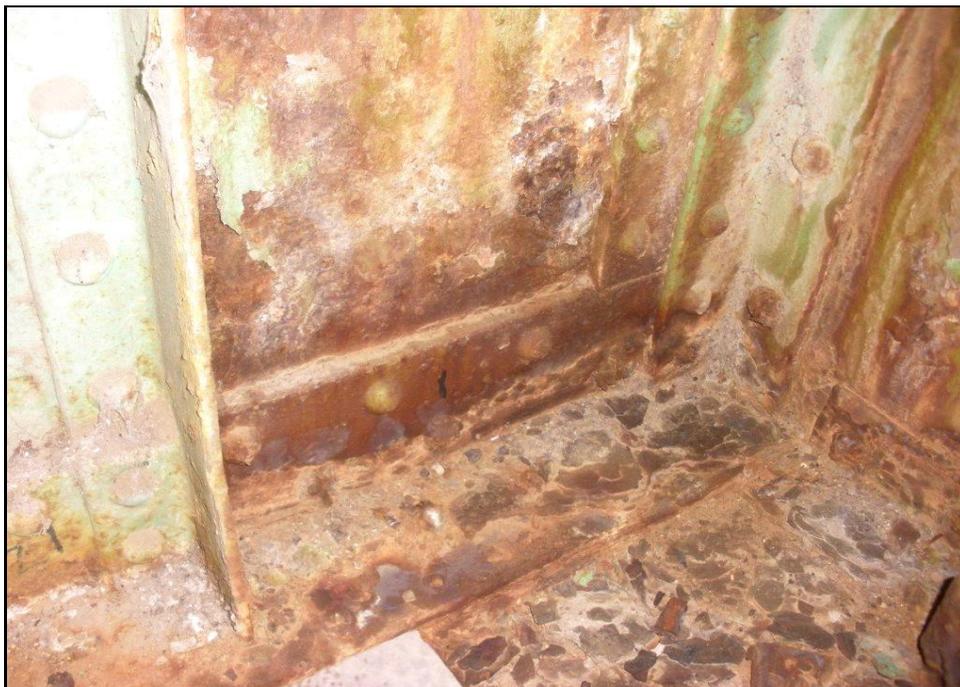
Floorbeam 4, Bay G showing corrosion of the floorbeam web and bottom flange (worst-case floorbeam corrosion)

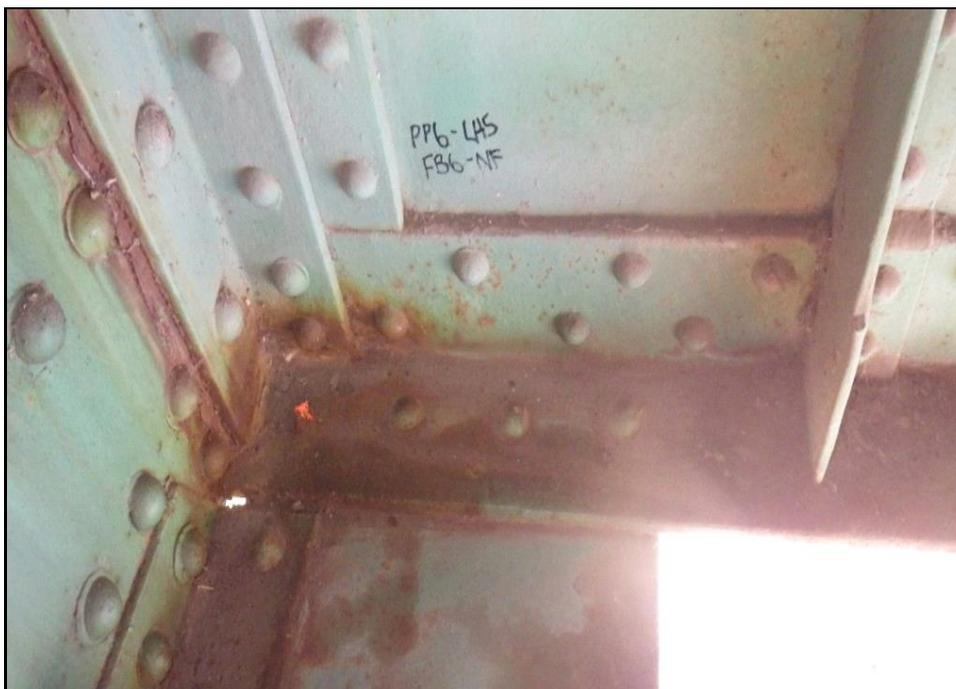
Floorbeam 6 north face, Bay A showing R2 corrosion of top surface of bottom flange with R4 corrosion of (1) rivet head

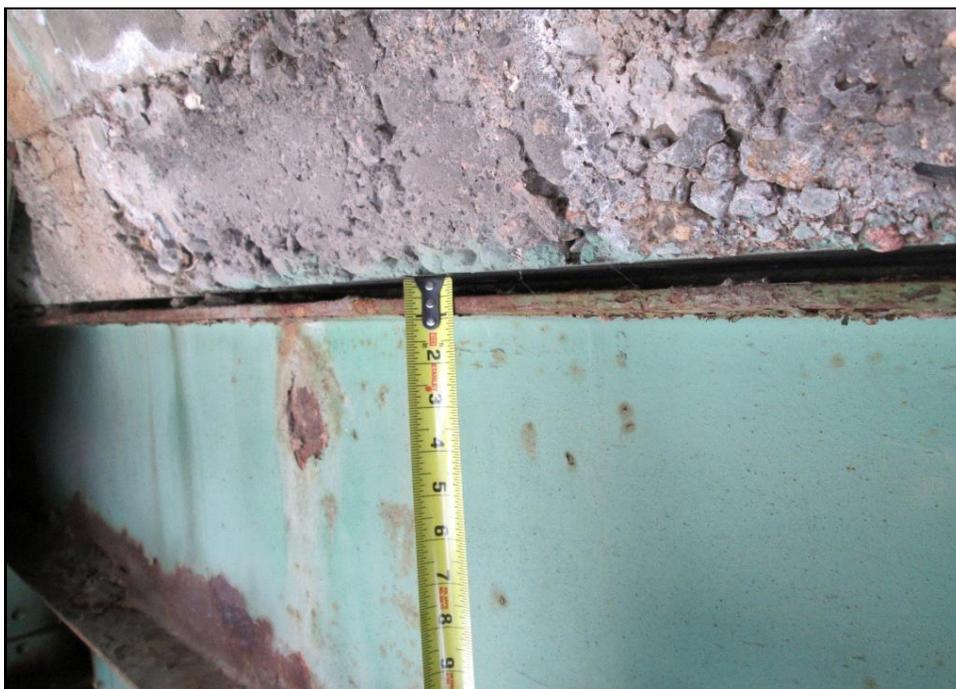
0.5 inch deck lift in Bay 1 over Stringer 1H

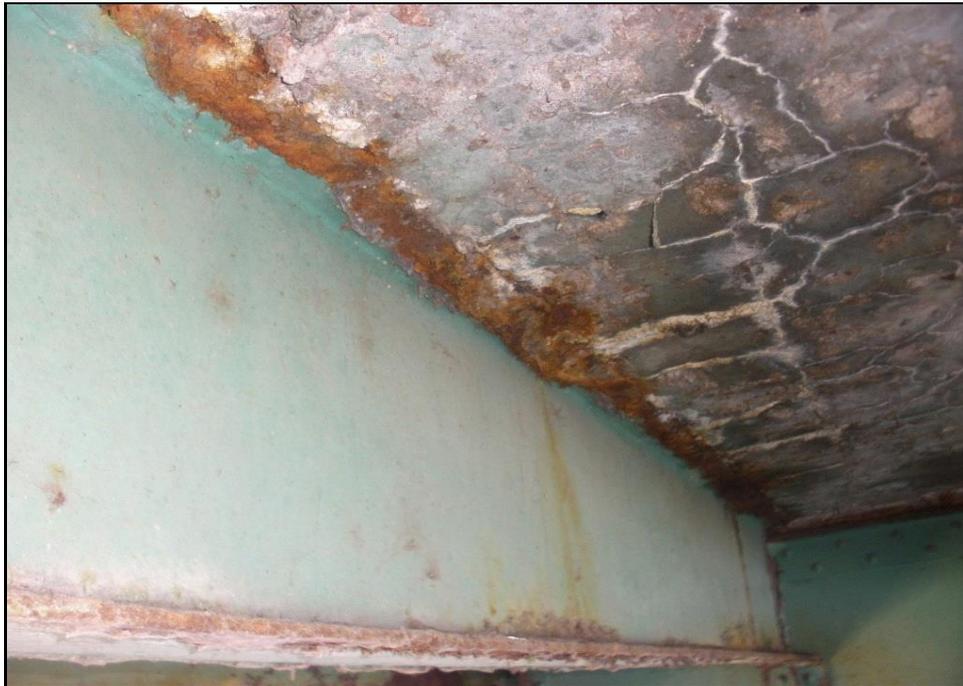
R3-R4 corrosion of Stringer 12G top flange

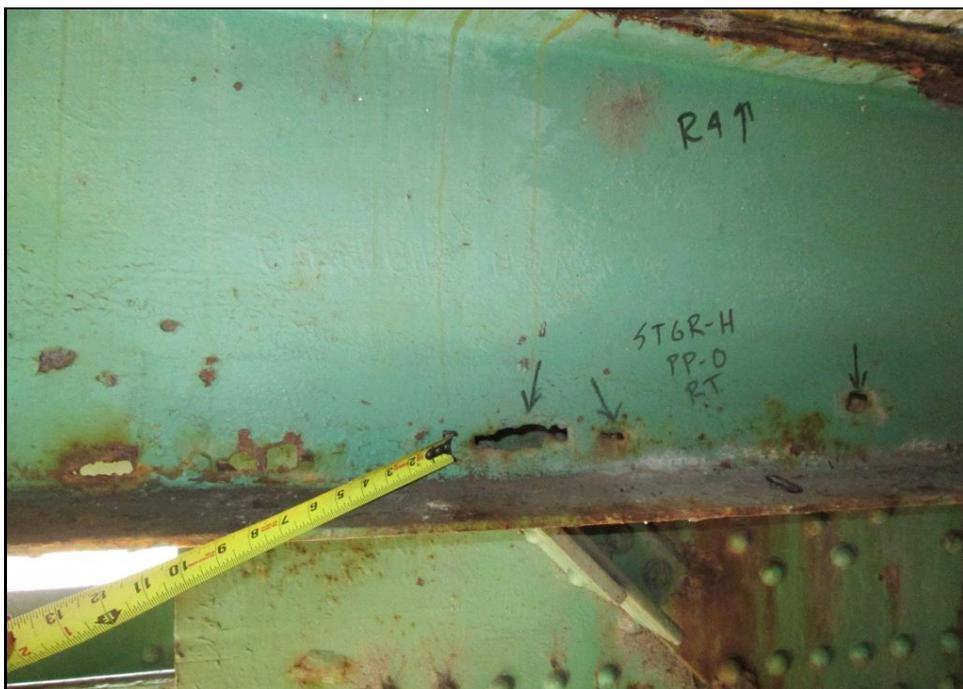
Perforations through web of Stringer 1H near bottom flange

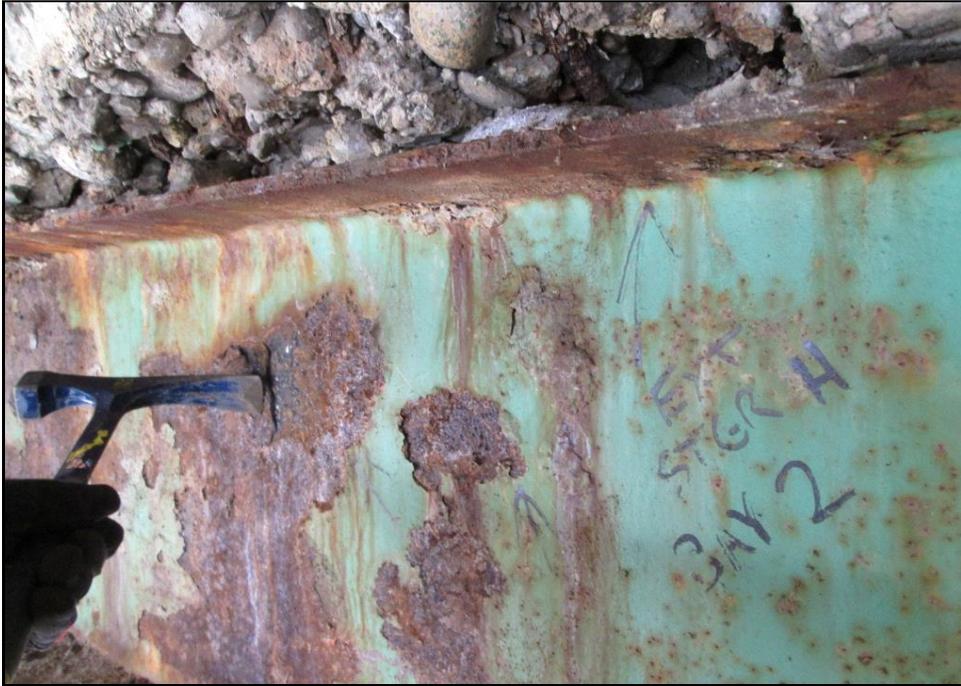
R2-R3 corrosion of Stringer 2H web

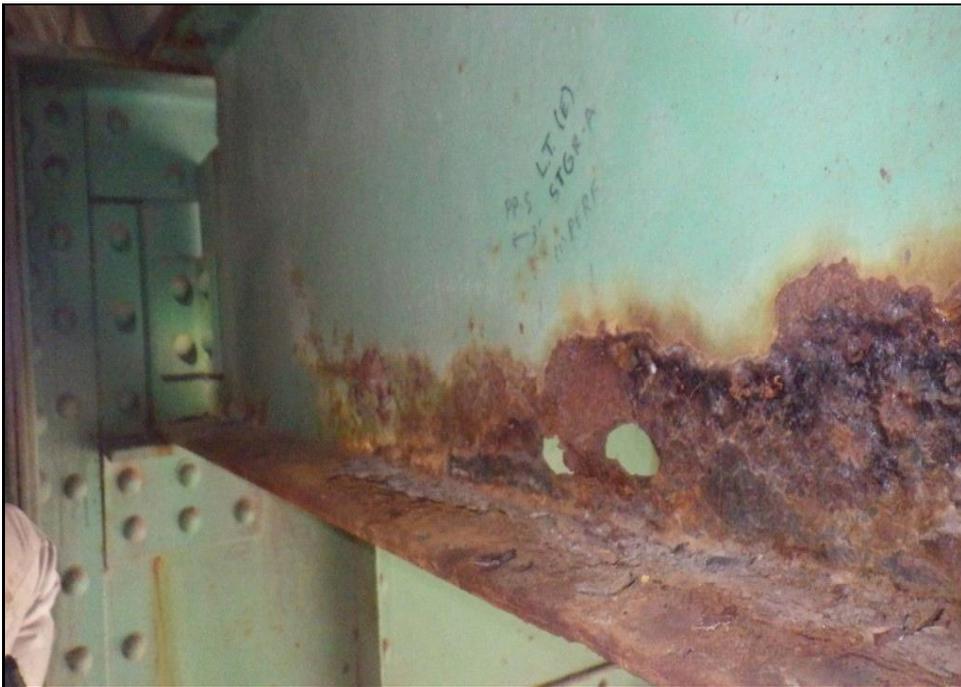
Perforations through web of Stringer 5A near bottom flange

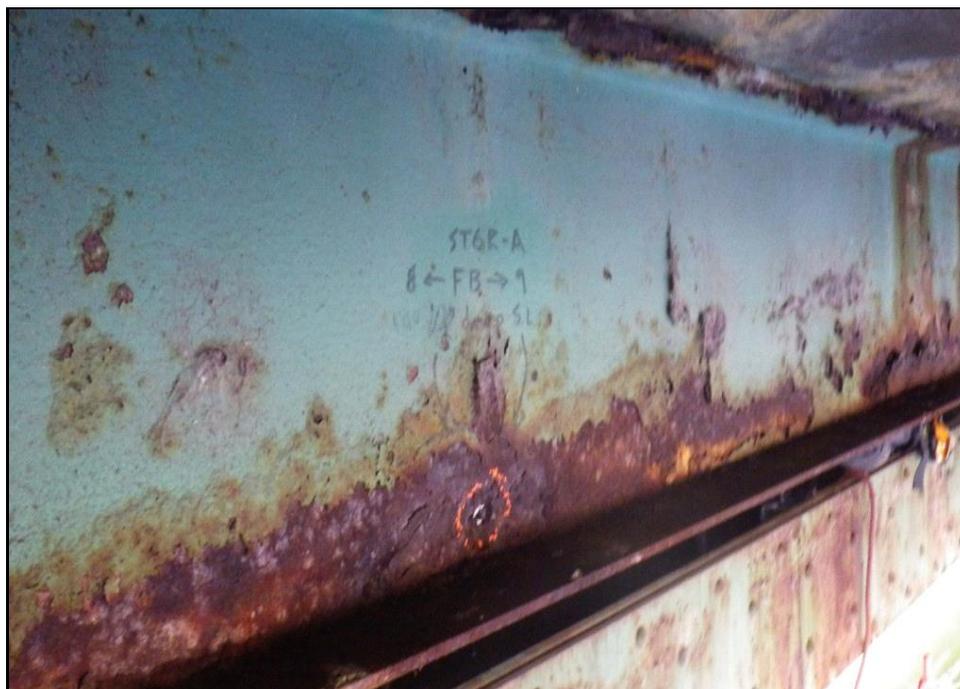
R4 corrosion and perforation in web of Stringer 9A near bottom flange
