In-depth Fracture Critical and Routine Inspection Report

Structure: K-18-R
Crossing: Arkansas River
Route: US 50 Business East-Bound
County: Pueblo
State: Colorado

Inspected by:
Stantec Consulting Services
2000 S. Colorado Blvd. Ste. 2-300
Denver, Colorado 80222
Frank J. Block, PE, NBI Team Leader

Inspection Date:
March 11, 2014

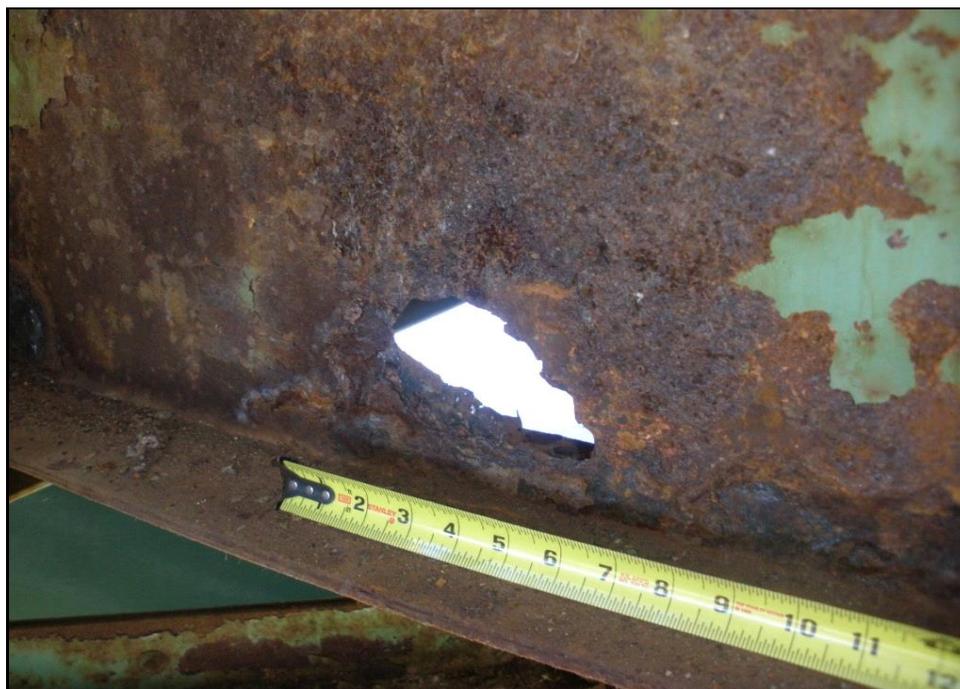
Perforation through web of Stringer 15H near bottom flange

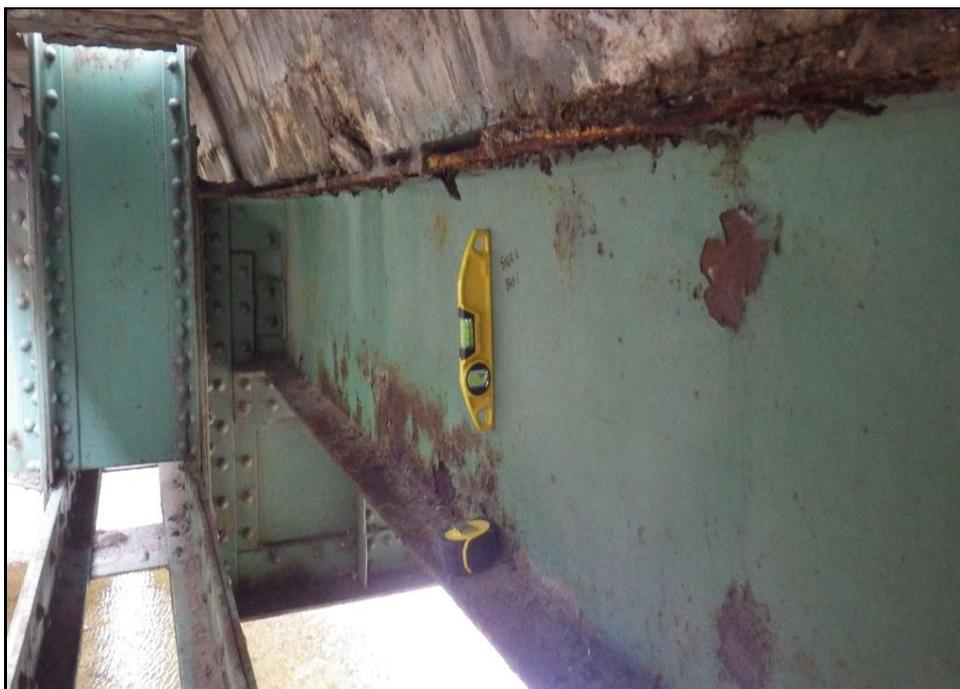
Partial rotation of Stringer 1A due to laminating corrosion and pack rust of the top flange

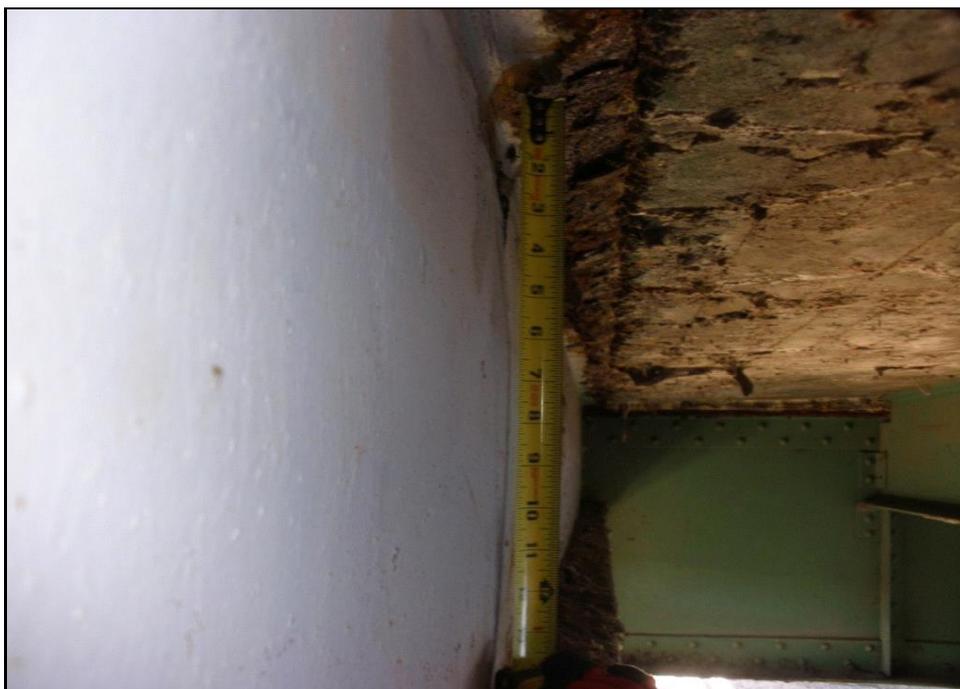
Slight buckling of Stringer 16G web

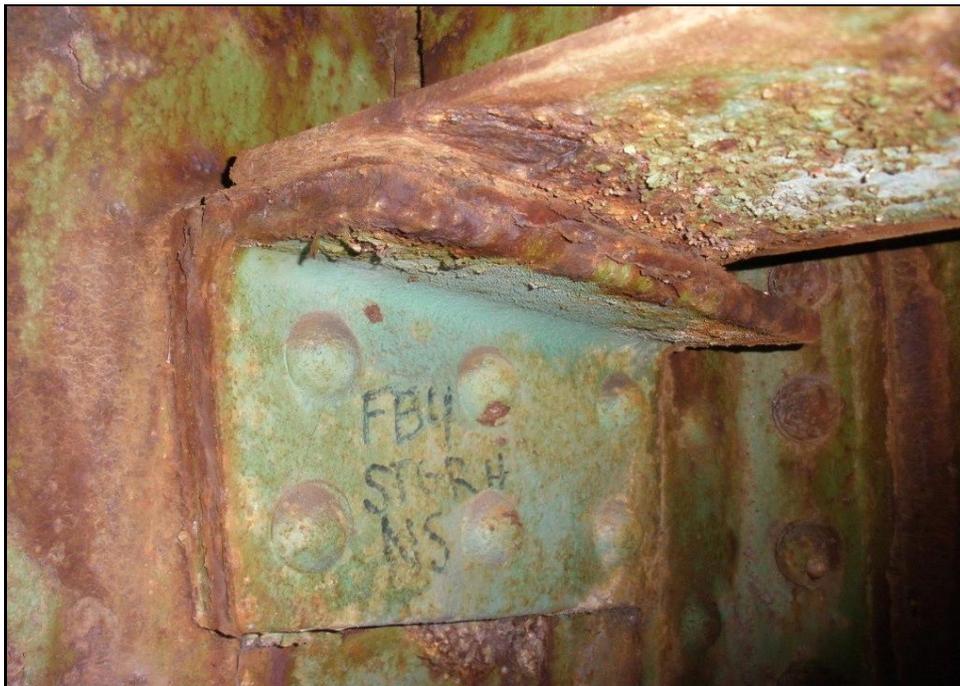
Stringer 4H clip angle to Floorbeam 4 showing corrosion and pack rust between the clip angle bearing and stringer bottom flange

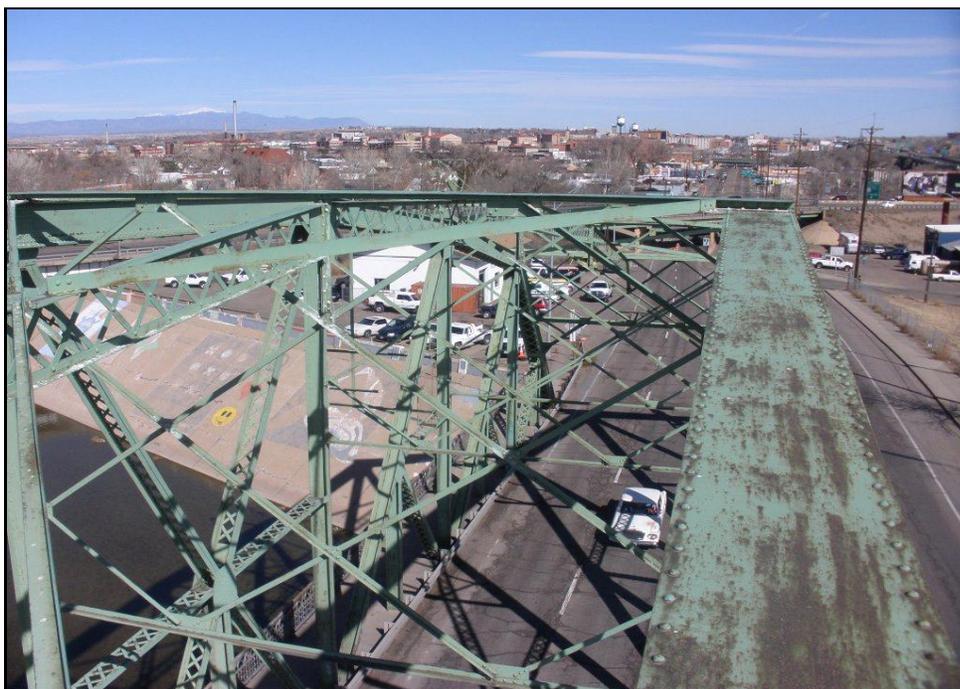
Overview of truss upper chords and bracings showing typical peeling paint and R1 corrosion

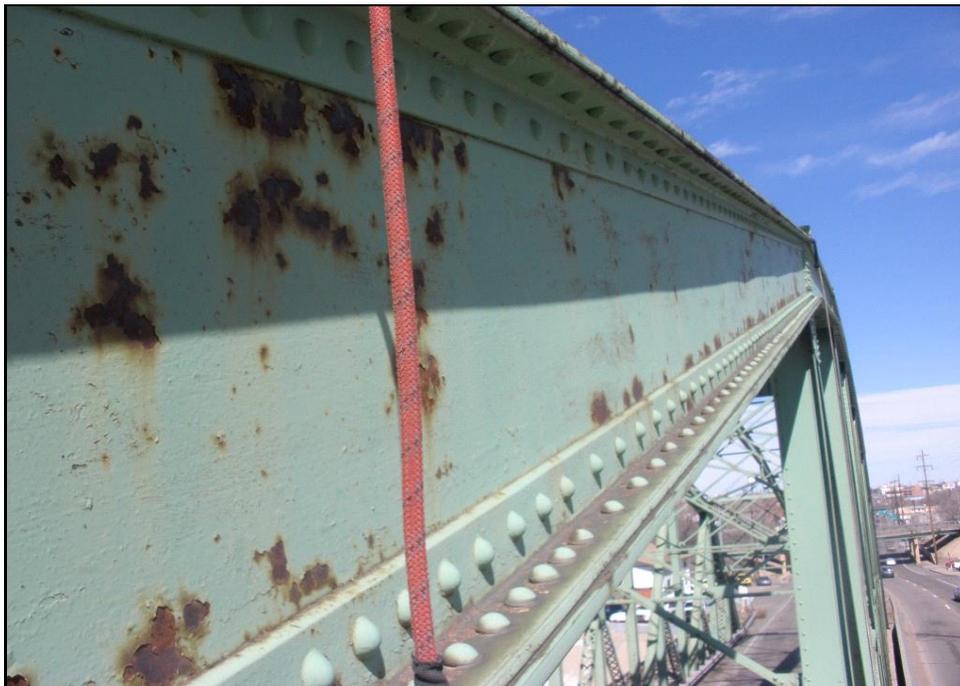
Typical upper chord web with spotty R1 corrosion throughout

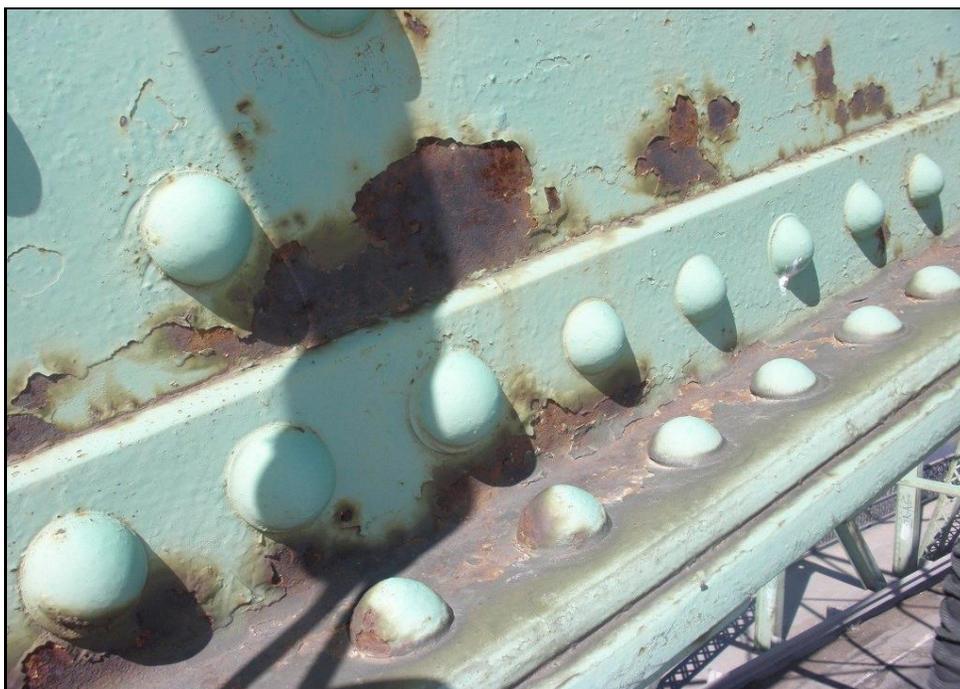
Typical peeling paint with R1 corrosion of upper chord bottom flanges

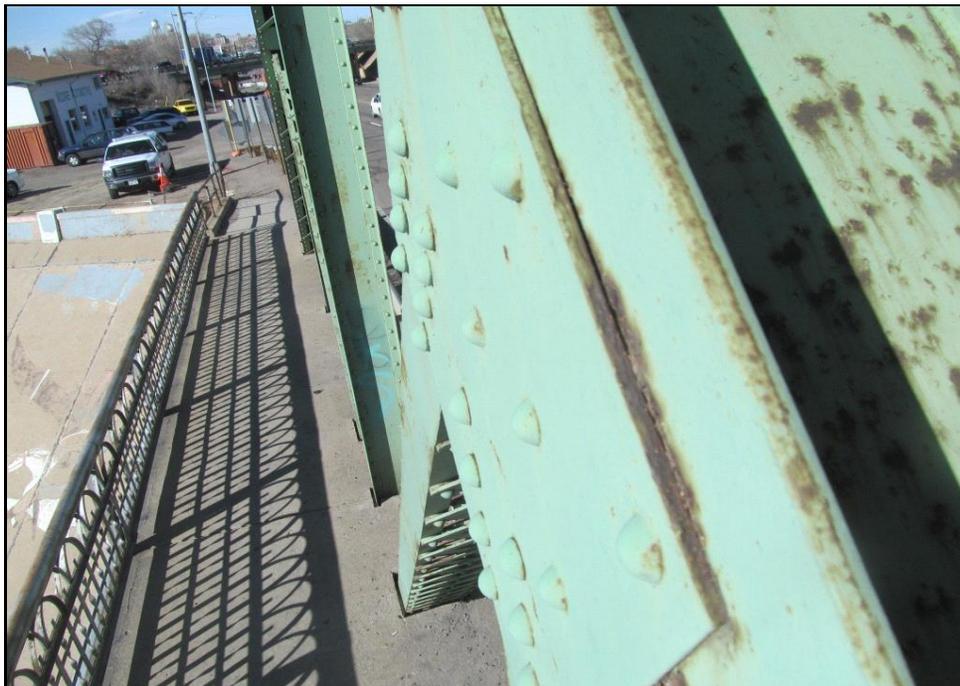
Gusset plate connection between Right Truss Vertical L3M3 and diagonals with pack rust distorting plate 0.125 inch

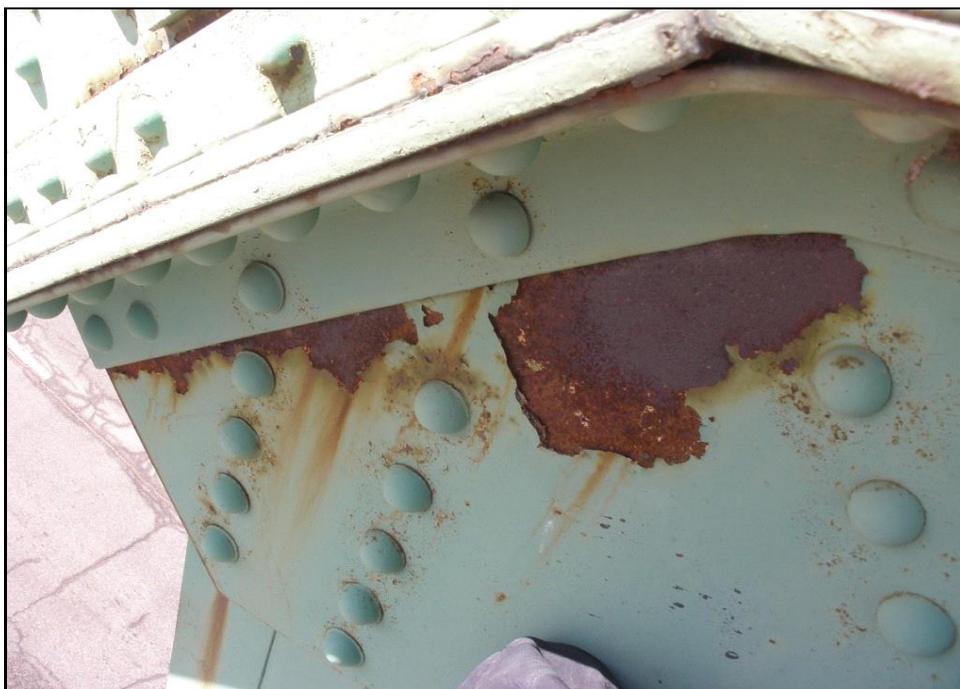
Left Truss gusset plate at U14 with R1 corrosion

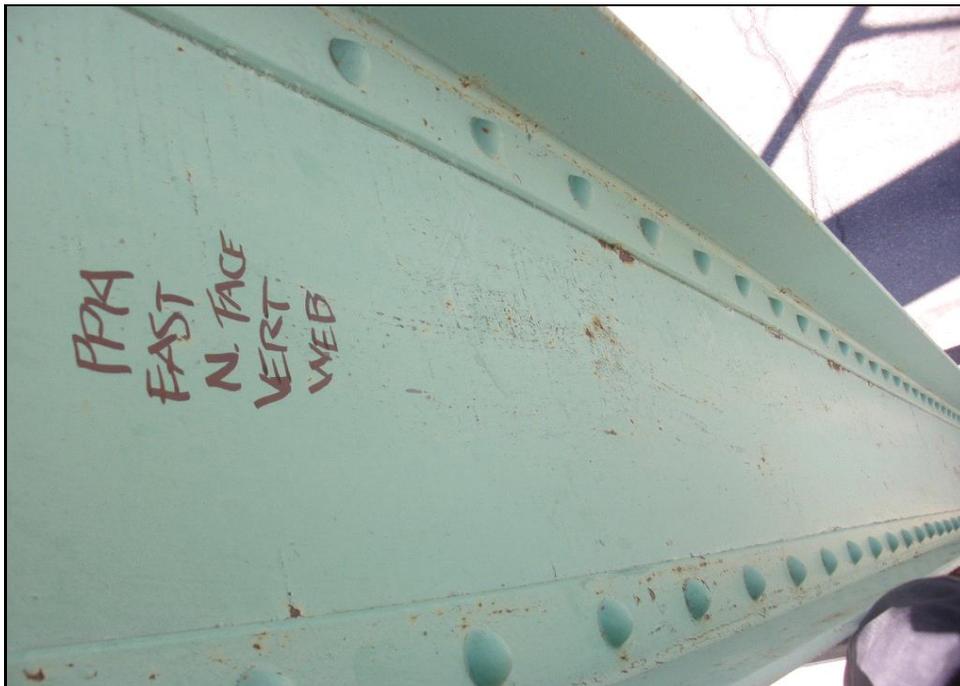
Typical vertical member with spotty R1 corrosion

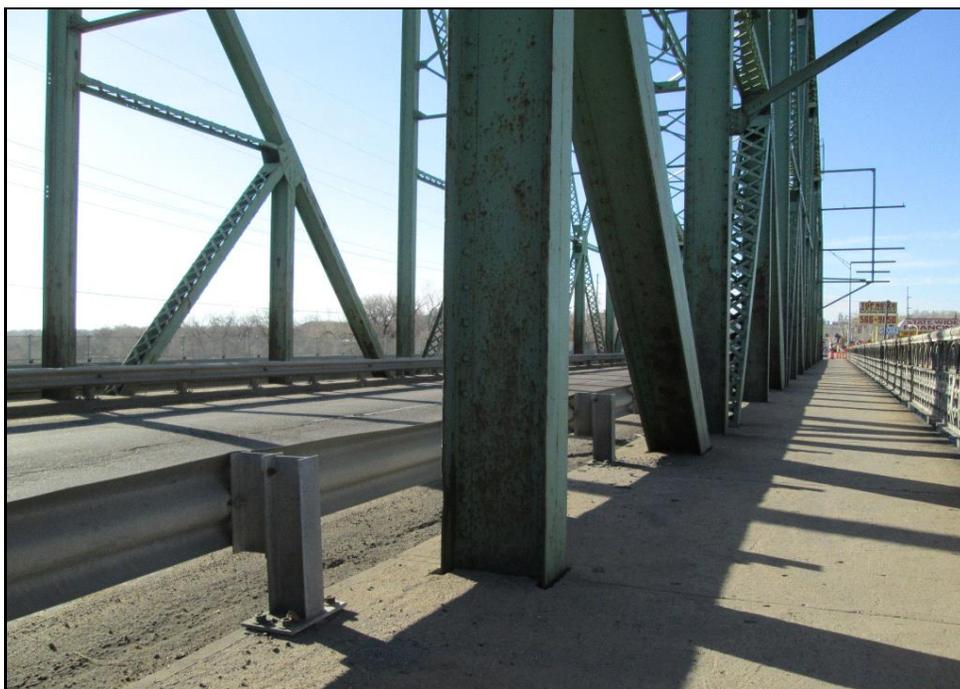
Typical increased corrosion of vertical and diagonal members within 10 feet of the deck surface

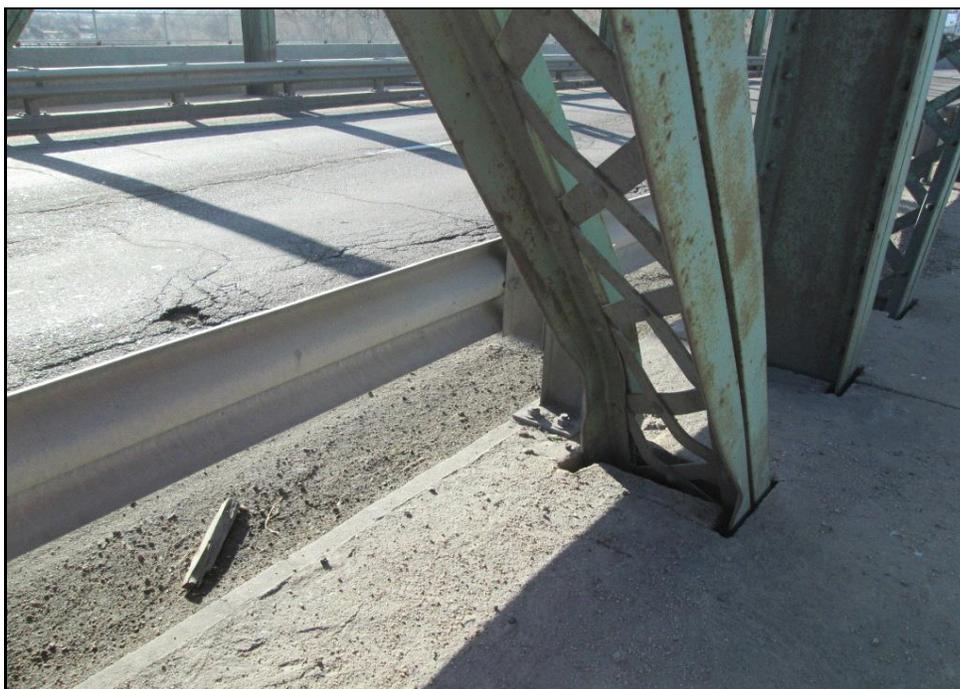
Impact damage to Diagonal M7L8

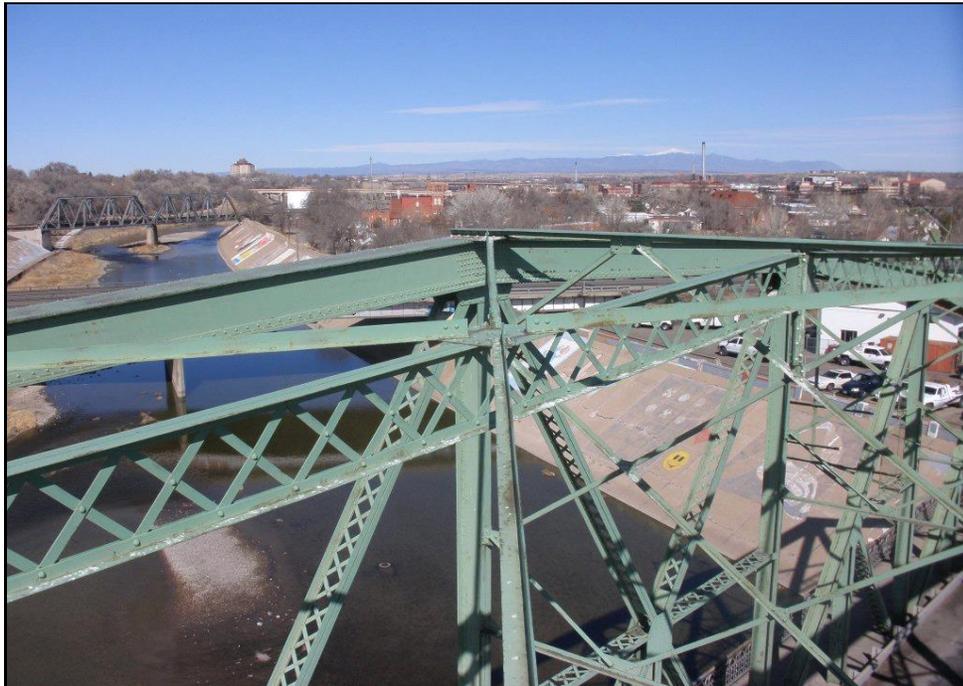
Overview of truss upper lateral bracings showing spotty R1 corrosion

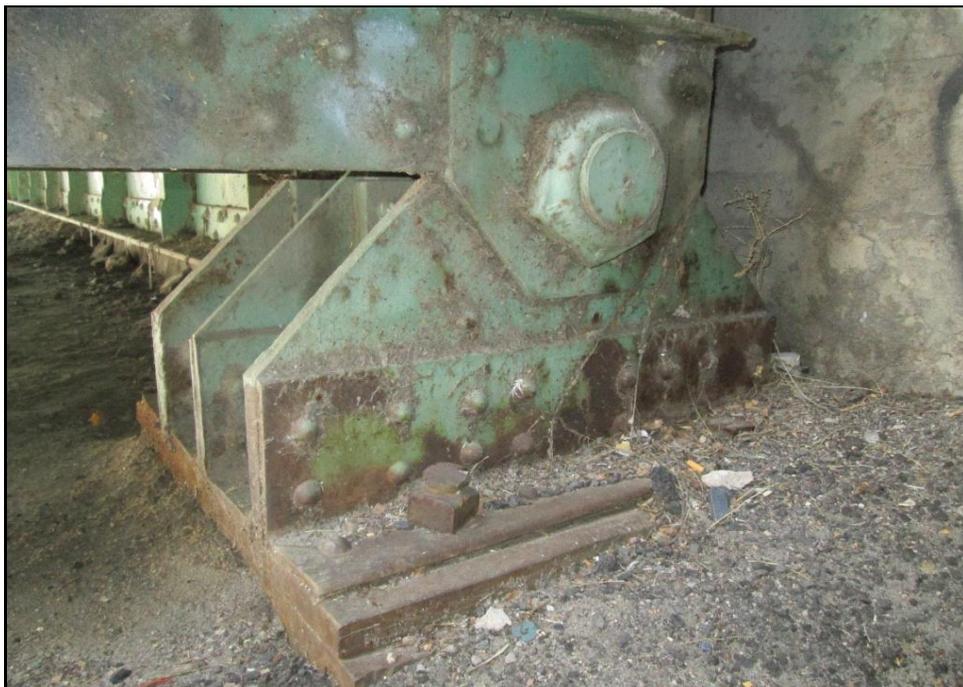
Overview of Left Truss fixed bearing at Abutment 1 showing R1 corrosion with pack rust formation and deflection of clip angle legs, no visible rotation

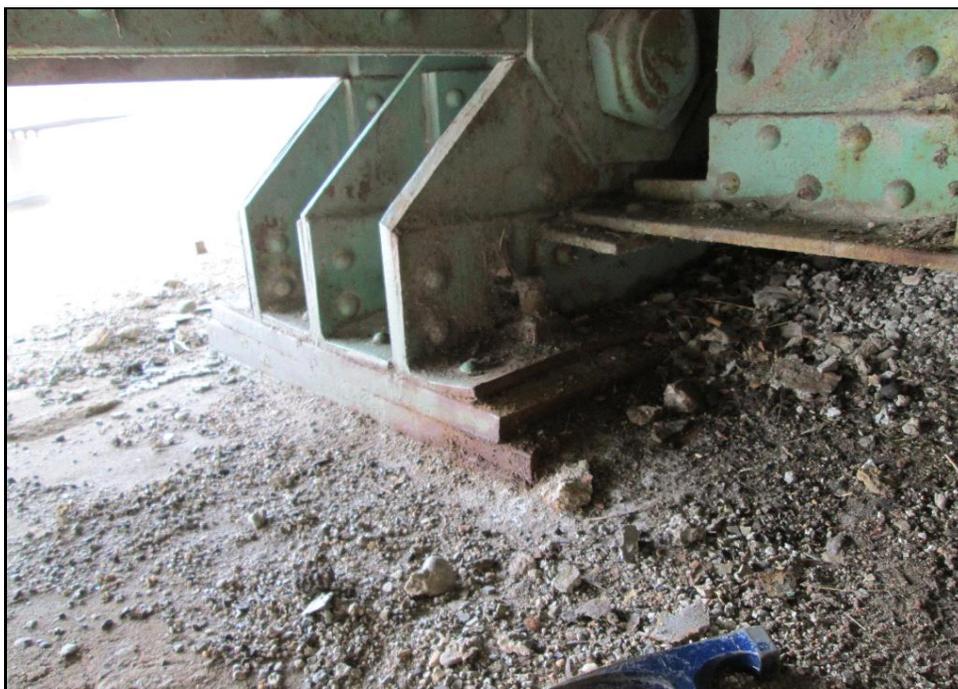
Overview of Right Truss fixed bearing at Abutment 1 showing R1 corrosion with pack rust formation and deflection of clip angle legs, no visible rotation

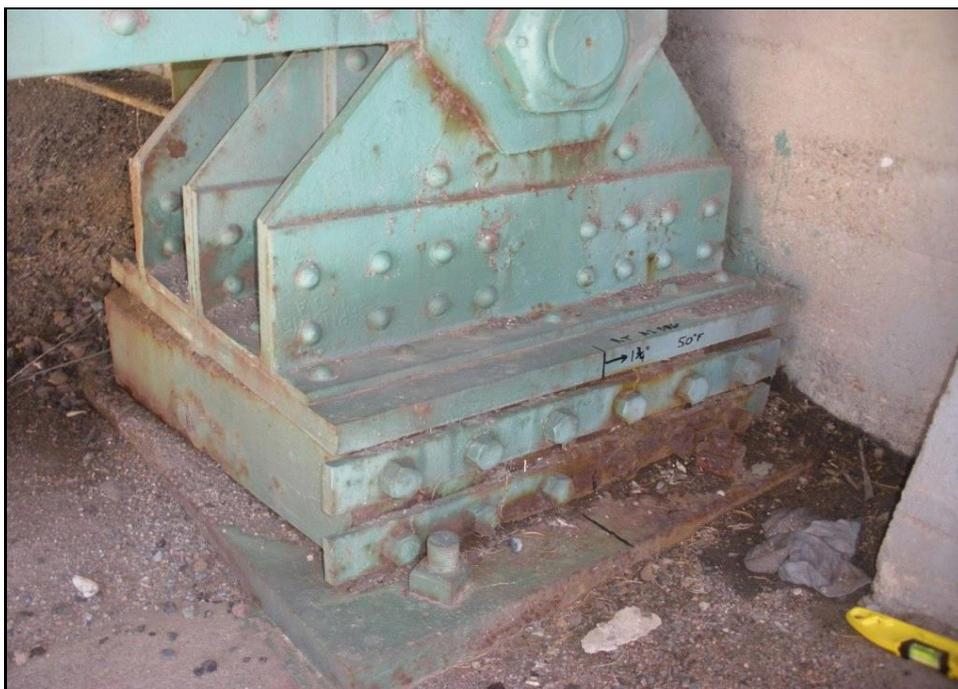
The rocker nests at Abutment 2 have failed. Large amounts of debris from the previously failed expansion joint above have accumulated along the bearing seats and contributed to significant corrosion of the bearing elements. The retaining bars, which maintain alignment of the individual rockers, have corroded and broken away allowing the rockers in each nest to misalign at different angles from 0 to 45 degrees. The misaligned rocker nests are essentially fixed leaving the truss to absorb expansion and contraction of its members. Sole plates at the east and west bearings are off-center from masonry plates by approximately 2 inches and 1 3/4 inches respectively. This suggests the truss is locked in a state of expansion (see photos on pages 36 to 39 of Appendix B).

Overview of the Right Truss rocker nest expansion bearing at Abutment 2

The nested rocker bearing assemblies at Abutment 2 will also need to be repaired or replaced in order to return the ability of expansion and contraction to the structure.

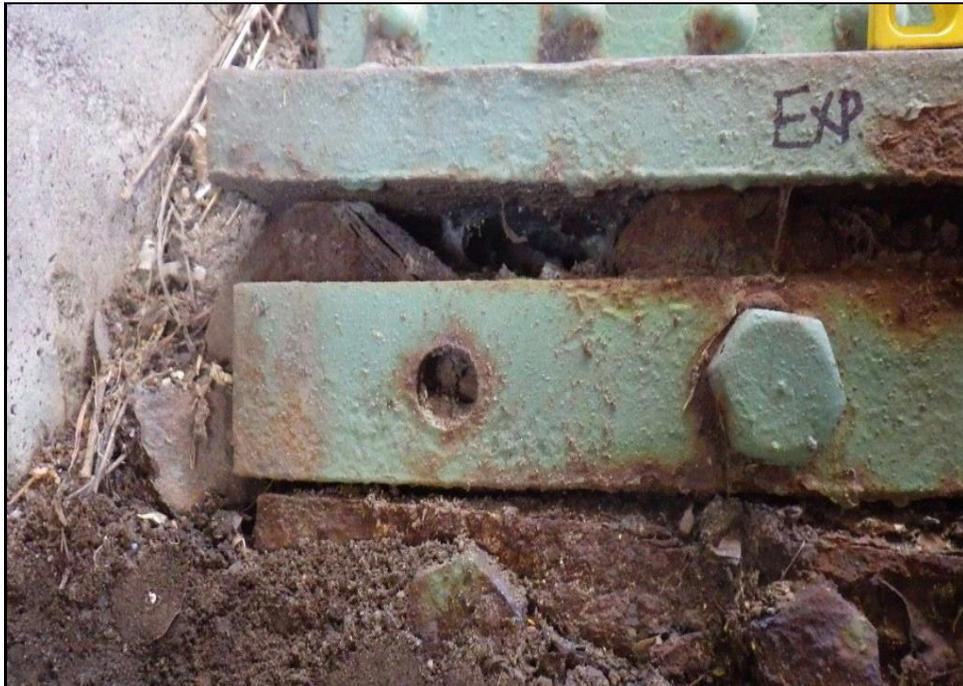
Missing bolt at rocker retainer bar causing south rocker to lay over out of alignment

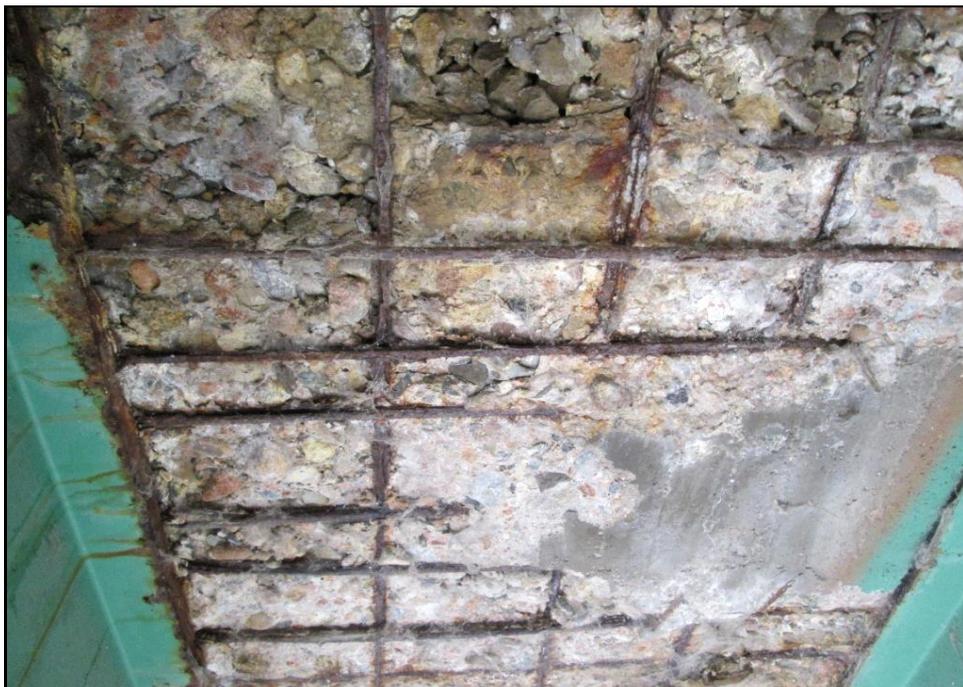
Deck soffit within Bay 1 between Stringers G and H with significant spalling and exposure of reinforcing

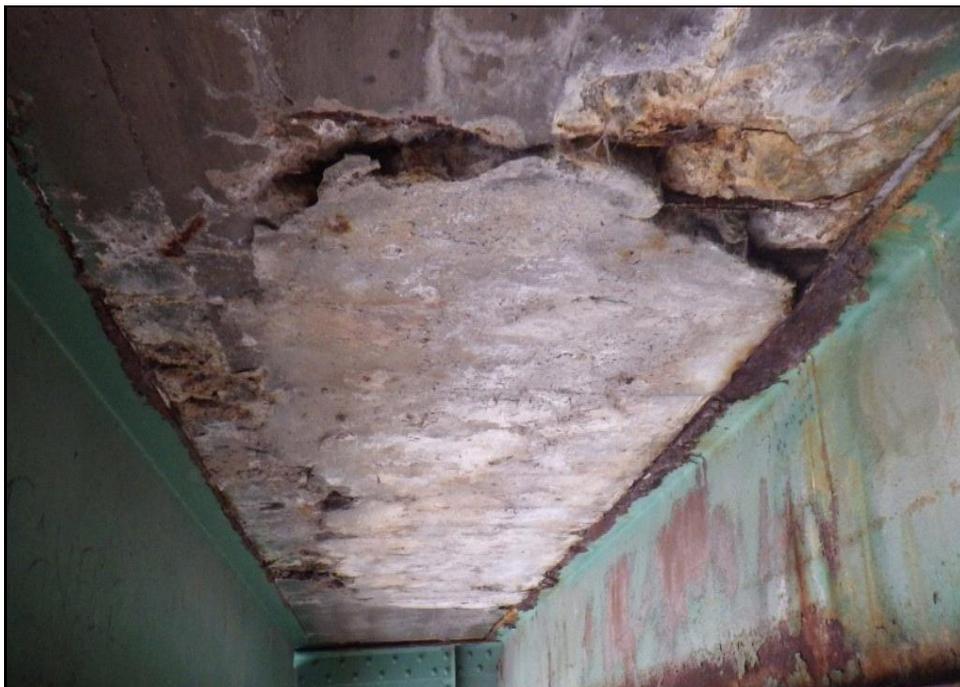
Deck soffit of Bay 2 between Stringers A and B showing previous full-depth deck patch with perimeter spalling and exposure of reinforcing

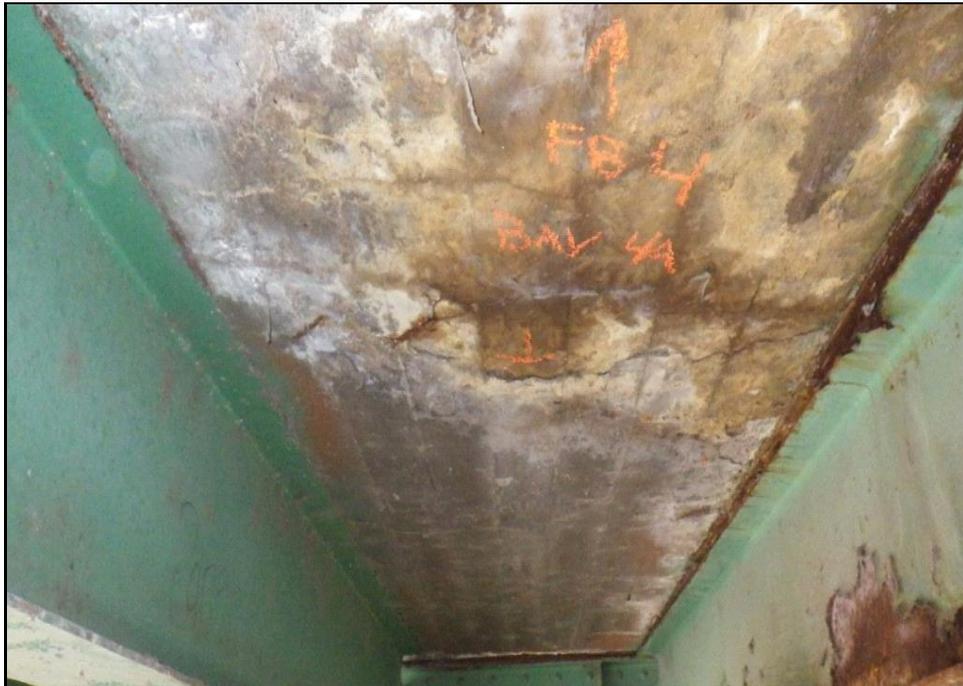
Deck soffit of Bay 4 between Stringers A and B with cracking and active leakage

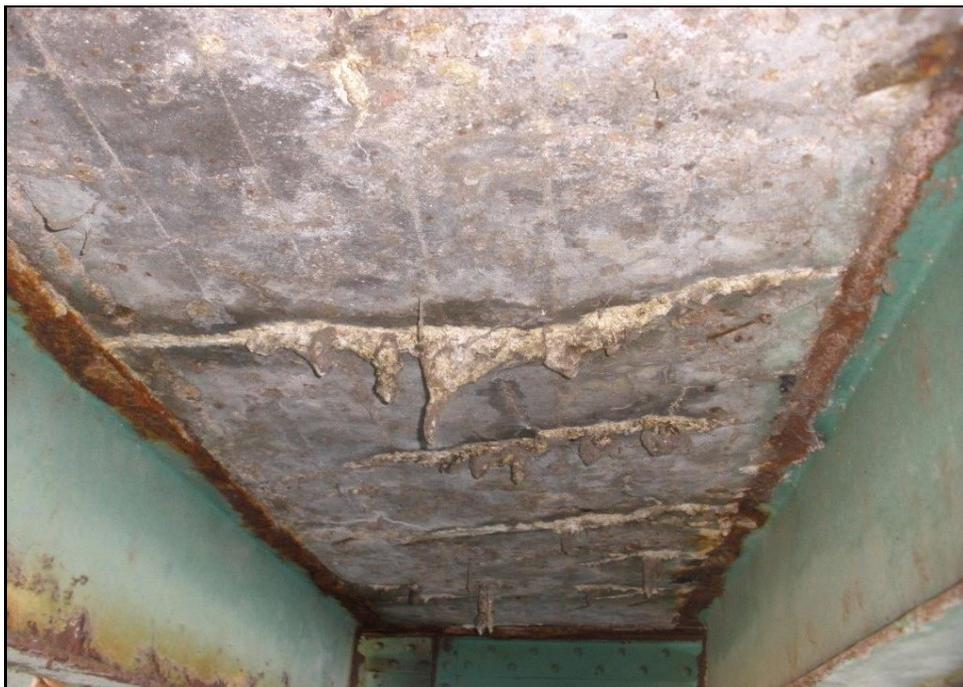
Deck soffit of Bay 12G with transverse cracking and heavy efflorescence stalactites

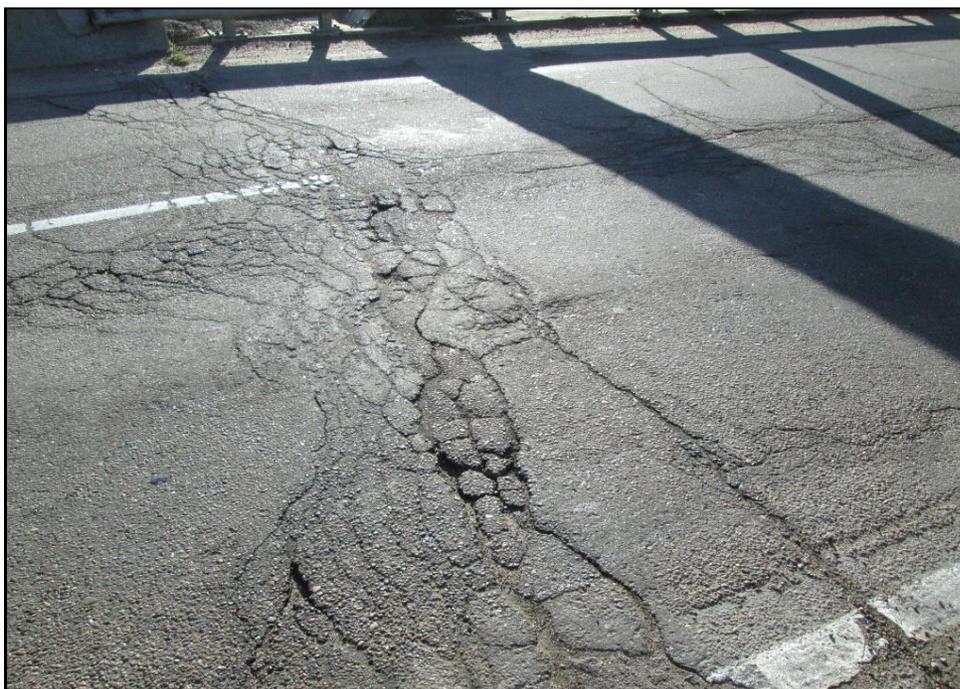
Transverse and tightly spaced pattern cracking with impending potholes in north approach asphalt

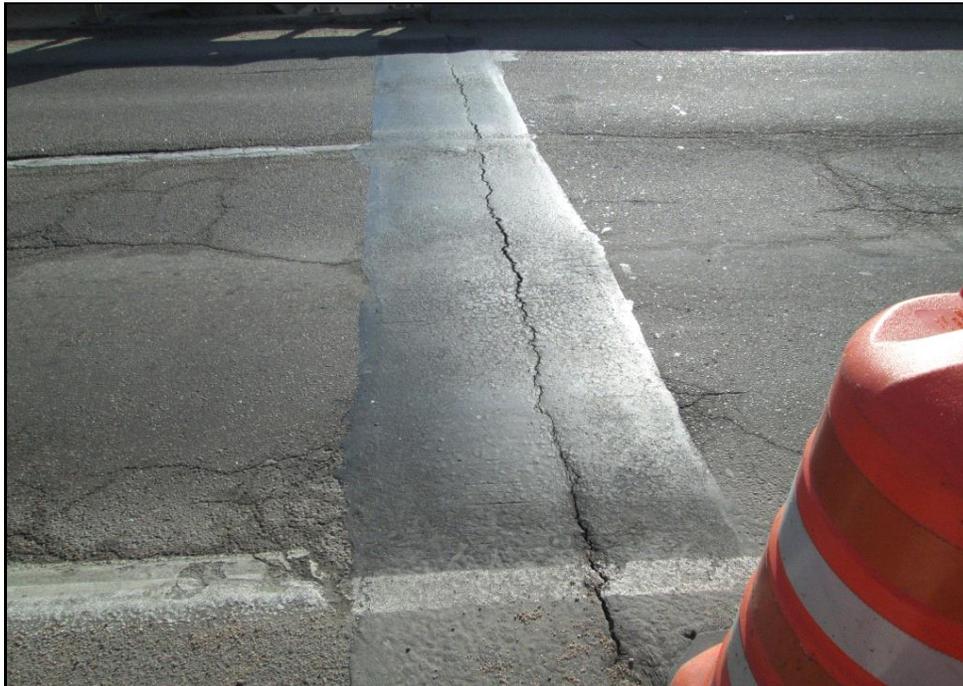
Asphaltic plug joint at south approach with minor rutting and crack transverse to roadway open 0.25 inch wide

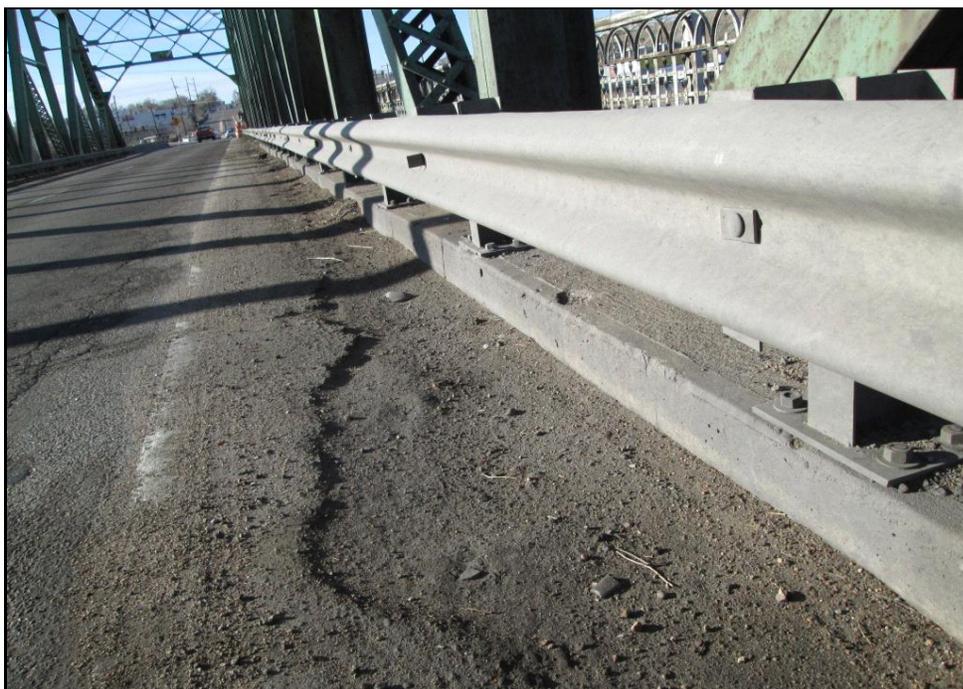
Ravelling of asphalt deck overlay typical near curbs

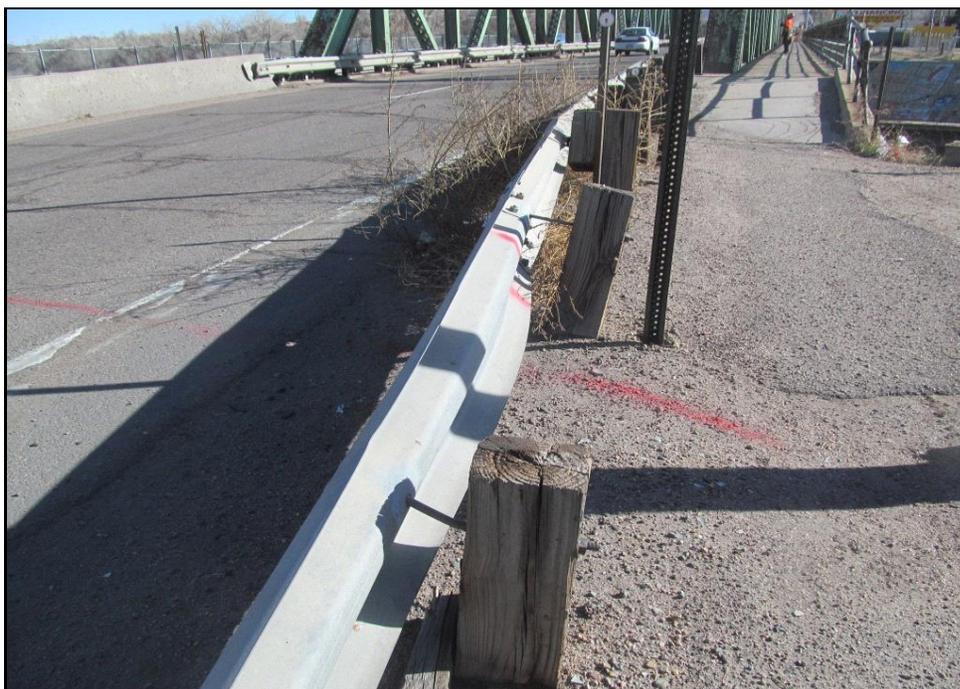
Northwest approach rail with two posts missing timber blockouts

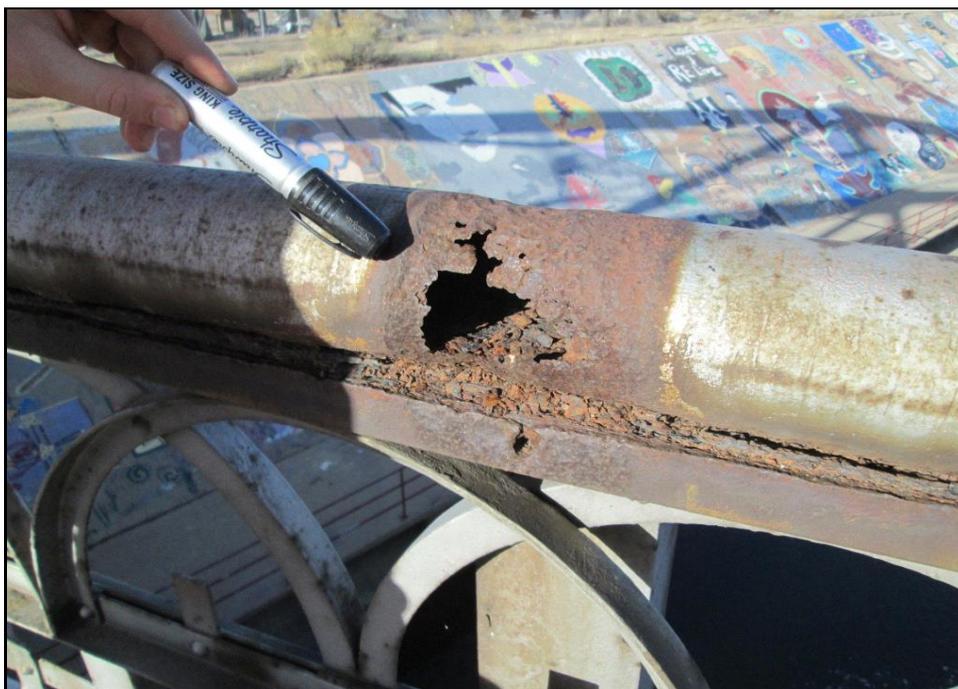
West pedestrian rail top rail with missing splice cover plate and corrosion perforation of welded splice

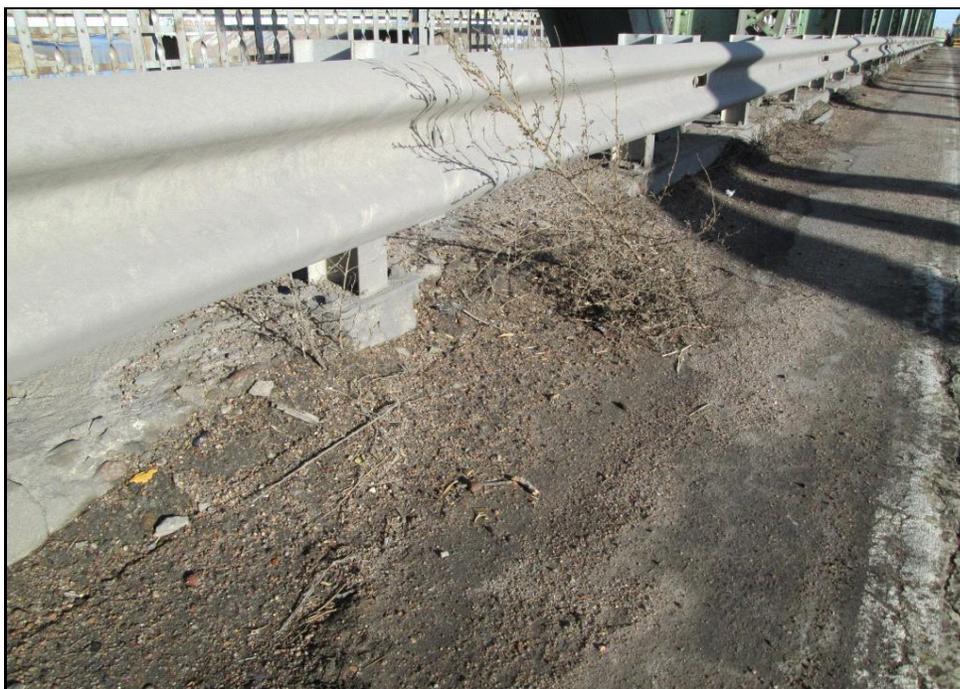
Spalling and disintegration of west concrete curb near Panel Point 11

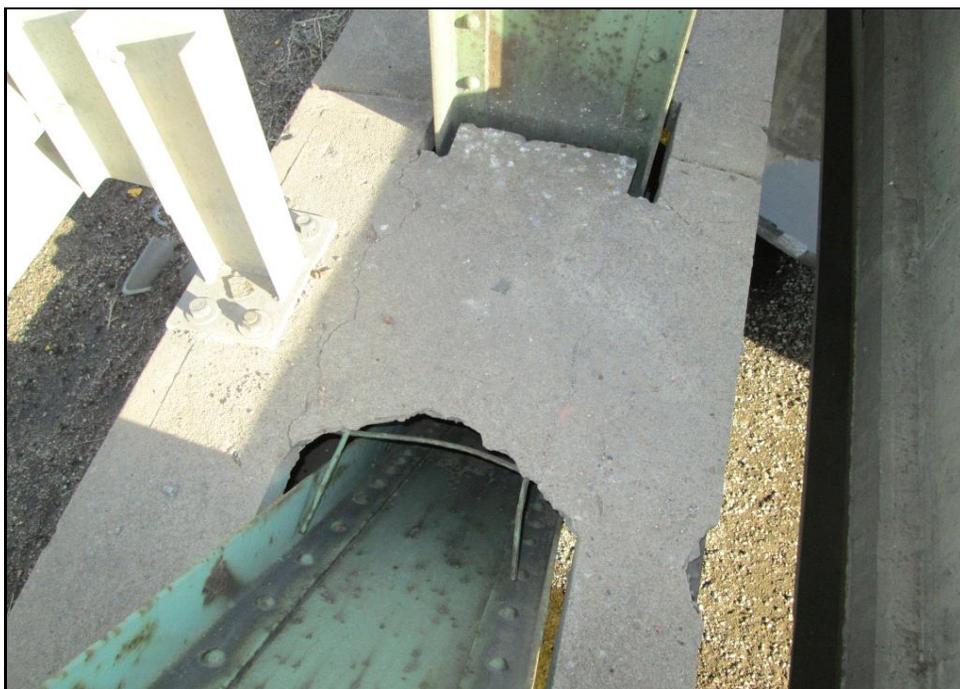
Typical cracking in concrete sidewalk and spall with exposed reinforcing near Panel Point 10 of the East Truss, typical at multiple locations

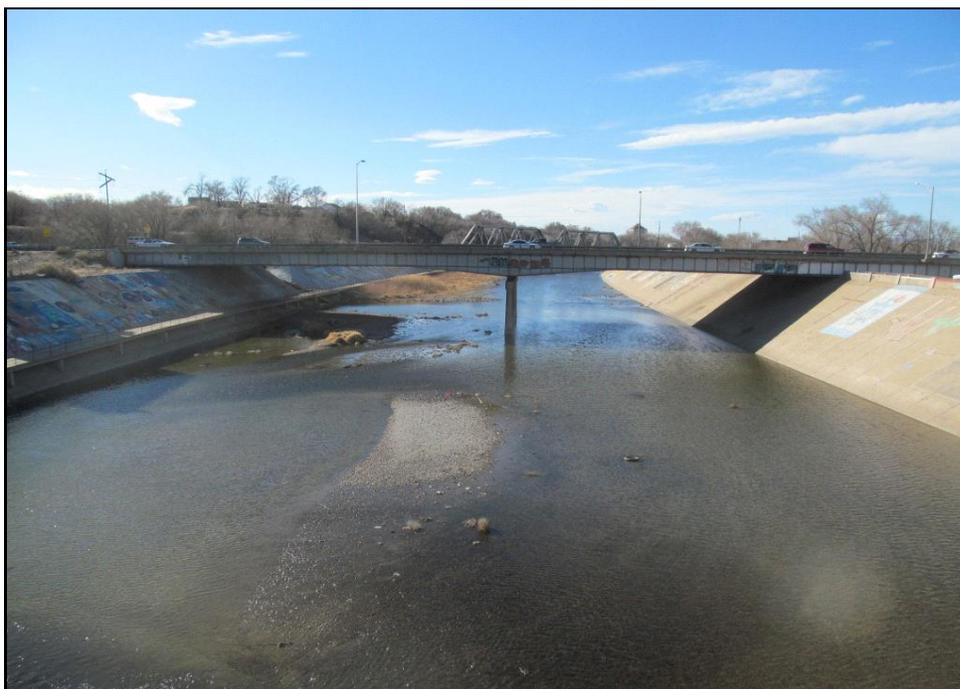
Channel looking upstream

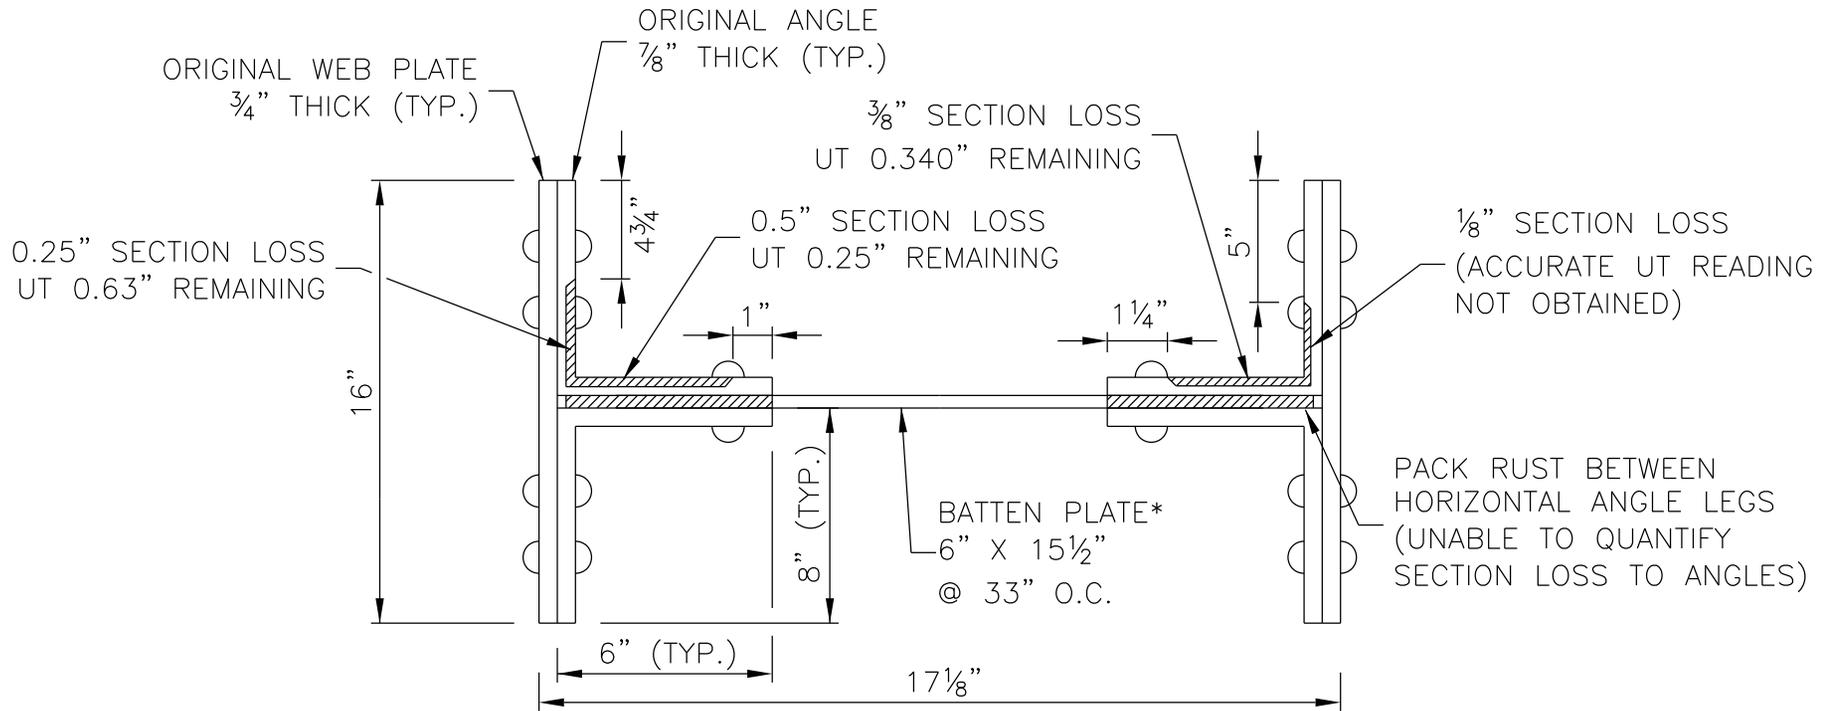
WORST-CASE SECTION LOSS, RIGHT TRUSS LOWER CHORD
 BAY 10, 32 INCHES NORTH OF PANEL POINT 10

Isolated areas of R2 to R4 laminating corrosion of the lower chord top angles exist where debris has accumulated causing up to 5/8 inch section loss. The worst case lower chord top angle section loss was observed within Panel 10 of the right truss and Panel 12 of the left truss. Detailed measurements of section loss were recorded at these locations and are included in the cross-sectional sketches within Appendix D.

NOTE: SECTION LOSS IN CROSS SECTION SHOWN
 DEPICTS 12" LONG AFFECTED SECTION
 OF LOWER CHORD

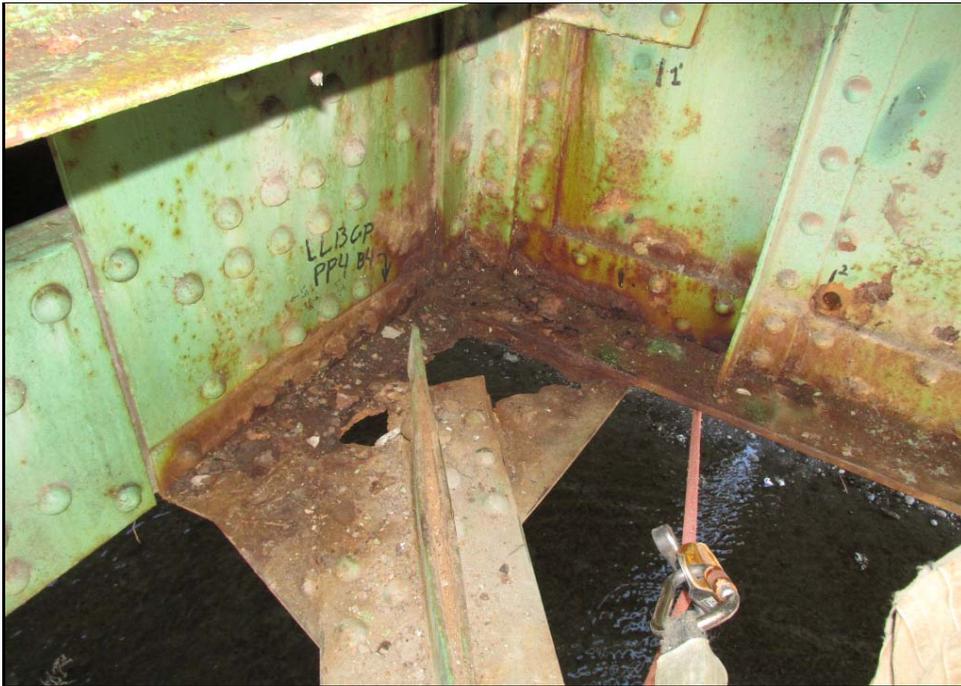
Typical condition of floorbeam connection and deterioration with corrosion to end
4 to 6 feet of floorbeam (each face, each end)

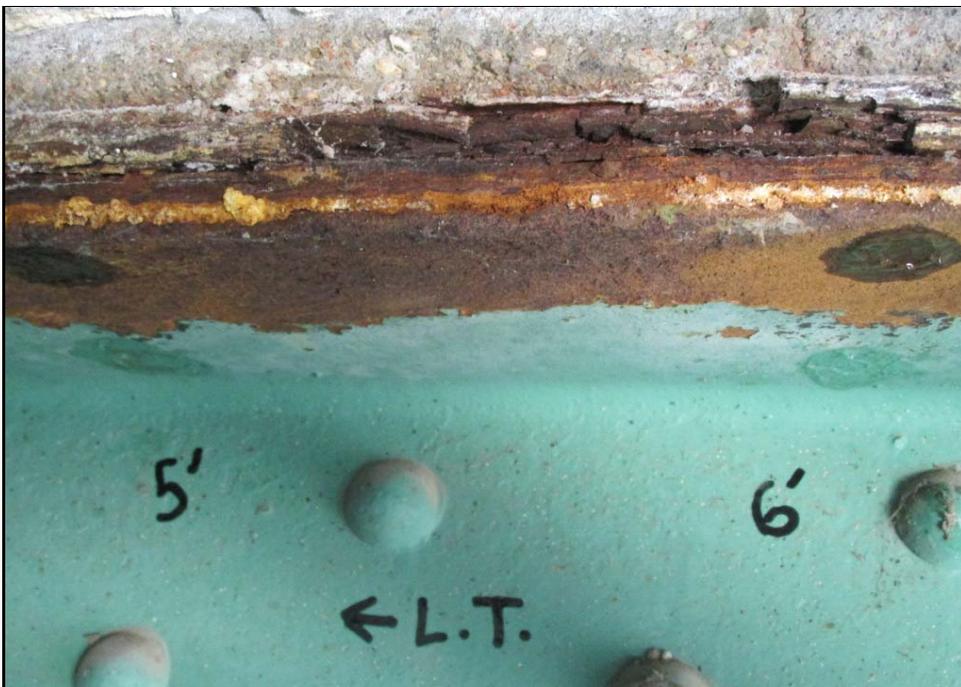
Typical condition of floorbeam top flange from 0 to 8 feet at each end of floorbeam
