In-depth Fracture Critical and Routine Inspection Report

Structure: K-18-R
Crossing: Arkansas River
Route: US 50 Business East-Bound
County: Pueblo
State: Colorado

Inspected by:
Stantec Consulting Services
2000 S. Colorado Blvd. Ste. 2-300
Denver, Colorado 80222
Frank J. Block, PE, NBI Team Leader

Inspection Date:
March 11, 2014

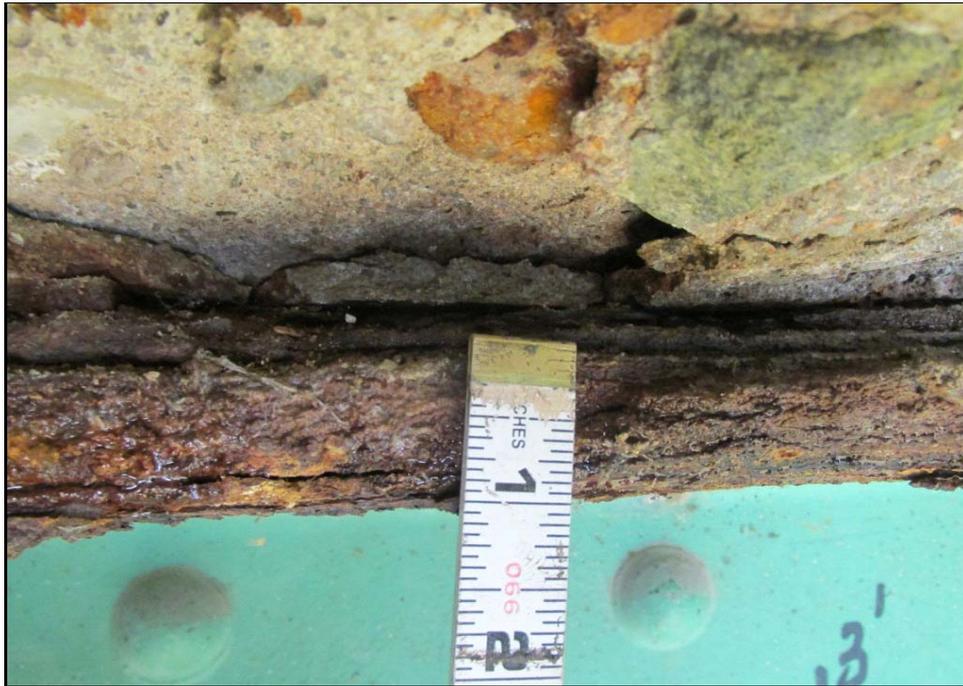
Close-up of inherent laminations in leg of top flange angle from active corrosion

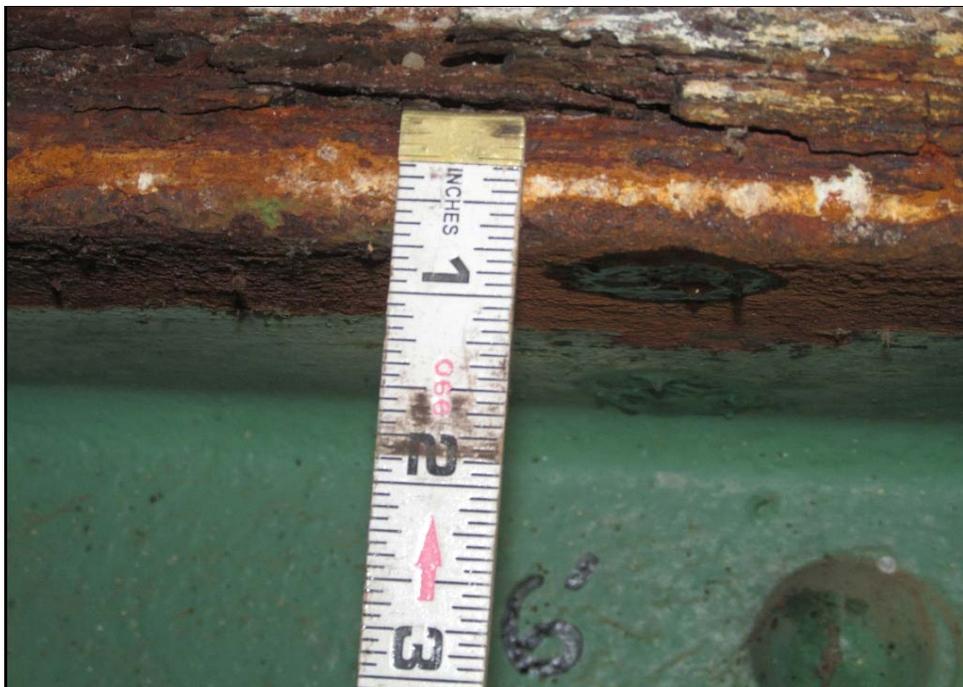
Close-up of inherent laminations in leg of top flange angle from active corrosion

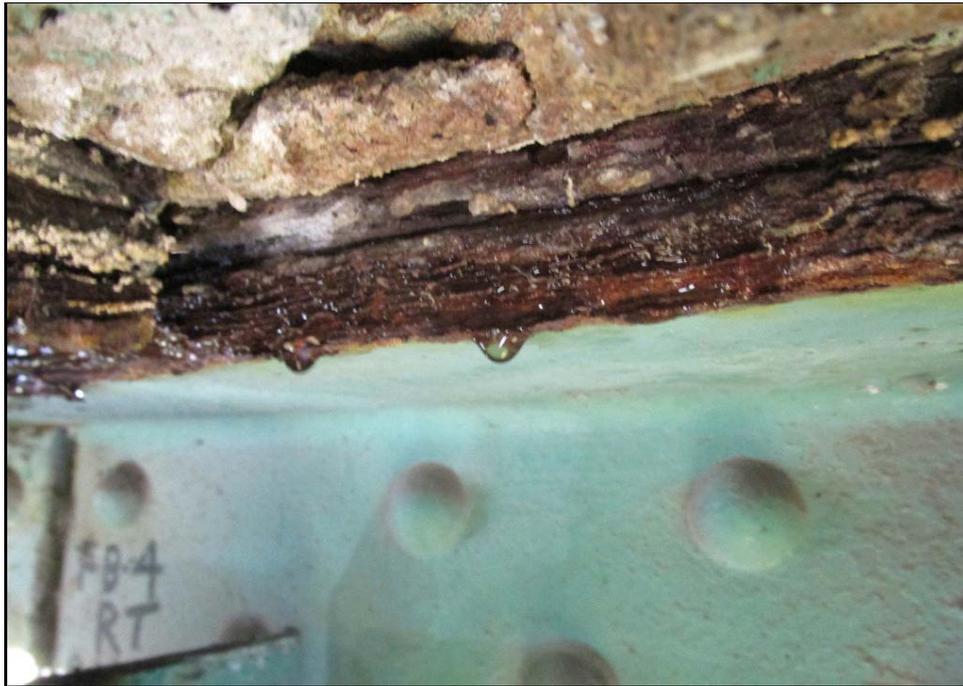
Active leakage from construction joint in deck above floorbeam top flange

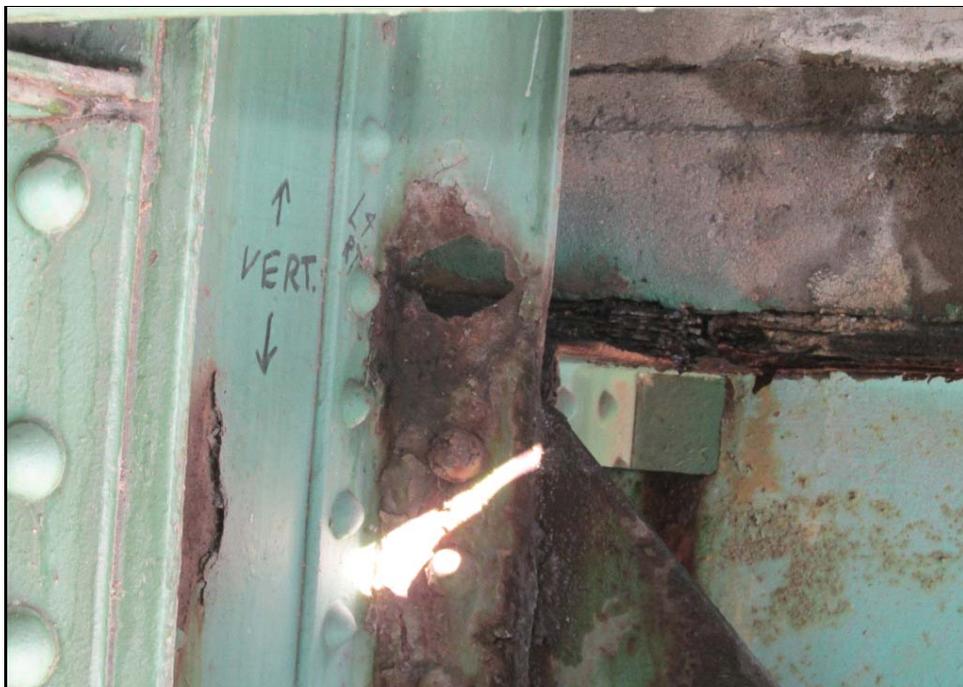
Right truss vertical (L4U4) at L4 connection with Floorbeam 4 with perforation
