**RENOVATION SPECIFIC ASBESTOS
AND LEAD-BASED PAINT INSPECTION
REPORT FOR**

BRIDGE STRUCTURE ID E-17-JP

**INTERSTATE I-70 OVER HAVANA STREET
AT MILE POST 280.667**

April 4, 2012

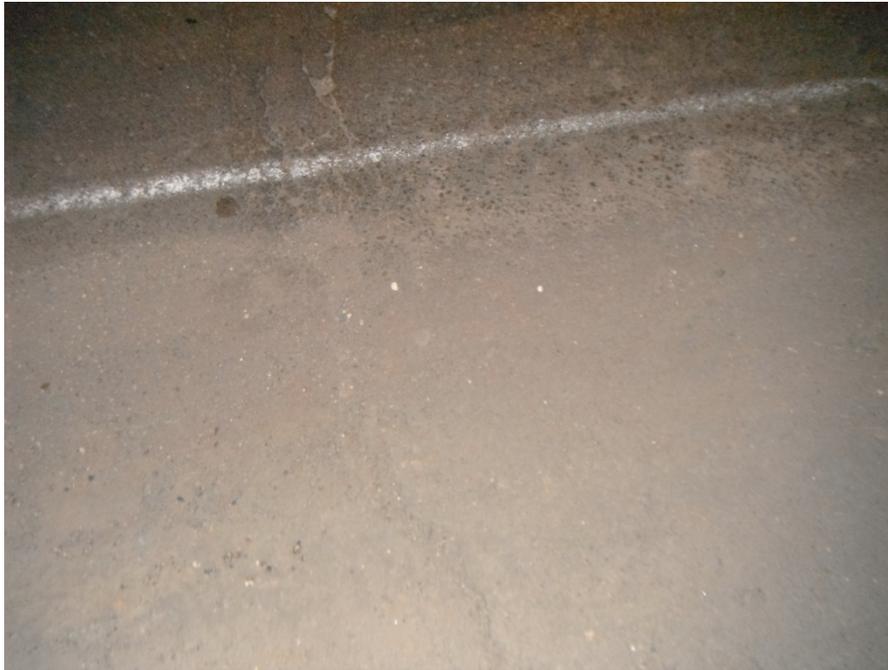
Sample IDs	Material Description	Material Condition	Analytical Result	Approximate Quantity
E-17-JP-ARB01-01 E-17-JP-ARB01-02 E-17-JP-ARB01-03	Asphalt road base, black/brown, granular, with tar, tar impregnated waterproofing membrane, deck of the bridge	Good	None Detect	30,302 Square Feet
E-17-JP-EJM01-01 E-17-JP-EJM01-02 E-17-JP-EJM01-03	Expansion joint material, brown, woven, fibrous, located at the east and west bridge seams beneath the bridge deck	Good	None Detect	~278 Linear Feet

Photo 2 – View of asphalt road material – ARB01

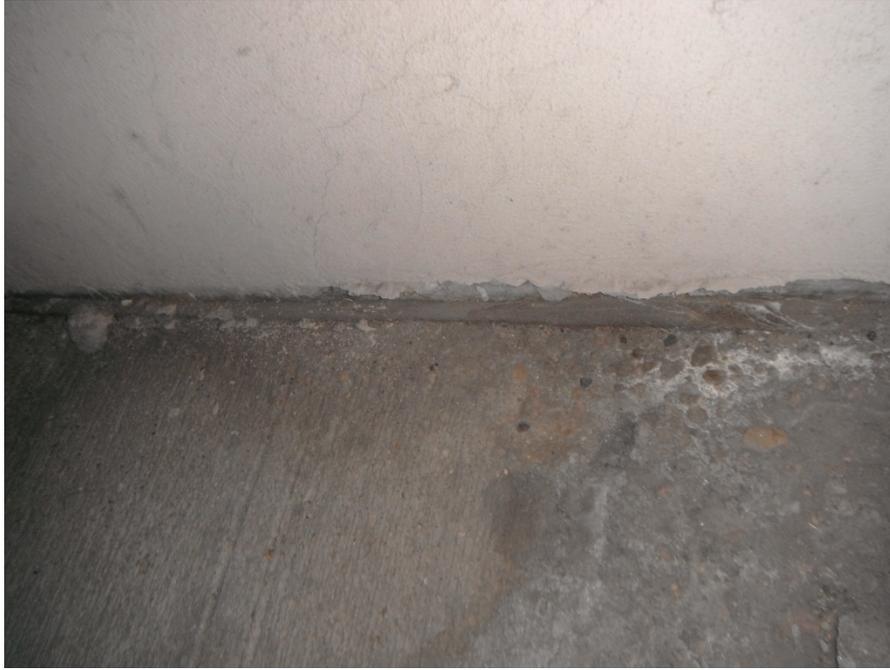
Photo 3 – View of brown expansion joint material – EJM01

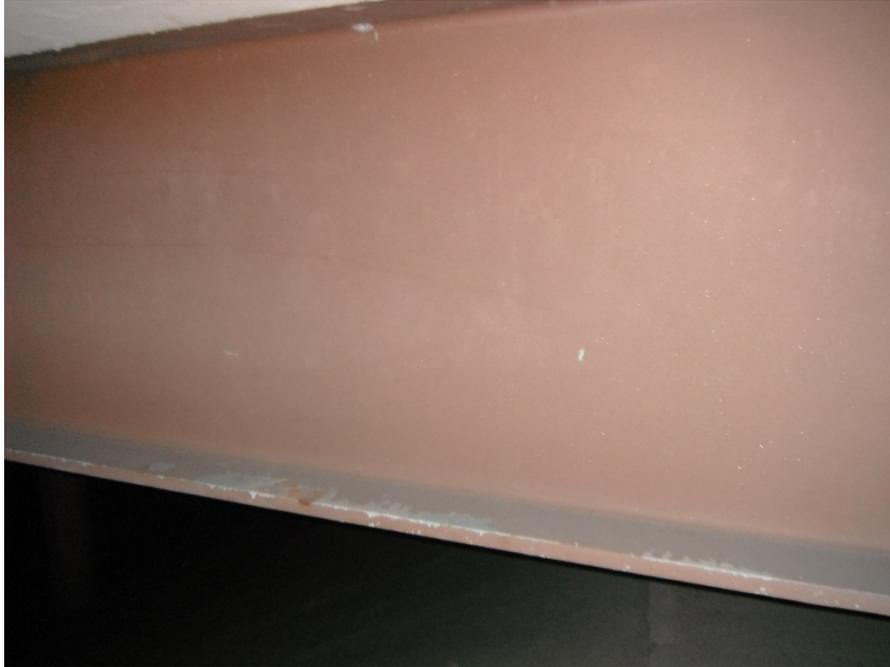
Sample IDs	Paint Description – Sample Location	Material Condition	Analytical Result %	Status*
E-17-JP-LBP01	Brown paint located on structural steel girders beneath the bridge deck – S side of S girder, 10' f E	Good	7.745	LBP
E-17-JP-LBP02	Tan paint located on concrete foundation/wall – east wall, 65' f S, 3' up	Good	<0.004	ND

Photo 4 – View of brown paint on structural steel beam – LBP01

- Brown paint located on structural steel girders beneath the bridge deck (LBP01).

Renovation activities involving LBP are subject to the OSHA Construction Industry Standard for Lead (Title 29 CFR, Part 1926.62). This standard is similar to other OSHA standards in that it addresses such issues as worker training, medical evaluations, personal protective equipment, exposure assessment, air monitoring, hygiene facilities and work practices.

To comply with EPA and CDPHE air, solid waste and water quality standards, appropriate work practices, engineering controls, and other precautions should be taken to ensure lead containing materials are not introduced into surrounding roadway, soil, road drainage systems, and waterways.

The types and locations of LBP/LCP paint, and regulatory requirements should be disclosed to the renovation contractor to avoid accidental disturbance, and for contractor compliance with applicable regulations (to ensure proper worker protection and material disposal).

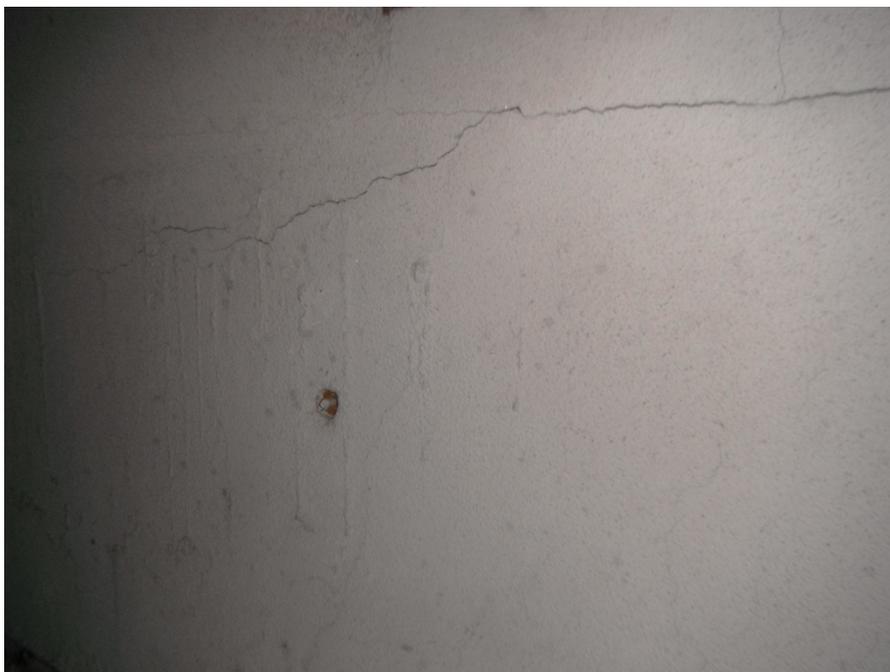
Photo 5 – View of tan paint on concrete wall – LBP02
