Appendix B

2009 Structure Inventory and Inspection Report

Colorado Department of Transportation
Structure Inspection and Inventory Report (English Units)

Bridge Key: F-16-EJ Inspection Date: 12/21/2009 Sufficiency Rating: 47.8 SD

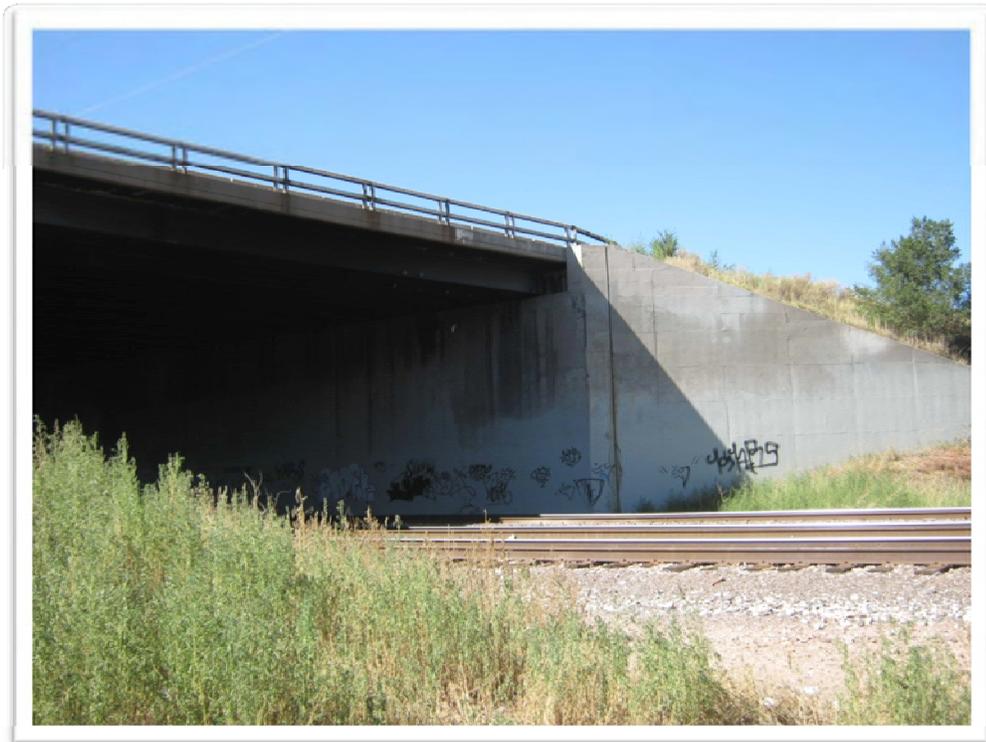
Photograph 3 – Existing abutment looking west

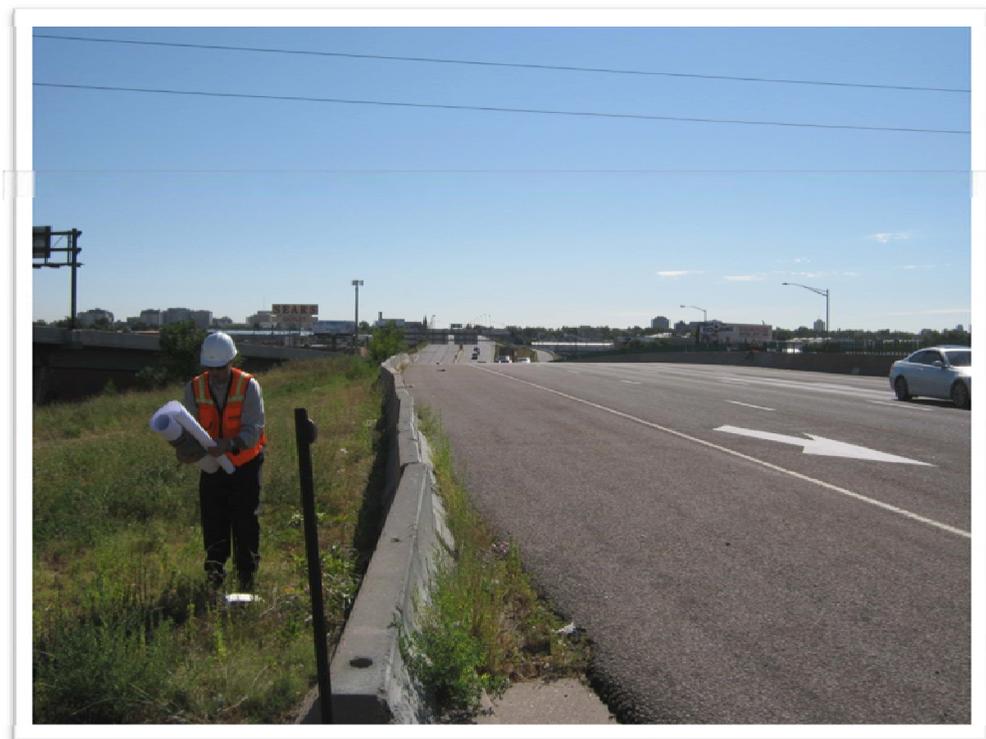
Photograph 4 – West approach looking east

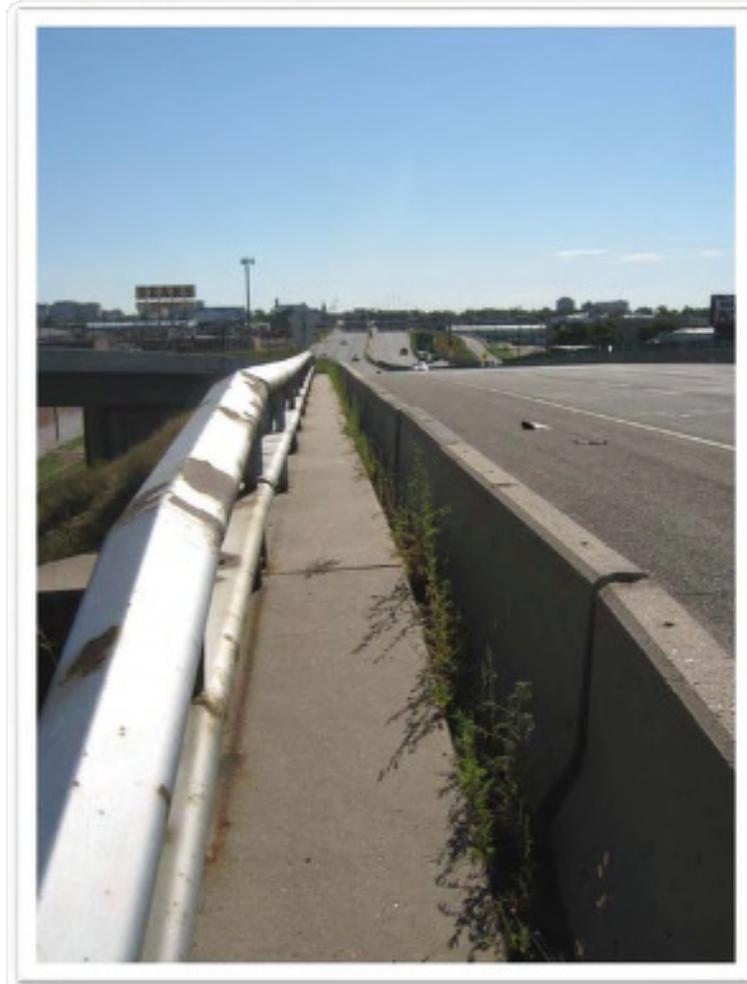
Photograph 5 – Existing bridge rail and deck looking east

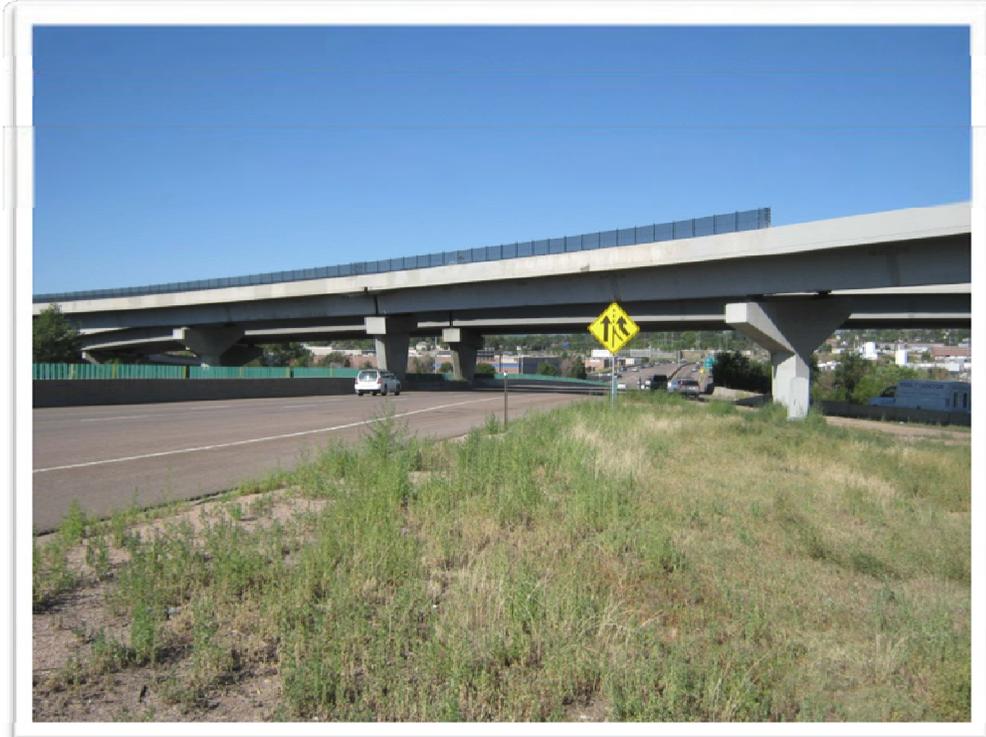
Photograph 6 – Existing US-6 under Structure F-16-OL looking west
