Report No. CDOT-DTD-R-92-3

GILSONITE, AN ASPHALT MODIFIER

Final Report
March 1992

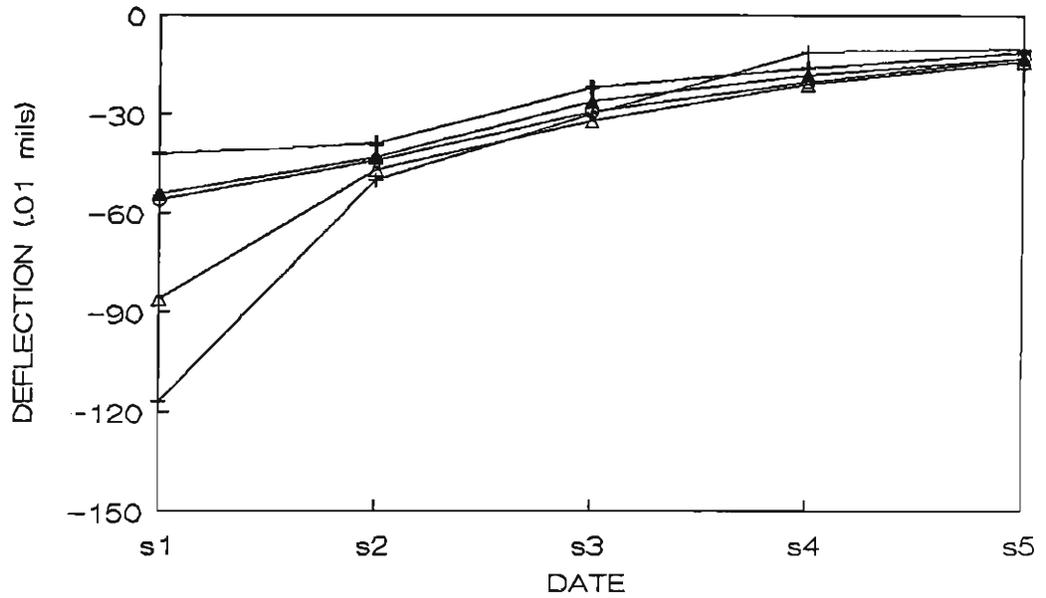
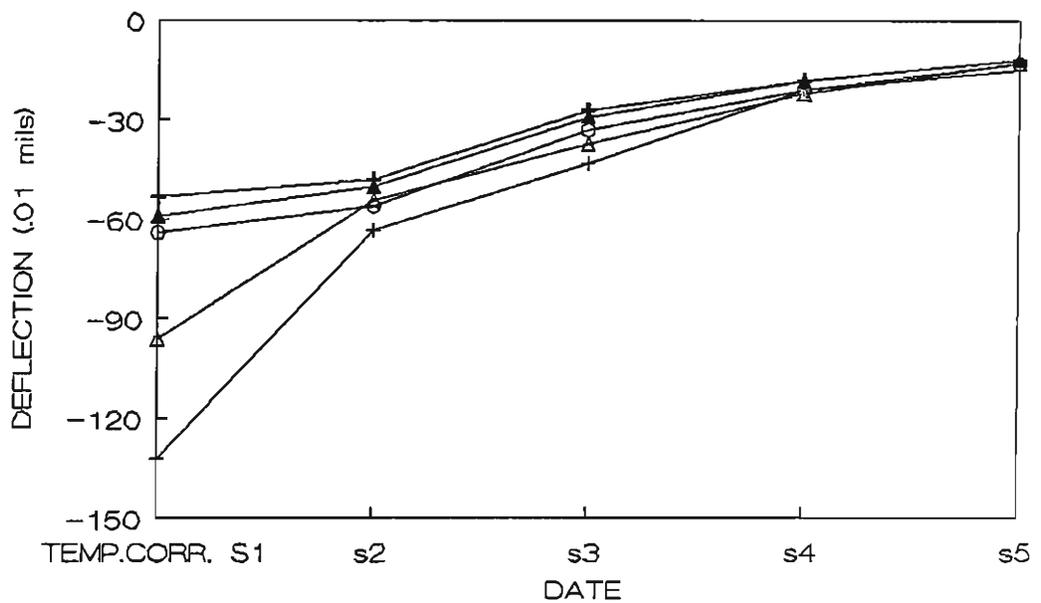
FIGURE 4

The deflection measurements taken prior to construction and over the evaluation period indicate that the load carrying capacity of the pavement section increased slightly following construction. The pavement appeared to become stronger over the first year following construction and then leveled off. There was no significant difference in the overall strength of the pavement when comparing the control and test sections. A graph of the deflection basins for the test and control sections over the evaluation period can be found at the end of this section (figure 4).

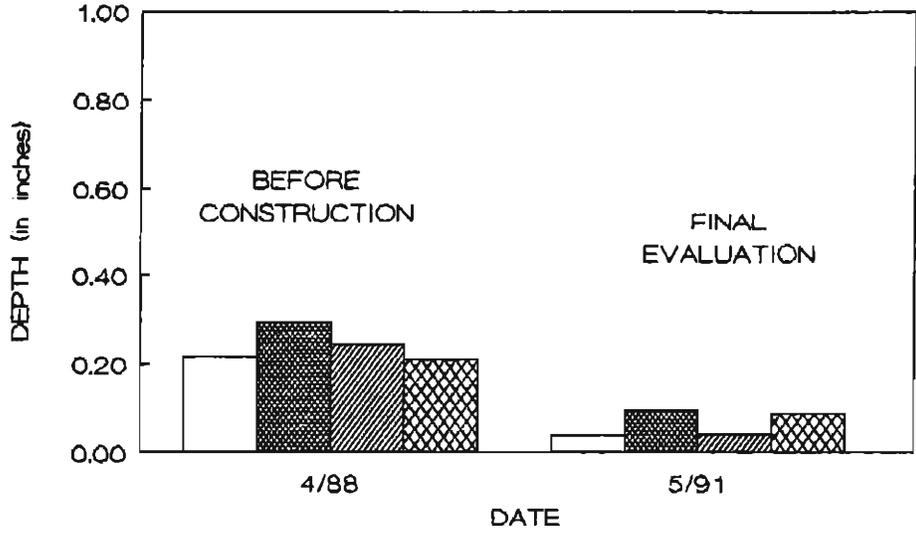
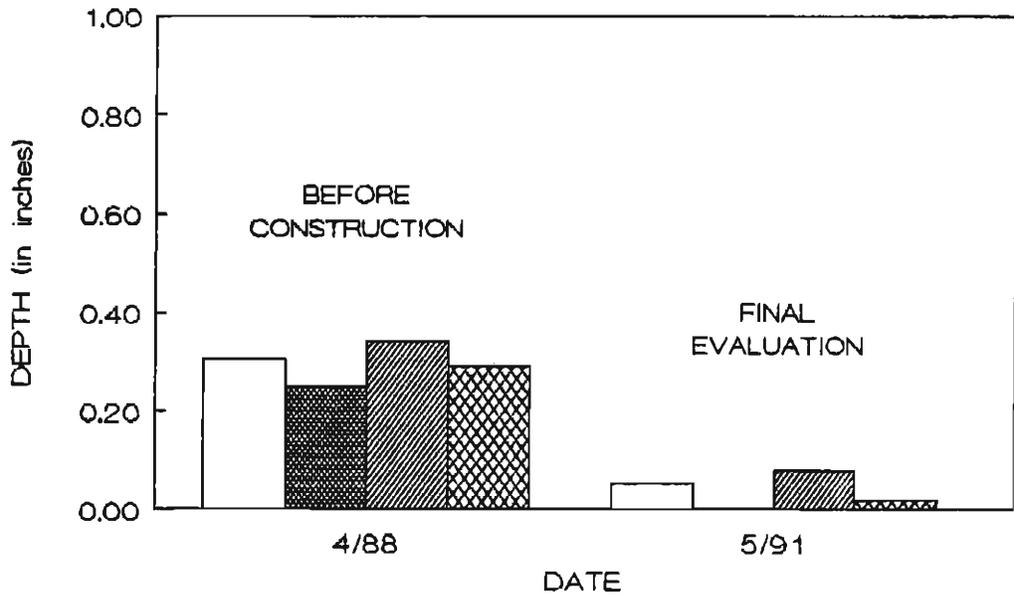
FIGURE 5

Rutting measurements were taken each year. The rutting measurements taken during the last evaluation (spring 1991) indicate that rutting was not a significant problem in either section; however, the Gilsonite appears to be

helping the pavement resist the rutting and shoving action placed on the pavement at the intersection.

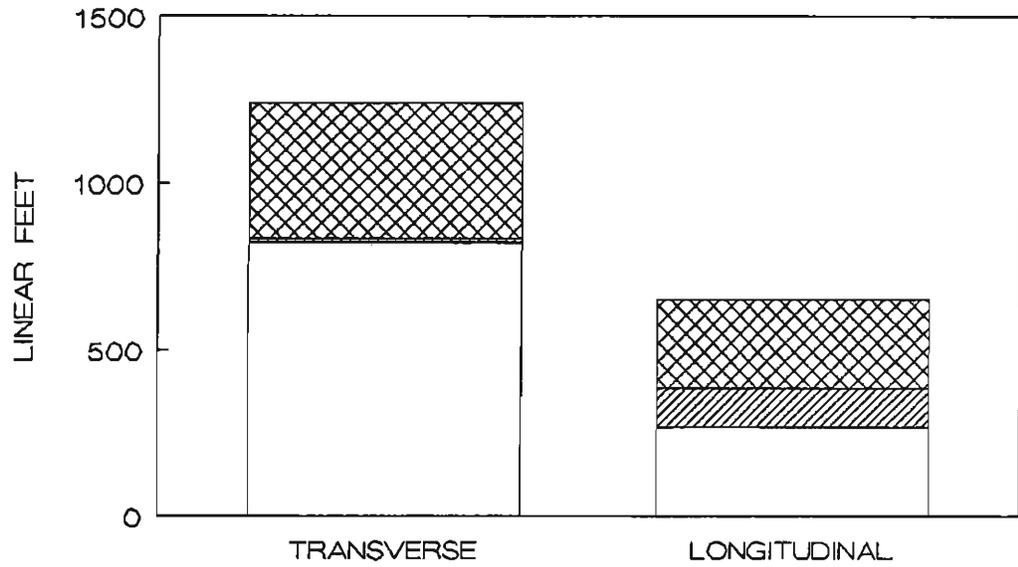
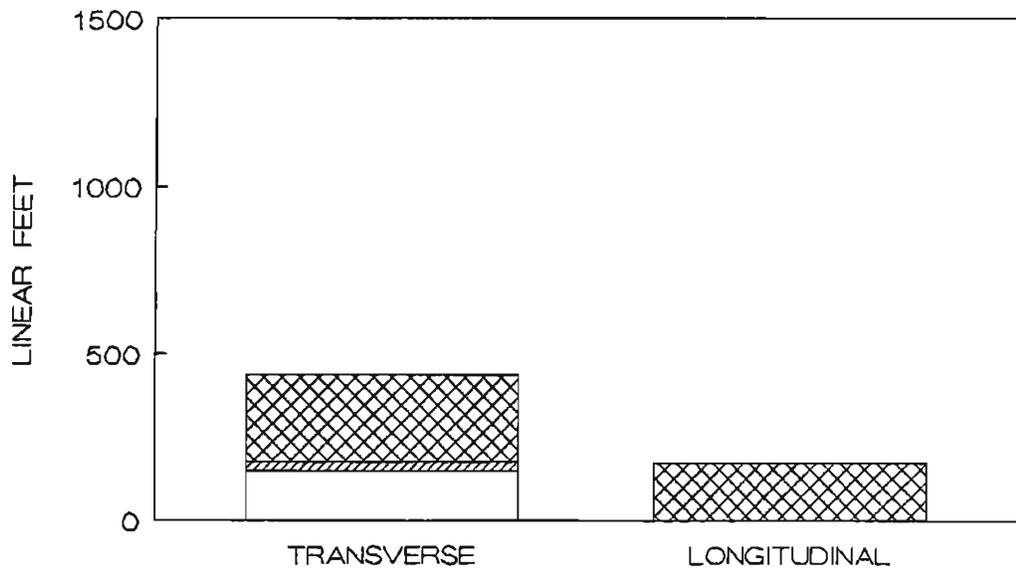
FIGURE 6

Cracking maps were drawn for the test and control section during each post-evaluation. During the first year, the Gilsonite test section developed a longitudinal crack that extended along the center line for nearly one half the length of the test section. Longitudinal cracking did not appear in the control section until three years after construction. In the Gilsonite test section there was approximately six times more transverse cracking than in the control section after the first year.

Following the final evaluation, cracking in the control section was minimal compared to the Gilsonite test section. The total cracking in the Gilsonite test section was approximately three times the amount in the control section. In May 1991, the Gilsonite section had a total of 1864 linear of cracking of which 1240 feet was transverse. During the same evaluation the control section had 567

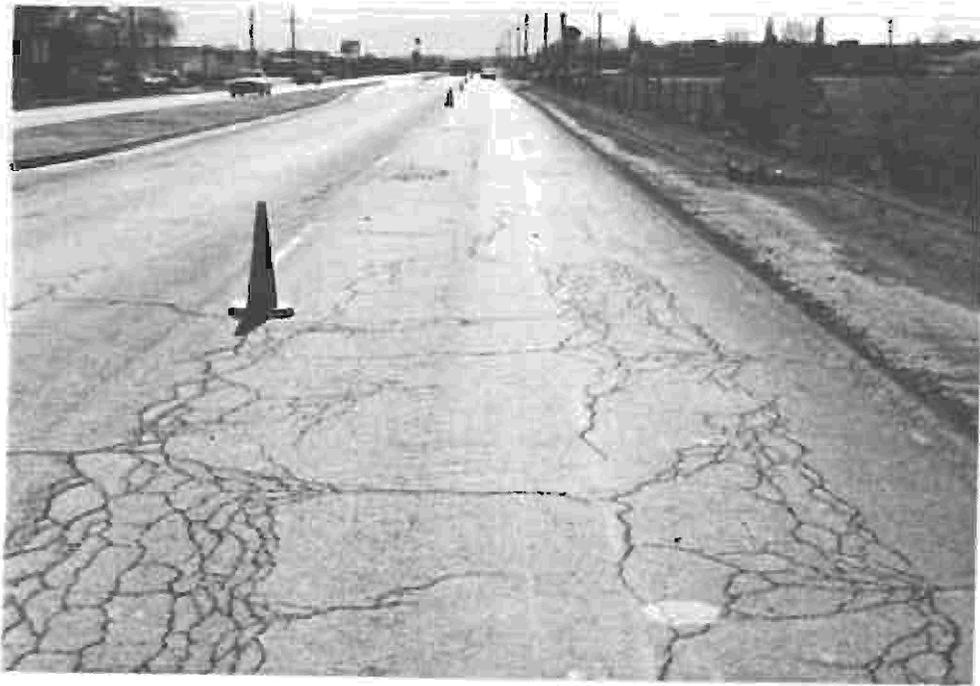
The pre-construction evaluation revealed that the existing pavement was alligator cracked in both wheel paths. This was intermittent throughout the project. The cracking pattern of the test and control section was fairly uniform and considered comparable.

Prior to construction alligator cracking was found intermittently in both wheel paths of the driving lane. This cracking pattern was found in the test and control sections.

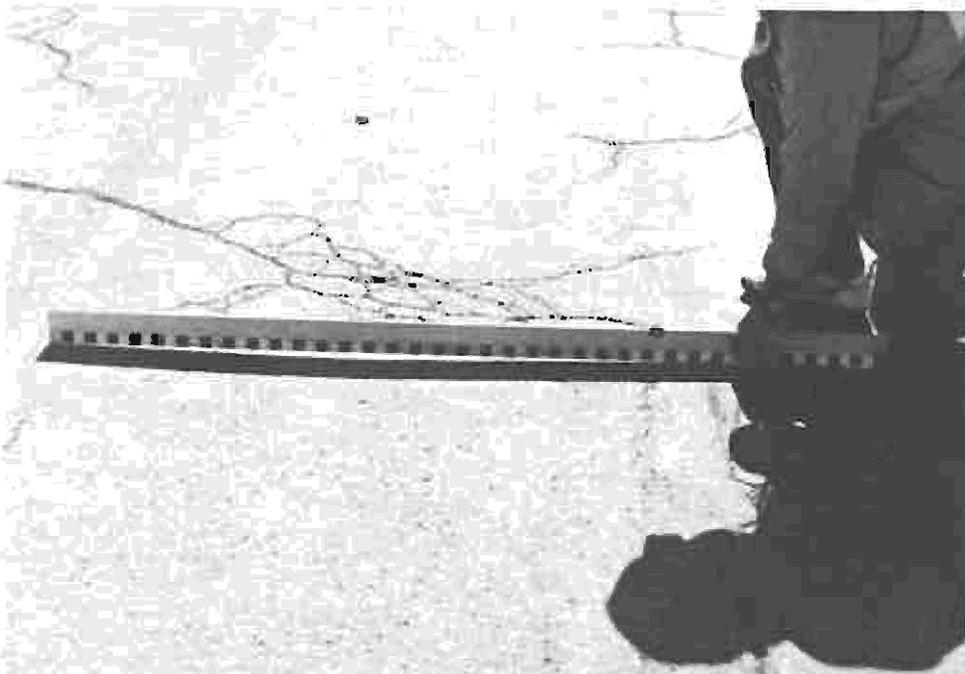
The rutting measurements taken prior to construction ranged between one-tenth of an inch to one-half of an inch. Typical rutting in the test and control sections was comparable prior to construction, except at the Unweep intersection where rutting was slightly higher.

Rutting on the pavement prior to construction ranged from 1/10 of an inch to 1/2 of an inch.

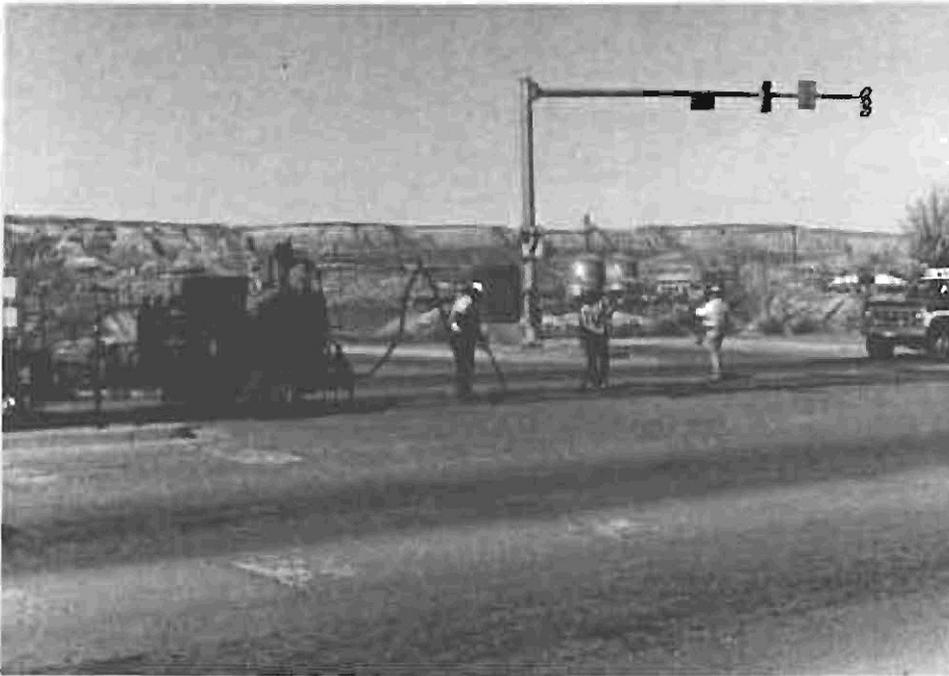
Prior to construction the cracks were cleaned and filled with a scrap rubber crack filler material.

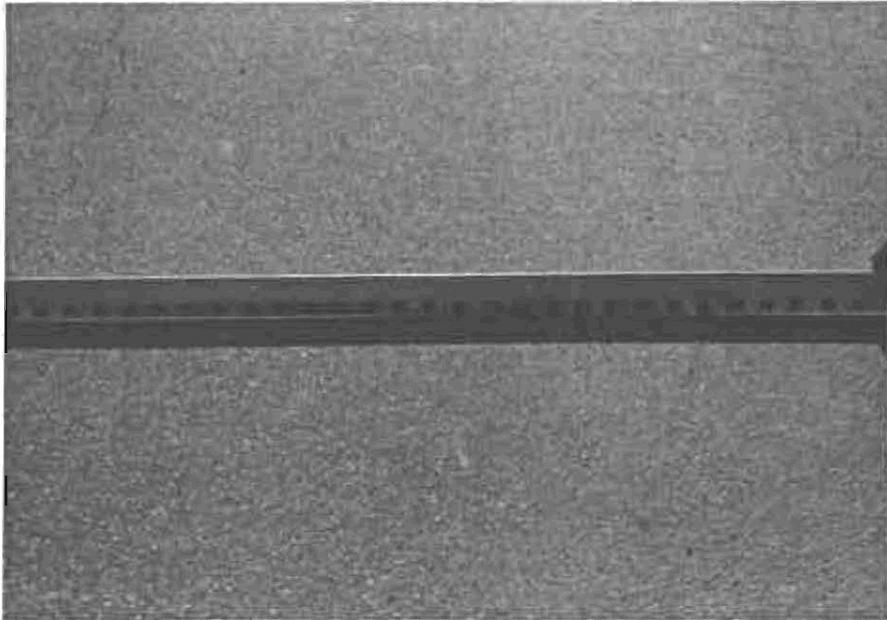
Rutting in the test and control section during the last evaluation was not significant.

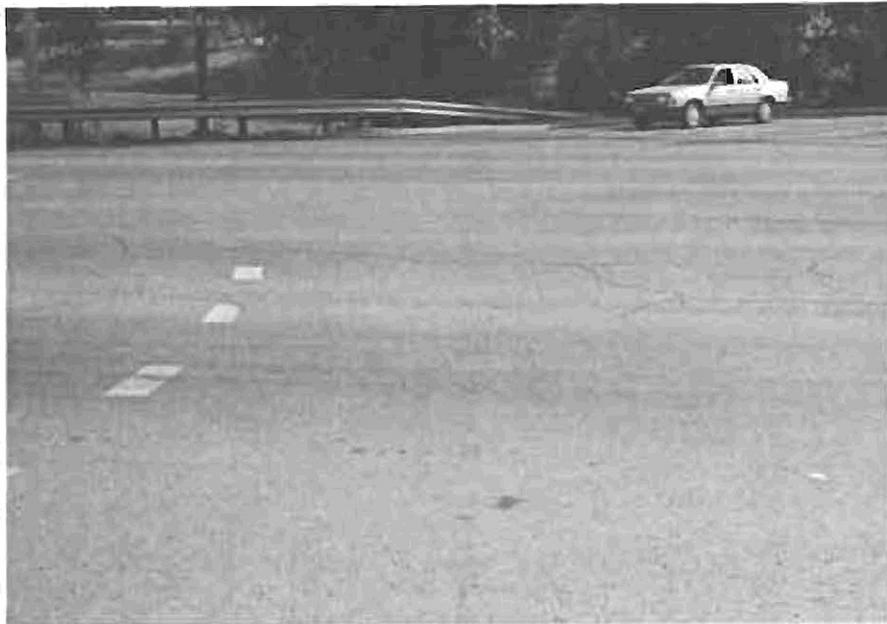
linear feet of which 399 feet was transverse. In addition, the cracks in the Gilsonite test section were wider and were deteriorating at a faster rate than the cracks in the control section. See photos on page B-5 in Appendix B.

This photo shows the amount of cracking in the Gilsonite test section at the last evaluation. August 1991

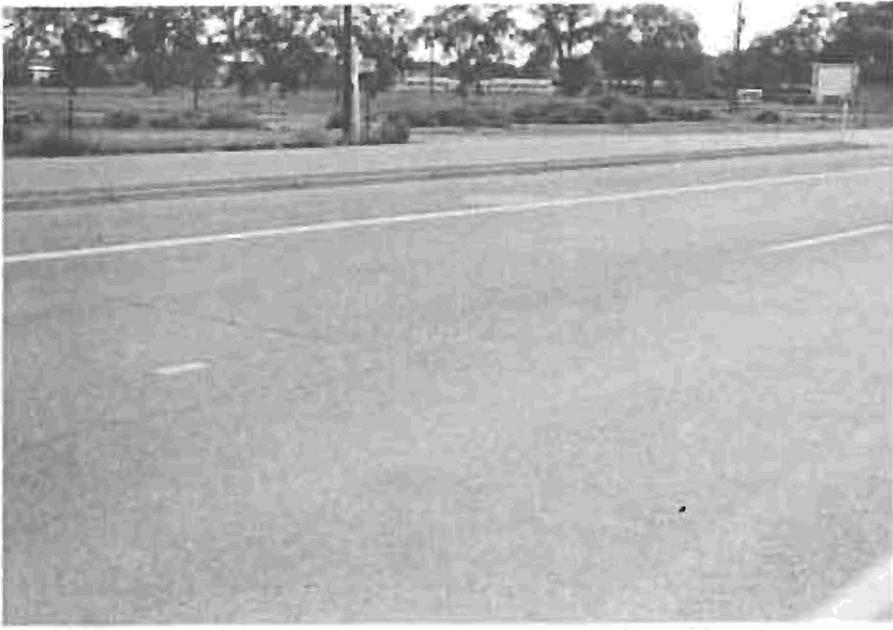
This photo shows a section where cracking has begun to appear in the control section. Photo taken August 1991.

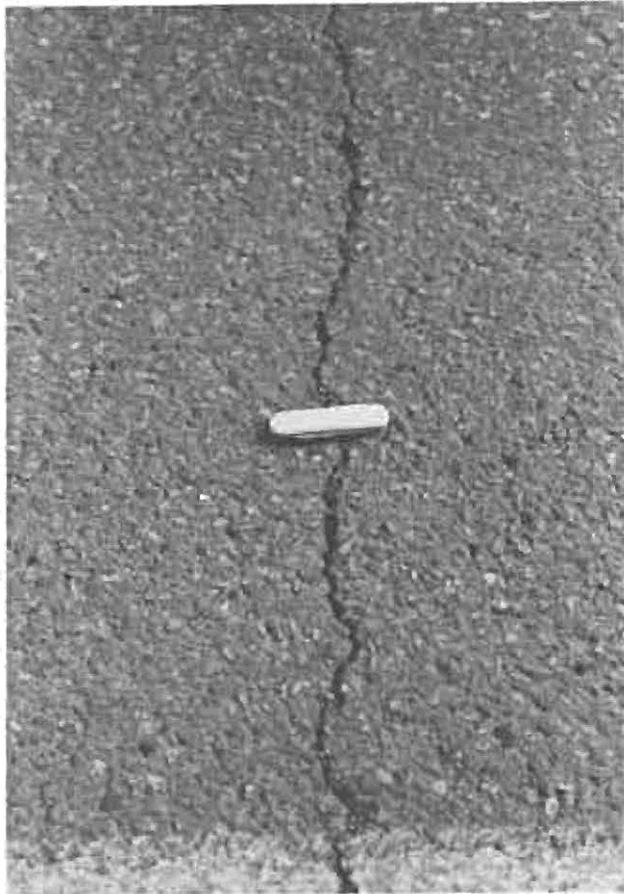
August 1991
control section

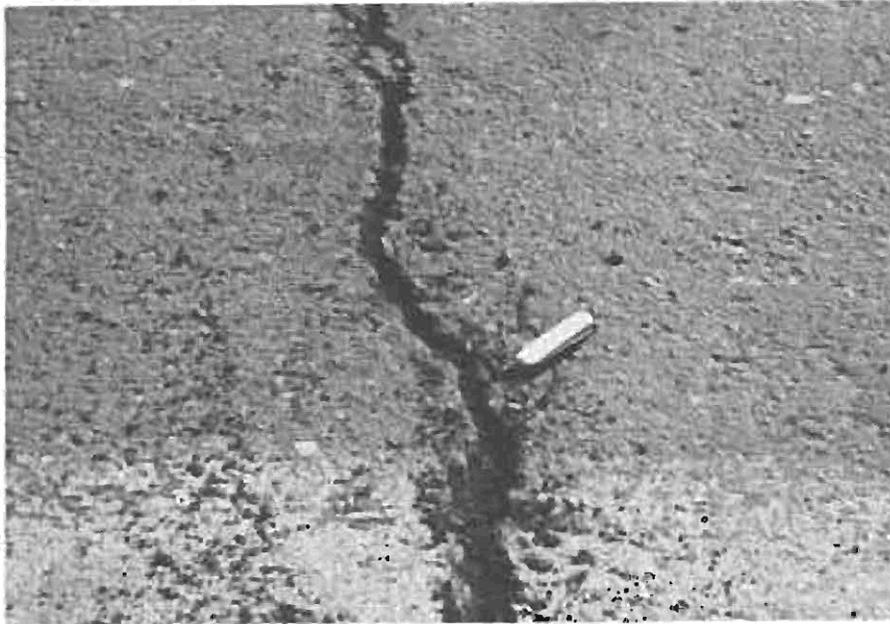
The cracks in the Gilsonite section are much wider than the cracks in the control section. August 1991 Gilsonite section

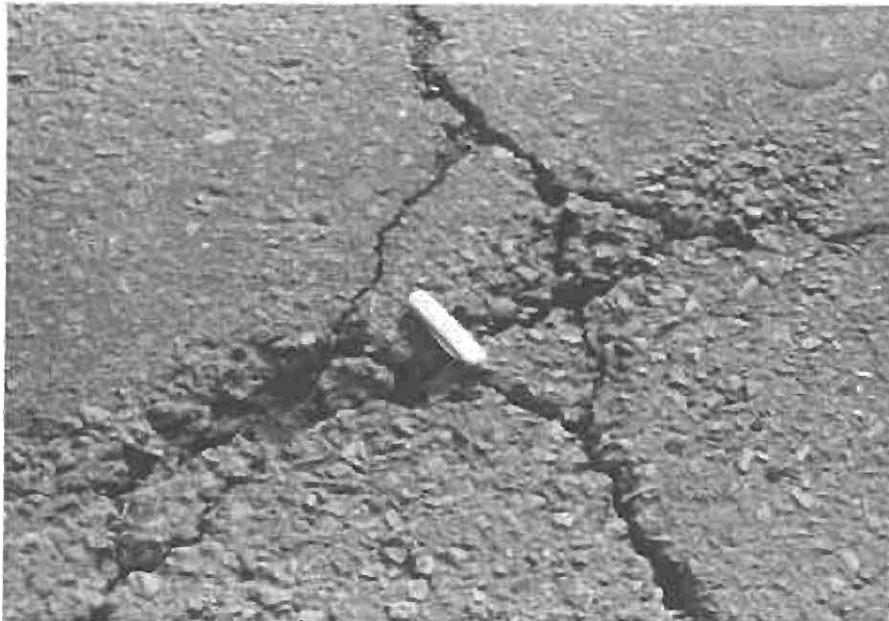
After considering these factors, the data collected over the evaluation period indicated the addition of Gilsonite appeared to reduce or retard rutting, however it tended to harden the pavement creating a structure that was more susceptible to premature cracking. The cracking appeared at a much faster rate and the cracks tended to deteriorate quicker and to a greater extent.

The cracks in the Gilsonite section are also deteriorating faster.

Based on the performance of this test section, the addition of Gilsonite cannot be justified. The consequence of increased cracking is much more severe than the benefit of the potential reduction in rutting.
