Report No. CDOT-DTD-R-91-9

POLYETHYLENE PIPES FOR USE AS HIGHWAY CULVERTS

Thomas R. Hunt
Colorado Department of Transportation
4201 East Arkansas Avenue
Denver, Colorado 80222

Final Report
July 1991

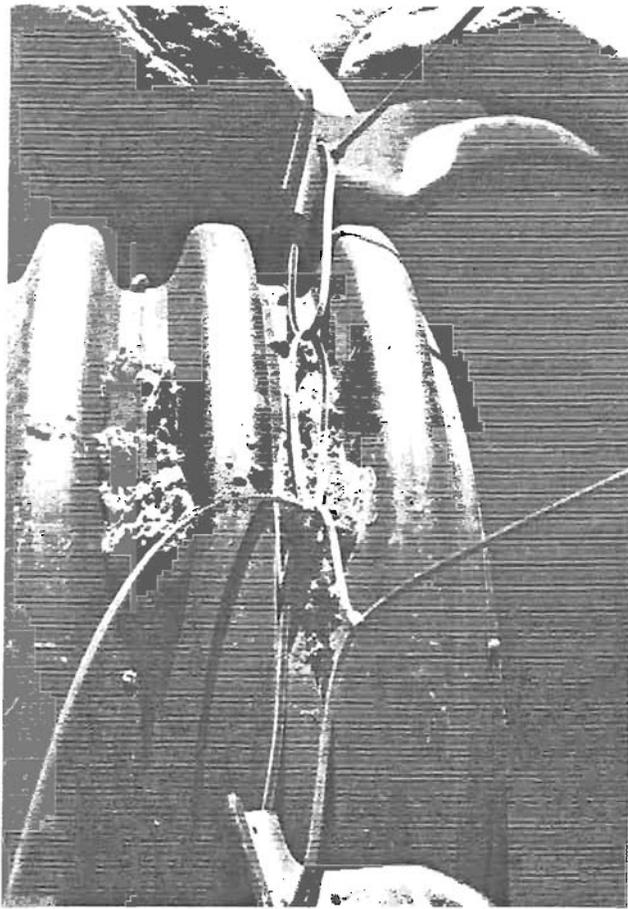
These nylon straps were used to attach the end sections. Despite concerns of deterioration or breakage, they remain intact after three years. On new installations, end sections are held in place with a threaded rod instead of the nylon straps.

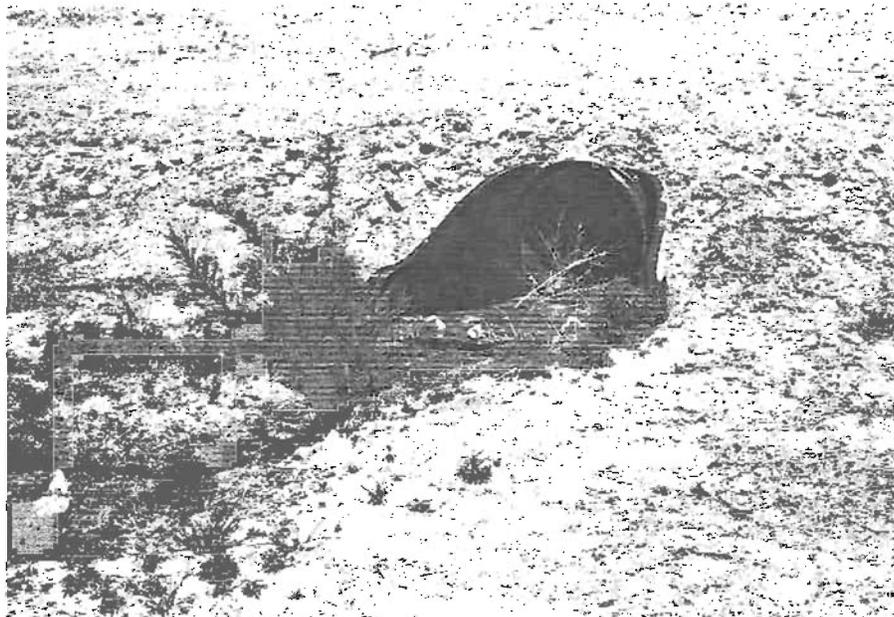
The end sections have not moved out of position either, despite their light weight. Some of them, like the one above, still look brand new. The others are only dirty.

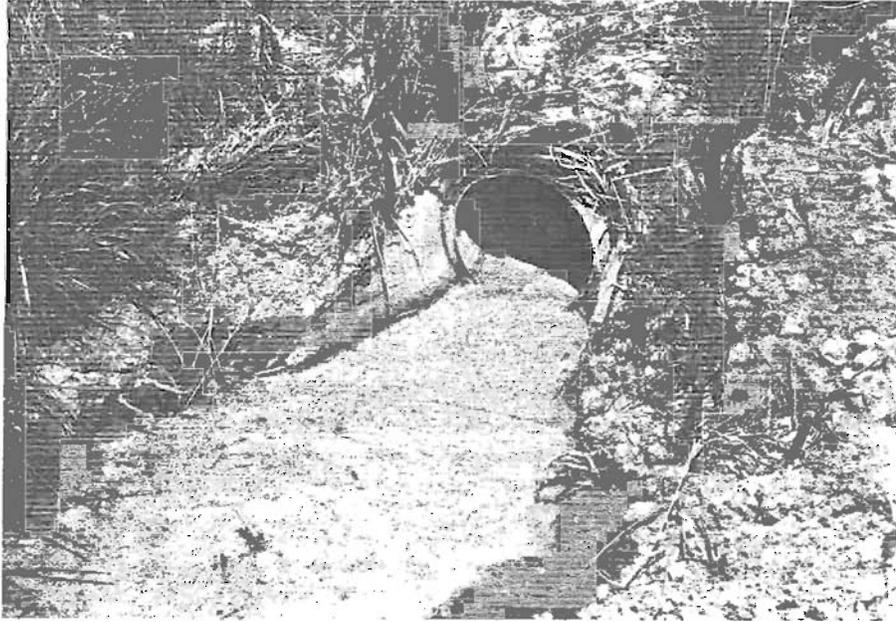
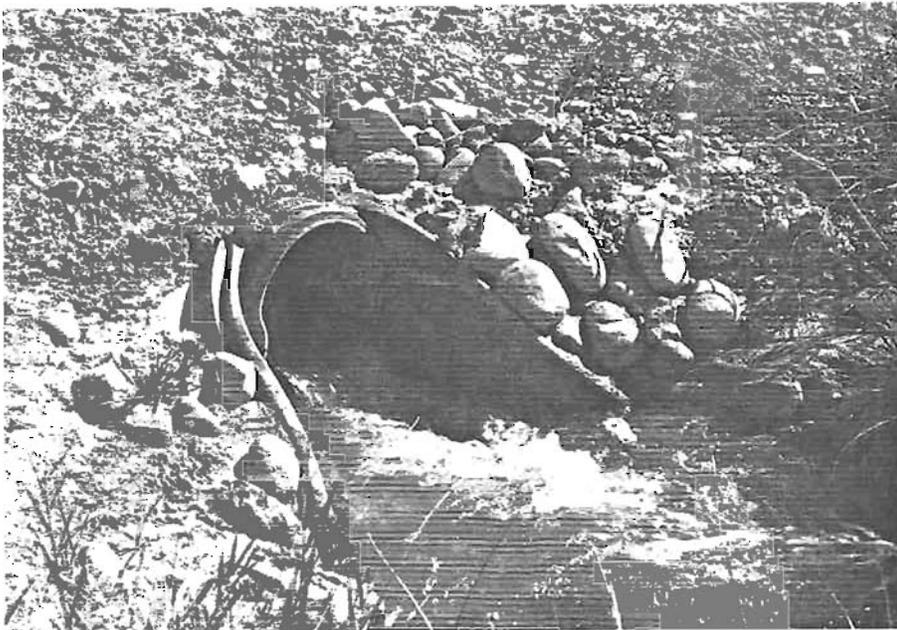
Sometimes the flow in the culverts is very murky and abrasive as in the photo above from October of 1990. At other times, like October of 1988, below, the water is more translucent. The pipes do not show any evidence of deterioration from abrasiveness or chemical action.

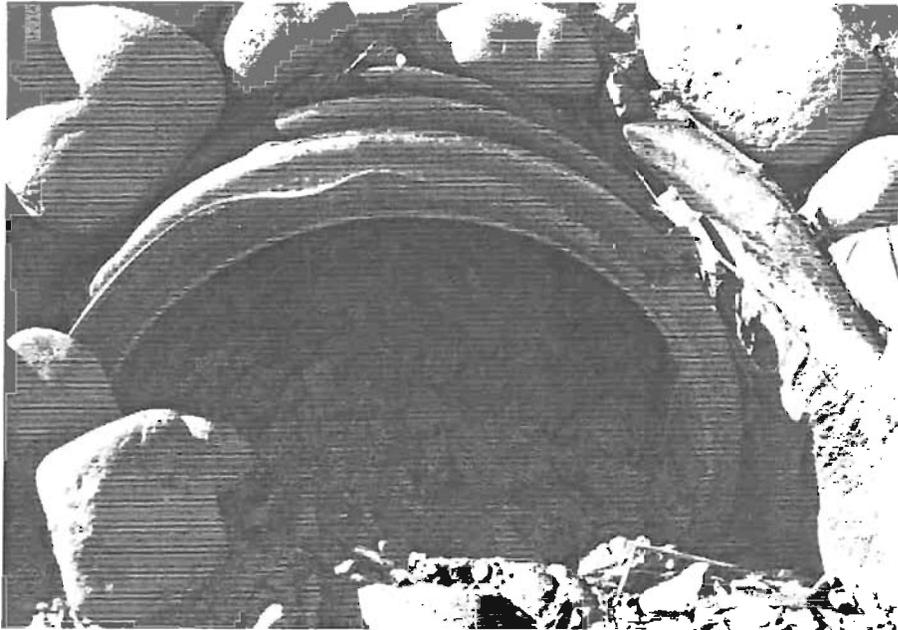
This culvert was over one-third full of rocks and sediment after only eight months of service. This illustrates the large flows which sometimes occur in these pipes, and accelerated the deterioration of the metal culverts.

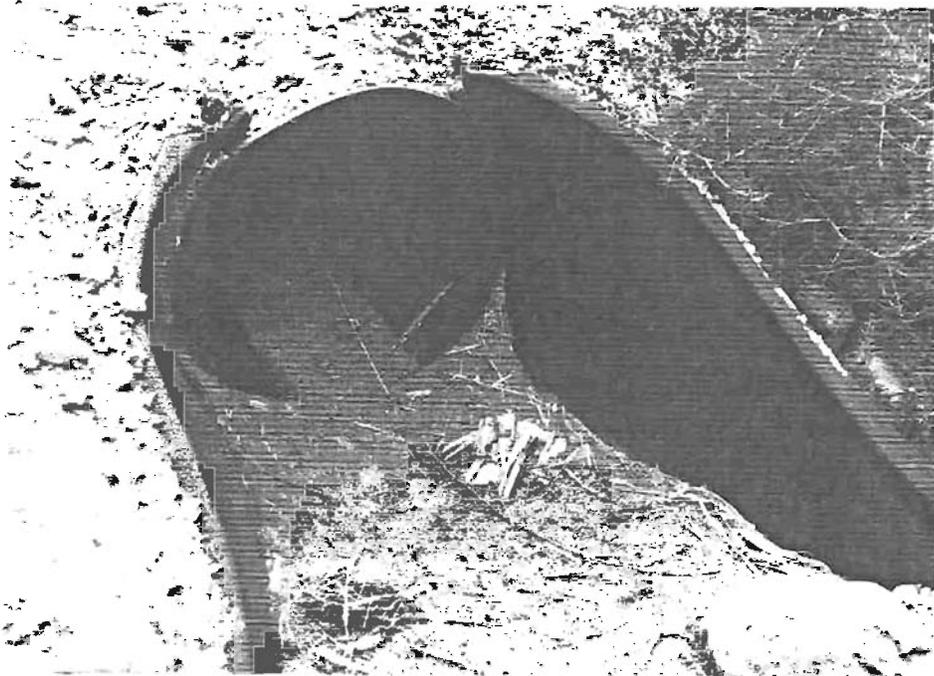
Right after the fire, the opposite end of the culvert still contained sawdust several inches thick.
