Report No. CDOT-DTD-R-93-6

CRACK-REDUCTION, PAVEMENT-REINFORCEMENT, GLASGRID

Final Report
APRIL 1993

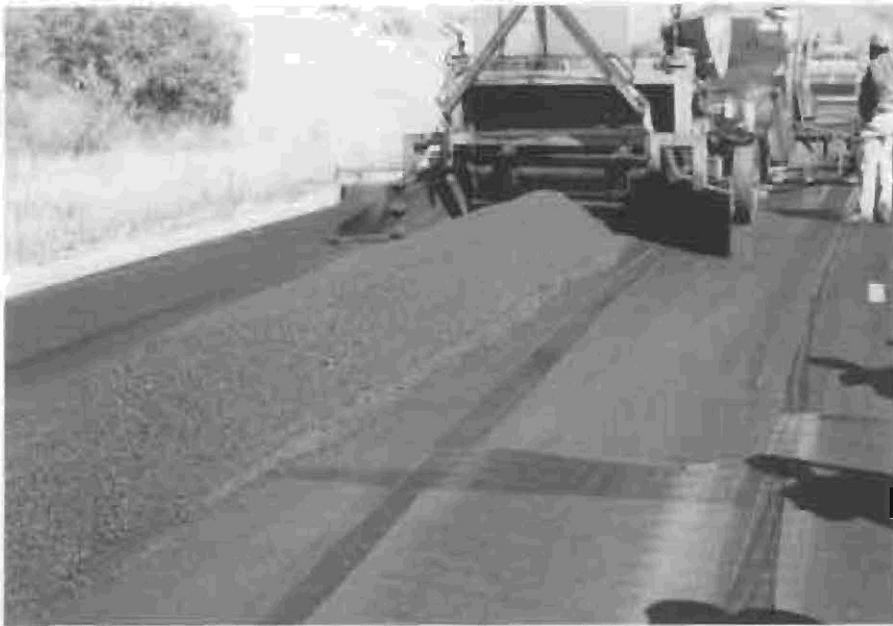
Photograph 1

Glasgrid comes in five feet wide rolls, 330 feet long. On this section five widths of Glasgrid were placed covering the ten foot outside shoulder and 12 foot driving lane (Appendix A, Photograph 1). The width of the longitudinal overlap was approximately six inches. The specifications for Glasgrid requires a minimum of two inches longitudinal overlap.

The Glasgrid was placed in five widths covering the outside shoulder and driving lane.

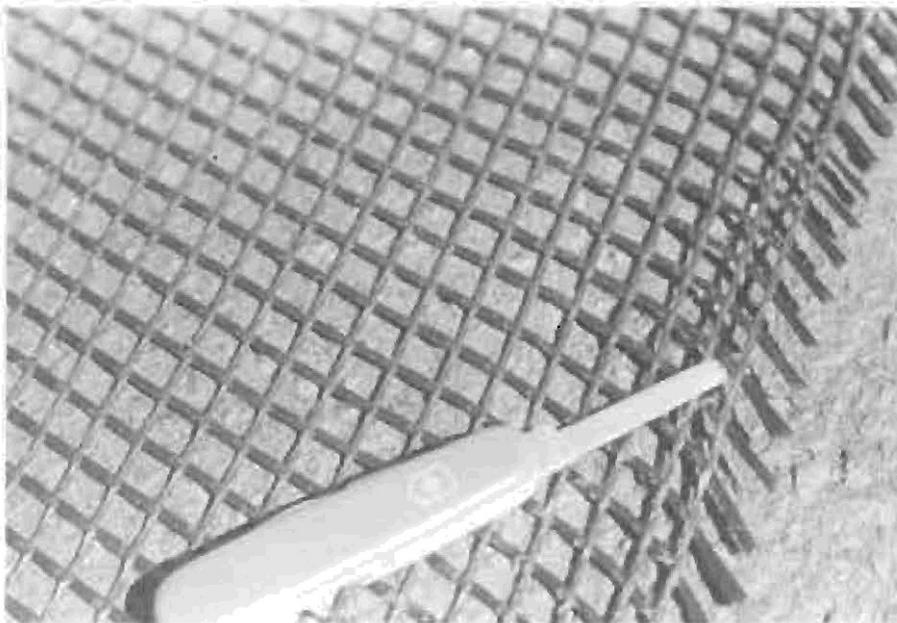
Photograph 2

Glasgrid is a fiber grid with an adhesive backing which eliminates the need for a tack coat during placement (Appendix A, Photograph 2). A specially adapted tractor was used to place the material (Appendix A, Photograph 3). Once the material was placed on the pavement a rubber tire roller was used to insure a good bond between the Glasgrid and pavement. Since other fabrics require a tack coat, a rubber tire roller is not required with other paving fabrics (Appendix A, Photographs 4 and 5).

Glasgrid has an adhesive backing which eliminates the tack coat. A rubber tire roller is used to reinforce the bond between the Glasgrid and the pavement surface.

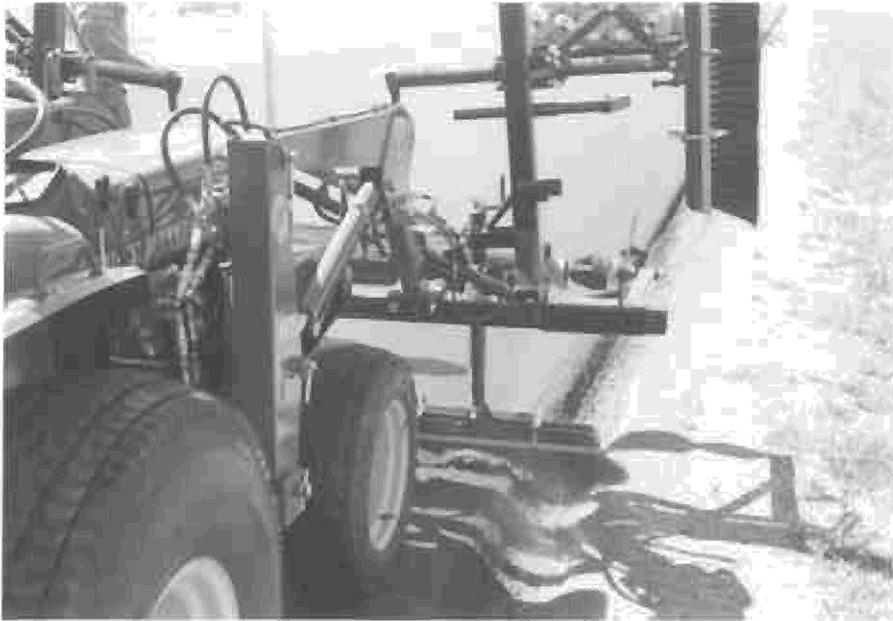
Photograph 3

Specially adapted tractor used to place Glasgrid

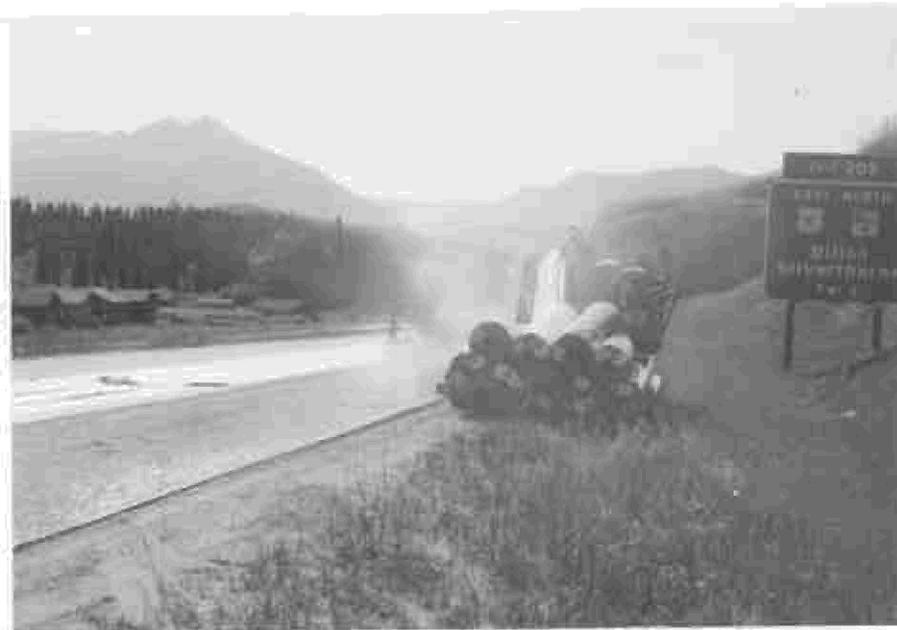
Photograph 4

A tack coat was placed prior to laying the Trevira Spunbond.

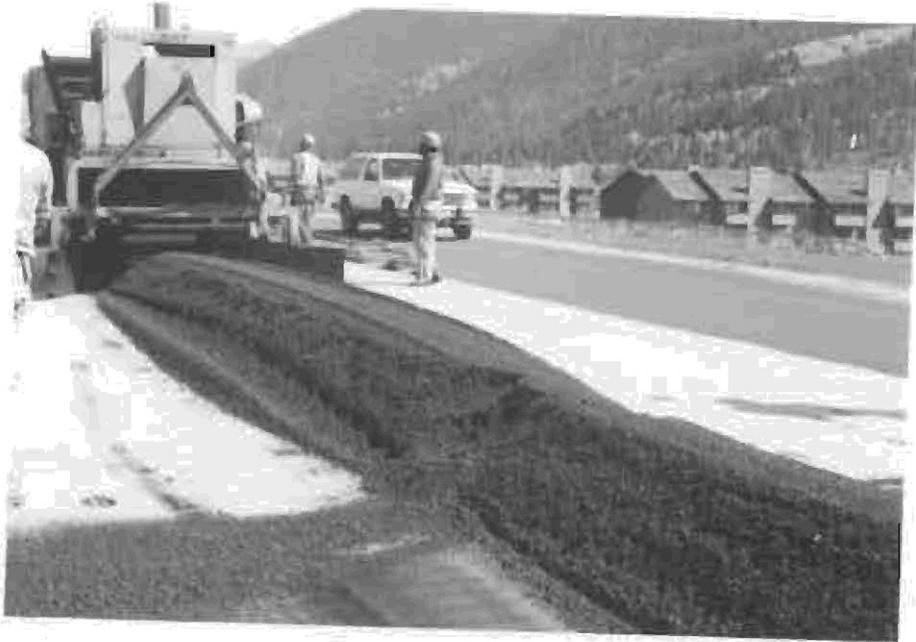
Photograph 5

The asphalt paving material is placed directly on top of the paving fabrics.

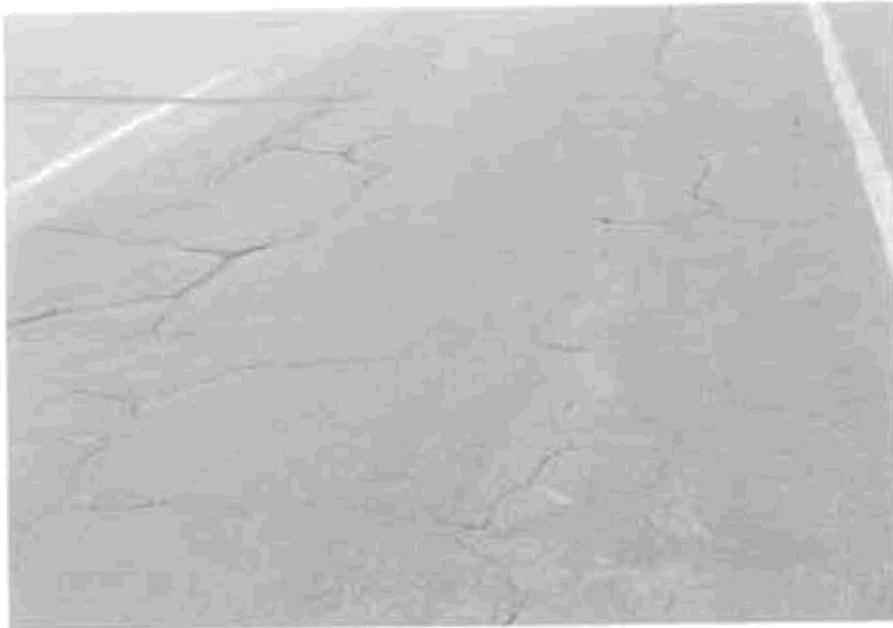
Photograph 6

Prior to construction, crack maps were drawn of the evaluation section. It was concluded that the three evaluation sections were similar in surface distress (Appendix A, Photograph 6). These crack maps were used to determine if cracking appearing during the evaluation period was reflective.

Typical cracking pattern before overlay

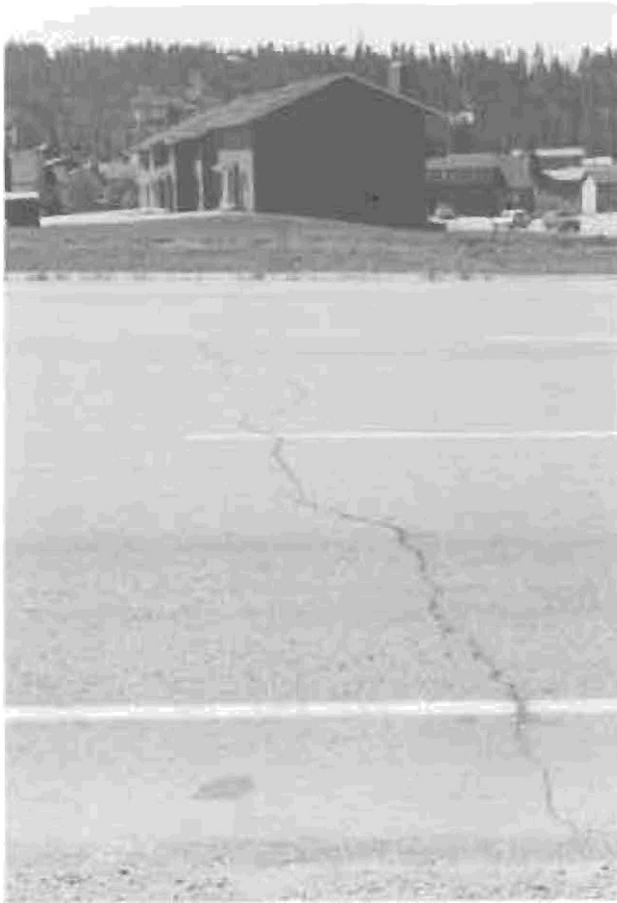
Photograph 7

The first evaluation following construction was made June 6, 1989. Reflective transverse and longitudinal cracking had appeared in all three evaluation sections. Typically paving fabrics have not shown to be effective in reducing transverse thermal cracking so the appearance of transverse cracking was expected (Appendix A, Photograph 7). The longitudinal cracking appears to be the result of the longitudinal construction joint and not contributed to the paving fabric (Appendix A, Photograph 8). Cracking at this point of the evaluation was considered minimal.

Typically paving fabrics have not been effective in controlling transverse thermal cracking.

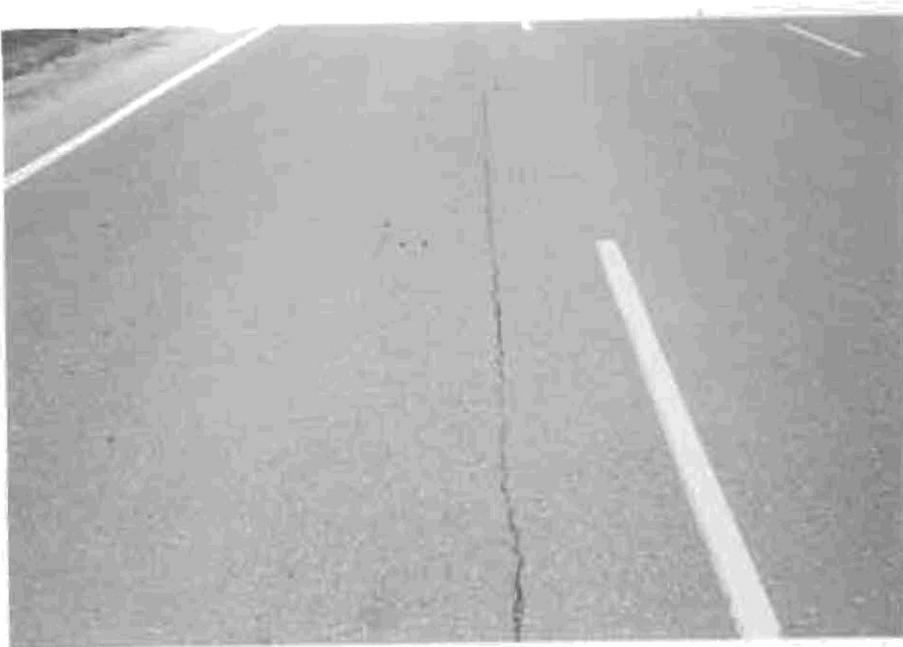
Photograph 8

Majority of the longitudinal cracking in the evaluation sections were determined to be the result of the construction joint.

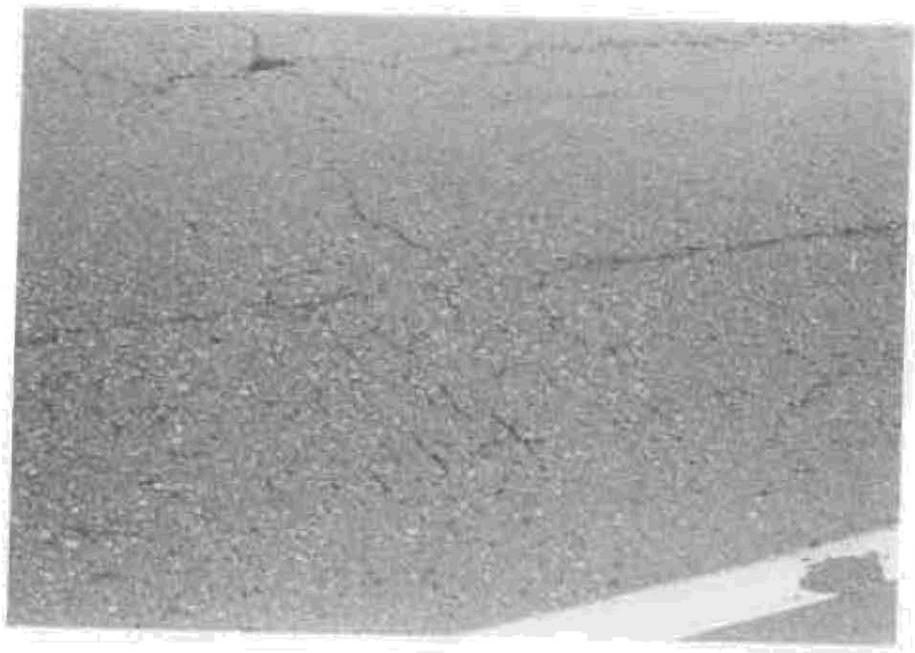
Photograph 9

The Trevira and control sections appeared to demonstrate typical reflective transverse and longitudinal cracking. However, the cracking in the Glasgrid section had increased dramatically since the previous April 1990 evaluation. In addition to what appeared to be typical reflective transverse and longitudinal cracking patterns, short longitudinal and transverse cracks were beginning to appear in the wheel paths of the Glasgrid section (Appendix A, Photograph 9).

May 20, 1991
Cracking in
Glasgrid test
section.

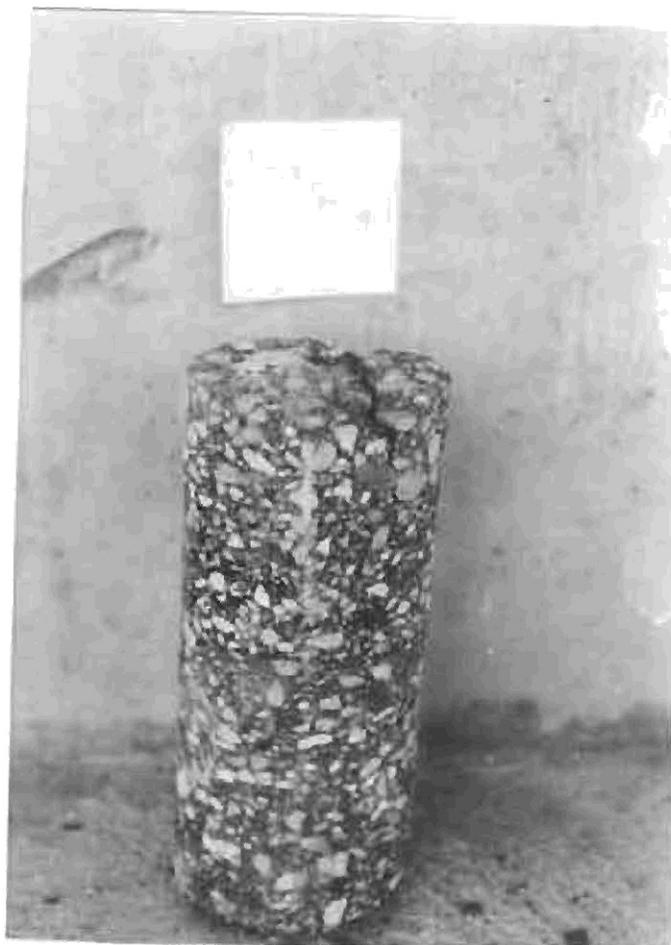
Photograph 10

On May 14, 1992 the evaluation included core samples and FWD measurements. In the Glasgrid section cores were taken from areas not exhibiting cracking in addition to cores taken over longitudinal cracks and transverse cracks. The cores taken from the areas which were not cracked on the surface did not show any signs of cracking in the lower lifts either. The cores taken over the longitudinal cracks showed no cracks in the lower lifts; the crack only appeared in the overlay and was cracked down to the Glasgrid interlayer (Appendix A, Photograph 10). The core taken over the transverse crack was cracked the entire depth of the pavement (Appendix A, Photograph 11).

Some of the
longitudinal
cracks only
appeared in the
top mat in the
Glasgrid section.

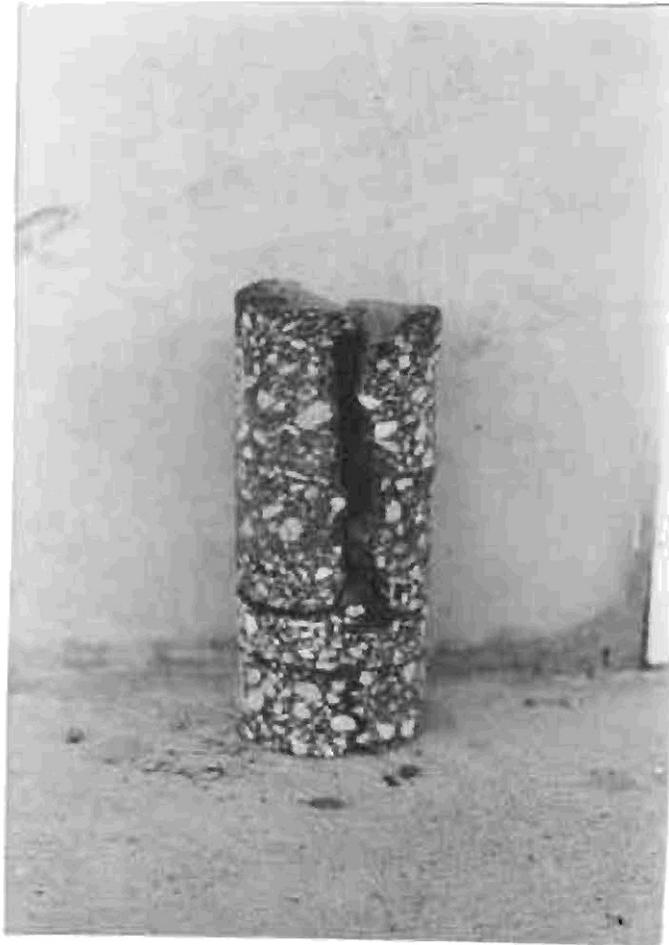
Photograph 11

The transverse crack in all the evaluation sections went through the entire depth of the pavement. The pavement surface is at the bottom of the photograph.

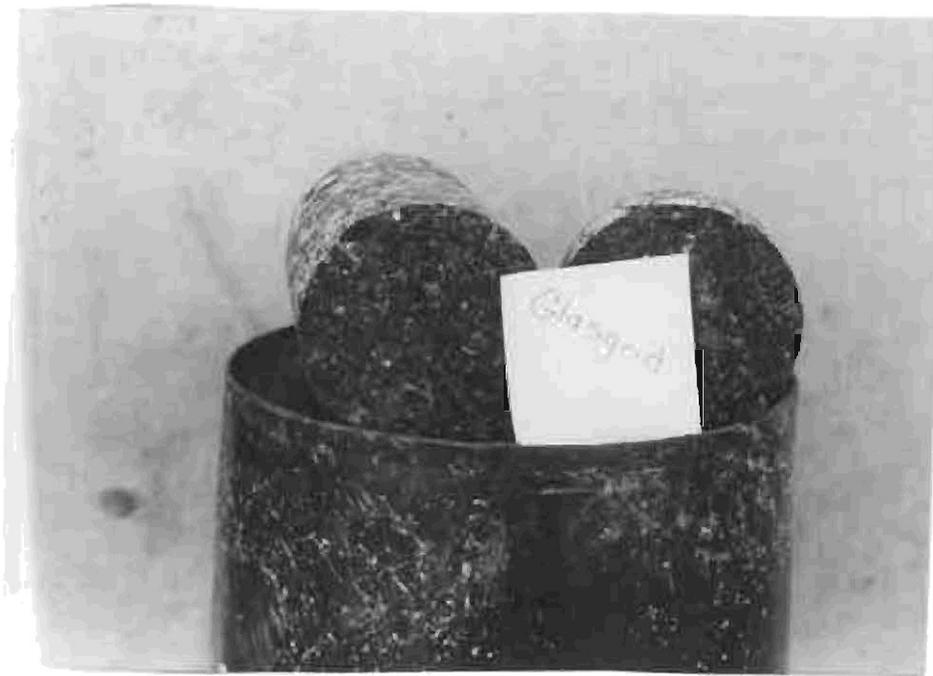
Photograph 12

All the cores taken in the Glasgrid section separated easily at the Glasgrid. Even the cores taken over the uncracked areas tended to separate easily at the Glasgrid interface (Appendix A, Photograph 12).

Based on the amount and severity of distress at the I-70 location, the Trevira and untreated sections performed better than the Glasgrid section. The FWD data taken in 1992 did not provide conclusive evidence for this difference. However, the cores collected during the 1992 evaluation indicate the Glasgrid placed without a tack coat acted as a bond breaker and prevented the overlay from

bonding to the existing pavement. This may have caused the overlay to slip under traffic, resulting in loss of effective structural strength which led to alligator cracking in the wheel paths of the Glasgrid section.

The Glasgrid cores broke at the interface between the Glasgrid and the new pavement.

In addition, since the results of this study indicated that the I-70 failure could have resulted due to a bond failure between lifts. It is recommended that a tack coat be considered in future Glasgrid applications and special care be taken to prevent slipping and folds of the material when the paver crosses it.

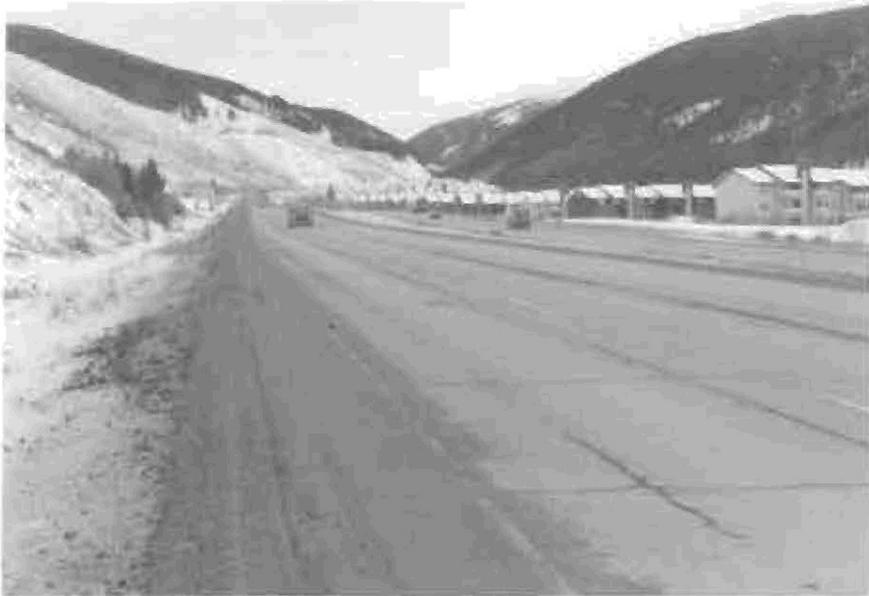
Photograph 13

The final evaluation was made on March 17, 1993. This evaluation consisted only of a visual observation of the surface. The pavement in the Glasgrid section has a significant larger amount of cracking in the wheel paths than the Trevira and untreated sections (Appendix A, Photograph 13). Most of the longitudinal cracking in the wheel path has deteriorated into alligator cracking. Neither of the other two sections are showing any signs of this type of distress (Appendix A, Photograph 14). Cracking in the Glasgrid section has appeared at a much faster rate than cracking in the Trevira and untreated sections.

March 17, 1993
Looking east into
Glasgrid
evaluation
section. This
section had more
cracking in the
wheel paths than
the other two
evaluation
sections.

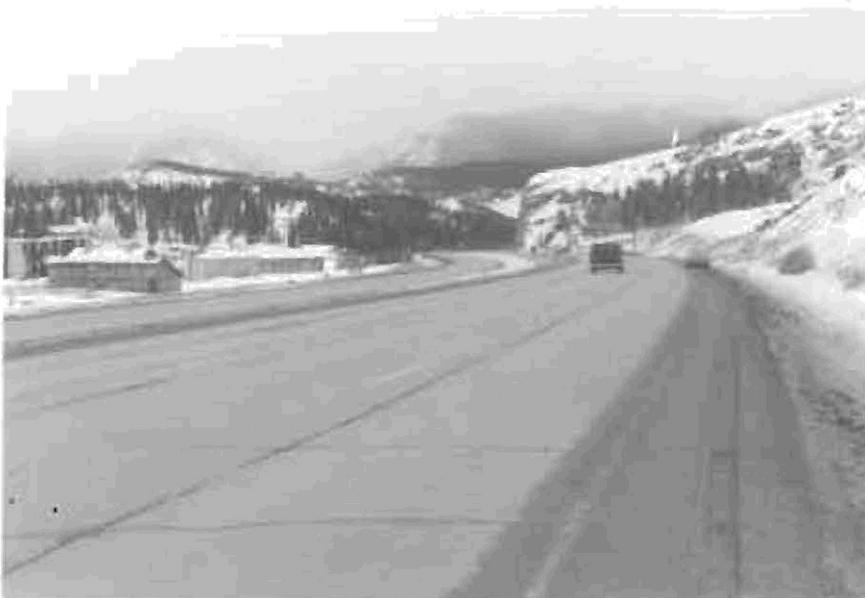
Photograph 14

March 17, 1993
Looking west into
untreated
evaluation
section. The
cracking in the
wheel path is
quite different
than in Photograph
13.

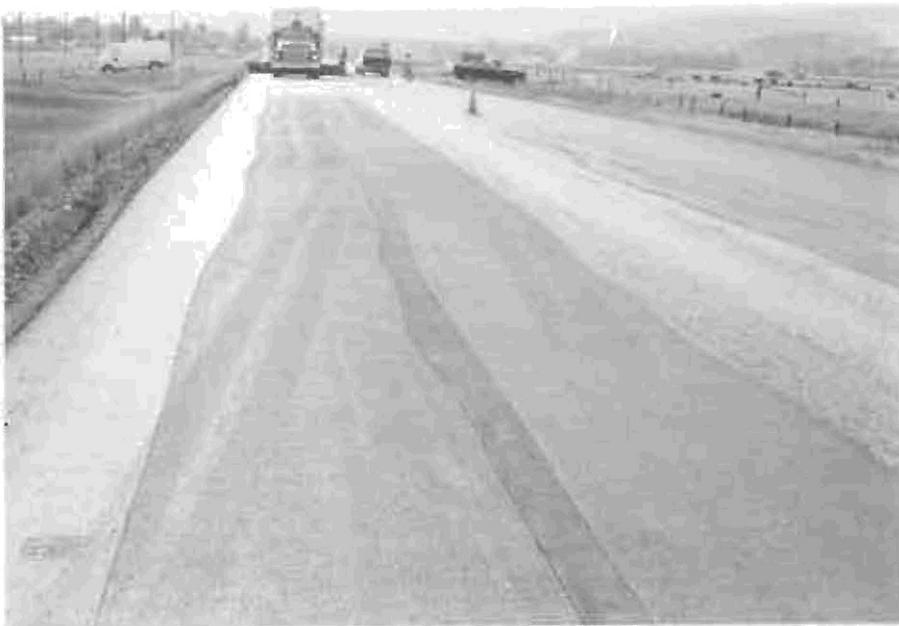
Photograph 16

reflective cracking that typically occurs at the a longitudinal construction joint between the existing roadway and the widened section. The material was placed 4 feet in from the shoulder edge, two widths wide for approximately 150 feet (Appendix A, Photograph 16). This covered two feet of the new shoulder, construction joint, and 6 feet of the driving lane. This section was located approximately 2770 feet from the beginning of the west end of the project in the eastbound direction. Figure 3 shows the location of the evaluation sections on this project. This section contained a leveling course, the Glasgrid and a 1" GR E HBP mat (GR E is a 3/4" dense graded mix). This section was covered with a 3/4" PMSC Type B on July 19, 1989.

Glasgrid was placed on the construction joint in the widened section.

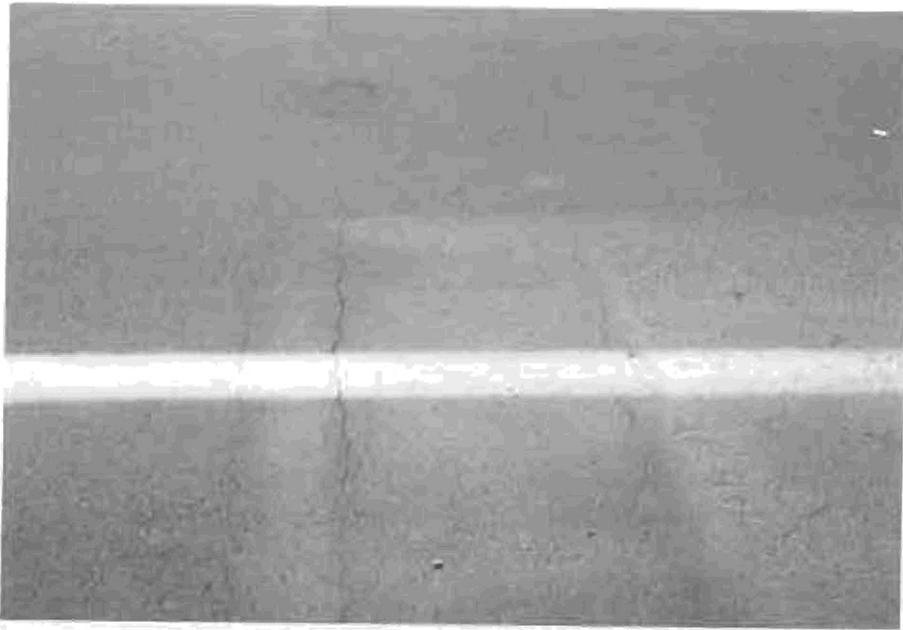
Photograph 17

During the Spring 1990 evaluation, one year after construction, the evaluation section over the abandoned railroad tracks was showing signs of reflective cracking (Appendix A, Photograph 17).

The pavement over
the railroad
tracks began to
crack within one
year after
construction.
