Report No. CDOT-DTD-R-93-8

**Rehabilitation of Rutted
Asphalt Pavements
Project IR-25-3(96)**

Final Report
June 1993

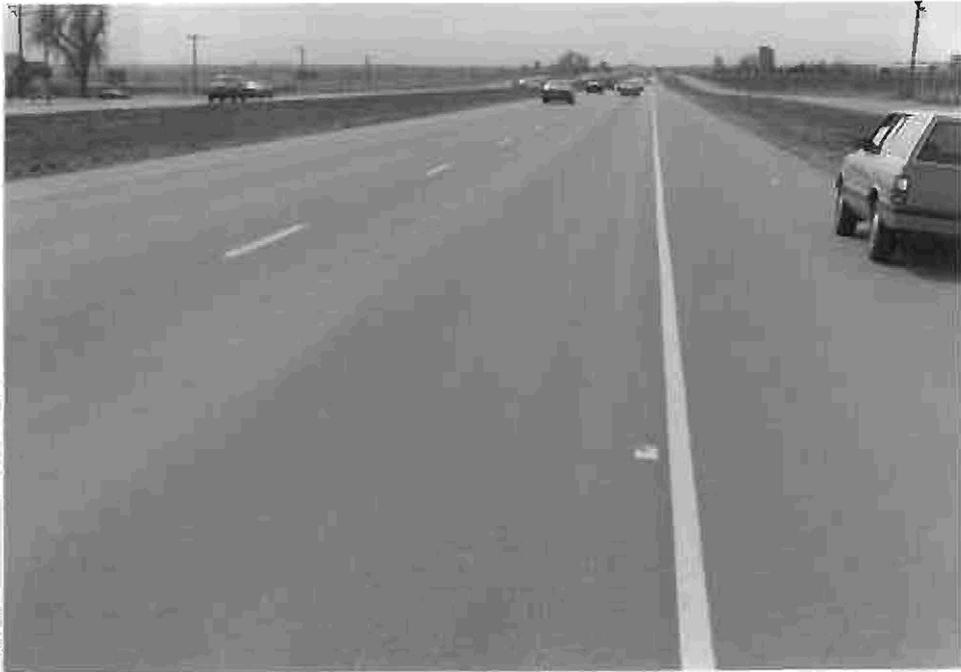
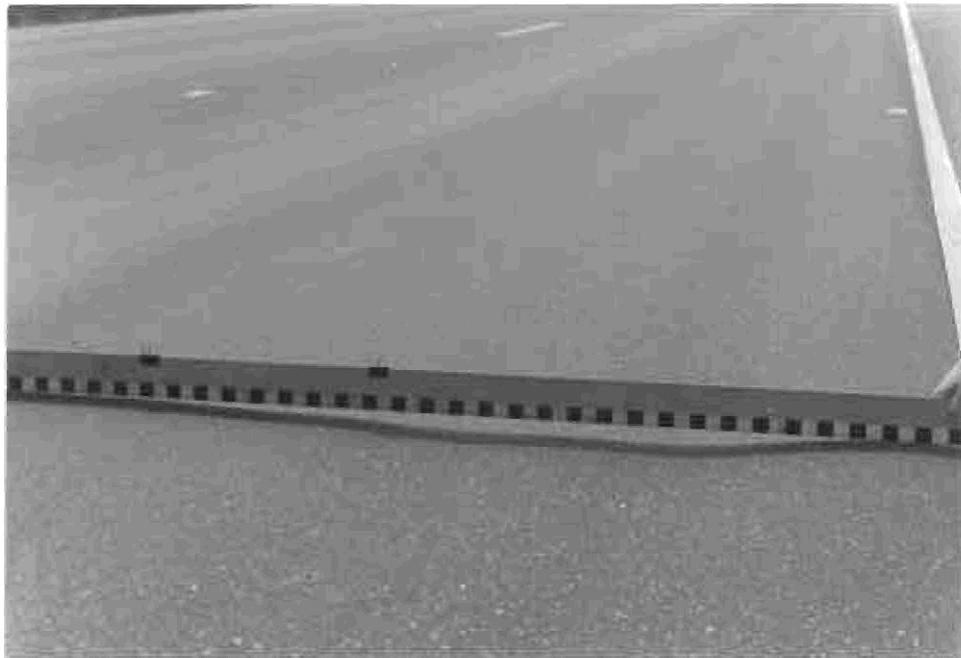
Photo 1 & 2: I-25 Southbound with dual-wheel trace ruts approaching one inch.

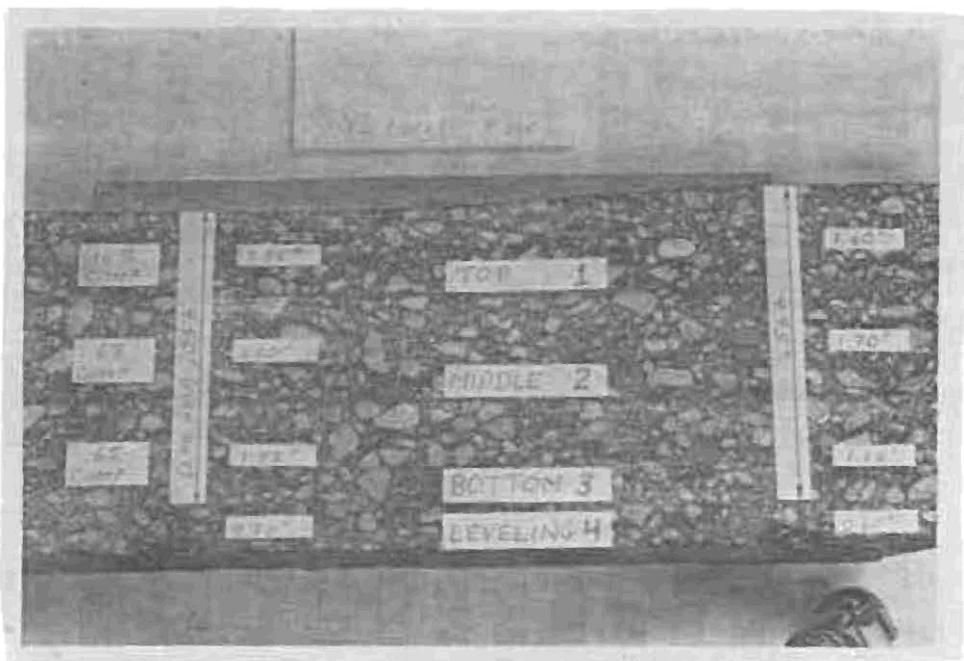
Photo 4: Measurements showed that the largest part of the rut developed in the top mat of the pavement.

As shown in the above table, the top layer exhibited the greatest rutting (16 percent), while the middle and the lower layers had been consolidated only about 6 percent. This suggests that rutting is indeed a surface phenomenon.

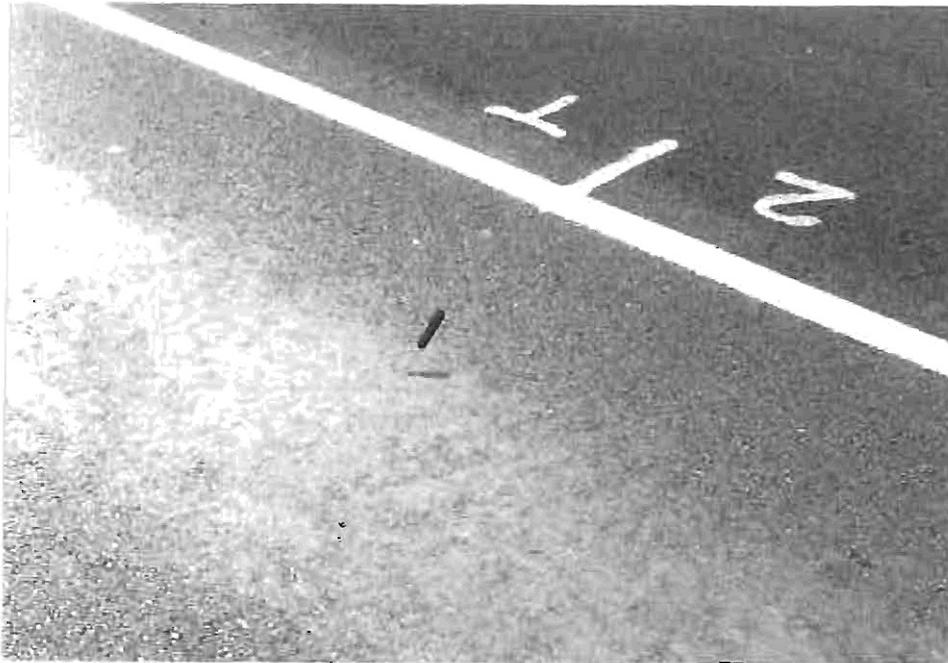
One of the major problems encountered was with the AC content of the PMSC. The AC content of the PMSC used exceeded the amount design called for; as a result the entire length of the driving and the passing lanes started to flush (Photographs 7 and 8). The PMSC was rejected and the contractor was directed to mill out the defected material and replace it with a PMSC that contained the proper amount of asphalt cement.

Photo 7: Flushing of the PMSC at MP 236.6, note the difference in texture between the shoulder and the driving lane.

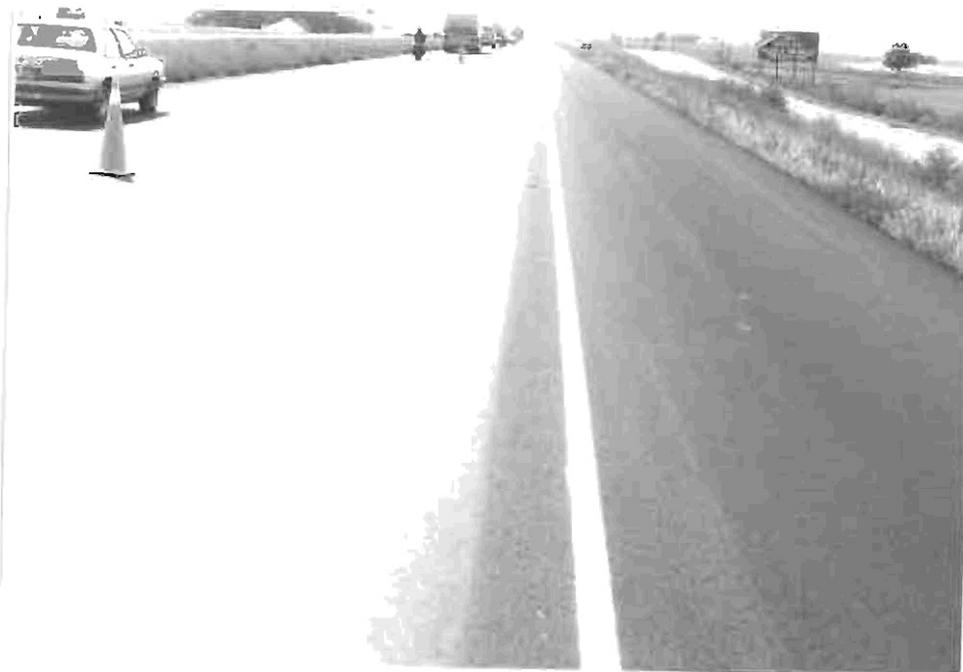
Photo 8: Flushing of the PMSC was noticeably higher around MP 240.

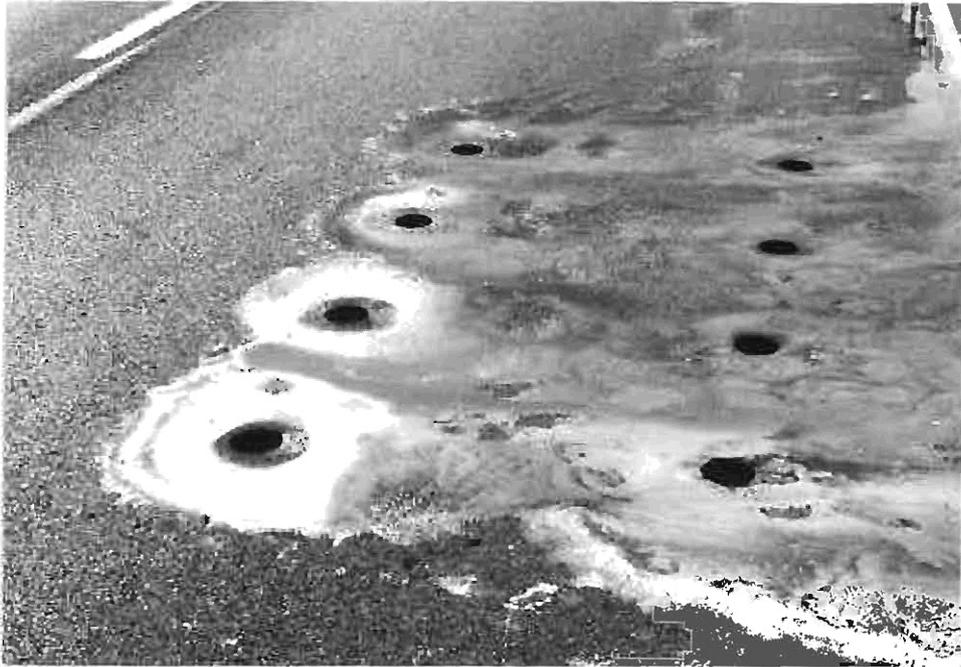
Photo 9: View of the cores taken from the southbound lanes.
