Report No. CDOT-DTD-R-98-1

I-76 Truck Study

**David A. Price
Colorado Department of Transportation
4201 East Arkansas Avenue
Denver, Colorado 80222**

**Final Report
February 1998**

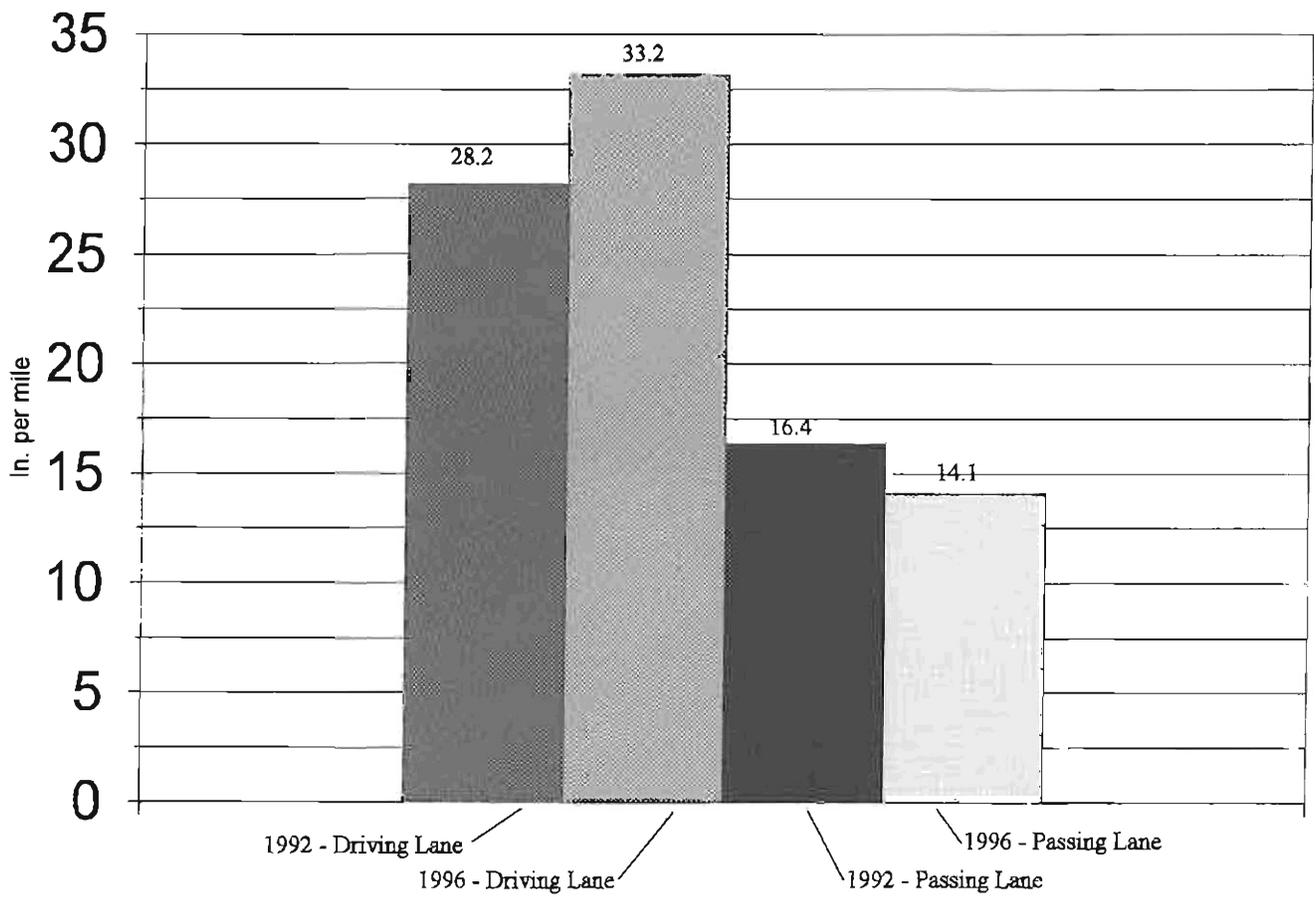
Figure 1

Table 1 shows the testing results for the test and control section over the four-year period. The control section data is shown graphically in figure 1. From this graph it can be seen that the driving lane experienced an increase in roughness of five inches per mile over the four-year period. At the same time it can be seen that the passing lane had a decrease in roughness of 2.3 inches per mile. This was the section of roadway where the truckers were not asked to drive within the passing lane (standard section of roadway). The test section shown in Figure

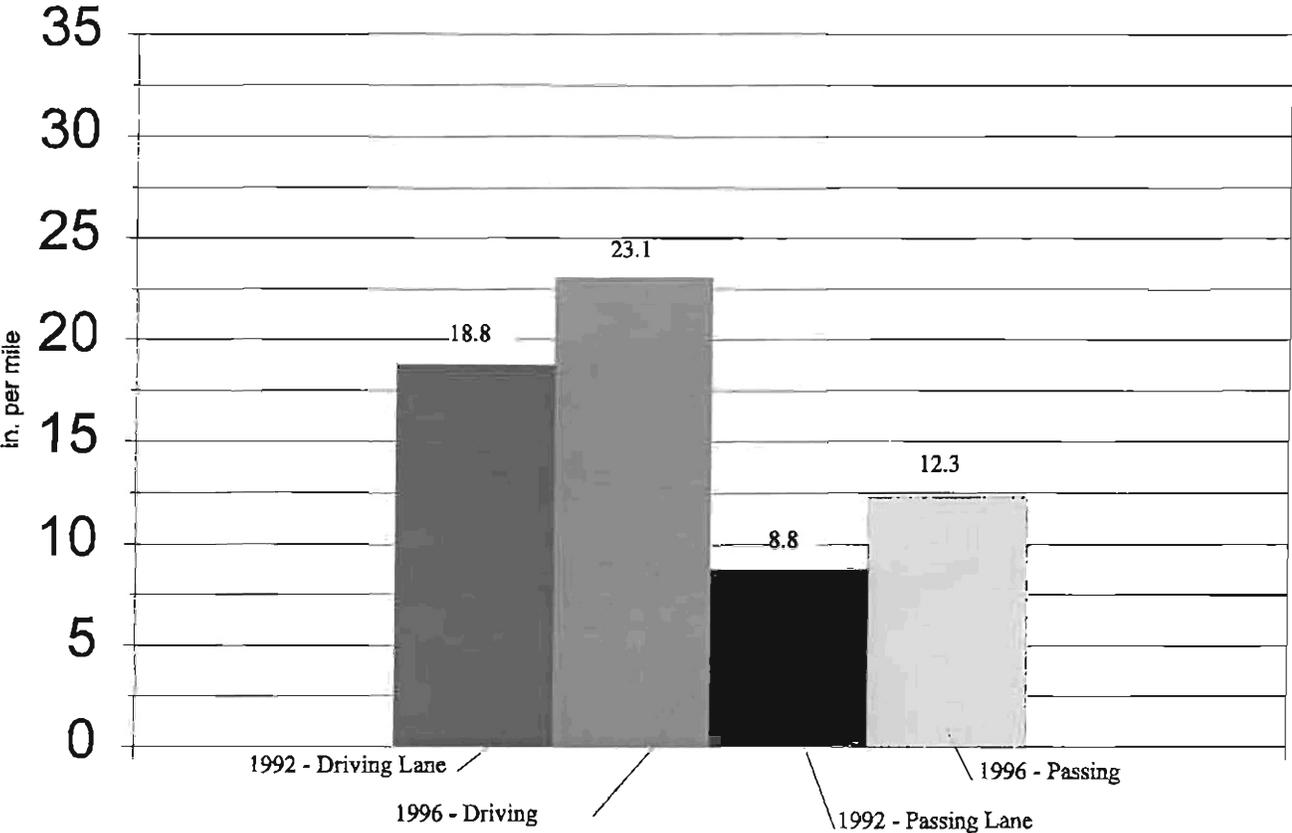
Figure 2

2 demonstrates an increase in roughness in both lanes. Driving lane roughness increased by 4.3 inches per mile and the passing lane also increased in roughness by 3.5 inches per mile. These results show that the driving lane and passing lane in the test section are deteriorating at a much more even rate than the control section. This is possibly due to the heavy trucks being placed into the passing lane and evening out the truck distress between the two lanes.

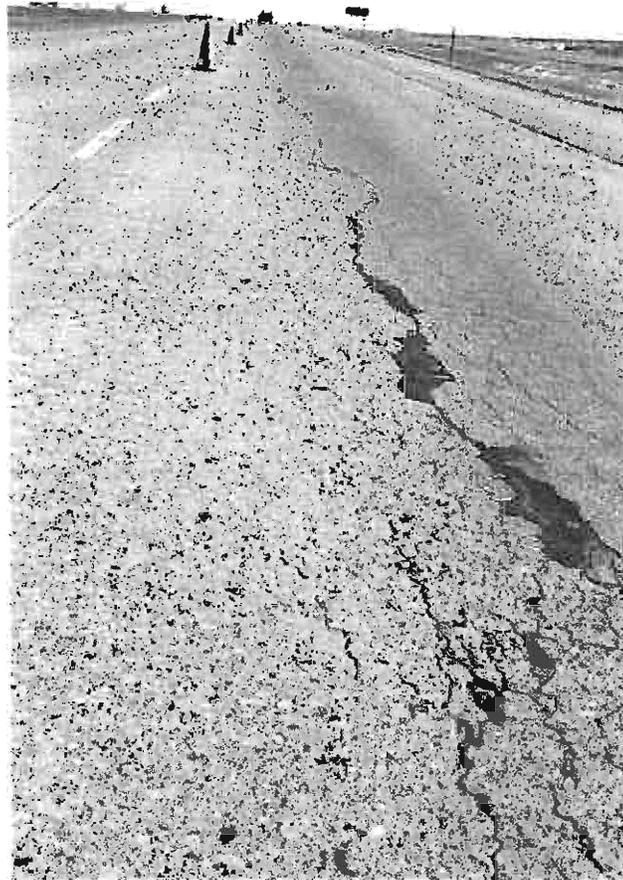
Photo 4 – Control section driving lane with longitudinal cracking and reactive aggregate. Typical in both the control section and the test section.

Using the above criteria the driving lane within both sections showed a medium severity in longitudinal cracking throughout the site. The passing lane in both sections showed little if any longitudinal cracking. Typical longitudinal cracking can be seen in photo 4. These cracks showed minor increases in length and width over the four-year period. Photo 4 also shows reactive aggregate distress with the driving lane being the most severe in crack widths.

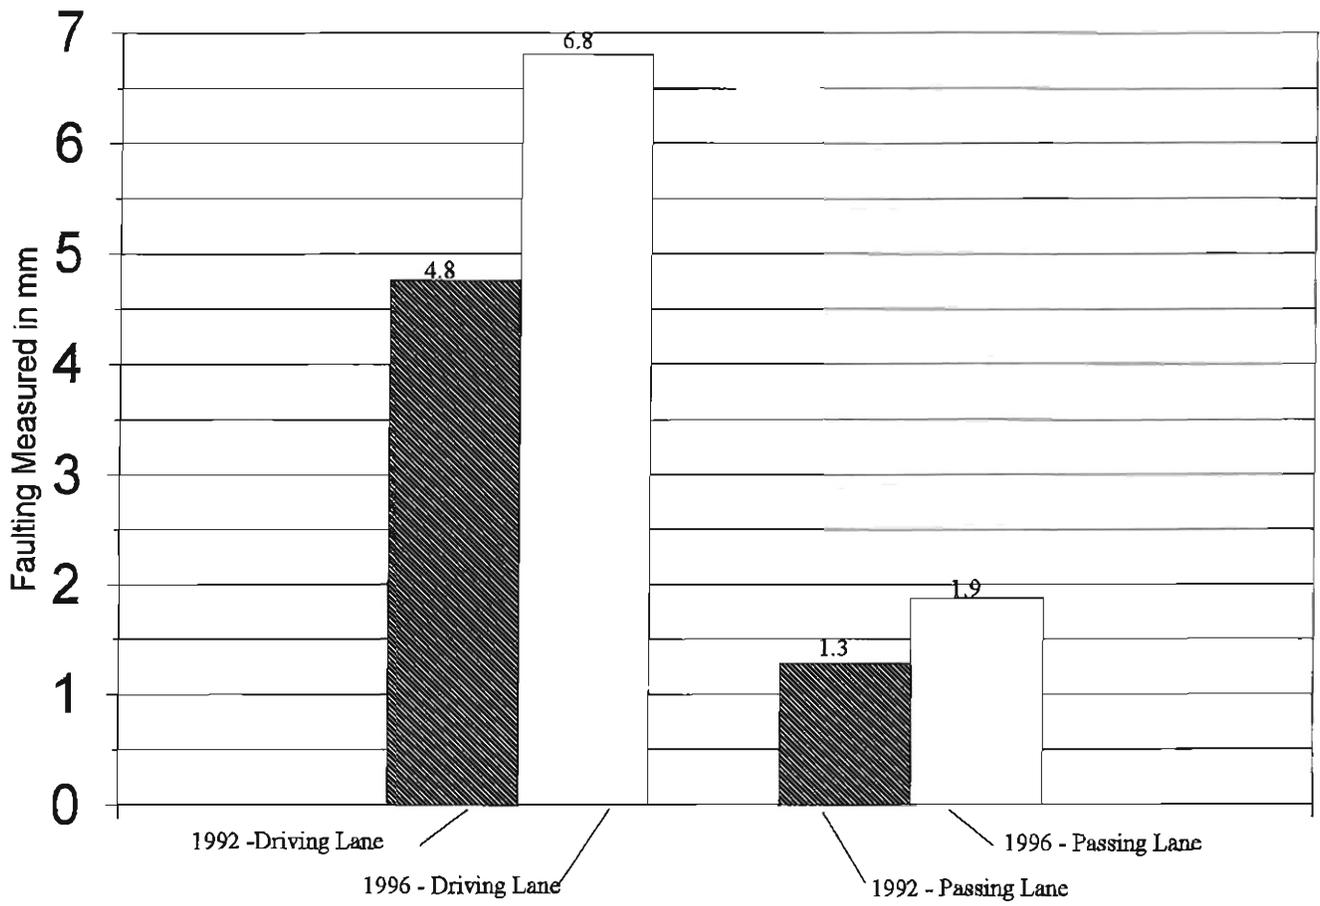
nearest tenth of a millimeter. Photo 3 shows the Georgia fault meter prepared to take a measurement across a joint. Figure 3 shows graphically the fault measurements taken from the test section where there was a small increase in the driving lane as well as a small increase in faulting within the passing lane. The test section shows a small increase in both lanes demonstrating that placing truck traffic in the passing lane may help even out the faulting distress between the two lanes. Using the "Highway Pavement Distress Identification Manual" criteria listed above, the faulting with both the test and control section in 1990 would be placed within a medium severity for faulting. The faulting continued to rise within the test section over the four-year period not showing a reduction compared to the control section.

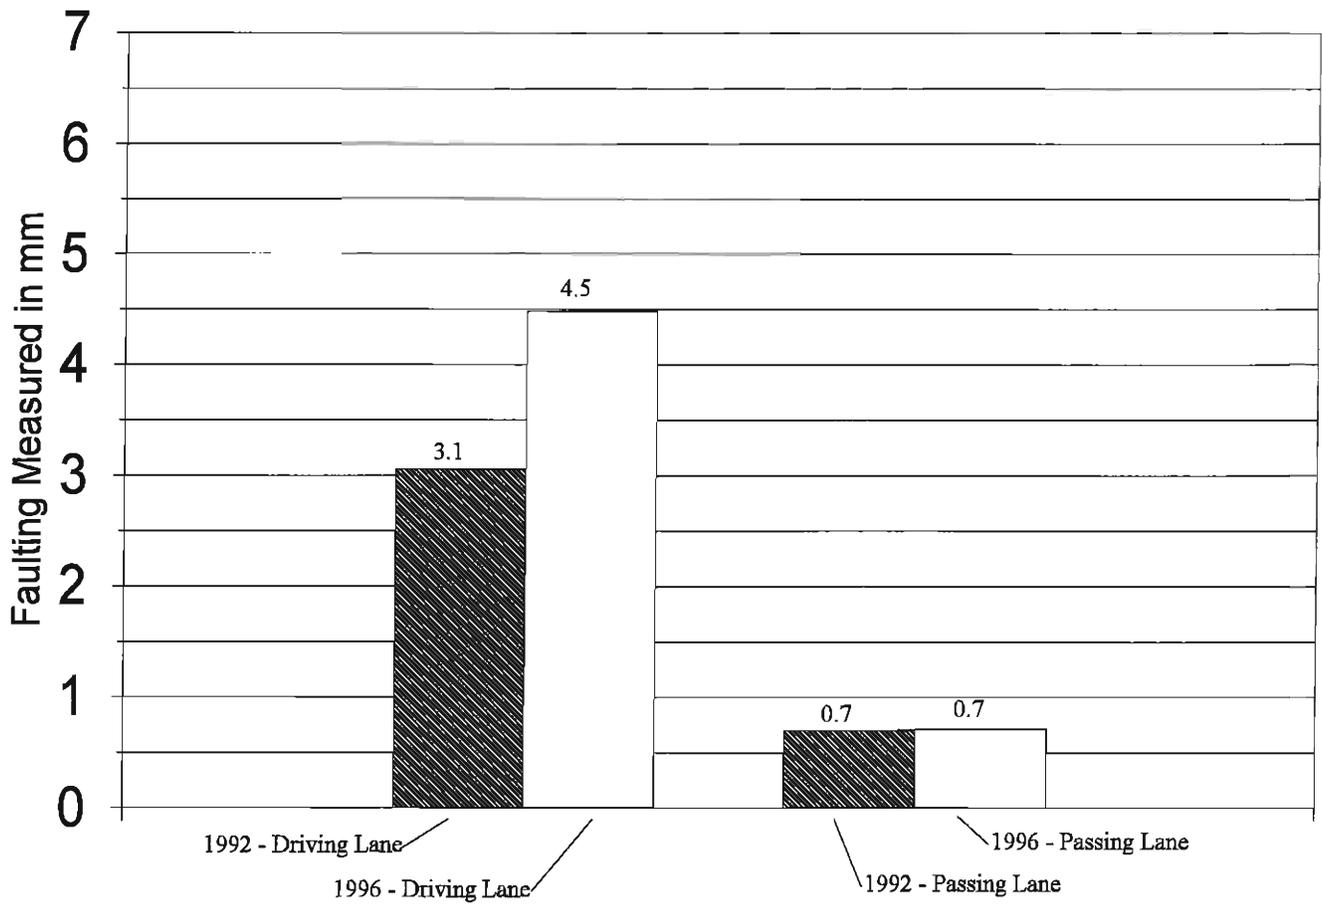
Figure 4 shows the control section (m.p.35 eastbound lanes) faulting in 1992 compared with four years later in 1996. The control section shows an increase in faulting within the driving lane of 46.5%. During the same time period there was no faulting increase within the passing lane. This section (control) did not ask truck drivers to use the passing lane.

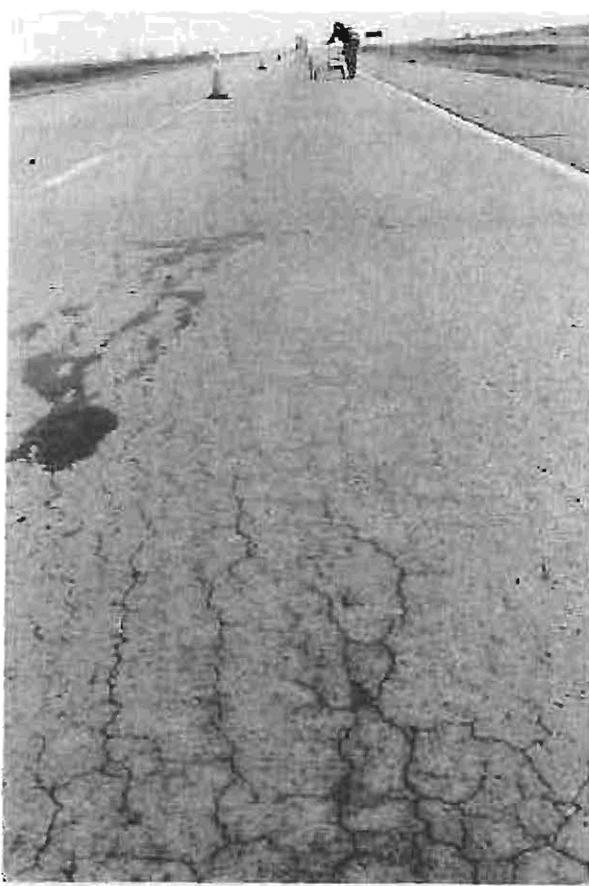
Photo 5 – Reactive aggregate distress can be seen in both lanes however, the driving lane is the most severe.

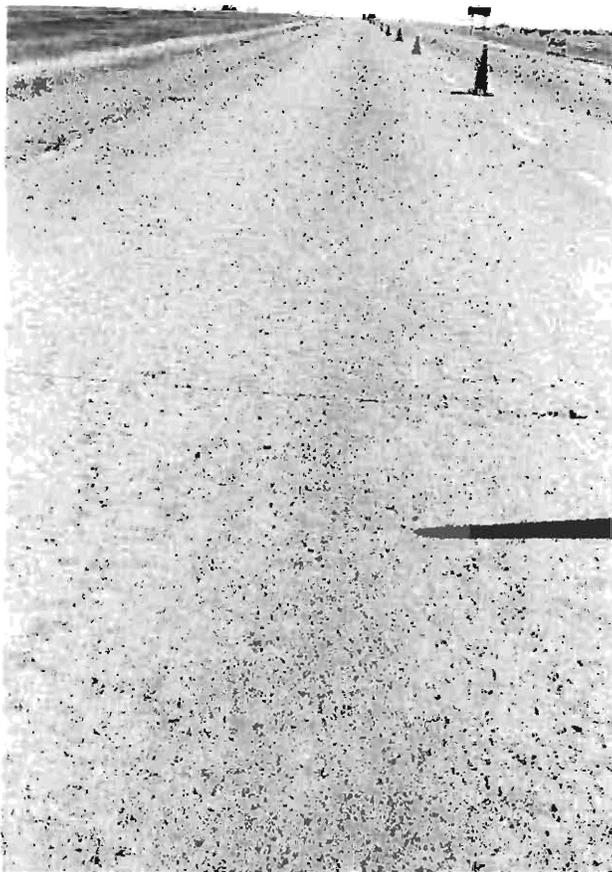
Photo 6 – Control section passing lane showing little distress compared to driving lane. Typical within this area of roadway.

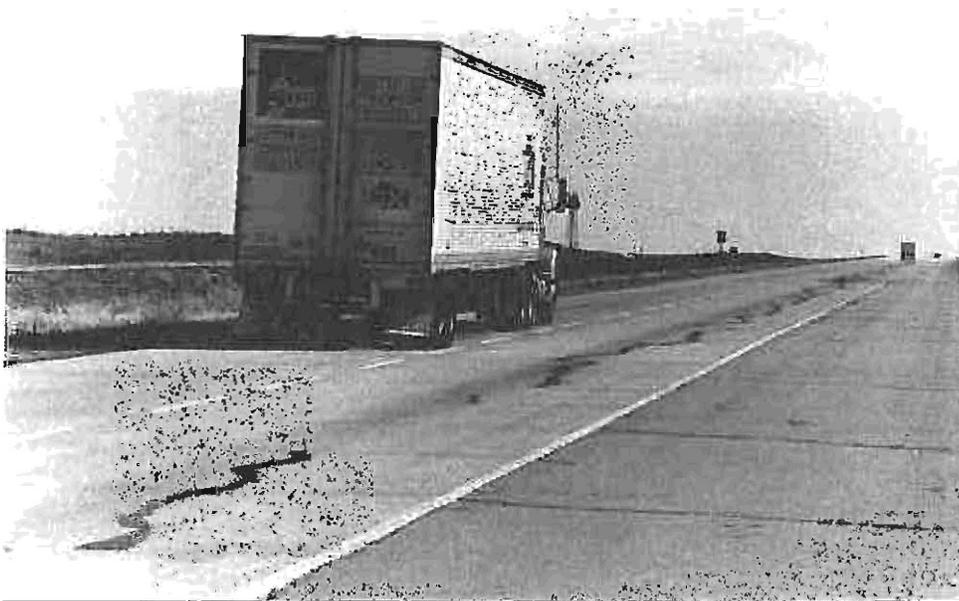
Photo 7 – This photo demonstrates the severity of the longitudinal cracking in the driving lane.

Placing truck traffic into the inside-passing lane appears to be a logical way to temporarily prolong the life of the outside driving lane. On roadways where the driving lane is severely cracked and distressed, placing heavy vehicles on the better conditioned passing lane may help prevent concrete blow outs caused by the heavy trucks and allow the section of roadway to be reconstructed as funds become available.

Looking at traffic data and distress data it is recommended that the truck traffic continues to use the inside passing lane as a primary driving lane to help prolong the life of the driving lane until reconstruction of I-76 can be completed.
