Report No. CDOT-2009-9
Interim Report

SHORT-TERM CRACK SEALANT PERFORMANCE AND REDUCING BUMPS AND TRANSVERSE CRACKING IN NEW HOT MIX ASPHALT OVERLAYS OVER CRACK SEALANTS

November 2009

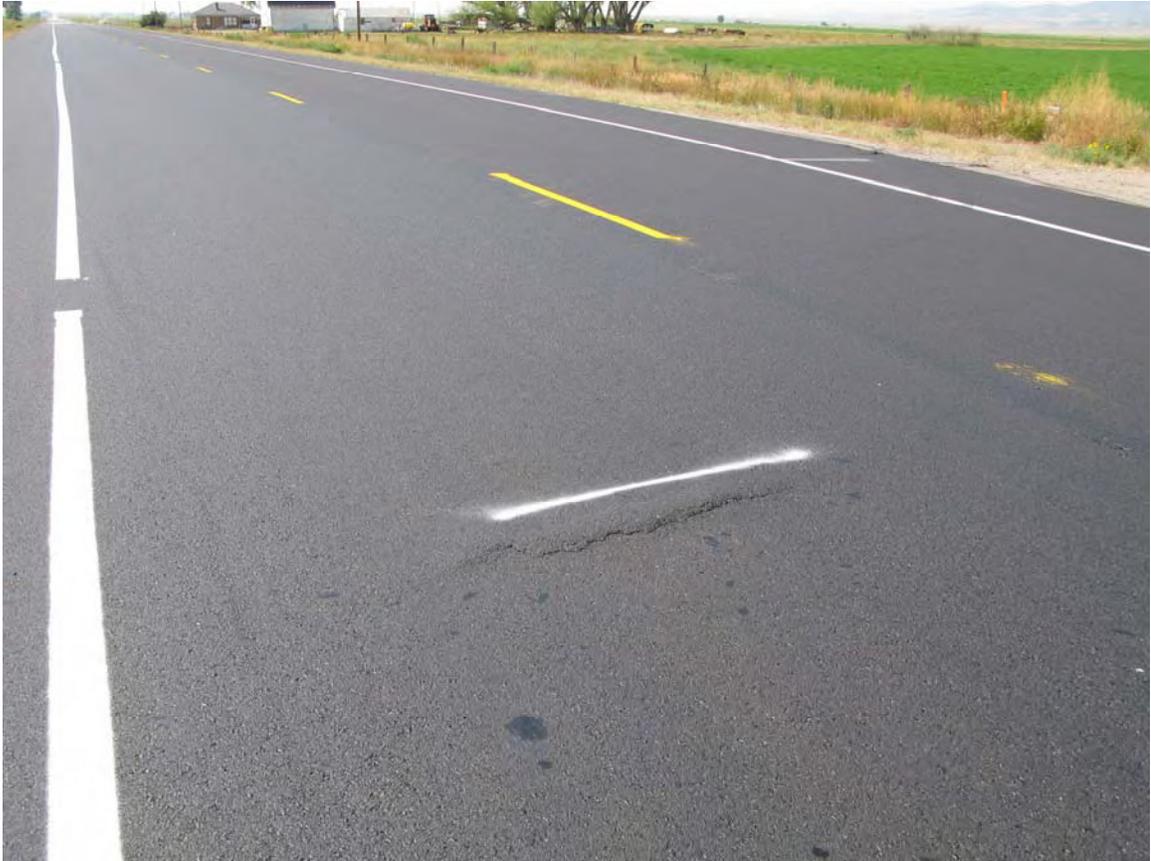
Bumps and transverse cracks began to appear on the project during previous leveling course construction south of the test sections at approximately Station 150+00 as shown in Figure 12. The contractor mitigated further occurrence of this distress by changing from vibratory steel rollers in vibrating mode on breakdown compaction to pneumatic tired rollers. The vibratory steel rollers being used were a Bomag BW190AD and a Caterpillar CB534C. The pneumatic rollers were a Hypac C530AH and a Caterpillar PS150B. However, the material properties of the crack sealant used at Station 150+00 were unknown, therefore, it was not possible to conclude that the bumps and

Figure 12. Bumps and Transverse Cracks at Station 150+00

transverse cracks in the leveling course at Station 150+00 were not material related. Therefore, an experiment was developed to determine if the bumps and cracks could be reproduced within the crack sealant test sections. The experiment was developed as shown in Table 6. Paving was northbound in the southbound driving lane and shoulder with rollers used for breakdown as shown.

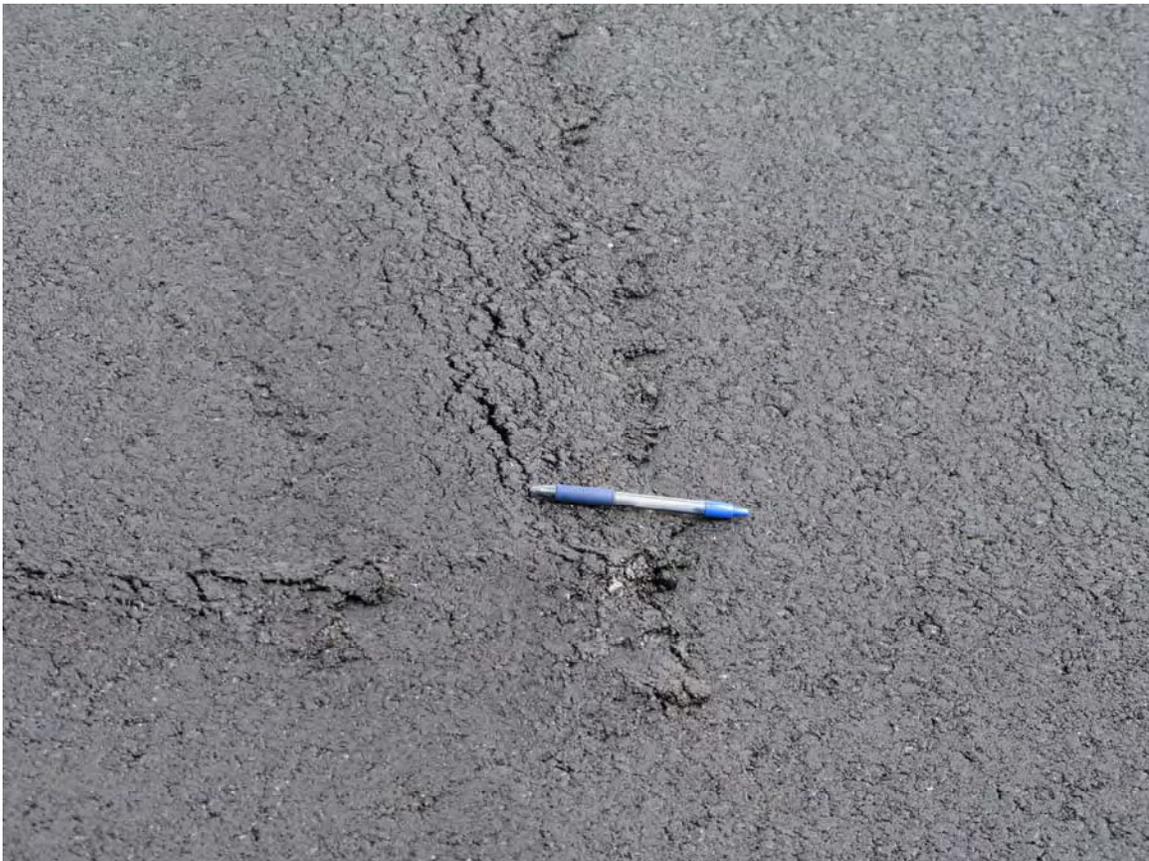
330 to crack 1. The experiment was repeated with some exceptions as shown in Table 7 in an attempt to create the bumps and transverse cracks witnessed at cracks 271 and 272 in the southbound lane on September 2. The first evidence of bumps and cracks occurred at cracks 271 to 275 as shown in Figure 13. These bumps were much more severe than those witnessed on September 2 in the southbound lane.

** Significant evidence of bumps and transverse cracks

Figure 13. Bump and Transverse Cracks Over Crack 271

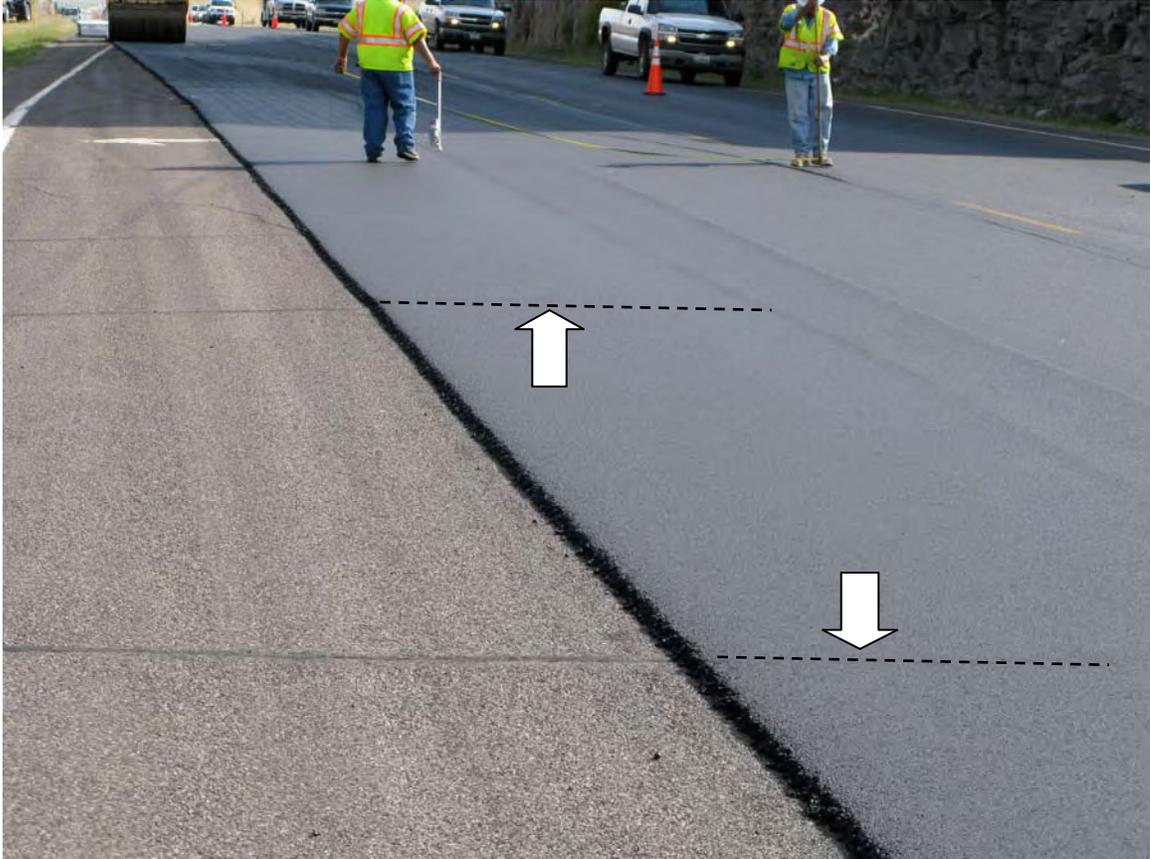
A second and third attempt to create the bumps and transverse cracks was done over cracks 199 to 204 and again at cracks 127 to 132. The results of this experiment are shown in Figures 14 and 15. The severity of the cracks and bumps appeared directly related to the number of passes of the vibrating roller. As cracks began to appear after the first pass of the roller, the contractor was reluctant to continue the experiment with additional roller passes. The severity of the cracks and bump shown over crack 271 was not observed over cracks 199 to 204 or 127 to 131 due to fewer passes of the vibrating rollers.

Figure 14. Bumps and Transverse Cracks Over Cracks 129, 130 and 131 Northbound

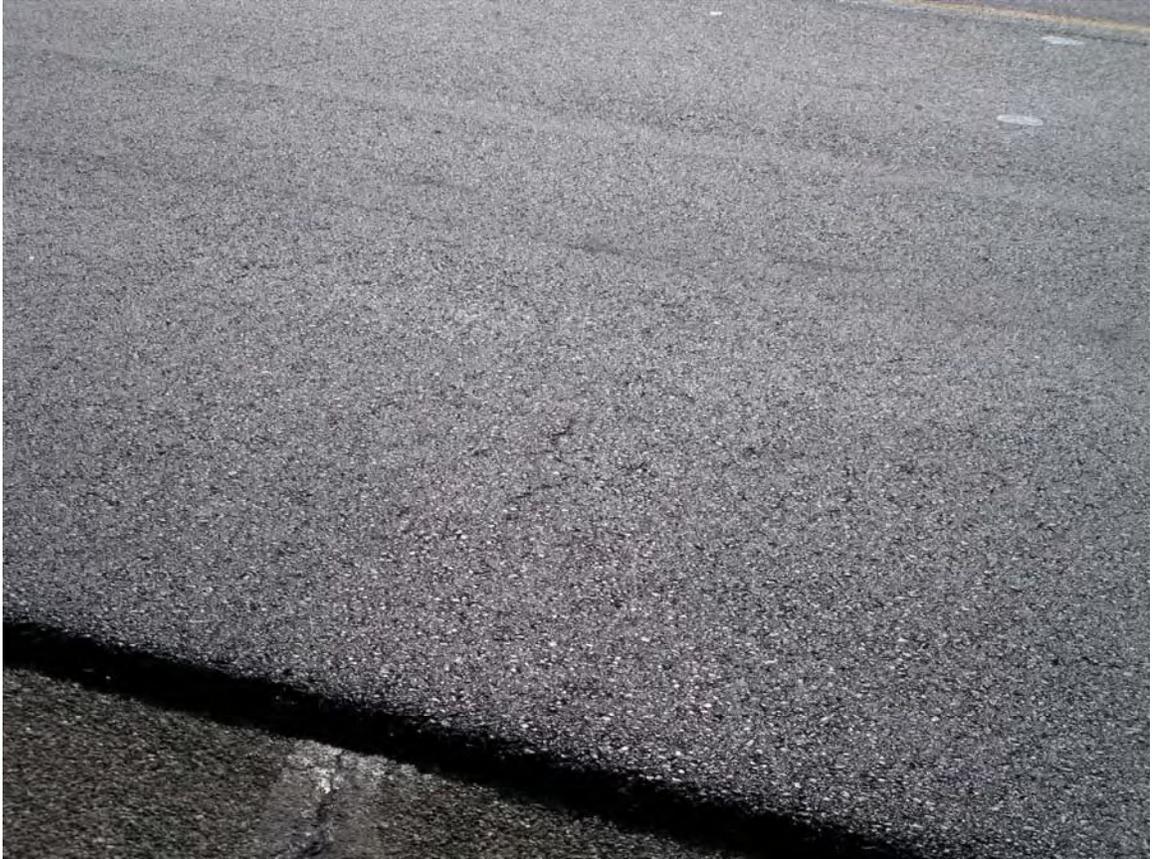
Figure 15. Transverse Crack Forming Over Crack 201 Northbound
