Report No. CDOT-2011-10
Final Report

INVESTIGATING CRACK SEALANT PERFORMANCE AND CAUSES OF BUMPS IN NEW HOT MIX ASPHALT OVERLAYS OVER CRACK SEALANTS

Scott Shuler

July 2011

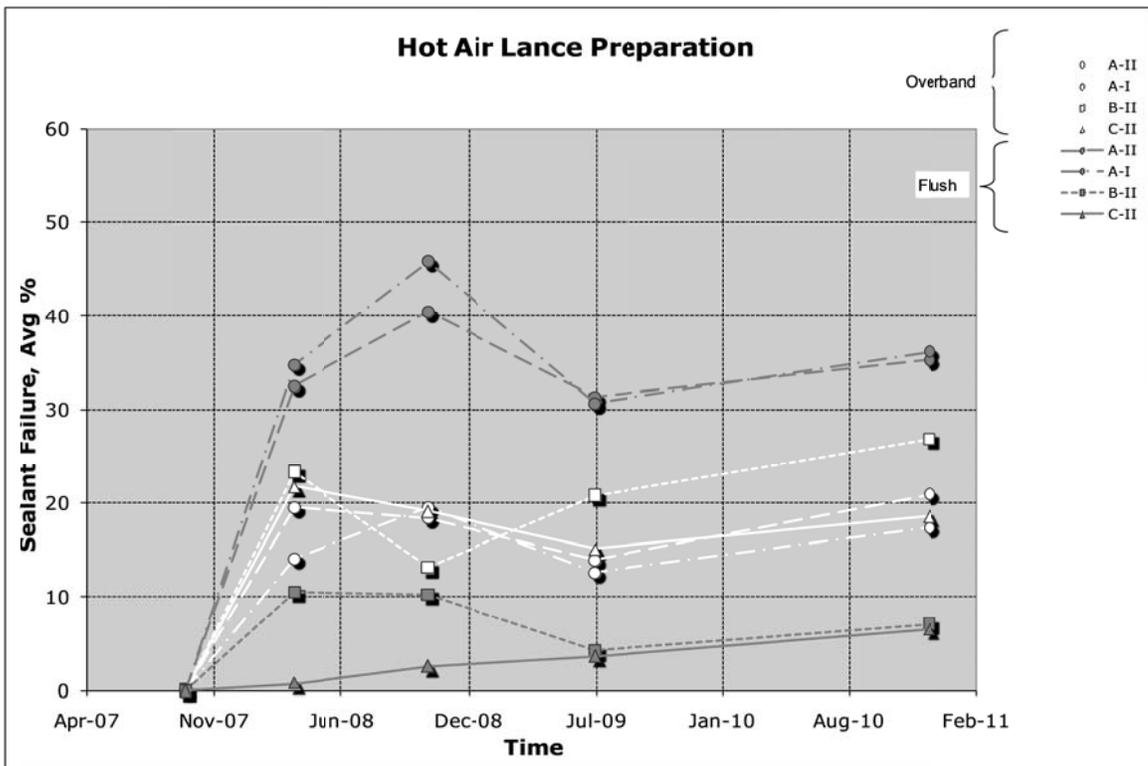
Figure 10. Sealant Performance on US 350-Cracks Prepared by Hot Air Lance

reaches 15 percent failure for the air blow and overband process on US 285. Supplier C reaches 4 percent failure on US 350 in Figure 10 for a hot air lance and flush application and Supplier A-I has an 11 percent failure rate on US 350 for the air blow and overband application shown on Figure 11.

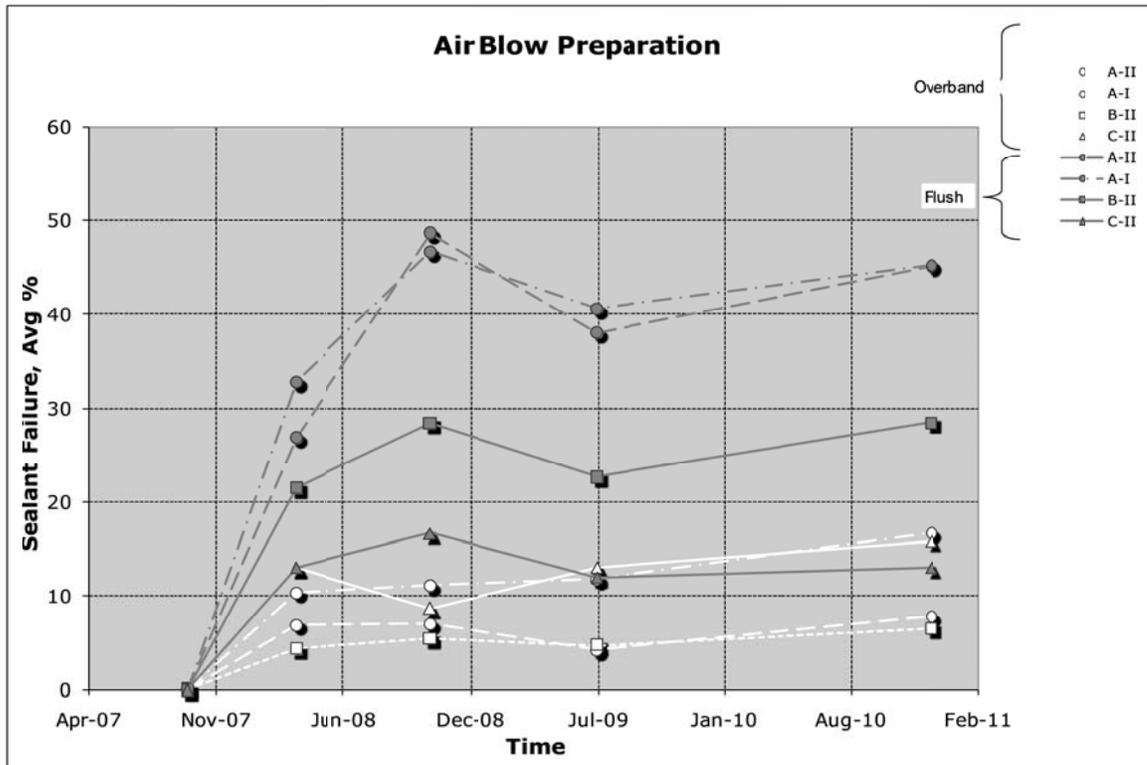
Figure 11. Sealant Performance on US 350-Cracks Prepared by Air Blowing

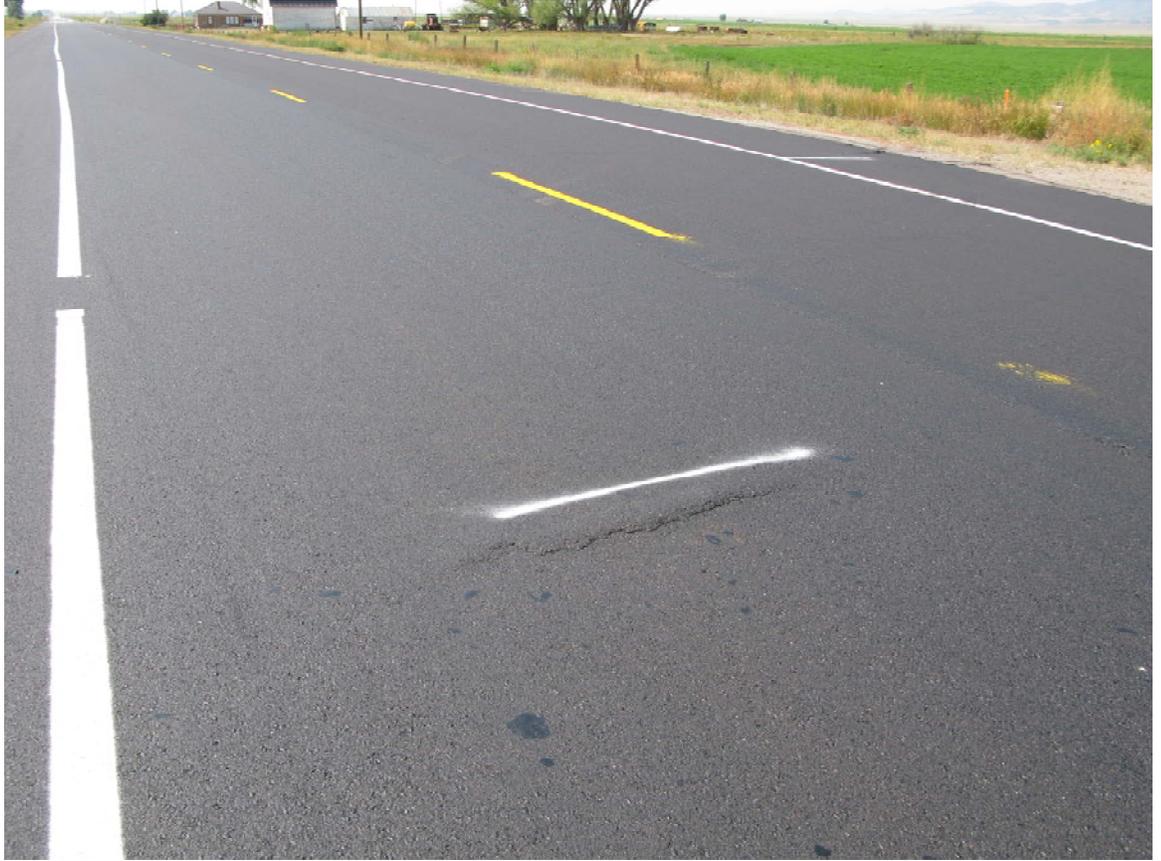
Bumps and transverse cracks began to appear on the project during previous leveling course construction south of the test sections at approximately Station 150+00 as shown in Figure 12. The contractor mitigated further occurrence of this distress

Figure 12. Bumps and Transverse Cracks at Station 150+00

by changing from vibratory steel rollers in vibrating mode on breakdown compaction to pneumatic tired rollers. The vibratory steel rollers being used were a Bomag BW190AD and a Caterpillar CB534C. The pneumatic rollers were a Hypac C530AH and a Caterpillar PS150B. However, the material properties of the crack sealant used at Station 150+00 were unknown, therefore, it was not possible to conclude that the bumps and transverse cracks in the leveling course at Station 150+00 were not material related. An experiment was developed to determine if the bumps and cracks could be reproduced within the crack sealant test sections.

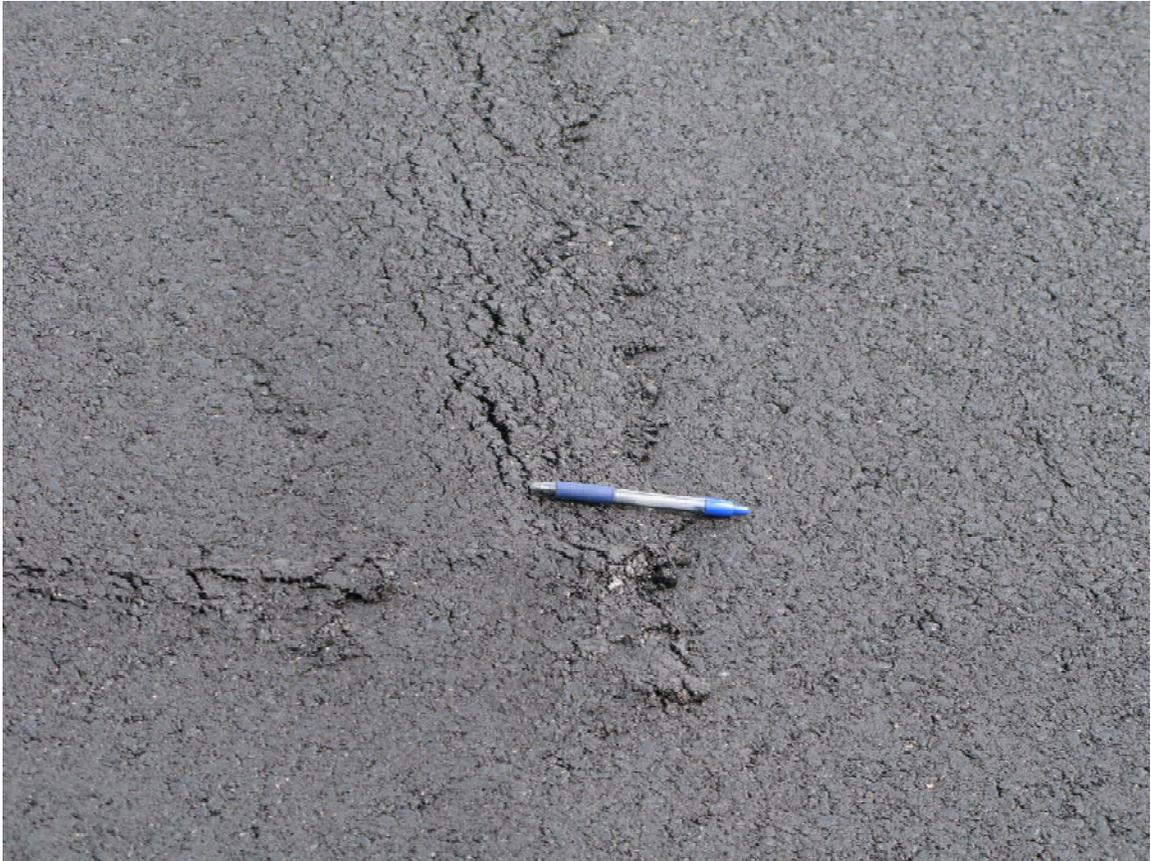
330 to crack 1. The experiment was repeated with some exceptions as shown in Table 7 in an attempt to ‘create’ the bumps and transverse cracks witnessed at cracks 271 and 272 in the southbound lane on September 2. The first evidence of bumps and cracks occurred at cracks 271 to 275 as shown in Figure 13. These bumps were much more severe than those witnessed on September 2 in the southbound lane.

Figure 13. Bump and Transverse Cracks over Crack 271 on US 285

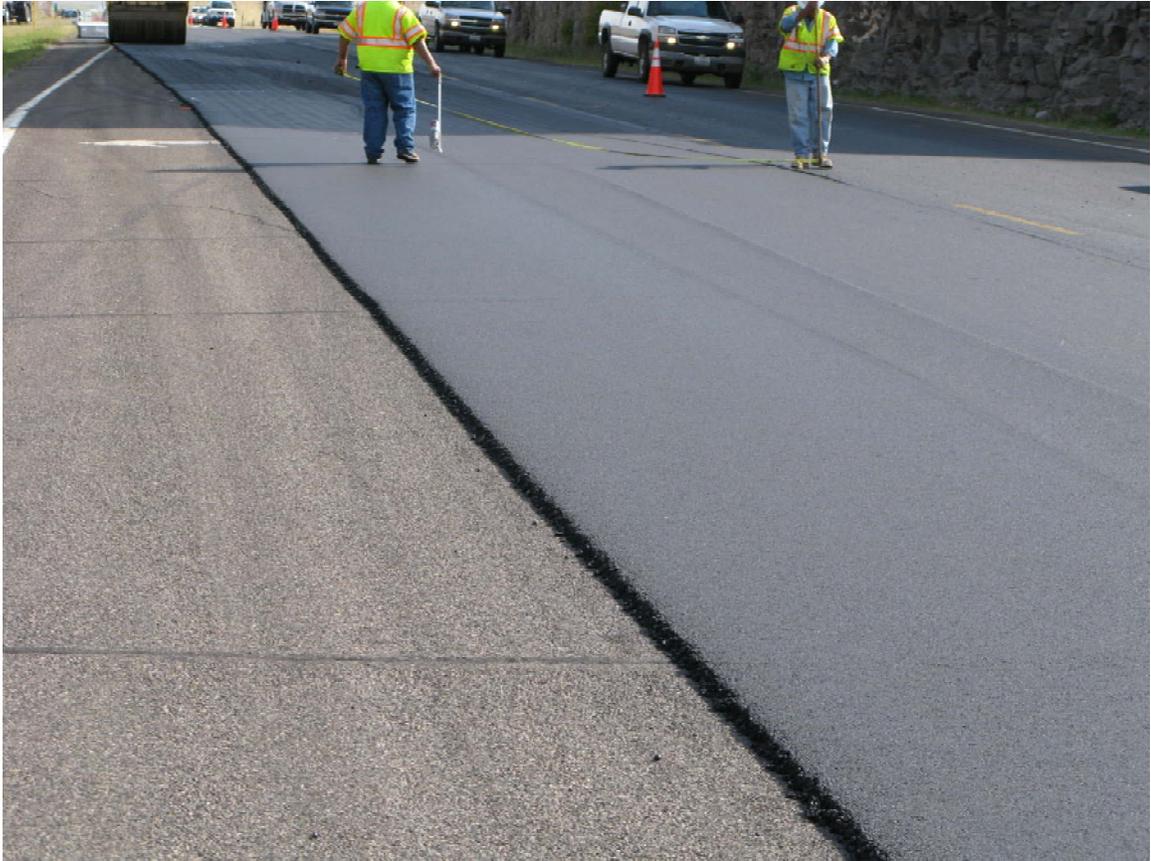
Second and third attempts to create the bumps and transverse cracks were done over cracks 199 to 204 and again at cracks 127 to 132. The results of this experiment are shown in Figures 14 and 15. The severity of the cracks and bumps appeared directly related to the number of passes of the vibrating roller. As cracks began to appear after the first pass of the roller, the contractor was reluctant to continue the experiment with additional roller passes. The severity of the cracks and bump shown over crack 271 was not observed over cracks 199 to 204 or 127 to 131 due to fewer passes of the vibrating rollers.

Figure 14. Bumps and Transverse Cracks over Cracks 129, 130, and 131 Northbound US 285

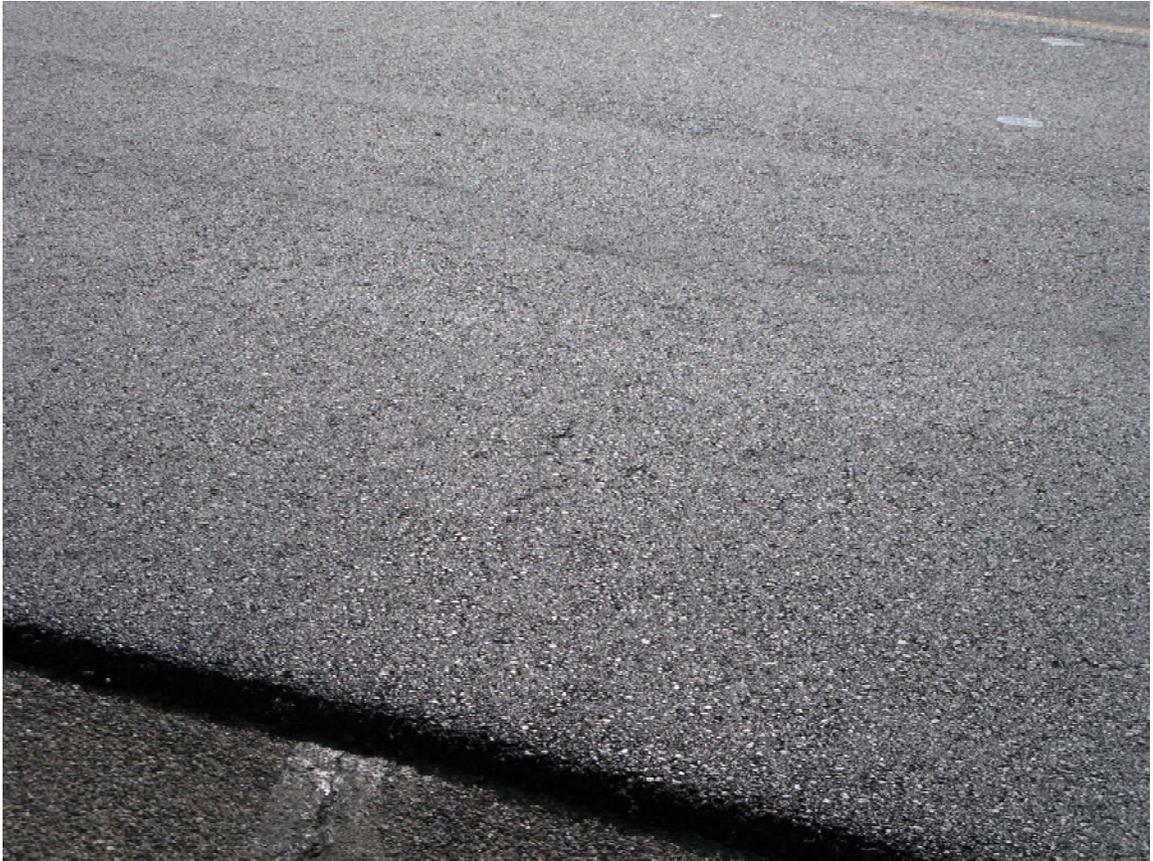
Figure 15. Transverse Crack Forming over Crack 201 Northbound US 285
