EVALUATION OF BRIDGE DECK
REPAIR AND PROTECTIVE SYSTEMS

Interim Report
December 1977

1. Report No. FHWA-CO-RD-77-8		2. Government Accession No.		3. Recipient's Catalog No.	
4. Title and Subtitle EVALUATION OF BRIDGE DECK REPAIR AND PROTECTIVE SYSTEMS				5. Report Date December 1977

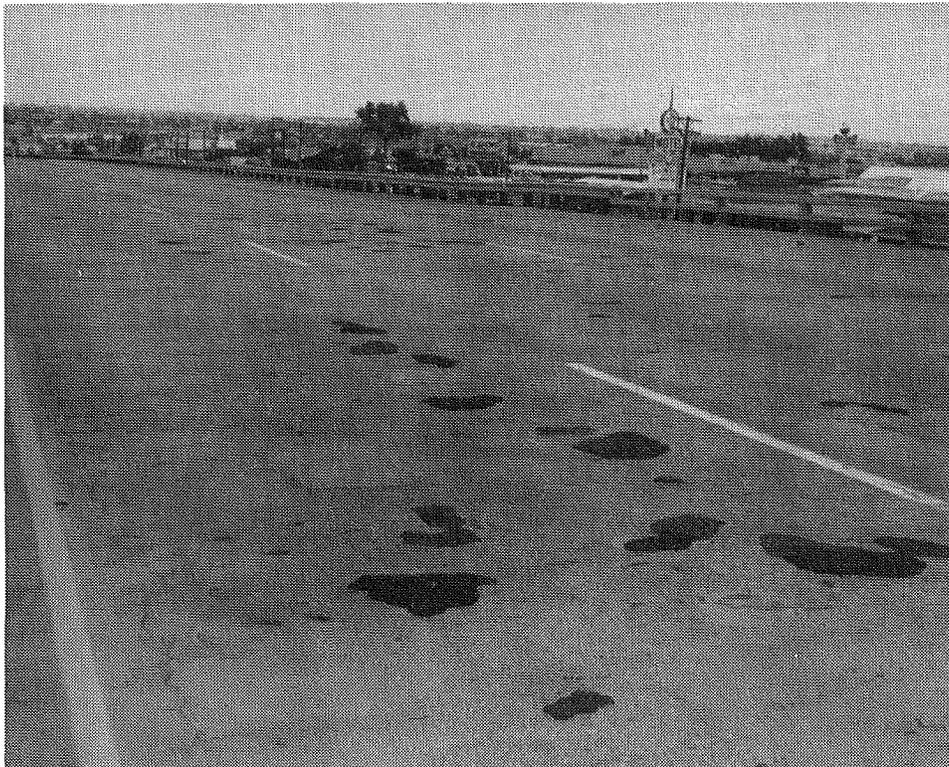
Photograph No. 1
Structure No. E-16-HE - Eastbound Over 32nd Avenue shows
badly deteriorated bridge deck

More recently some badly deteriorated decks have been repaired by cleaning off all delaminated concrete to the level of the top reinforcing steel, sandblasting the rust from the steel and then resurfacing with one of two methods. The first method is to apply a surface layer of quick setting patch cement material covered by an asphalt membrane and an asphalt concrete overlay. A second method is to apply a latex modified concrete wearing course.

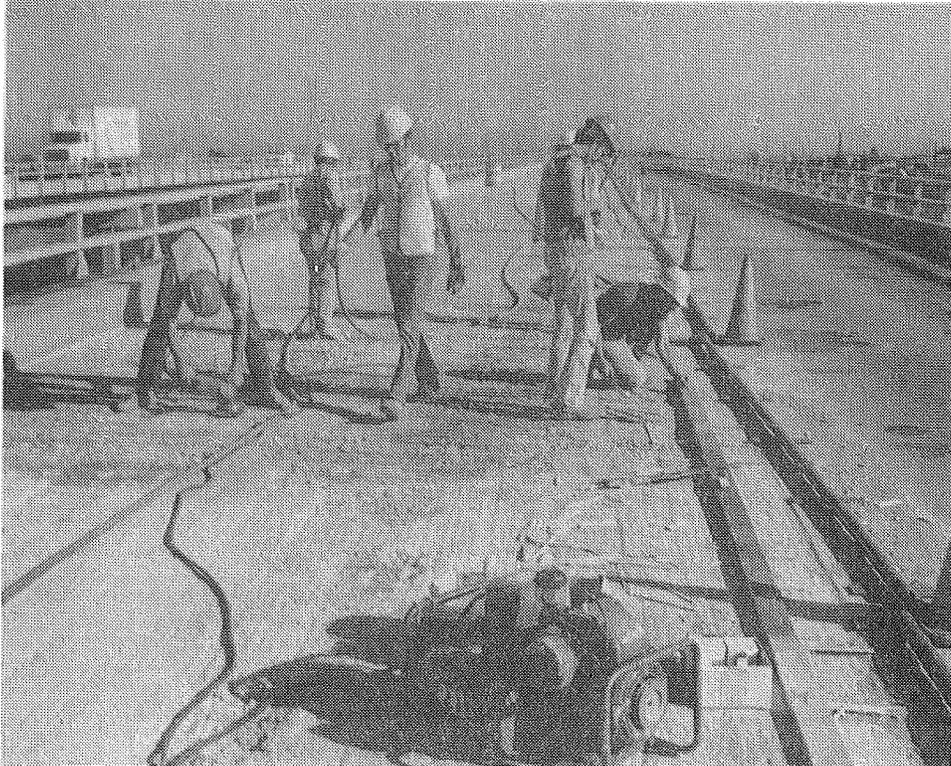
Photograph No. 3
Structure No. E-17-JT - I 225 Northbound Over Sand Creek
Removing Delaminated Concrete

Preparation included grinding about 2 cm (.78 in) of concrete from the entire deck followed by jackhammering to remove delaminated concrete and sandblasting to remove rust from the steel.

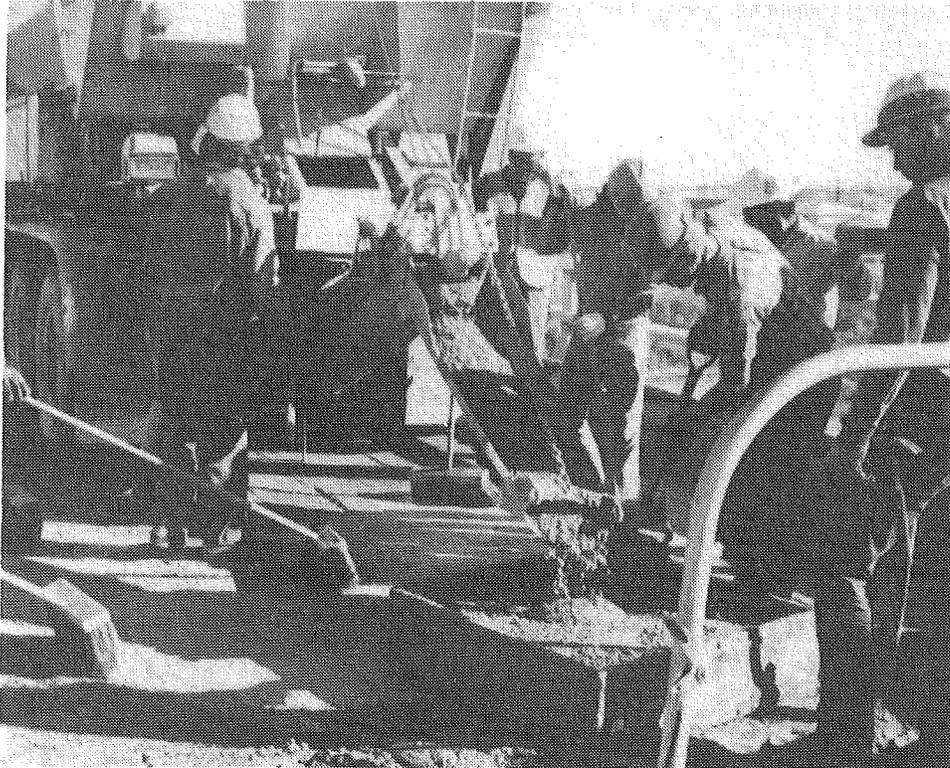
Liquid latex was mixed with the concrete in special trucks on the job, placed and finished to a minimum thickness of 3.8 cm (1.5 in). A mechanical finishing machine leveled, vibrated and finished the latex modified concrete. (See Photograph No. 4).

Photograph No. 4
Structure No. E-17-JT - I 225 Northbound Over Sand Creek
Pouring Latex Modified Concrete

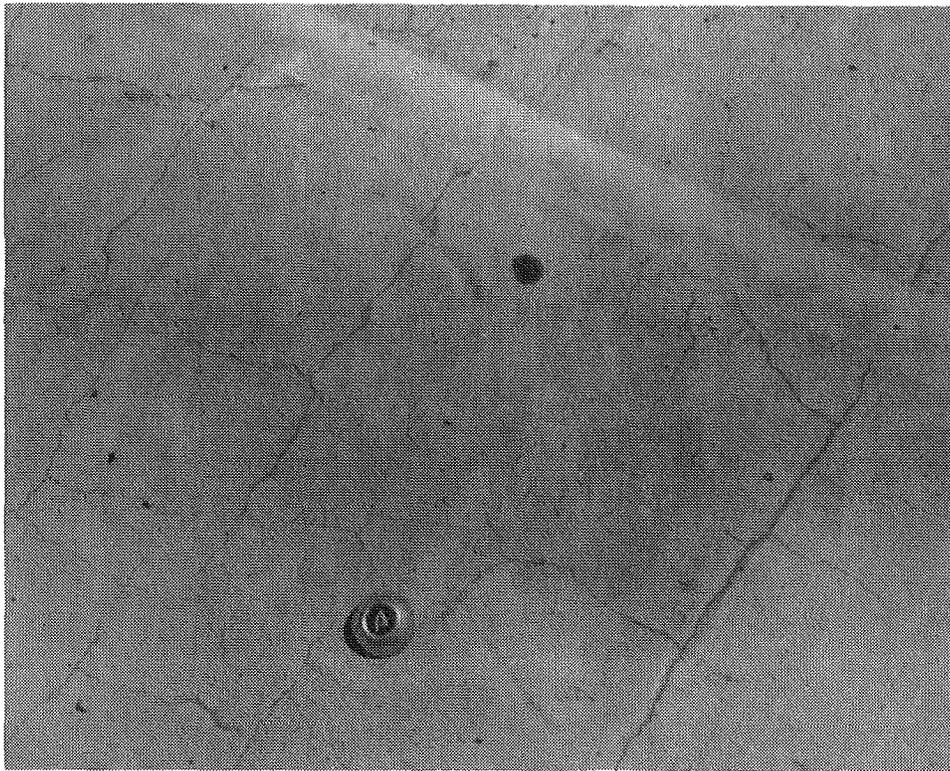
This material cracked quite extensively in a random pattern within a few days. There did appear to be more cracks in a transverse alignment corresponding to the reinforcing steel. A high water cement ratio is probably responsible for some of the cracking. Less water in the mix would have reduced the shrinkage cracks and would have produced a stronger material. Proper curing measures were not carried out soon enough after placement and finishing of the concrete. Nearly a hundred shrinkage cracks were removed by cutting

around each crack with a diamond saw and then chipping out the concrete within that area. These areas were then patched with new latex modified concrete. The repair and patching was completed within four days. During the next two years the surface continued to crack to the extent shown in Photograph No. 5, taken in 1976.

Photograph No. 5
Structure No. E-17-JT - I 225 Northbound Over Sand Creek
Fall 1976 - Extensive Cracking

In September of 1977 a rolling delamination detector was used on the Sand Creek Bridge. Analysis of the data from this test indicates that 19% of the surface is delaminated. The thickness and strength of the modified concrete may be resisting pop-outs to date, but this deck may require another repair project in the next few years.

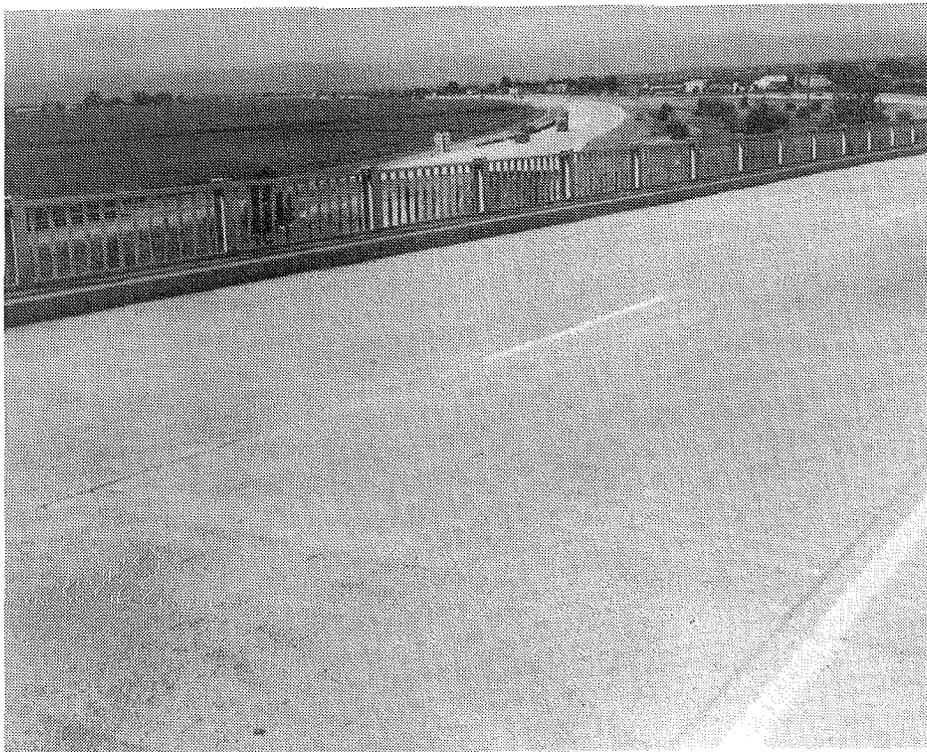
Photograph No. 6
Structure No. E-17-DQ - Westbound Over SH 85
Fall 1976 - Shortly After Treatment

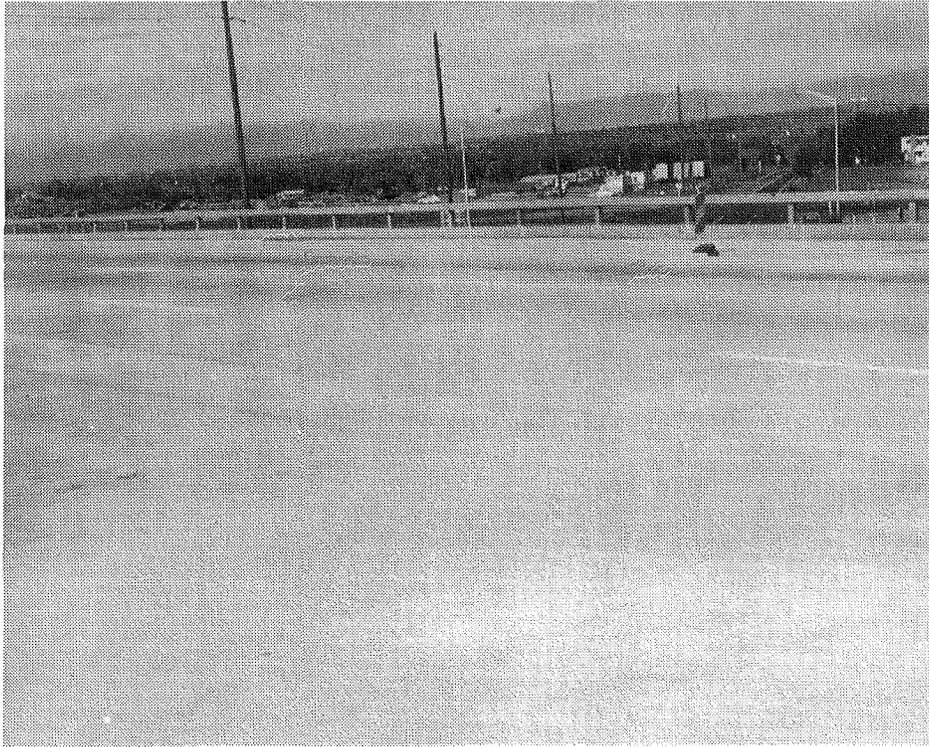
Photograph No. 7
Structure No. E-17-KT - I 76 Over 96th
August 1976 - New construction Class D Concrete was used as structural concrete and 3.8 cm (1.5 in) of latex modified concrete was used a a surface course.

On Structure E-17-KT - I 76 Over 96th Avenue, many hairline cracks had developed especially in the center of the spans. Core samples proved that 75% of these cracks were 7.5 cm (3.0 inches) deep and intercepted the steel. Therefore, the latex modified surface course was not 100% watertight or chloride-proof.

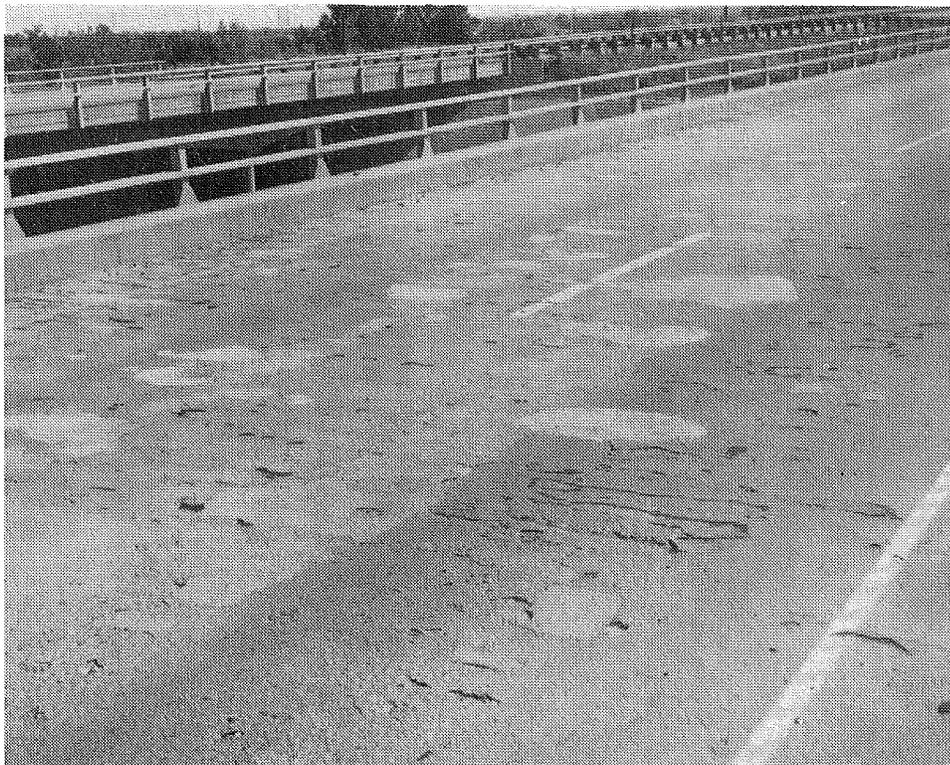
Photograph No. 9
Structure No. E-17-1B - I 76 Eastbound Over I 270
Before receiving the latex modified concrete repair and protective system this structure was badly delaminated and patched.

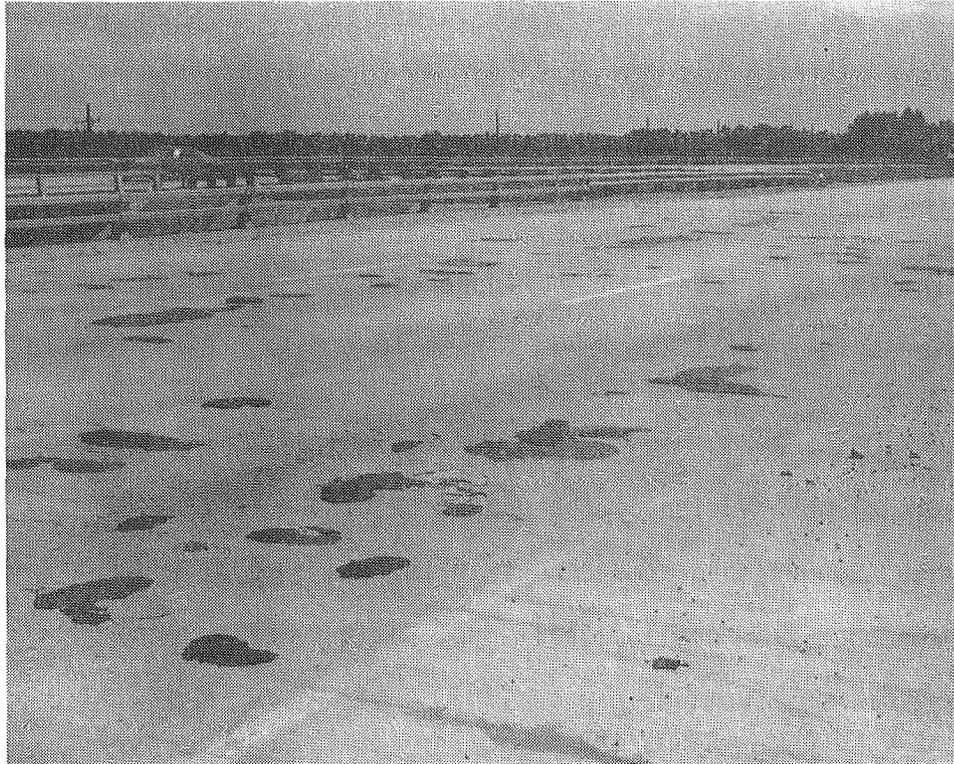
Photograph No. 10
Structure No. E-16-HF - I 70 Westbound Over 32nd Avenue
Before corrective and protective treatment.

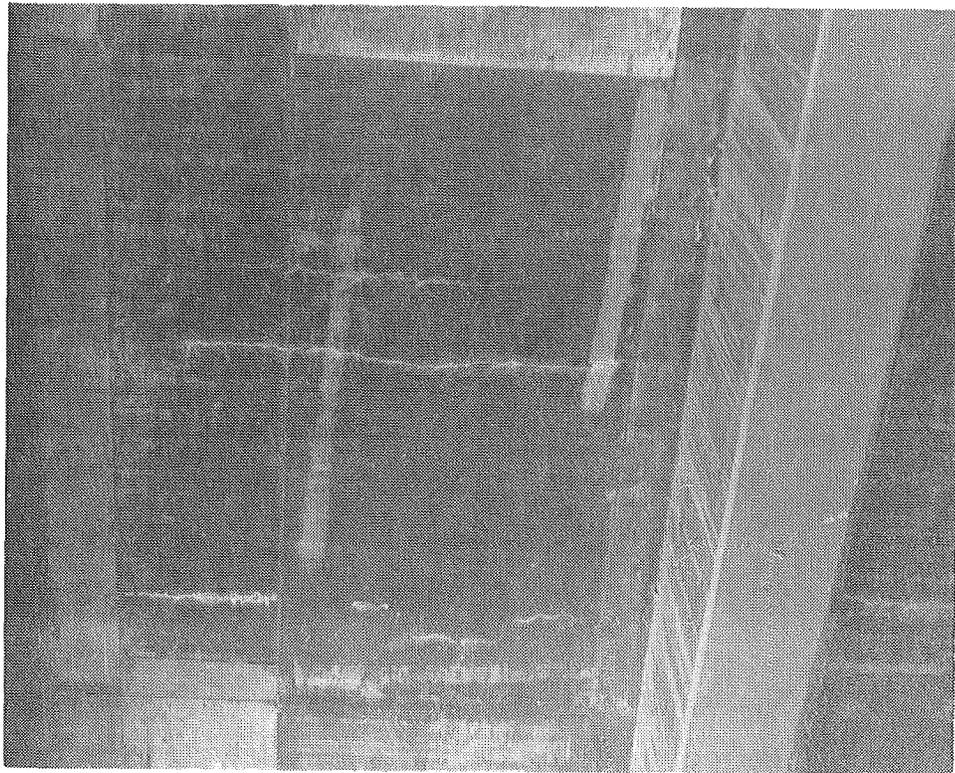
Visual observation of the underside of the four decks at I 70 at 32nd and 20th Avenues have some cracks in the original deck and residual salt efflorescence from previous salt applications. The surfaces all looked very good after construction.

Photograph No. 11
Structure No. E-16-HF - I 70 Westbound Over 32nd Avenue
Underside showing some cracks and residual salt
from previous deicing operations.

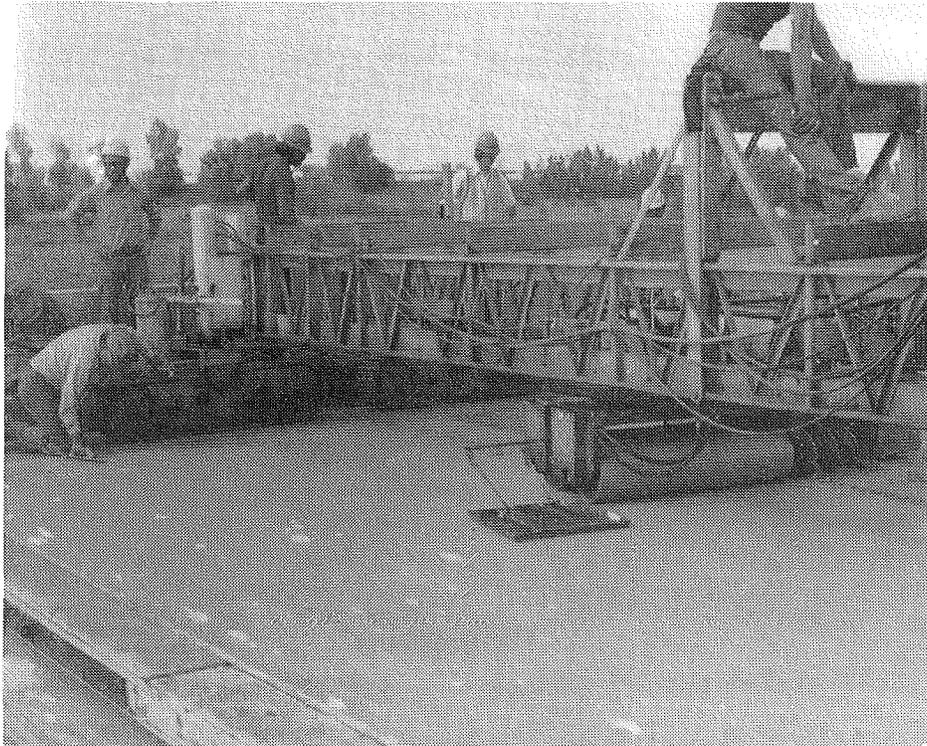
One small problem encountered in the repaired decks was that small spots of latex rich water surfaced after the finishing process. The water was sprayed on before the latex modified concrete was dumped to obtain a good bond with the old concrete. These spots are thought to have been caused by excess free water standing in low areas of the cleaned and jackhammered deck.

Photograph No. 12
Structure No. E-17-1B - I 76 Eastbound Over I 270
Finishing Machine.
White spots are water and latex.

Some free water collected in the low spots. Vibrating and finishing caused the water to come to the surface carrying some latex with it. The opinion of project personnel was that not enough latex was lost to worry about. The white spots were worn off by traffic after a few weeks. (See Photograph No. 12.)

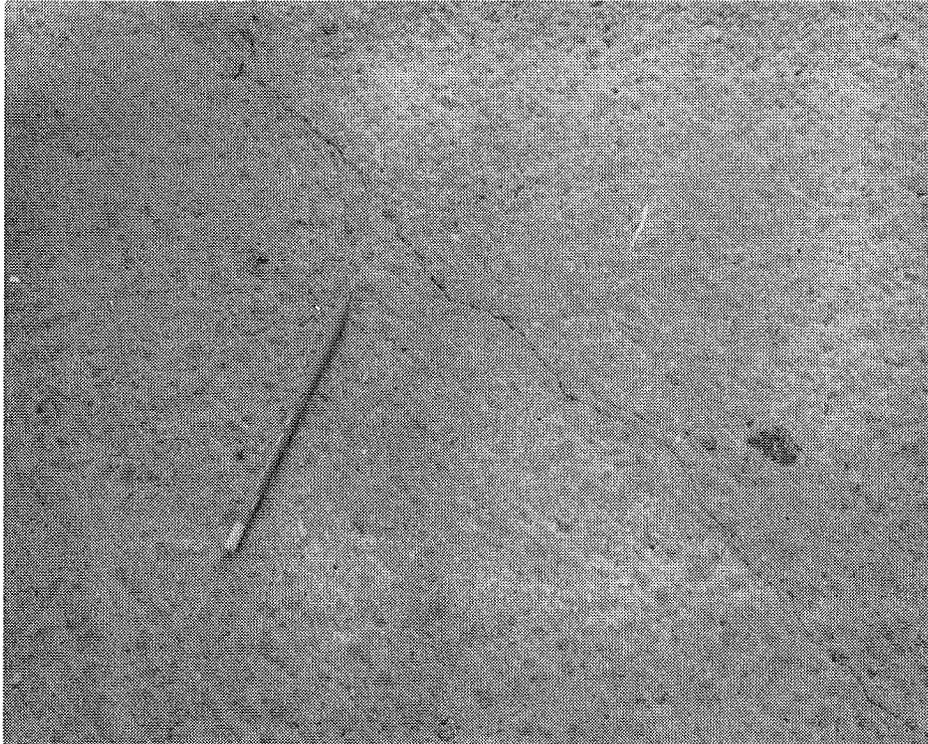
Photograph No. 14
Structure No. F-16-HK - I 70 Westbound Over 20th Avenue
Resurfaced in 1977 - Photograph taken four
months after resurfacing.
Cracks recently appeared in this and several
other latex modified concrete decks.

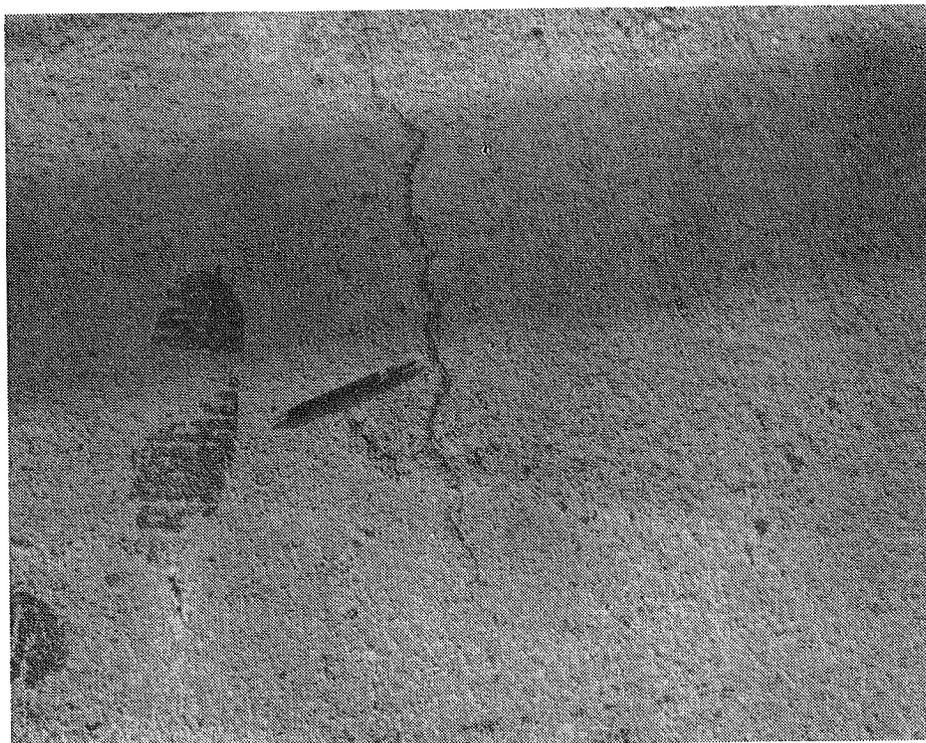
Photograph No. 15
Structure No. E-17-IT (Top Deck - I 225 Over I 70)
Resurfaced in 1976 - Some new cracks have recently
appeared in the latex modified surface.

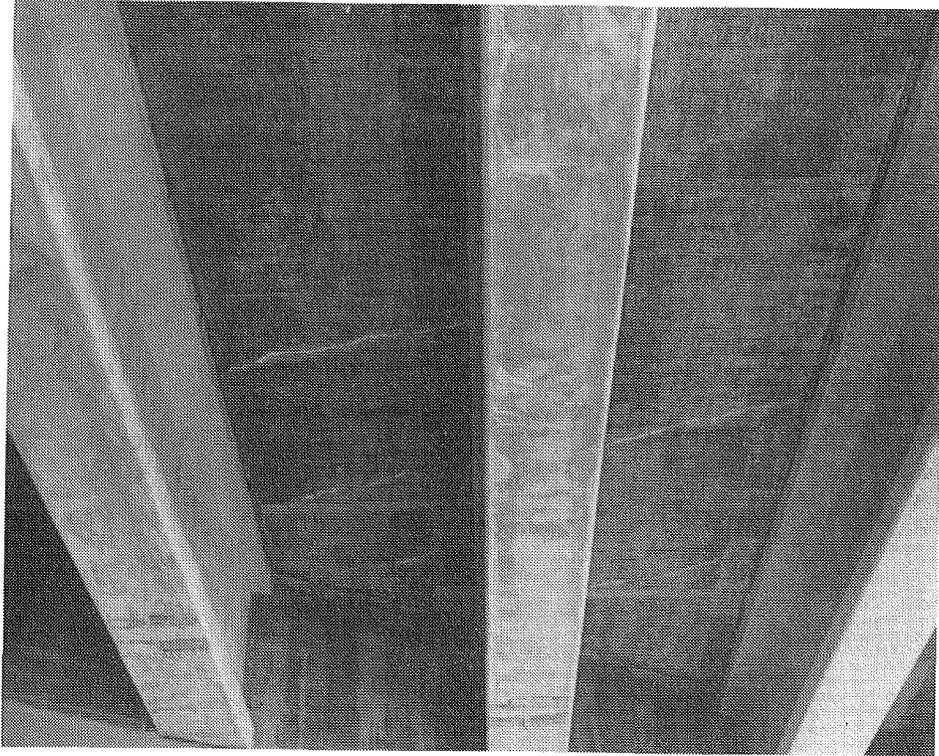
This is the new structure built in 1976. There are a considerable number of cracks in this deck. (See Photograph Nos. 16 and 17.) These cracks are continuous and vertical from top to bottom through the top latex modified concrete and the bottom Class D concrete.

Photograph No. 17
Structure No. D-17-KT - I 76 Over 96th Avenue
Salt efflorescence near cracks on the underside of the
deck of this new structure

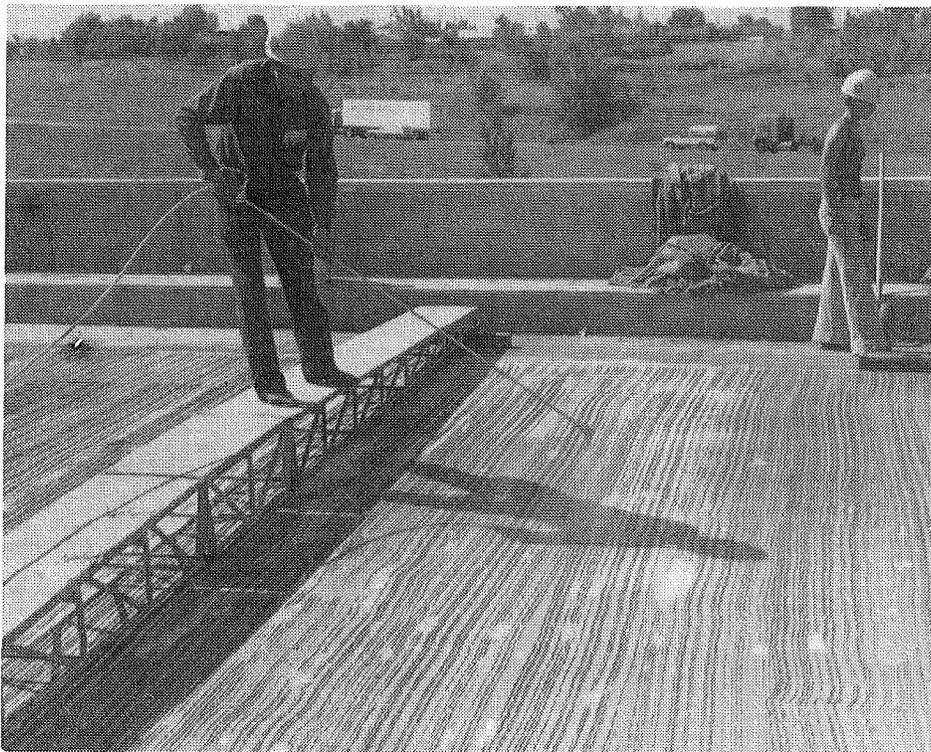
Photograph No. 18
Structure No. E-17-1B - I 76 Eastbound Over I 270
Spraying liquid curing compound in place of burlap
and plastic sheets.

Note: The bright white spots are not curing compound -
they are water and latex.

The results were very good and the only surface cracking occurred at a place where there was a delay in mixing and delivery of the concrete mix. These cracks are not the fault of the curing compound as this liquid curing compound is considered to be a definite advantage over wet burlap curing procedures.
