Report NO. CDOH-DTD-90-11

# BRIDGE DECK REPAIR DEMONSTRATION

Final Report  
October, 1990

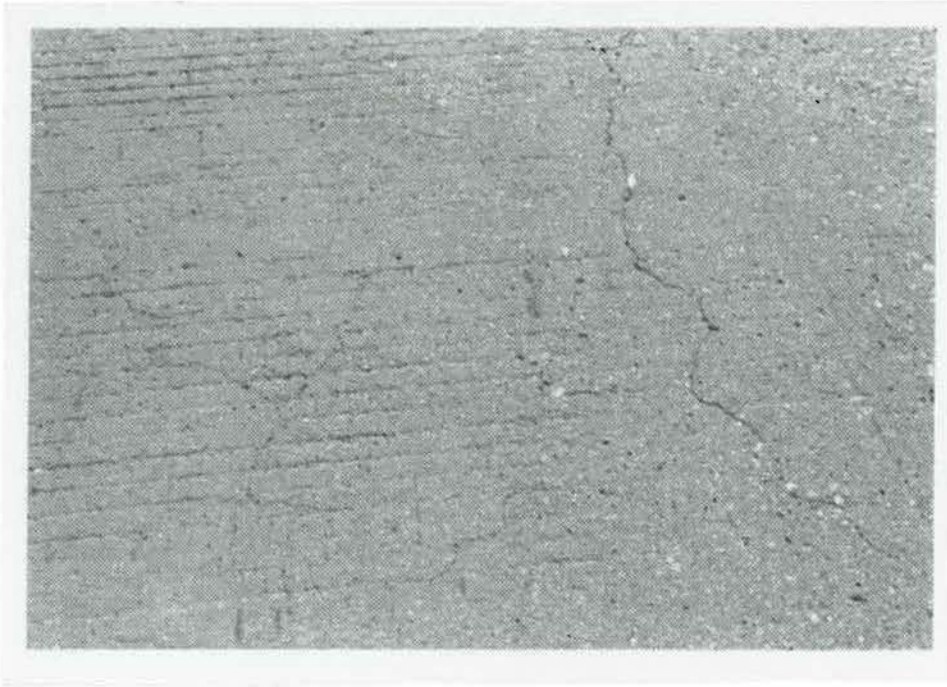
**Photograph 7.**  
Surface detail  
of deck C-17-AT.  
April, 1990.  
Low slump concrete  
with fly ash.

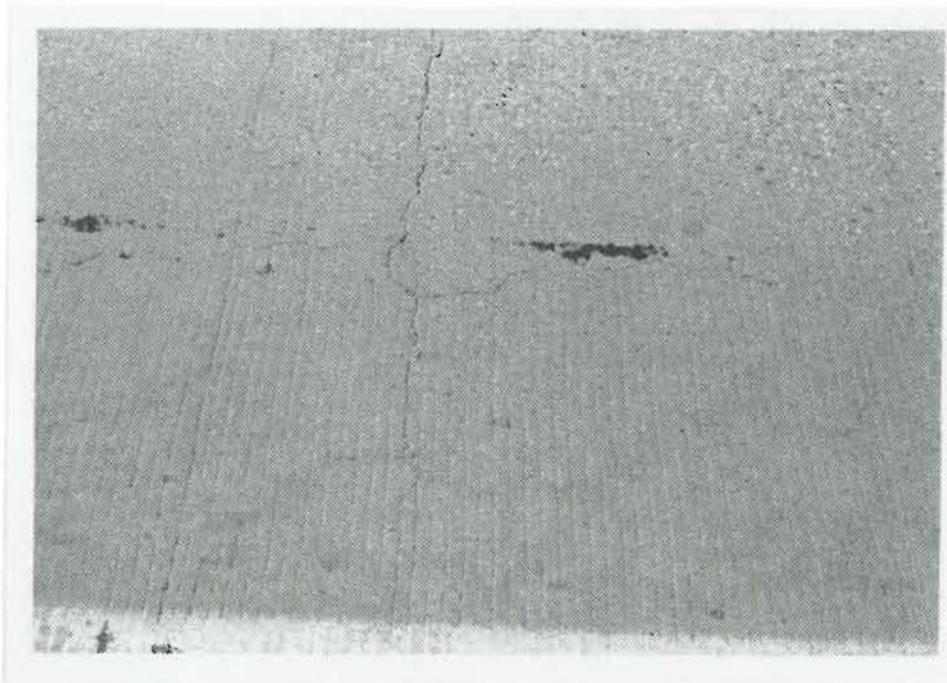
**Photograph 8.**  
Closeup of deck.  
Structure C-17-BQ.  
April, 1990.  
Low slump concrete  
with fly ash.

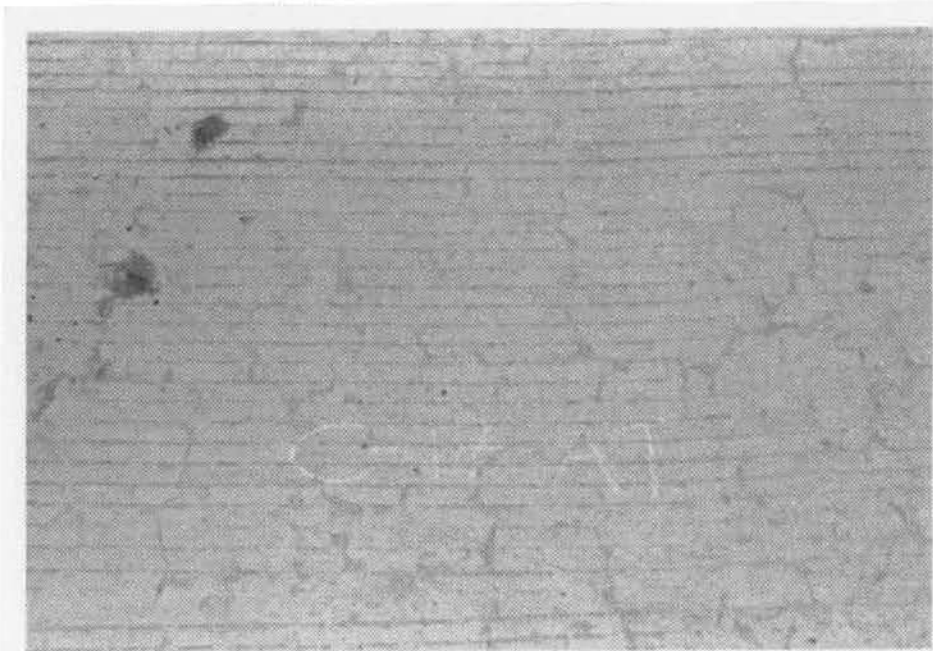
**Photograph 9.**  
Hairline cracks  
in deck. Structure  
C-17-AT.  
April, 1990.  
Low slump with  
fly ash.

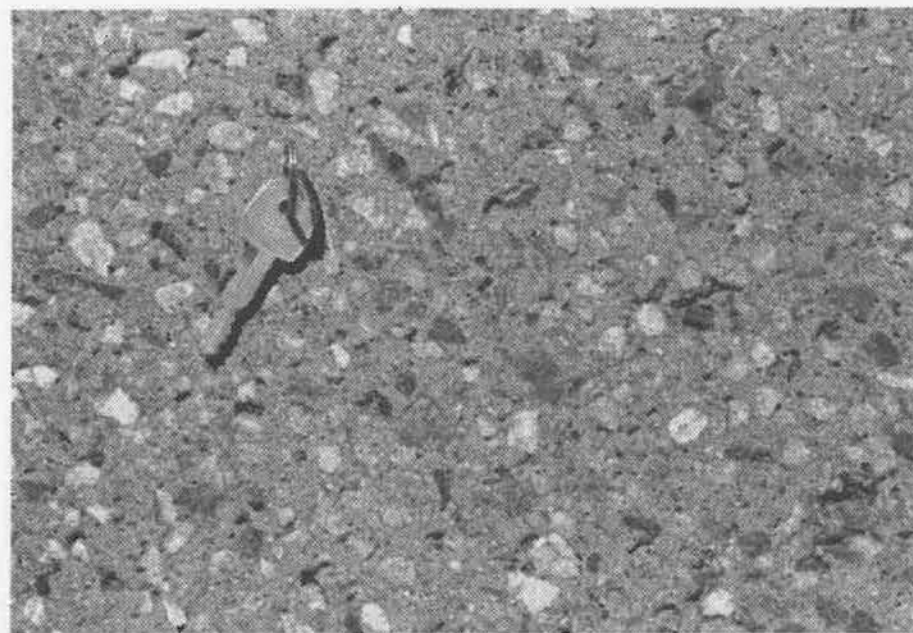
**Photograph 10.**  
Surface texture.  
Structure C-17-AT.  
April, 1990.  
Low slump with  
fly ash.

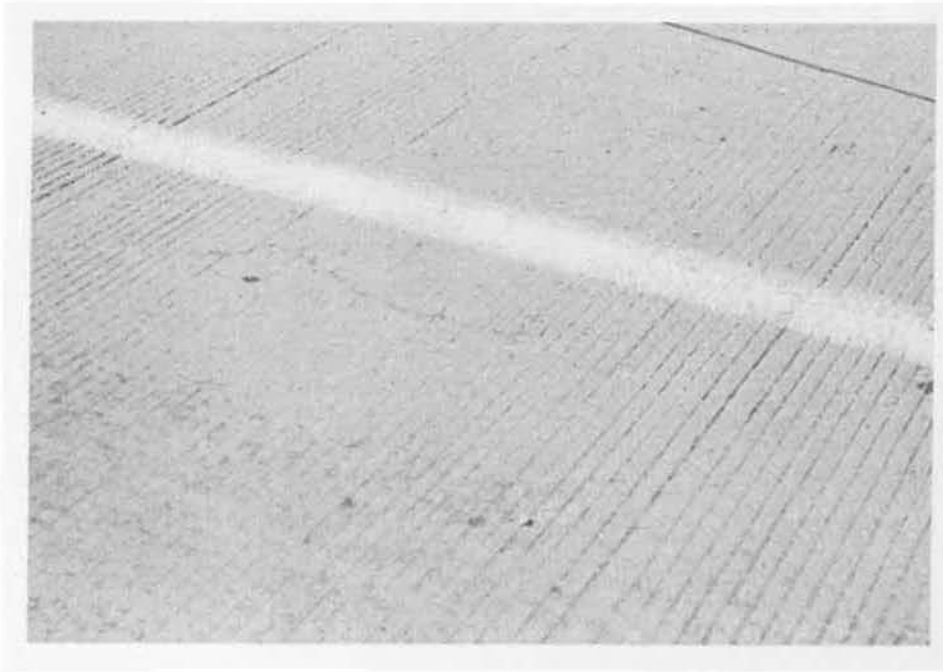
**Photograph 11.**  
Cracks in deck.  
Structure  
C-17-DY.  
April, 1990.  
Latex modified.

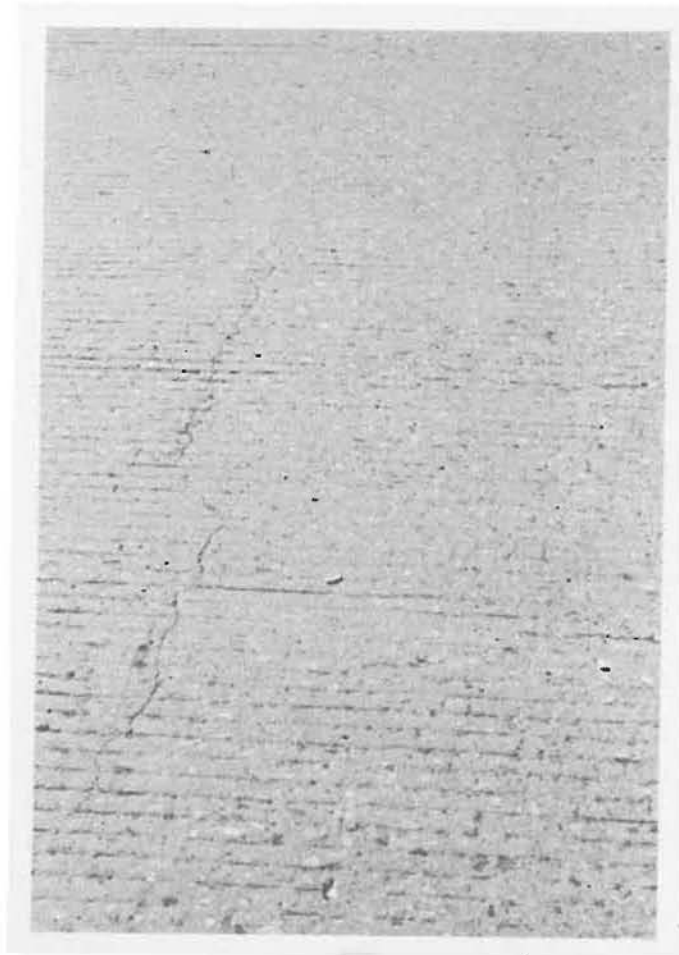
**Photograph 12.**  
Surface texture.  
Structure C-17-DY.  
April, 1990.  
Latex modified.

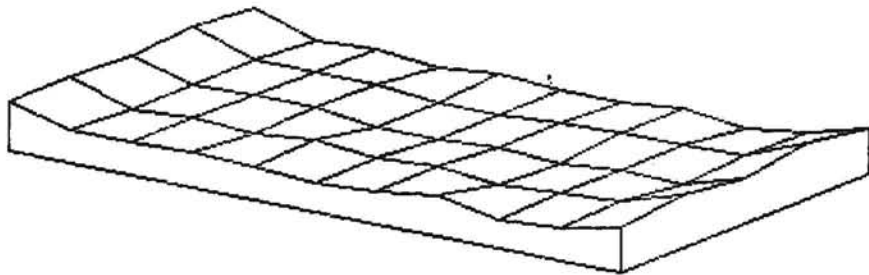
Half-cell Measurements C-17-DY (4/2/90)

20/22%

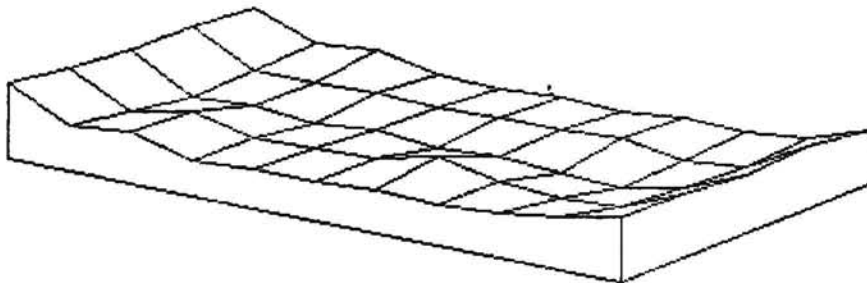
Half-cell Measurements C-17-BQ (4/2/90)

21/33%

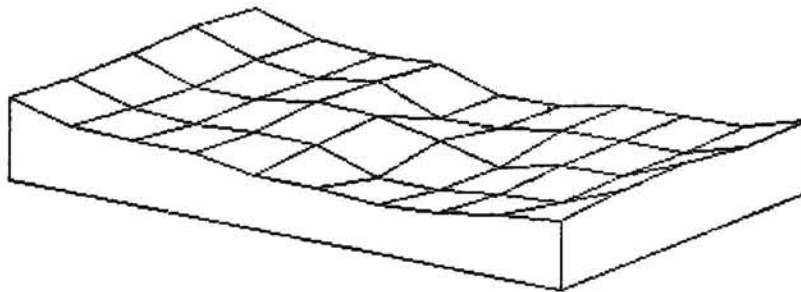
Half-cell Measurements C-17-AT (4/2/90)

86/94%

Plots of the half-cell readings for each deck for each of the six evaluations are shown in Appendix B. The plots show the half-cell voltages plotted as a surface above the deck. Apparent from the readings, is the increase in voltage near the ends of the deck. Most readings are in the range of 0.0 to 1.0 volt. For the purpose of evaluation, a reading of 0.3 V indicates probable corrosion and a reading over 0.35 V indicates the presence of active corrosion.

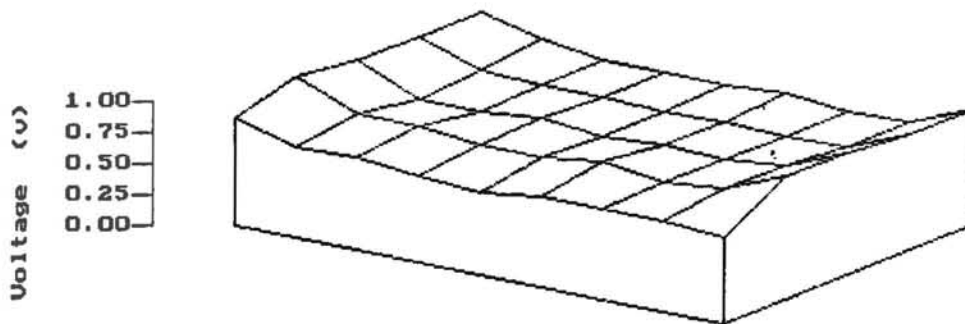
Half-cell Measurements C-17-CE (4/2/90)

100/100%
