Report No. CDOH-DTD-R-90-4

PAVEMENT MARKING MATERIALS

Final Report
July 1990

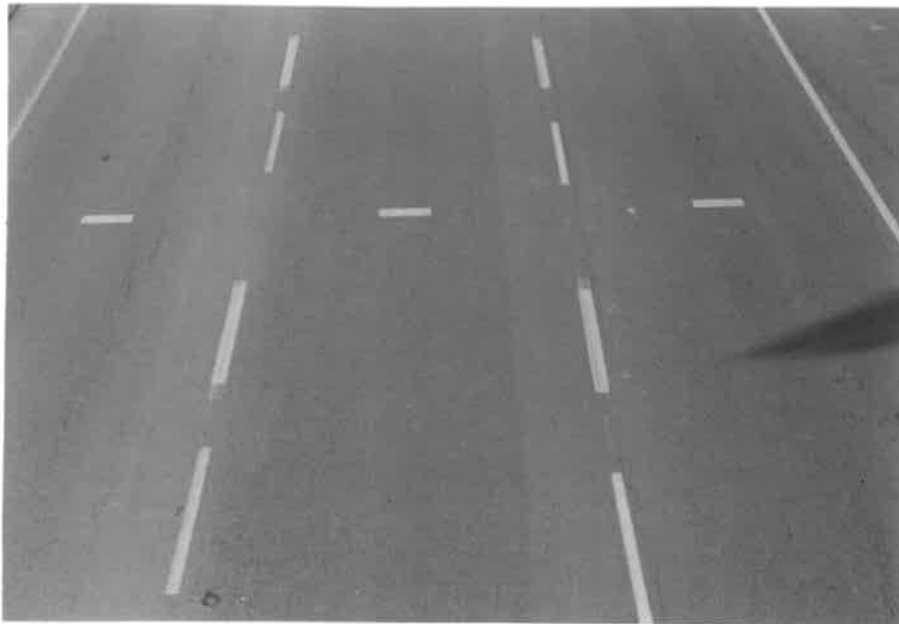
Photo 2. 3/16/87
I25 southbound, milepost
163.4, north of Monument,
1984 epoxy paint.

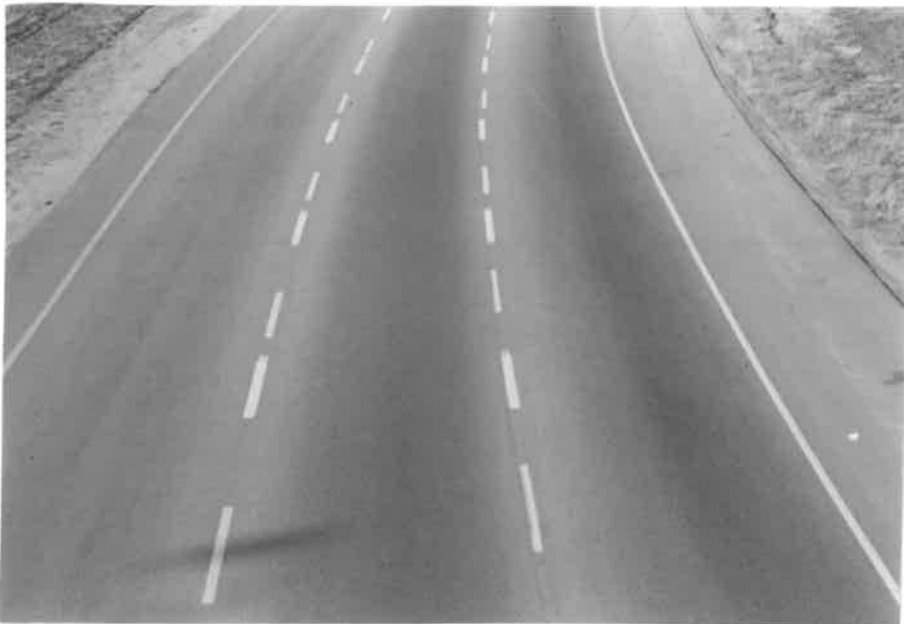
Photo 3. 12/84
I70 eastbound, milepost
248, near El Rancho
Interchange, 1984 epoxy
paint.

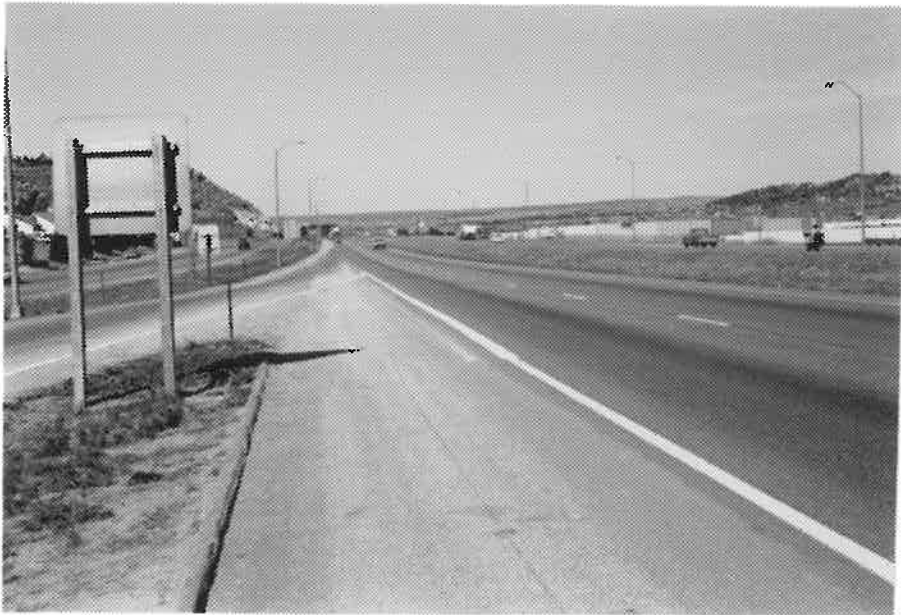
Photo 4. 12/84
I70 westbound, milepost
248, near El Rancho
Interchange, 1984
polyester paint installed.

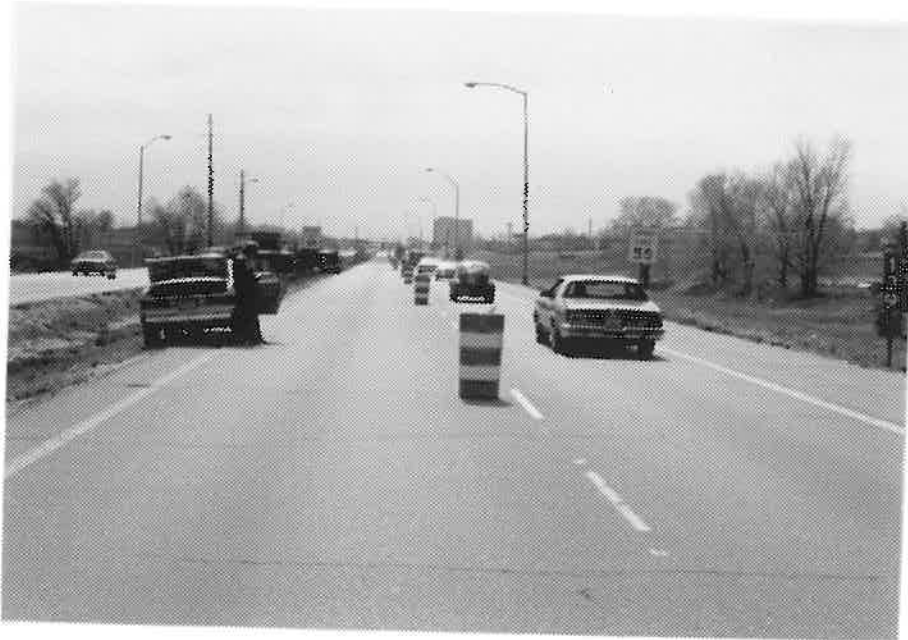
Evaluation on January 25, 1988 found the epoxy skip stripes to be 80 to 85 percent intact with fair appearance and a retroreflectivity of only 65 on the beadreader. This lower retroreflectivity may be partially due to dirty pavement markings. See Photo 6.

Photo 6. 1/25/88
I25 southbound, milepost
145, 1985 epoxy paint.

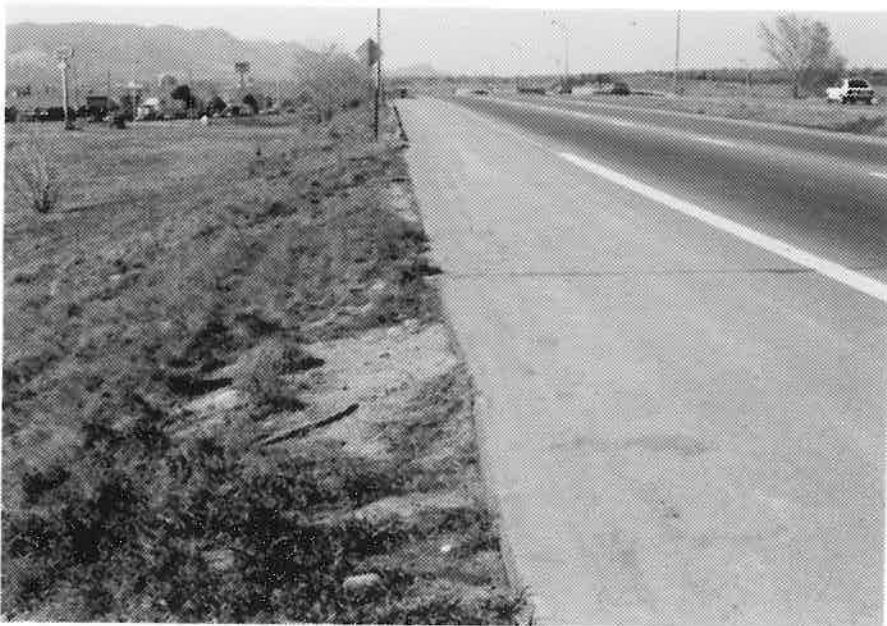
Photo 7. 4/17/89
I25 southbound, milepost
139, 1985 and 1988 epoxy
paint.

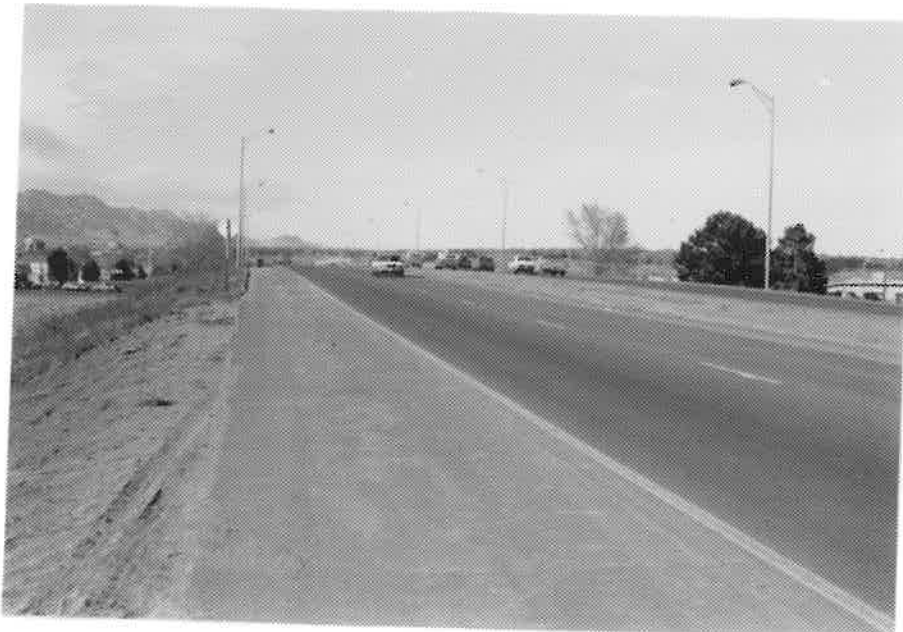
The material was evaluated on March 26, 1987 and found to be 95 percent intact with very good appearance. See Photo 8. Retroreflectivity was marginal in some areas (90) and good in others (120) as measured by the CDOH beadreader.

Photo 8. 3/16/87
I25 southbound, milepost
138, Harrison Road
Interchange, 1986 epoxy
paint.

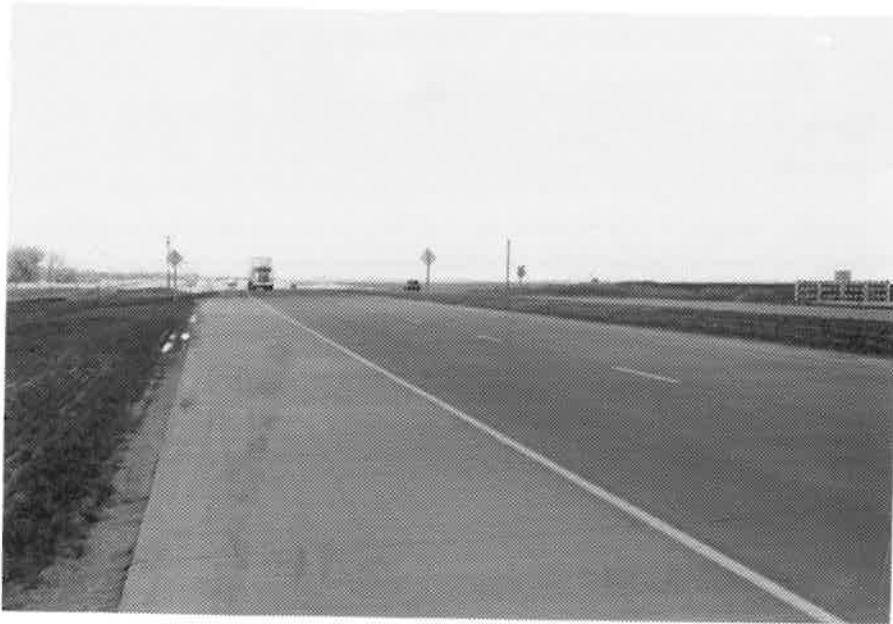
The evaluation on January 25, 1988 found dirty skip stripes which were 95 to 100 percent intact with good appearance and a marginal retroreflectivity of 95 to 100. See Photo 9.

Photo 9. 1/25/88
I25 southbound, milepost
138, Harrison Road
Interchange, 1986 epoxy
paint.

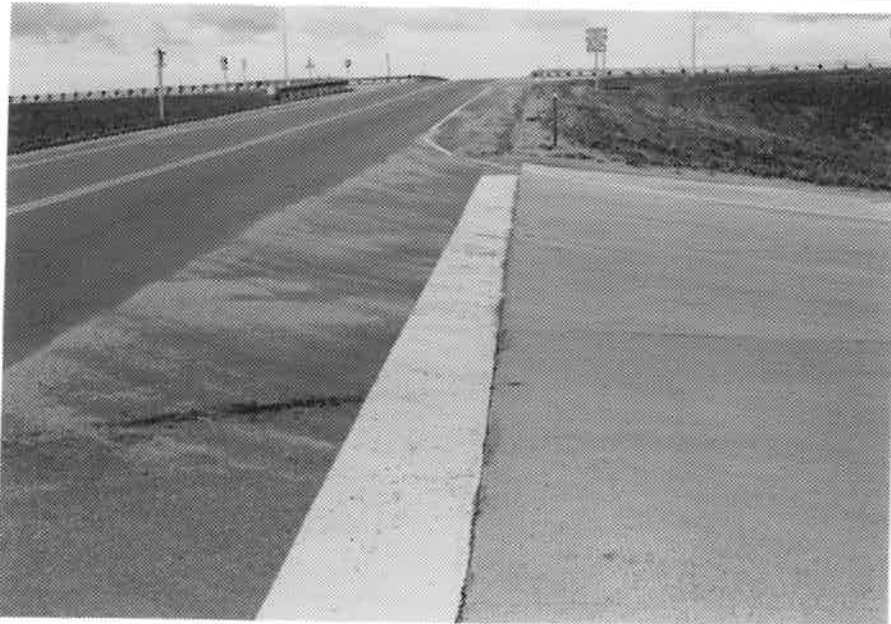
Photo 10. 4/13/87
I76 southbound, just
south of Bromley Lane,
1986 epoxy paint.

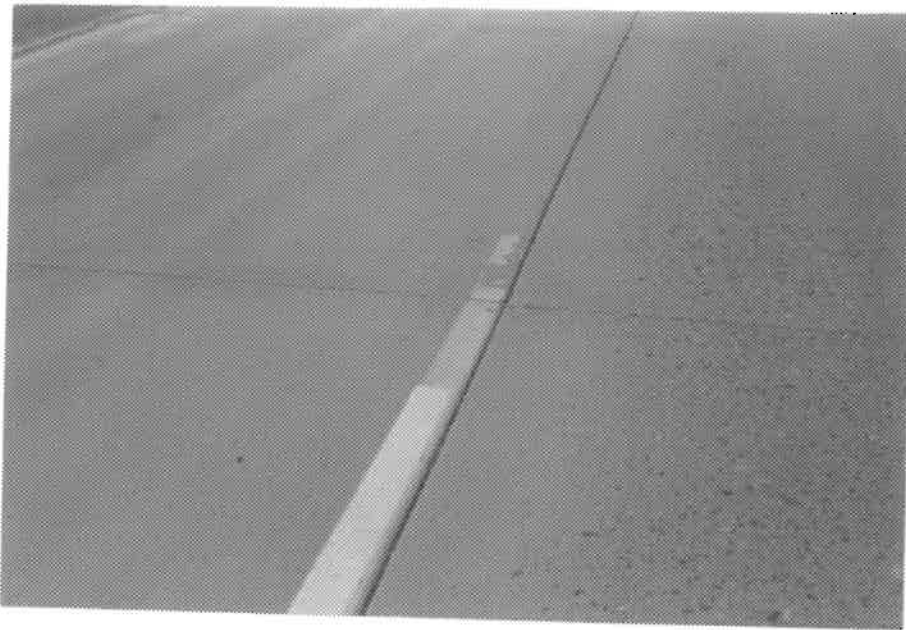
The material was evaluated by the study panel on March 26, 1987 and found to be 100% intact with good appearance. Retroreflectivity was good with readings of 120 to 150 on the CDOH beadreader. Adjacent alkyd traffic paint stripes were almost completely gone. See Photo 12.

Photo 12. 4/13/87
I76 northbound, just
north of Bromley Lane,
1986 epoxy paint in
lower left, and alkyd
paint in upper right.

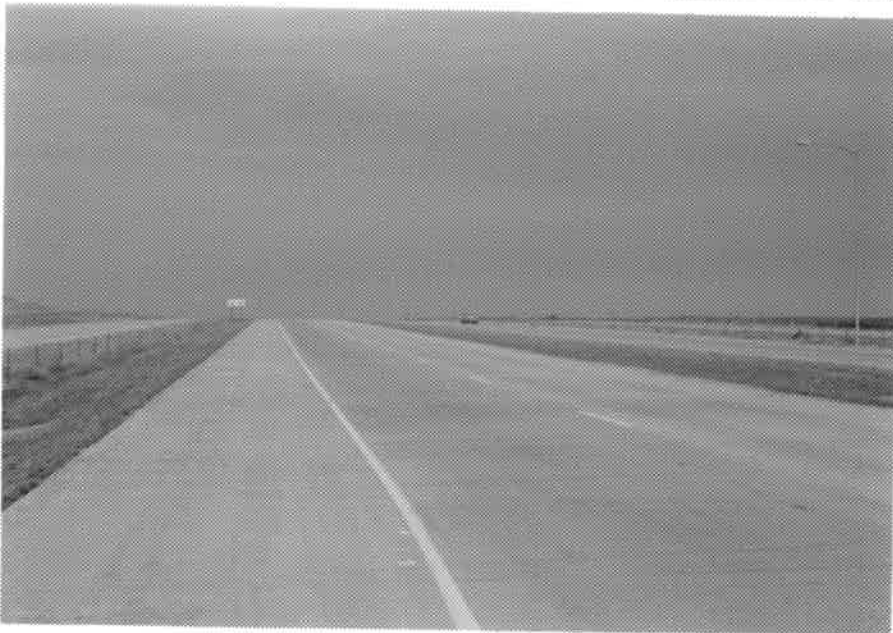
Photo 13. 1/25/88
I76 southbound, just north
of Bromley Lane, 1987
fast-dry alkyd paint on
bottom, 1986 epoxy paint
on top of photo.

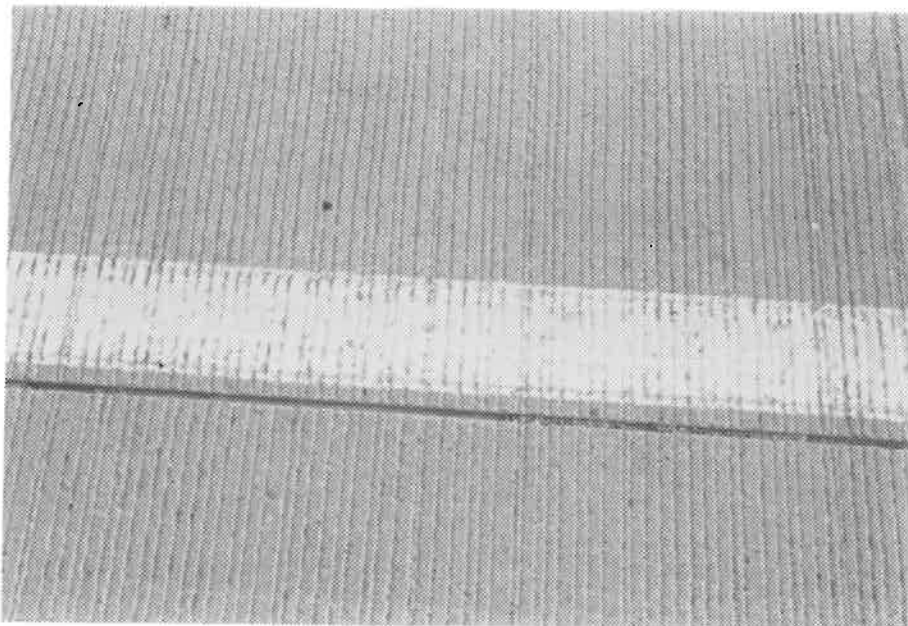
The epoxy paint may still be 85% intact, but the fast-dry paint on top makes it difficult to judge. The epoxy paint further northwest, which was not over-stripped with alkyd paint, was observed by the panel and found to have poor daytime visibility. The yellowing of the epoxy paint with age and the off-white color of concrete pavement results in weak contrast which leads to poor visibility. The epoxy stripes, however, were still quite visible at night.

Photo 14. 2/27/89
I76 southbound, just north
of Bromley Lane, 1986
epoxy paint overstriped
with fast-dry alkyd paint.

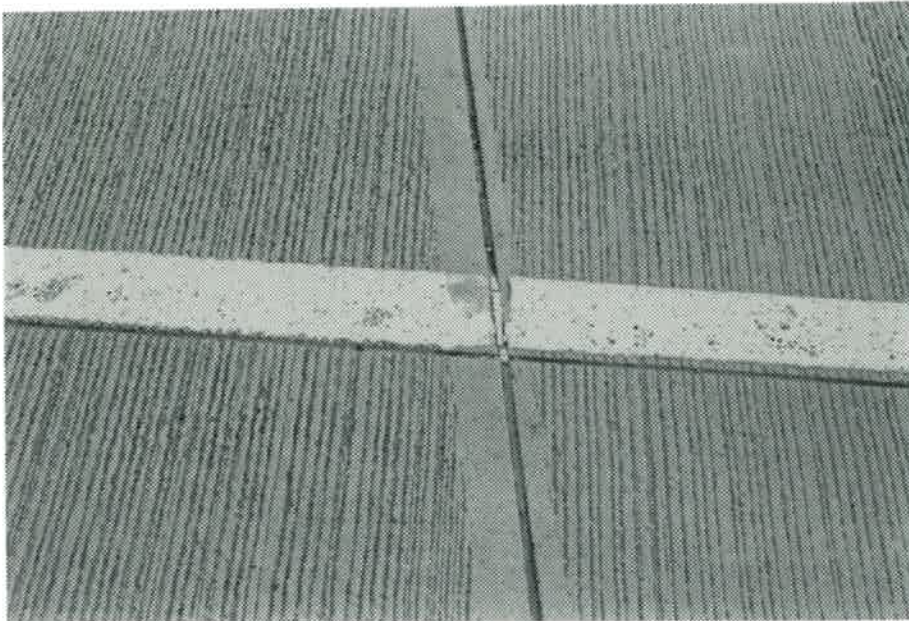
Photo 15. 1/25/88
I25 southbound, milepost
269 near Fossil Creek,
1986 epoxy paint skip
stripe.

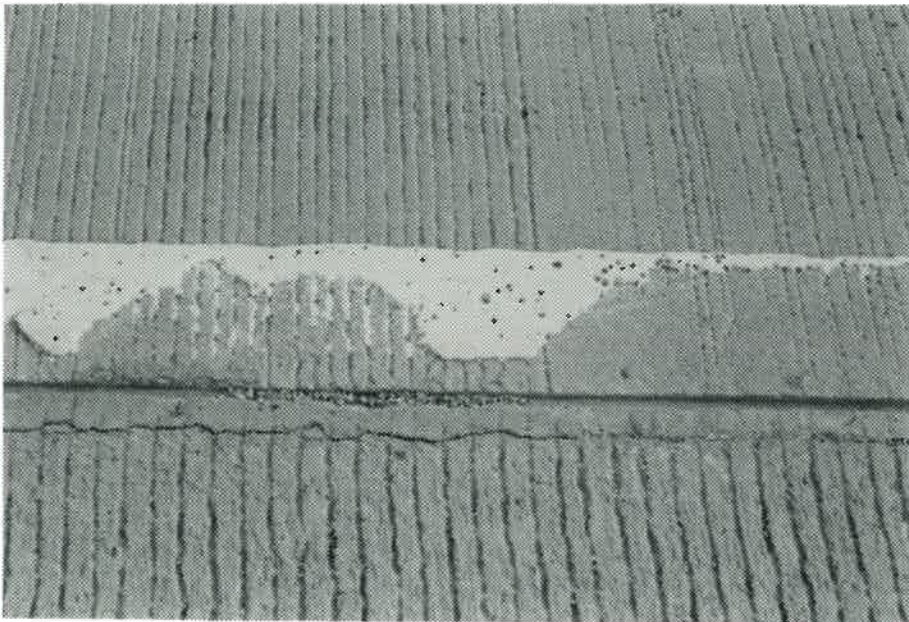
Photo 16. 1/25/88
I25 southbound, milepost
260 near Fossil Creek,
1986 extruded thermoplastic
skip stripe.

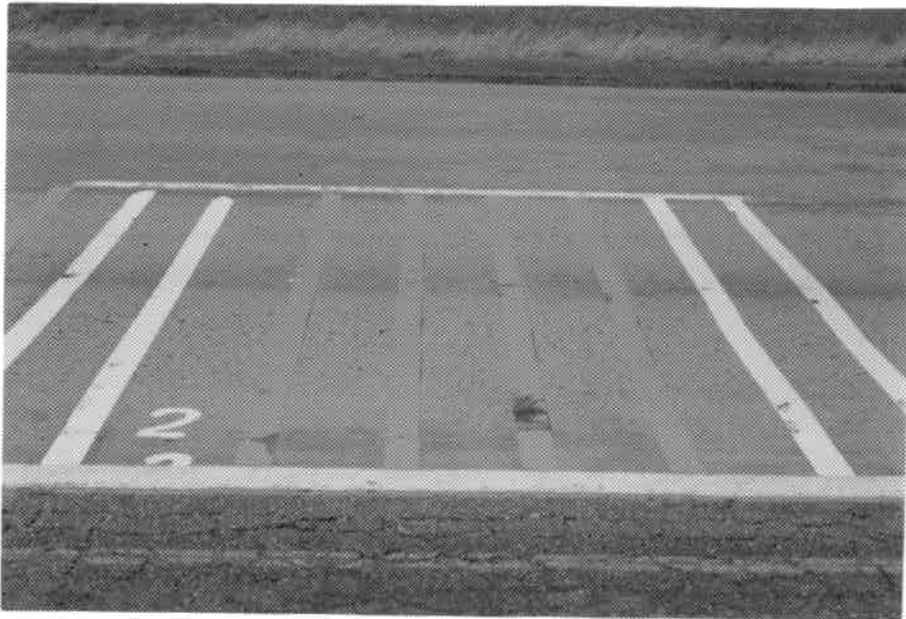
All the materials remained 99 percent intact on March 29, 1988 (end of test for removable materials) except for the 3M removable grade which had significant losses resulting in being only 70% intact. See Photos 21 through 25. Because these removable grade markings are intended to be temporary, it's interesting to look back at the condition of the 3M material during earlier evaluation sessions. During the fall evaluation (11/21/87), the 3M material was about 95 percent intact, (Photo 26) indicating that most of the loss occurred over the winter. The 3M removable material, therefore, is suitable for a shorter period of time and may not be suitable for winter time use on concrete.

Photo 21. 3/29/88
Cataphote removable grade
preformed plastic on
concrete.

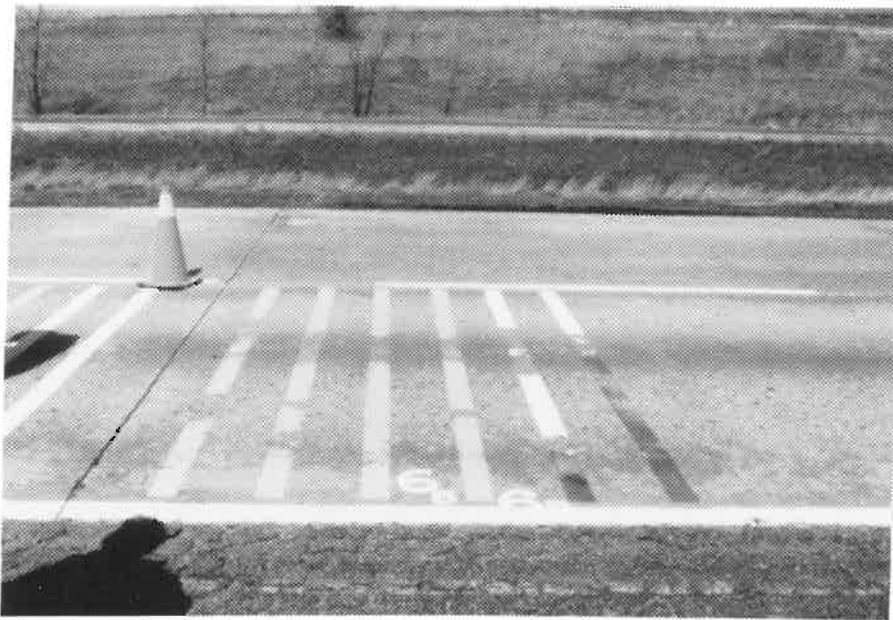
Photo 22. 3/29/88
Swarolite removable grade
preformed plastic on
concrete.

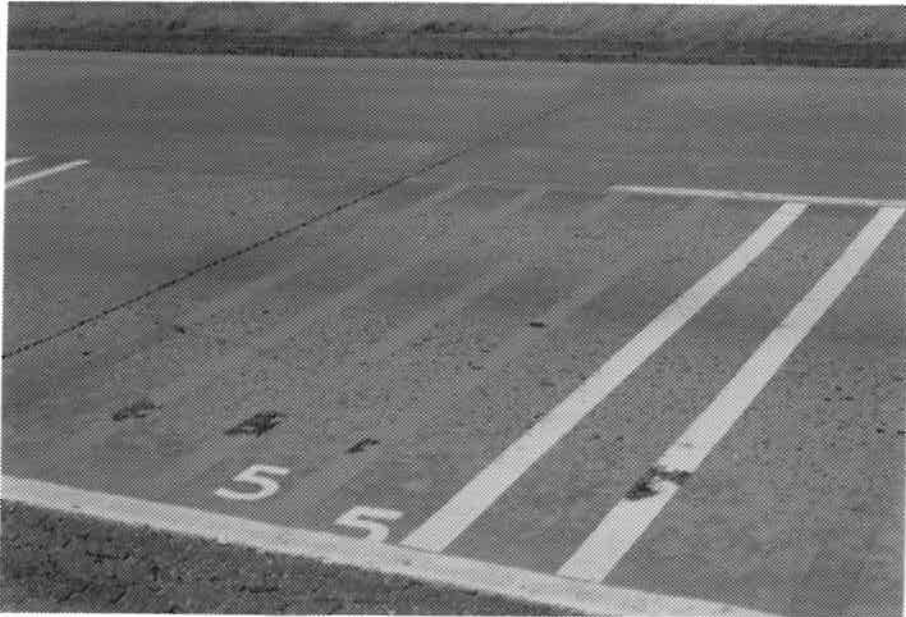
Photo 24. 3/29/88
Prismo removable grade
preformed plastic on
concrete.

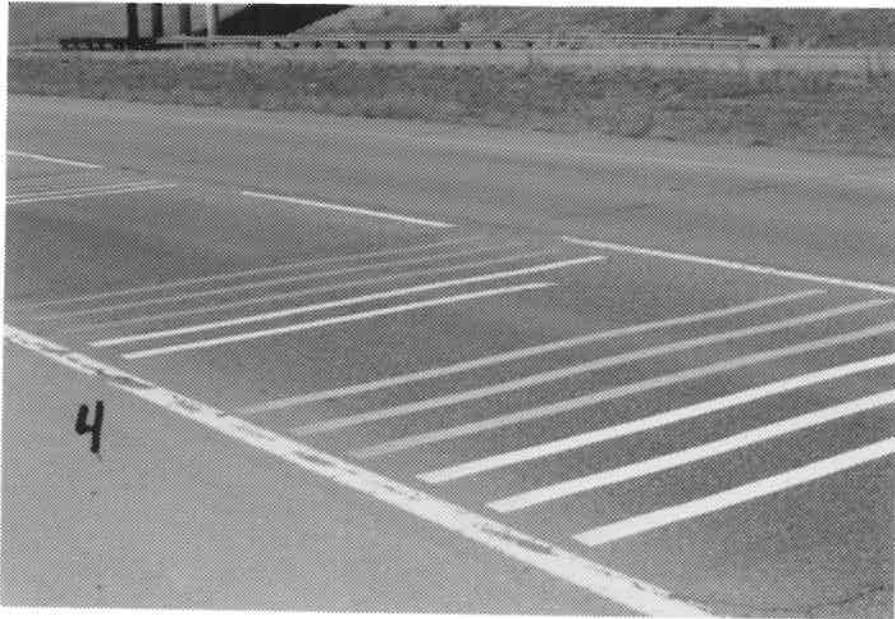
Photo 25. 3/29/88
PB Laminations removable
grade preformed plastic on
concrete.

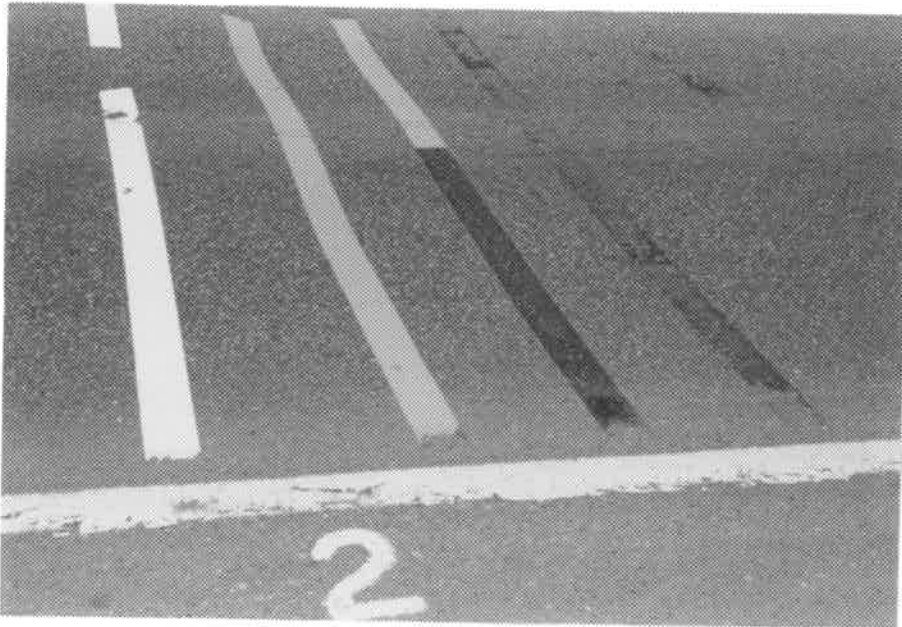
concerned. Photos 26 through 30 show the condition of the material on 3/29/88.

Photo 26. 3/29/88
Cataphote removable grade
preformed plastic on
asphalt. (Six stripes in
foreground)

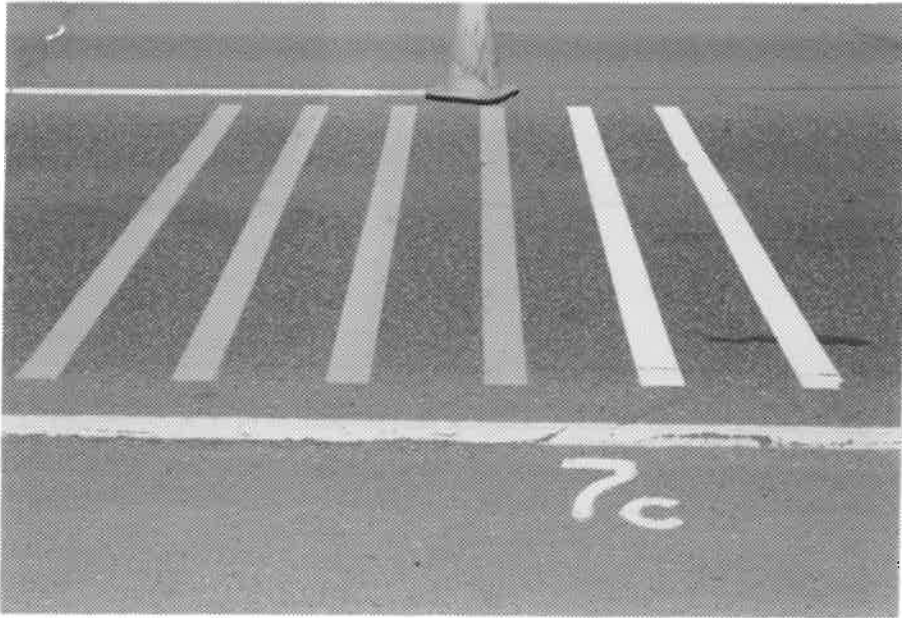
Photo 27. 3/29/88
Swarolite removable grade
preformed plastic on
asphalt.

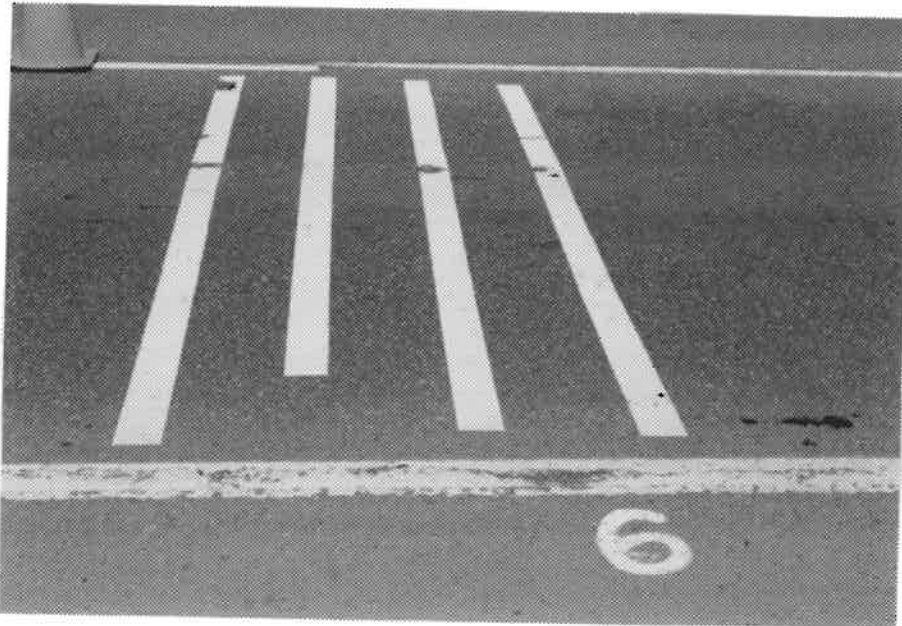
Photo 29. 3/29/88
Prismo removable grade
preformed plastic on
asphalt.
