Report No. 90-B

JOINT SEALANT EVALUATION IN COLORADO

Colorado Department of Transportation
4201 East Arkansas Avenue
Denver, Colorado 80222

Final Report
July 1991

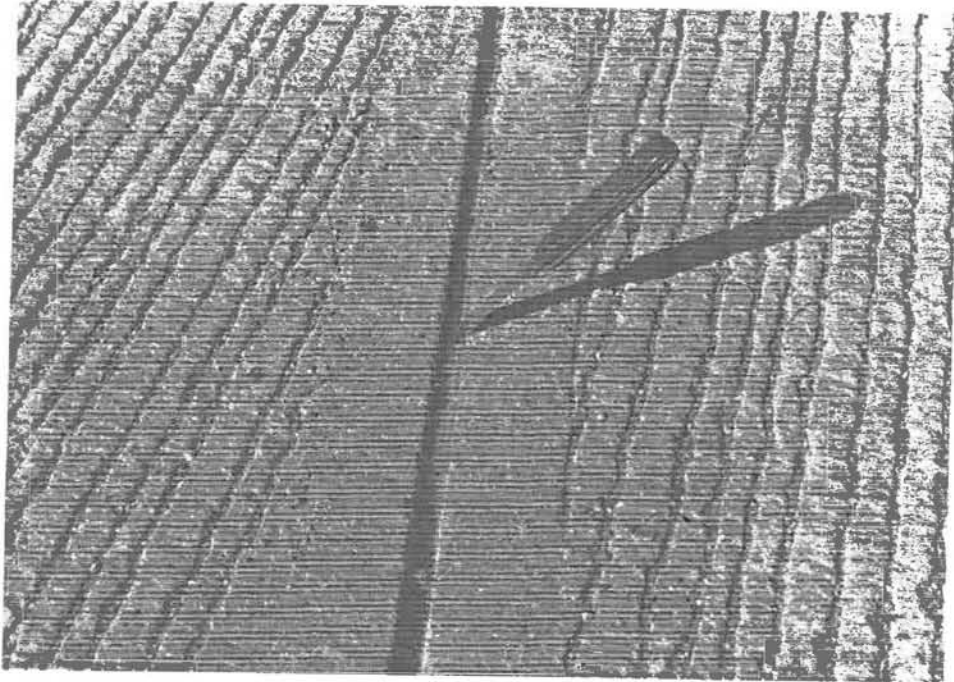
The silicone section on I-25 north of S.H. 34 was inspected first. The silicone at this location was installed in the 1984 construction season. However it appeared that the joints were recently sealed (Photograph 1). Some intrusion was noted, but it was not severe enough to have adversely effected The performance of the sealant. It is possible that the intrusion had happened before the silicone had fully cured. A portion of the silicone was cut and stretched about 50 percent to check for elasticity. It appeared that the silicone had uniformly cured and rebounded fairly quick (Photograph 2). At a few locations the concrete near the joint face found to have raveled (Photograph 3 and 4); ,however it remained bonded to the sealant. According to to a FHWA publication (Ref. 1) this type of failure is mainly due to the microcracks created during the joint sawing operation in cold weather. The panel member were pleased with the performance of the silicone at this location.

Photograph 1: 7-year old silicone on I-25 north of S.H. 34

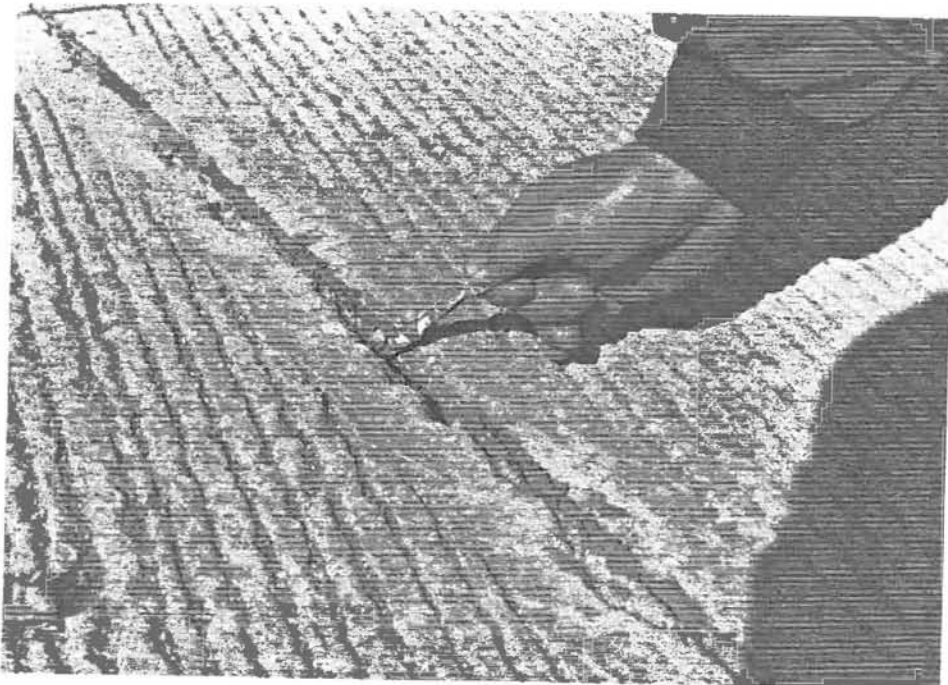
Photograph 2: Checking the elasticity of silicone

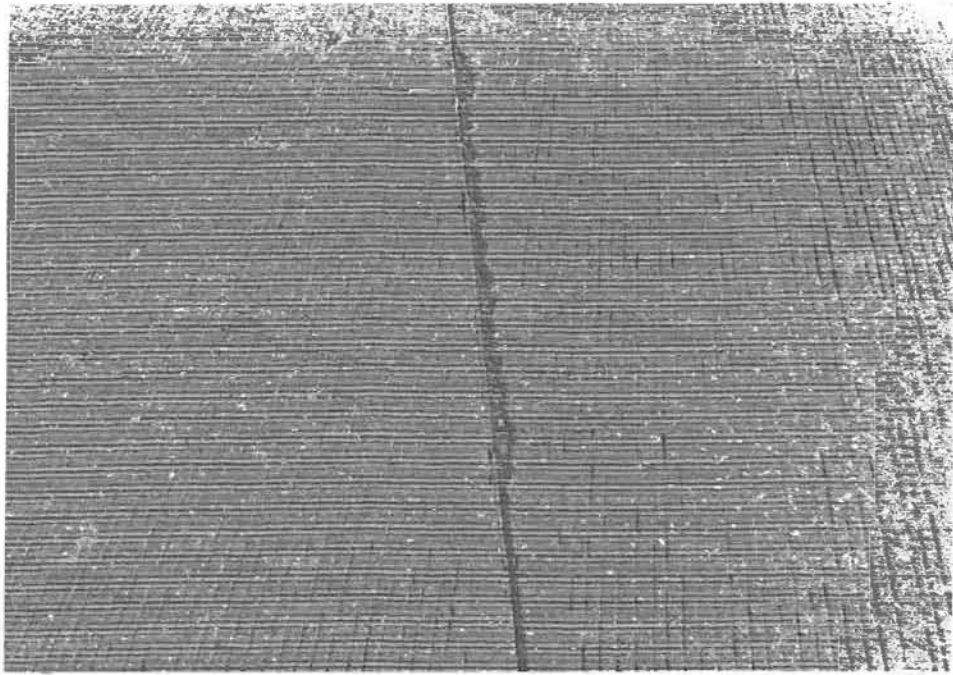
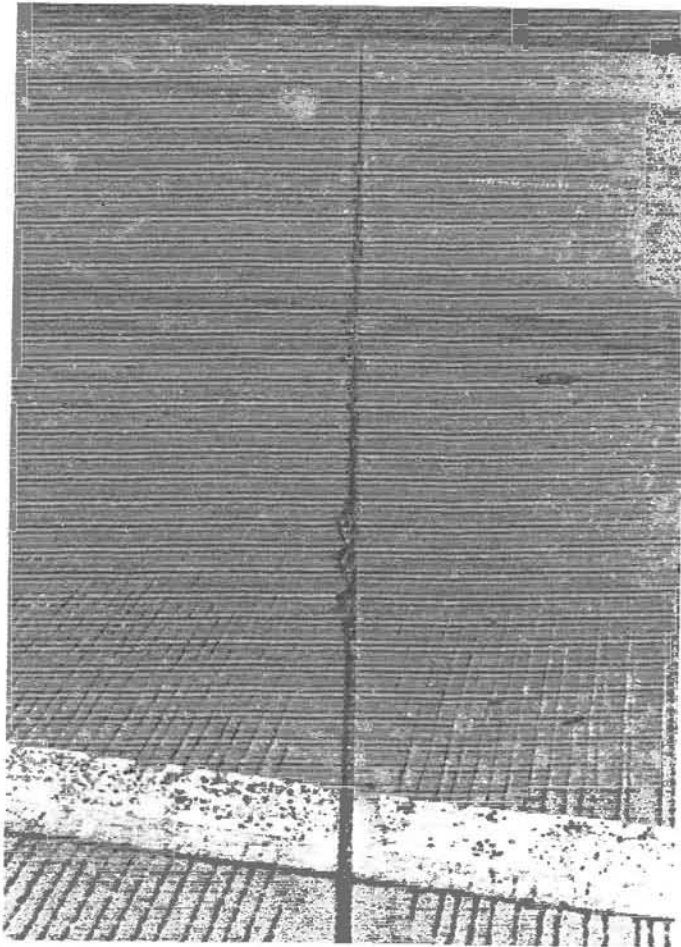
Photograph 3 & 4: Raveled concrete near the joints

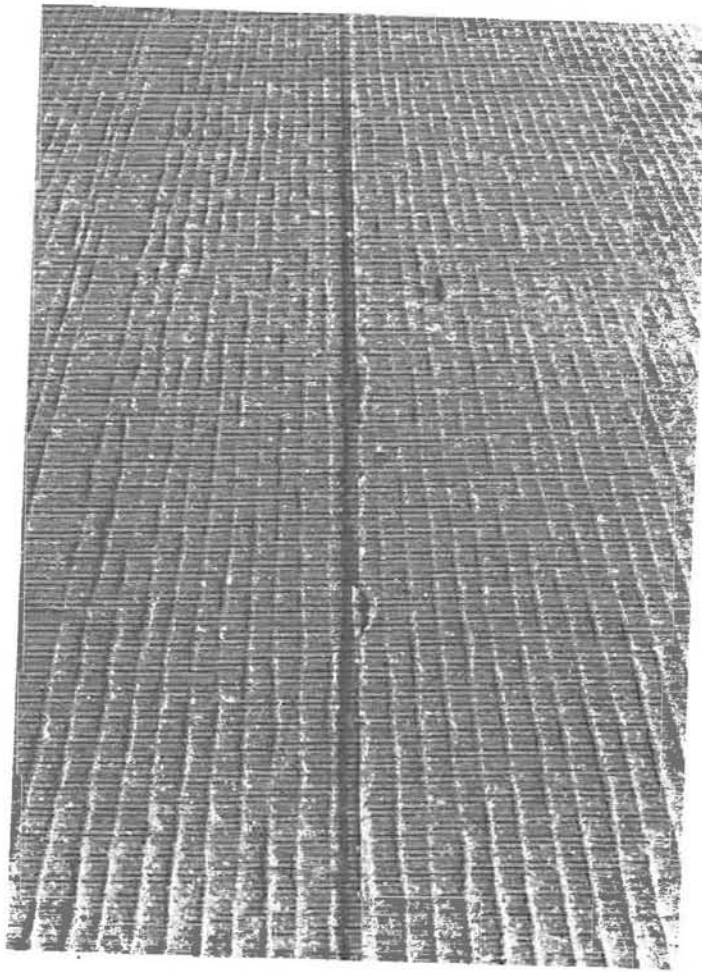
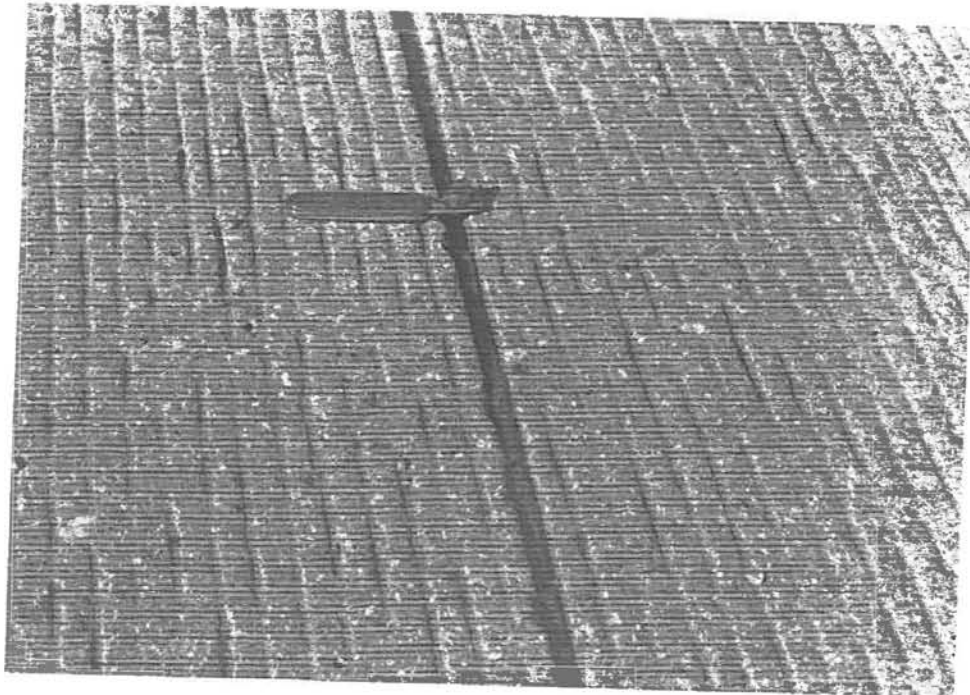
I-25 between mile post 252-255 was investigated next. The ASTM D-3406 used at this location was placed during the 1985 construction season. The principal failure mode observed at this location was adhesion failure at the sealant-joint interface (Photograph 5) with moderate extrusion failure (Photograph 6). Some cohesion was also detected. The intrusion of the incompressibles were minimal. The plastic parting strip used for the longitudinal joint at this location showed some minor spalling; however, for most part the performance was satisfactory (photograph 7).

Photograph 5 & 6: Adhesion and extrusion failures on I-25

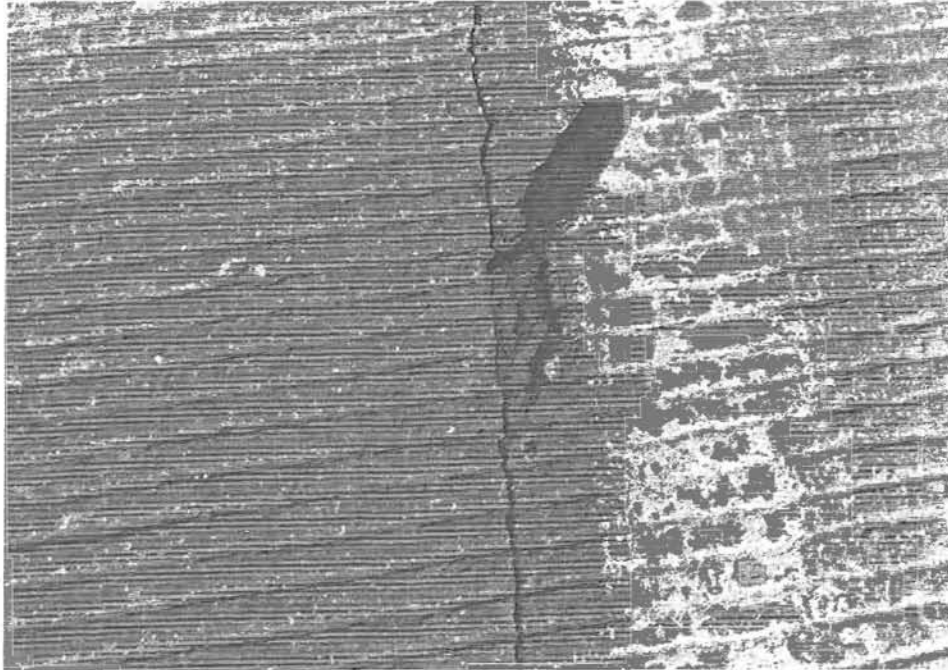
Photograph 7: Plastic parting strip on I-25

- The plastic parting strip showed fair performance with low levels of spalling failures. Their use are recommended for longitudinal joints.

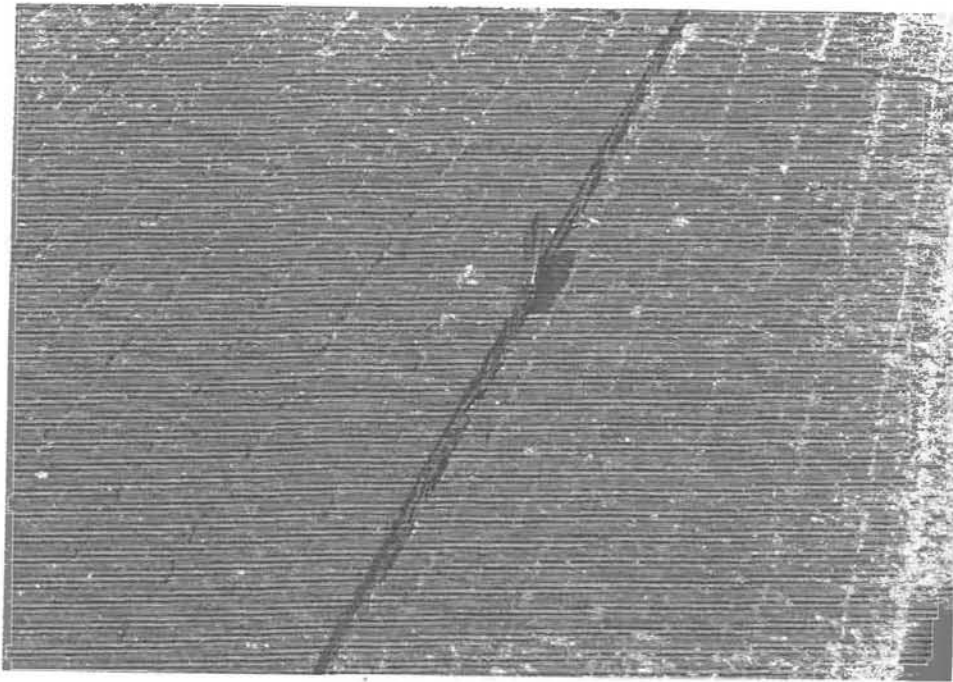
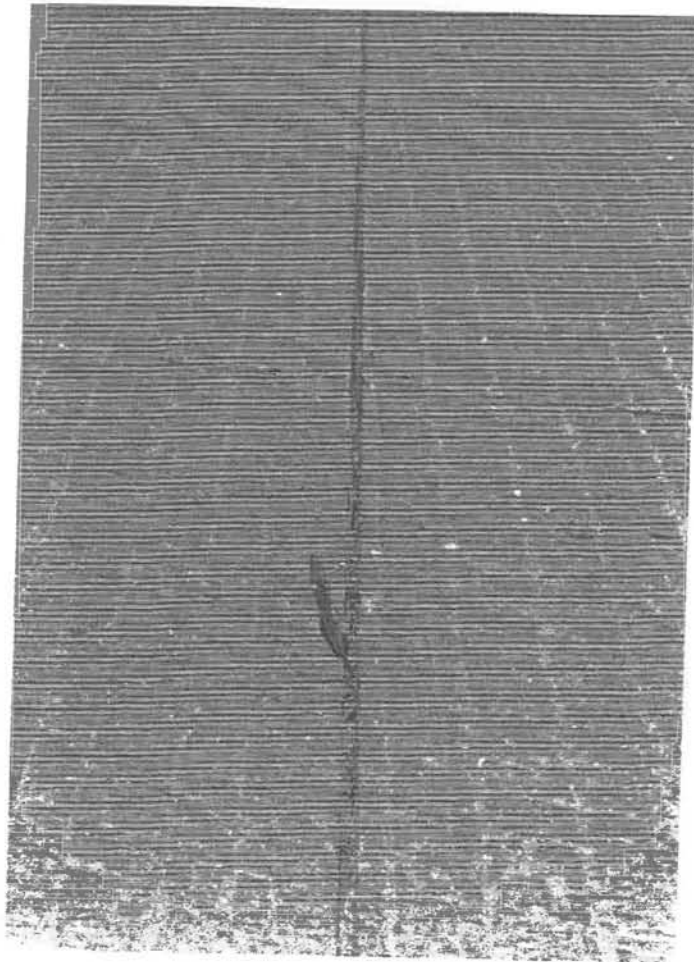
ASTM D-3405 was used on I-70 between Tower Road and Colfax. In general the condition of this 2-year old sealant looked good. However, problems such as adhesion, cohesion, and the intrusion of the incompressibles were quite apparent in few isolated locations (Photograph 8 and 9).

Photograph 8 & 9: Badly failed sealant on I-70 east of Denver

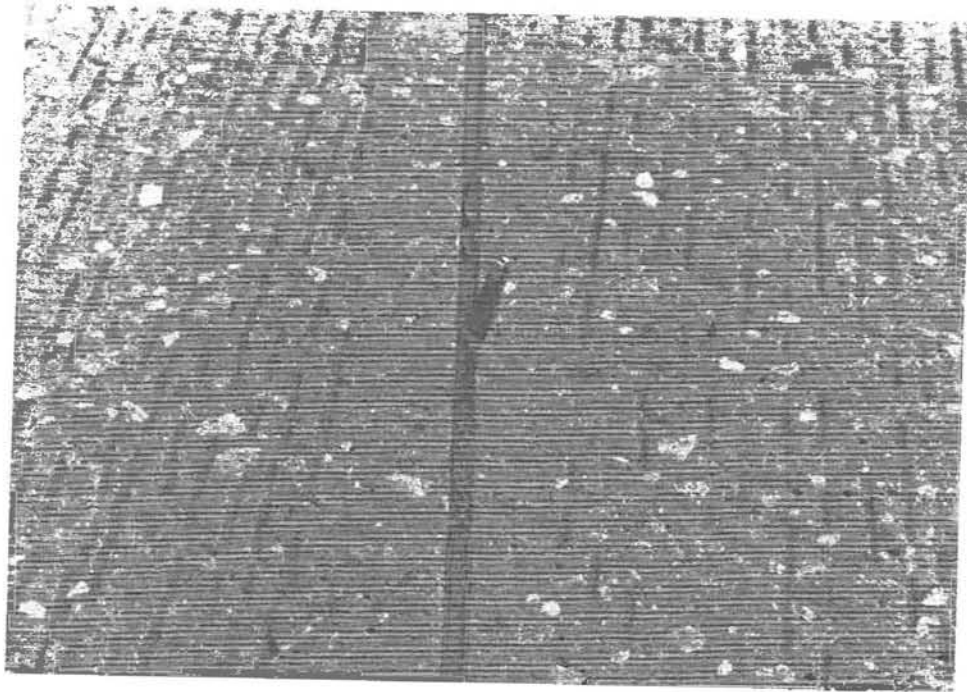
Some minor adhesion failures were noted for the 4-year old silicone on C-470, between I-25 and Quebec Avenue. The failure was noted only in the right-wheel-path and the left-wheel-path in the driving lane (Photograph 10). The consensus are that the silicone was not either cured fully or it was installed at improper temperature. The curing rate of the silicone is dependent upon temperature and humidity: curing rate decreases as the humidity and temperature decrease. silicone cures very slowly at or below 40° Fahrenheit (Ref.1). The plastic parting strip that was used for the longitudinal joints showed good performance with very little spalling (photograph 11).

Photograph 10: Silicone at C-470 (presence of incompressibles in the right-wheel-path)

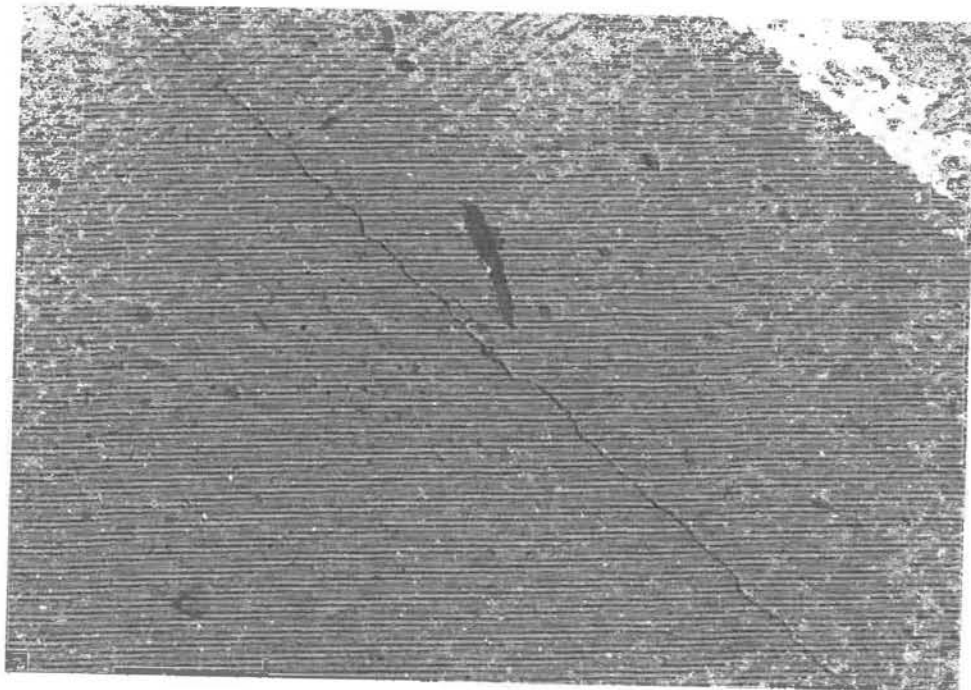
Photograph 11: Plastic parting strip on C-470
