Report No. CDOH-DTD-R-90-2

# **EXPERIMENTAL GRAVEL SHOULDERS**

Final Report  
January 1990

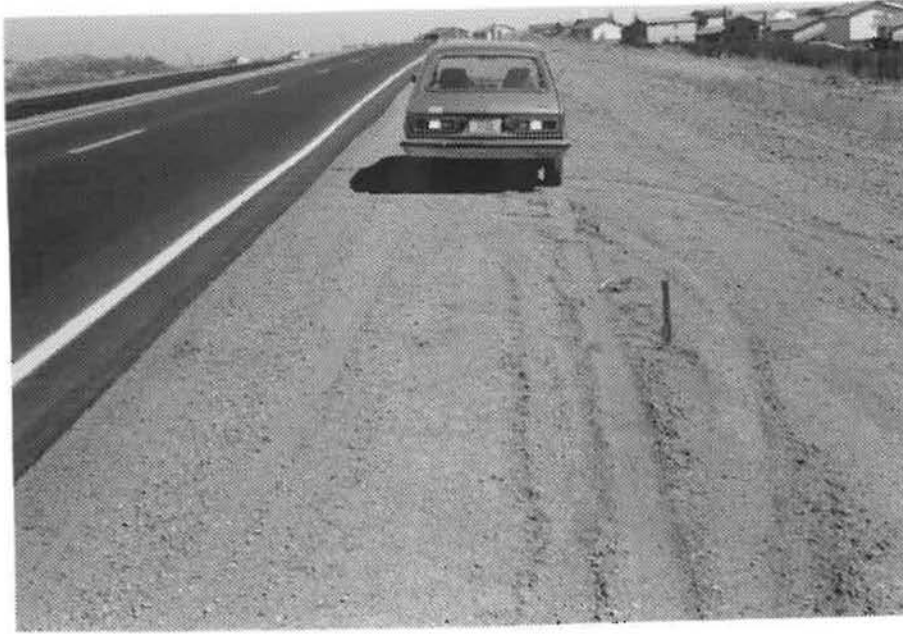
Photo 1 - Completed gravel shoulder on S.Kipling Blvd.

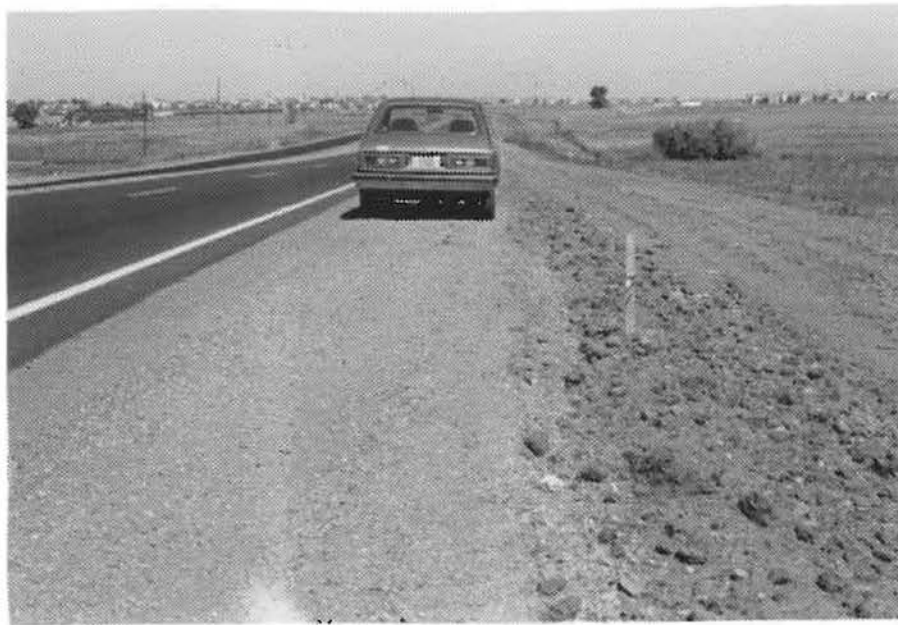
After completion of construction on S. Kipling St., the initial evaluation of the completed shoulder was performed. Photos 1 and 2 in Appendix B show the newly constructed gravel shoulder. At this point the shoulders looked good and well constructed. However, a visit to this site in November 1983, after some precipitation had fallen, showed that moisture had produced soft spots in the gravel shoulders. Photos 3 thru 5 in Appendix B were taken approximately 48 hours after snow had fallen. Temperatures were high enough to melt the snow and allow some drying of the gravel, however. extreme rutting was caused. Up until this point the shoulders had not been bladed.

Photo 2 - Same as above.

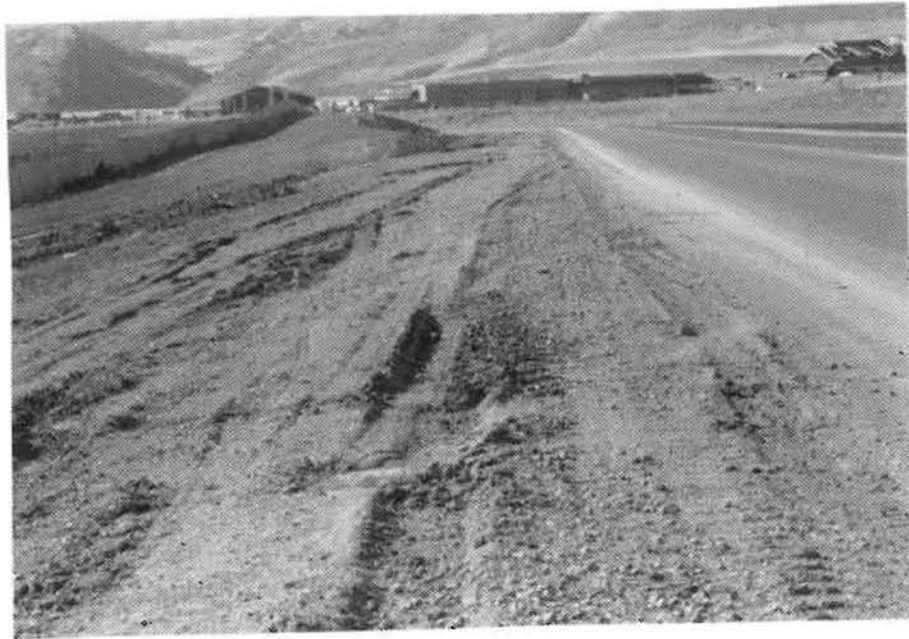
Visual inspections were performed annually for the next five years. The inspections showed the same problem described above concerning moisture within the gravel causing soft spots in the shoulder. The only cure for this was for maintenance crews to add additional ABC Class 6 material and blade the shoulder level to the pavement.

Photo 3 - This photograph and the next two show soft sections in the shoulder. The soft areas were caused by moisture.

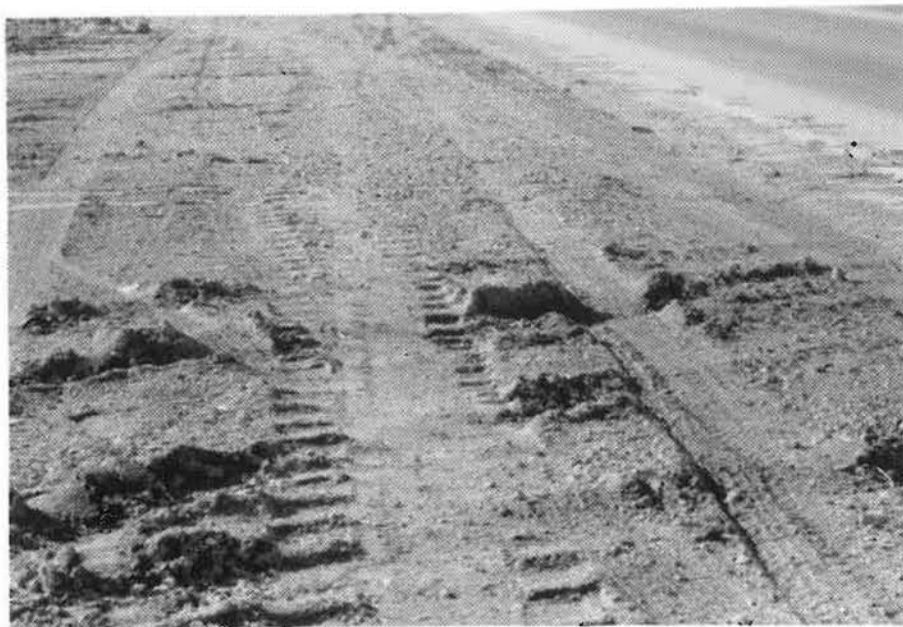
Photo 4 - Soft areas, same as above photo.

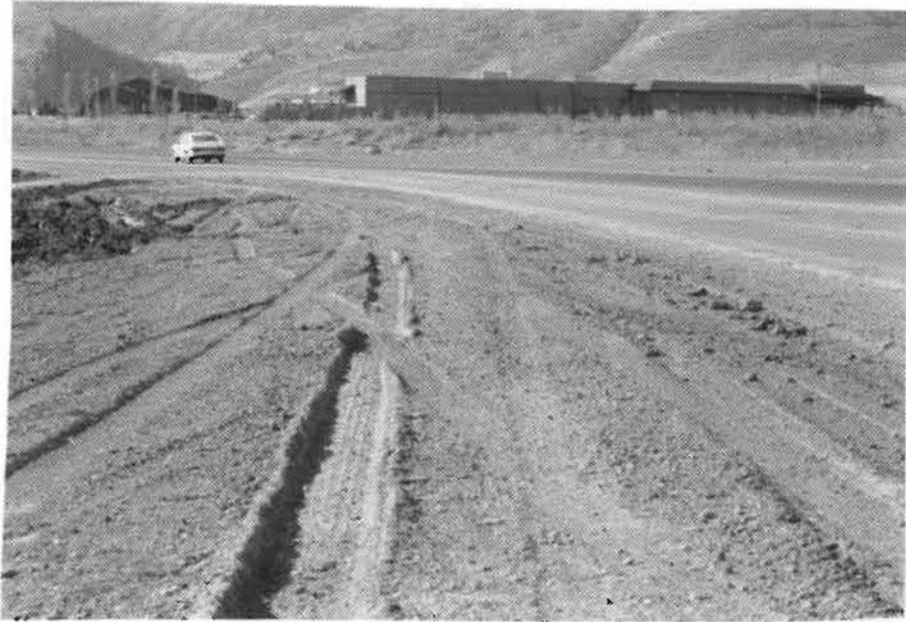
Photo 5 - Another soft area on the S.Kipling gravel shoulder.

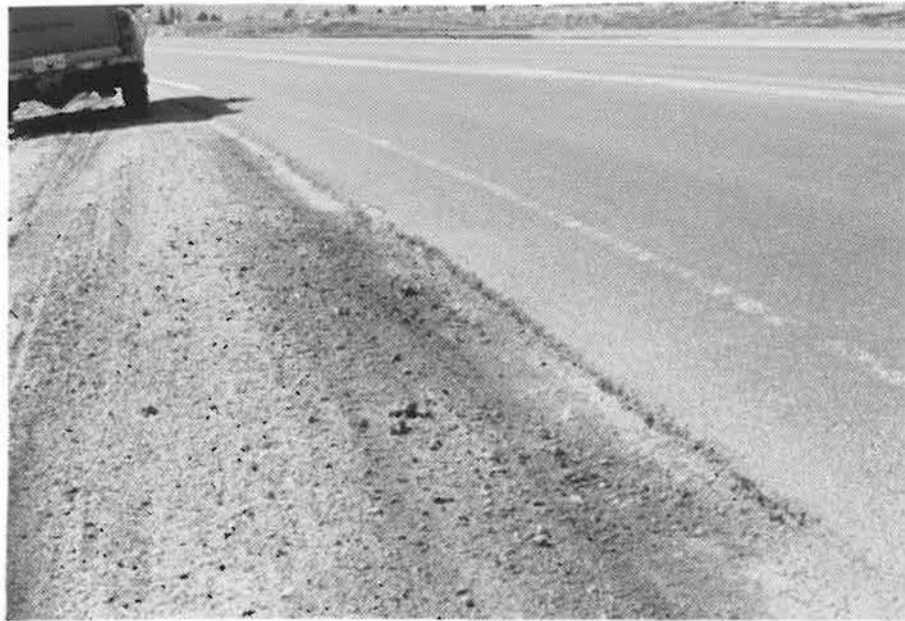
Other noticeable problems occurred where the pavement edge meets the gravel shoulder. Erosion of the gravel at this point was produced by moisture running off the pavement and washing away the ABC material and vehicle tires leaving the roadway which caused rutting to occur. As the gravel shoulder level began to drop, it allowed for a weak spot in the adjacent HBP. Vehicles driving over the shoulder caused this weak point to break off and spall. Photo 6 in Appendix B shows a spalled pavement edge on S. Kipling St. The spalling problem severity depends upon how well maintenance patrols are able to keep the gravel shoulder at the same grade as the asphalt roadway. On S. Kipling St. some spalling has occurred, but as of the fall of 1989, this condition is not a major problem.

Photo 6 - This photo shows an area on S.Kipling where the pavement edge is spalling at the point where the gravel shoulder has been eroded away by vehicle traffic.

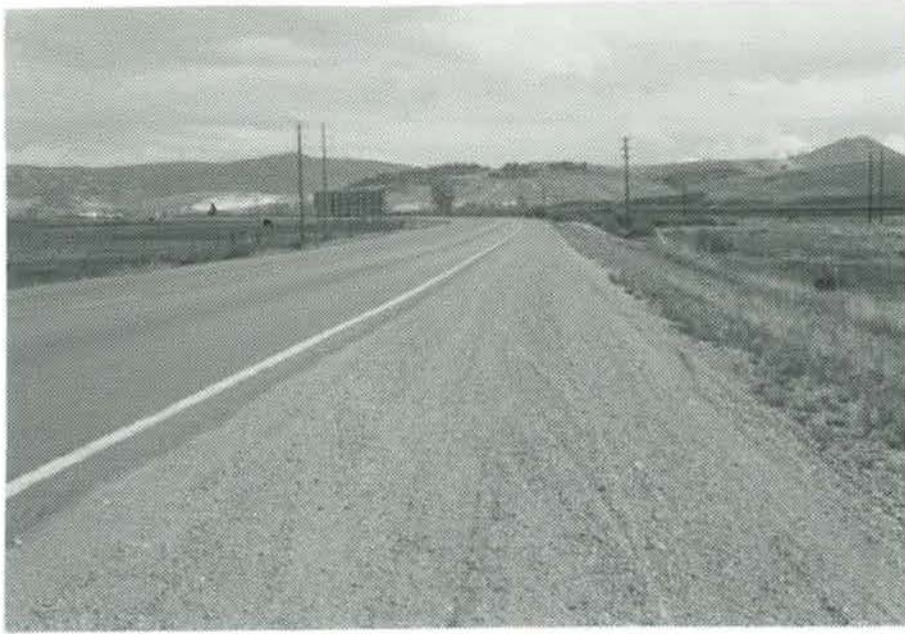
Photo 7 - Completed gravel shoulder on SH-40 near the town of Granby.

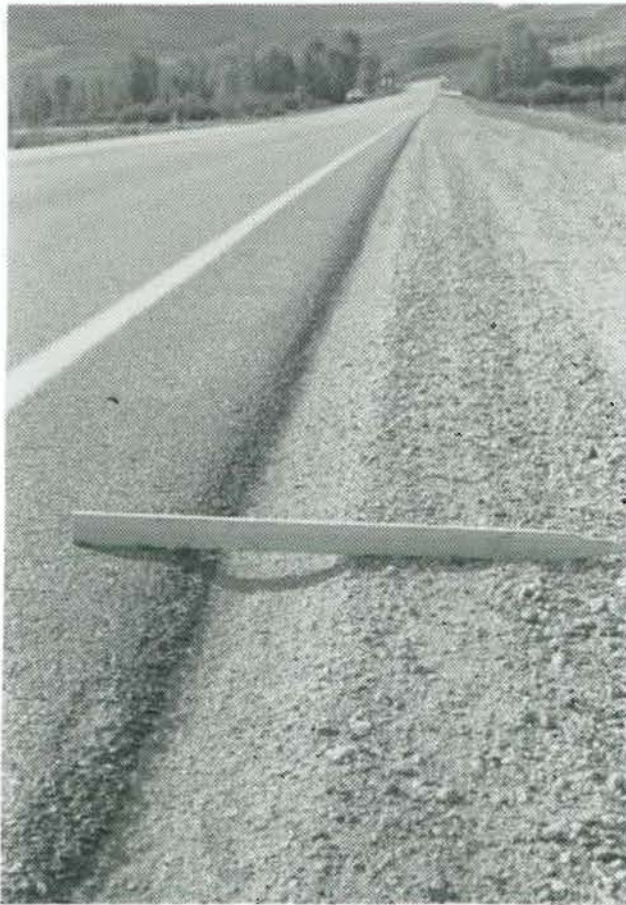
During the fall 1989 evaluation of the SH-40 site, rutting between the pavement and the gravel shoulder was measured. The overall results varied from 0 inches to 1 inch in depth. Photo 8 in appendix B shows an average rut adjacent to the asphalt pavement.

Photo 8 - Approximately 1 inch of rutting has occurred directly off the pavement within 3 weeks of maintenance work on the area.

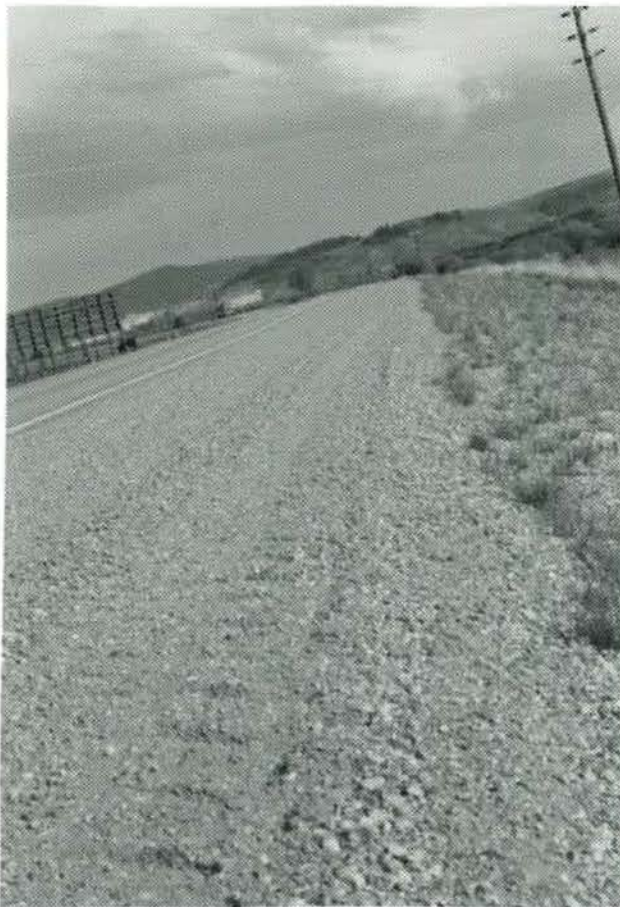
Photo 9 - Shouldering material in good condition on SH-40.

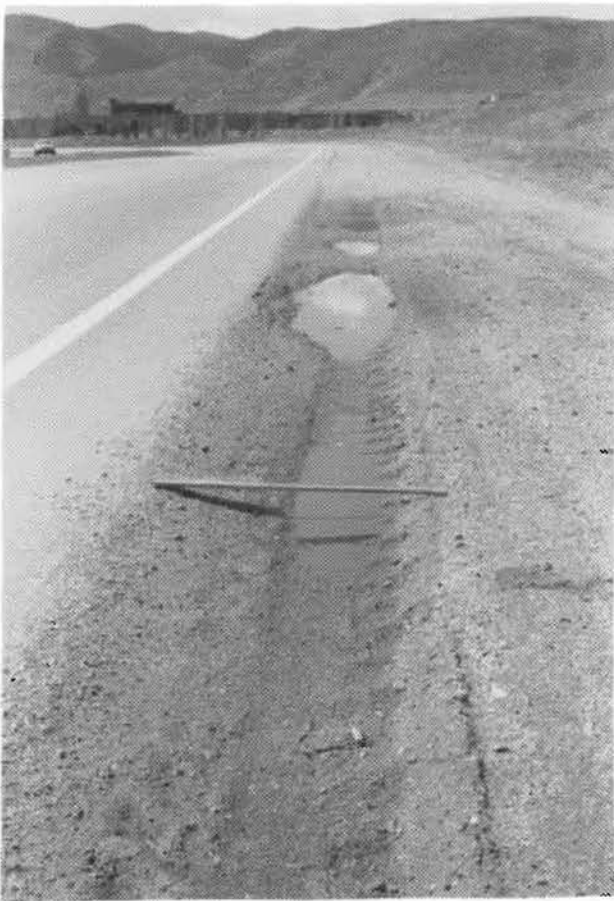
Photo 10 - Photo's taken in early spring before maintenanc crews had rebladed the area. This photo taken from the S.Kipling site.

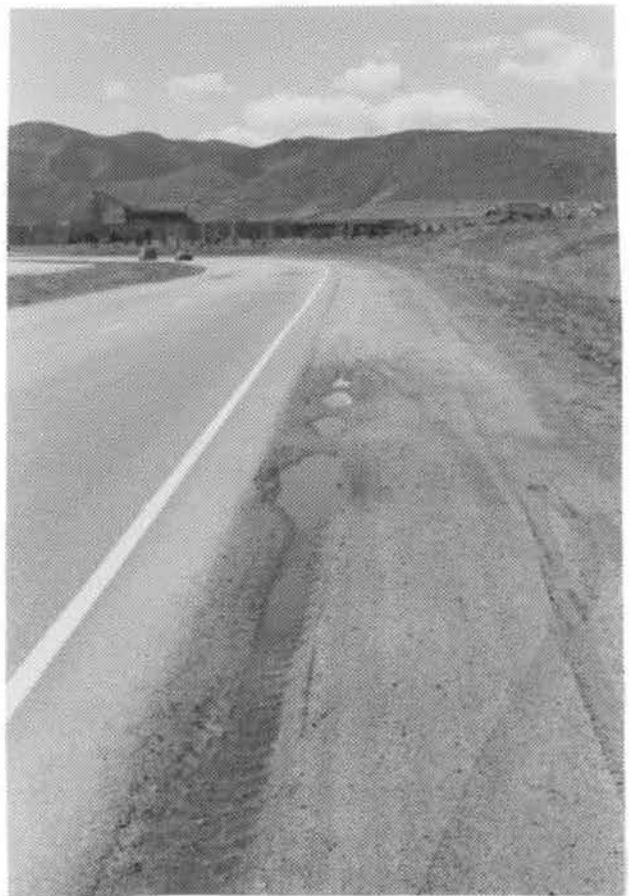
Photo 11 - Same as above. An obvious hazard exists if these shoulders are not properly maintained.
