Report No. CDOT-DTD-R-91-4

RUT-RESISTANT COMPOSITE PAVEMENT DESIGN

Donna S. Harmelink
Colorado Department of Transportation
4201 East Arkansas Avenue
Denver, Colorado 80222

Final Report
July 1991

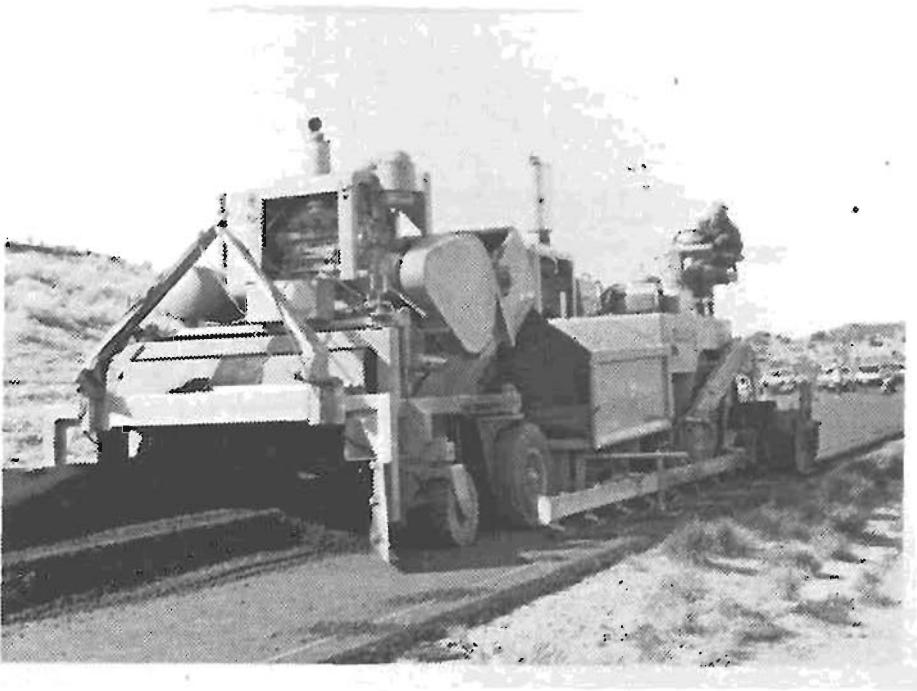
PHOTO 1

A paving operation using windrow placement.

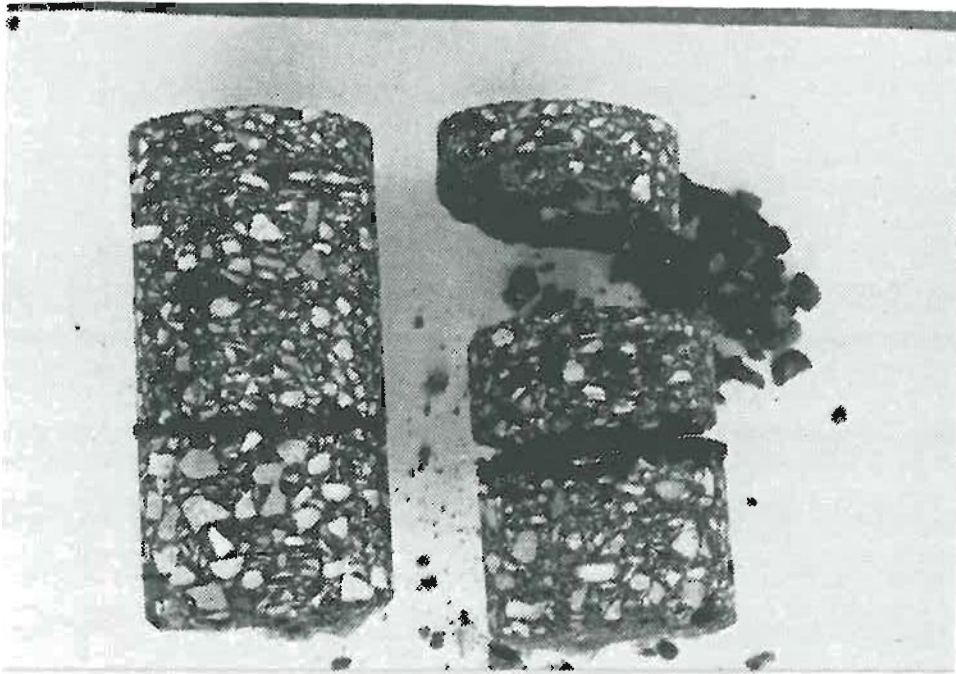
PHOTO 4

The final evaluation at the Debeque site showed no signs of failure on the surface, rutting was low and cracking was minimal. However, the cores showed signs of stripping in the layer immediately below the PMSC as shown in Photo 4.

This photo shows how stripping progresses. The core on the left taken in 1990. The core on the right taken in 1991 at the Debeque evaluation site. Note that the top lift of PMSC is undisturbed.

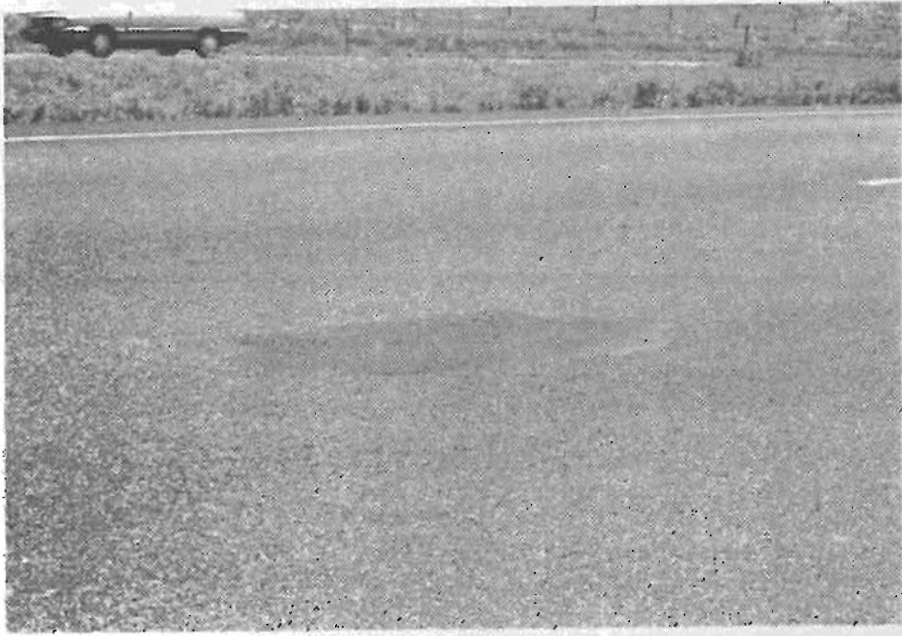
PHOTO 6

Photos 6 through 10 show examples of the failures on the C470, between US 285 and I-70 and on the I-70, east of Agate locations. Photo 9 taken on I-70, east of Agate was taken before this site was added to this study. Photo 10 was taken after the rehabilitation of the RRCP. This pavement was not a high-stability (RRCP) design.

C470, US 285 to I-70
The first sign of the stripping failure is the appearance of rich spots on the surface. These rich areas are randomly spaced and typically found in the wheel paths.

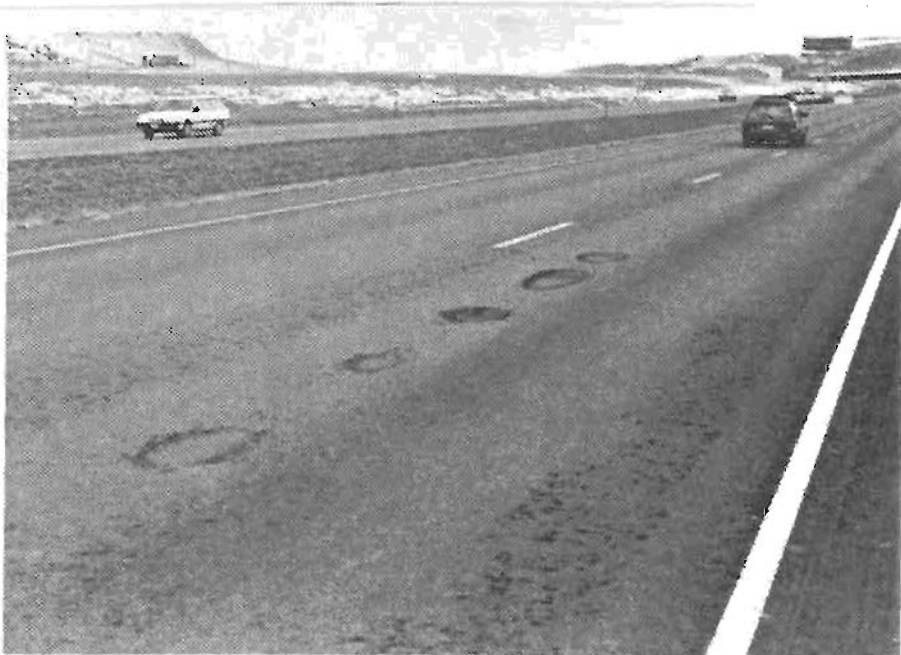
PHOTO 7

C470, US 285 to I-70
This photo shows areas which have stripped under the PMSC. Evidence of raveling in the right wheel path is a result of extensive stripping in the RRCP layer below the PMSC.

Evaluations from data collected indicates the failure mechanism is not due to rutting or cracking, but appears to be directly associated with stripping caused by hydrostatic pressure immediately below the PMSC layer. Once the stripping process becomes visible on the surface the pavement fails rapidly. The pavement fails early in its design life before signs of rutting or cracking appear. As the stripping becomes more severe the pavement begins to rut and shove.

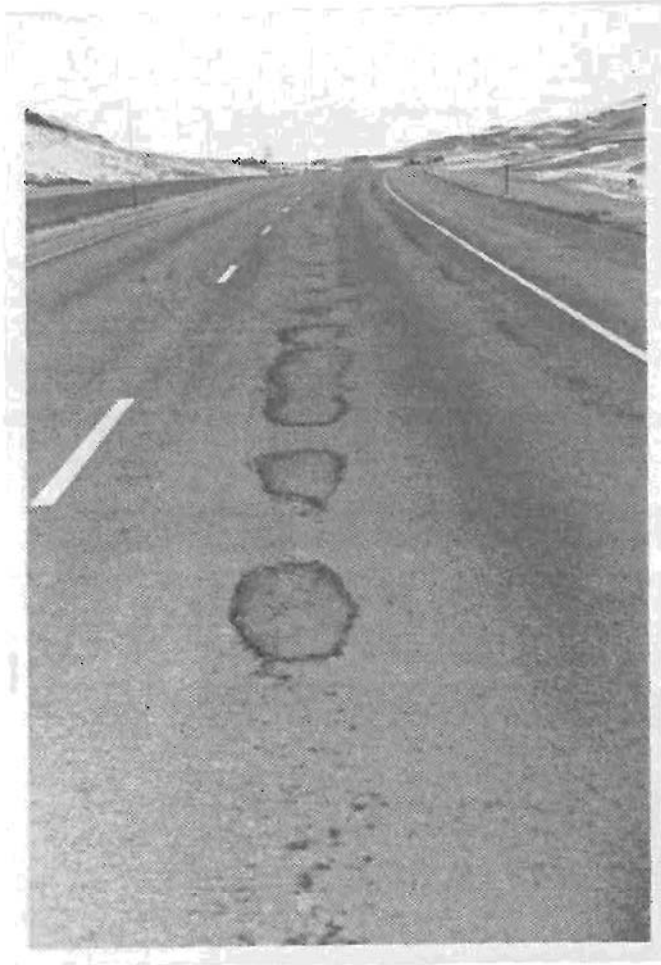
PHOTO 8

C470, US 285 to I-70
This type of
distress was found
throughout the
project.

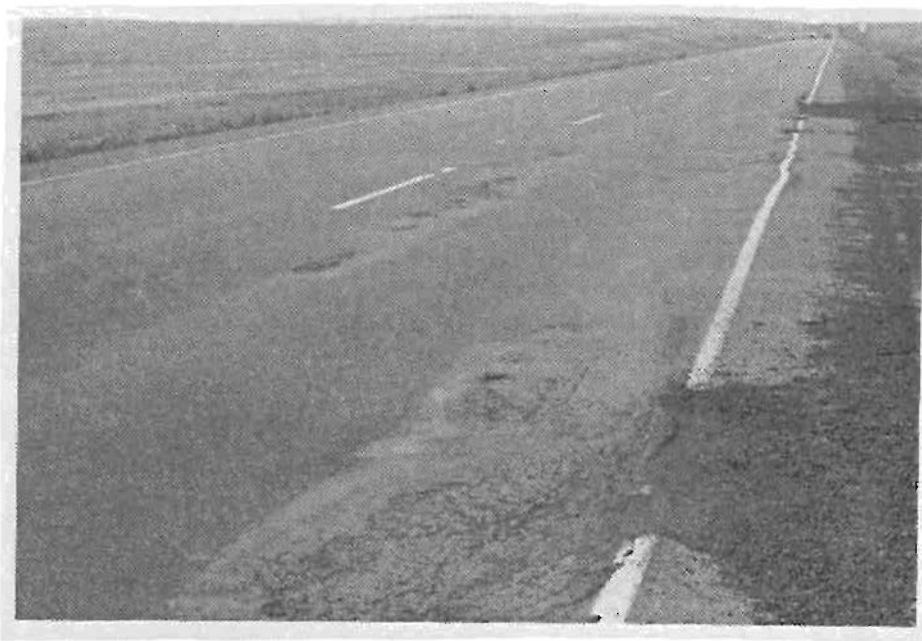
PHOTO 9

This photo was
taken on I-70, east
of Agate eight
months after
construction using
the RRCP design.
This type of
distress was
typical throughout
the project.

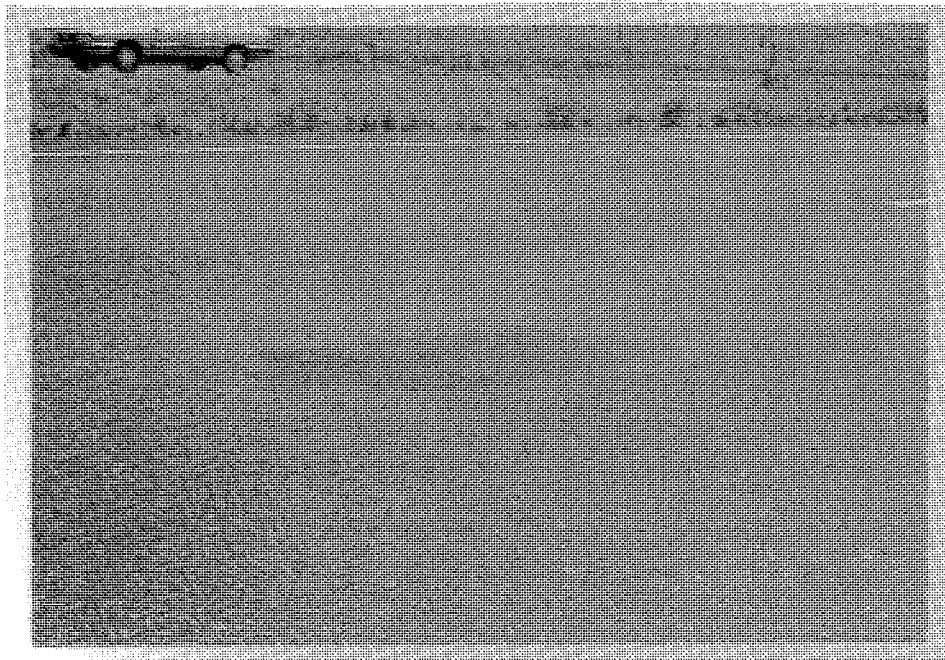
PHOTO 6

C470, US 285 to I-70
The first sign of the stripping failure is the appearance of rich spots on the surface. These rich areas are randomly spaced and typically found in the wheel paths.

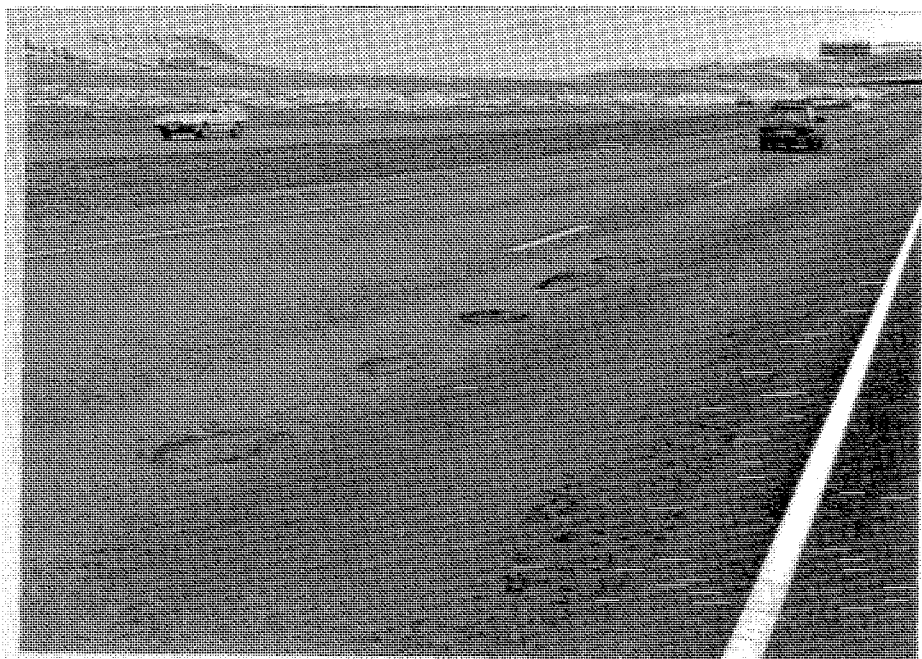
PHOTO 7

C470, US 285 to I-70
This photo shows areas which have stripped under the PMSC. Evidence of raveling in the right wheel path is a result of extensive stripping in the RRCP layer below the PMSC.

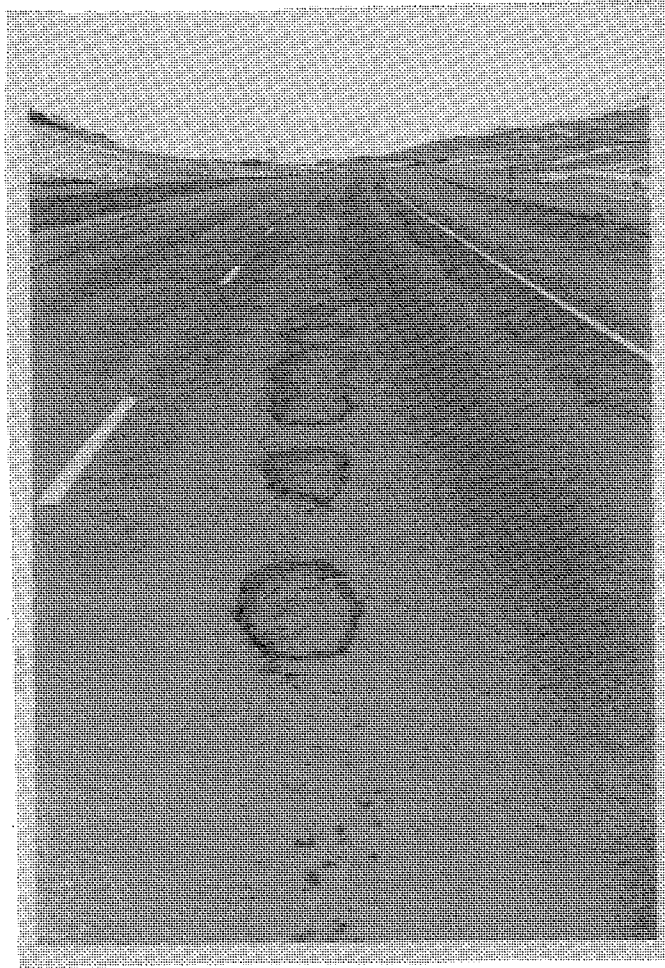
PHOTO 8

C470, US 285 to I-70
This type of
distress was found
throughout the
project.

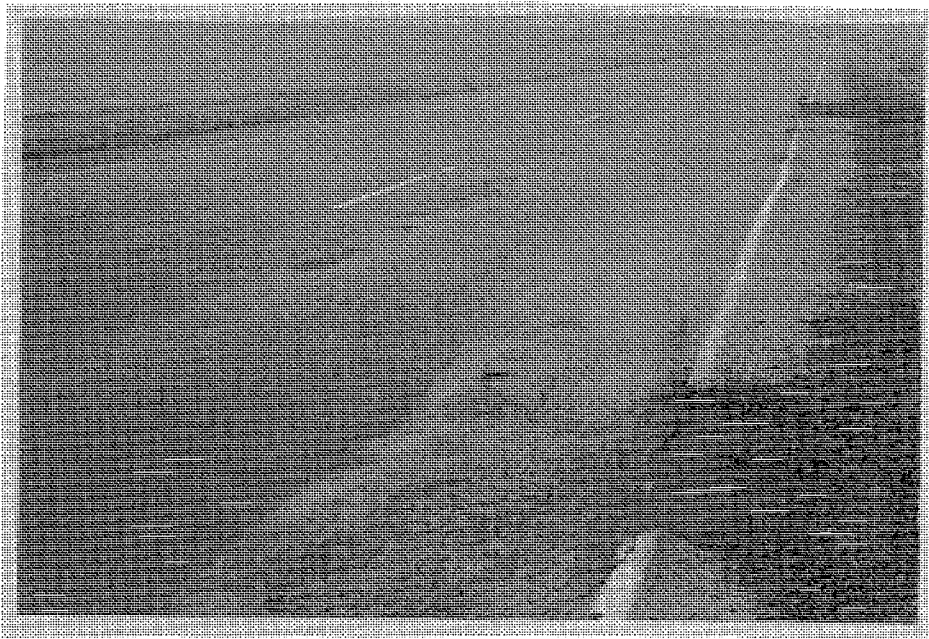
PHOTO 9

This photo was
taken on I-70, east
of Agate eight
months after
construction using
the RRCP design.
This type of
distress was
typical throughout
the project.
