Report No.CDOT-DTD-R-93-9

Cold Hand Patching Materials

**Colorado Department of Transportation
4201 East Arkansas Avenue
Denver, Colorado 80222**

**Final Report
August, 1993**

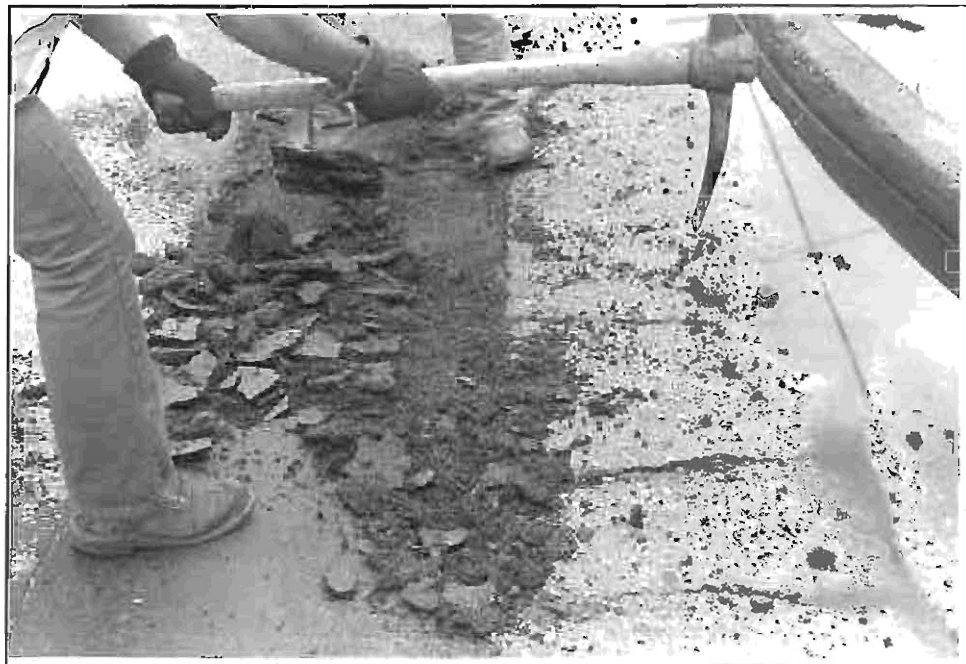
The damaged pavement was cut out down to the base. Then the entire area, about 100 square feet, was replaced using UPM for the west end and Styrelf for the east end of the patch. Since the asphalt was about six inches thick, the cold mix was laid in two lifts and compacted using a vibrating steel roller on each lift. The patch stood up well to traffic, which is heavy at this location, but it proved that even the expensive mixes are not invincible. About two months after the patch was made it began to fail because of the water that was able to penetrate the base from the cracks in the adjacent gutter. The photo on this page shows the UPM mix being removed. Notice the severe cracking in the concrete gutter to the right of the patch. There was water

standing in the gutter when the picture was taken. The patch appears to have been solid for about two inches on top and then loose gravel below. This type of failure has occurred in

other large patches using this type of cold mix in other parts of the state. Several large patches made with UPM cold mix were observed by research personnel during this study, both at test sites for the study and at other locations in the state. All of

the patches that failed had a poor base below the patch, either a consistently wet base, as was the case at US 285 and Downing St., or severely cracked asphalt which could not provide adequate support for the patch material.

This is an example of an emergency repair that can be made using cold mix. The surface was made usable for a short time so plans could be made to do the extensive necessary repairs to prevent a recurrence of the problem.

Large areas should be patched with cold mix only in emergency situations, and should be permanently repaired with hot mix as soon as possible.

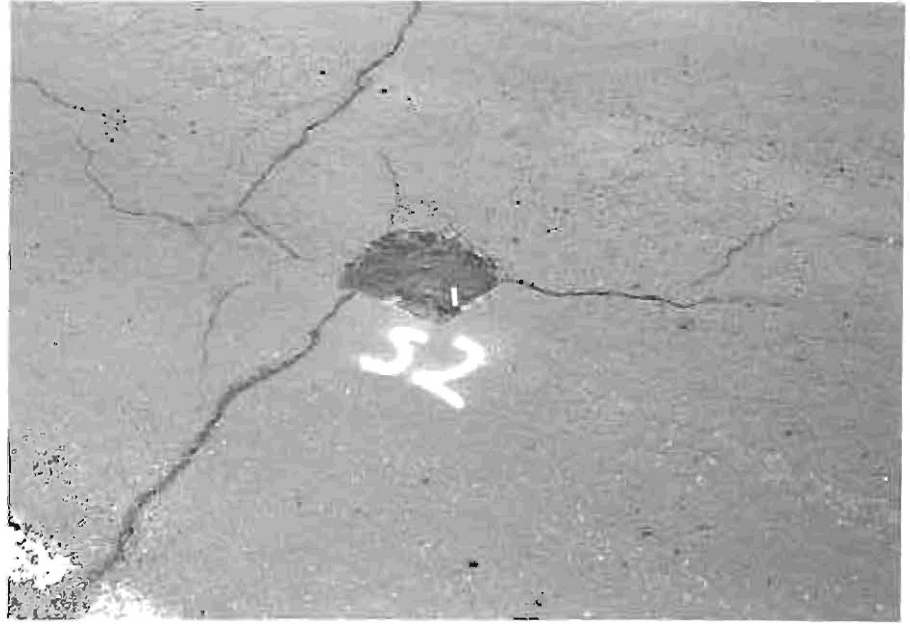
FIG. 1

This set of photos is of a patch made with UPM by Sylvax. Preparation for a patch starts with trimming the edges and cleaning out all loose debris. For this type of cold mix there is no need to use a tack coat before placing the mix into the hole. All clumps are broken and the mix is levelled slightly above the surrounding surface.

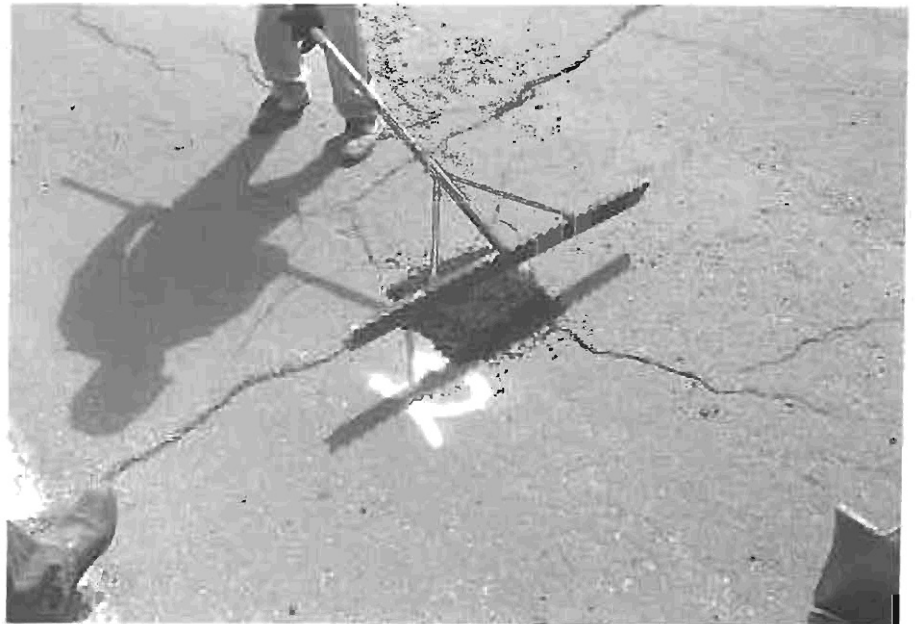
In FIG. 2 the texture of the UPM mix can be seen. It resembles coated pea gravel. Done on Wolf Creek Pass, US 160, this patch was made when the air temp was about 60 deg. and the surface was about 75 deg. During colder weather the mix is hard and difficult to work with. Bringing it inside over night will make it much easier to work with. During warm weather the patch will feel soft, but

will harden in a few days. It is advisable to sift a thin coat of fine sand or dirt over the fresh patch so traffic does not track the mix out of the hole before it hardens.

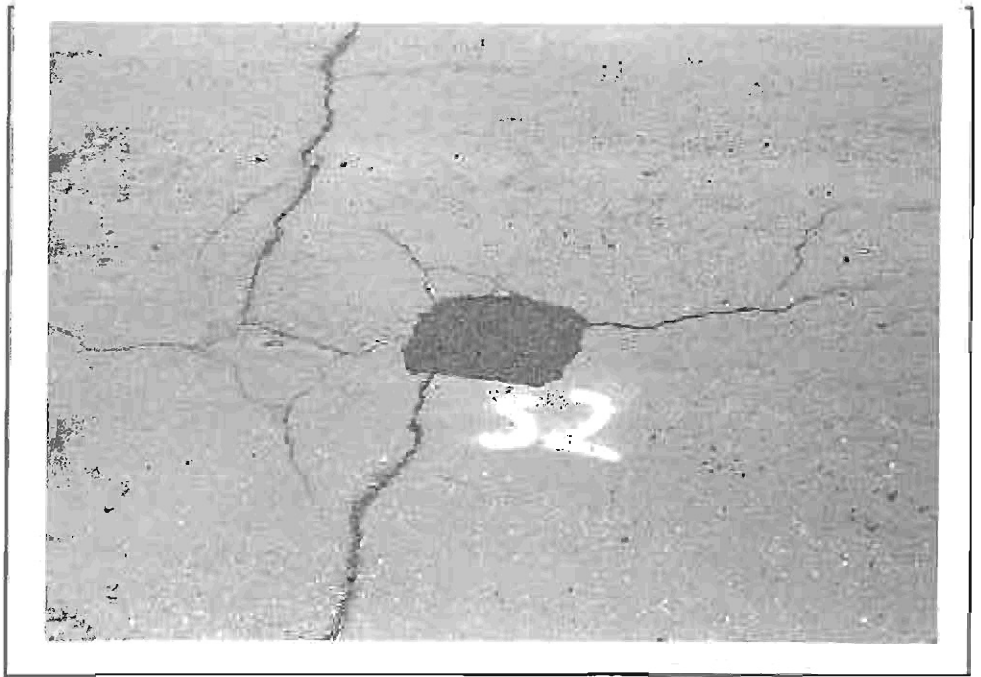
FIG. 3

The patch is complete and has been rolled using the tires of a one ton dump truck. Notice the shiny surface of the patch.

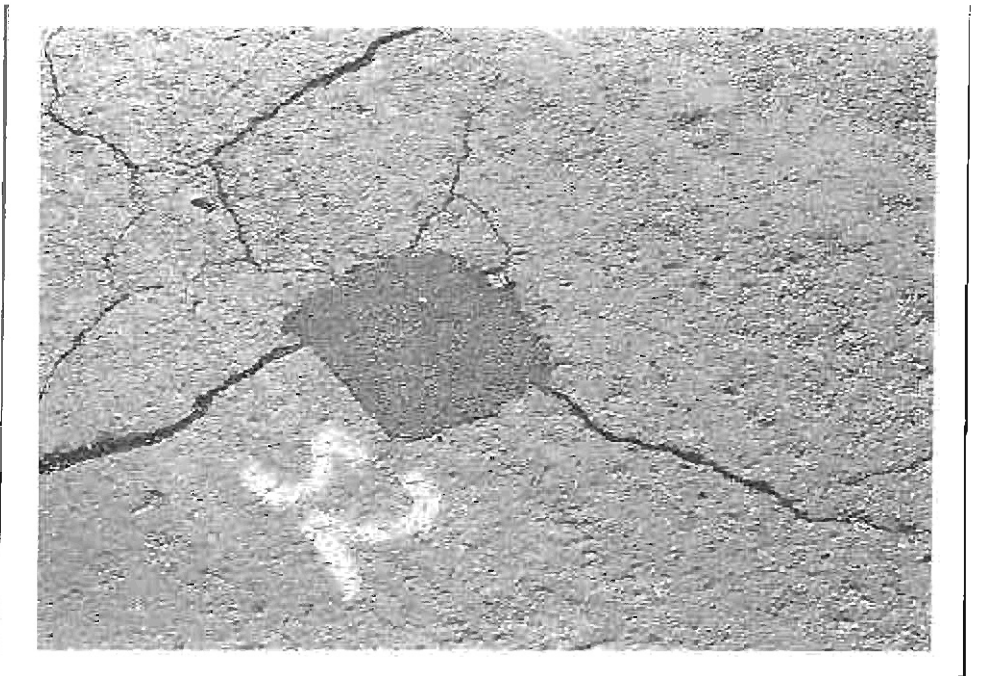
FIG. 4

This is the same patch after two weeks. The surface is no longer shiny and the patch has hardened. At this time there is no evidence of separation of the patch from the surrounding pavement or of ravelling or any other type of failure. Traffic has compacted the patch to the level of the surrounding pavement.

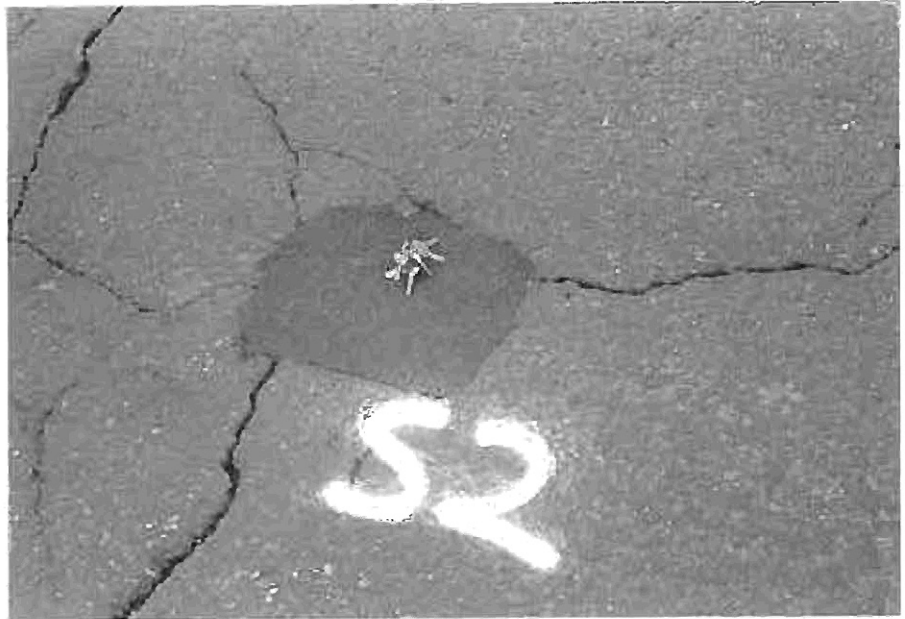
FIG. 5
Three months after the repair was made the patch is still in excellent condition. Comparing this photo to FIG. 4 shows the edges of the patch to be even tighter than they were. There was a light rain the night before this photo was taken. Some moisture is visible in the cracks but there is none around the patch.

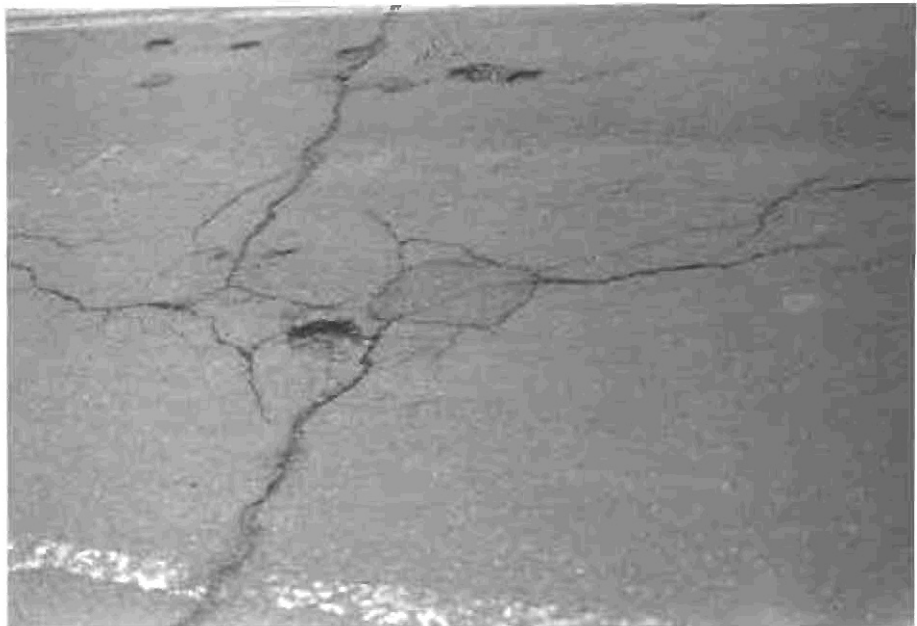
FIG. 6
The patch is nearly thirteen months old in this photo. Notice that the cold mix has not ravelled or broken out. A crack has reflected through the patch but it still is tight and shows no signs of failing.

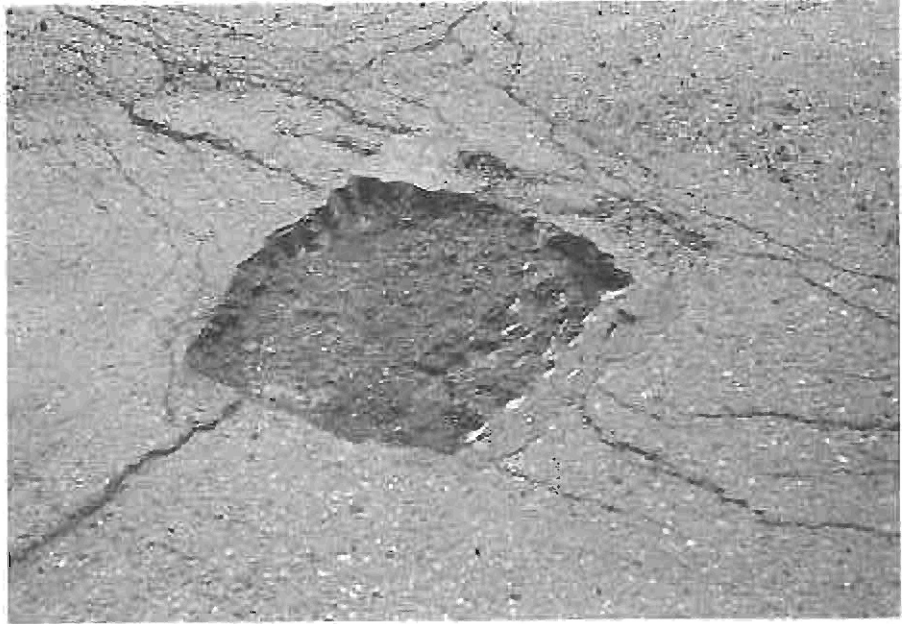
FIG. 7
The next six photos are of a patch made using MC-250 with fibers. This patch is on US 160 on Wolf Creek Pass also. In FIG. 7 the edges of the hole have been trimmed using a slide hammer and all loose debris has been removed from the hole.

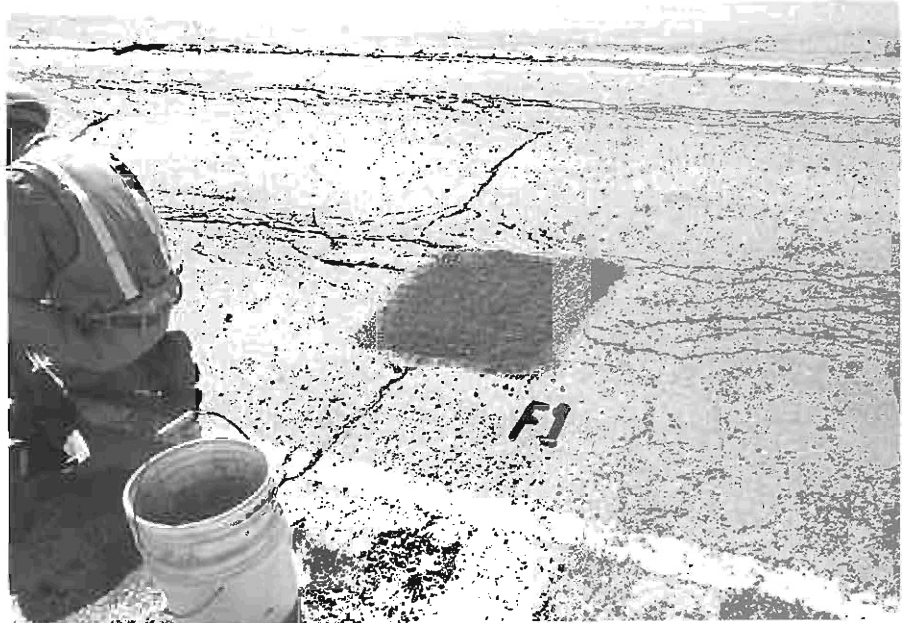
FIG. 8
The hole has been filled with the MC-250 mix and raked level. Notice the tack oil on the pavement surface surrounding the hole. MC-250 with fibers is slightly harder to work than the same mix without fibers. The fibers tend to cause the mix to ball up making it harder to get a smooth surface on the patch.

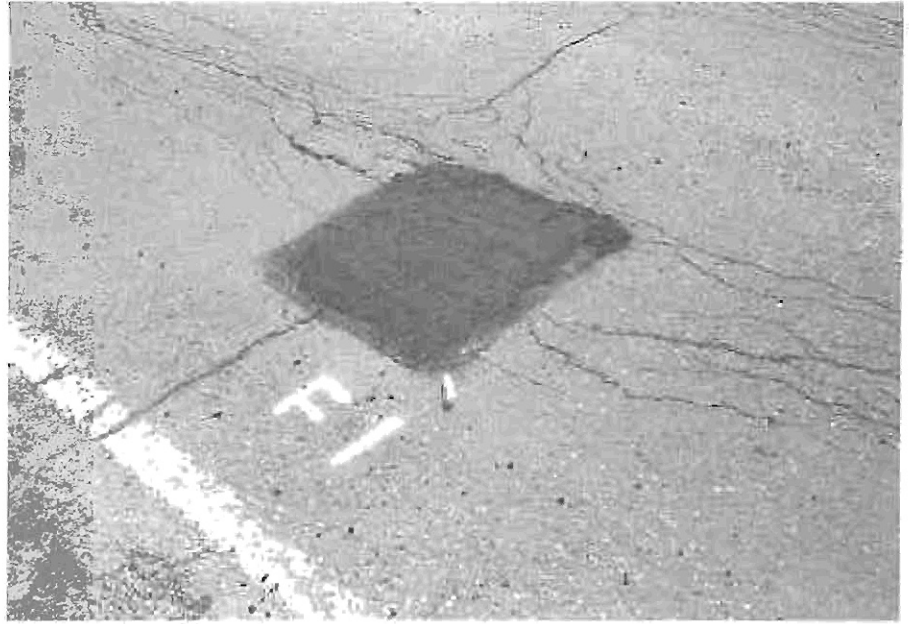
FIG. 9

This photo shows the patch after it was rolled with the truck tires. Notice the tack oil around the edge of the patch and the different texture from the UPM patch in the first series of photos.

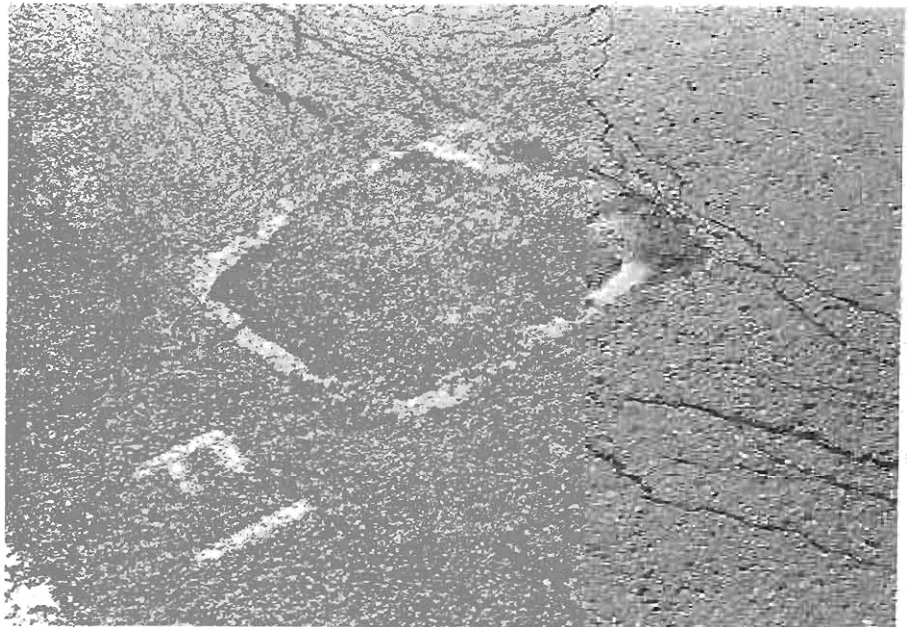
FIG. 10

This is the MC-250 patch after two weeks. Traffic has compacted the surface to the level of the pavement. Compare the surface texture in this picture with the UPM in FIG. 4.

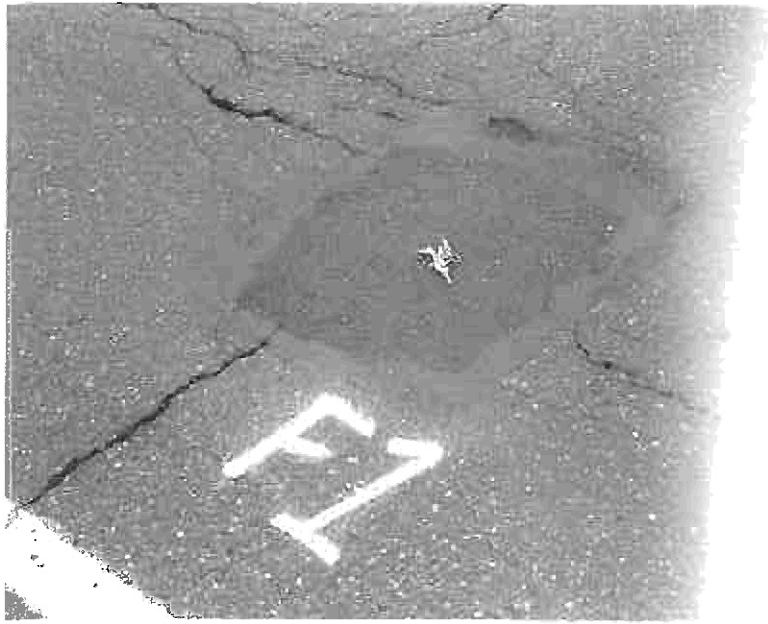
FIG. 11
The MC-250 with
fibers patch is
tight around the
edges and shows no
signs of problems
after three months.

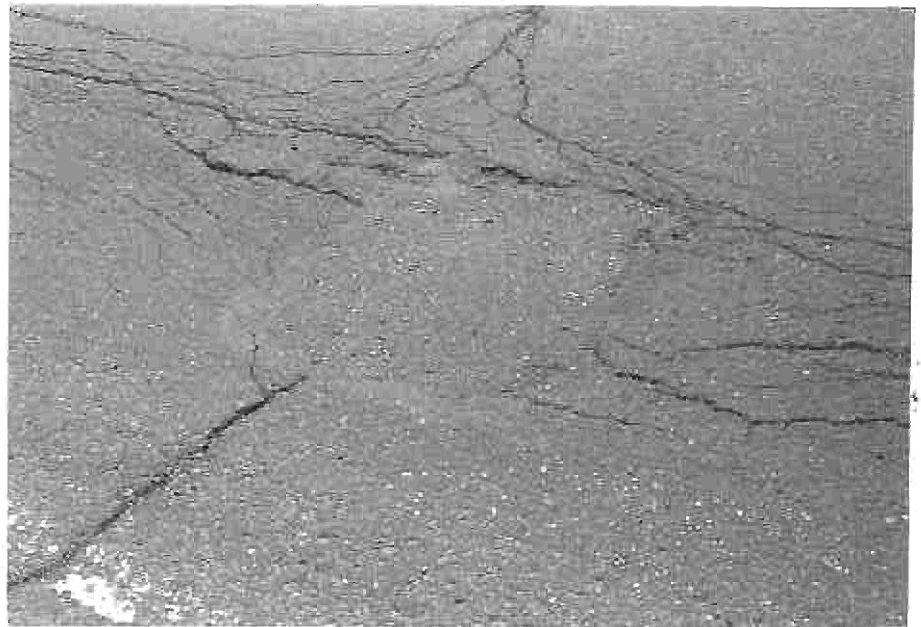
FIG. 12
After thirteen
months the patch is
solid. There is no
separation around
the edges and the
alligator cracking
around it has not
damaged the patch.
