Report No. CDOT-DTD-R-93-12

# **CURTAIN DRAINS**

Final Report  
December, 1993

U.S. Highway 550 near Electra Lake has had a history of problems with a muddy slope and moisture under the pavement. Project CXFC 20-0550-21 was initiated in 1986 to widen the roadway through this area. During the design process it was determined that slope stability and subsurface pavement moisture problems were likely. In order to mitigate these problems, it was decided to place curtain drains in the slope above the highway. These curtain drains were to intercept the groundwater at the top of the slope and conduct it to the opposite side of the roadway. Appendix A shows the plans and specifications for this project.

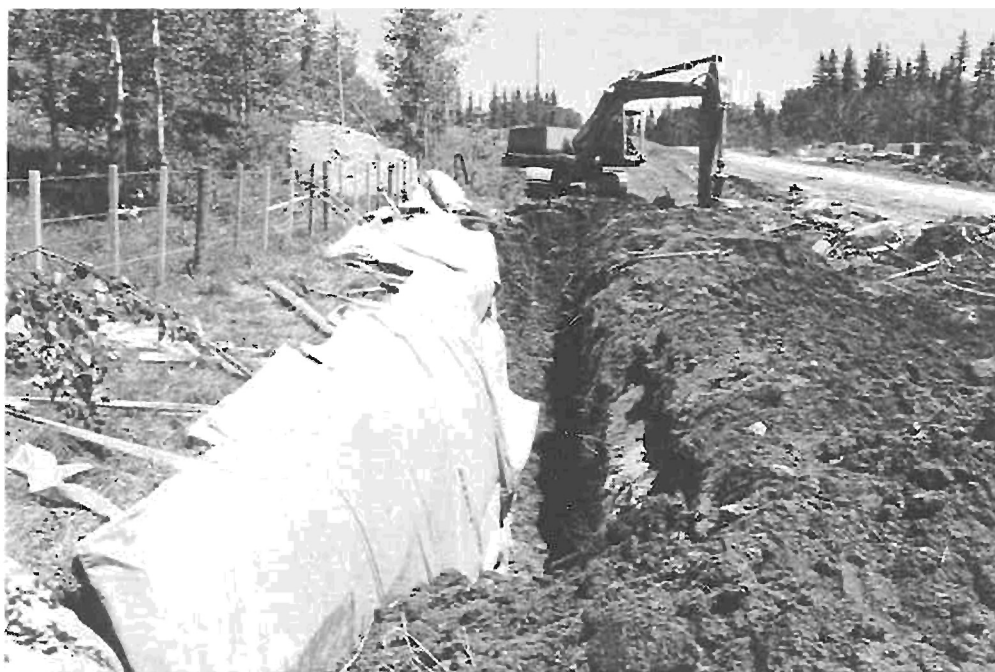
**Figure 4** Pictured here is the installation on the south end of the project. The trench was dug in relatively dry soil which made it easy to hang the curtain drain sections from the fence, place them neatly and backfill the trench.

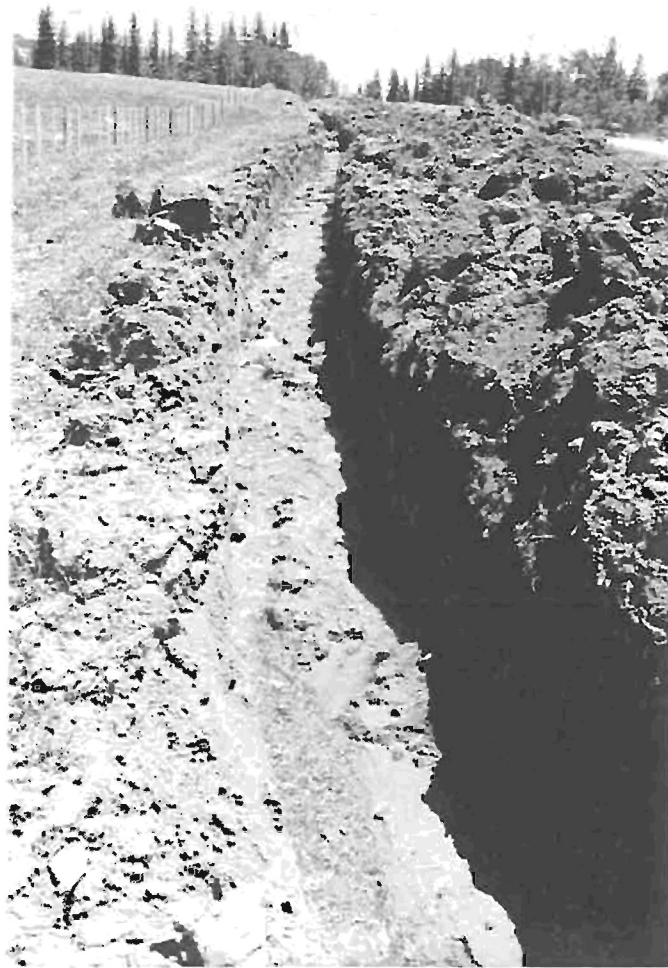
Figure 3 This is the initial phase of trenching at station 431+73 to 438+75. A stream of water can be seen flowing in the bottom of the trench.

It was during this phase of the installation that the drain sections were buried deeper than they should have been. The drains did not reach near the top of the trench as they should have. Instead, they appeared to be buried about one to one and a half meters (four feet) below the surface. (Upon excavation it was found that the depth was a little more than one and a half meters (five or six feet).)

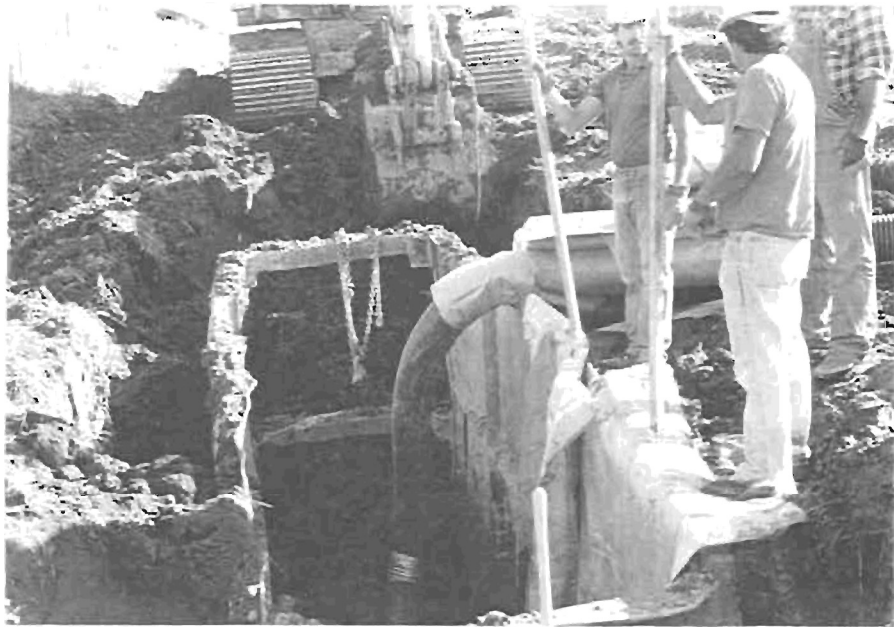
Figure 3 On the north side of this project it was necessary to use a trench box to keep the moisture saturated walls of the trench from collapsing. In this photo, the installation operation is progressing away from the camera. The perforated pipe is being fed through the bottom of the next drain section. When the leading backhoe pulls the trenchbox forward, the men on the right side of the photo will use the sticks with hooks to lower the drain sections under the brace and pull them back into place.

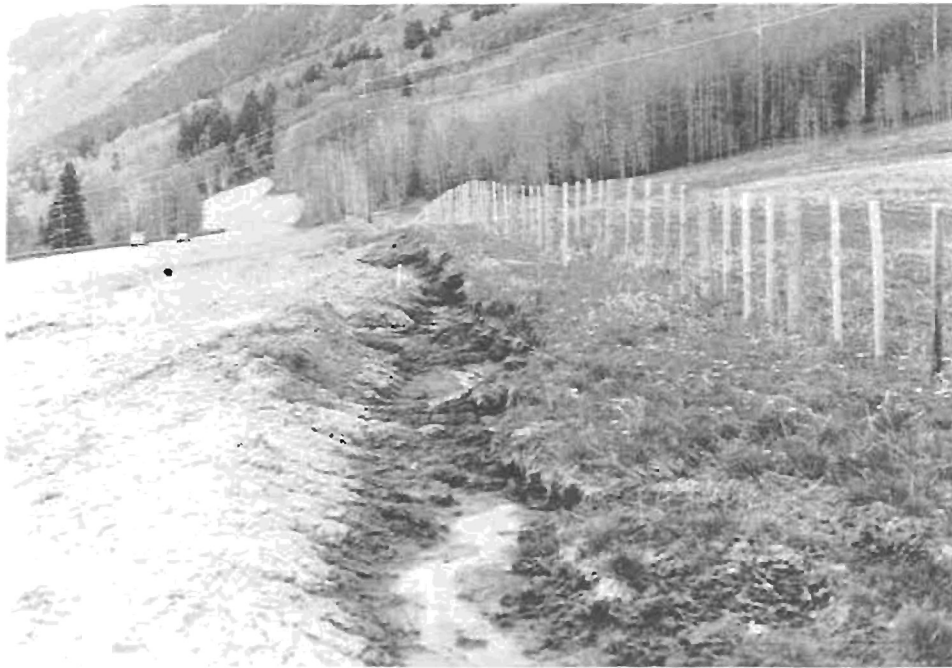
Figure 9 After the curtain drain was installed, it became apparent that there was a need to collect surface runoff as well. This ditch was dug at the top of the hill next to the right-of-way fence. The water was channeled to the roadside ditch.

A drainage ditch dug at the top of a slope such as on this project can be very effective at removing moisture and keeping the surface of the slope relatively dry. This water must be

transported away from the slope to avoid re-infiltration or erosion of the slope.

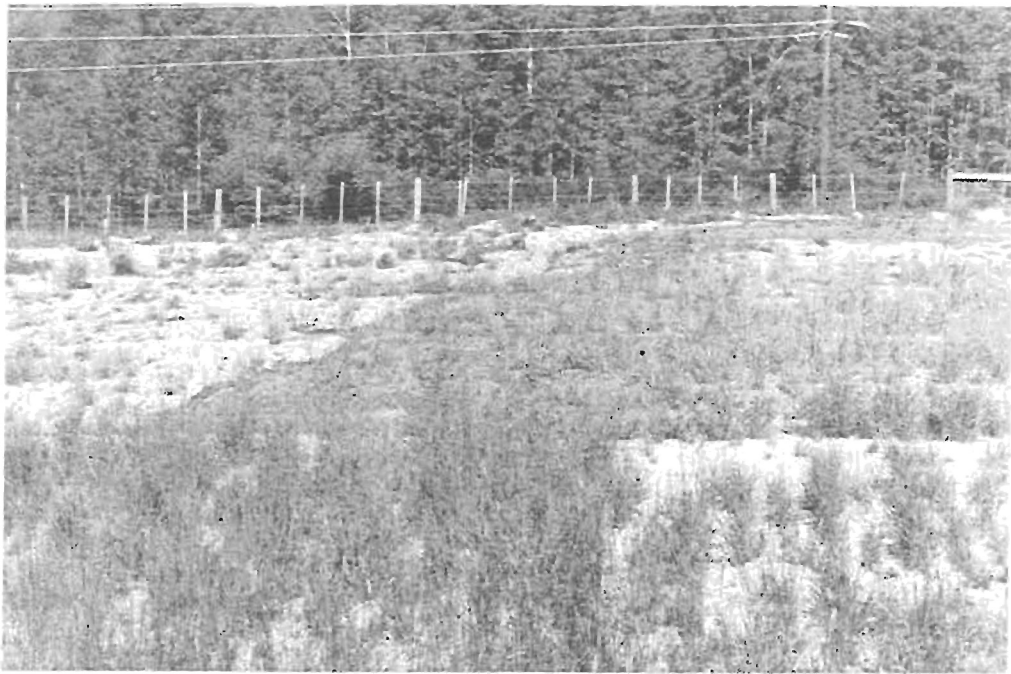
**Figure 10** The dark area in the middle of the photo is where the surface is saturated on the slope below the interceptor ditch and curtain drain. This shows that the system is not completely effective. This photo was taken in July of 1989.

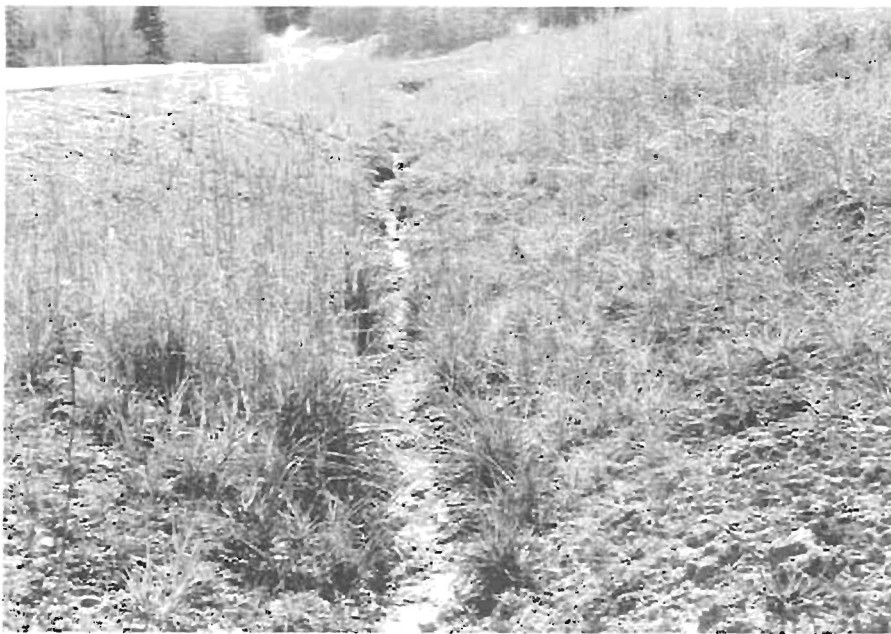
**Figure 11** Water in the ditch at the base of the hill indicated that the ground water level just barely reached the bottom of the ditch in October of 1988.

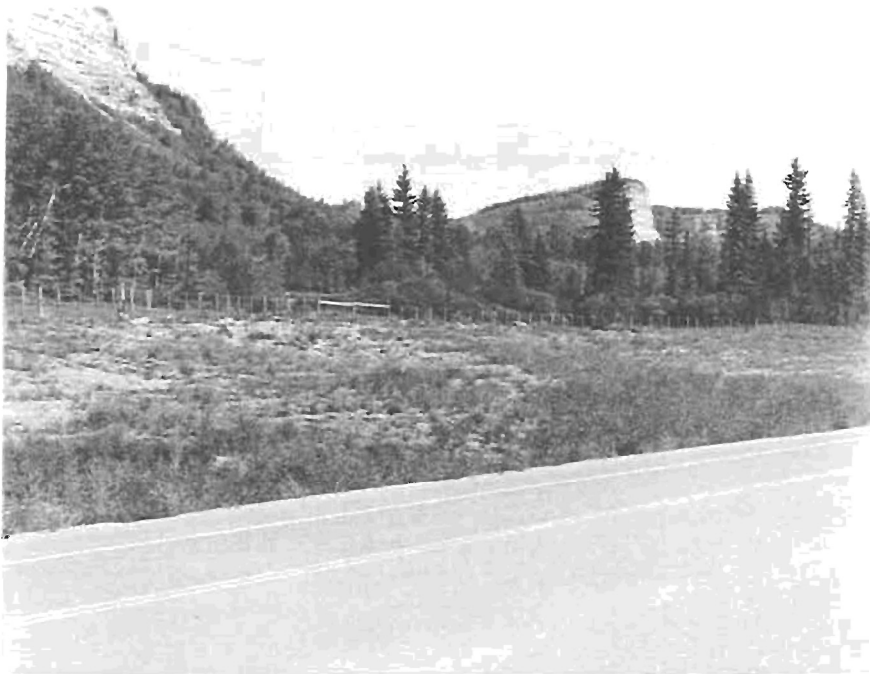
**Figure 12** At the bottom of the hill on the other side of the roadway cattails and other dense wetland vegetation can be seen where the ground water reaches the surface.

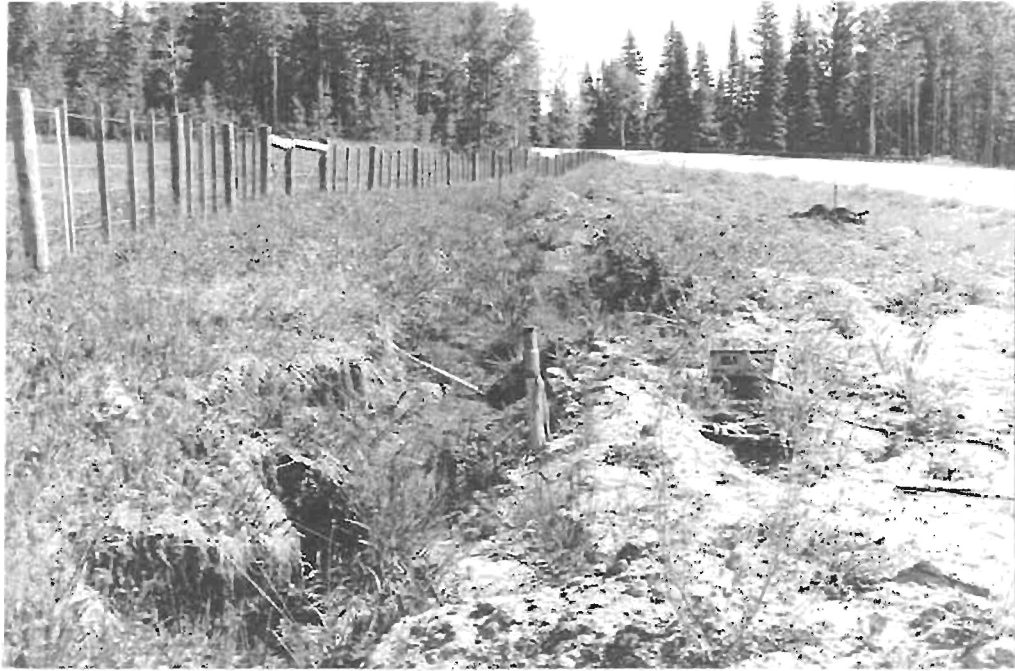
**Figure 15** This moisture tube is adjacent to the interceptor ditch on the uphill side of the curtain drain.

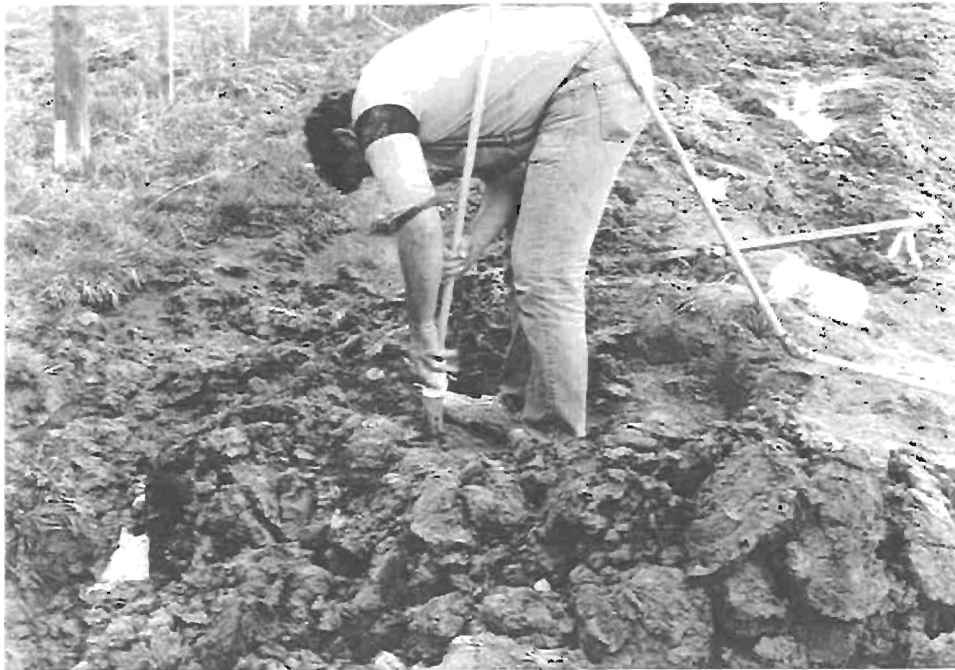
**Figure 16** Water sometimes got into the tube. This made it necessary to extract the water from the tube as is being done in this photo.

When using the nuclear moisture probe method, the moisture tubes can be unreliable and difficult to work with because they can get water in them, which precludes taking readings, and they have a tendency to separate at the couplings.

Groundwater monitoring wells should be used instead of nuclear moisture gages for ease of measurement and accuracy if all that is needed is the groundwater level or potentiometric surface. These wells are more common and less expensive than the nuclear method.

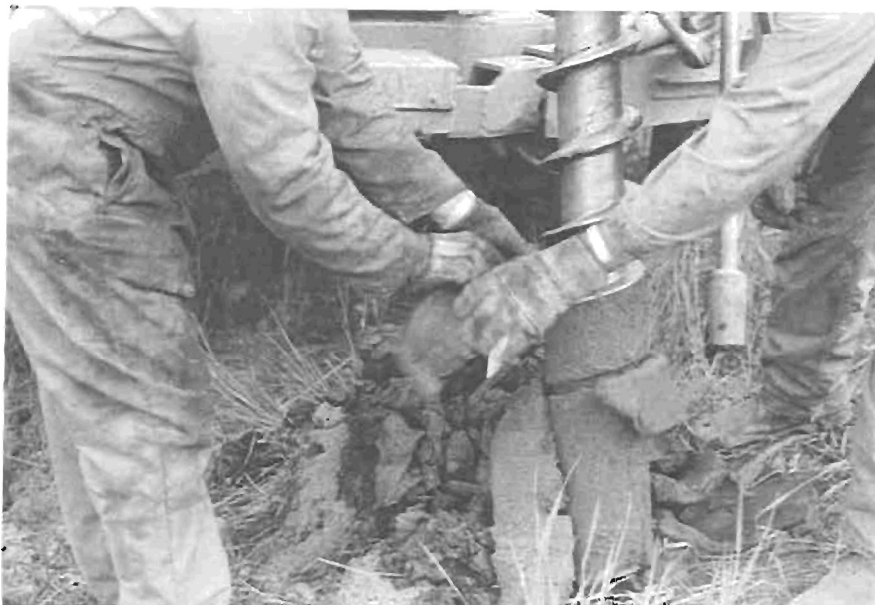
When the wells were drilled, no water was found in the bottom of the wells, although the clayey soil was wet. Small stones that were dropped into the well made a thud as they hit the bottom. This situation was temporary. Within a few days, a few meters of water had risen in the wells. This experience shows how slowly water moves through dense clayey soil.

**Figure 18** The cohesiveness of the clay was demonstrated by the way strips of mud were peeled off the auger during the installation of the monitoring wells.

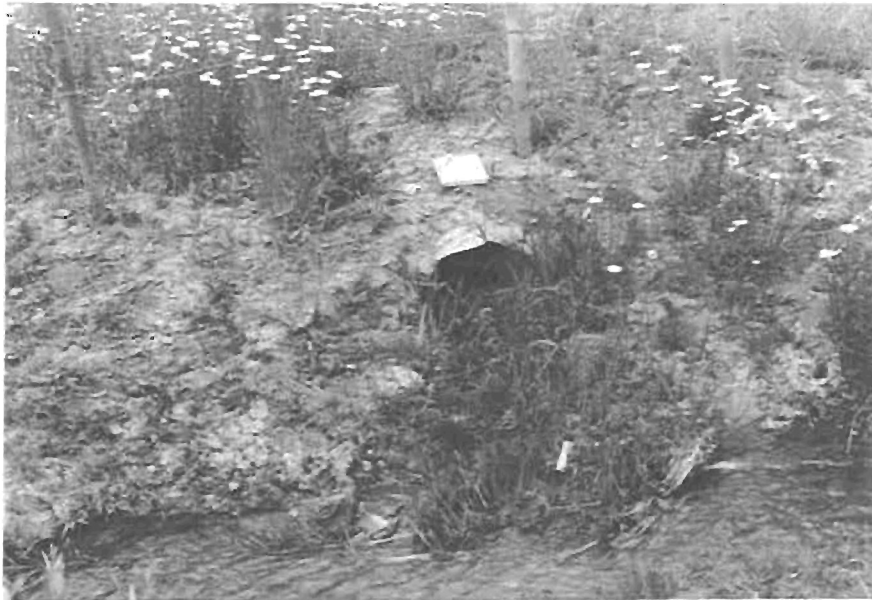
**Figure 20** A relatively small amount of water, as seen coming from this pipe on the east side of the roadway, was collected by the system. The most observed was about 20 liters (5.3 gallons) per minute. The water in the foreground is from the roadside ditches and the channel above the curtain drain.

The use of a flow meter to continuously measure the flow from the system, and a series of monitoring wells to get a more detailed profile of the groundwater elevation is recommended to more accurately determine the effectiveness of the drain systems.

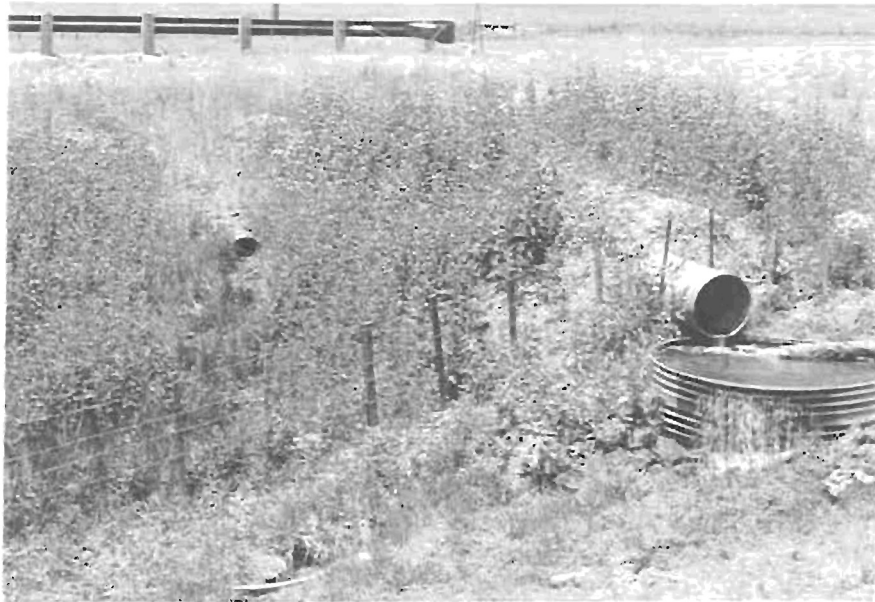
Figure 21. The culvert feeding into the tank on the right is bringing water from the ditch at the top of the slope on the other side of the roadway. The culvert to the left carries water from part of the southern section of curtain drain. This culvert is carrying very little water.

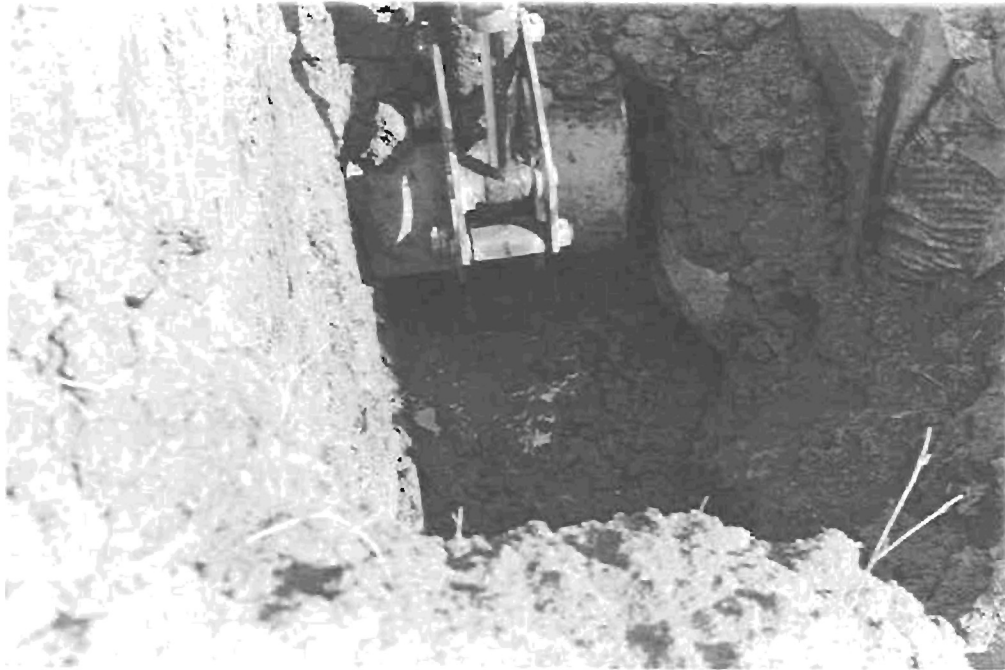
The downhill side was backfilled, and then the uphill side was excavated. When the backhoe reached the bottom of the curtain drain, a section of the drainage pipe at the bottom of the system was accidentally ripped up. Some water from the uphill side of this pipe poured into the hole. This flow seemed to decrease slightly after a short period of time. The hole was widened to provide better access to the damaged pipe. This however cut into some nearby springs and let more water into the hole. The banks began to collapse and fill in the hole again. A two meter section of perforated 8" pipe was finally placed next to the bottom of the uphill side of the curtain drain to hopefully transfer water around the missing pipe section.

The pipe would not have been damaged had it been beneath the curtain drain as expected. Instead it was about 0.6 meters (two feet) off center to the uphill side. No groundwater was encountered flowing next to the curtain drain.

**Figure 22** In September of 1990, a section of the drain was excavated with a backhoe and examined. The top of the curtain drain was found at a depth of almost two meters (six feet). The water in this photo at the bottom of the trench is due to the accidental cutting into the perforated pipe.

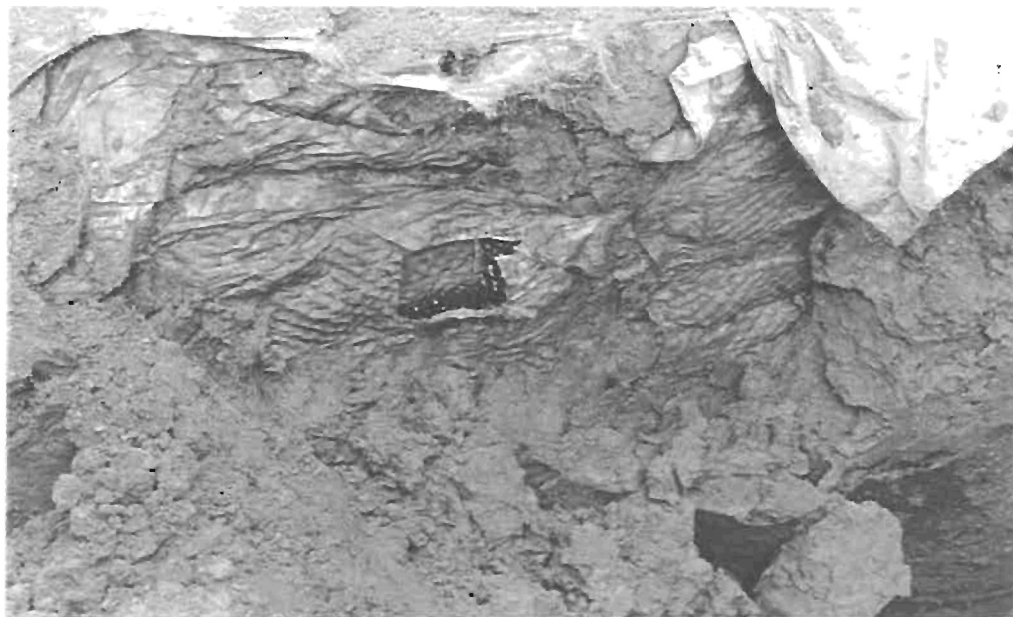
The fabric from the excavated piece of drain panel was tested by a modified permitivity test and was generally found to be only slightly less permeable than the virgin filter fabric of the same manufacturer. The specifications for this fabric are in Appendix C.

**Figure 23** A piece of the curtain drain was cut out for further examination.

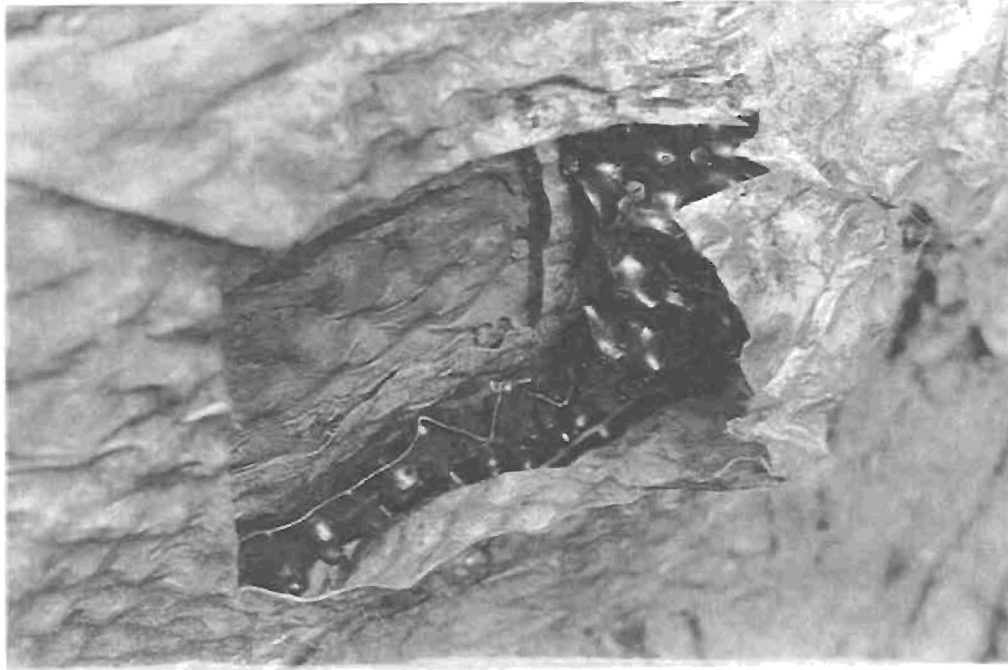
**Figure 24** This is a close-up of the area where the curtain drain section was removed. The fabric did not appear to be clogged on either side of the curtain drain. The indentations in the fabric show that the soil was pushing in against the sides and intruding into the open space. There were a few beads of water on the uphill side of the plastic core.

The filter fabric did not appear to be clogged. Though the fabric intruded into the space in the polyethylene core, this did not appear to be a problem in clayey soil. If a great deal of flow were occurring due to fissures or springs, the reduced flow area might cause problems. With the greater soil pressure that occurs at depth, there is a greater chance of the fabric being pushed into the core and the flow impeded.

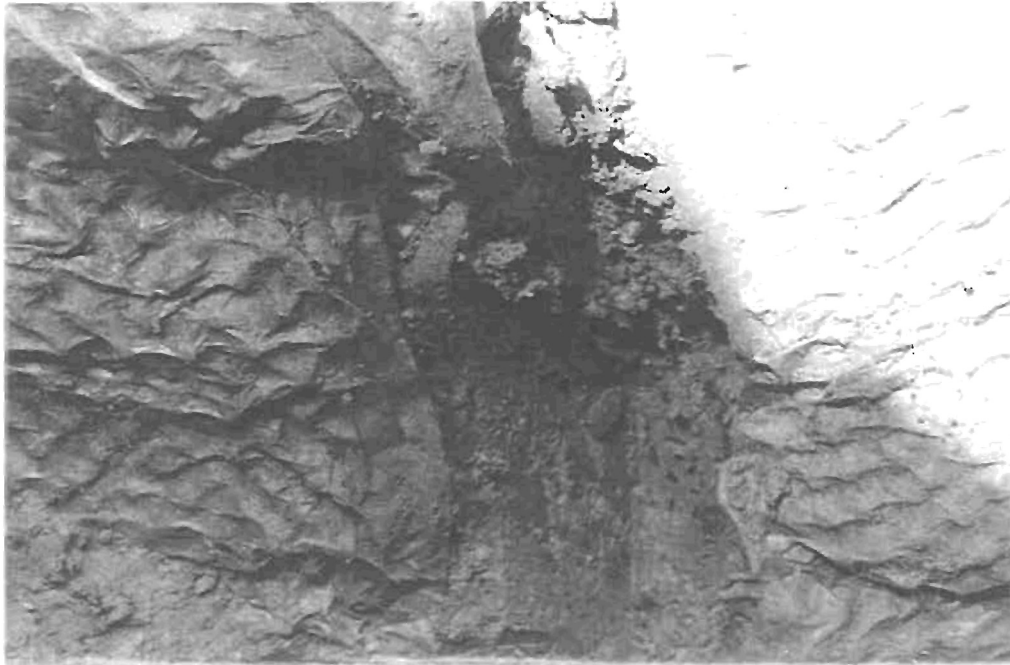
The inside of this piece was completely clean, and the outsides of the filter cloth had only traces of dirt on them. The plastic core of the sample had a few traces of moisture on the uphill side, and was completely dry on the downhill side. The filter fabric was compressed partway into the polyethylene core, but this was probably not a problem since the flow from the soil was slow. At the point where adjacent panels were to overlap, a 20cm (eight inch) gap was found in some places.

**Figure 25** This photo shows a 20cm (eight inch) gap where adjacent curtain drain sections pulled apart, presumably during construction.
