Report No. CDOT-DTD-R-93-17

# **In Service Evaluation of Highway Safety Devices Experimental Project No. 7**

Final Report  
April, 1994

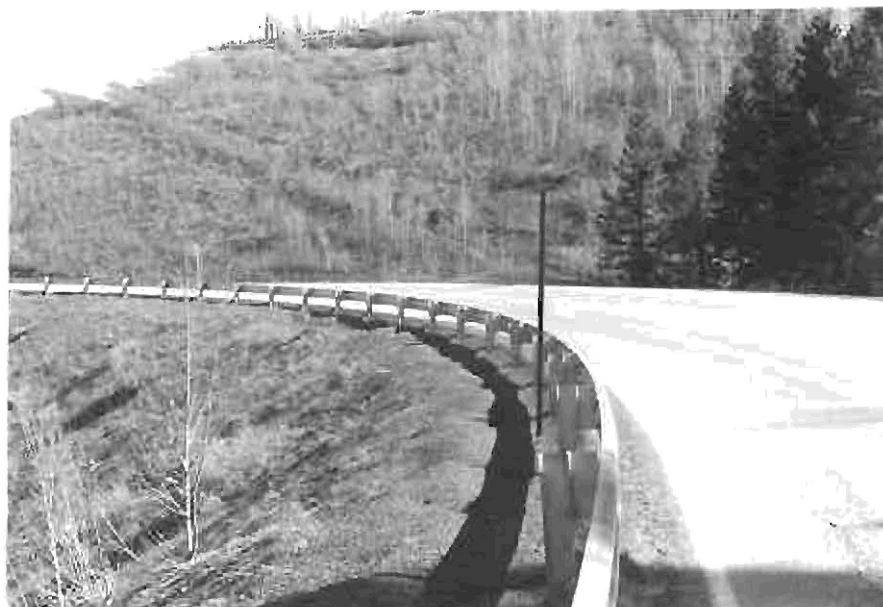
Figure 1 shows how galvanized rail and posts stand out; Figure 2 shows how the corrosion resistant rail mounted on wood posts blends into the landscape.

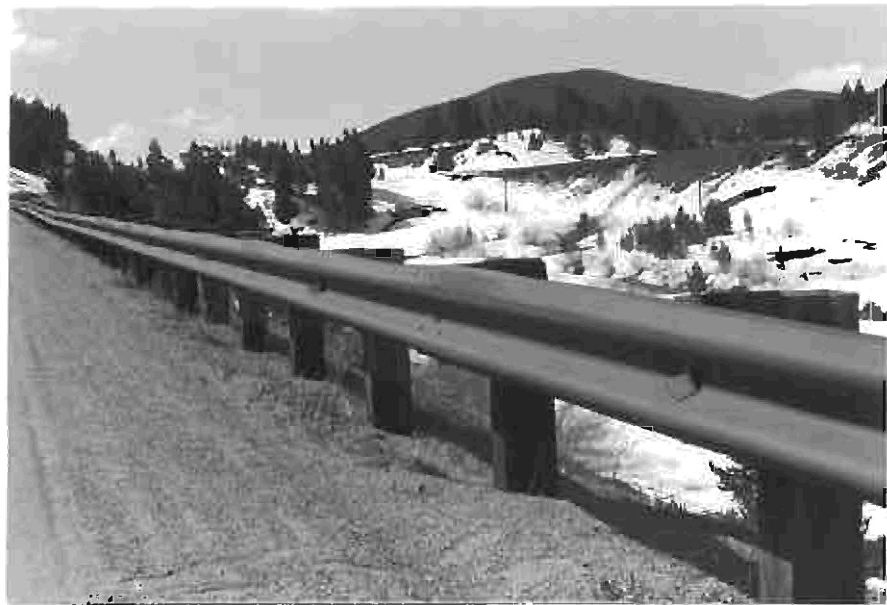
In the mountains, much of the damage to guardrails happens during the winter from snow plows hitting the rails as well as accidents caused by slippery roads. Snow plow operators sometimes scrape rails with the plow blade while trying to clear a road as completely as possible. Also wet snow is dense enough to bend guardrails when pushed off the side of the road.

rust resistant 10 gauge rail in two separate incidents; this required replacing about 400 feet of rail each time. The foreman for the area said the 10 gauge rail had been hit several times but was not damaged badly enough to need replacement. Figure 3 shows the damage done by snow plows to corrosion resistant guardrail.

Readers will notice the flattening of the rail at the second post from the right and the wavy appearance farther along.

Based on experiences at the site on US 24, installation of 10 gauge W-beam guardrail is recommended where plowing operations and relatively minor accidents bend, flatten, and disfigure 12 gauge guardrail.

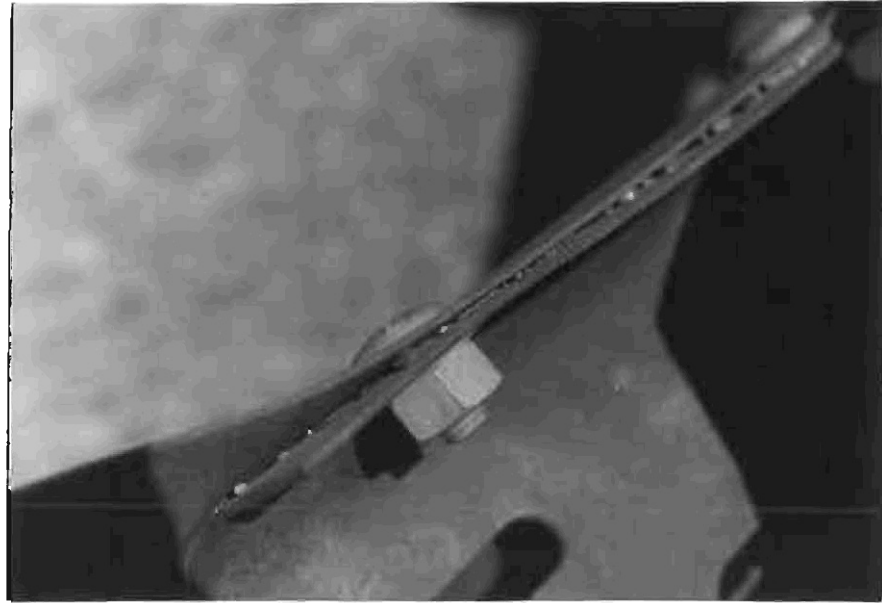
Figure 4 shows the relative thickness of 10 gauge and 12 gauge materials. A 12 gauge end treatment is bolted to a section of 10 gauge W-beam guardrail. The thicker 10 gauge material can be seen on the nut side of the bolts. The foreman for the Eagle area, which includes this project, has requested that 10 gauge rail be used on some safety projects to be done in the area.

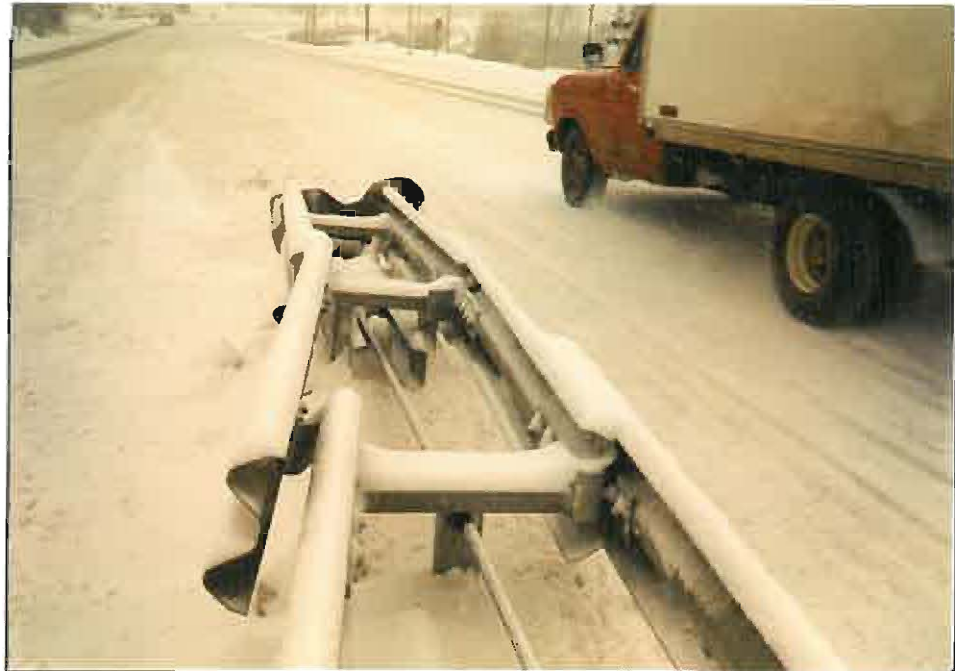
Figure 6 shows a terminal after a minor impact. It also shows the conditions that led to most of the hits on the terminals in this study. The Brakemaster did the job well in every case reviewed for this study. In the 65 MPH accident, referred to above, people at the scene felt the terminal probably saved the driver's life.

A hit on the end of the system can result in the need to completely replace the terminal or just replace damaged parts. On January 4, 1991, a 1984 Toyota pickup, travelling at 45 MPH, slid on icy pavement and hit the end of the terminal in Figure 6.

The nose cover, laminated straps, several panels, and the breakaway arm and its accessories had to be replaced; however, the braking mechanism was not damaged and was not replaced. The repairs cost \$2623 plus labor. There were no injuries, but the truck had to be towed to a repair shop.

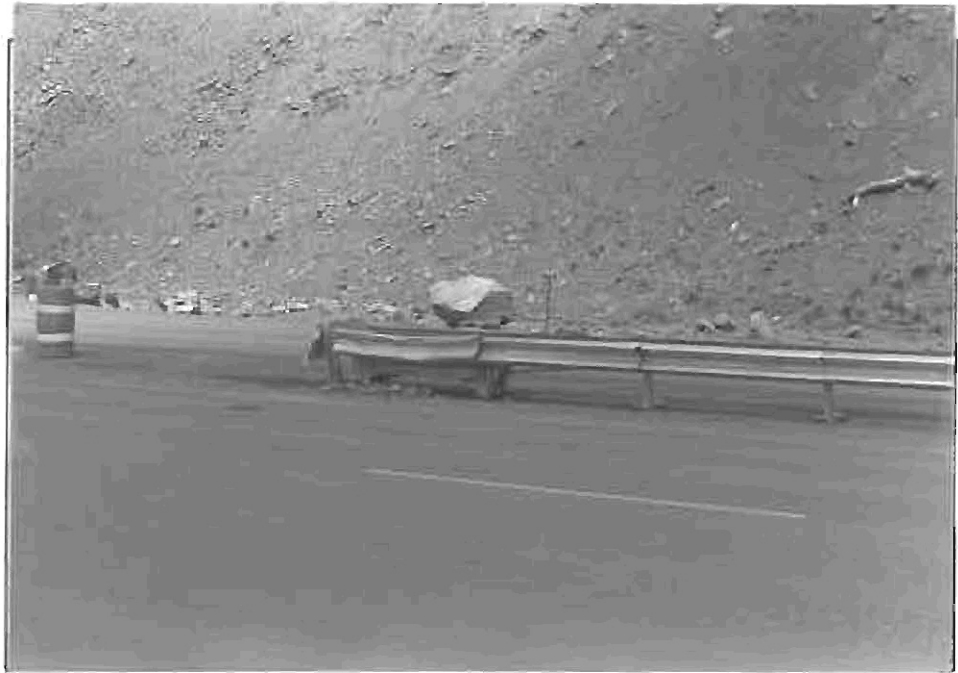
**Figure 7**

Figure 7 shows a terminal damaged by a four foot boulder that rolled down from the hill beside the road. The nose and one panel had to be replaced. Materials cost was \$978. A CDOT maintenance crew repaired the terminal in about one-and-a-half hours. There was no apparent damage to the boulder which can be seen behind the terminal.
