Report No. CDOT-DTD-R-97-6

# **Evaluation of the Iowa Vacuum Tester**

Interim Report  
July, 1997

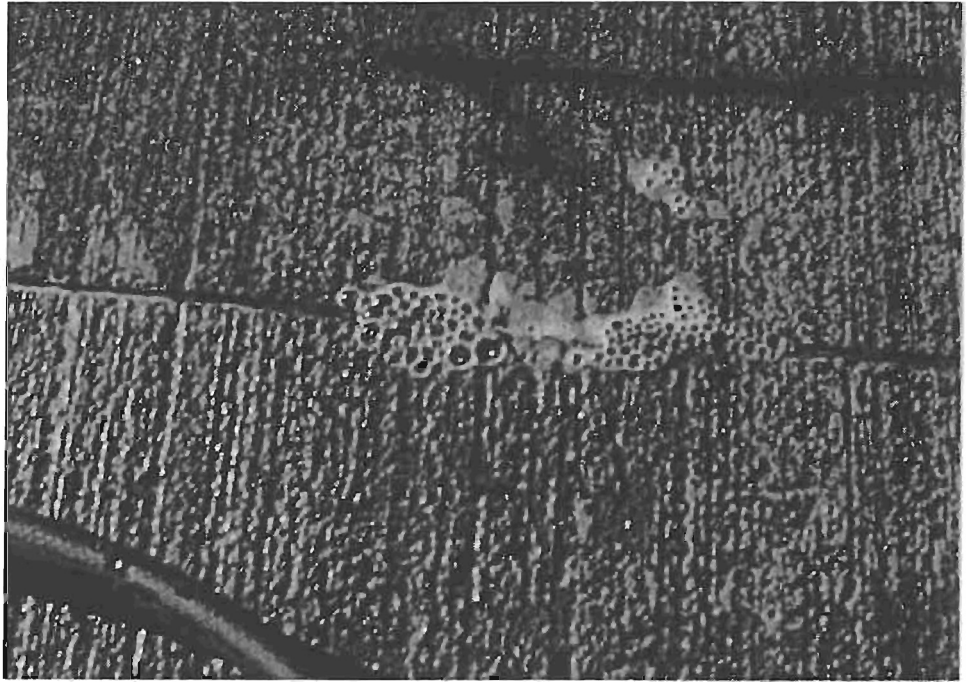
**Figure 4** Two groups of bubbles indicate two leaks in the joint.

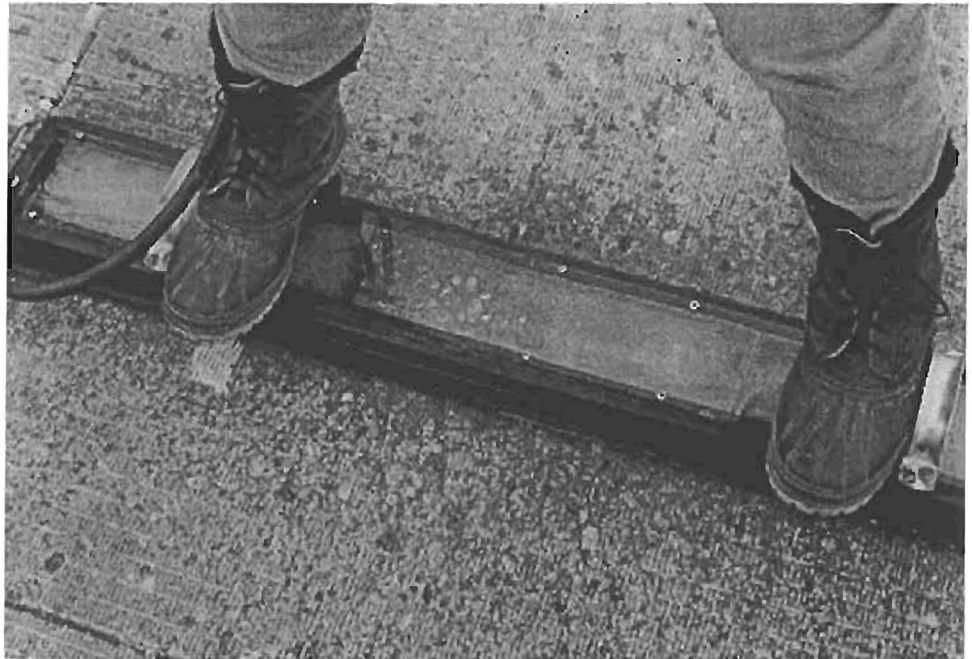
**Figure 5** The drops in the center of the chamber show a severe leak. The air flow through the failure can't bubble; it just sprays the solution on the bottom of the window. This can also happen if the vacuum level in the chamber is too high with a smaller leak.

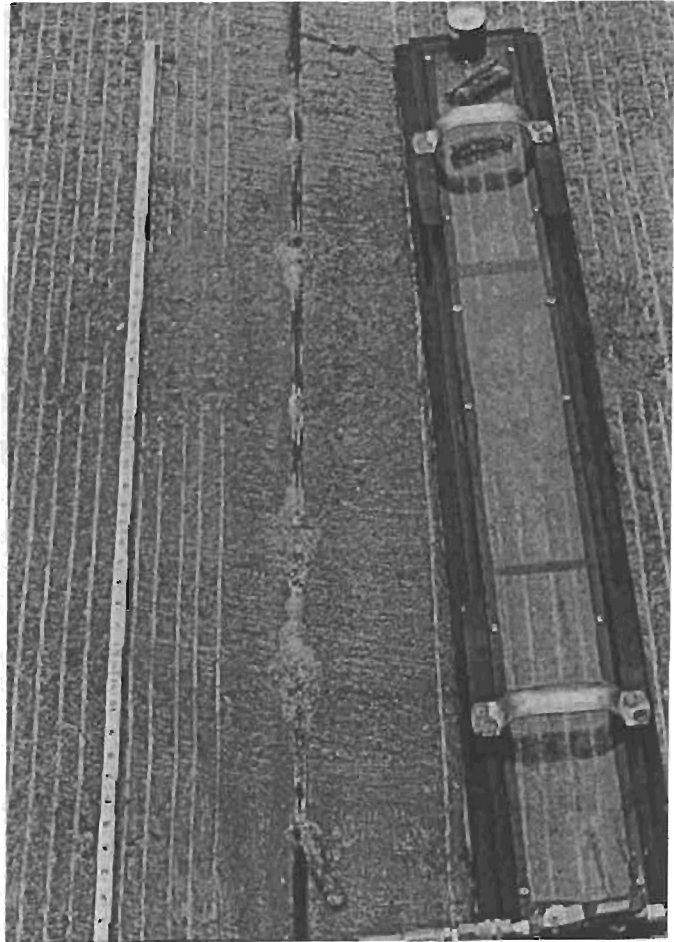
**Figure 6** This is where tie IA-Vac excels. This is a compression seal with several leaks. It is very difficult to find adhesion failures visually. However, as this picture shows, the IA-Vac finds them easily. The quantity and size of a group of bubbles indicates the severity of the leak.

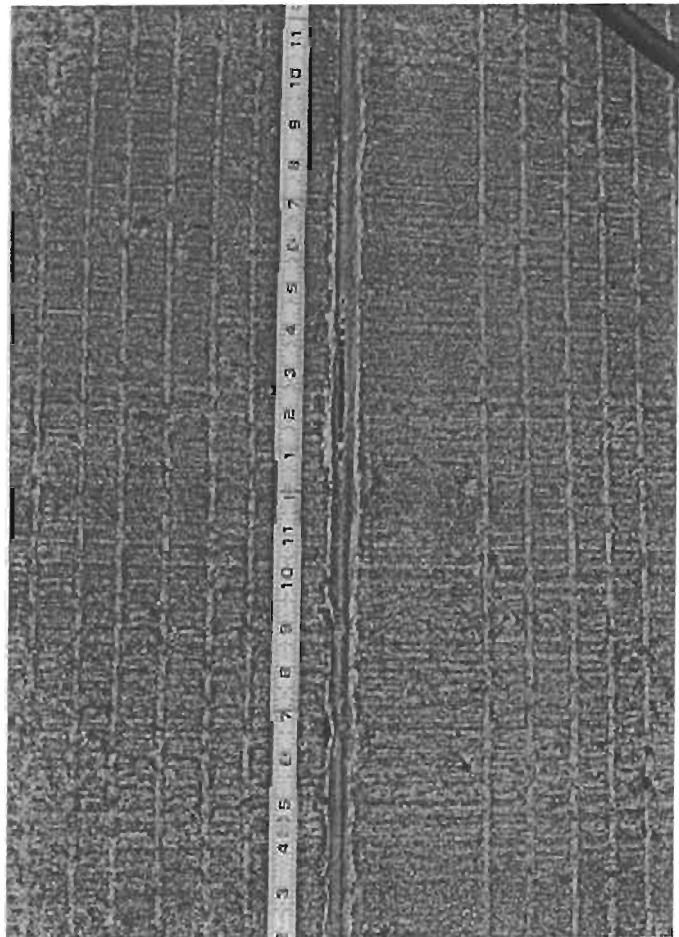
**Figure 7** A severe spall at 7" and a cohesion failure at 1' 3" will not bubble. These two severe joint failures allow so much air to pass that other failures in the area cannot be detected.
