Report No. CDOT-DTD-R-98-5

# **Evaluation of the Iowa Vacuum Tester**

Final Report  
April, 1998

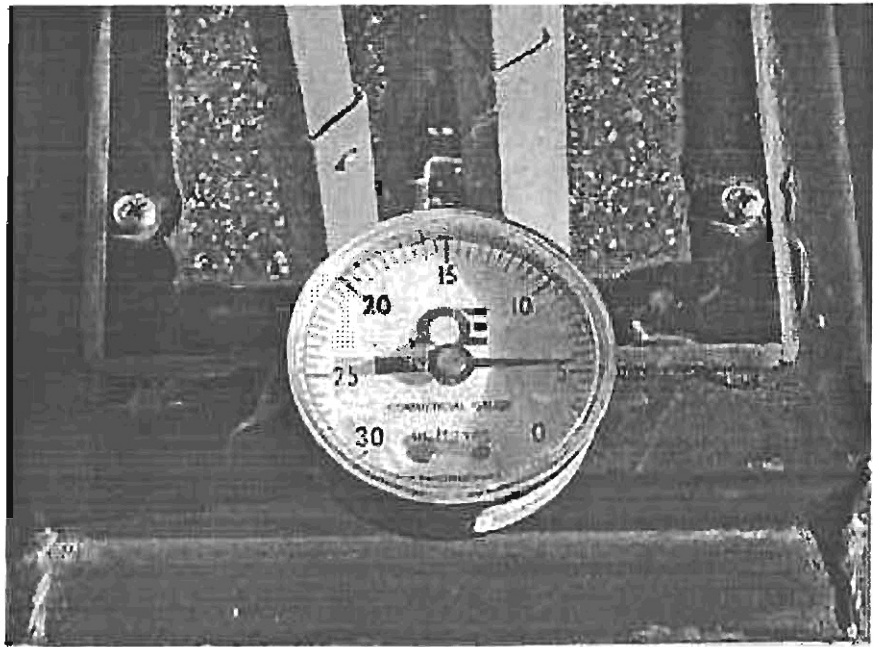
NOTE: The vacuum gauge on the test chamber used for this study reads 5 in. Hg with no vacuum applied to the chamber (Figure 7). It is important to be sure that the change from static position on the chamber gauge does not exceed 125 mm Hg during testing. Higher vacuum can damage the chamber seal by causing it to roll and tear away from the base of the chamber.

**Figure 7** The vacuum gage on the test chamber reads 5 in. Hg when the system is disconnected. If possible, it should be re-calibrated. If it is used in this condition the vacuum level in the chamber must be read as the change in the gage reading when vacuum is applied.

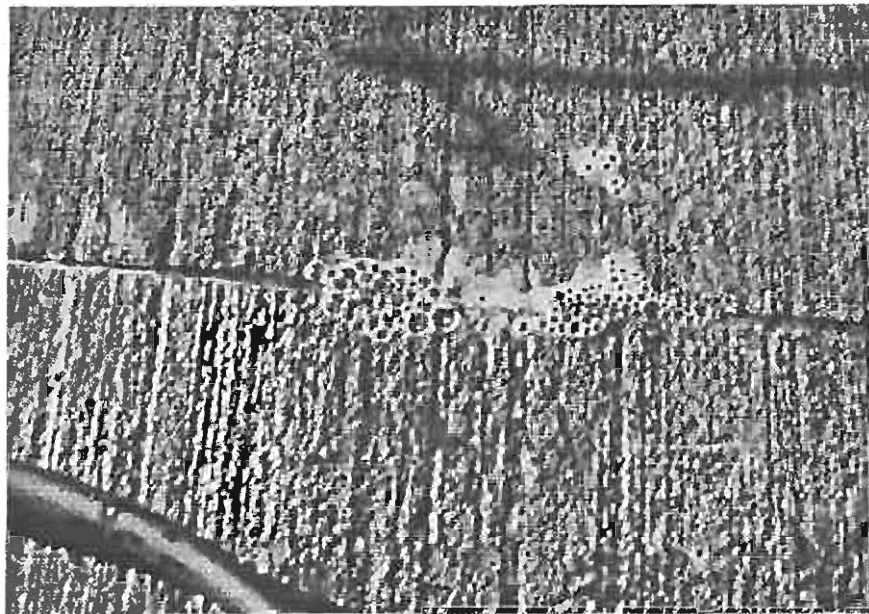
5. Mark locations on the pavement at the side of the chamber if specific analysis of the causes of bubbles is to be made. Size of the bubbles (Figure 8) is a good indicator of the size of the failure.

**Figure 8** Bubbles show a leak in the seal. The larger bubbles to the left indicate a larger leak than the one to the right. The small bubbles to the rear of the joint may indicate a pinhole in the concrete or a micro crack that could develop into a spall.

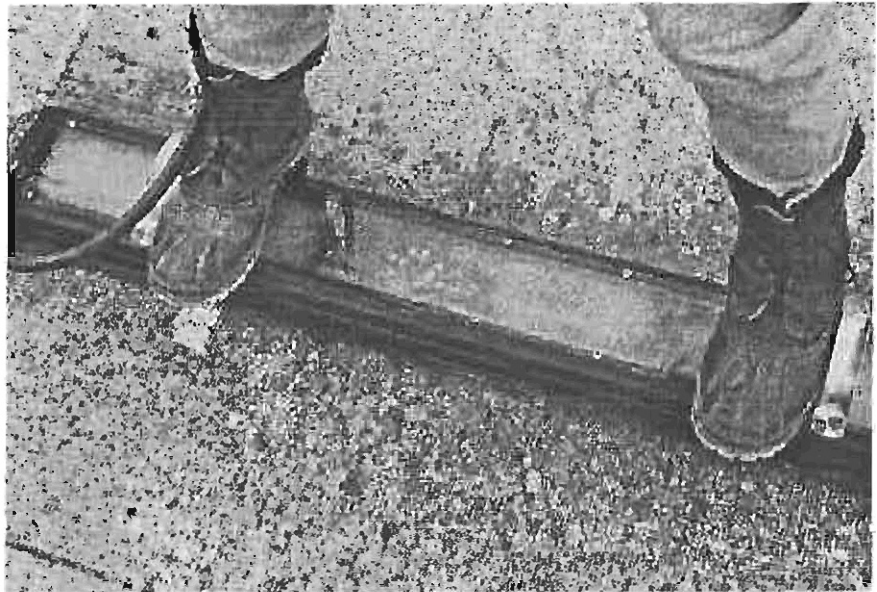
A wet spot on the bottom of the glass (Figure 9) and no bubbles on the joint probably indicate a large failure that passes so much air that bubbles can not form. Usually a failure this large will be easily seen

**Figure 9** The drops on the glass show a large failure that is passing air too rapidly for bubbles to form. A failure this large is usually easily seen.

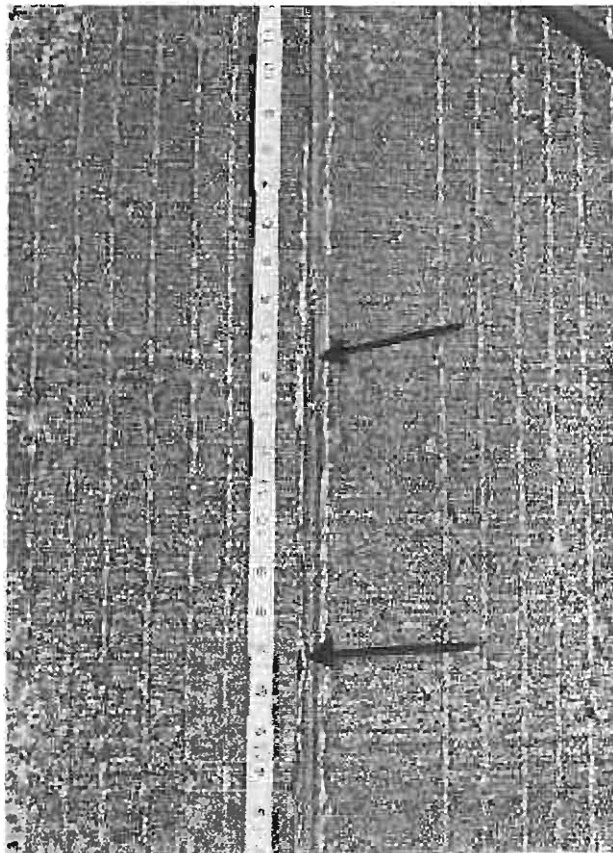
**Figure 10** Both of these failures are too large to allow bubbles to be made. A cohesion failure (at the top arrow) was caused by the sealant being too thin. A spall (at the bottom arrow) has left a large opening through the seal. Openings this large may pass so much air that no other failures in the area will bubble. It may be necessary to move the chamber if the adjacent section of seal needs to be tested.

**Cohesion Failure:** A failure in the seal material itself. The failure in the photo on page 9 could be cohesive. (It could also be a construction problem if the seal was tooled too thin or the backer rod was too high, resulting in a thin seal. Close investigation is necessary to determine the actual cause.)

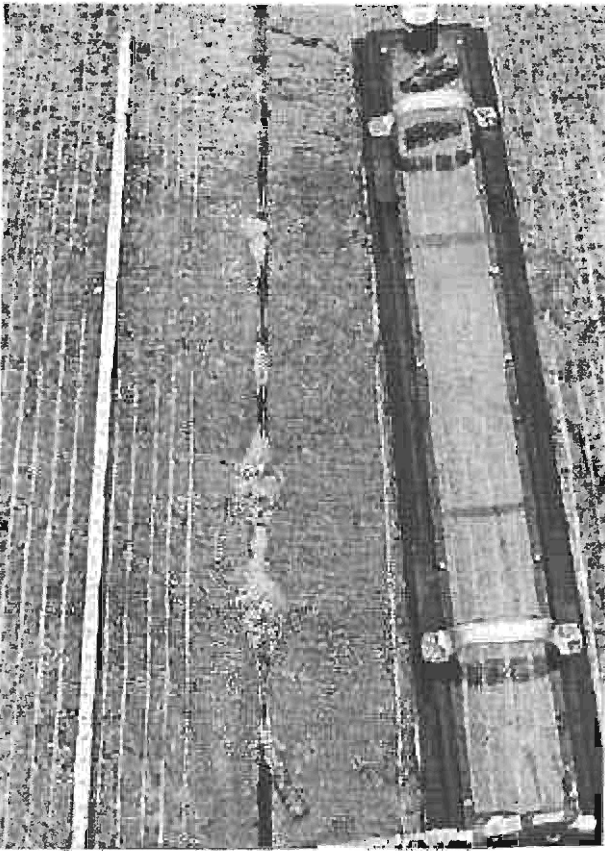
Problems experienced during construction of the neoprene joints at the SHRP site described earlier in this report left several of the seals twisted in the joint (Figure 12). The

IA-Vac, or a similar method, may be the only reliable way to evaluate the function of this type of seal. Visual examination clearly indicated the twisting problem but there was no way to determine if the seals were performing properly. The IA-Vac tests showed that while some of the twisted seals did leak, some of those that were severely twisted had no leaks at all at 70°F. (At lower temperatures the neoprene seals may leak.)

**Figure 12** This is a neoprene seal. As the bubbles show, there are eight leaks in the seal. During a visual inspection these failures would be extremely hard to locate. This particular seal was twisted during installation. Twisting does not always cause leaks. Other seals that were also twisted showed no leaks when tested with the IA-Vac.

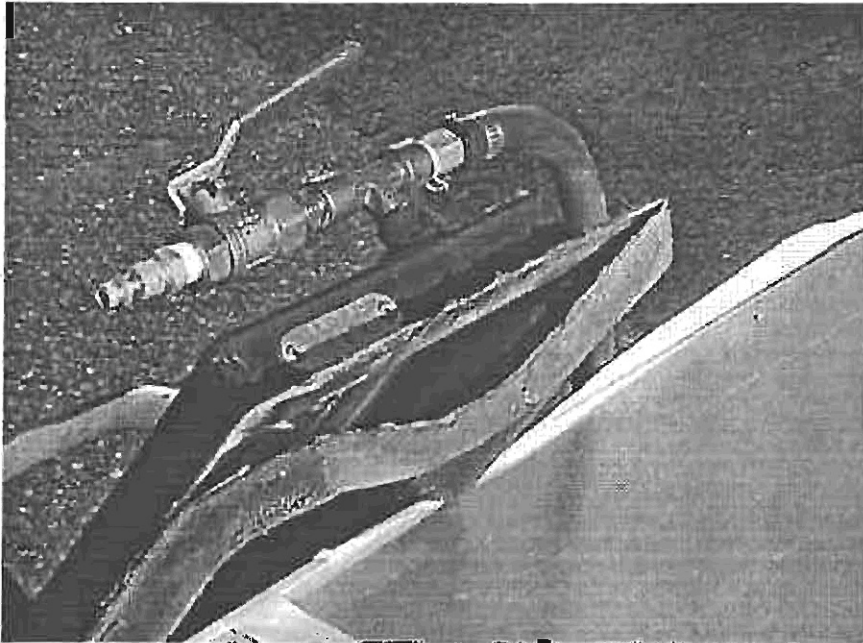
It is possible for part of the seal to pull loose from the test chamber without being damaged otherwise (Figure 14). If this happens, a thin coat of silicone caulking applied to the base of the chamber will provide a quick way to reattach it. The system can be used with a short portion of the seal loose from the base of the chamber. However, extra care must be taken to prevent tearing the seal when it is unsupported. It should be re-glued to the chamber as soon as

**Figure 14** The seal can pull loose from the base of the chamber during normal use. A thin film of silicone caulking applied to the base of the chamber makes a quick, semi-permanent repair. This happens fairly often and does not prevent testing. However, it should be repaired as soon as possible to prevent further problems. The system can be used while the caulking cures.
