Report No. CDOT-DTD-R-2001-6

Results and Recommendations of Forensic Investigation of Three Full-Scale GRS Abutment and Piers in Denver, Colorado

June 2001

**COLORADO DEPARTMENT OF TRANSPORTATION
RESEARCH BRANCH**

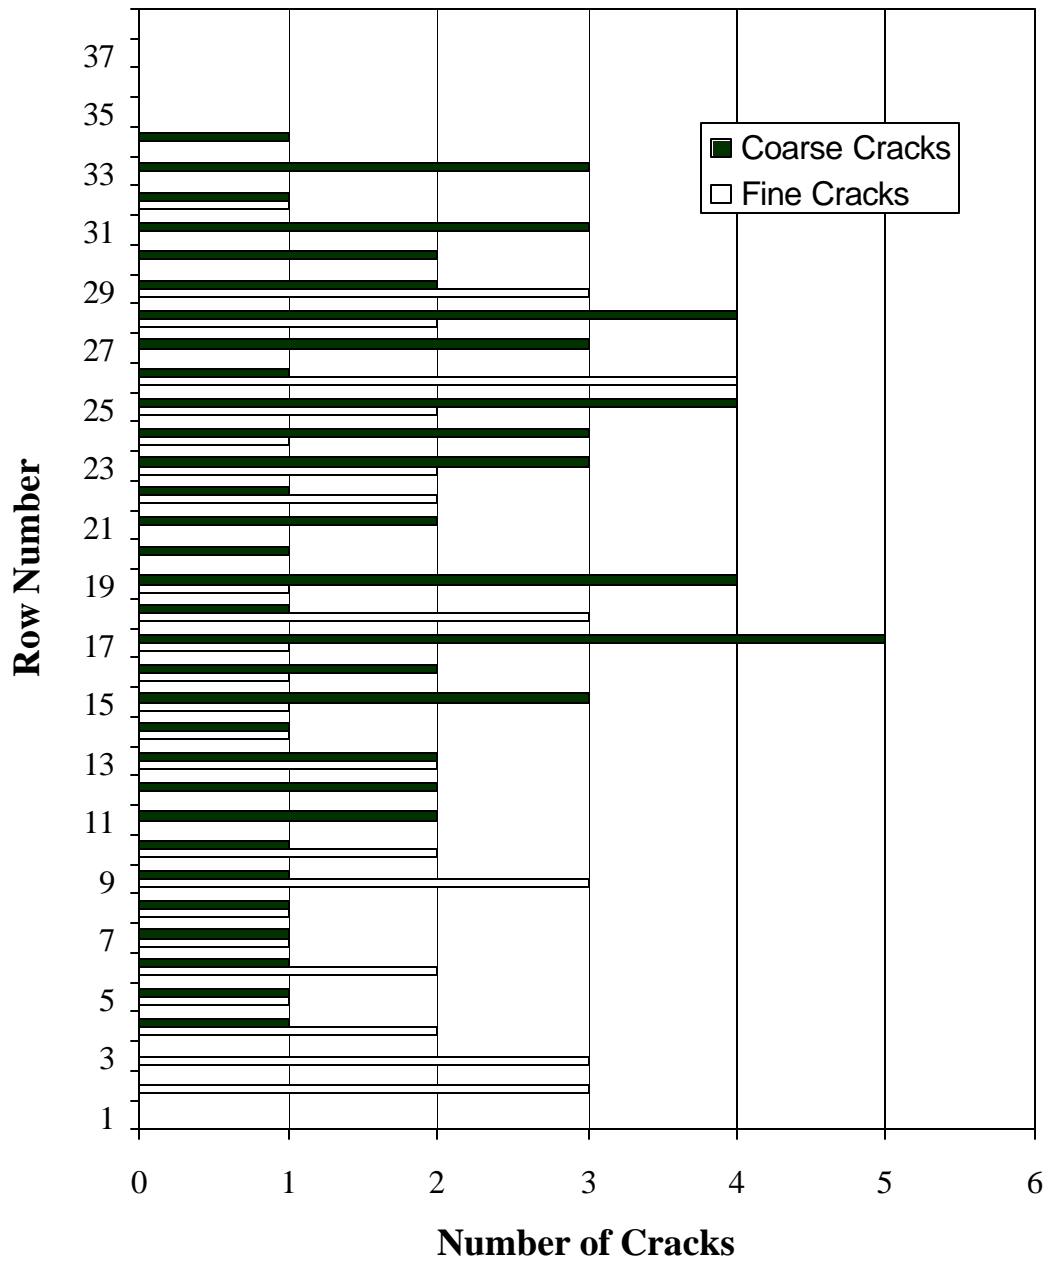
Figure 6 Density of Cracking along the East Face of the Outer Pier

Different types of blocks were used in the construction of the three Havana Yard Structures (Figures 3 to 5). There were few cracks visible in the external face of the abutment before the dismantling began, but during dismantling, a fairly large percentage – as high as 50% – of the blocks in some layers was broken. On most of the levels, most of the broken blocks were on the side where the surcharge load was applied (Figure 1). There were no visible cracks in the external face of the center pier (the pier that was not surcharge loaded) and no internally broken blocks were found during the dismantling operations. The facing of the outer pier (see Photo 5 and 6) was severely damaged, as was observed in the cracking of the external face (Figure 6) and

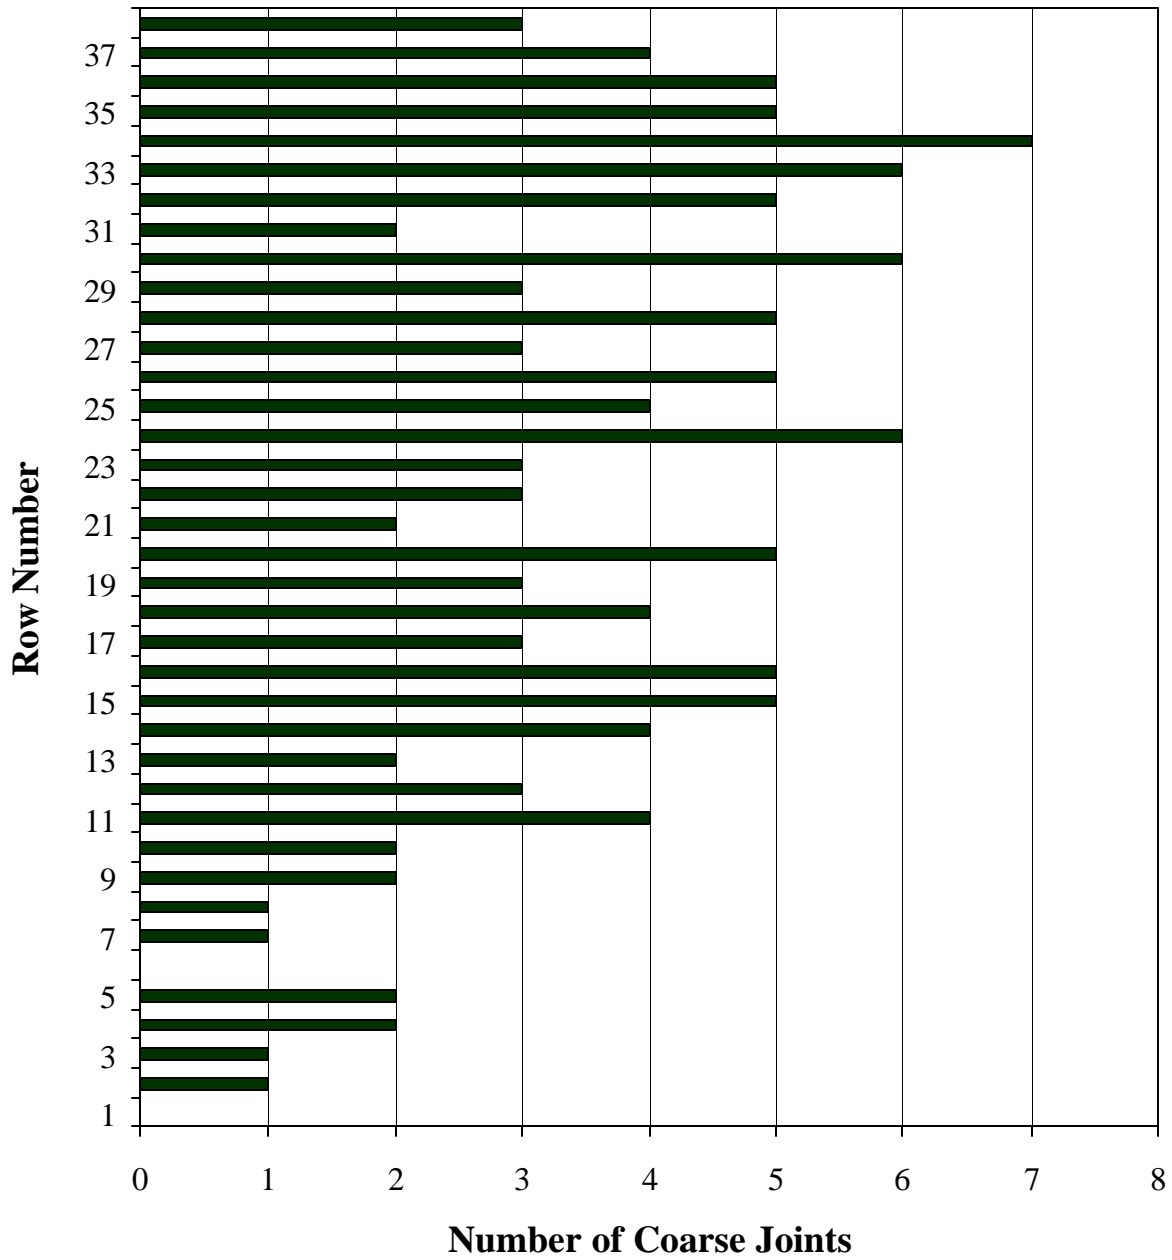
Figure 7 Density of Opened Joints along the East Face of the Outer Pier Indicating Movement Parallel to the Facing

broken internal sides of the blocks (Figures 11 to 13). The facing of the outer pier experienced excessive movements, especially the upper four layers. This movement decreased with the depth from the top of the pier (Figures 7 to 10). Additional descriptions of the movement and damage of the pier and possible causes for this response are provided in the next section.

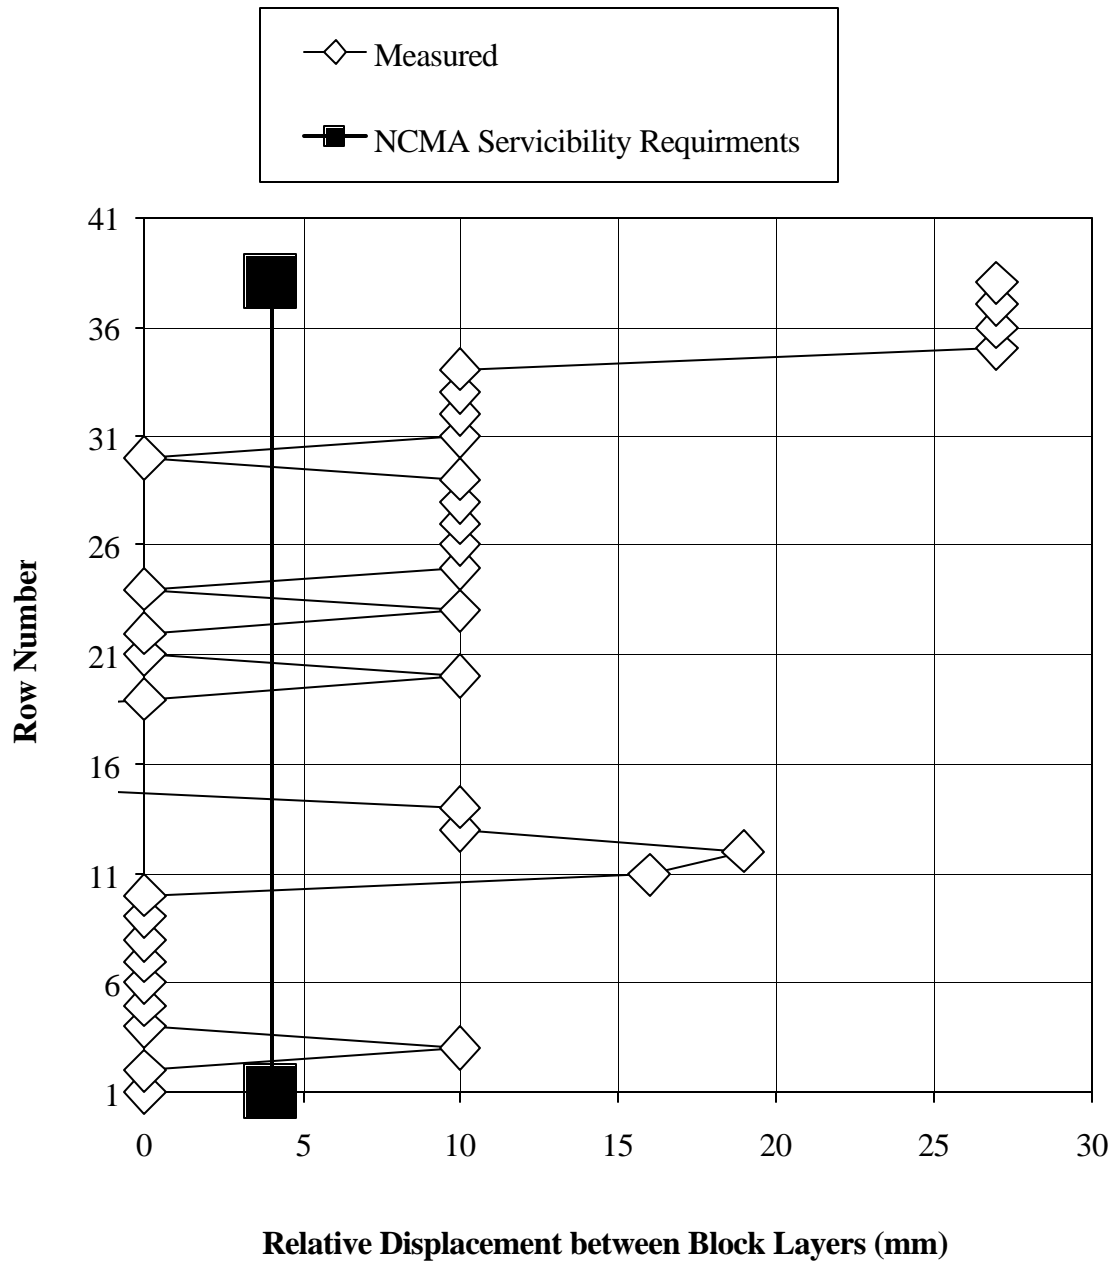
Figure 10 Measured and Maximum Recommended Relative Outward Displacements between Block Layers

facing connection capacity is not developed at the expense of unacceptable wall movement. A relative displacement between block layers below 2% of the height of the block (4 mm in our case) is recommended by NCMA guidelines to insure that serviceability block-to-block connection (or interface shear) capacity criterion is met (Bathurst and Simac, 1997). Results of Figure 10 indicate this criterion was not met for the upper 14 block layers (rows 25 to 38). In the Havana Yard outer pier structure, a fabric layer was placed between block layers and the hollow concrete blocks were filled with uniform size gravel. This facing system developed its block-to-block connection capacity by interface friction between blocks and reinforcements and between gravel and reinforcements. That is, no interlock with shear key or other form of mechanical or positive connection was used.

Both the results of forensic investigation (Figure 10) and facing connection stability analysis (Table 5) indicated that layers 25 to 38 of the outer pier failed to meet the serviceability block-to-block connection requirements (i.e., relative displacement between block layers larger than 4 mm). If higher soil friction angles of 36 and 40 degrees were employed in the analysis, the connection capacity would still be exceeded for block layers above 27 and 29, respectively. This indicates that serviceability connection capacity would have been exceeded in the upper zone of the outer pier structure even if the backfill had been well compacted. Therefore, some form of positive block-to-block mechanical connection was needed for a geosynthetic-reinforced soil structure supporting a high surcharge load.

- ❑ In the top 1.6 m of piers loaded with a high surcharge load, it is recommended to: 1) place reinforcements with a wrapped-around procedure behind the facing, and 2) employ mechanical connection between blocks and between blocks and reinforcements. Results of this research and other studies suggest that the friction-based facing connection strength in the lower zone of the pier is adequate.

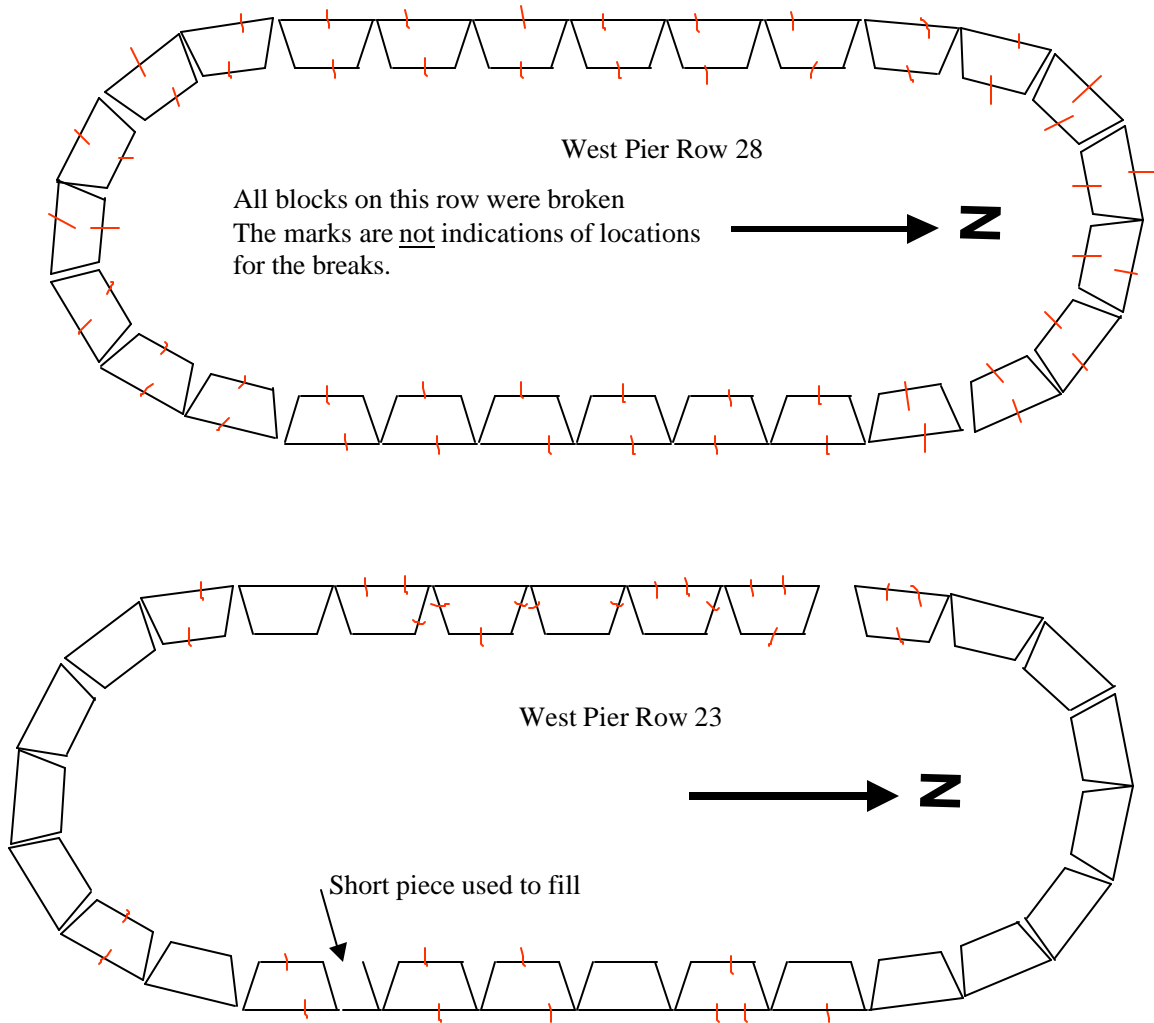
Figure 11 Mapping Results for the Blocks' Breaks in the Upper Zone of the Outer Pier
 (Note: Marks indicate the broken sides, not location of the breaks)

No damage was noticed for the internal sides of the upper four block layers (rows 35 to 38), but all other layers had broken blocks. In rows 33 and 34, the blocks were broken into several pieces. As the dismantling progressed, it became apparent that many of the blocks that appeared from the outside to be whole were also broken. Typical mapping results for the blocks' breaks at different levels in the pier structure are shown in Figures 11, 12, and 13. Note that the marks indicate the broken sides, not exact location of the breaks. From layer 32 down to 30 all of the blocks were broken (~ 27 blocks per layer). In rows 29 through 27 there were only five unbroken blocks. On row 27, all blocks were broken, on row 26 there were two unbroken blocks, on row 25 there were 7 unbroken blocks, and on row 24 there were 5 unbroken blocks. For the entire pier, more blocks on the straight sides of a given layer were broken than in the curves at the ends of the layer (Figure 11 to 13). Most of the unbroken blocks were either on the curves or at the end of the straight sides of the pier (see Figures 11 to 13). From rows 32 to 24, there were almost no unbroken blocks in the straight part of the pier. It is also clear from the mapping results that the lower layers had more unbroken blocks. The breaks in all of the blocks were nearly vertical from the top to the bottom of the block; no intersection of one break with another was observed. Most broken blocks had at least two breaks. Most blocks had only one break per side and most breaks were near a corner, although multiple breaks in a side and breaks near the centers of the faces were found. While many of the blocks were broken in several places, none was shattered.

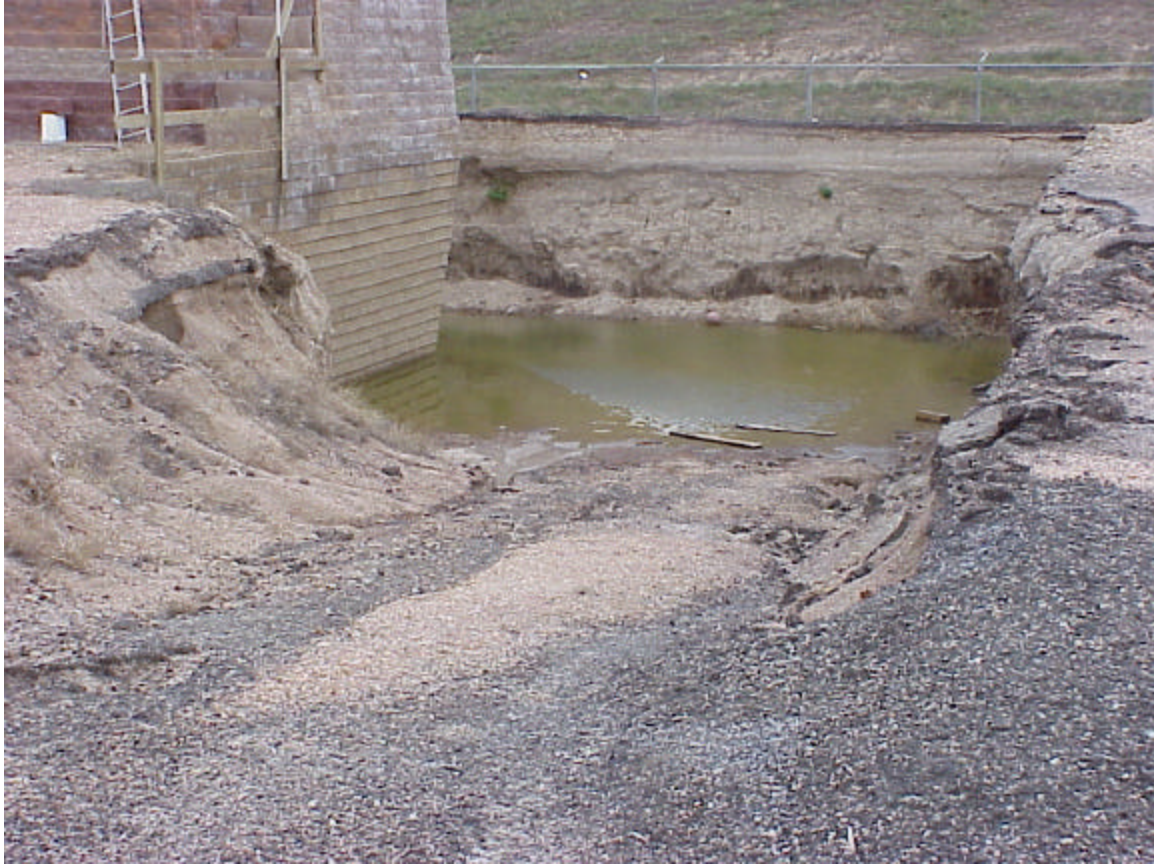
Photo 3. Lower Portion of the Abutment Structure. Note the negative batter. This was done only on the east side of the abutment and only below the ground level.
