**Report No. CDOT-DTD-R-2003-7
Final Report**

EXTENT OF TOP-DOWN CRACKING IN COLORADO

In 2000, a forensic evaluation was conducted on a project that was exhibiting early longitudinal cracking near the wheel paths. A team of national asphalt experts conducted this forensic evaluation. The forensic team concluded that the cracking on the project was surface initiated cracking and was caused by a number of contributing factors. One of the contributing factors to the early distress that was identified by the experts were the pockets of segregation that were observed at the bottom of the surface lift but were not apparent on the surface.

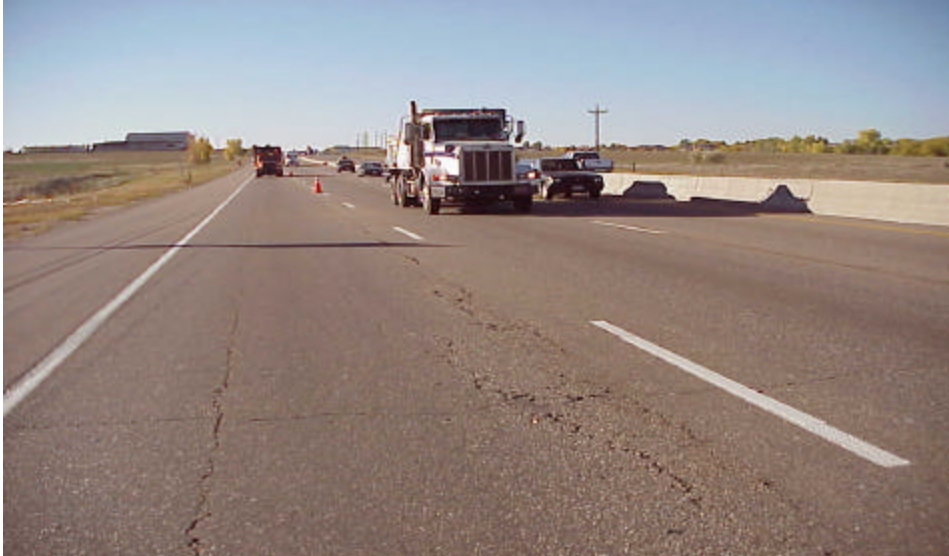
Figure 1. Longitudinal cracking was found on this project as shown in this photograph. This cracking pattern was consistent throughout the entire length of the project.

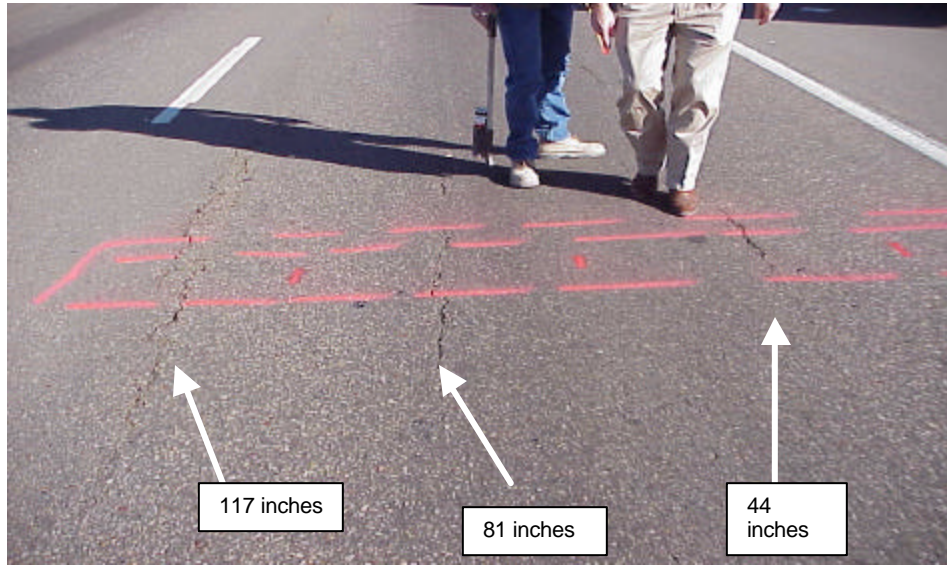
Figure 2. This photograph shows the location of each crack with respect to the other cracks. The distance is measured from the outside shoulder stripe.

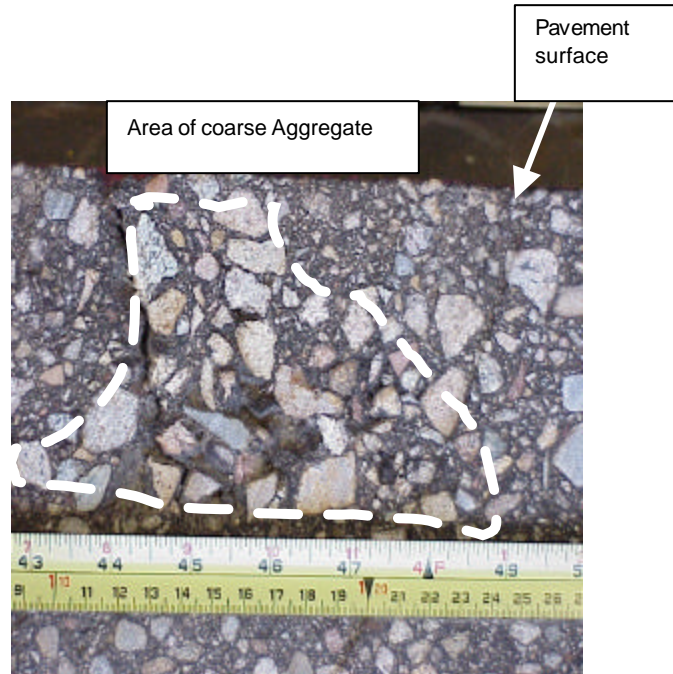
Figure 3. There was segregation present within the mat at each of the cracks. The segregation was particularly severe at the 44-inch crack.

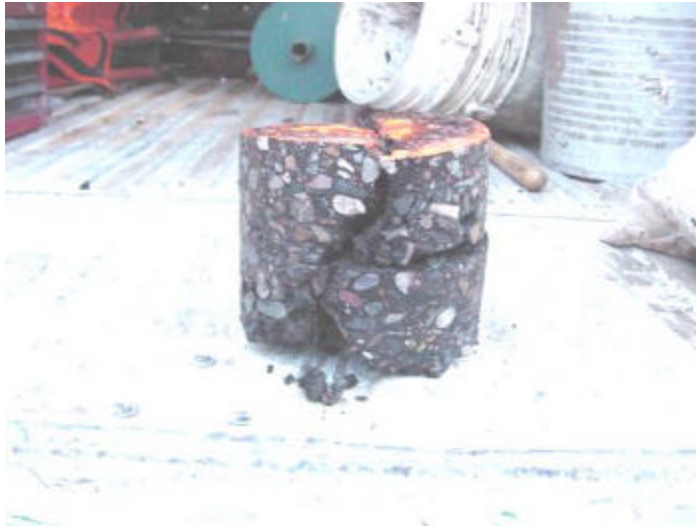
Figure 6. This crack is reflective, as it goes through the entire thickness of the pavement

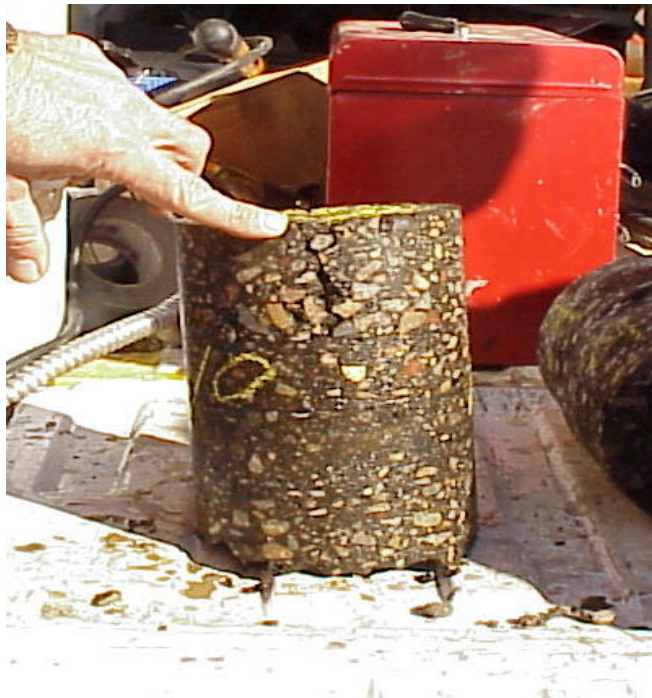
Figure 7. This crack is top-down as you can see it is only visible in the top lift

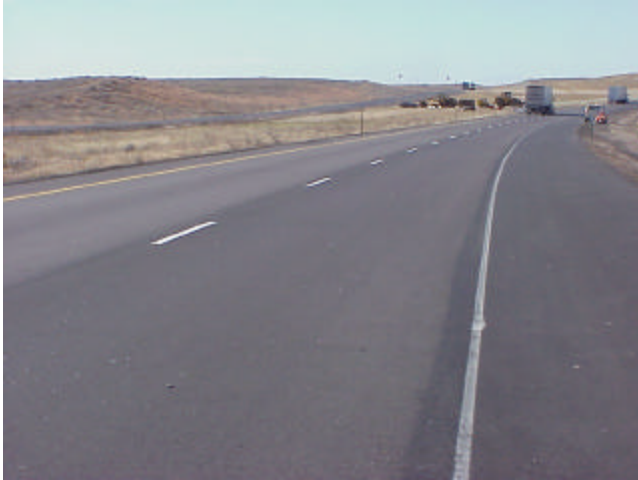
Figure 11. This photograph was taken 4 years after construction. There are two areas where segregation has begun to appear.

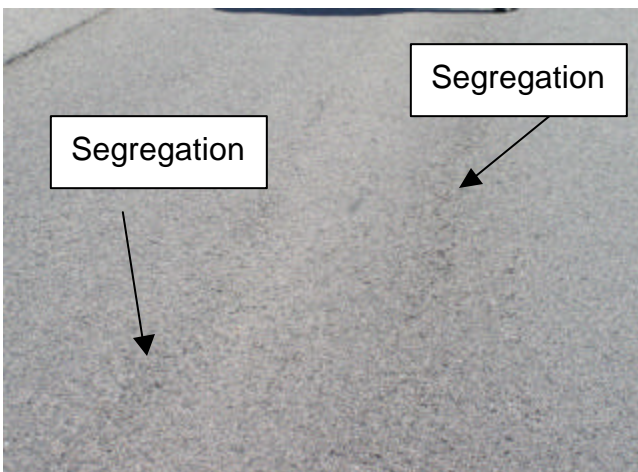
Figure 12. This is a close-up of the segregated area in Figure 11.

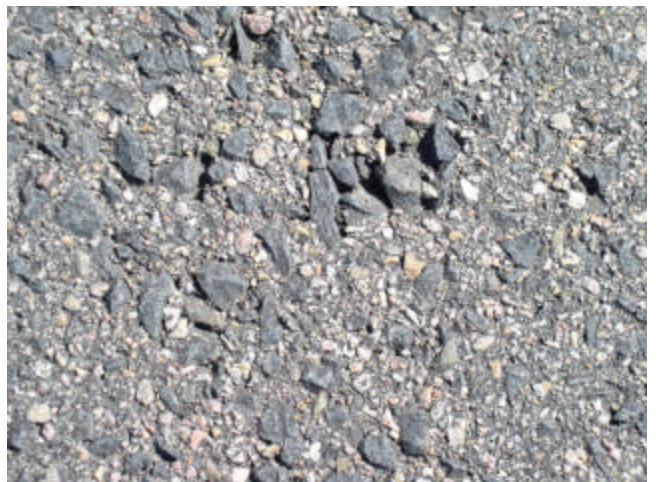
Figure 13. Photograph of core taken over a top-down crack. This crack was only found in the top mat; it was not apparent in the lower mat. Although it is not well defined it does appear that the material around the crack is coarser than the material on either side of the crack.

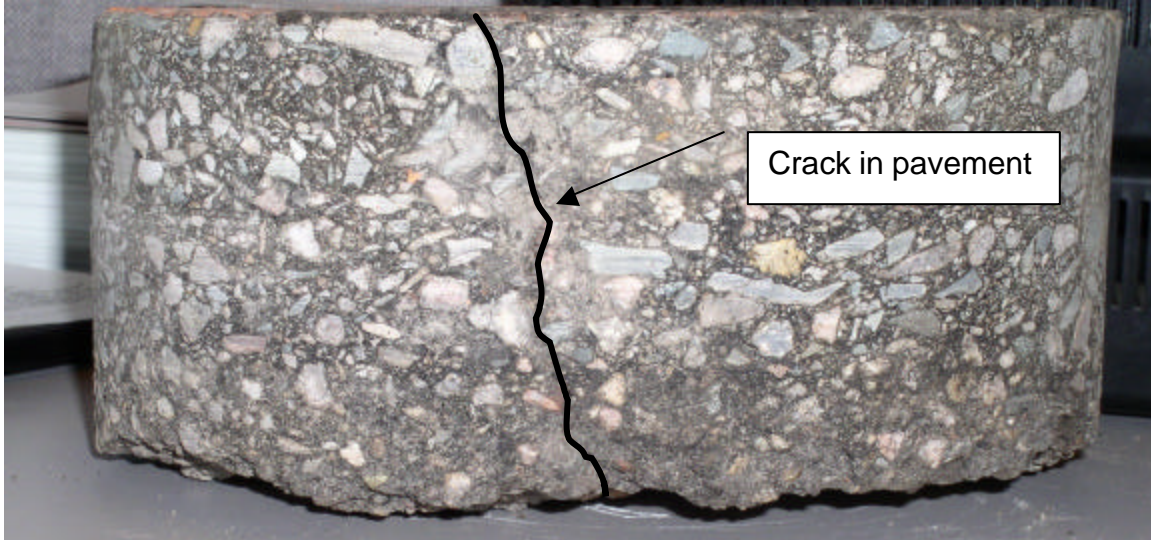
Figure 13 shows a photograph of a core taken from another project that has exhibited top-down cracking. This core was taken centered over the top-down crack. As you can see in the photograph, it is apparent that around the cracked area there are less fines than in the non-cracked area of the core.

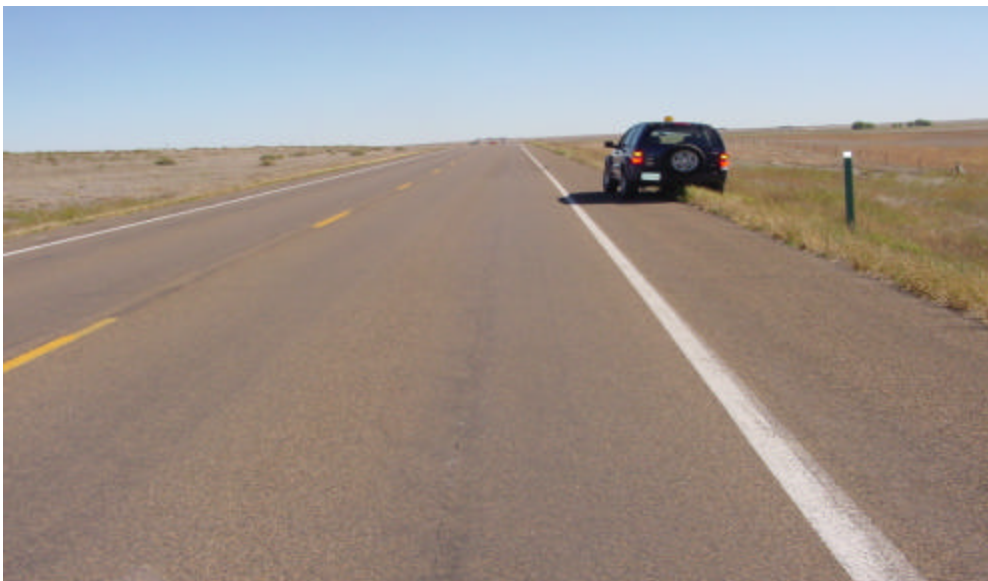
Figure 14. This distress was a reflective crack. Note the linear straightness and low severity of the crack.

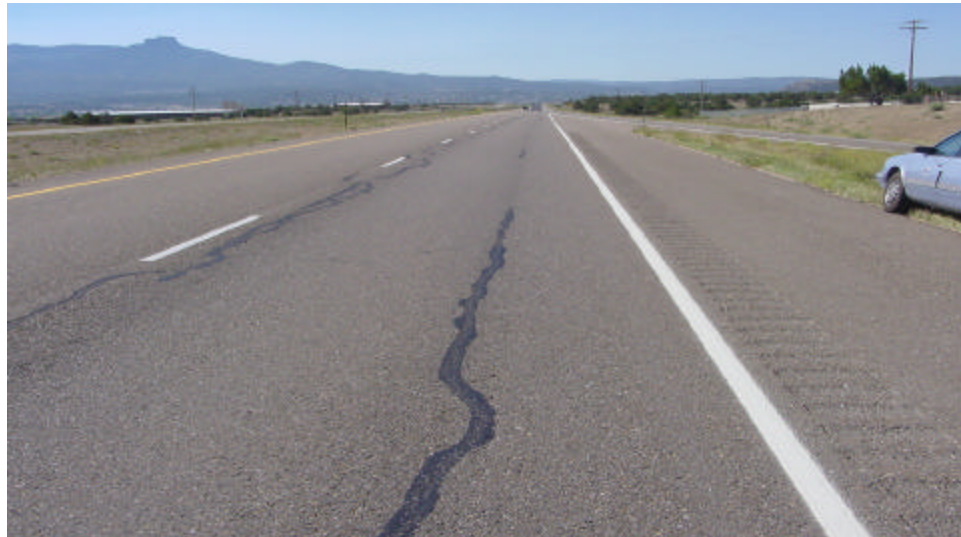
Figure 15. This crack was top-down. Although the crack is straight, the severity was enough to warrant crack sealing.

Since approximately 67% of the top-down cracking cores had visual signs of segregation, it is recommended that the cracks be sealed as soon as possible. If moisture is allowed into the pavement through the cracks the segregated areas

will be prone to rapid deterioration. Sealing the crack will prevent moisture from penetrating the pavement and deteriorating the pavement further.

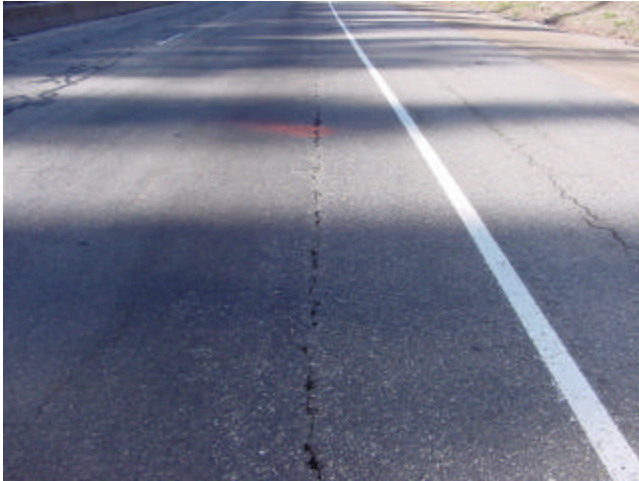
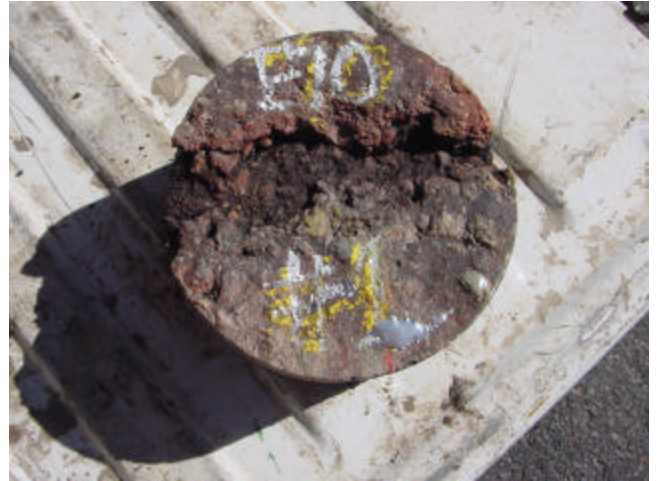
Site 1 (I-70, MP 185.7, Vail Pass)

Top-Down Cracking

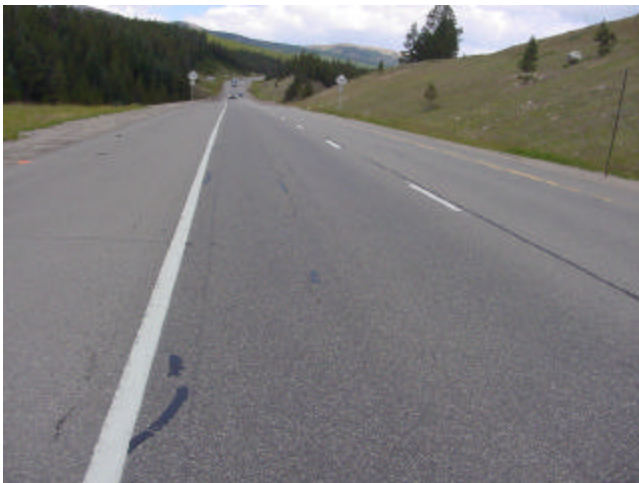
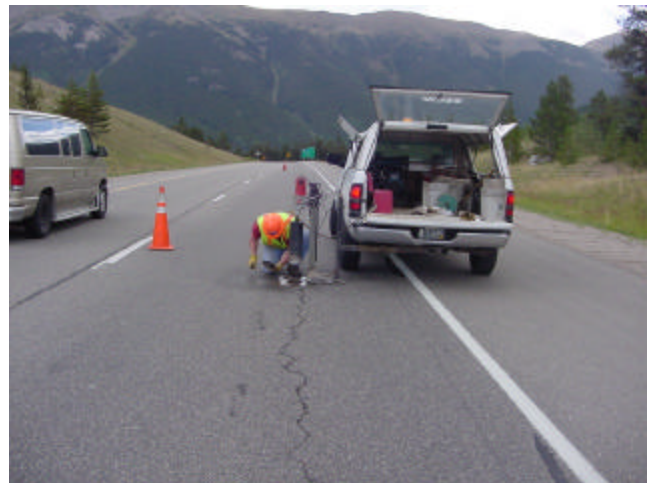
Site 2 (I-70, MP 193.8 – W. of Copper Mtn)

Top-Down Cracking

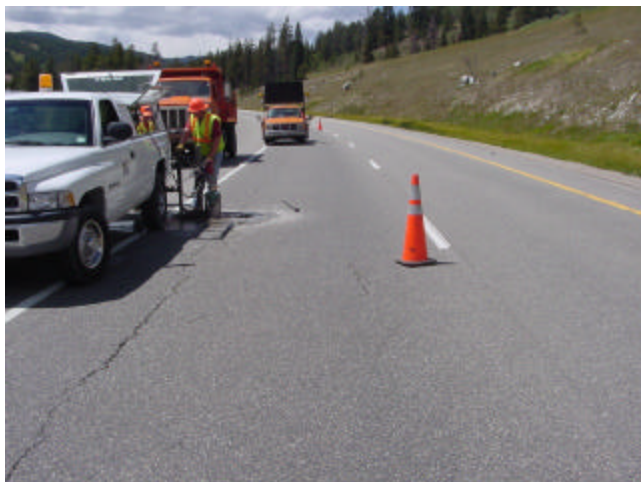
Site 3 (I-70, MP 194.3 W. of Copper Mtn)

Top-Down Cracking

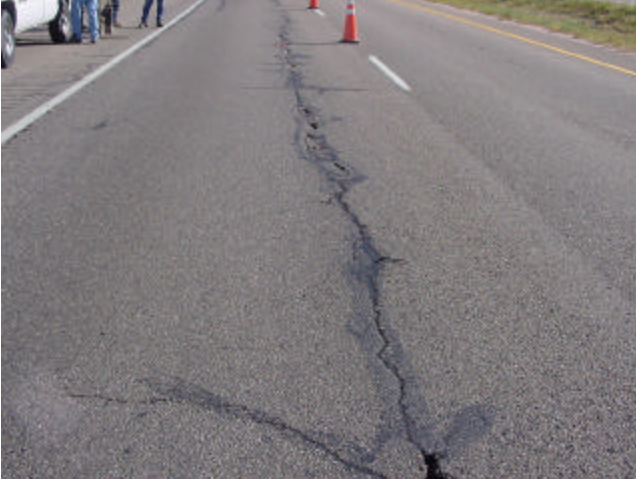
Site 5 (I-25, MP 75.3, Colorado City)

Reflective Cracking

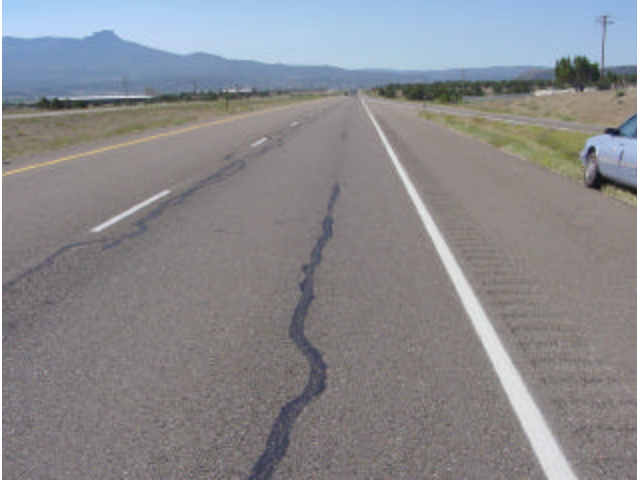
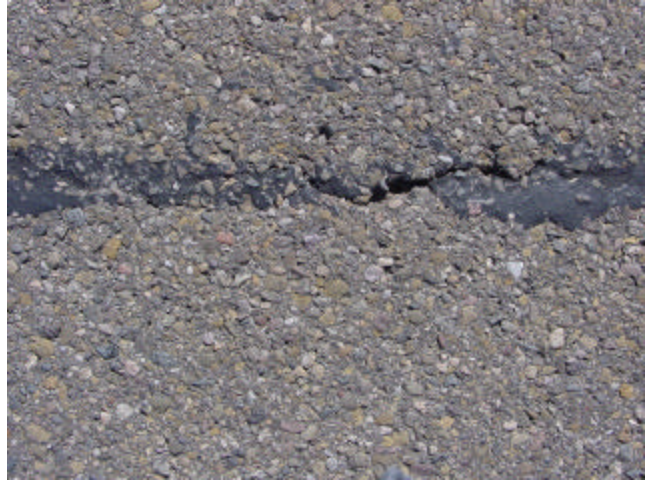
Site 6 (I-25, MP 17.6, N. of Trinidad)

Top-Down Cracking

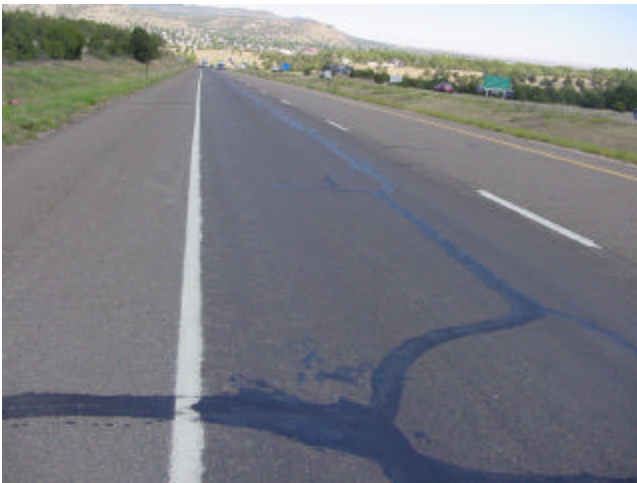
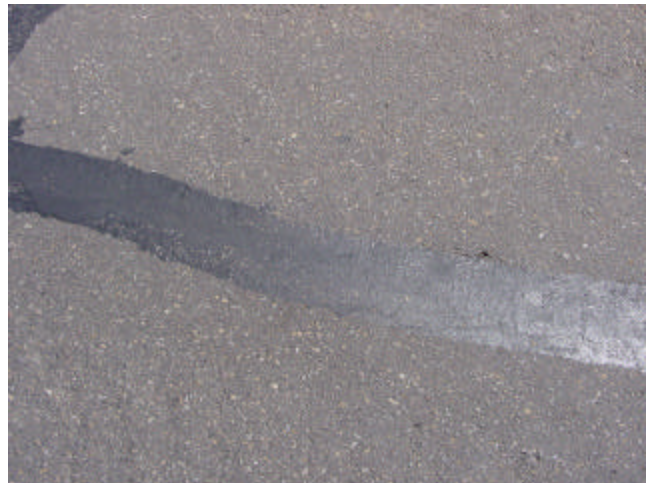
Site 7 (I-25, MP 11.7, S. of Trinidad)

Reflective Cracking

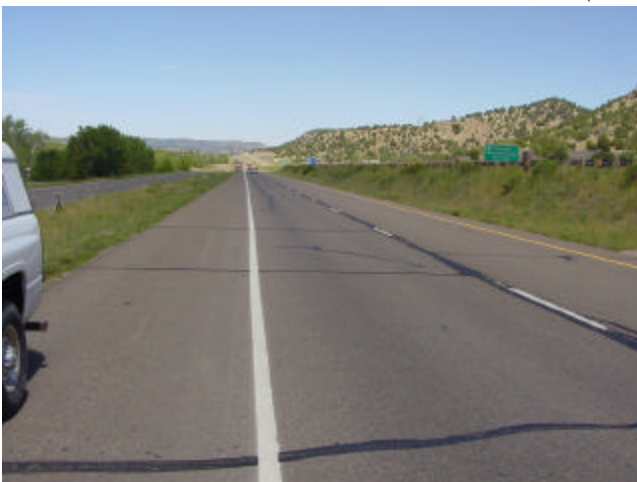
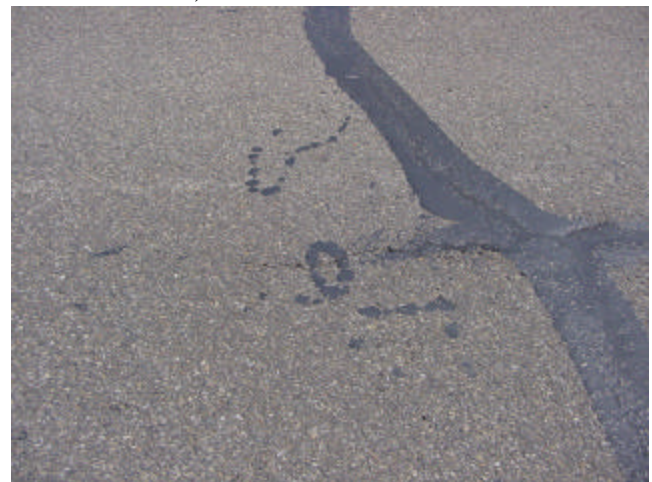
Site 8 (I-25, MP 9.2 Raton Pass)

Reflective Cracking

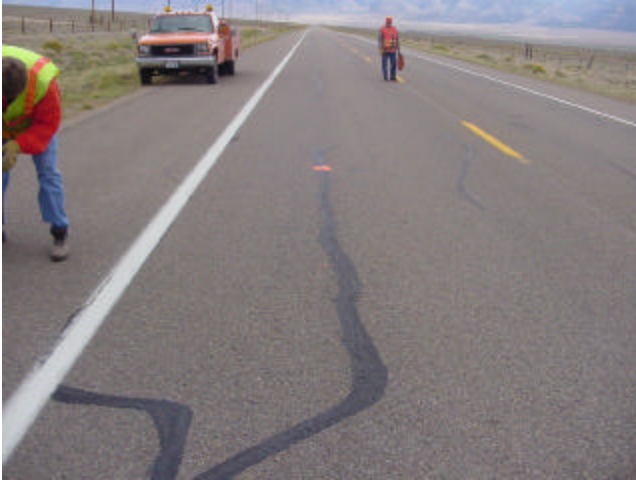
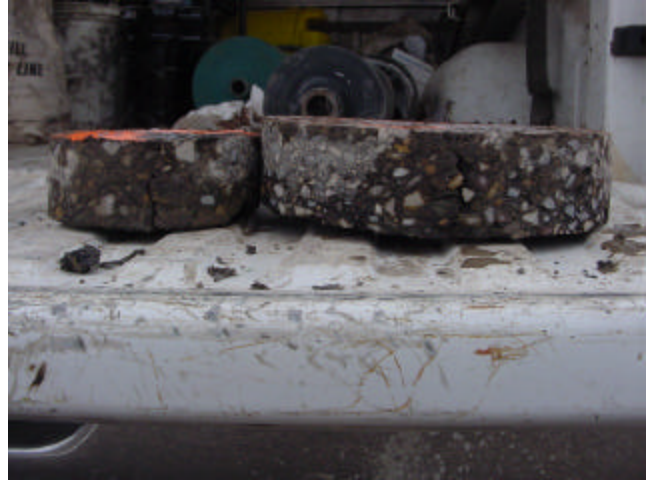
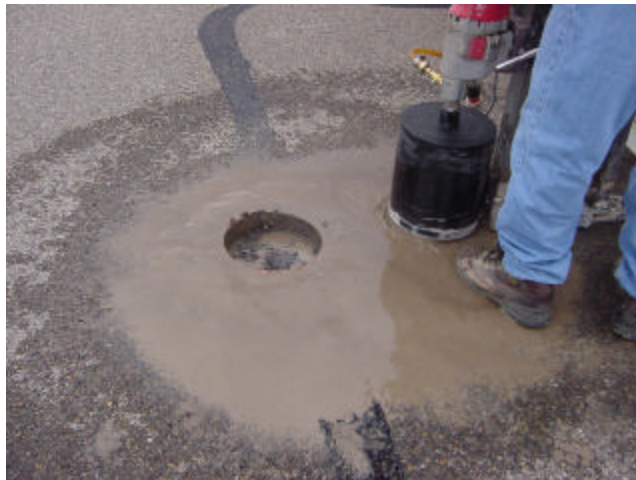
Site 12 (US 285, MP 96.5 – Saquache)

Top-Down Cracking

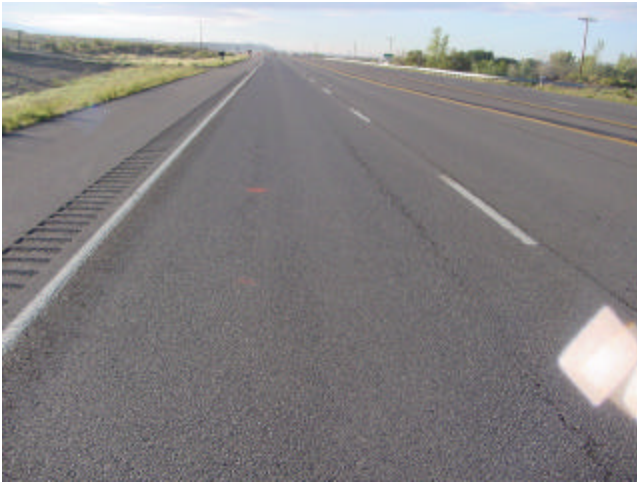
Site 13 (US 50, MP 41.2 – Red Mountain)

Top-Down Cracking

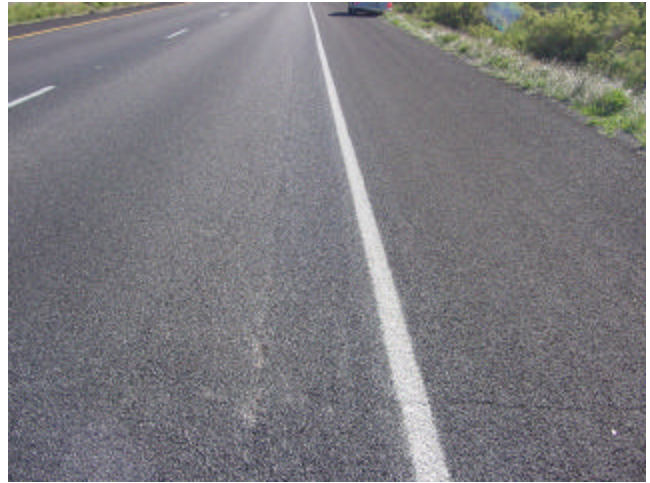
Site 14 (I-70, MP 38.2- Clifton)

Top-Down Cracking

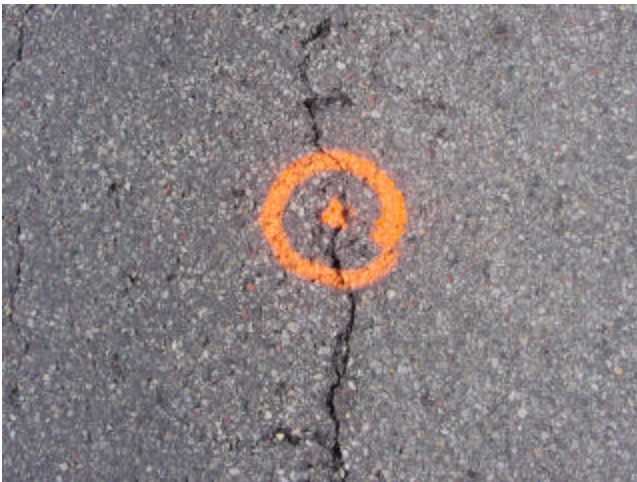
Site 15 (I-70, MP 64.0 – DeBeque)

Top-Down Cracking

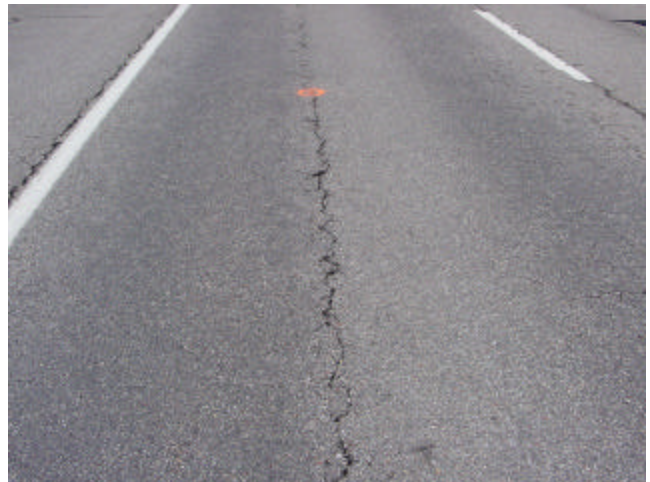
Site 16 (I-70, MP 74.1 – Parachute)

Top-Down Cracking

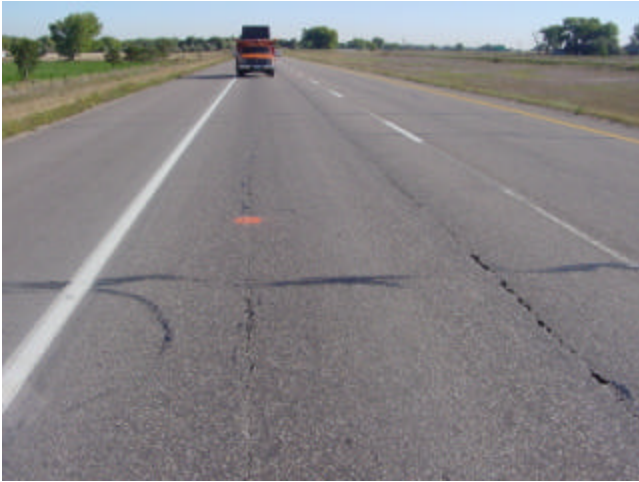
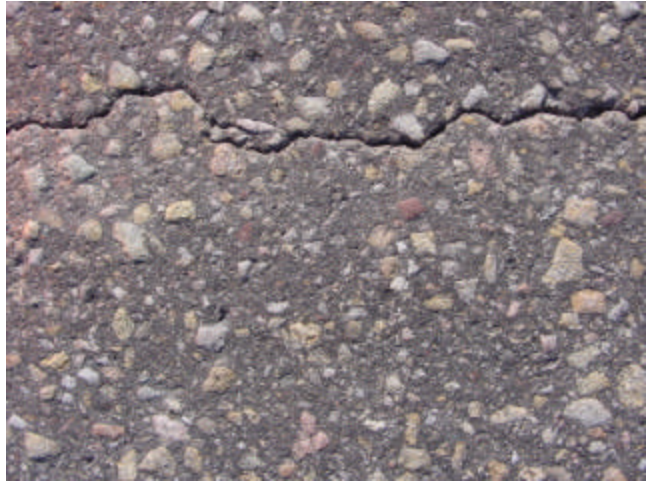
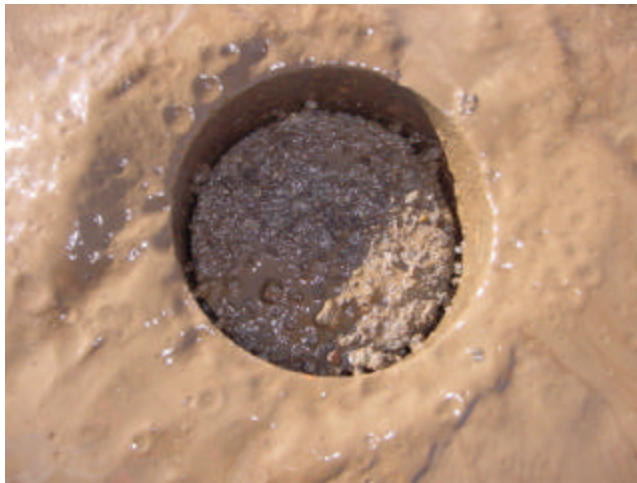
Site 17 (SH 119, MP51.7 – Longmont)

Top-Down Cracking

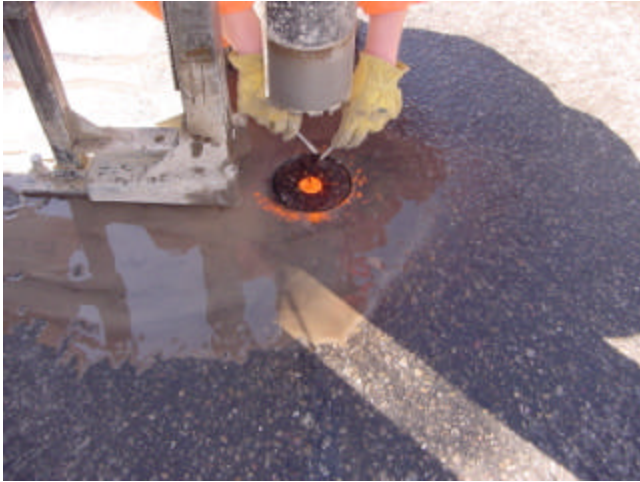
Site 18 (US287, N. of 9th Street, Longmont)

Top-Down Cracking

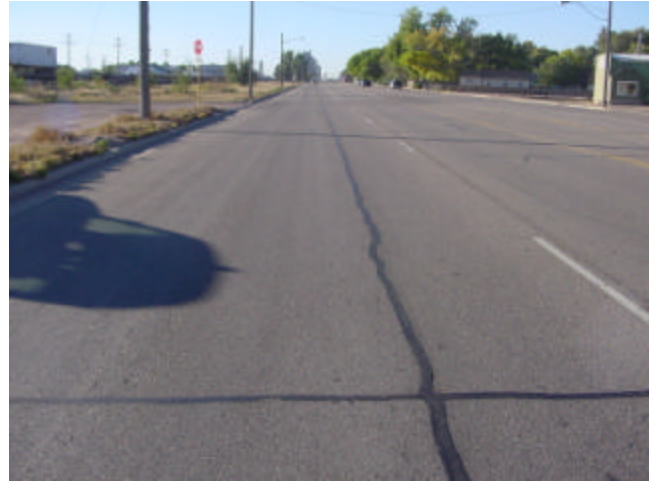
Site 19 (US 85, MP 280.2 – Ault)

Top-Down Cracking

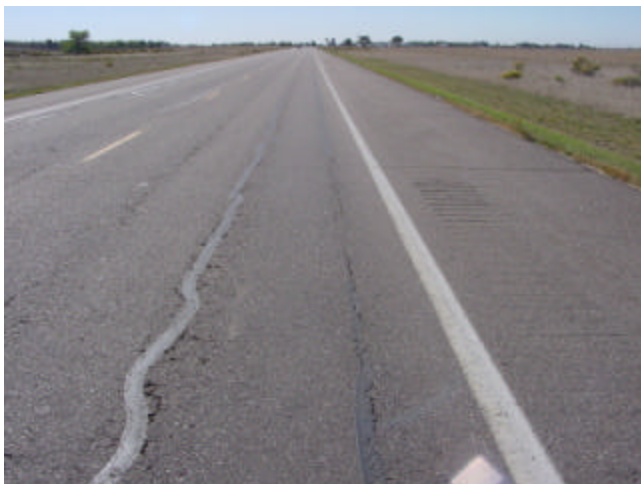
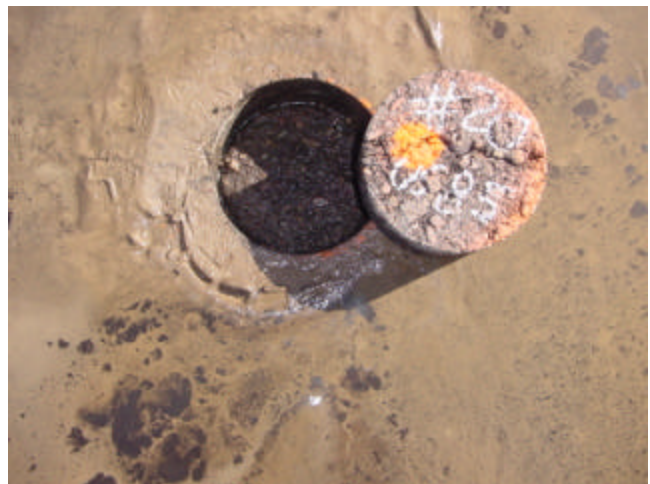
Site 20 (US 85, MP 290.2 – Nunn)

Top-Down Cracking

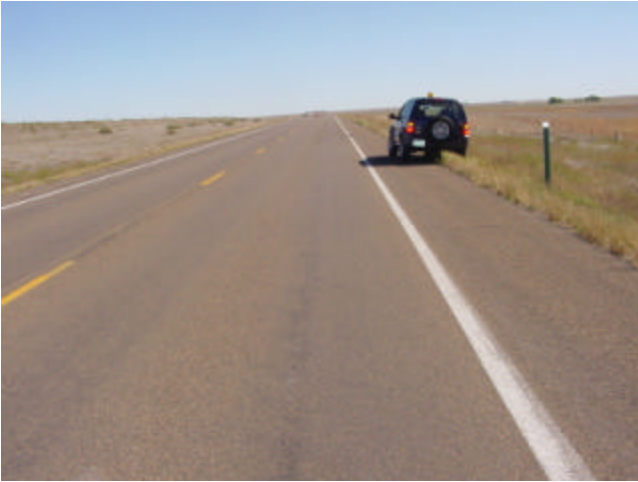
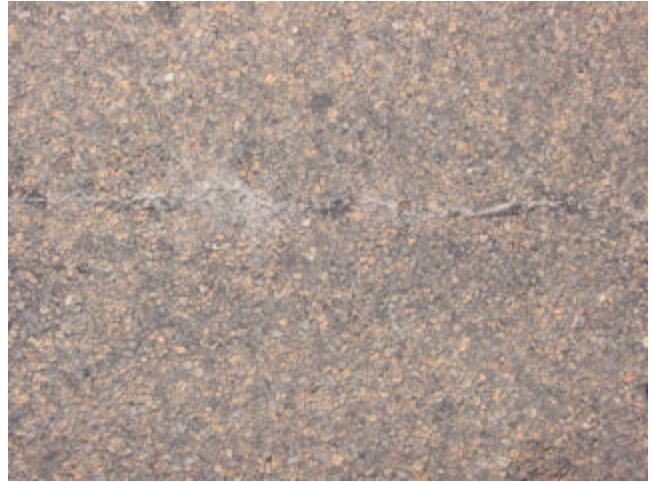
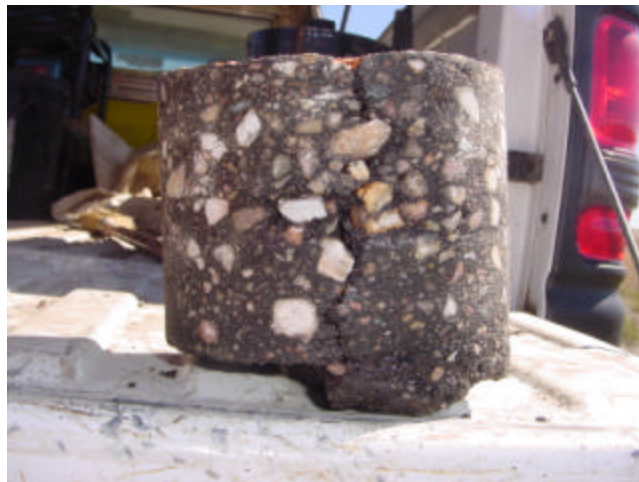
Site 21 (SH114, MP 198.8 – E. of Buckingham)

Reflective Cracking

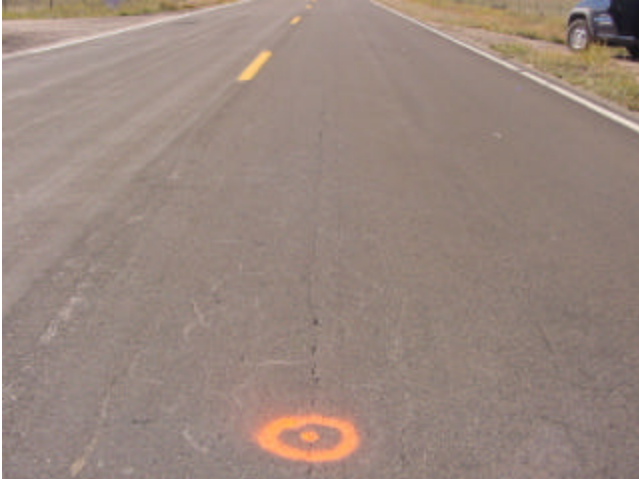
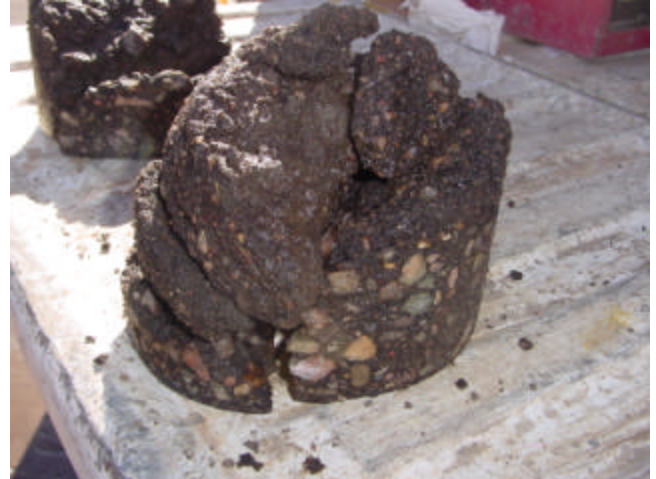
Site 22 (US 385, MP 253.3 – N of Wray)

Reflective Cracking

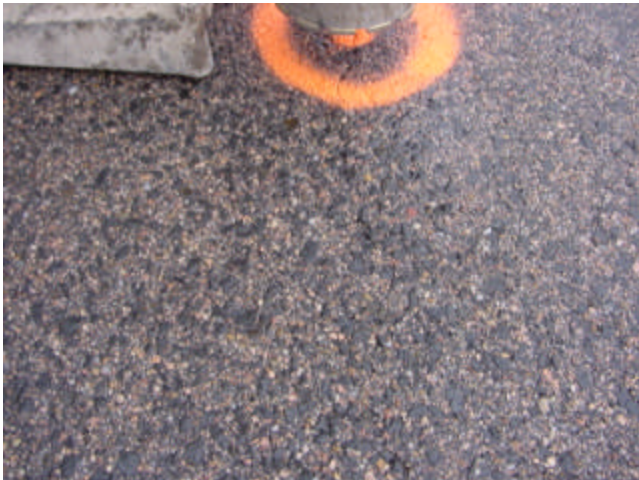
Site 23 (I-76, MP 127.3 – Sterling Rubblization Site)

Top-Down Cracking

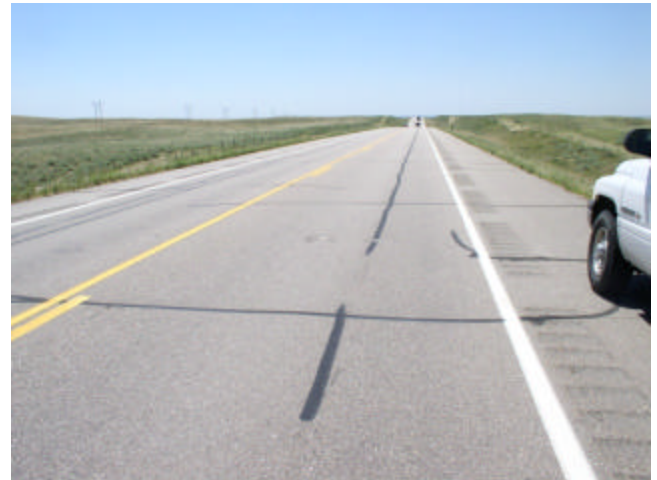
Site 24 (US6, WB, MP 409.2, (Sterling))

Reflective Cracking

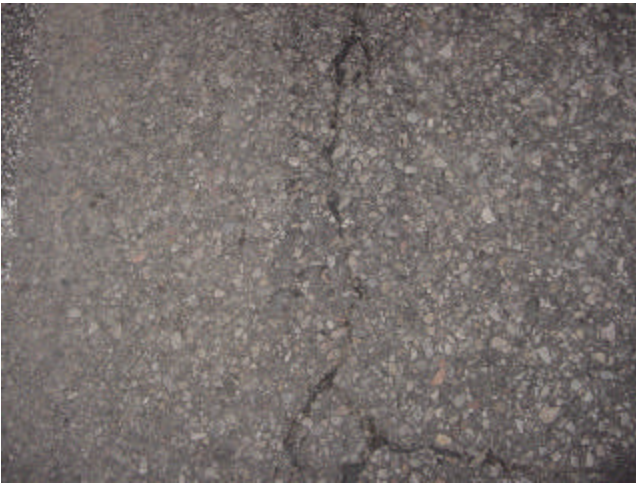
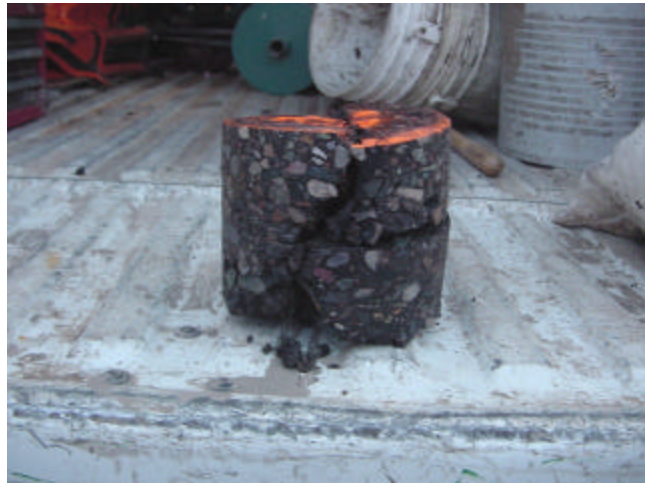
Site 10 (US160, MP87.7, Jct US550 in Durango)

Reflective Cracking

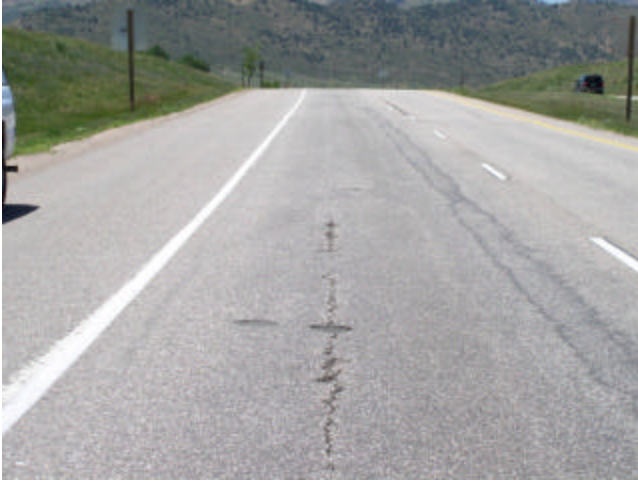
Site 25 (US 285, NB MP 251.3)

Top-Down Cracking

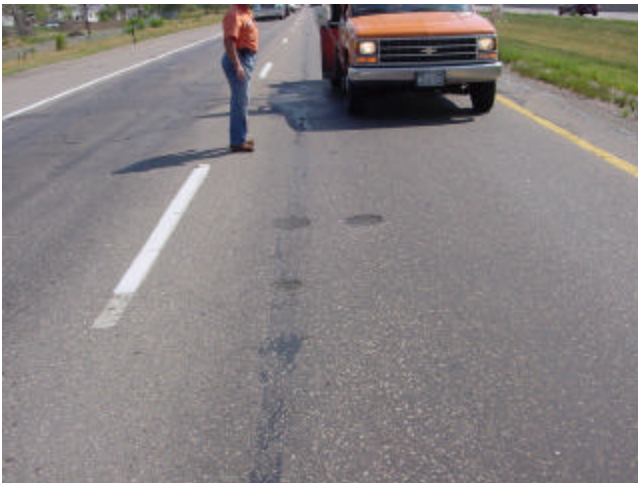
Site 27 (I-76, WB Passing Lane; MP 1.3)

Top-Down Cracking

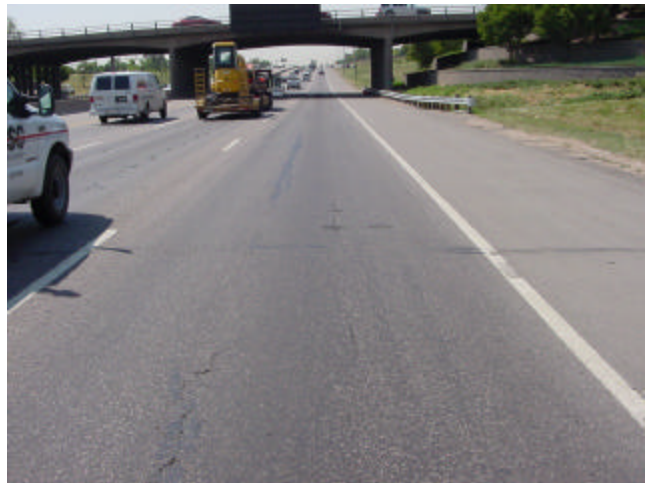
Site 28 (I-25, SB Driving Lane; MP 218.6)

Top-Down Cracking
