Report No. CDOT-DTD-R-2003-5

**CRACK REDUCTION STRATEGIES ON A
PAVEMENT WARRANTY PROJECT
(INTERSTATE 25 AT FOUNTAIN,
COLORADO)**

**March 2003
Final Report**

**COLORADO DEPARTMENT OF TRANSPORTATION
RESEARCH BRANCH**

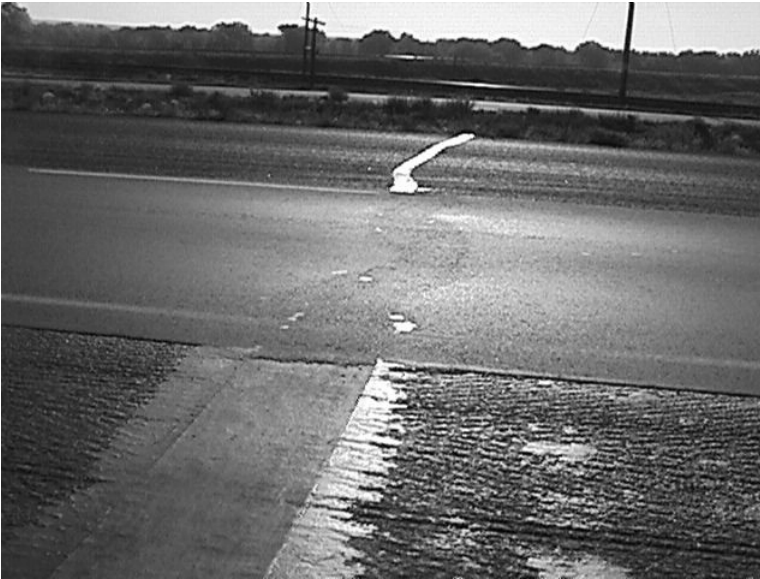
Figure 13 –Typical Petrotac treatment after the trenched section has been overlaid.

Shown in Figure 13 is a typical Petrotac treatment after the trenched section had been overlaid. The picture shows some of the excess tack material bleeding through the 1-1/2 inch overlay. The excessive tack was not apparent once the final lift was placed. Subsequent tack coat applications were reduced to ensure that the tack did not bleed through the mat and also to eliminate the shoving of the Petrotac fabric.

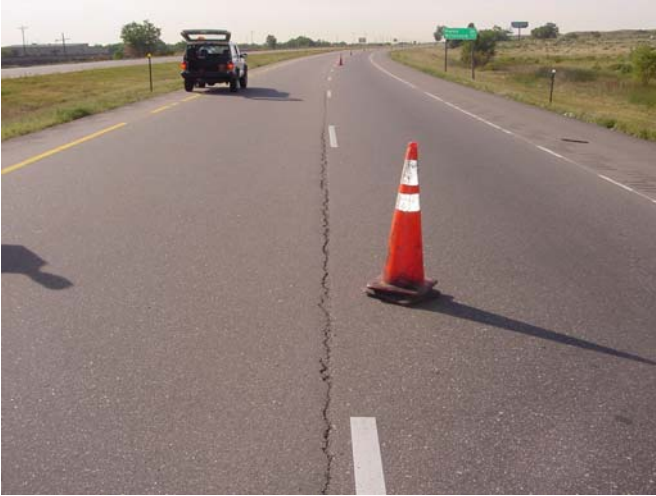
There was, however, an inordinate amount of longitudinal construction joint failure throughout the project, as validated by the Pavement Evaluation Panel (PET) after the end of the warranty period (3 years). The Principal Investigator of this report was present at the evaluation, and the series of photographs (Figures 14, 15, 16, 17, 18, 19, 20, 21, 22, and 23) will demonstrate this failure mode.

Figure 14 – Longitudinal construction joint failure at end of warranty period. Longitudinal crack is evident throughout most of the project.

The recommendation of the PET led to a corrective project, consisting of milling approximately a one-foot-wide section along the construction joint and patching the milled area. Although such remedial action will prolong the life of this project for some time, the remedial action resulted in the replacement of one open joint with two well-sealed joints, which could ultimately exacerbate the problem (Figure 24).

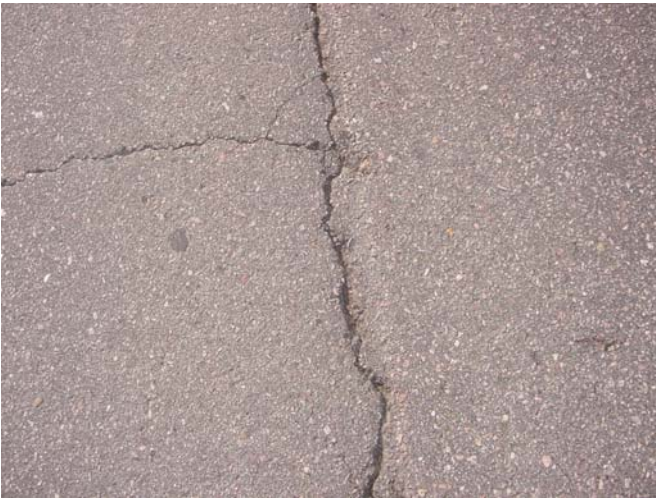
Figure 15 - Close-up view of a fairly open construction joint crack.

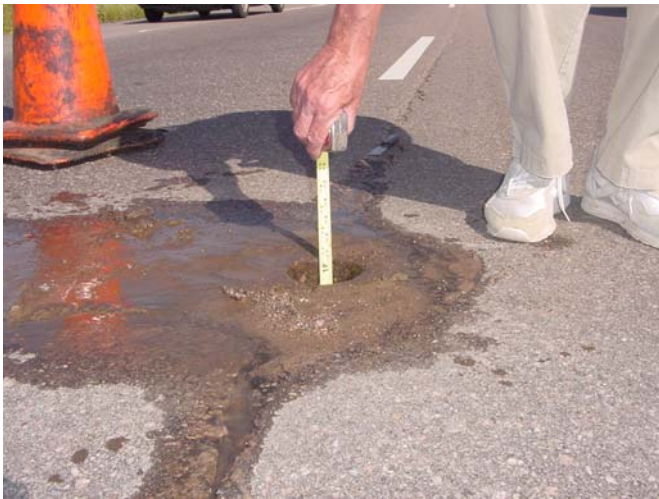
Figure 17 - Full-depth (11inch) pavement with exploratory core sample removed. Stripped aggregate material can be seen adjacent to the core hole.

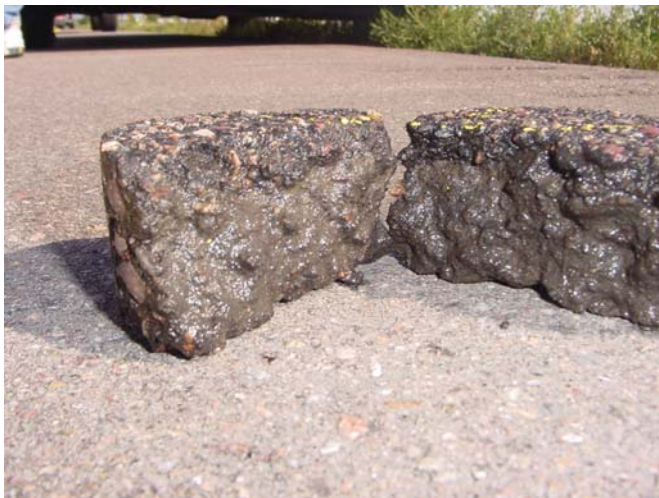
Figure 18 - Lack of AC as result of stripping at the construction joint.

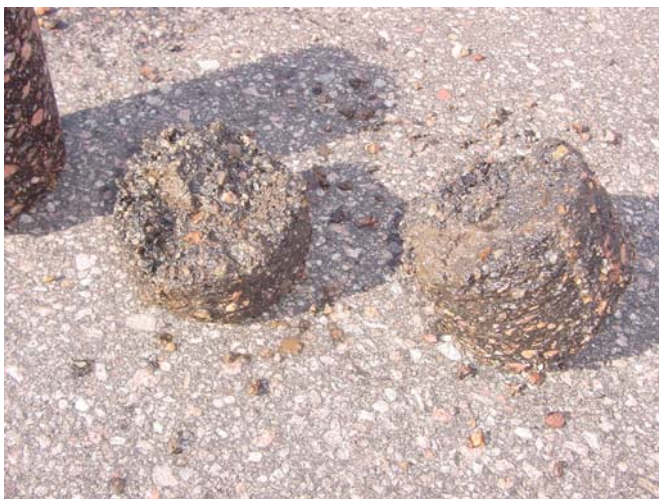
Figure 19 - Fragmented and badly stripped cores .

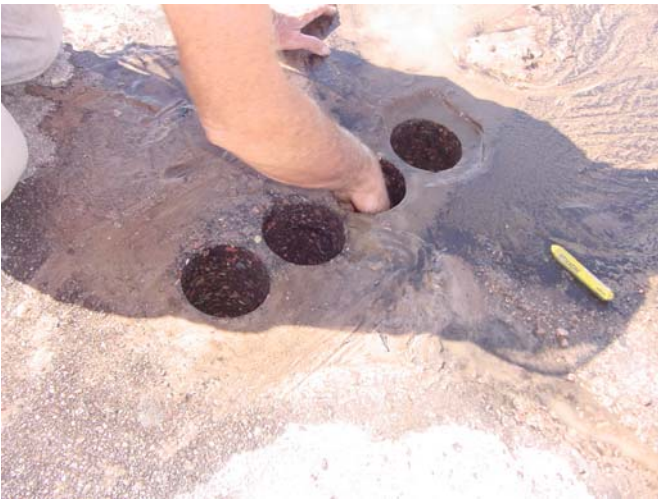
Figure 20 - In order to determine the lateral extent of stripping, additional cores were obtained at six-inch intervals transversely to the construction joint.

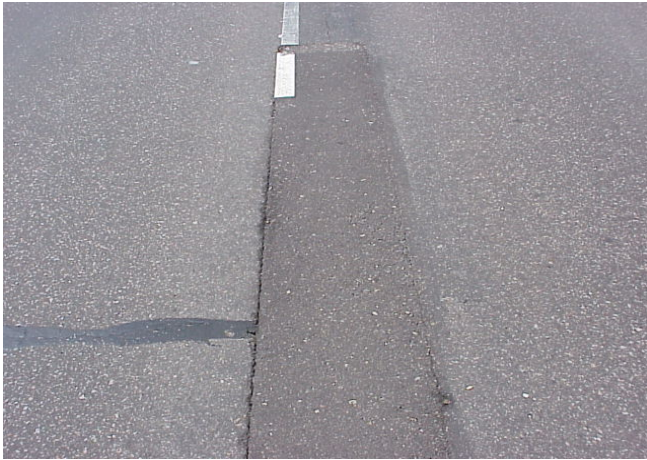
Figure 24 – This photo shows the initial longitudinal joint crack on the left. Then the contractor milled and filled one foot to the right of the crack. Eventually this pavement cracked on the edge of the 1-foot mill and fill, creating 2 cracks.
