**Report No. CDOT-DTD-R-2006-2
Final Report**

**FLOWFILL AND MSE BRIDGE APPROACHES:
PERFORMANCE, COST, AND RECOMMENDATIONS
FOR IMPROVEMENTS**

February 2006

**COLORADO DEPARTMENT OF TRANSPORTATION RESEARCH
BRANCH**

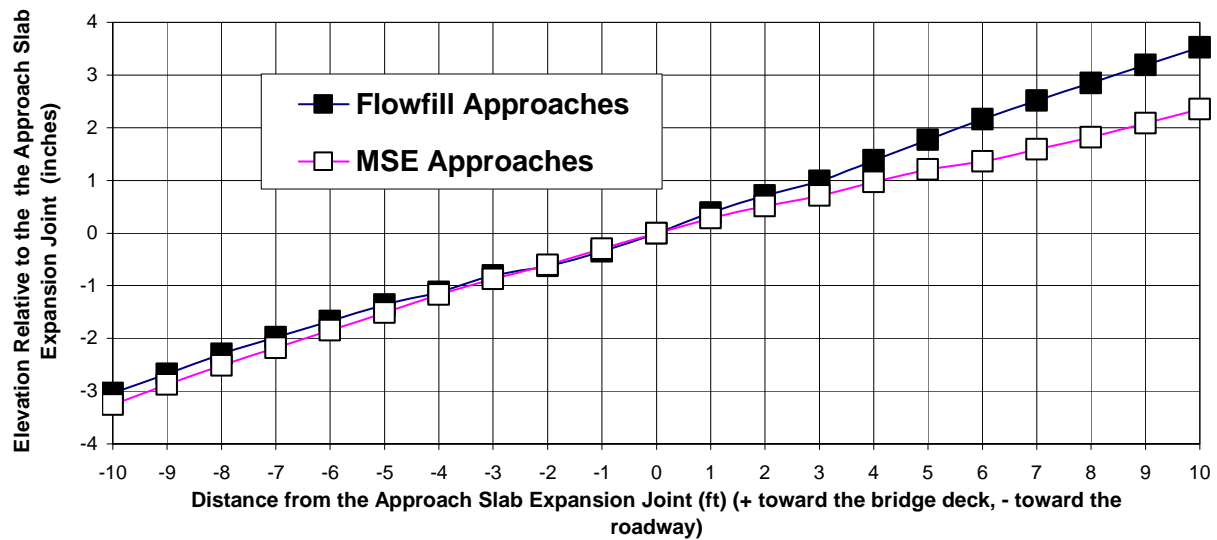
The visual observations and the results shown in Figure 4.1 suggest that the transition between the bridge and approaching roadway after almost two years in service is smooth and shows no signs of developing a bridge bump problem. Thus, we can conclude that the two systems of abutment backfill are performing well so far with comparable performance.

Figure 4.1. Measured Elevation Profiles for Structure C-15-U Where Side by Side Flowfill and MSE Approaches Were Constructed.

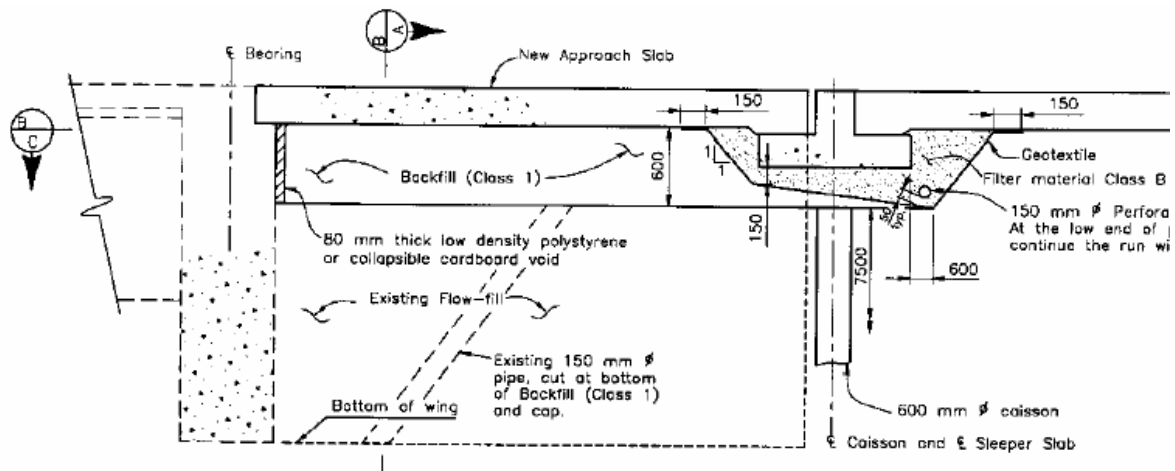
Figure 4.2. Use of Caissons in the Repair of the Bridge Approach Settlement Problem at Structure E-17-PQ.

In the 58th avenue bridge over I-25 bridge (constructed without the use of MSE or flowfill approaches), drilled shafts were employed to support the sleeper slab and repair the approaches. This bridge was inspected on October 23, 2003 and found to function well.

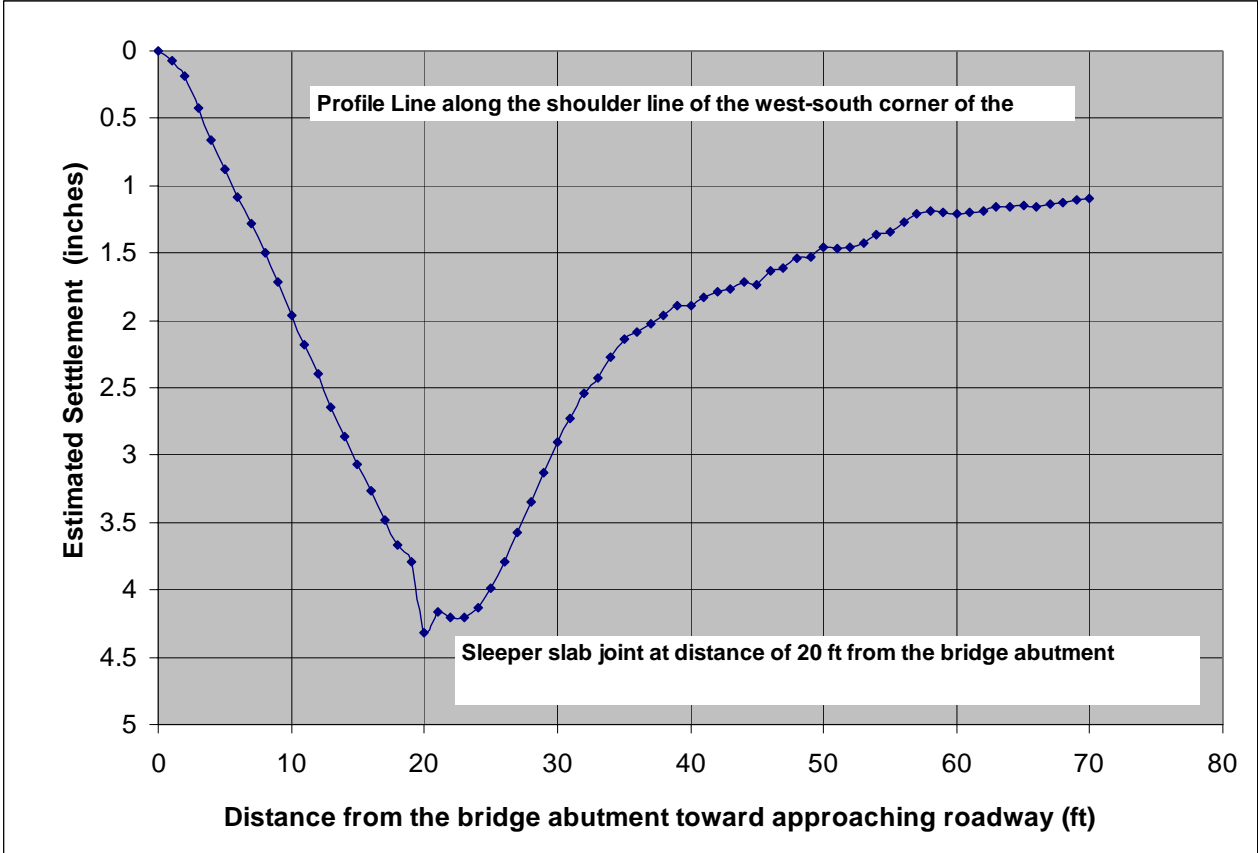
Figure 5.4. A Settlement Profile of the Bridge Approach along the Shoulder Line of the SW Corner of the Salt Creek Bridge Approaches.

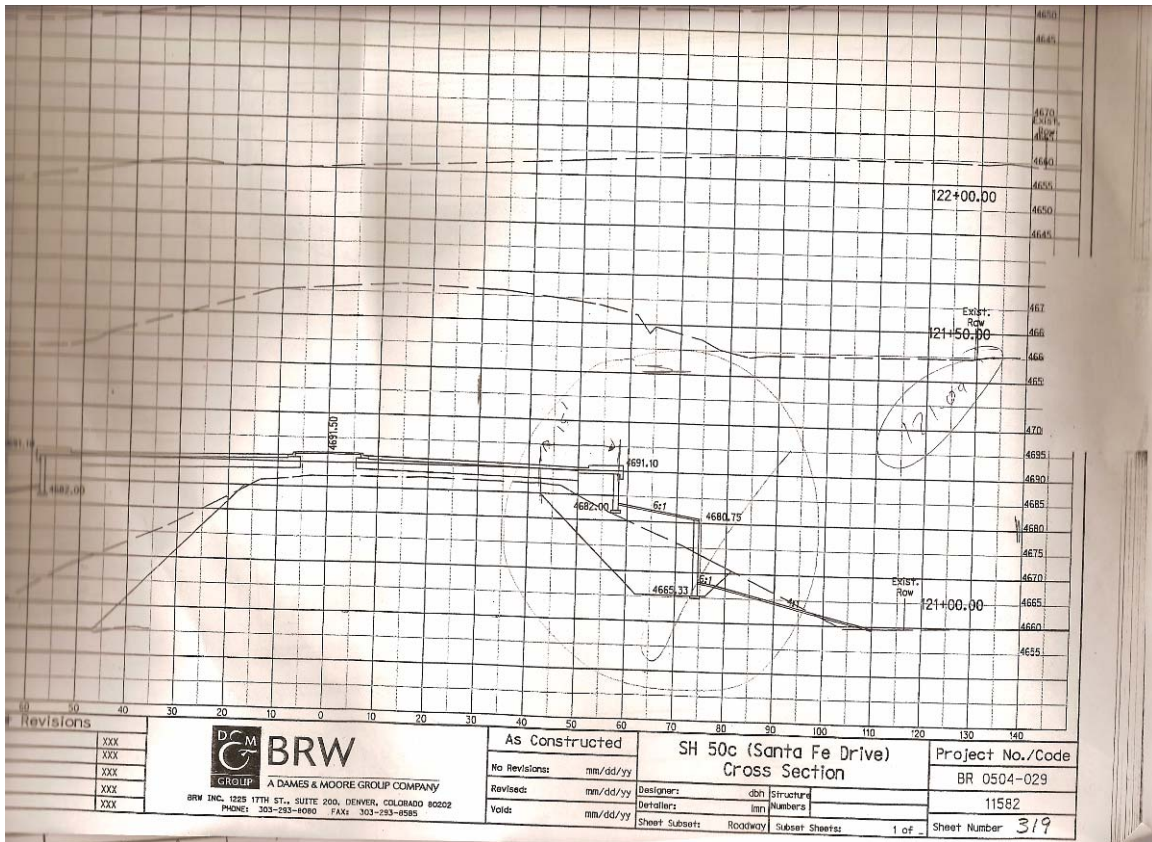
Figure 5.5. Elevation Profiles across the SW Corners of the Old (dashed line) and New (solid line) Bridge Approaches of the Salt Creek Bridge.

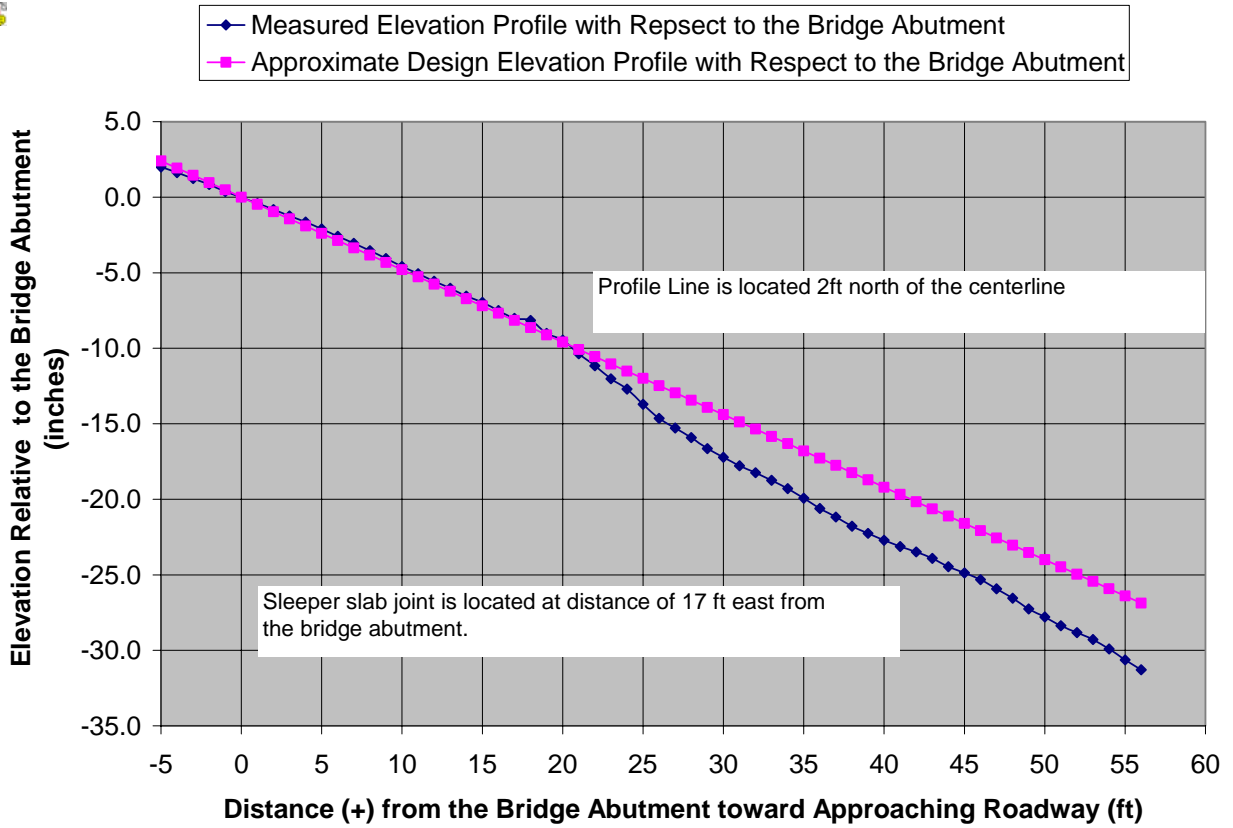
Figure 5.12. Elevation Profiles of the Eastern Approaches to the I-70/I-225 Structure.

To avoid the problems presented above in the future, it is important that the designer ensures uniform or gradual change in the stiffness of the foundation systems supporting the approach roadways, both parallel and across the roadway. Also, high quality granular soil material should be placed beneath the sleeper slab and adequate drainage measures should be placed in that zone to collect and drain any excess water before it reaches and softens the underlying silty or clayey soil layers.

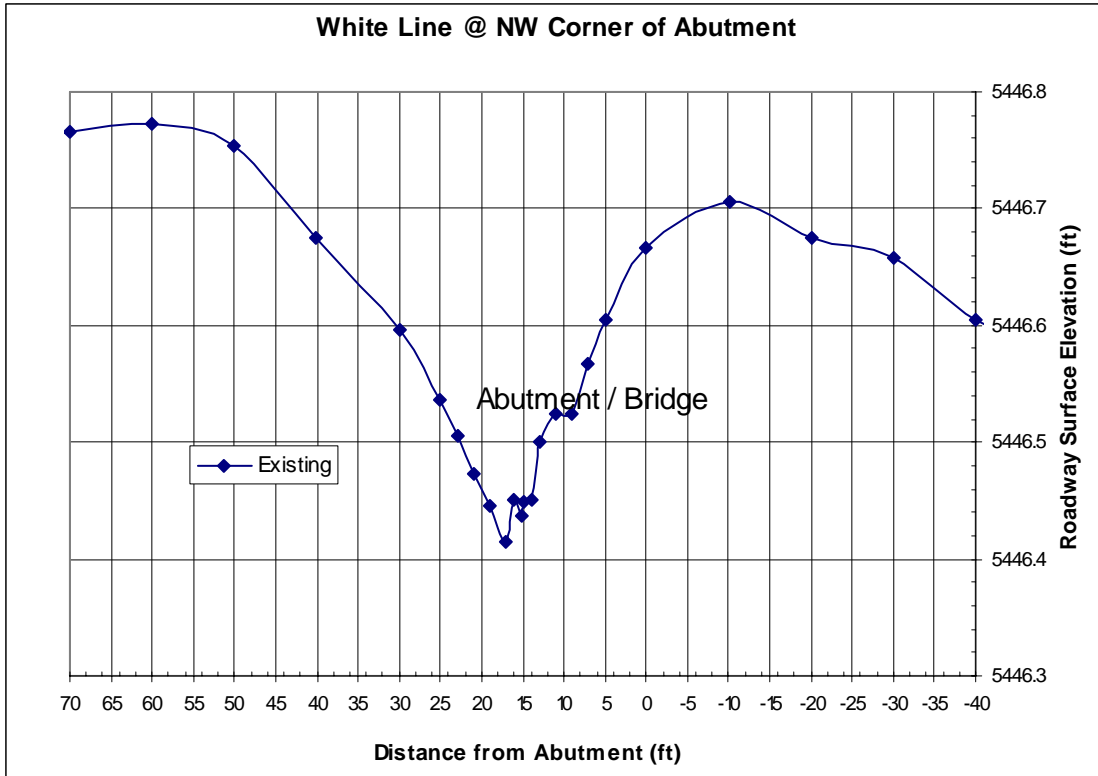
Figure 5.17. Elevation Profile of the Approaches of Structure E-19-Z Before It Was Repaired.

Based on the field test results, Alan Hotchkiss (2004) recommended the use of high pressure compaction grouting for this situation. Later in 2004, the bridge approaches were fixed with the compaction grouting. It is recommended that the long term performance of compaction grouting be monitored.

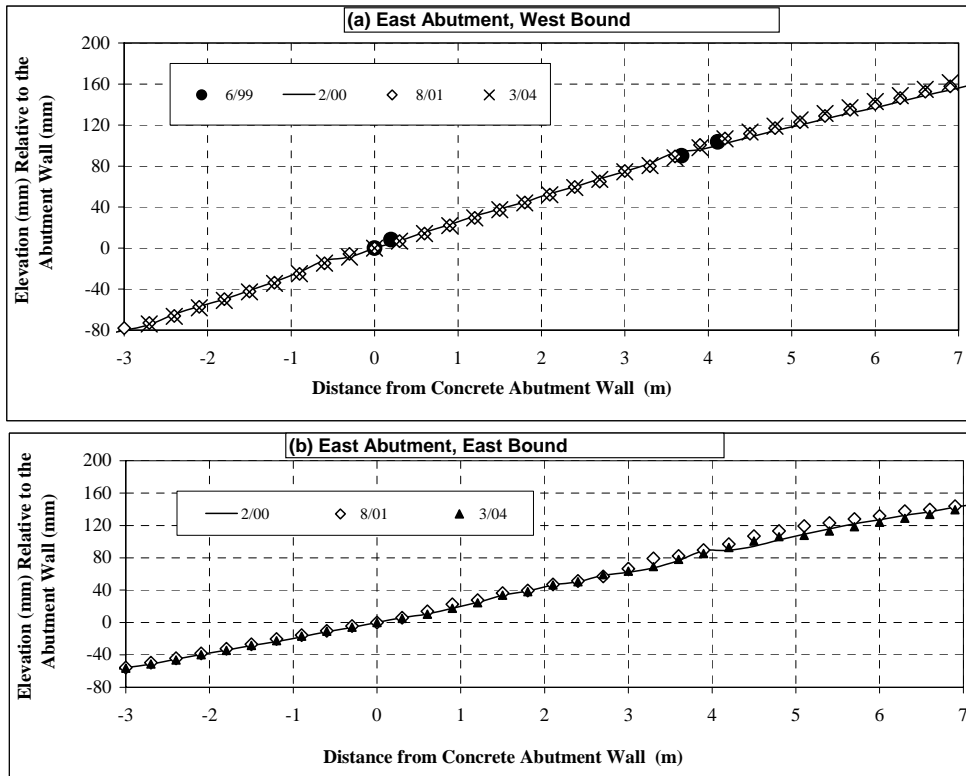
The results shown in Figures 6.4 and 6.5 indicate that the transition between the bridge and approaching roadway after five years in service is smooth and shows no signs of developing differential settlements between the bridge abutment and the approaching roadway (i.e. “bump at the bridge” problem). *The elevation profiles collected at different times essentially match each other, suggesting that settlements of the bridge superstructure and approaching roadway have been uniform.* That is, no evidence of differential settlement has been observed between the bridge superstructure and approaching roadway. *Thus, it could be concluded that the overall short- and long-term performance of the approaches of the Founders/Meadows structure is excellent because there is no evidence of the “bump at the bridge” problem after five years in service and even with no signs of structural distress to the approach slab and the bridge expansion device.*

Figure 6.4: Measured Elevation Profiles Relative to the Bridge Abutment for Two Lines over the East Abutment along the Traffic Direction (Note: Distance from bridge abutment is + towards the approach slab and is - towards the bridge deck).

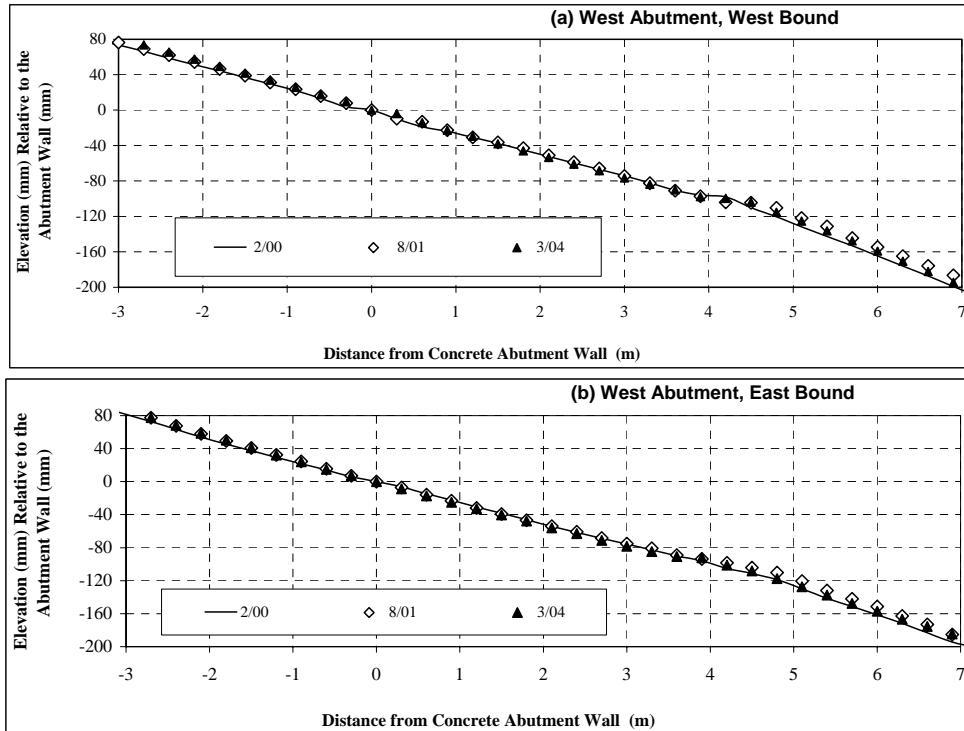
Figure 6.5: Measured Elevation Profiles Relative to the Bridge Abutment for Two Lines over the West Abutment along the Traffic Direction (Note: Distance from bridge abutment is + towards the approach slab and is - towards the bridge deck).

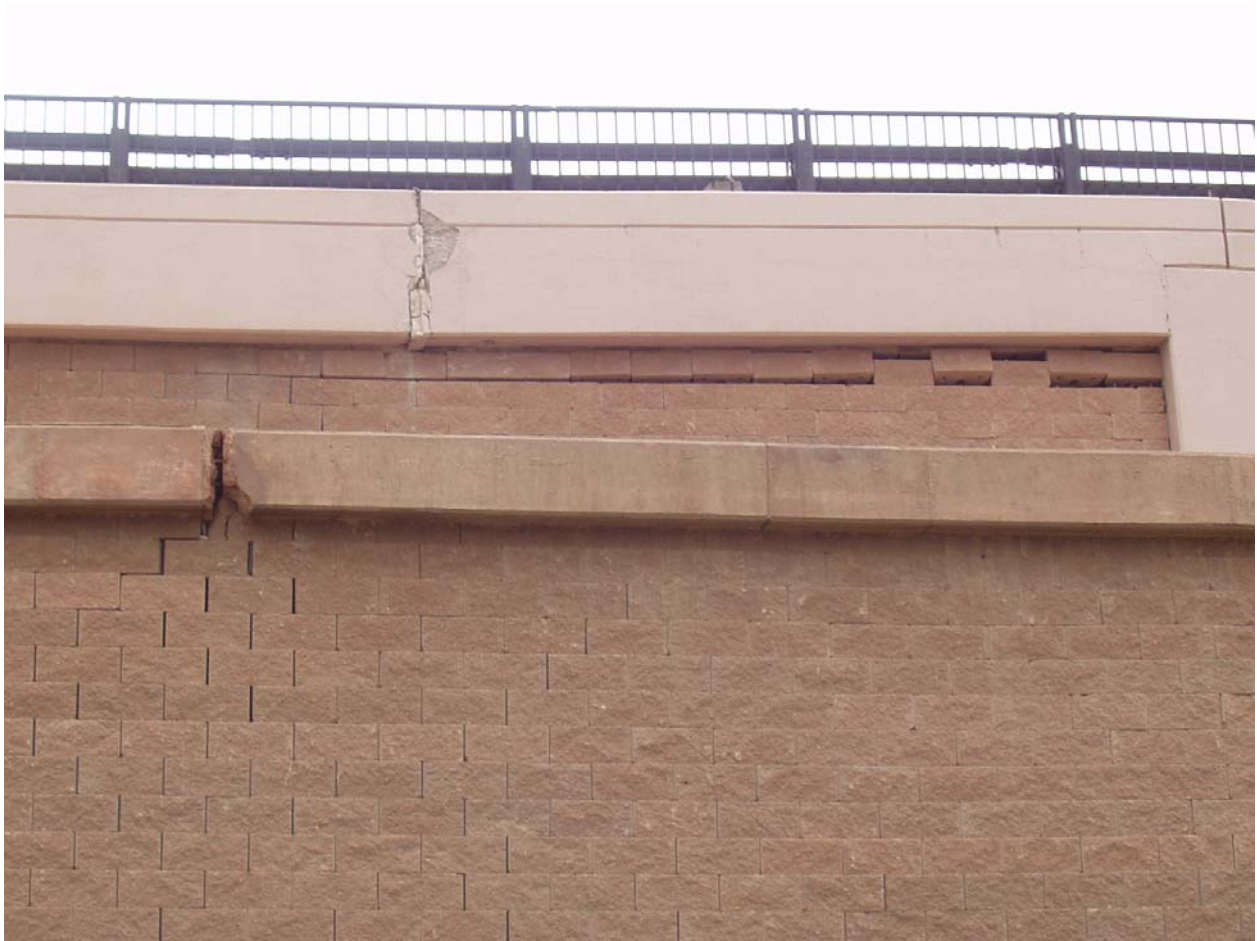
Figure C.1. A View from the South West Corner of the Salt Creek Bridge (Structure L-21-DB, Region 2)

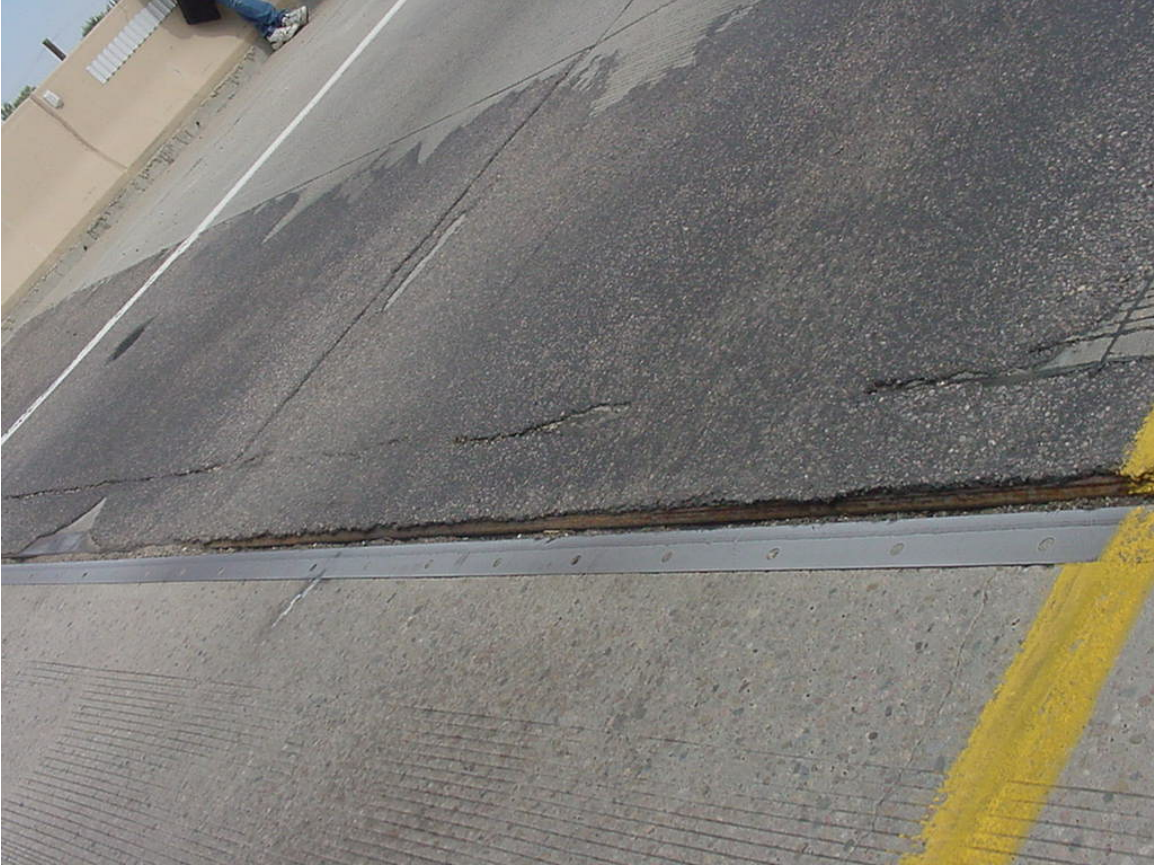
Figure C.2. The Eastern Side of the Roadway Approaches of the I-70/I-225 Interchange (Structure E-17-SW in Region 6).

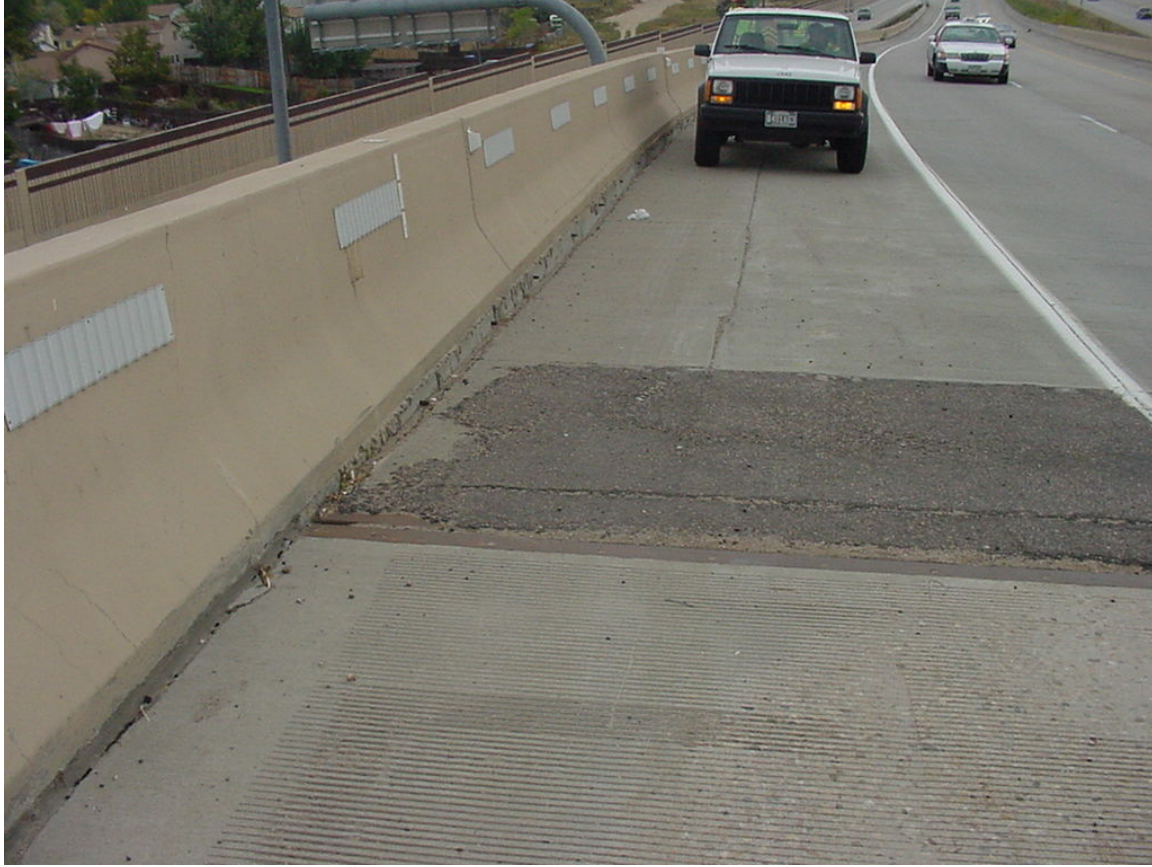
Figure C.3. Northern-Eastern Side of the Roadway Approaches of the I-70/I-225 Interchange (Structure E-17-SW in Region 6).

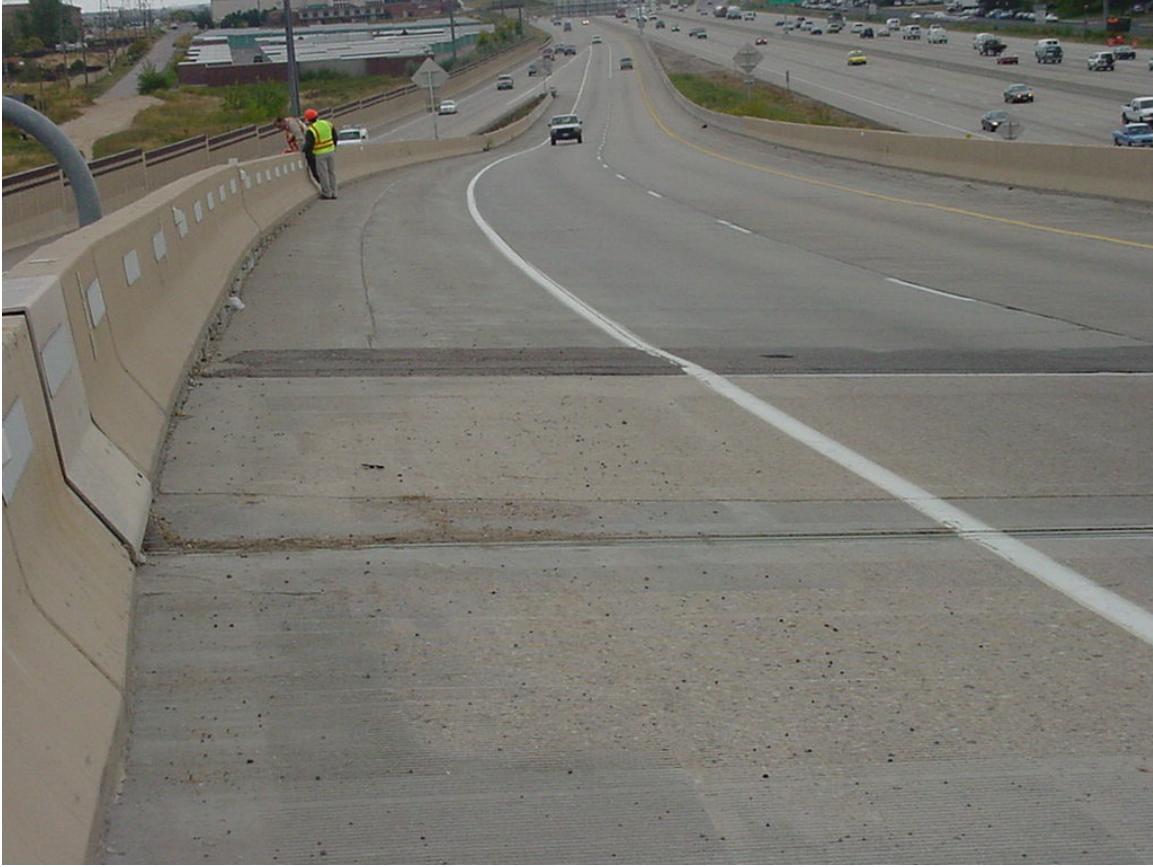
Figure C.4. The Eastern Side of the Bridge and Roadway Approaches of the I70/I-225 Interchange (Structure E-17-SW in Region 6).

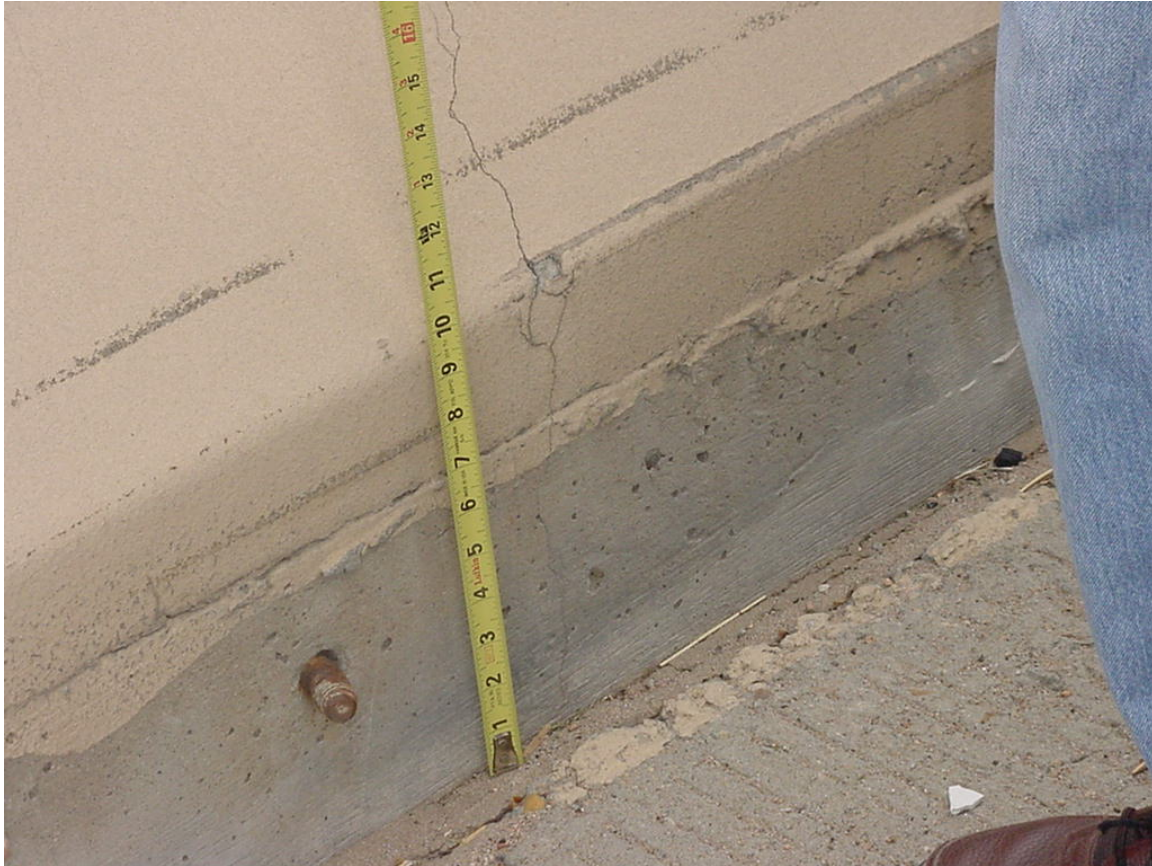
**Figure C.5. A Settlement of 6” Between the Roadway and the Bridge Concrete Rail:
North-East Side of Structure E-17-SW in Region 6.**

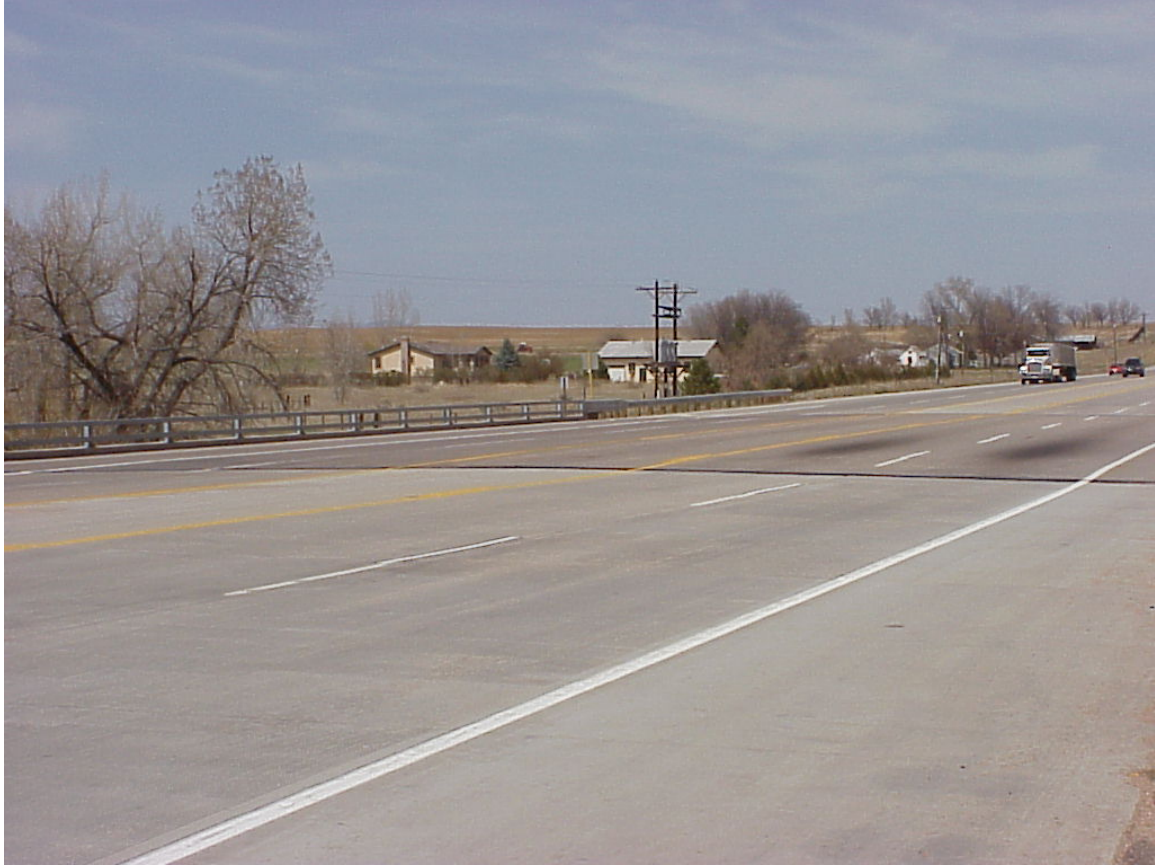
Figure C.6. A view from Structure C-16-DK in Region 4 located along SH 287, 4 Miles North of Longmont

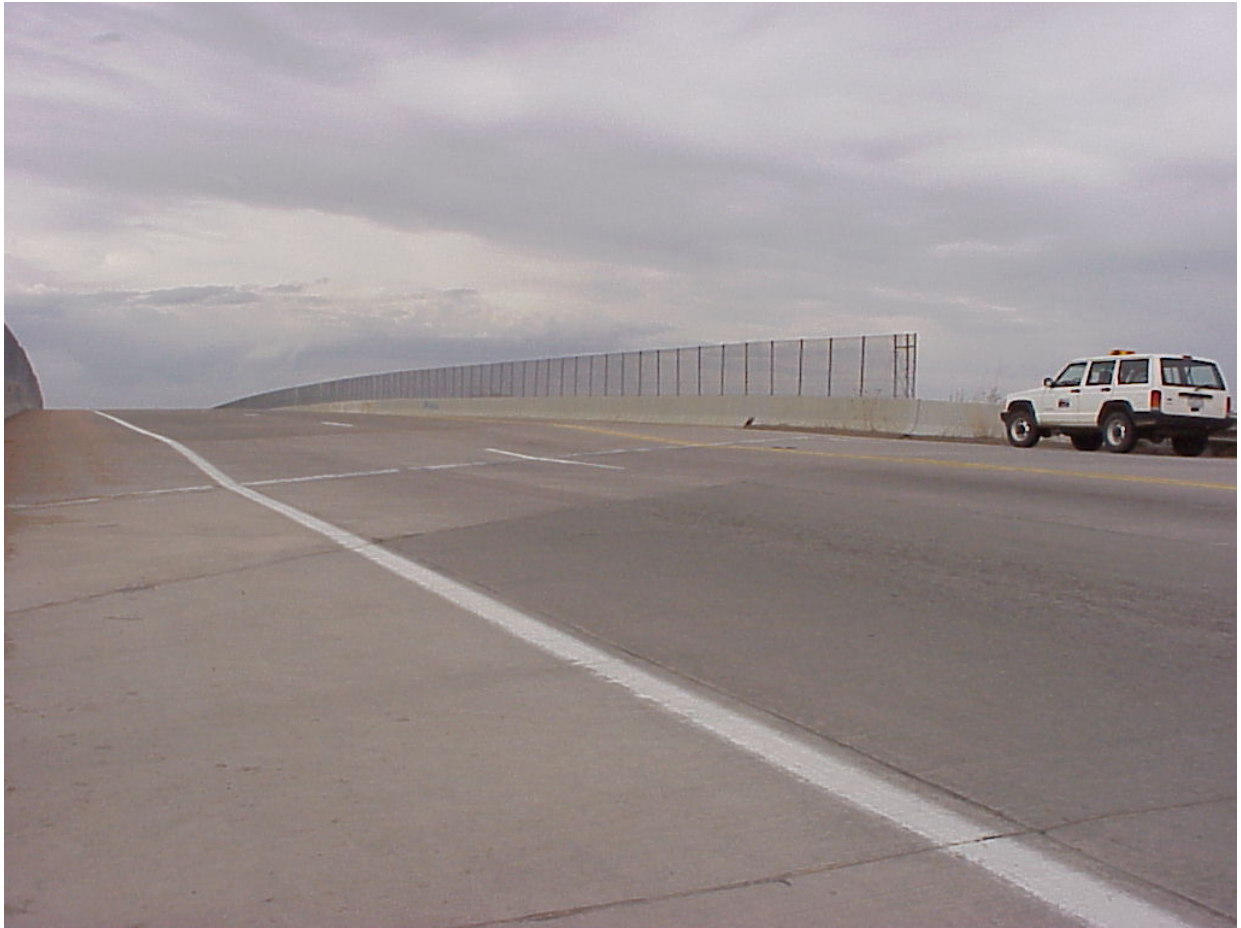
Figure C.7. The South Side of Buckley Over 1-76 (E-17-PQ, Region 6). This is a good Example of Bridge Bump Problem Generated at End of Construction.

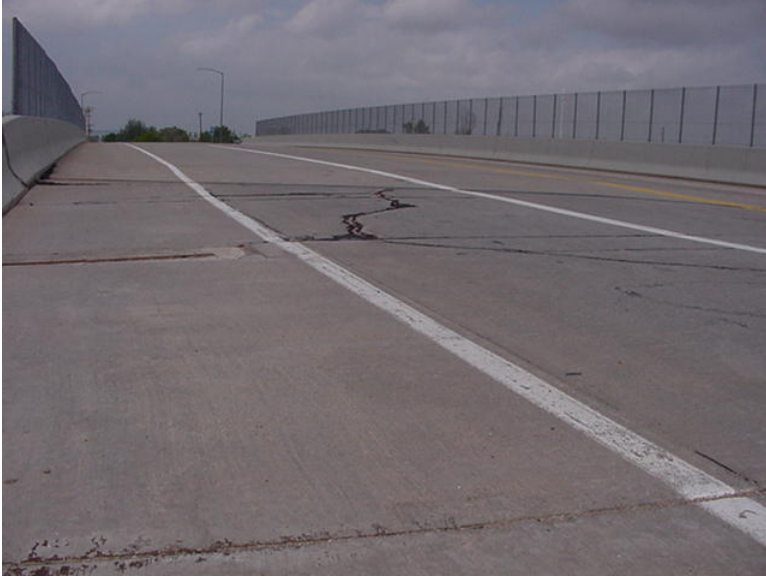
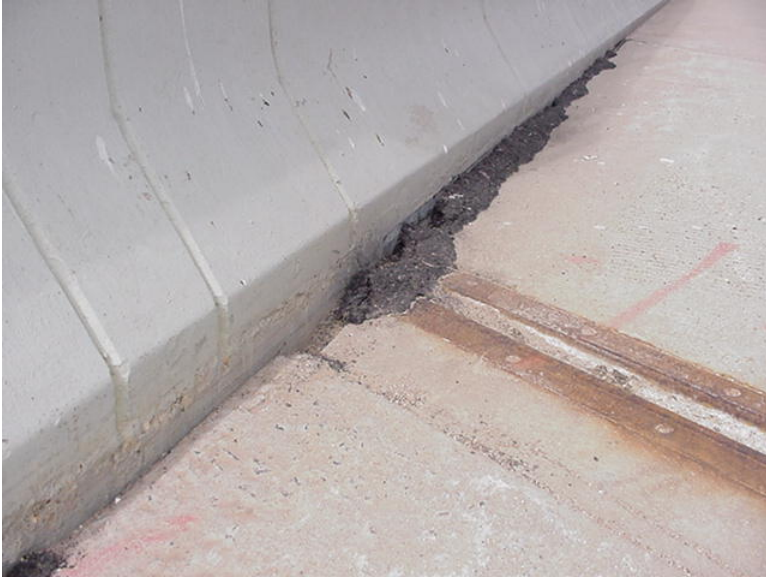
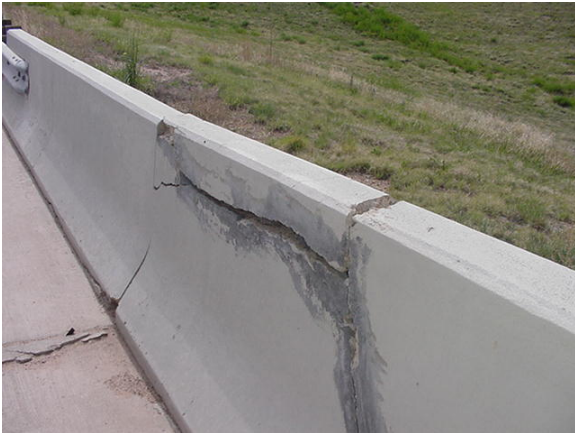
Structures E-17-PR (Figure C.8) and E-17-SW (Figures C.2 to C.5): for these two bridge structures with approaches ranked the worst, a detailed investigation to identify the causes of the problem was performed and the results are summarized in the next chapter. The approaches for structure E-17-PR were mud jacked for \$10,000. A field visit for the E-17-SW structure indicated that the wall's drainage pipes are clogged (not functioning) as the investigation suggests. The Uretex method was employed to fix the departure approaches of E-17-SW late 2004 and will be used to fix the arrival approaches in the Spring of 2005. For these two structures, the recommendations for repair (see next chapter) included drainage improvements and the use of compaction grouting or polyurethane deep injection.

Figure C.8. Photos of Structure E-17-PR in Region 6.

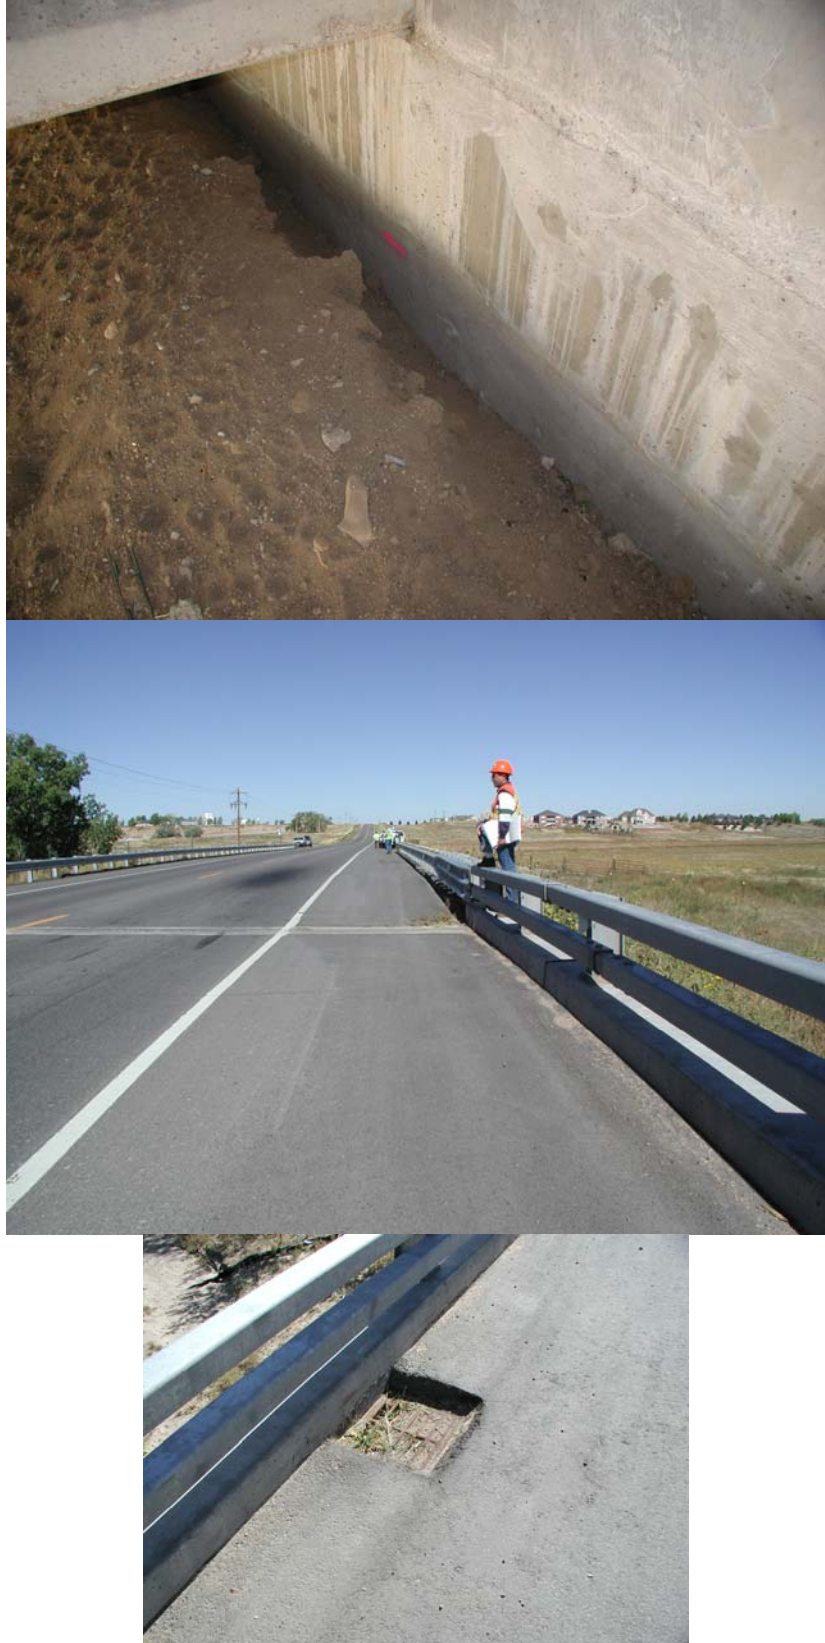
Figure C.15. Photos of Structure E-19-Z in Region 1 before Repair

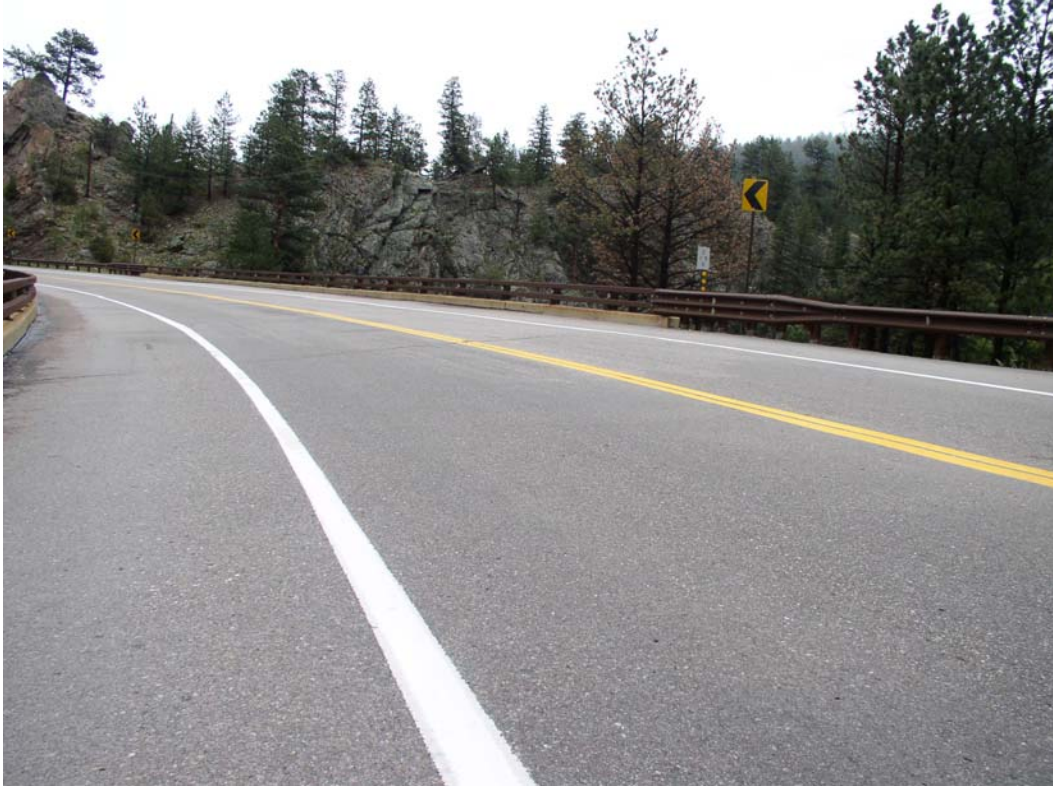
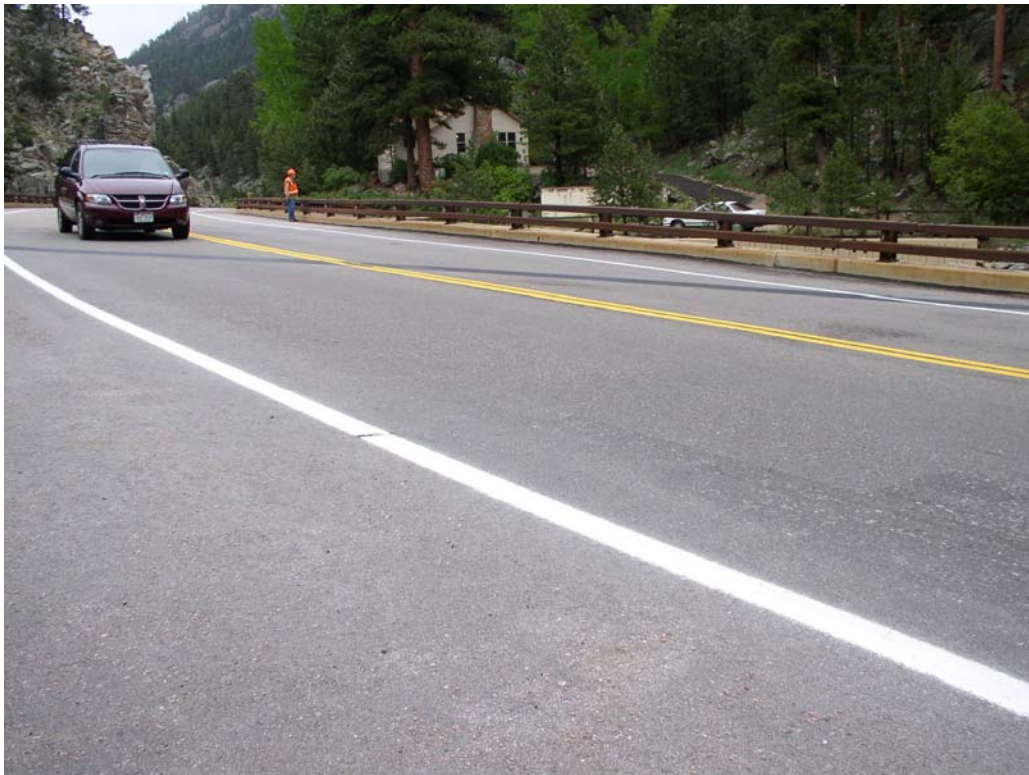
The two bridges were inspected on May 24, 2004; almost two years after the bridges had been in service. Pictures of the approaches were taken (Figure C.16). The development of differential settlement along the east side of C-15-U bridge was evaluated using a digital road profiler. Digital profiling data were collected (Figure 4.1) along two lines located along the north side of the bridge (where flowfill abutment backfill was used) and the south side of the bridge (where MSE abutment backfill was used). Note that the profiled lines are located on a horizontal curve (i.e., the bridge abutment is not perpendicular to the bridge centerline), so the two profiles should *not be expected to match*.

Figure C.16. Photos of Structures C-15-U and C-15-O in Region 4 (Side by Side Flowfill and MSE Backfill with Excellent Performance).
