**Report No. CDOT-DTD-R-2006-8
Final Report**

**PRECAST CONCRETE PAVING PANELS:
THE COLORADO DEPARTMENT OF
TRANSPORTATION REGION 4 EXPERIENCE,
2000 TO 2006**

Gary L. DeWitt, P.E.

August 2006

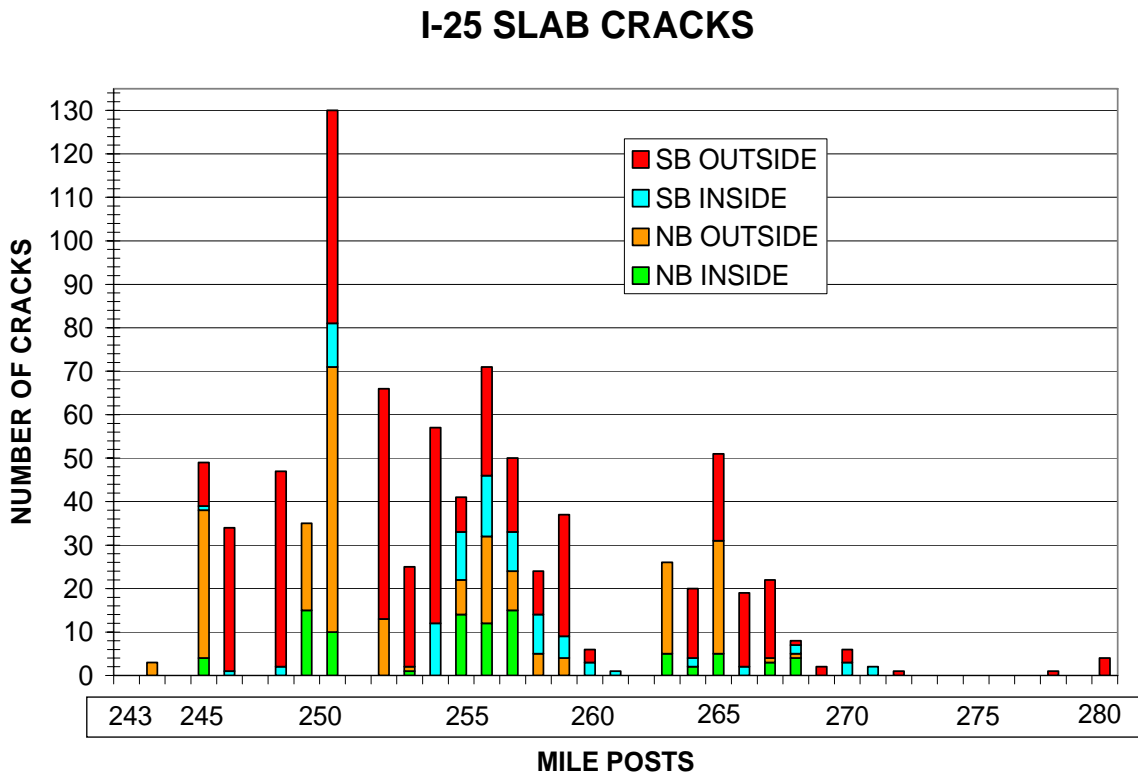
FIGURE 1 PANELS WITH 3 PLUS FULL-DEPTH CRACKS I-25

A field survey was conducted for the I-25 corridor to record the number of slabs that had 3 or more full-depth cracks.

<p>TOTALS Inside slabs83 Outside slabs.....352</p>

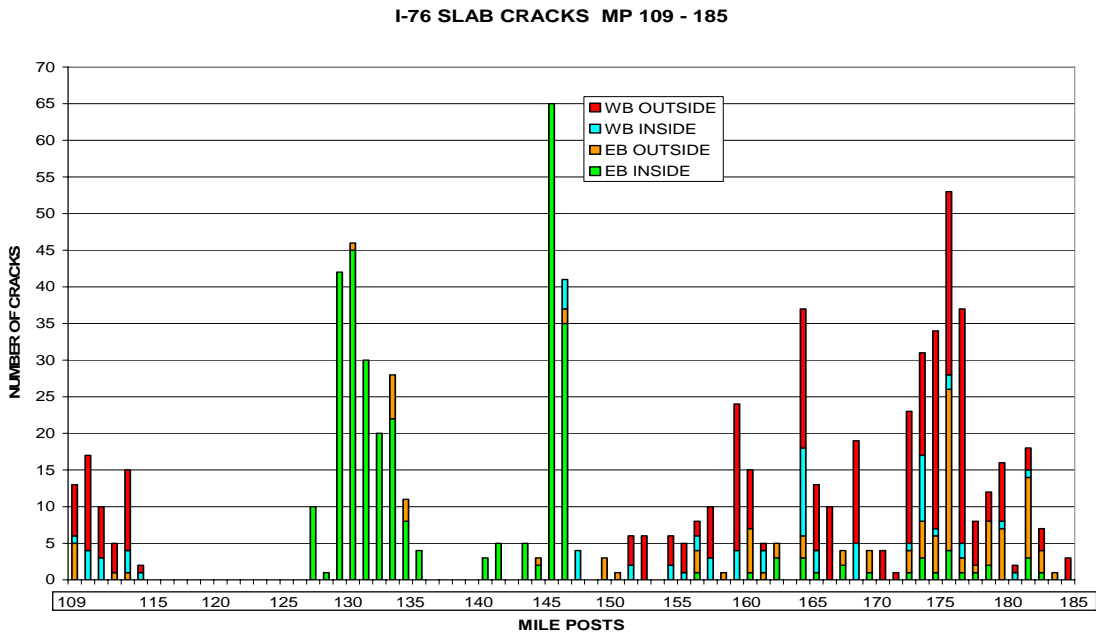
FIGURE 3
PANELS WITH 3 PLUS FULL-DEPTH CRACKS, MP 109 TO MP 185, I-76

<p>TOTALS Inside slabs.....179 Outside slabs.....659</p>
