**Report No. CDOT-2007-3**  
**Final Report**

## **DURAFLEX CURB**

**February 2007**

**COLORADO DEPARTMENT OF TRANSPORTATION**  
**RESEARCH BRANCH**

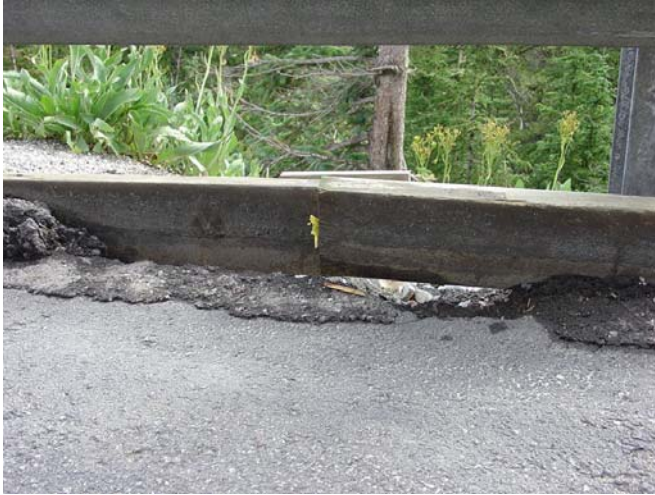
split, crack, twist and warp (**Figure 3**). That tendency is what led CDOT to try new curb materials.

**Figure 3. Wood curb can twist and warp.**

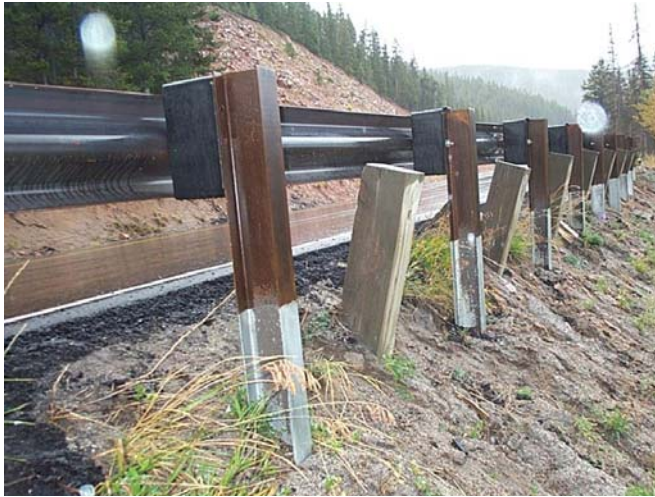
**Figure 4. US-50 has steep slopes to both sides.**

Much of the highway is cut into the side of the mountain with steep slopes above and below (**Figure 4**). About 2,000 feet of DFC and nearly 7,000 feet of composite curb was installed on the project. Annual average daily traffic is 2,300 with 20.1% trucks.

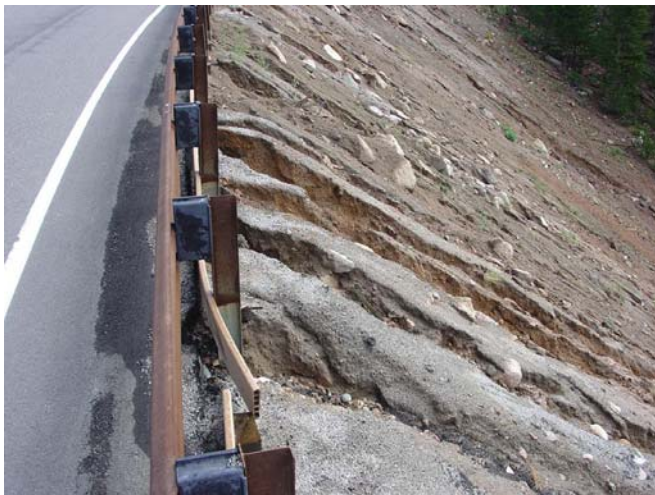
**Figure 5. Severe erosion can occur very rapidly.**

Most of eastbound US-50 at the site has guardrail on the right shoulder protecting high, steep embankments. In some areas the guardrail sits just outside the highway shoulder stripe. The area experiences heavy snowfall in the winter and sudden, intense rain storms in the summer. Both melting snow and heavy rain contribute to periods of heavy, fast-moving runoff that, if not controlled, can do extensive damage in a very short time. To make matters worse, the sparsely-vegetated and very steep sandy-gravel embankments (**Figure 5**) are highly susceptible to very rapid erosion. And in many places, they begin right at the edge of the pavement.

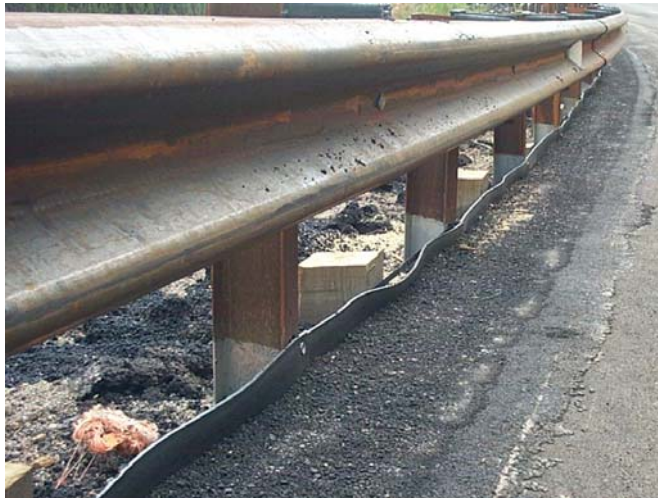
**Figure 6. The edge of the pavement was placed and compacted by hand.**

Unfortunately, having the block-outs and guardrail already in place prevented the paver and rollers from operating close to the guardrail posts, so the asphalt for about two feet out in front of the curb had to be placed and compacted by hand (**Figure 6**). This resulted in lower density, hence, lower strength in the mat next to the curb.

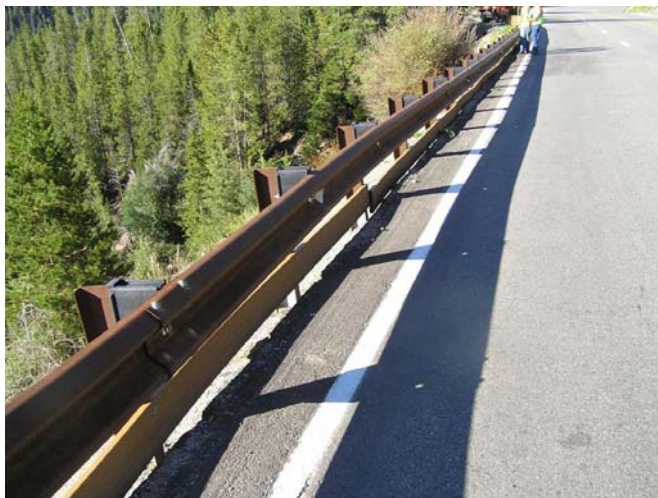
**Figure 7. Slight movement of the guardrail can render the curb completely ineffective.**

If a watertight condition can be maintained at the pavement/curb joint, any curb can be effective. However, it is virtually impossible to maintain a watertight joint over long periods with curbing material that relies on the guardrail posts for support. Any impact on the guardrail is likely to move one or more posts, and with them the curb, breaking the seal between the curb and the pavement surface.

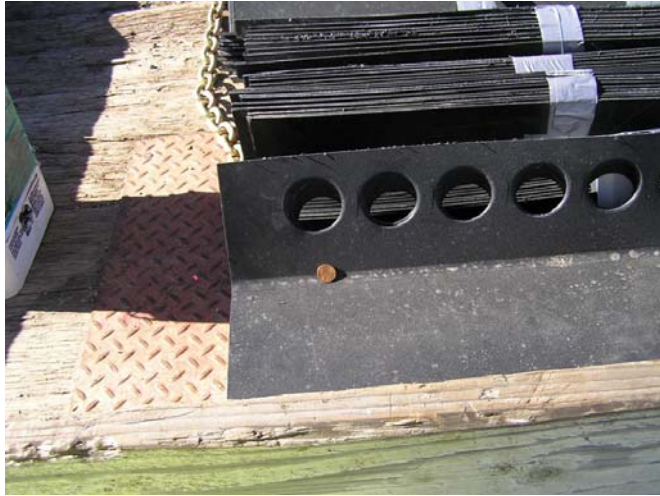
**Figure 8. Holes in the horizontal leg of the DFC help the layers of asphalt bond together to strengthen the curb.**

As **Figure 8** shows on the previous page, the HDPE had a memory; it tried to return to its original flat shape rather than maintain a 90° bend. Because the curb material had partially flattened out, it was difficult for the installers to push it tight against both the bottoms of the guardrail posts and the surface of the asphalt at the same time. They used shovels to hold the curb in place while it was nailed to the pavement along the edge of the horizontal leg (**Figure 10**). (The DFC was not nailed to the guardrail posts on US-24.)

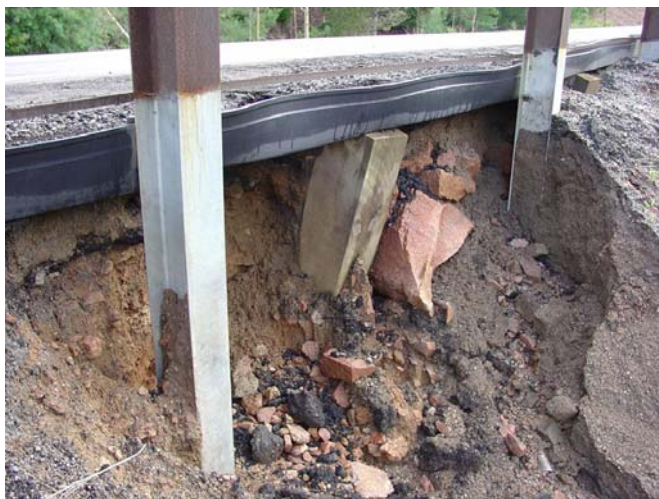
**Figure 9. Without the support of the DFC, the edge of the pavement would have collapsed.**

By virtue of its L-shape and overlap of the sections, DFC provides a continuous water-flow channel. In fact, the curb can even serve as reinforcement and support the edge of the pavement under some circumstances. **Figure 9** shows an area washed out behind the DFC. Apparently a high volume of water during a very heavy rain overflowed the curb and cut the base out from under the edge of the pavement.

water between the HDPE and the pavement. DFC's strength shown in **Figure 9** is also a potential weakness: Where the curb is embedded in the pavement it may provide a weakened plane and an access path for moisture to get into the pavement. Its efficiency practically guarantees the presence of some moisture all along the curb. In cold mountain locations, freeze-thaw cycles will almost certainly lead to failure if any moisture penetrates the pavement.

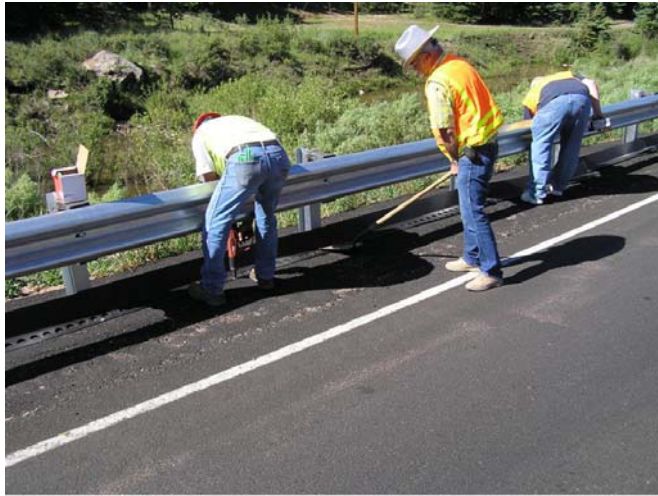
**Figure 10. Holding DFC tight against the post base and the pavement with a shovel.**

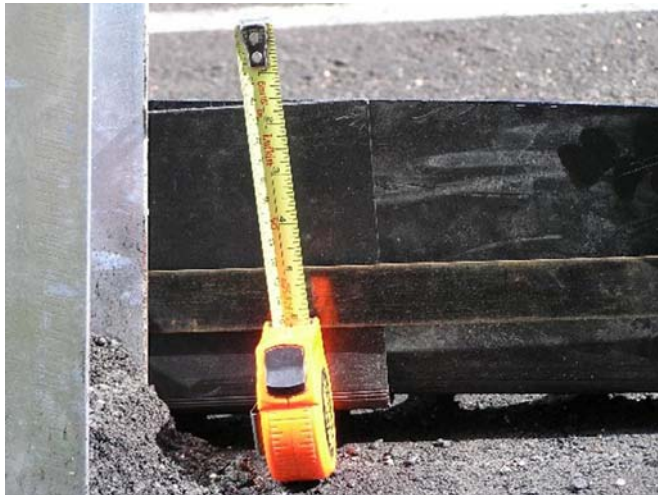
the curb continued to try to flatten out, it actually pulled many of the four-inch nails out of the asphalt. As **Figure 11** shows, the base of the curb was not tight against the pavement in many places. This was partly due to movement in the curb as described, and was partly due to the

**Figure 11. Air gaps between the curb material and the pavement surface.**

uneven surface below the curb. In any case, the gap causes a weak place in the pavement, and provides a path for water penetration.

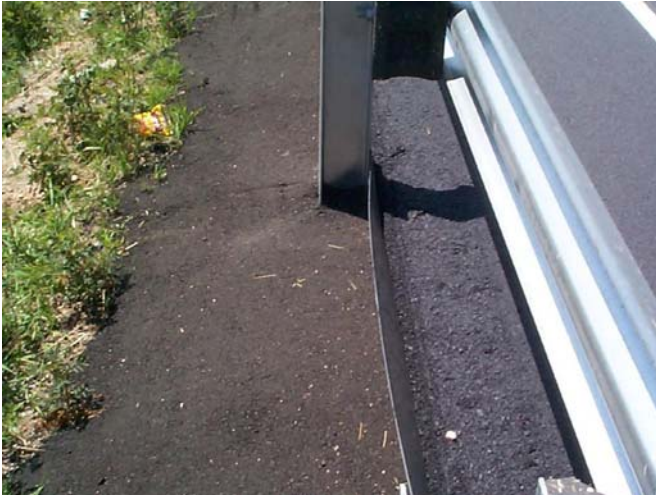
Another problem caused by the curb's memory resulted in bows in the vertical curb face between the guardrail posts. Heat and pressure from the final lift of asphalt on the face of the curb aggravated the effect. This condition, shown in **Figure 12**, was primarily a cosmetic problem. However, if it became too extreme, it would effectively lower the curb's height and reduce its water carrying capacity.

**Figure 12. Wavy curb face between guardrail posts is mainly a cosmetic problem.**

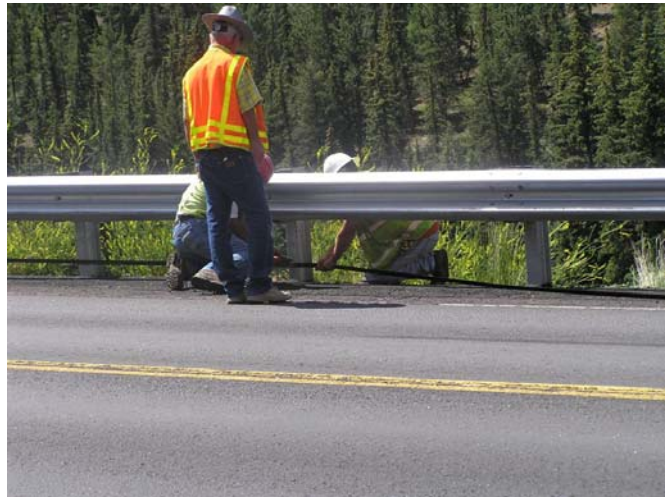
**Figure 13. Steel band was installed to provide support for the DFC between posts.**

as shown in **Figure 13**. While the band was not completely successful in eliminating the bows, it did provide some support for the vertical face of the curb.

To provide support for the DFC between posts the installers nailed a continuous one-inch steel band to the posts behind the top of the curb

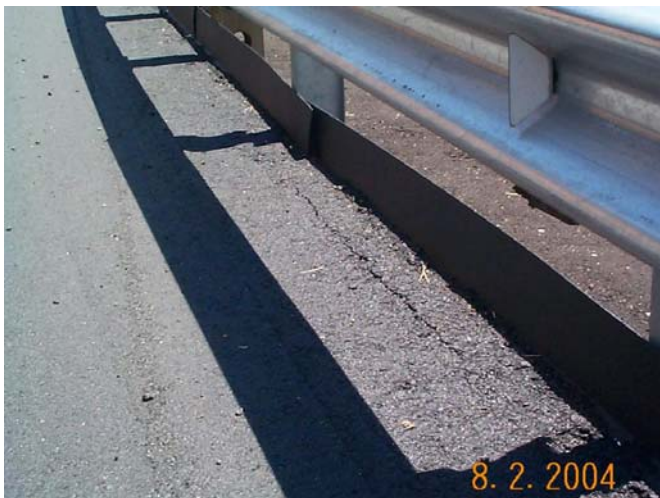
**Figure 14. Cracks along the edge of the HDPE on US-24.**

manufacturer thought the high temperature of the hot mix would soften the HDPE and allow the asphalt to bond to it, effectively making the curb a part of the pavement. However, a short time after construction, evidence of cracking along the edge of the embedded curb seemed to indicate that the bond between the curb and the asphalt did not develop. **Figure 14** shows a developing crack on US-24, **Figure 15** shows similar cracks at the end of a DFC section on US-50.

**Figures 14 and 15**, above, show cracks in the asphalt along the edge of the curb's horizontal leg. It appears that the HDPE promotes weakness in the asphalt which resulted in the pavement beginning to delaminate. Apparently, the asphalt did not bond to the curb, and there was not enough adhesion through the holes in the curb to prevent the top lift from separating. It is also likely that reduced density of the hand placed and compacted asphalt contributed to weakening the pavement in the area.

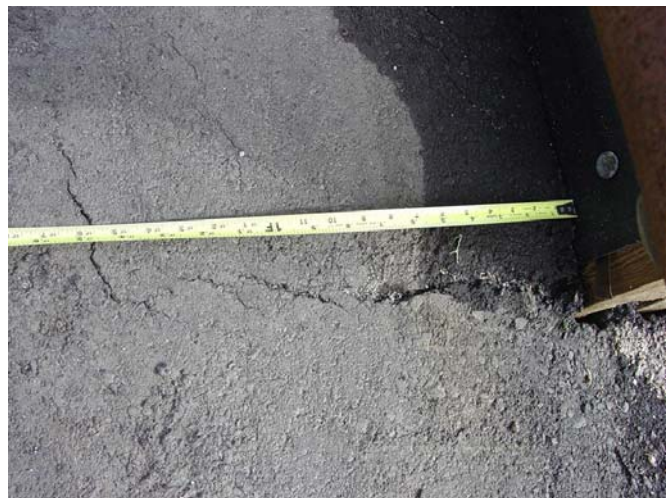
**Figure 15. Cracks are developing at the end and along the edge of the DFC on US-50.**

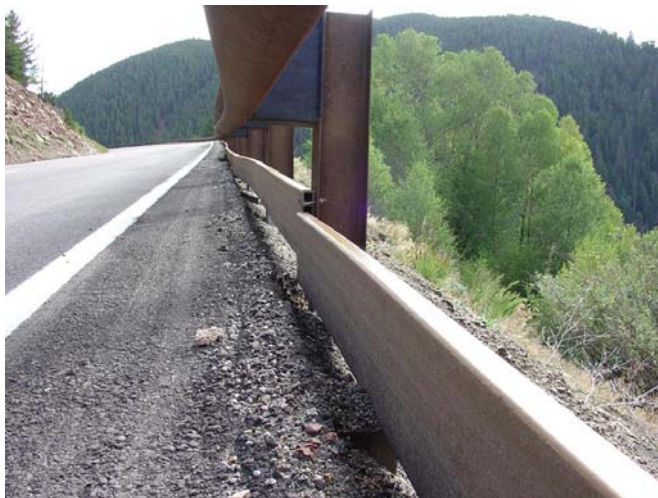
**Figure 20. A small movement of the guardrail separated this curb from the pavement.**

Composite lumber curb is totally dependent on the guardrail posts for support and positioning. Any movement of the guardrail will open a gap between the curb and the pavement allowing water to erode the shoulder. Sections of curb are easily replaced, however, if the damage was the result of movement of the guardrail posts, the curb will no longer fit tightly against the pavement and the gap will have to be filled. Hand construction of a berm against the face of the curb works well for smaller gaps, and may be advisable as a preventative measure.

Generally, if the curb is damaged, repairs consist of removing the damaged section of lumber, installing a new piece, backfilling any lost base material and patch paving in front of the curb. If the problem is due to the curb being separated from the pavement but not damaged, as happened in **Figure 20**, repairs usually consist of patching the separated area with asphalt. (Crack sealing materials were tried on small breaches between the curb and pavement, but none performed well.) This type of repair led maintenance personnel to form a small berm against the face of the curb using asphalt patching material. The curb

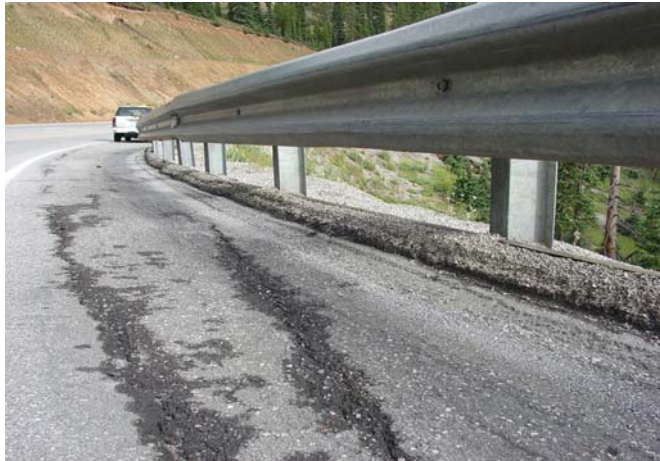
**Figure 21** shows an asphalt berm in front of a lumber curb. In locations where the guardrail is repeatedly subjected to small movements, this preventive maintenance treatment can be effective in reducing the repairs needed by the shoulder behind the curb.

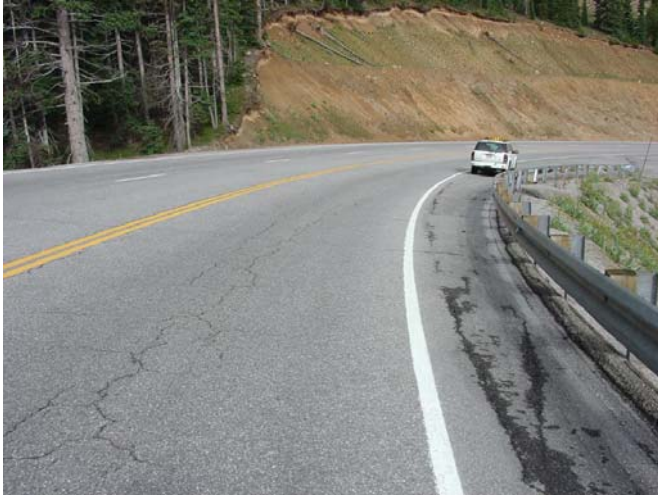
**Figure 22. Wide highway and steep shoulders.**

- US-50 on the west side of the pass is a two-lane highway with wide lanes and several passing zones. Its large surface area (**Figure 22**) collects a significant amount of water from rain and melting snow, and the grade and slope of the pavement give considerable velocity and force to the runoff. The water volume that the pavement gathers can overwhelm the curbs, which have an effective height of only four to six inches, with disastrous results – see **Figure 9**, above.

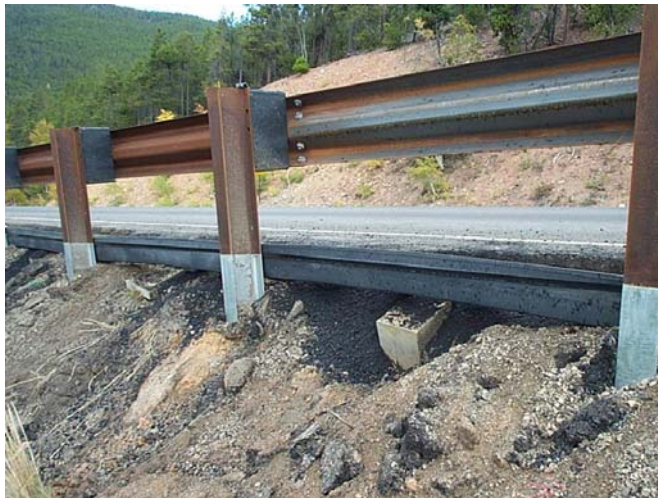
**Figure 23. Slopes start under the guardrail.**

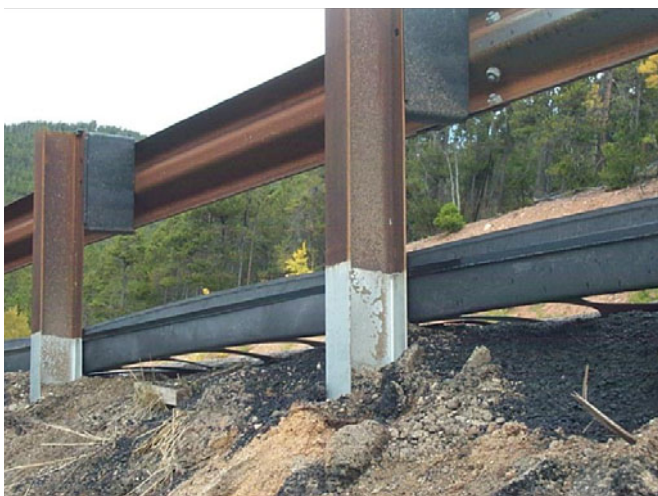
**Figure 24. Inadequate base for the DFC.**

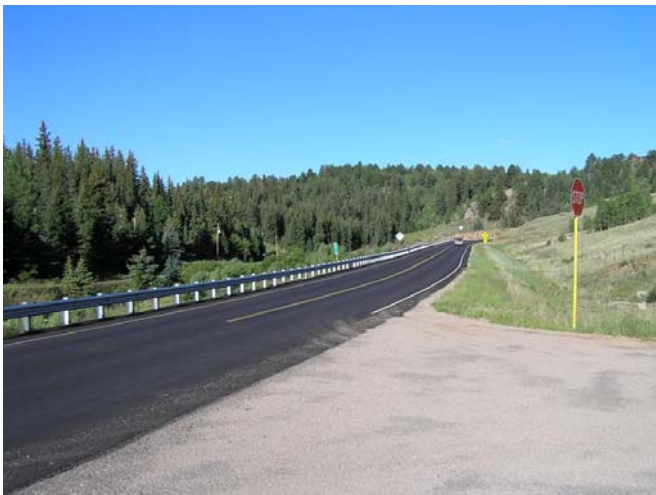
**Figure 25. US-24 on Ute Pass.**

roadway. US-24 near Divide **Figure 25** is such a location: a narrow, gently sloping, two-lane road, crowned in the center, with gently sloping shoulders. Water carried by the curb in this kind of location will have little energy to cause problems even if it does find a gap in the curb.
