**Report No. CDOT-2007-7
Final Report**

FORENSIC INVESTIGATION OF PAVEMENT FAILURE ON VASQUEZ BOULEVARD

May 2007

**COLORADO DEPARTMENT OF TRANSPORTATION
RESEARCH BRANCH**

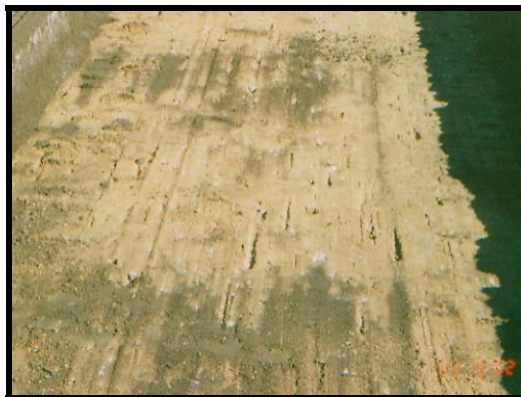
Figure 3: Roadbase exposed during asphalt remediation

During the remediation of problem areas along Vasquez Boulevard, it was observed that newer SMA asphalt was very malleable to the touch and could be picked apart from old HMA quite easily. The SMA and the top few inches of HMA asphalt were saturated with moisture during removal. Frost had formed between the HMA and SMA layers, indicating that moisture could have seeped through and become trapped within interconnected voids. A cross section of the removed pavement showed that rutting in the top layers of the asphalt had not pushed into the roadbase but had stressed the top few inches of HMA. The roadbase appeared to be in very good condition at the time of the repair. Images of this repair are in Appendix A.

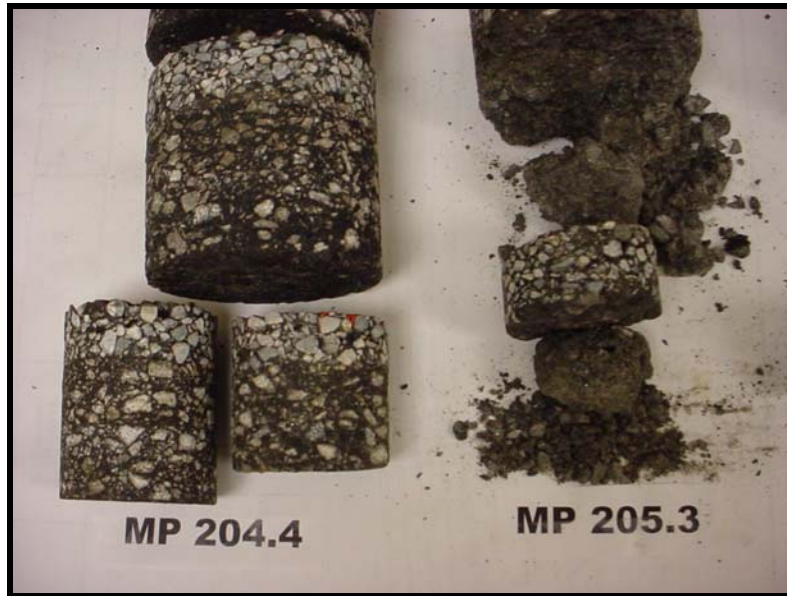
Figure 11: Core samples from I-75 south of Atlanta, Georgia

After taking core samples of the asphalt, GDOT investigators found that the HMA had stripped out completely and in some areas could only be removed with a spoon. The old HMA layer was a pre-lime mix design and was placed in 1979. The HMA was between three inches to eight inches on top of a concrete base. Preliminary cores before the I-75 project showed that HMA layers were intact and did not indicate immediate failure. In areas where asphalt deterioration was the most severe, GDOT removed three and one half inches of the HMA layers replaced them with two inches of three quarter inch Superpave mix.

This picture shows the structural failure of the pre-lime Georgia HMA. The MP 205.3 core has nearly disintegrated.

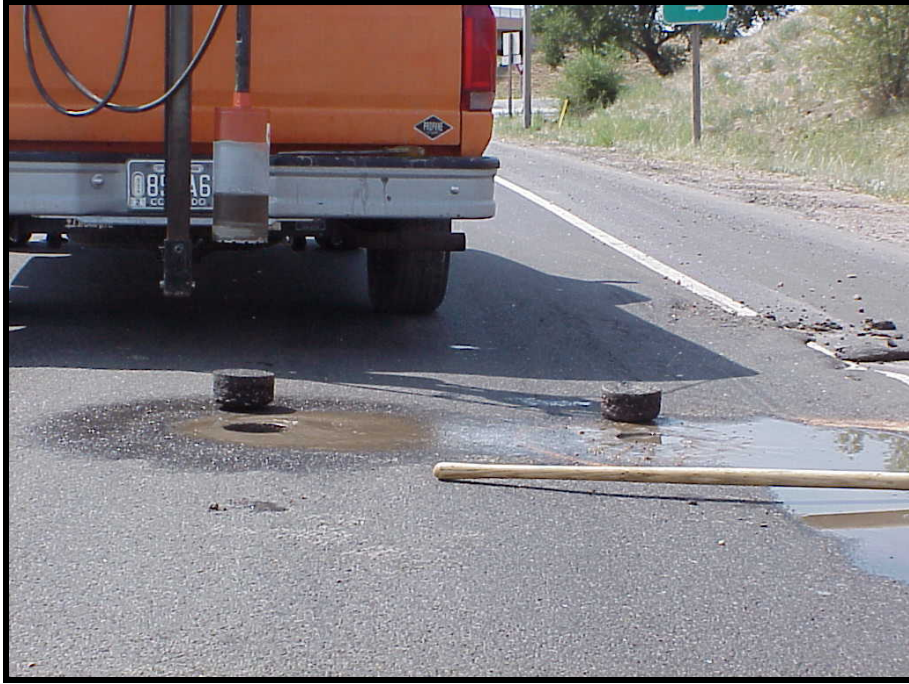
Figure 28: Coring location 5 for investigation

One to two inch ruts in the number 2 lane where truck traffic was concentrated

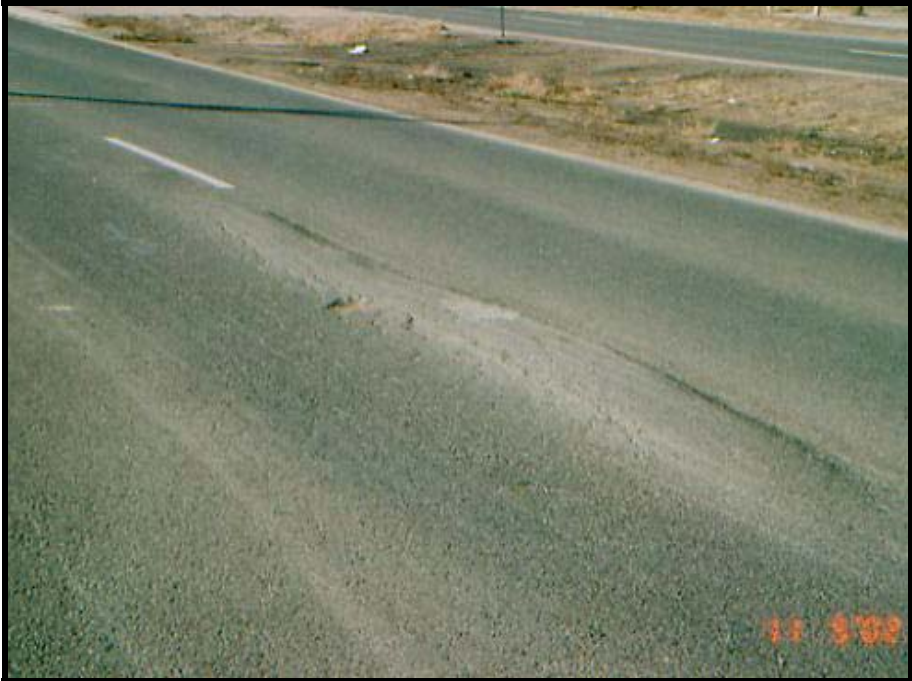
Figure 29: Failed SMA

Rutting and shoving evident during the remediation construction

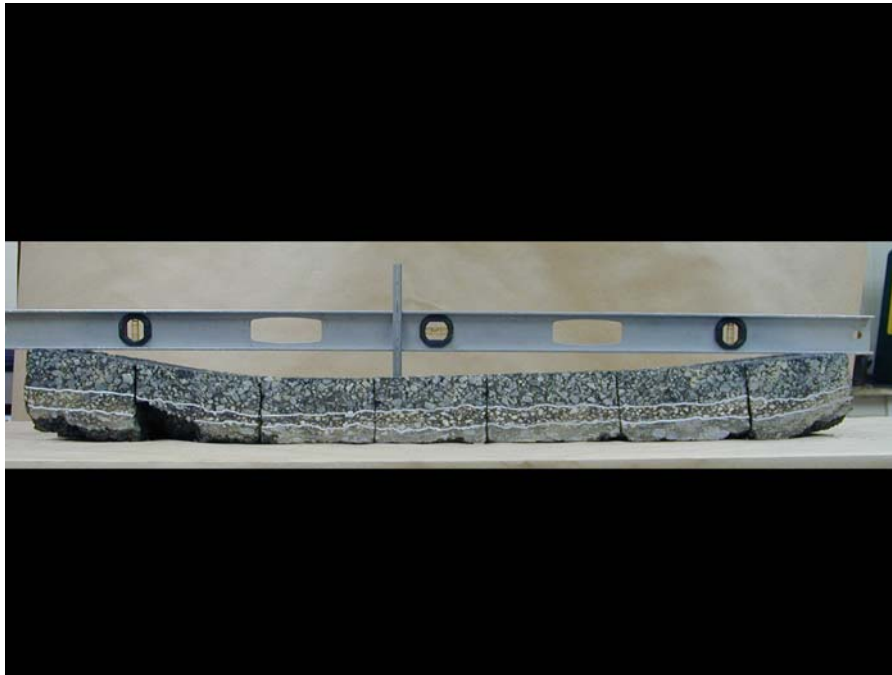
Figure 40: Cross section removed from I-495 showing 2"-3" ruts in SMA
