Department of Transportation

# Preventing Transverse Bumps and Cracks in New Asphalt Overlays over Crack Sealants

Report No. CDOT-2017-02

January 2017

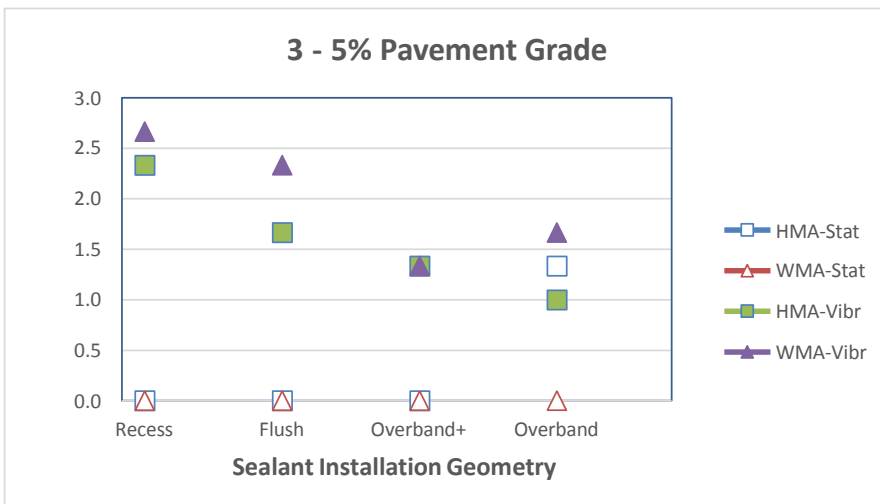
Vibratory breakdown rolling produced the most significant bumps and cracks over the overbanded and overbanded with release agent crack sealant for the hot mix overlay. However, bumps and cracks also appeared over the recessed and flush filled cracks after two or three passes of the roller. Bumps and cracks also occurred in the warm mix overlay over all four types of crack preparation, but generally required one additional pass of the breakdown roller to occur. The results of these observations are determined as an average for five cracks in each test section depicted in Figure 1 so decimal values instead of whole numbers often represent the number of passes required to generate bumps.

**FIGURE 1. Appearance of Bumps after Breakdown Rolling at 300 feet per minute**

Results shown in Figure 1 suggest that vibratory breakdown rolling has a larger effect on bump generation than mixture temperature since bumps occurred in both the warm mix and hot mix sections when vibrating during breakdown. However, only the hot mix section with the overbanded crack sealant displayed bumps when static rolling was done.
