COLORADO
Department of Transportation

EVALUATION AND PERFORMANCE OF HDPE PIPES UNDER CDOT HIGHWAYS, T-REX, AND OTHER LOCATIONS

Report No. CDOT-2018-09
March 2018

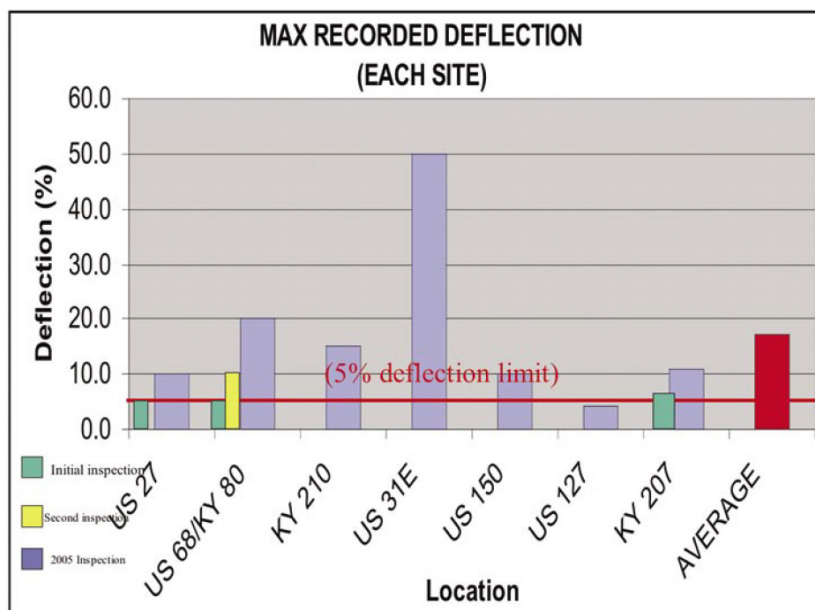
Figure 13. Experience with Kentucky DOT’s HDPE pipe performance.

Figure 46 presents a summary of experience with Kentucky DOT’s HDPE pipeline installations. Measurements show that after the initial-installation phase, recorded deflections continually increased through time. In almost all Kentucky DOT pipe installations, measured deflections exceeded the maximum 5% failure limit.

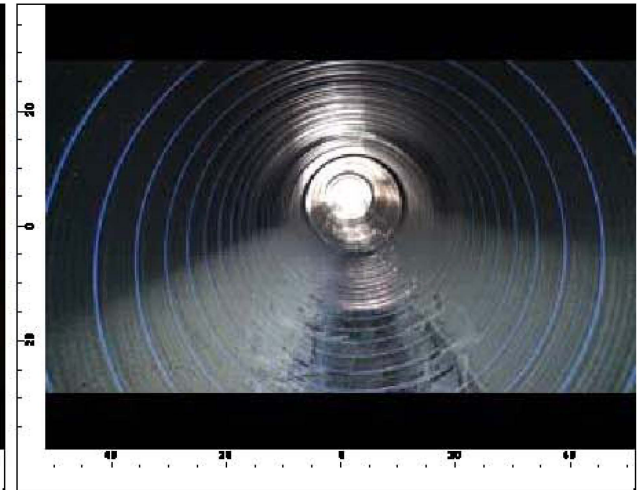
View of pipe at start, no noticeable deflection or defects.

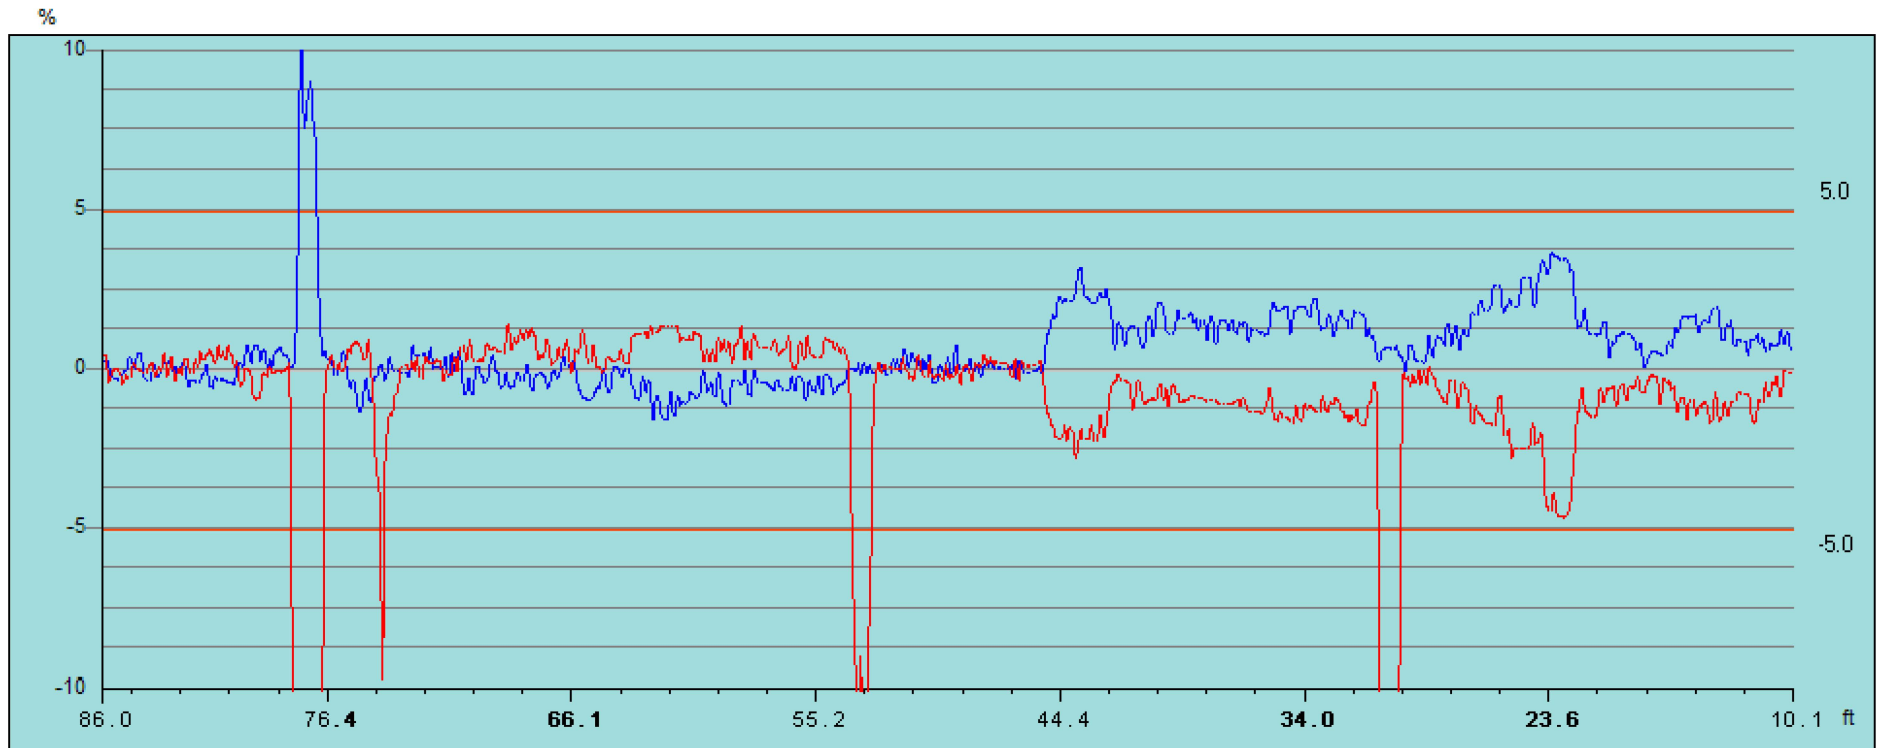
Ovality Summary Report

Ovality under 5%, spikes due to camera going over joints

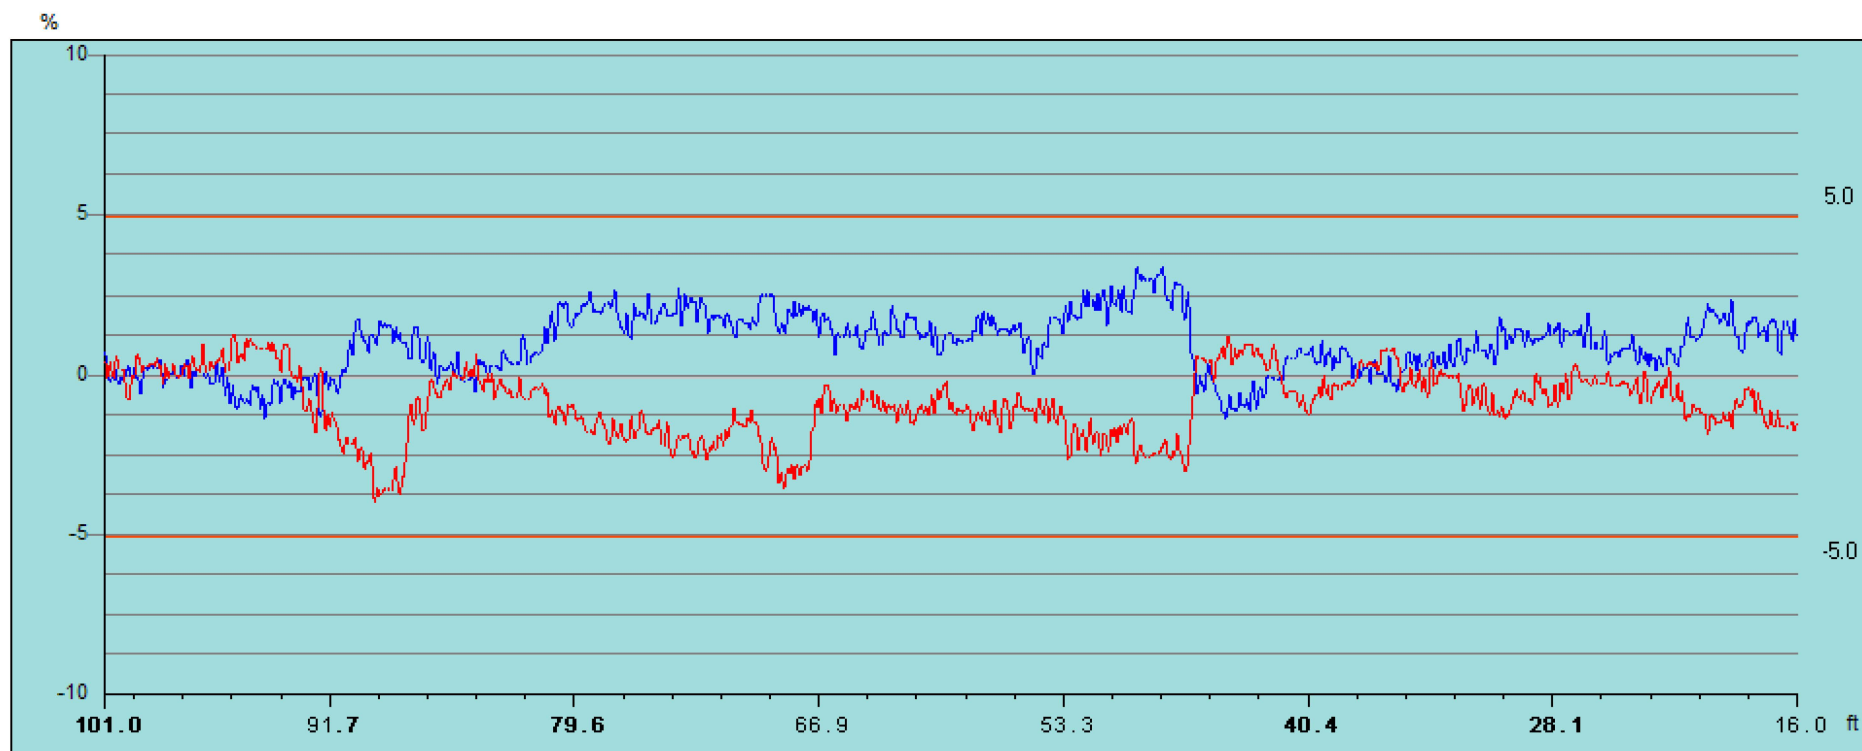
Ovality Summary Report

Ovality slightly over 5% at 90 ft. Spike due to camera tilting at joint.

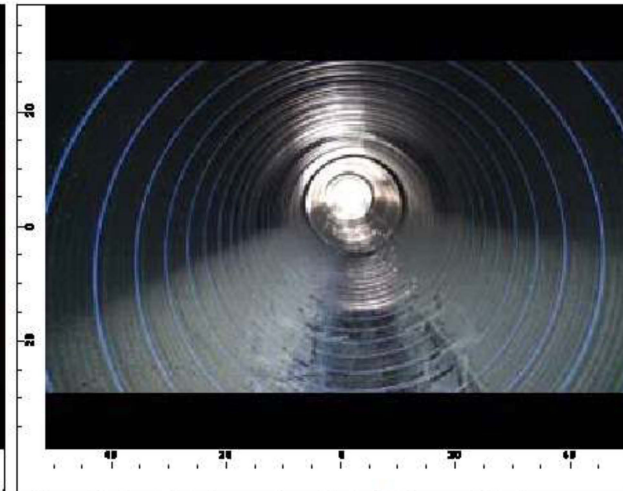
View of pipe at start, no noticeable deflection or defects.

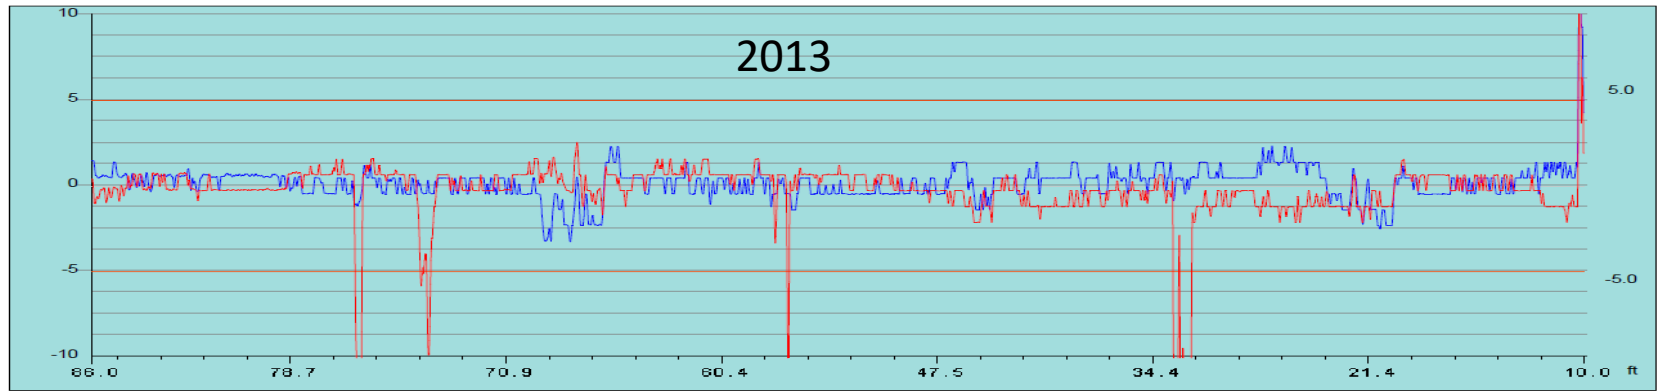
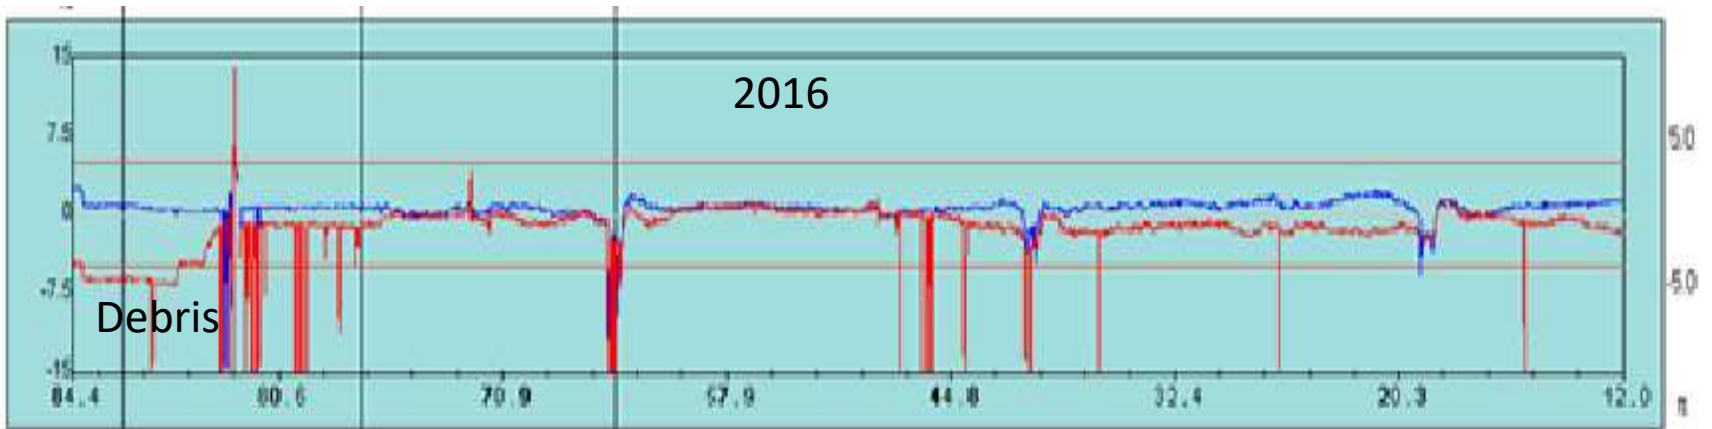
Performance Summary MP 123 (Northern Pipe)

The inlet end of the structure had been severely damaged by a vehicle, minor punctures from construction stakes were still visible. Overall no significant change was observed in the overall condition or shape of the structure.

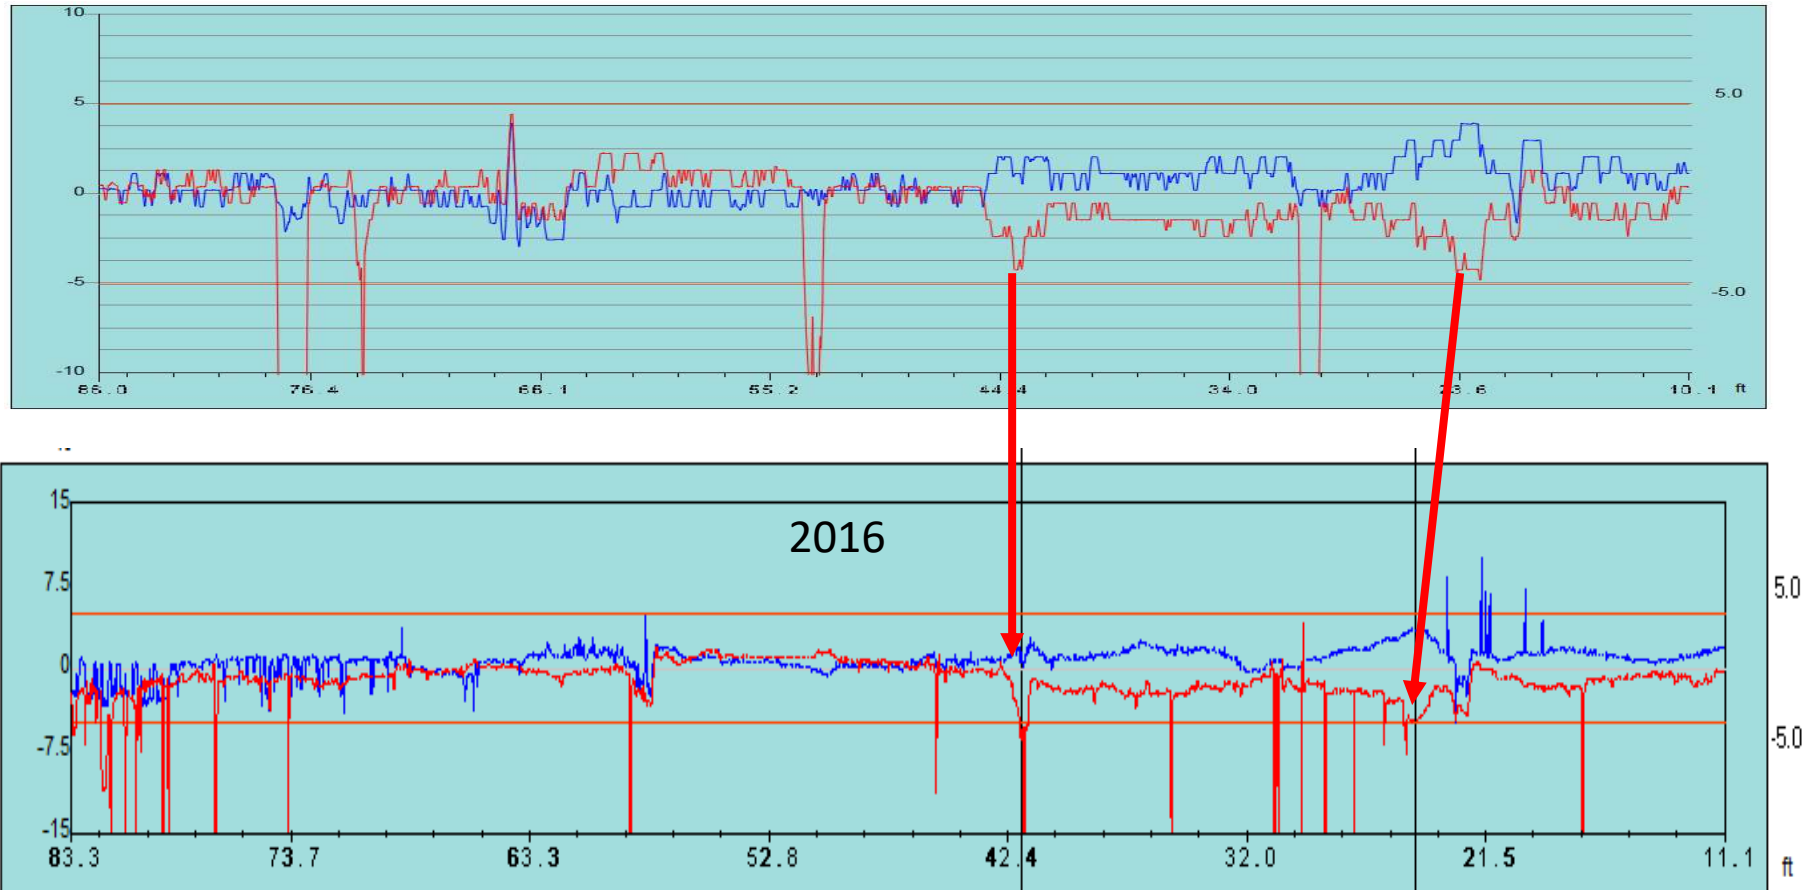
Performance Summary MP 123 (Middle Pipe)

The inlet end of the structure had been severely damaged by a vehicle, minor punctures from construction stakes were still visible. It appears that some possible slight increase in deflection has occurred around at 23 and 42 ft. Deflection at 5%.

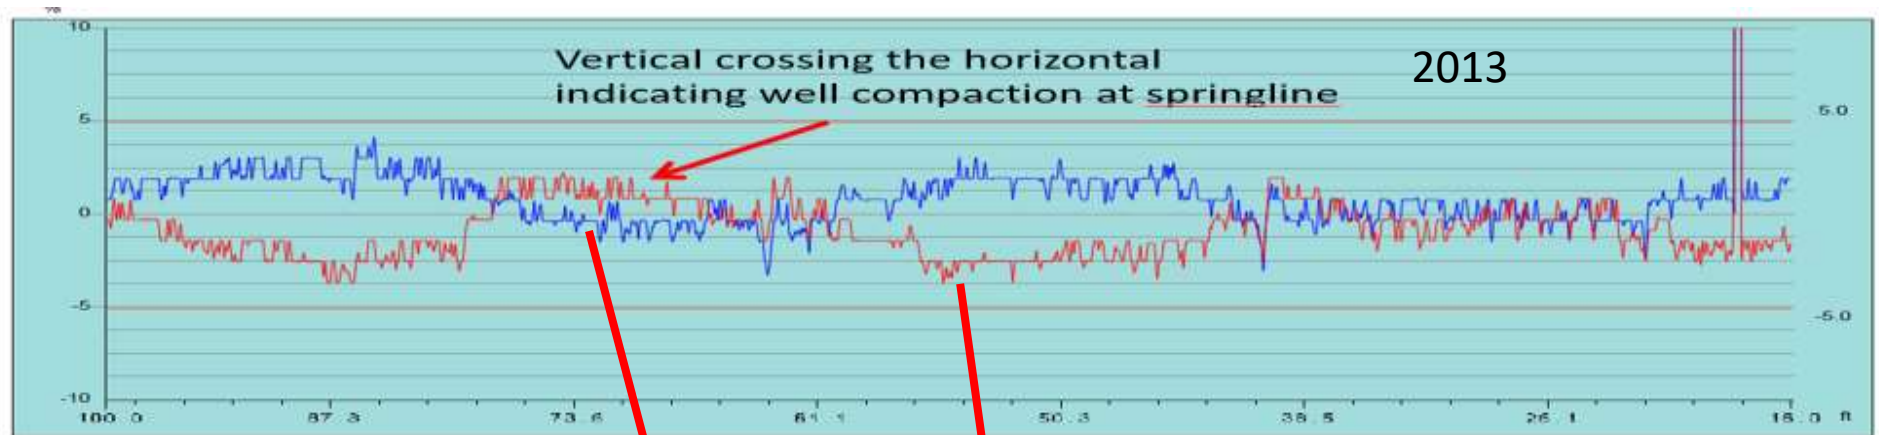
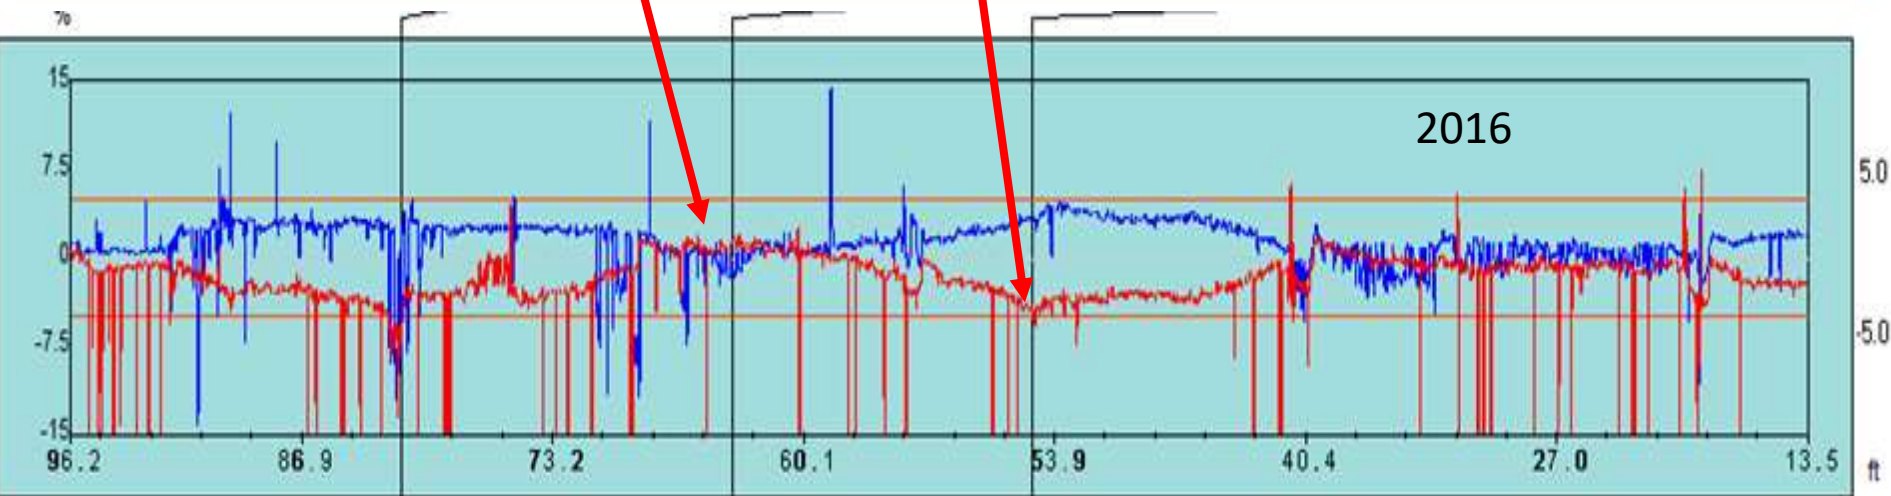
Performance Summary MP 122.5

Minor puncture was noted near the outlet end during the 2016 inspection that was not documented during the 2013 inspection. Deflection is still under 5%, but it appears that additional deflection has occurred in the center of the structure since the 2013 inspection.

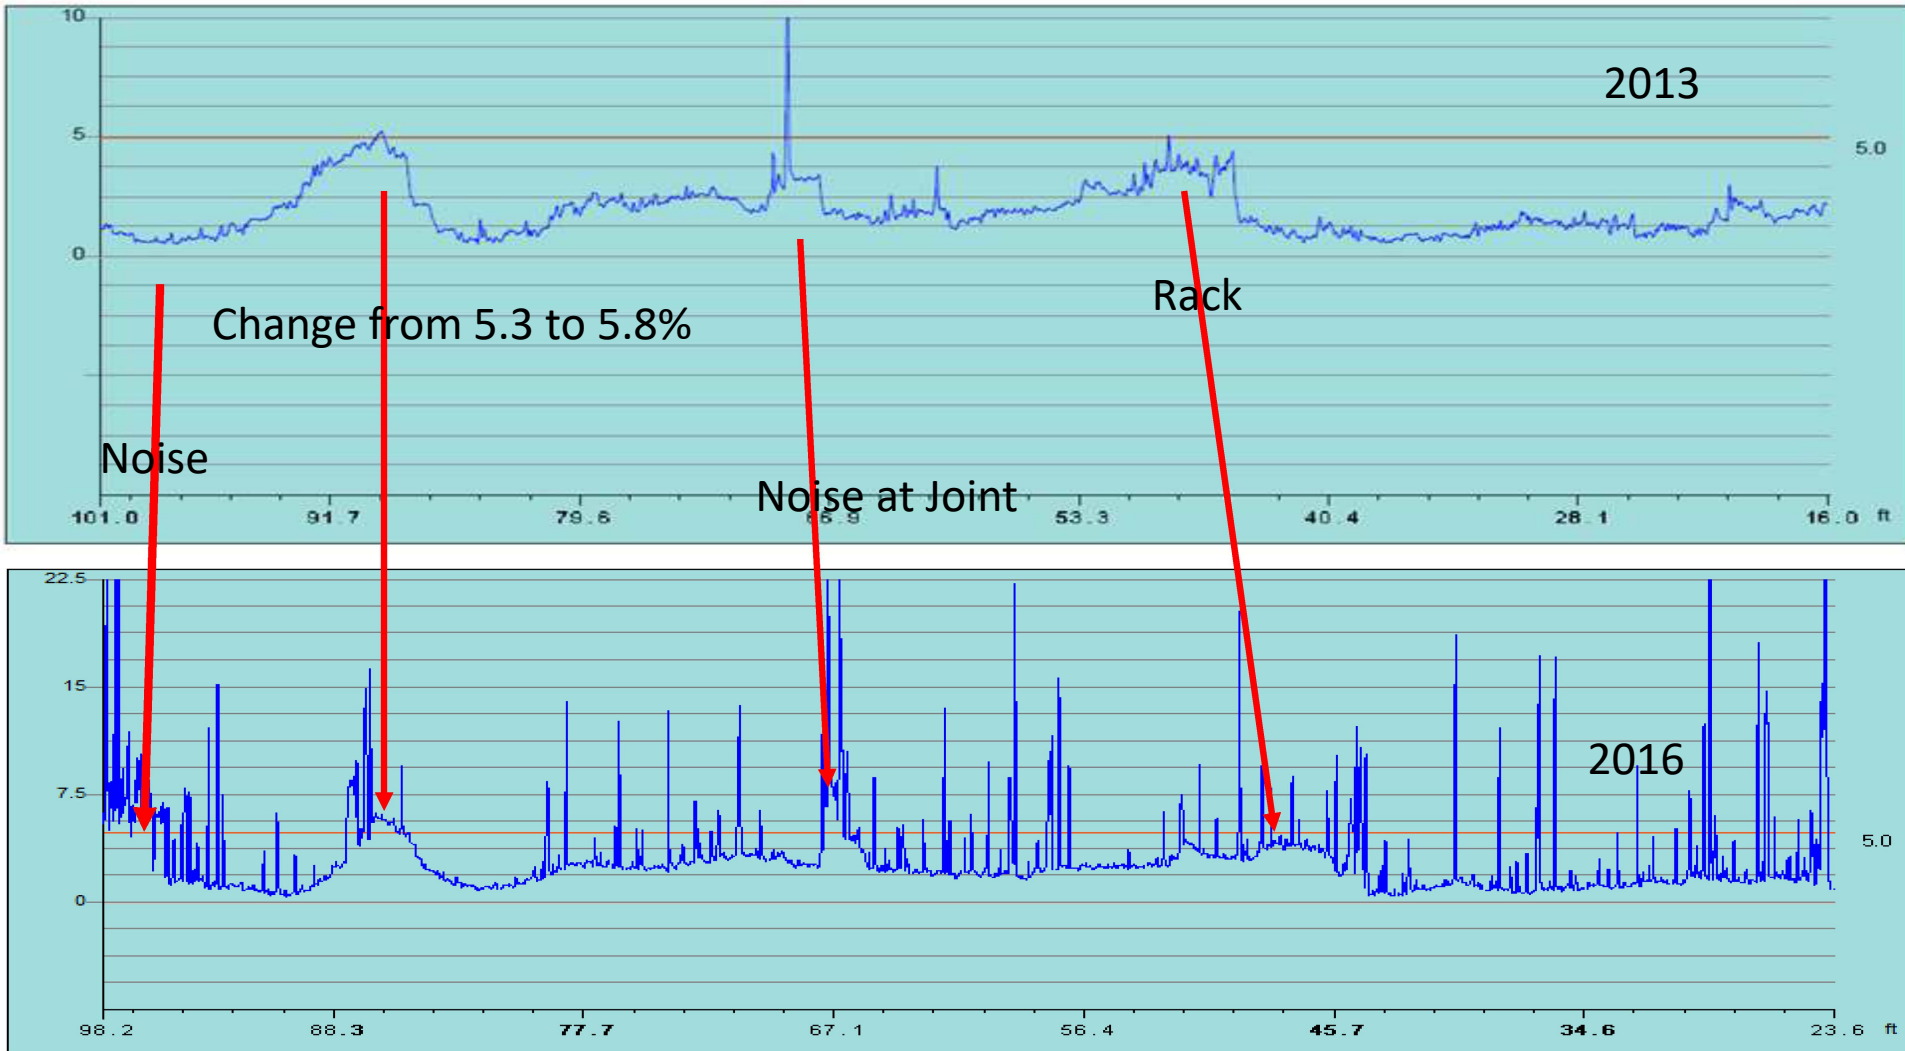
Performance Summary MP 122

Racking, Deflection, Minor punctures have been documented near the outlet end of the structure. Uneven flowline/hump and wall waviness have been documented mid pipe. Dent, deflection and racking has been documented towards the inlet end. Increased has occurred towards the inlet end of the structure that is not under pavement. Crown and possible invert curvature has occurred.

Conclusion: Punctures through the wall of the pipes observed during the 2013 inspection have not impacted the performance of the structures. Most of the punctures were due to the shallow cover and damage due to wooden stakes driven through the crown of the pipe during placement of straw wattles. Severe damage was observed in the inlet ends of two of the three pipes at MP 123 due to vehicle damage. Only a slight increase in deflection was observed in three of the five structures. Four of the structures are at or below 5%, and the other is at 5.8% with some signs of crown flattening and potential inverse curvature. This is outside the pavement area and in areas of shallow cover. In summary no significant changes have been observed since the 2013 inspection other than the damage due to vehicle damage. Settlement within the pavement reported in one of the locations does not appear to be due to issues with the underlying pipe structures.
