Rehabilitation and Load Rating of Deteriorated Timber Bridges in Colorado: Parametric Investigations and Implementation

1. Report No. CDOT-2023-06		2. Government Accession No.		3. Recipient's Catalog No.	
4. Title and Subtitle Rehabilitation and Load Rating of Deteriorated Timber Bridges in Colorado: Parametric Investigations and Implementation				5. Report Date May 2023

Part III: Rating of Constructed Timber Bridges Repaired with Steel Beams

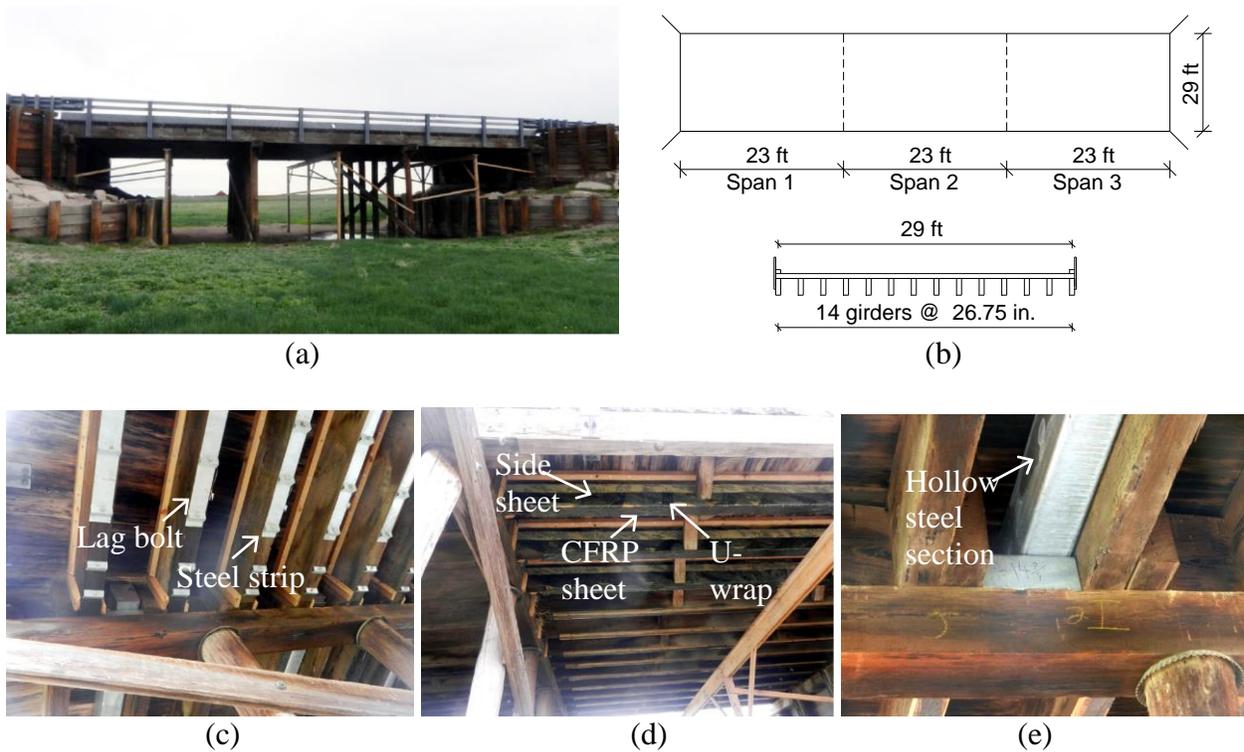
Fig. I.1. F-22-V Bridge: (a) overview; (b) dimensions; (c) retrofit with lag bolts; (d) retrofit with CFRP sheets; (e) retrofit with hollow steel section

The F-22-V Bridge situated in Washington County, Colorado, USA, was constructed in 1938 with Douglas Fir lumber (Fig. I.1(a)). The load-bearing system was composed of 3 spans and 14 girders (23 ft long, each), as depicted in Fig. I.1(b). Due to aging and deterioration, the superstructure of the bridge was rated to be 4 (*Poor Condition*, FHWA 1995) and the Owner (Colorado Department of Transportation) decided to strengthen the girders using three approaches in each span (Figs. I.1(c) to (e)): lag bolting, CFRP, and hollow steel section (HSS). The size of the bolts was 0.75 in. in diameter, which was embedded every 16 in. at an angle of 45° with steel strips (Fig. I.1(c)). The CFRP sheets were bonded to the bottom and sides of the girders (Fig. I.1(d)). The rectangular HSS beams, 12 in. deep by 8 in. wide by 0.31 in. thick, were mounted adjacent to the girders and mechanically fastened (Fig. I.1(e)). Details of these applications (e.g., material properties and installation procedures) are described in the next section. To confirm the effectiveness of the individual approaches, girders were taken out of a decommissioned bridge having similar characteristics to the retrofitted bridge and were tested in the laboratory.

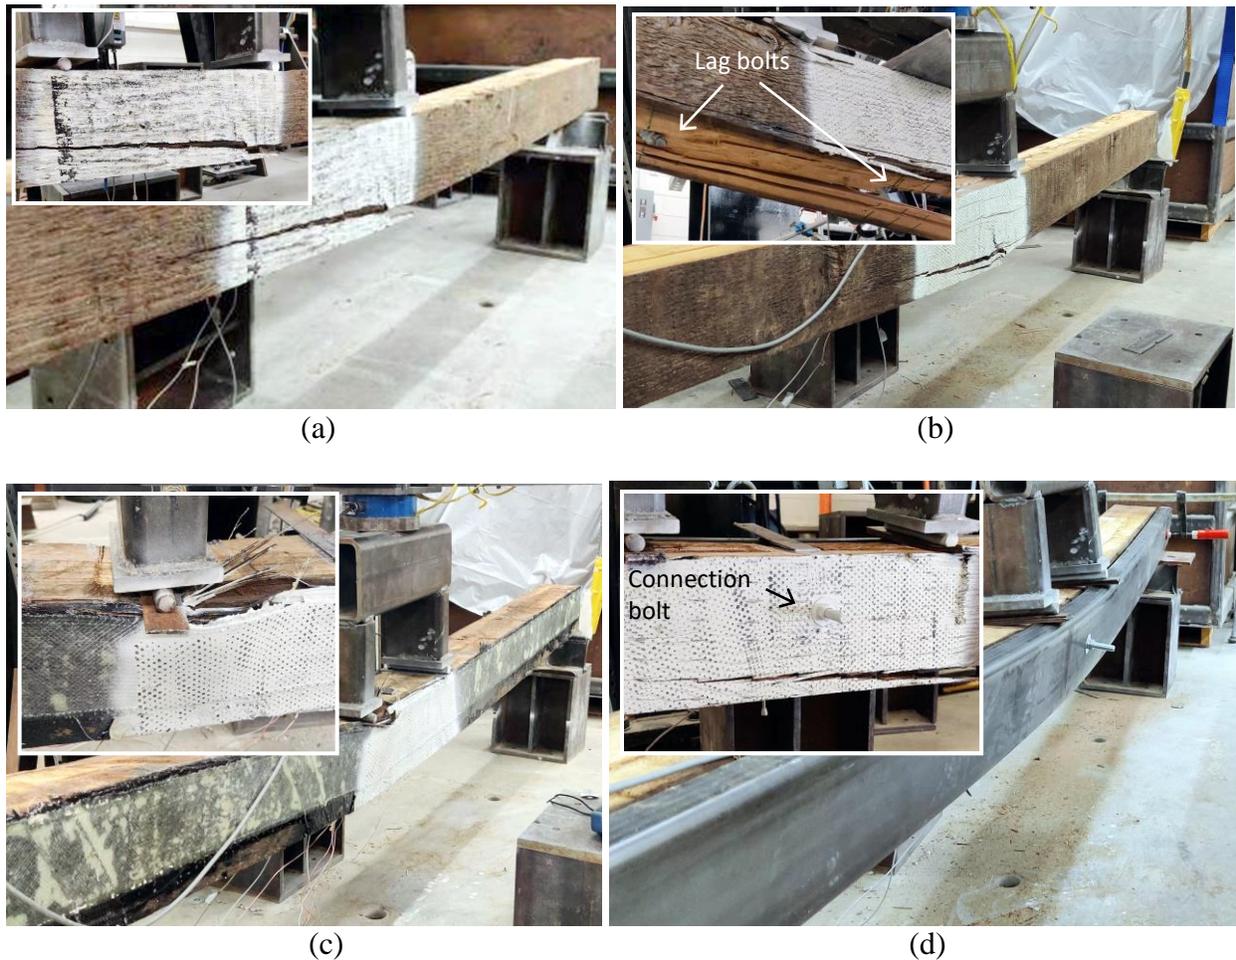
Fig. I.9. Failure mode: (a) Cont; (b) Bolt; (c) CFRP; (d) HSS

Pictured in Fig. I.9 are the failure modes of selected girders (the inset photos were taken immediately after failure). For the Cont girder (Fig. I.9(a)), grain-splitting initiated in the tension

zone right below a loading point and advanced in the horizontal direction at an angle of 30°. While the Bolt girder revealed a splitting pattern similar to the control (Fig. I.9(b)), the fractured segments were not localized because the lag bolts interfered with the progression of the splits and distributed stresses (Fig. I.9(b), inset). Unlike these girders, no perceivable damage was noticed in the CFRP girder except for the crushed grains underneath the loading point (Fig. I.9(c)). The pristine CFRP sheets at the global level confirm the adequacy of the strain-based bond assessment that was discussed in Fig. I.8(d). The bending of the timber-steel assembly was apparent, as shown in Fig. I.9(d), and their integrity was well preserved even with three connection bolts. The yielded steel beam demonstrated permanent plastic deformations and the timber girder suffered grain fractures (Fig. I.9(d), inset). No physical impairment was observed in the vicinity of the connection bolt, justifying the feasibility of the HSS retrofit method on site.

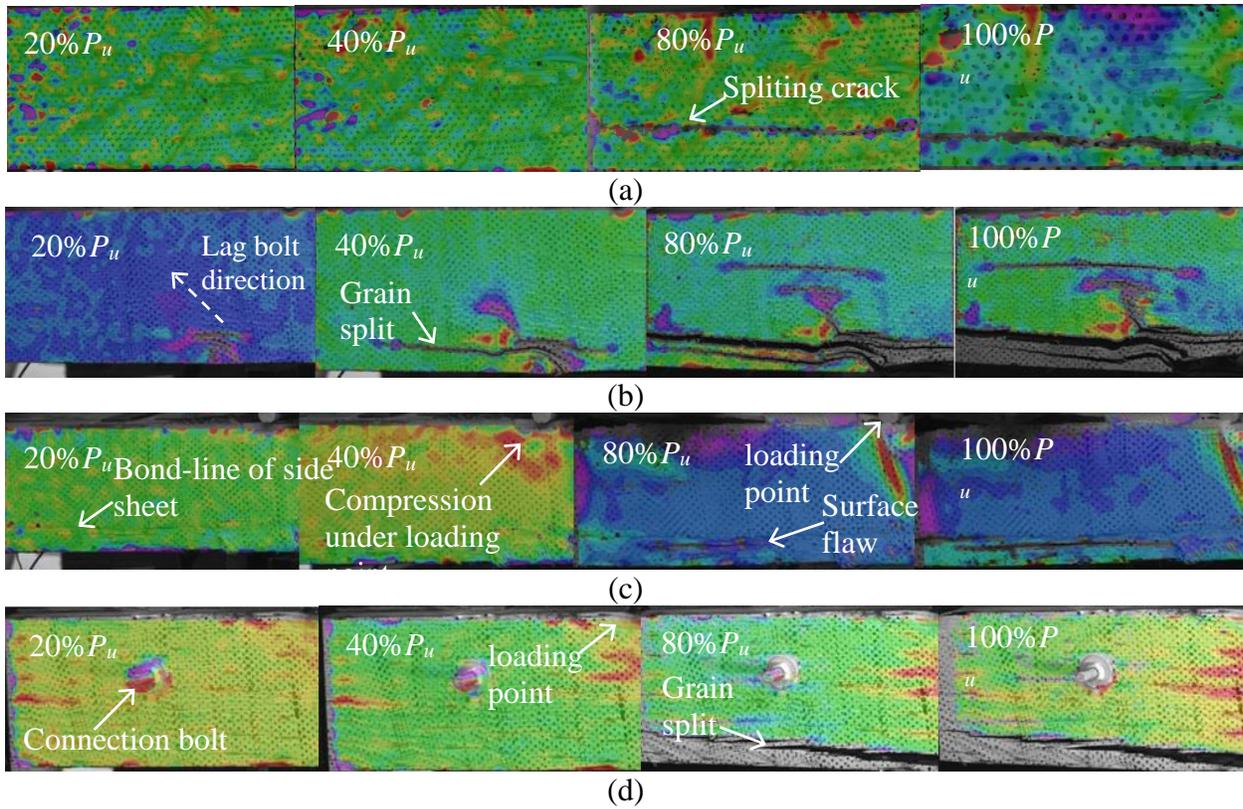
Sequential images describing the failure of the test girders are provided in Fig. I.10. The scanned surface of the Cont girder clarified that no splitting occurred at 20% P_u and 40% P_u (Fig. I.10(a)); on the other hand, a wood check was captured at 80% P_u and widened through 100% P_u . At a load level of 20% P_u in the Bolt girder (Fig. I.10(b)), an abnormality was identified at the location of an embedded lag bolt, which served as the weak link of the retrofitted girder. Guided by the direction of the lag bolt, the formed damage was conspicuous and the flexural loading resulted in the horizontal grain split (40% P_u to 100% P_u). The CFRP girder did not exhibit noticeable deterioration up to 40% P_u , other than the concentrated stress beneath the loading point (Fig. I.10(c)). The inclined vertical distress represented by the reddish contours at 80% P_u and 100% P_u accounts for the compression failure of the CFRP girder (Fig. I.10(c)). It is worth reporting that marginal surface-level flaws were discernible along the bond-line of the side sheet (80% P_u and 100% P_u), indicating the enlarged mismatch with the substrate that was induced by shear slipping. For the HSS girder (Fig. I.10(d)), anomalous deformations were not seen around the connection bolt and the grain splits led to the failure of the specimen.

Fig. I.10. Sequential failure: (a) Cont; (b) Bolt; (c) CFRP; (d) HSS

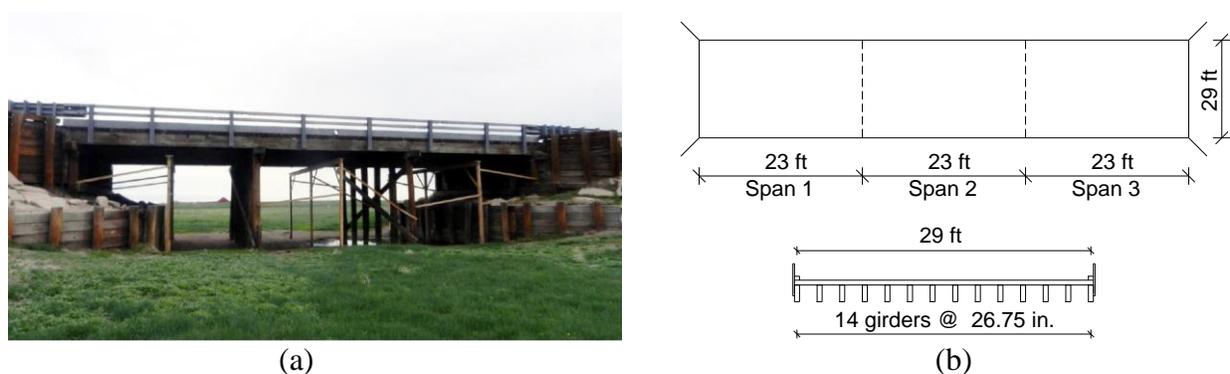
A strengthening project is carried out to elevate the performance of an 83-old timber bridge. The background of bridge configurations and implementation procedures are outlined. To quantify the efficaciousness of the retrofit, the bridge is loaded using a truck with known weights and its flexural responses are logged.

Fig. II.1. The F-22-V Bridge: (a) overview of site; (b) structural configuration

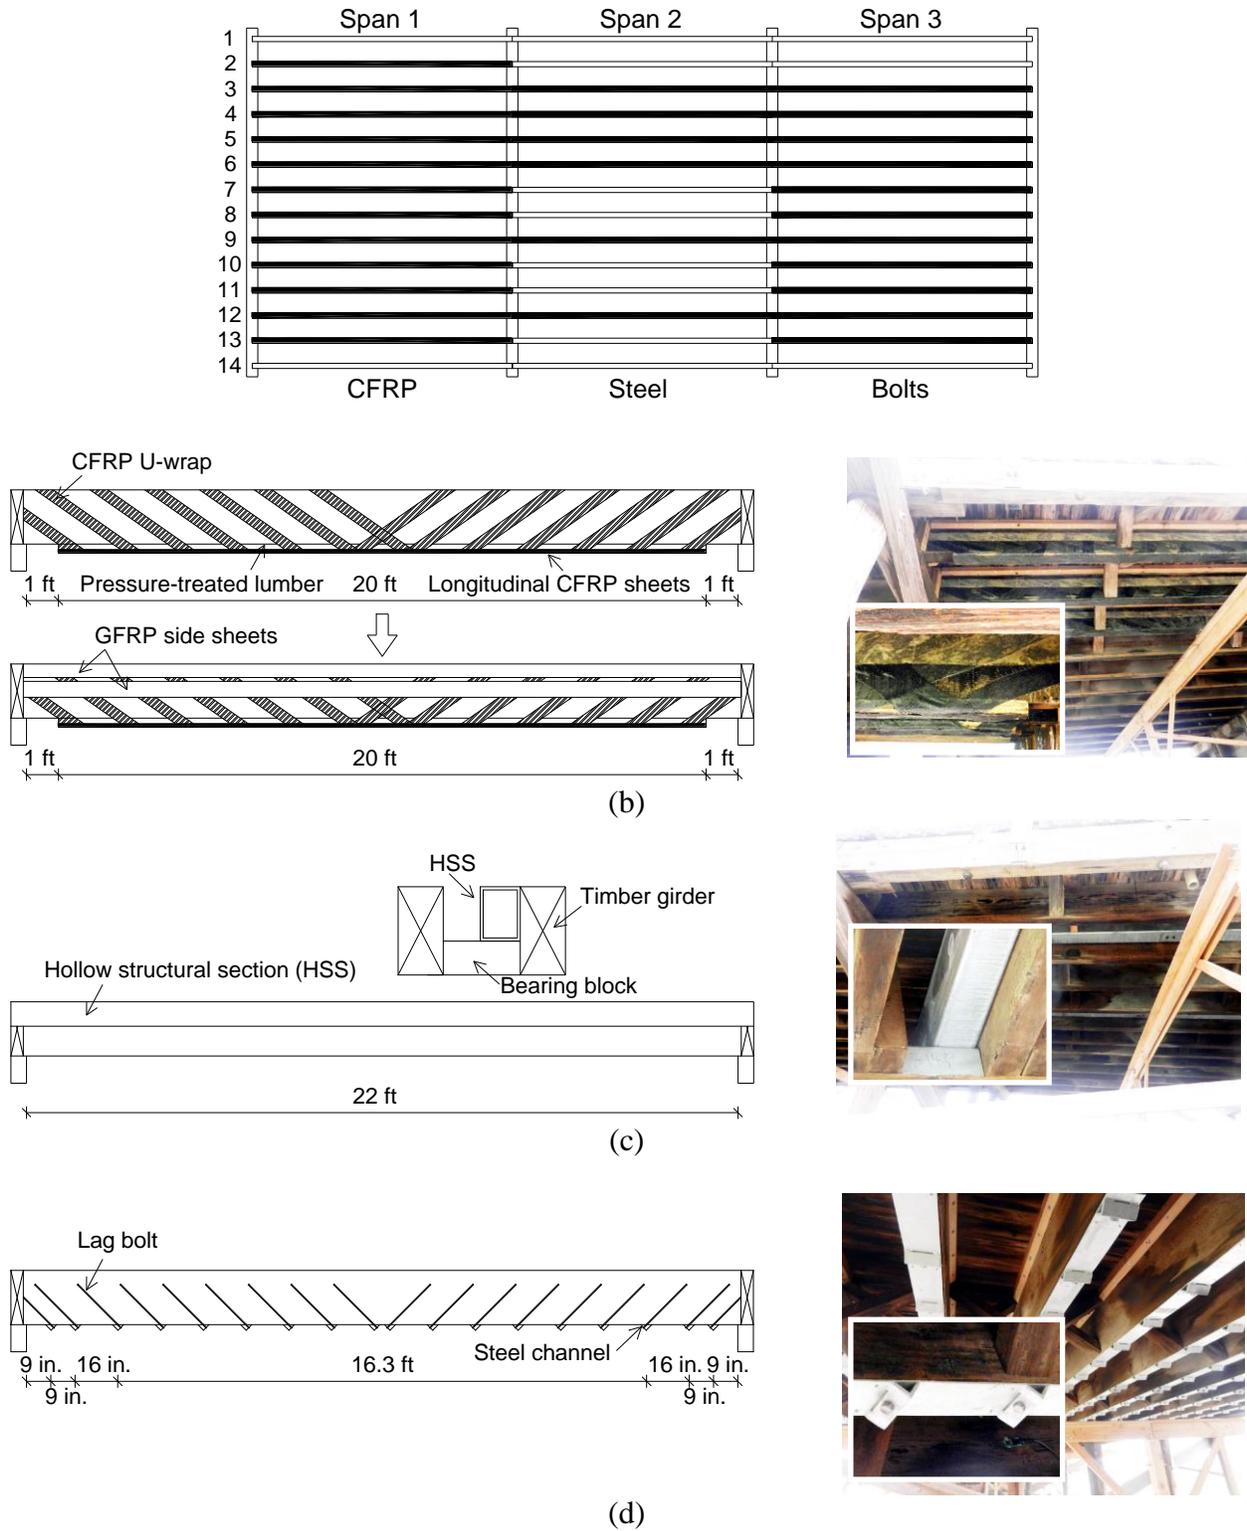
Fig. II.2. Strengthening methods: (a) plan view of girders (solid = retrofitted girder); (b) CFRP sheets; (c) HSS beams; (d) lag bolts

These retrofit strategies can be categorized into two groups: i) enhanced performance of the respective timber girders by raising their resistance (lag bolts and CFRP) and ii) reduced magnitudes of live load by sharing applied distress (HSS beams). The actual cost ratio of the CFRP, steel beam, and lag bolt methods was 1.32: 1.0: 0.72, respectively, including materials and labor.

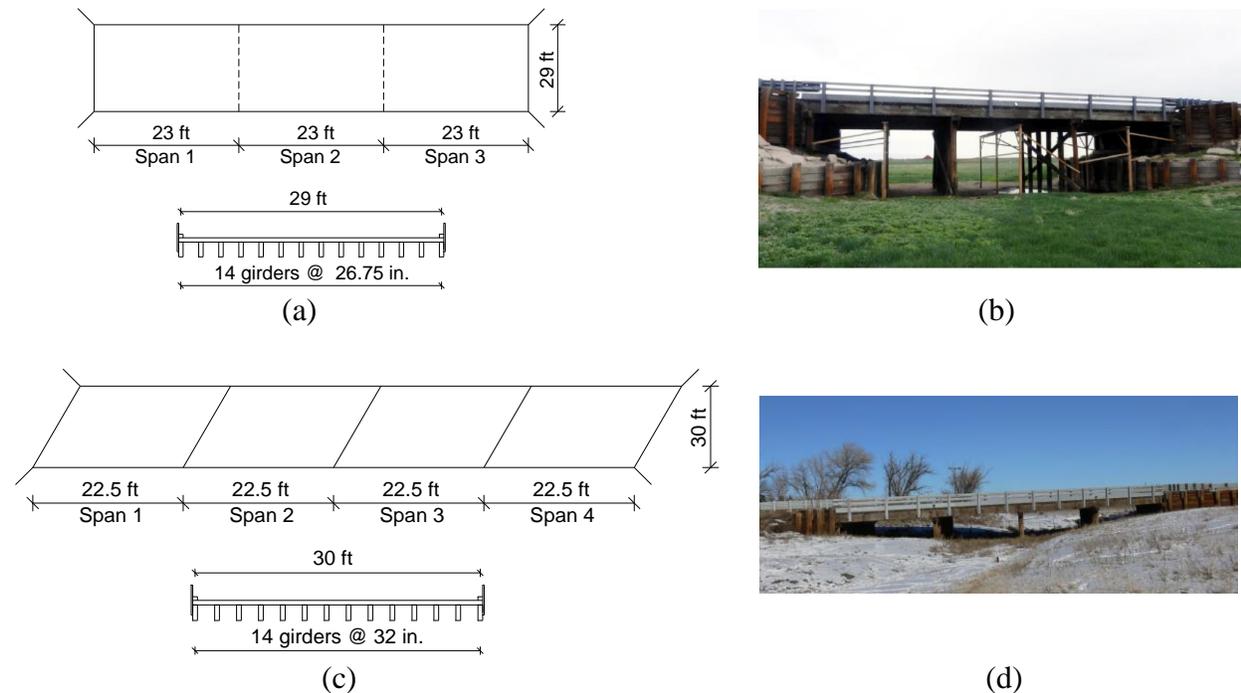
Transportation (CDOT) initiated repair projects to improve the performance of the superstructures.

Fig. III.1. Constructed timber bridges in Colorado, USA: (a) dimension of F-22-V; (b) site view of F-22-V; (c) dimension of H-20-T; (d) site view of H-20-T

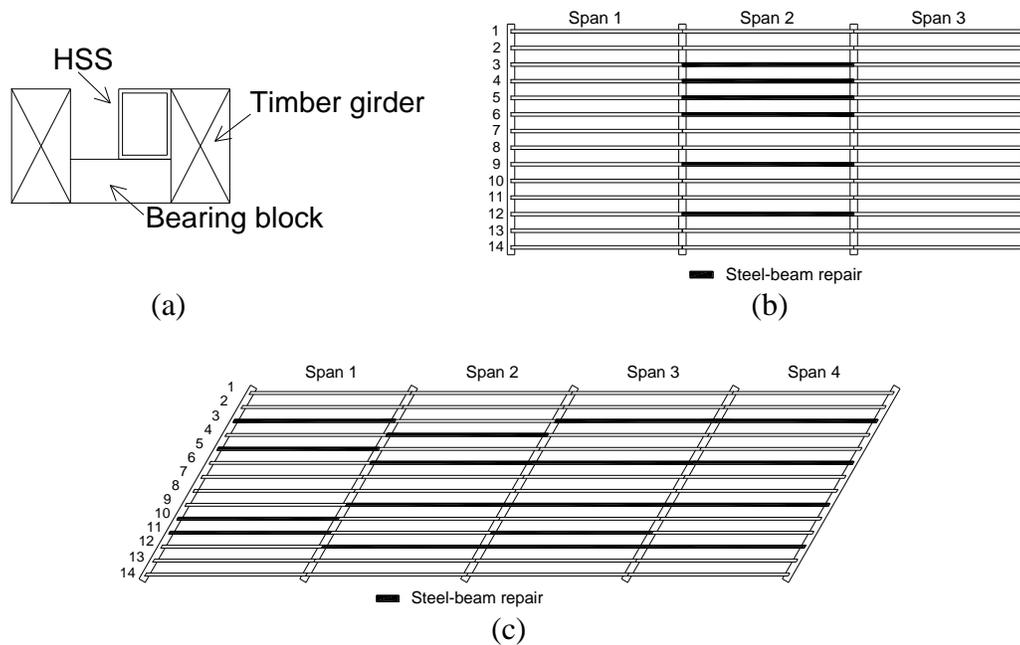
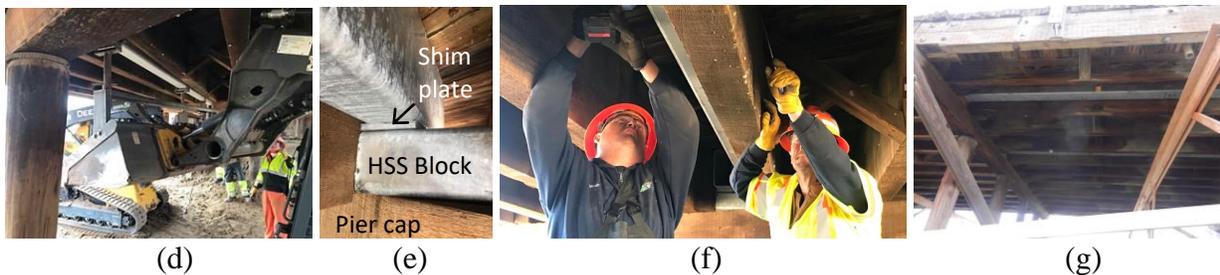
Fig. III.2. Repair with hollow structural sections (HSS): (a) schematic view; (b) HSS installation locations of F-22-V; (c) HSS installation locations of H-20-T; (d) lifting of HSS; (e) assembled HSS system; (f) drilling for connection; (g) completion
